## **APPENDIX F WATER RESOURCES**

**Waters of the US Determination Report**  
**State Road (SR) 49 at County Road (CR) 950 North (N)/Calumet Avenue (Ave)**  
**Porter County, Indiana**  
**Intersection Improvement Project**  
**Des. No. 2301097**

Prepared by: Christian Radcliff, SJCA Inc.  
[cradcliff@sjcainc.com](mailto:cradcliff@sjcainc.com), (317) 566-0629  
Report Completed on: January 2, 2026

**Date of Field Investigation:** October 1, 2025

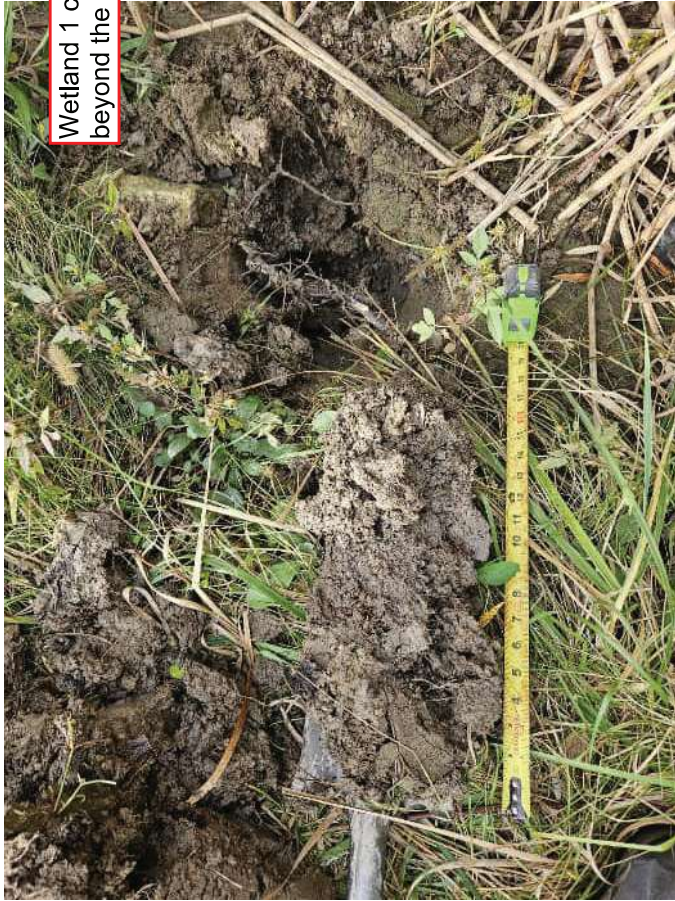
Photo 5. SP1 soil and pit (Wetland 1)

**Wetland 1** is an emergent wetland located south of CR 950 N/Calumet Ave and west of SR 49 within the roadside ditch. The Cowardin classification for this wetland is likely PEM5A (palustrine, emergent, *Phragmites australis*, temporarily flooded). The boundaries of the wetland were determined by the slopes of the ditch and subsequent shift in vegetative communities and soil conditions; however, Wetland 1 continues south beyond the investigated area limits within the slopes of the ditch. The presence or absence of hydric soils along the wetland boundaries were determined with the use of a soil probe. Confirmation of the presence of hydric soils was used in the areas with disturbed vegetation to determine where hydrophytic vegetation would likely be present in undisturbed conditions. Approximately 0.362 acre of Wetland 1 is within the investigated area. The vegetative community within Wetland 1 is largely dominated by narrow leaf cattail (*Typha*

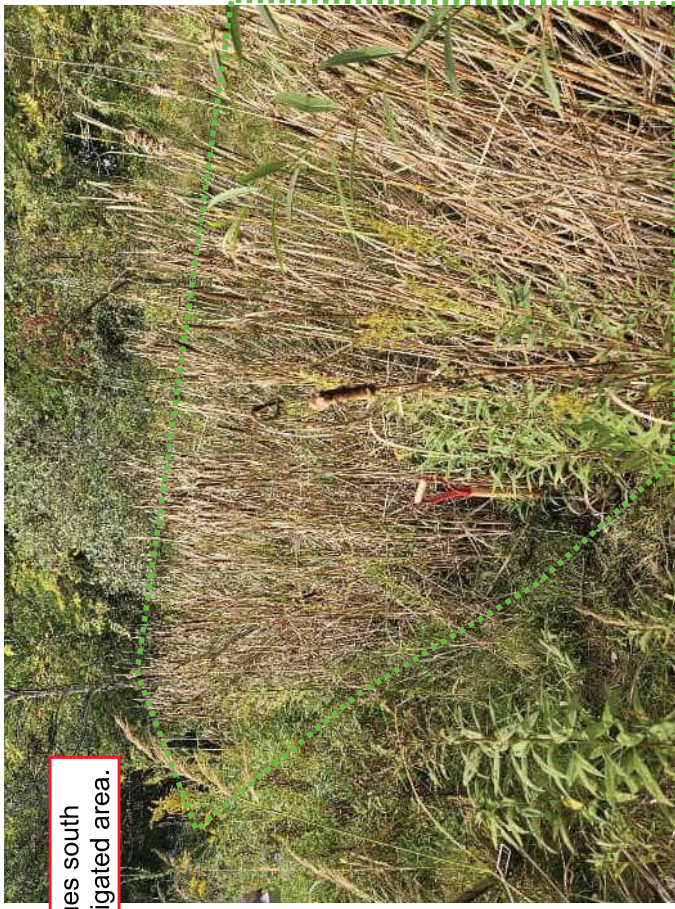
Wetland 1 continues south beyond the investigated area.

Photo 6. SP1 facing southwest within Wetland 1

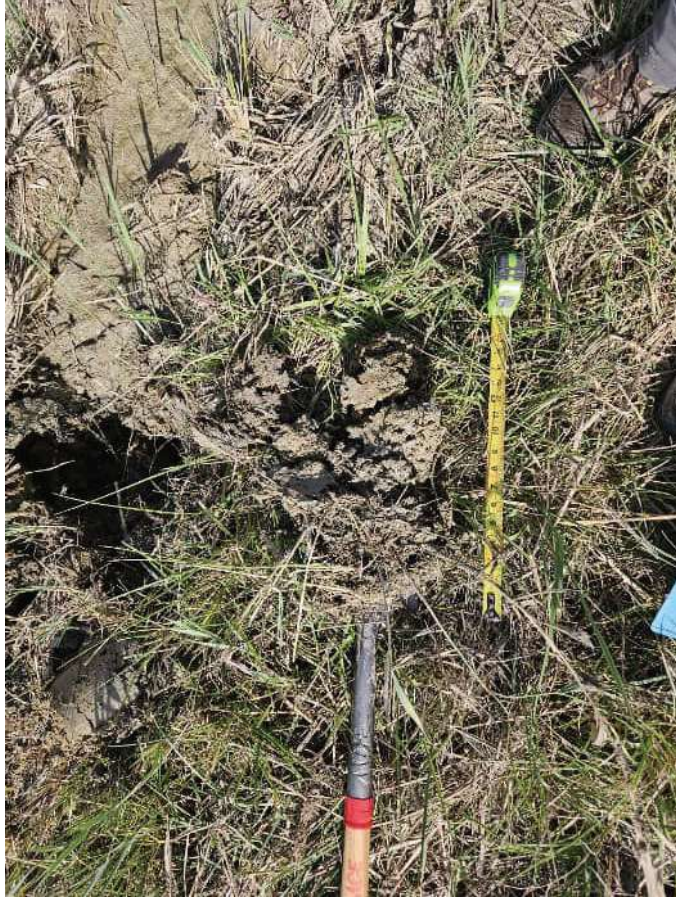
Photo 19. SP3 soil and pit (Wetland 2)

**Wetland 2** is an emergent wetland located in the median of SR 49 and south of CR 950 N/Calumet Ave within the median. The Cowardin classification for this wetland is likely PEM1A (palustrine, emergent, persistent, temporarily flooded). The boundaries of the wetland were determined by the slopes of the ditch and subsequent shift in vegetative communities and soil conditions. The presence or absence of hydric soils along the wetland boundaries were determined with the use of a soil probe. Wetland 2 is contained entirely within the investigated area. Approximately 0.024 acre of Wetland 2 is within the investigated area. The vegetative community within Wetland 2 is dominated by narrow leaf cattail (*Typha angustifolia*, OBL) and the invasive reed canary grass (*Phalaris arundinacea*, FACW). Wetland 2 is a poor-quality wetland due to its lack of habitat for aquatic flora and fauna, its low species diversity, and presence of invasive species communities. Wetland 2 provides poor hydrological function but helps convey drainage via culverts to Wetlands 1 and 3-5. There was no direct surface connection observed between Wetland 2 and a jurisdictional water resource. Therefore, Wetland 2 is likely an isolated wetland under the jurisdiction of IDEM. See photos 19 to 29 for images of Wetland 2, SP3, and SP4.

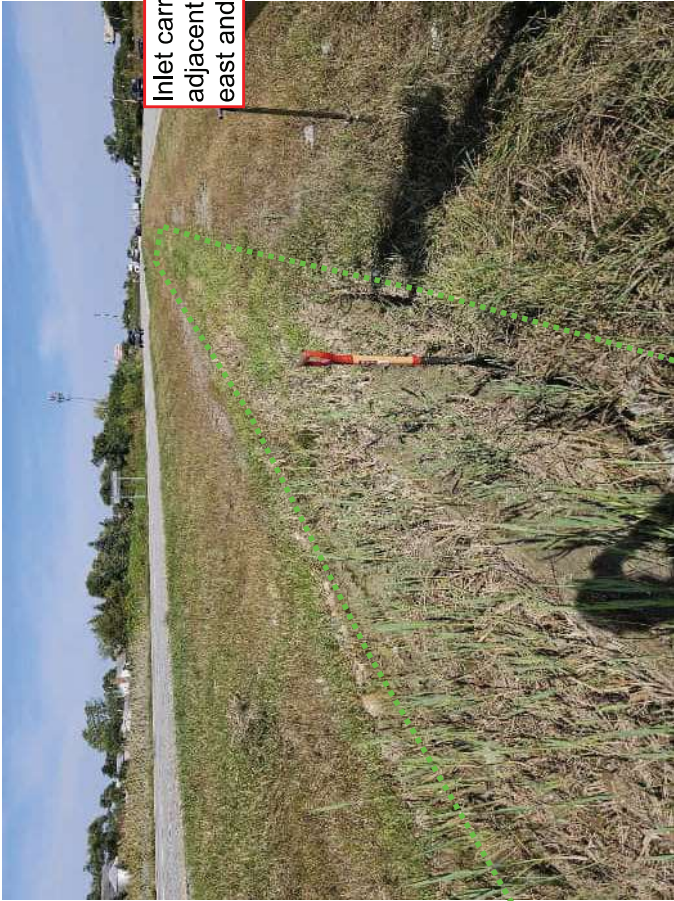
Inlet carries drainage to adjacent ditch wetlands east and west of SR 49

Photo 21. SP3 facing northwest in Wetland 2

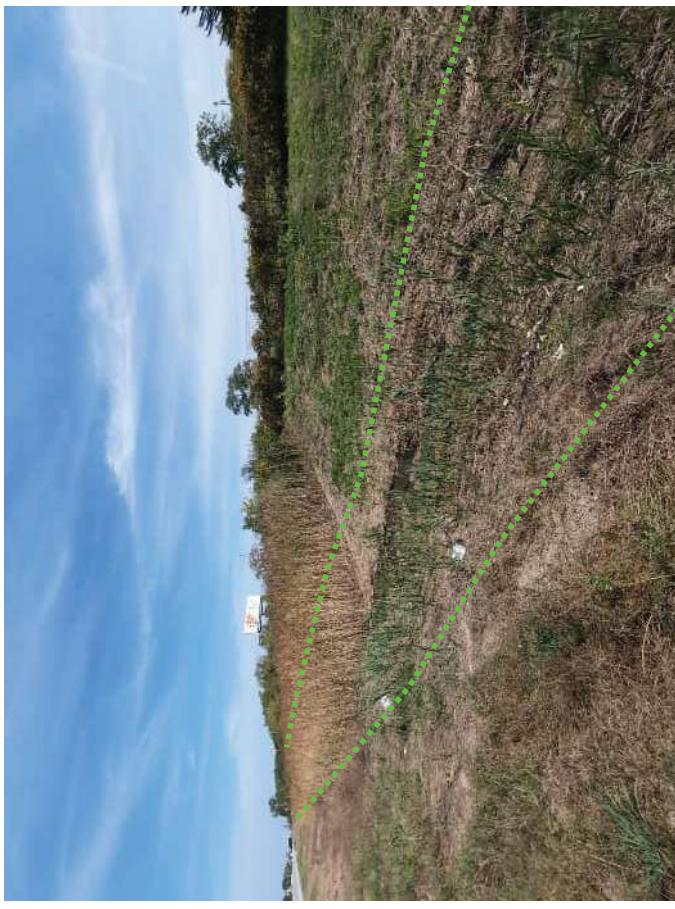
Photo 38. Shift in vegetative community within Wetland 3 facing northeast

**Wetland 3** is an emergent wetland located south of CR 950 N/Calumet Ave and east of SR 49 within the roadside ditch. The Cowardin classification for this wetland is likely PEM5A (palustrine, emergent, *Phragmites australis*, temporarily flooded). The boundaries of the wetland were determined by the slopes of the ditch and subsequent shift in vegetative communities and soil conditions; however, Wetland 3 continues south beyond the investigated area limits within the slopes of the roadside ditch. The presence or absence of hydric soils along the wetland boundaries were determined with the use of a soil probe. Approximately 0.318 acre of Wetland 3 is within the investigated area. The vegetative community within Wetland 3 is dominated by narrow leaf cattail (*Typha angustifolia*, OBL) and the invasive reed phragmites (*Phragmites australis*, FACW). Wetland 3 is a poor-quality wetland due to its lack of habitat for aquatic flora and fauna, its low species diversity, and presence of invasive species communities. Wetland 3 provides moderate hydrological function due to its connectivity via drainage culverts to Wetlands 1-2 and 4-5. There was no direct surface connection observed between Wetland 3 and a jurisdictional water resource, and it does not appear to have a direct surface connection to any jurisdictional resources beyond the investigated area limits. Therefore, Wetland 3 is likely an isolated wetland under the jurisdiction of IDEM. See photos 32 to 44 for images of Wetland 3, SP5, and SP6.

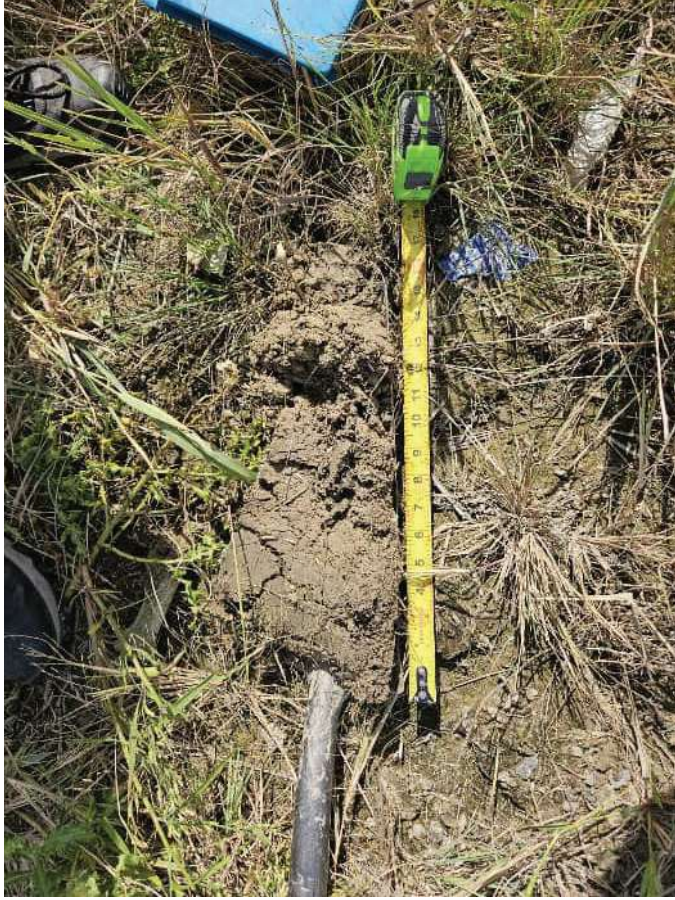
Photo 45. SP7 soil (Wetland 4)

**Wetland 4** is an emergent wetland located north of CR 950 N/Calumet Ave and east of SR 49 within the roadside ditch. The Cowardin classification for this wetland is likely PEM5A (palustrine, emergent, *Phragmites australis*, temporarily flooded). The boundaries of the wetland were determined by the slopes of the ditch and subsequent shift in vegetative communities and soil conditions. The presence or absence of hydric soils along the wetland boundaries were determined with the use of a soil probe. Wetland 4 is contained entirely within the investigated area. Approximately 0.052 acre of Wetland 4 is within the investigated area. The vegetative community within Wetland 4 is dominated by the invasive reed phragmites (*Phragmites australis*, FACW) and non-native foxtail barley (*Hordeum jubatum*, FAC). Wetland 4 is a poor-quality wetland due to its lack of habitat for aquatic flora and fauna, its low species diversity, and presence of invasive species communities. Wetland 4 provides poor hydrological function due to its connectivity via drainage culverts to Wetlands 1-3 and 5. There was no direct surface connection observed between Wetland 4 and any jurisdictional water resource, and it does not appear to have a direct surface connection to any jurisdictional resources. Therefore, Wetland 4 is likely an isolated wetland under the jurisdiction of IDEM. See photos 45 to 54 for images of Wetland 4, SP7, and SP8.

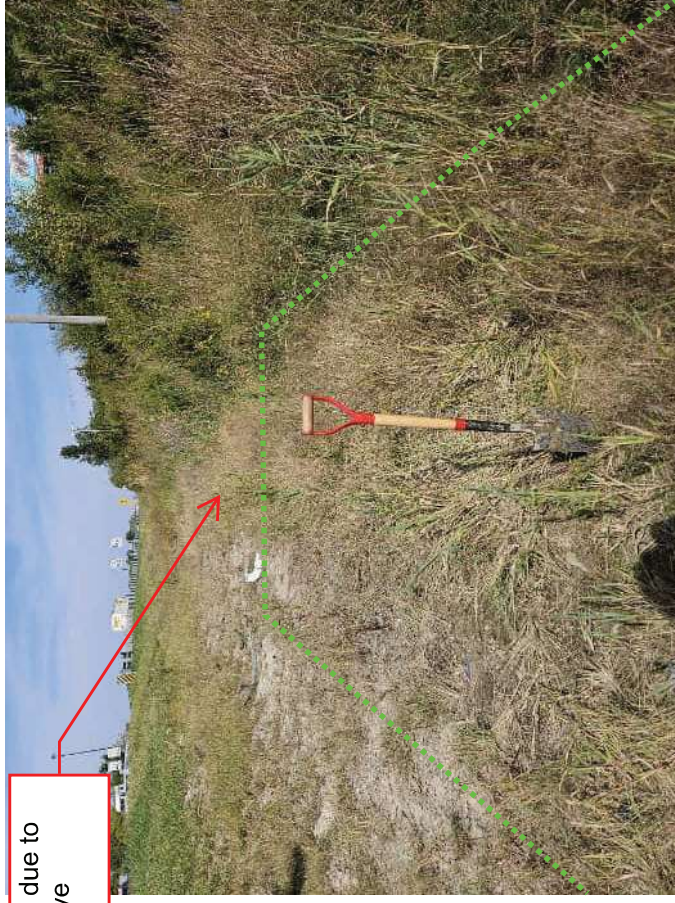
Photo 48. SP7 facing north within Wetland 4

Wetland 4 ends due to  
shift in vegetative  
community

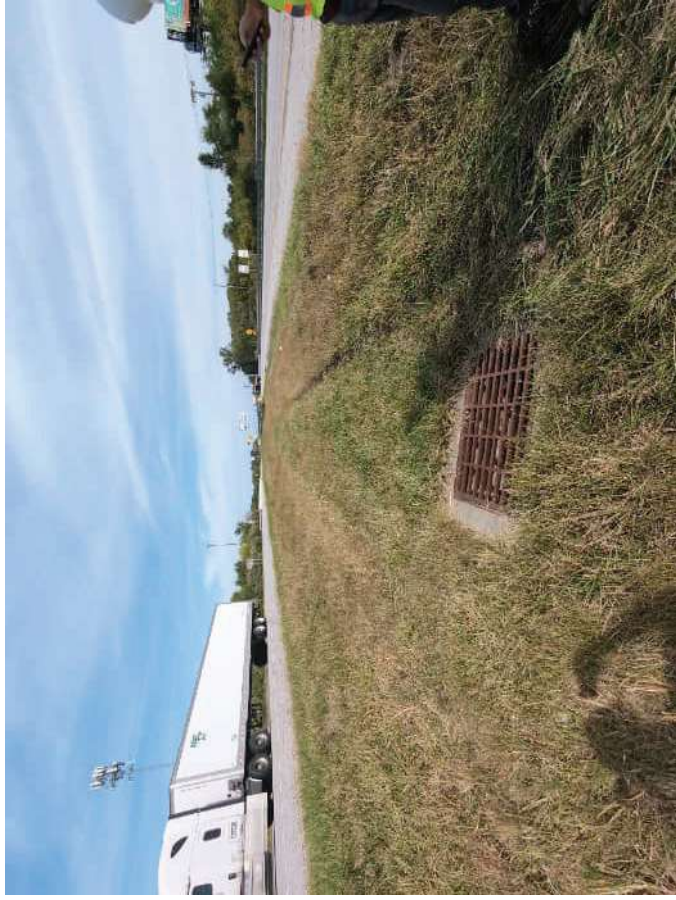
Photo 55. South side of median north of intersection facing north towards drainage inlet

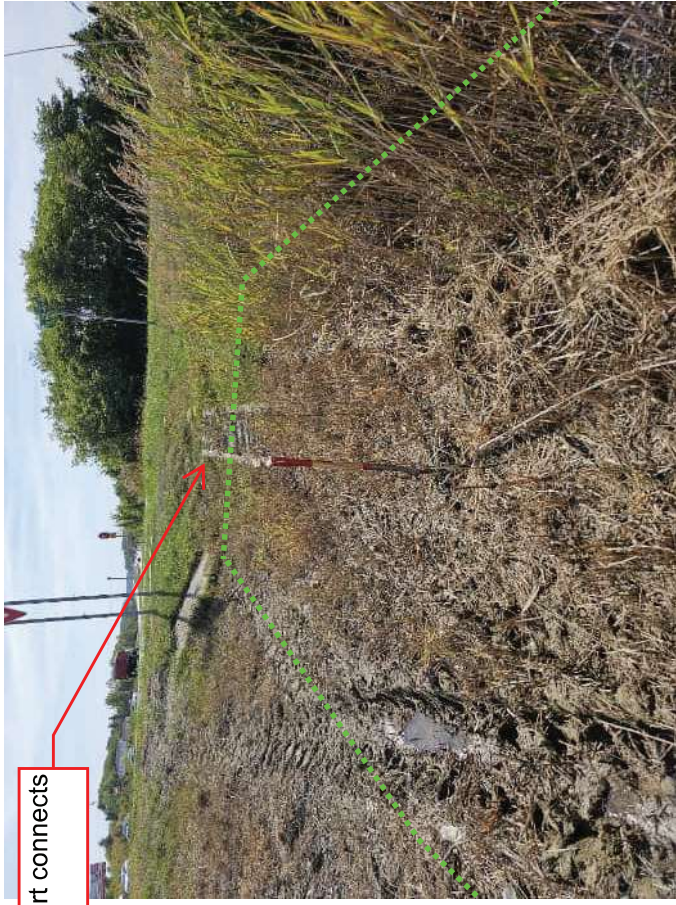
Photo 62. SP9 facing south within Wetland 5 towards drainage culvert

**Wetland 5** is an emergent wetland located north of CR 950 N/Calumet Ave and west of SR 49 within the roadside ditch. The Cowardin classification for this wetland is likely PEM5A (palustrine, emergent, *Phragmites australis*, temporarily flooded). The boundaries of the wetland were determined by the slopes of the ditch and subsequent shift in vegetative communities and soil conditions. The presence or absence of hydric soils along the wetland boundaries were determined with the use of a soil probe. Confirmation of the presence of hydric soils was used in the areas with disturbed vegetation to determine where hydrophytic vegetation would likely be present in undisturbed conditions. Approximately 0.028 acre of Wetland 5 is within the investigated area. The vegetative community within Wetland 5 is dominated by the invasive reed phragmites (*Phragmites australis*, FACW). Wetland 5 is a poor-quality wetland due to its lack of habitat for aquatic flora and fauna, its low species diversity, and presence of invasive species communities. Wetland 5 provides poor hydrological function due to its connectivity via drainage culverts to Wetlands 1-4. There was no direct surface connection observed between Wetland 5 and a jurisdictional water resource. Therefore, Wetland 5 is likely an isolated wetland under the jurisdiction of IDEM. See photos 58 to 70 for images of Wetland 5, SP9, and SP 10.

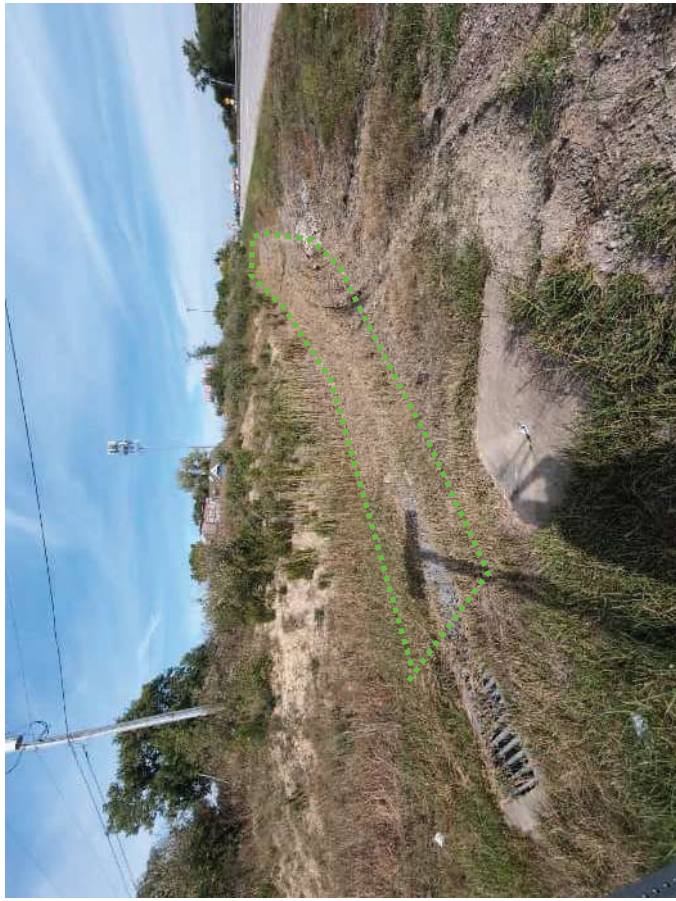
Photo 63. South end of Wetland 5 facing north with drainage culvert shown
