FHWA-Indiana Environmental Document
CATEGORICAL EXCLUSION / ENVIRONMENTAL ASSESSMENT FORM
GENERAL PROJECT INFORMATION

State Route (SR) 16, Jasper County

Des. No. 2300980

Small Structure Project, SR 16 over Spurgeon Ditch, 8.80 miles west of US 421. The project extends 111 feet west and 252 feet east of the structure center.

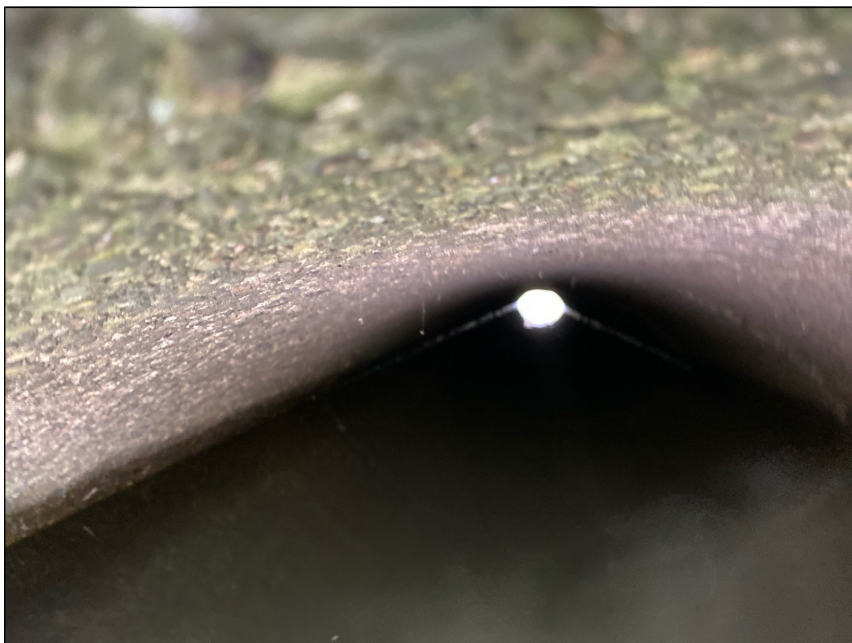
PHOTO #: Channel looking south

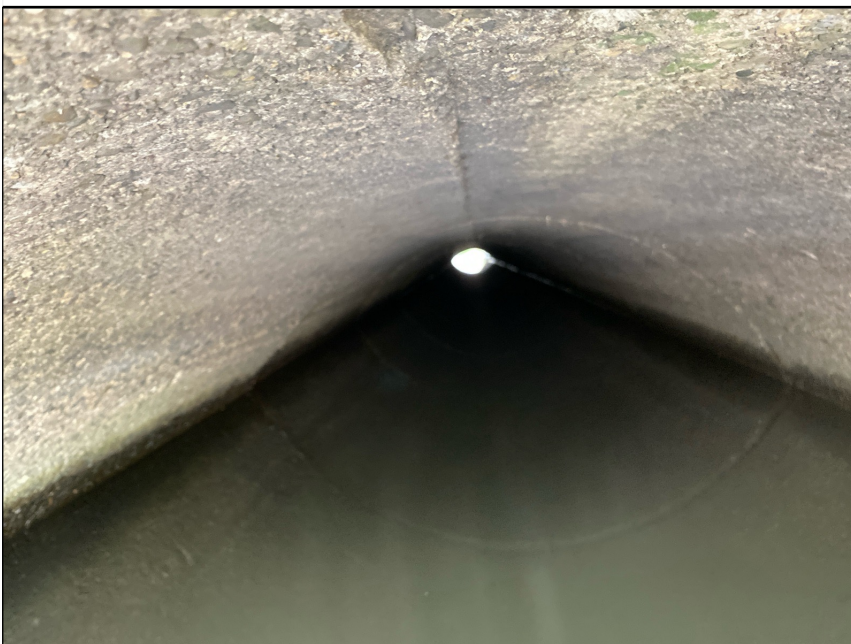
PHOTO #: Channel looking north
