# Appendix F

## **Waters of the U.S. Determination**

SR 26 in Tippecanoe County, Indiana  
Small Structure Project, 4.98 Miles West of US 52/231  
Designation Number: 1900333  
Asset Name: CV 026-079-28.10

September 19, 2022

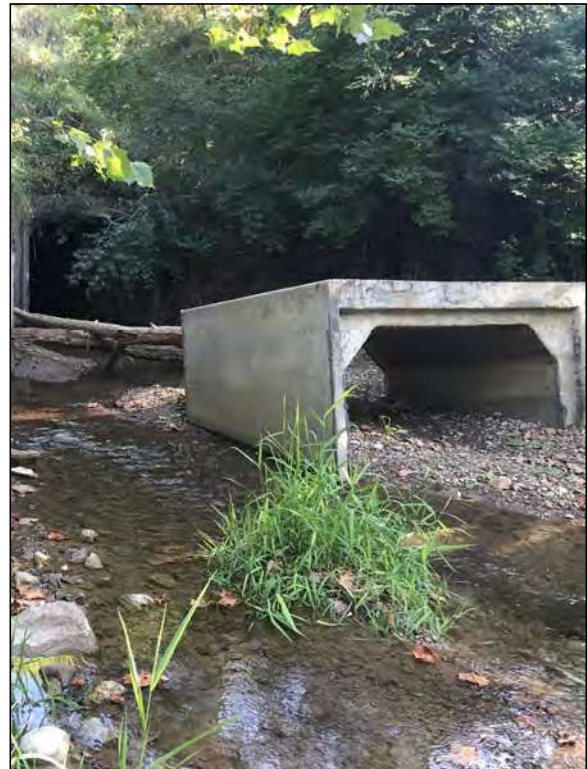
**Picture 2— Goose Creek upstream and detached project culvert CV 026-079-28.10 piece; north view; 1 SEP 2021.**

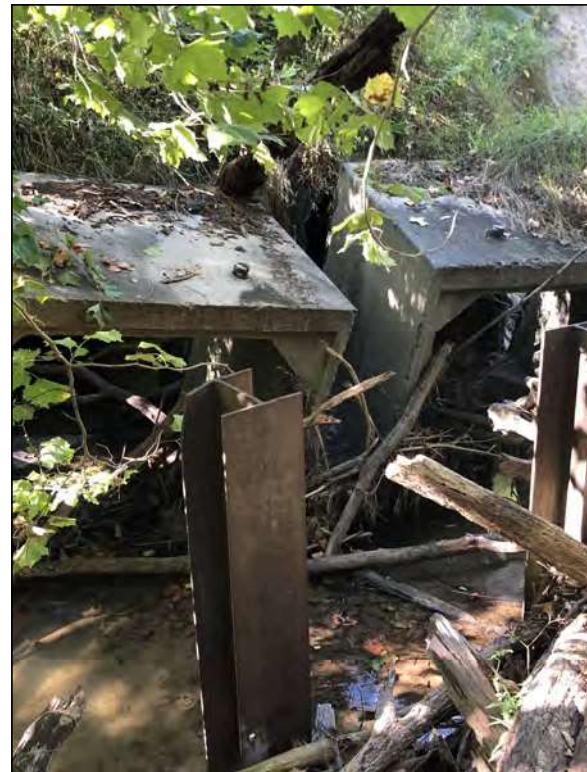
**Picture 12—Goose Creek structure CV 026-079-28.10 inlet; southwest view; 1 SEP 2021. Note that culvert end pieces have detached.**

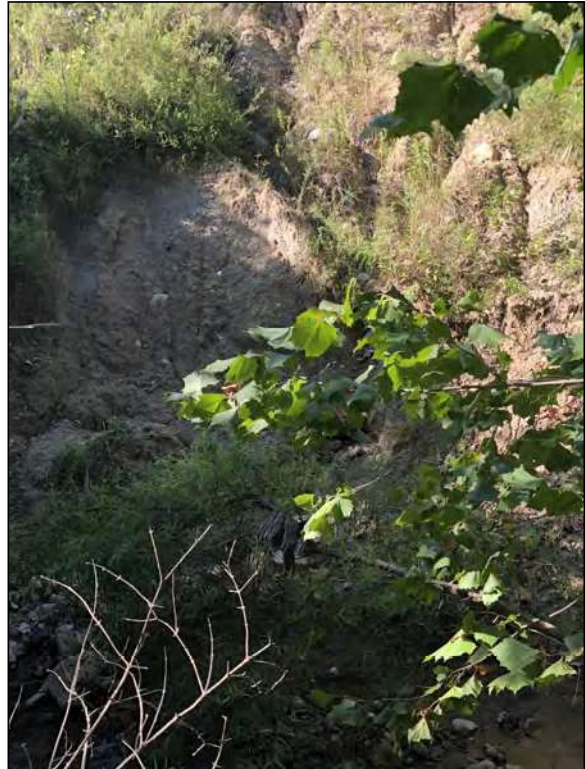
**Picture 50—Eroded area west of the Goose Creek structure CV 026-079-28.10 inlet. Erosion is extensive upslope to SR 26; southwest view; 1 SEP 2021.**

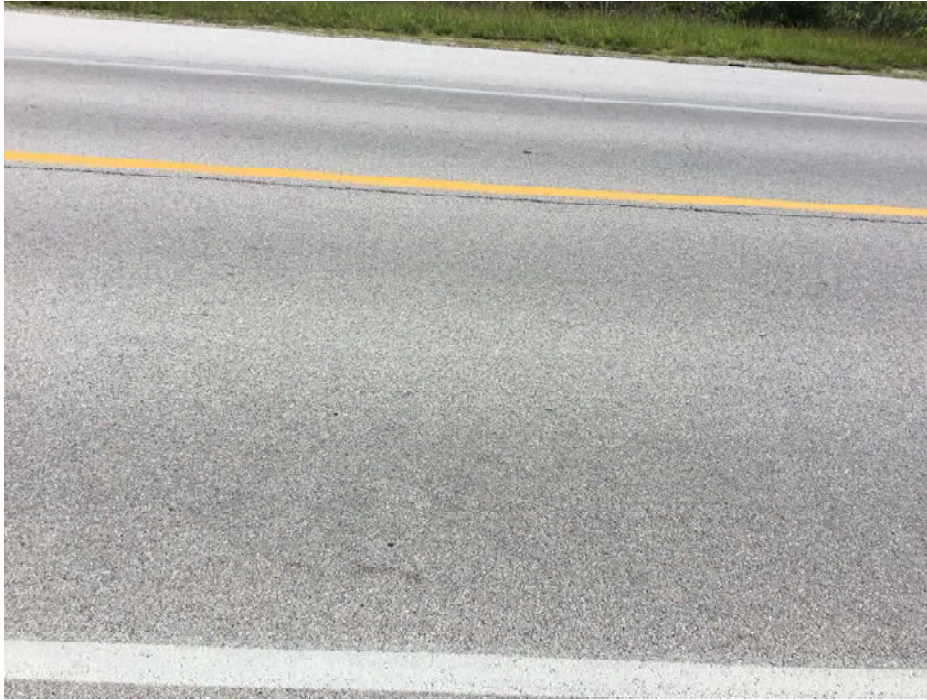
PHOTO 3 Condition  
Description Pavement condition above culvert

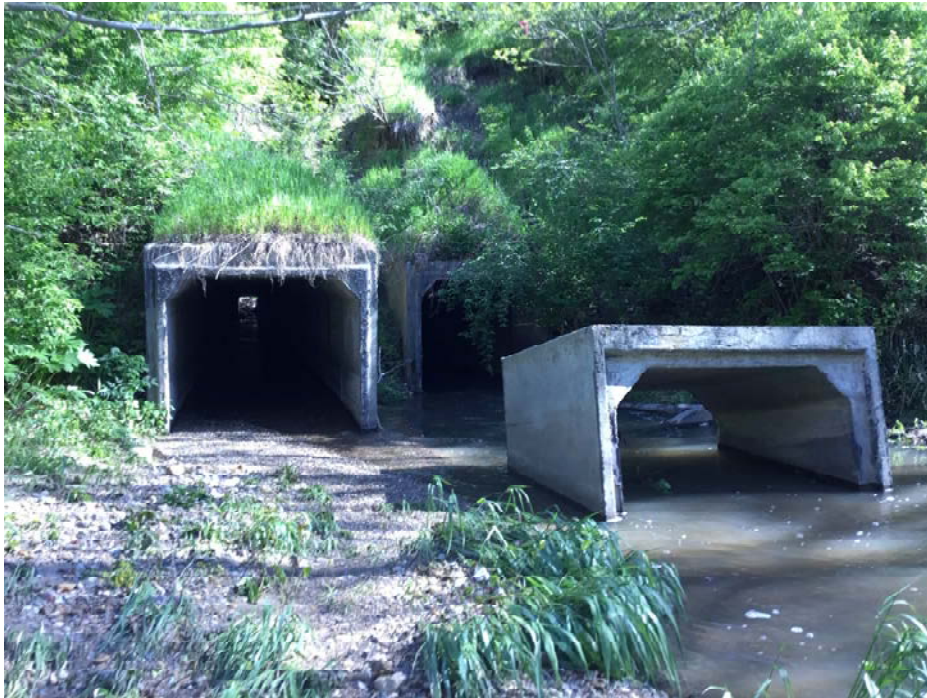
PHOTO 4 Elevation, Condition  
Description Profile looking North

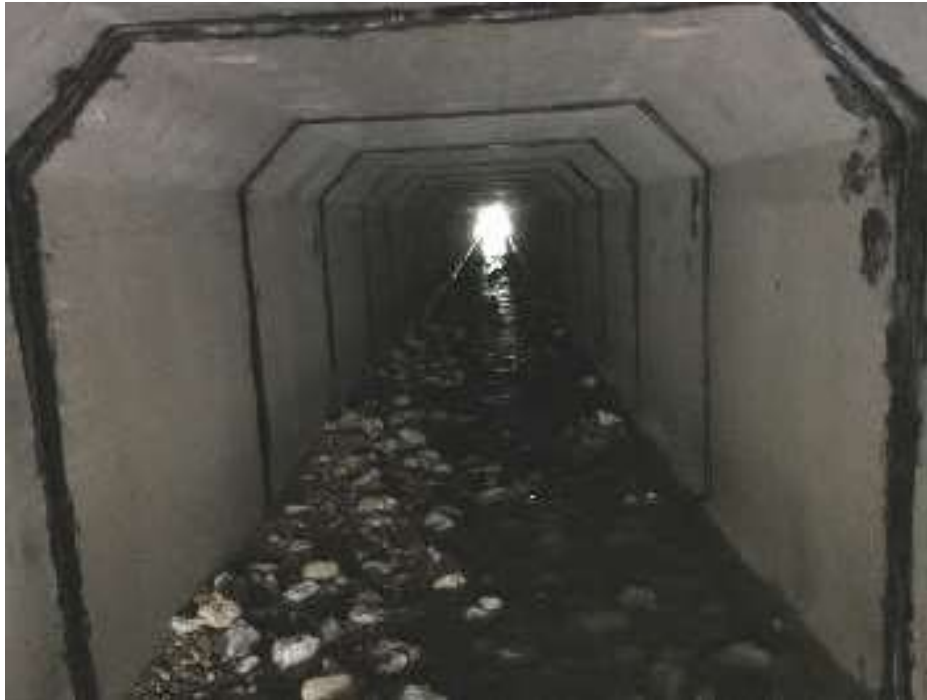
PHOTO 5

Description Looking South through West box

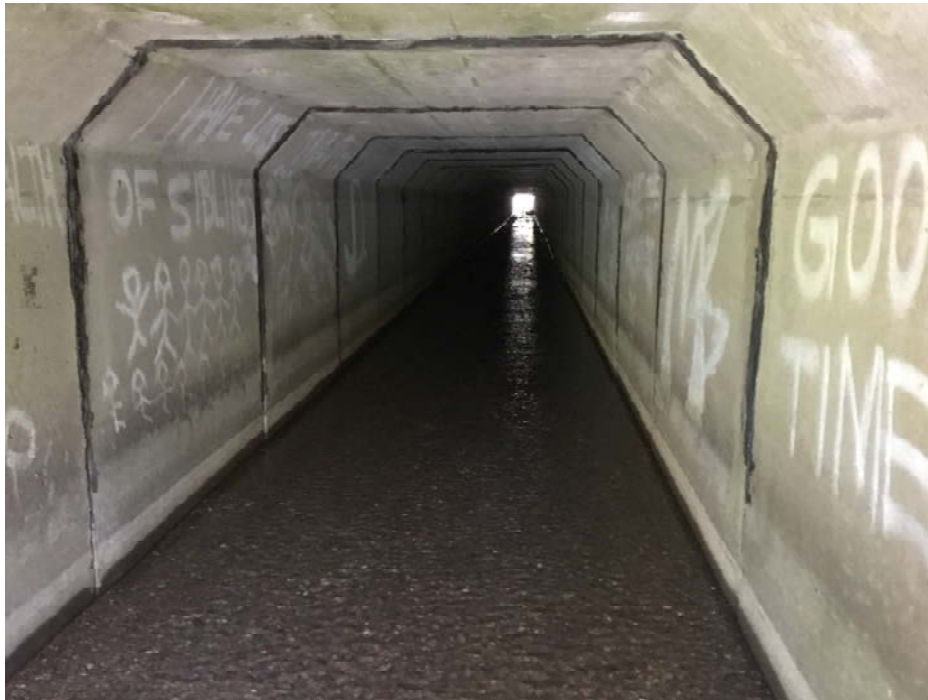
PHOTO 7

Description Looking North through West box

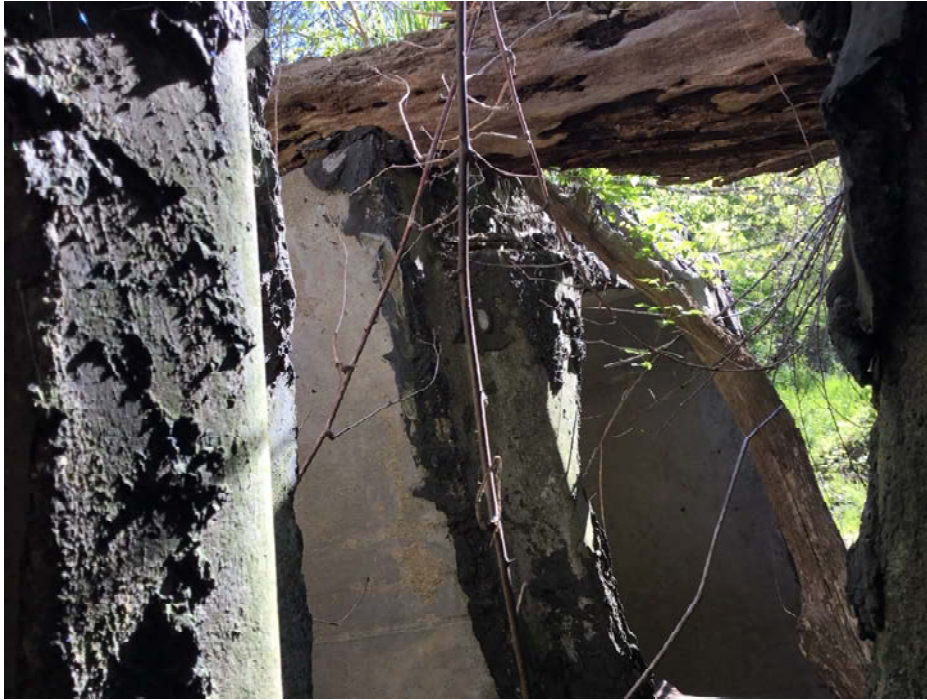
PHOTO 9

(62) Culvert Rating Comments: *North end of both boxes have the last segment disconnected. The south end of east box has the last 2 segments disconnected. All other joints are in good condition and box sections have good alignment. If erosion continues/goes unfixed more sections of the boxes could become disconnected. No obvious changes since last inspection.*

Description North segment from East box is off

Reported By: Dan Bewley  
Phone: 765-362-0820  
Email Address: dbewley@indot.in.gov  
Recommendation: Determine if erosion needs to be repaired or if can wait for bridge replacement (7/12/2023).

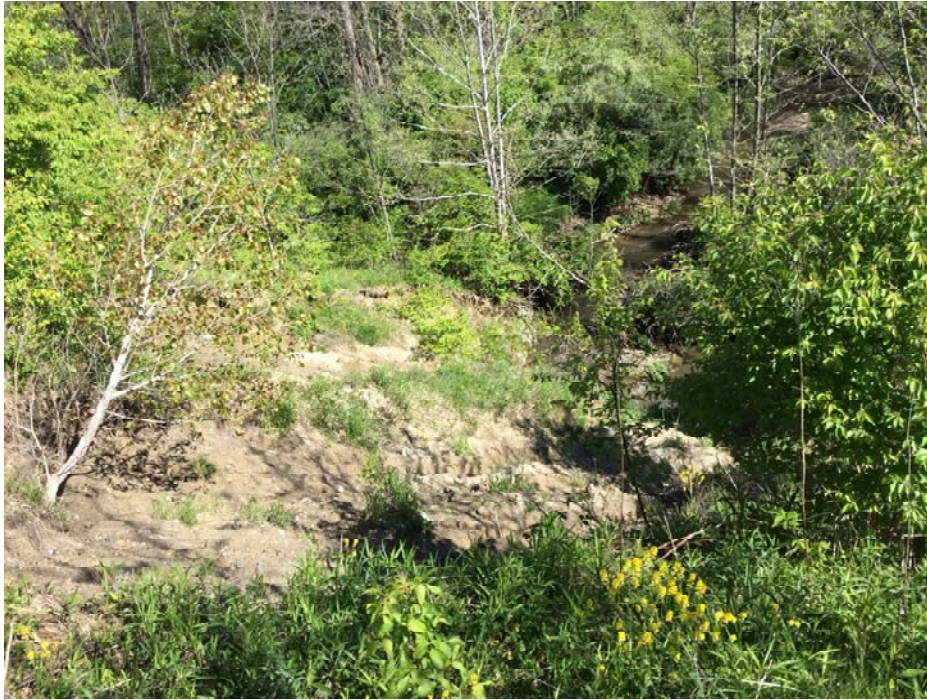
PHOTO 11 Condition

Description Erosion on North side of road. Showing erosion above the boxes

Date Reported: 05/13/2021 CV 026-079-28.10  
Priority: Yellow 93000628  
Work Code: Erosion Control/Riprap  
Deficiency Description: Both hill sides are "Sluffing" Large eroded areas are causing the ends of the segmental boxes to fall off.  
2nd letter for same concern. 1st one written 5/15/2020

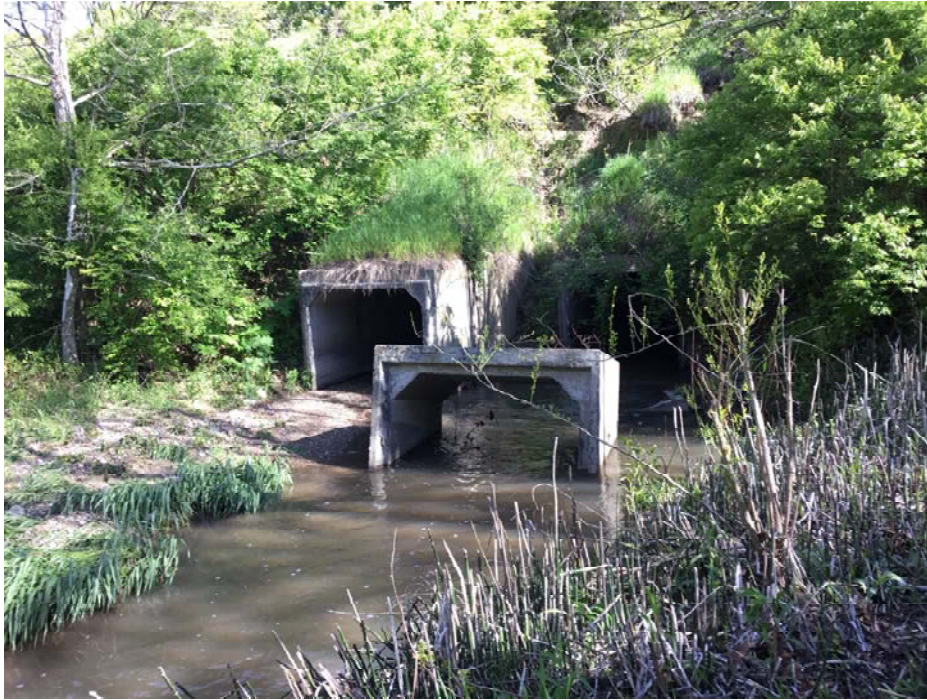
PHOTO 13 Condition  
Description Down stream alignment looking North or up stream

Date Reported: 05/13/2021  
Priority: Yellow  
Work Code: Channel Debris  
Removal  
Deficiency Description: 2nd letter, 1st one written 5/15/2020

Reported By: Dan Bewley  
Phone: 765-376-0820  
Email Address: dbewley@indot.in.gov  
Recommendation: Log jam behind the steel piling on North side of road, needs to be removed.
