FHWA-Indiana Environmental Document

CATEGORICAL EXCLUSION / ENVIRONMENTAL ASSESSMENT FORM

Road No./County:	Wells County, State Route (SR) 3
Designation Number(s):	1800051
Project Description/Termini:	This project is a bridge replacement with a 90 feet long single span prestressed concrete girder bridge on SR 3, 2.46 miles north of SR 18. The logical termini of the project extend to the limits of the full depth pavement replacement at either side of the existing bridge.

Des. No. 1800051

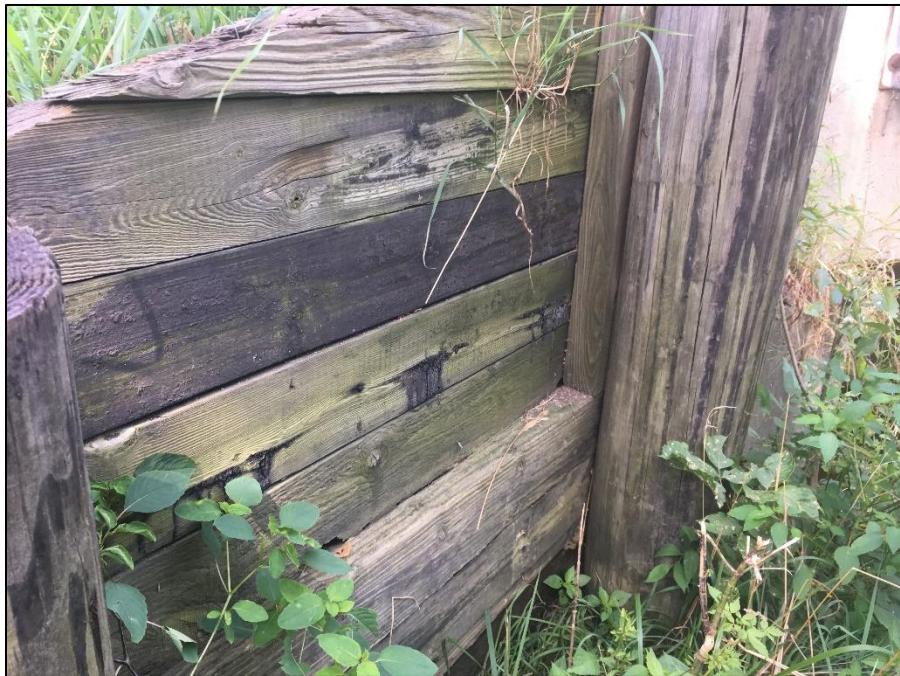
Figure 3: Timber wingwall

Existing Conditions: The bridge is 37 feet wide by 62 feet span single span pre-stressed concrete box bridge with wooden wingwalls. Structural deficiencies include heavy cracking, spalling, and efflorescence. Prairie Creek flows southwest to northwest through the bridge. The bridge is in a forested area with adjacent agricultural property. Photographs of the bridge are in Appendix B-15 to B-17. The existing typical section for SR 3 at this location is comprised of two 11 feet wide travel lanes, one in each direction, with a 6.5 feet wide paved shoulder. Approximately 125 feet from the structure, the paved shoulder tapers to 1 foot wide. The functional class of SR 3 is a Rural Collector.

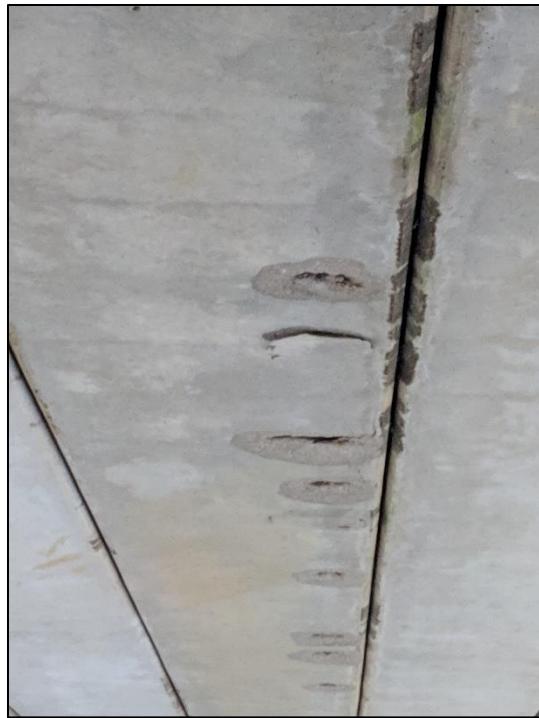
Figure 5: Prestressed box beam spalling and moisture between girders

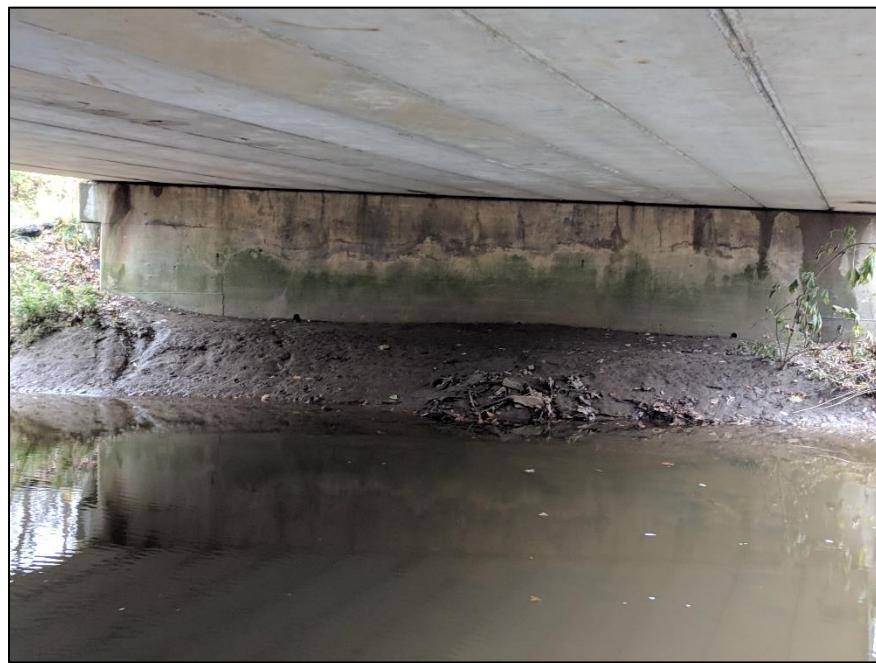
Figure 6: Looking at south abutment.

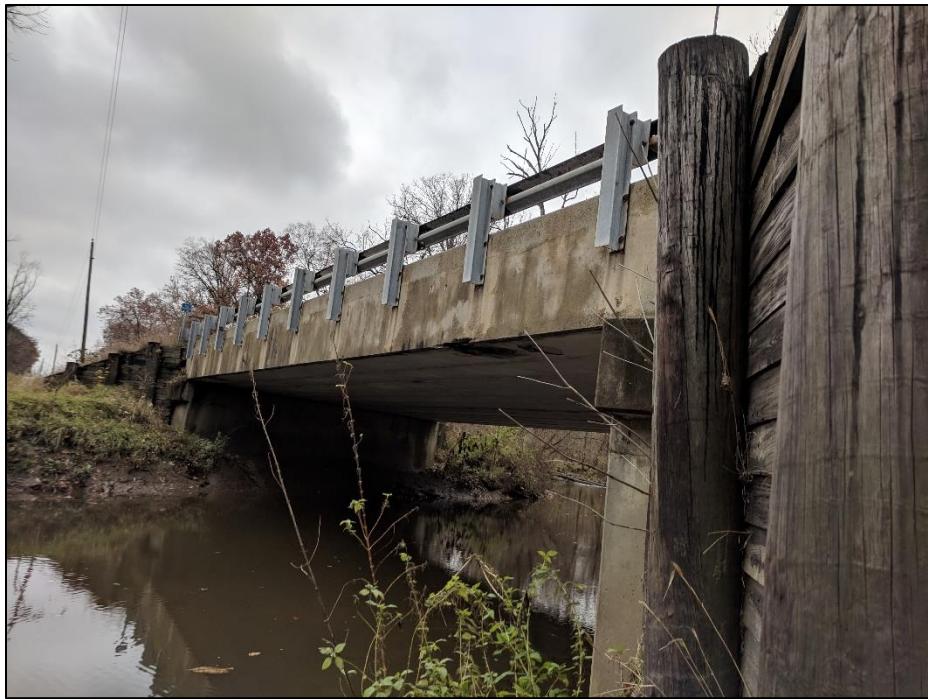
Figure 9: East side of bridge, looking at east coping line.

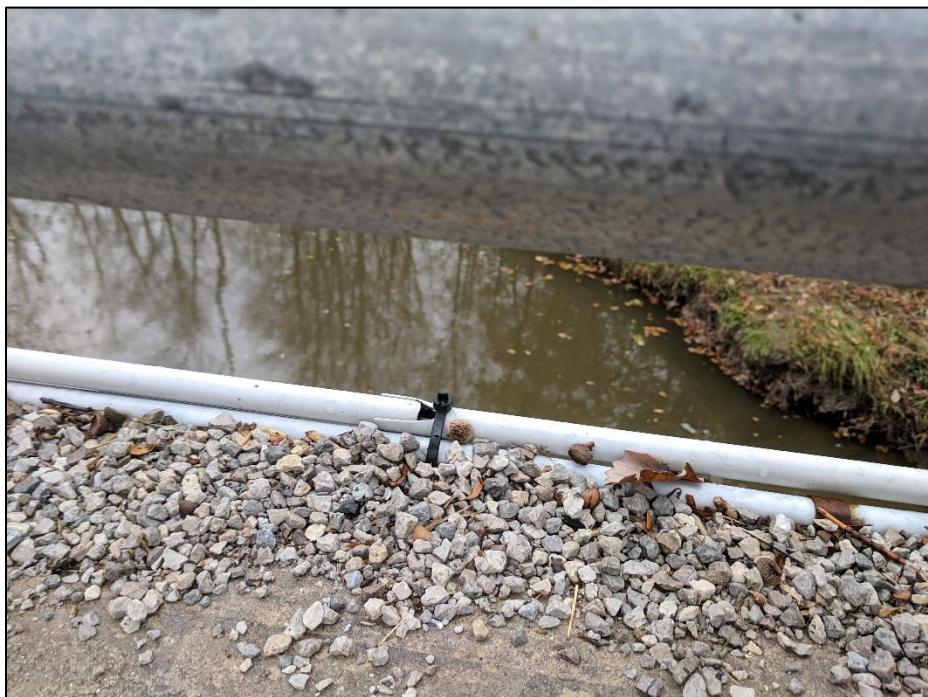
Figure 10: Utility attached to structure

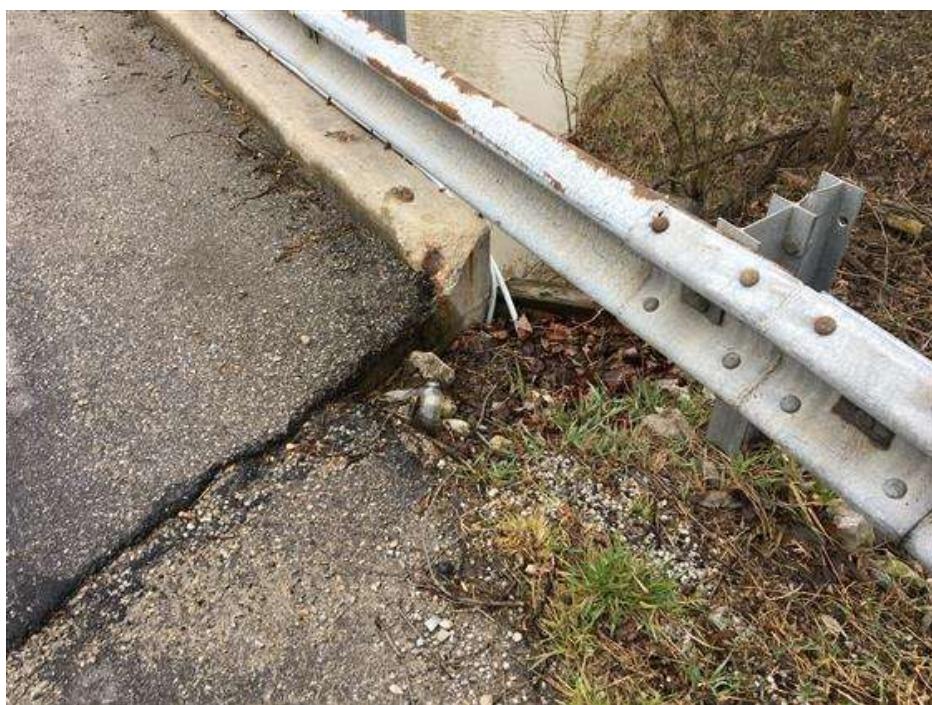
PHOTO 6

Description Erosion at NW Corner

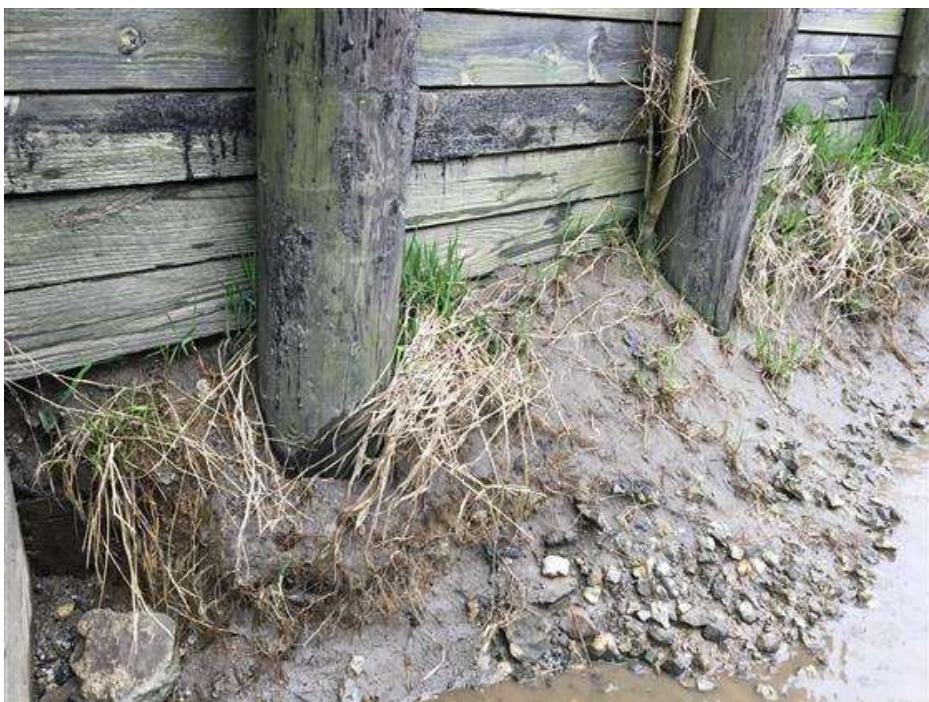
PHOTO 11

Description NE Wing (erosion at base)

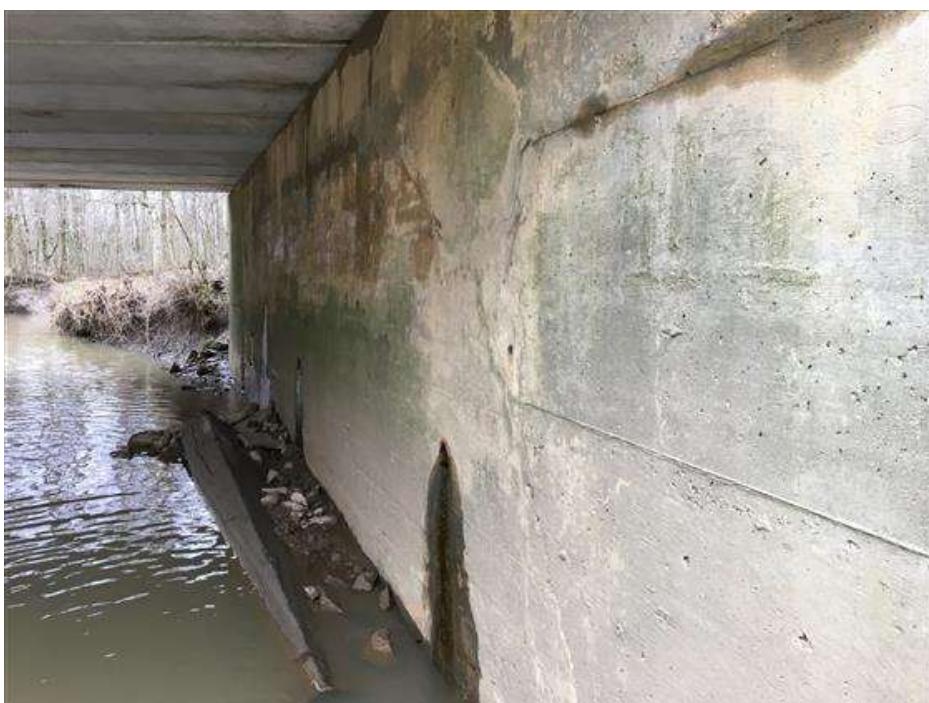
PHOTO 12

Description North Abutment (close-up)

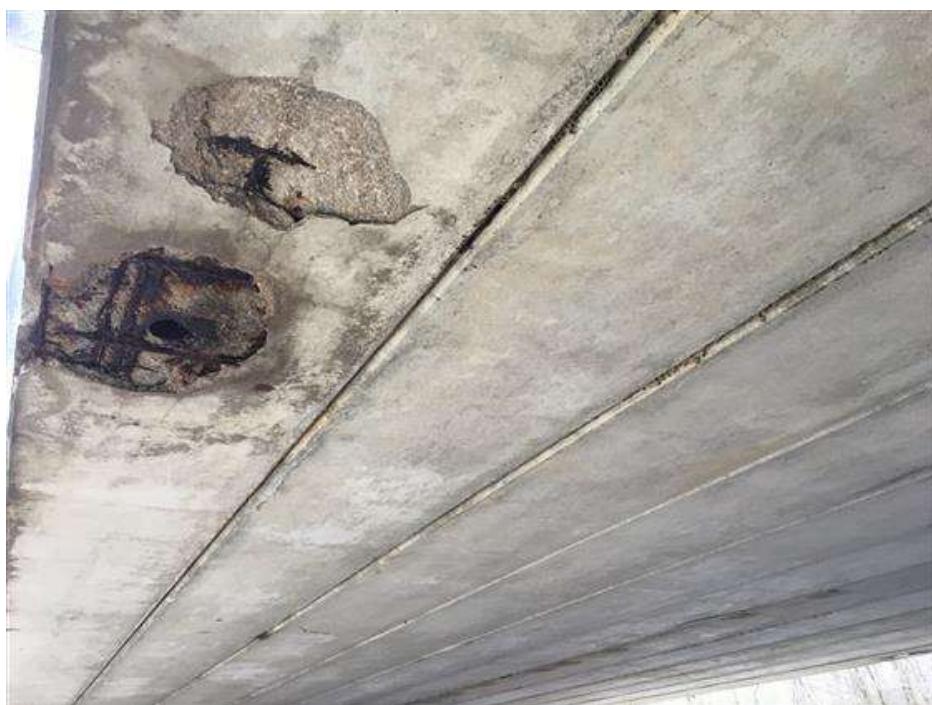
PHOTO 14

Description Box Beam 12 (deterioration around NE drain)

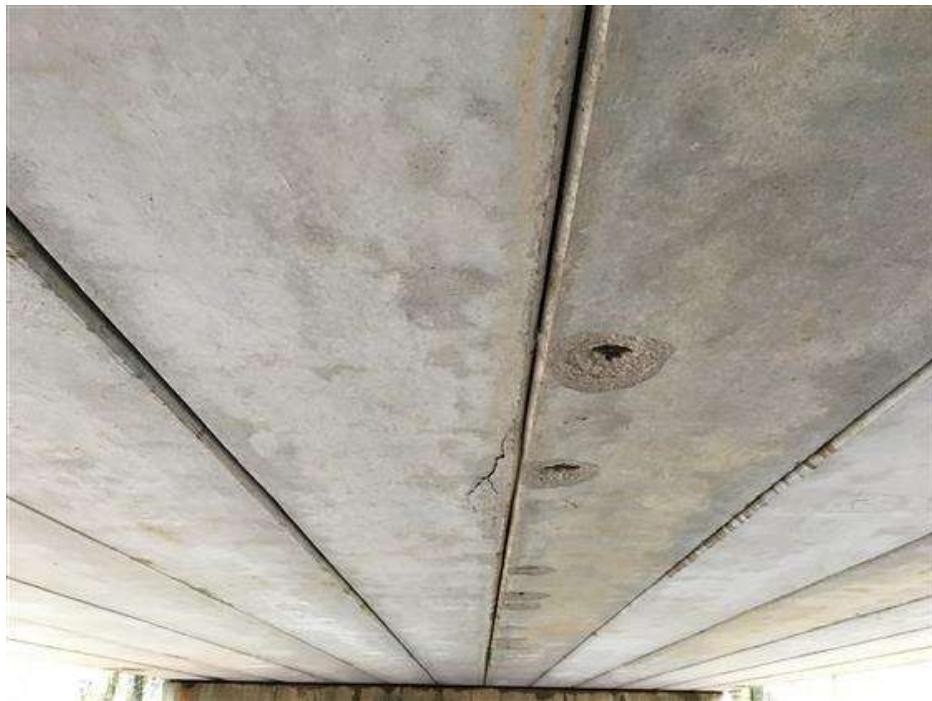
PHOTO 15

Description Box Beams 7 & 6 (looking south)

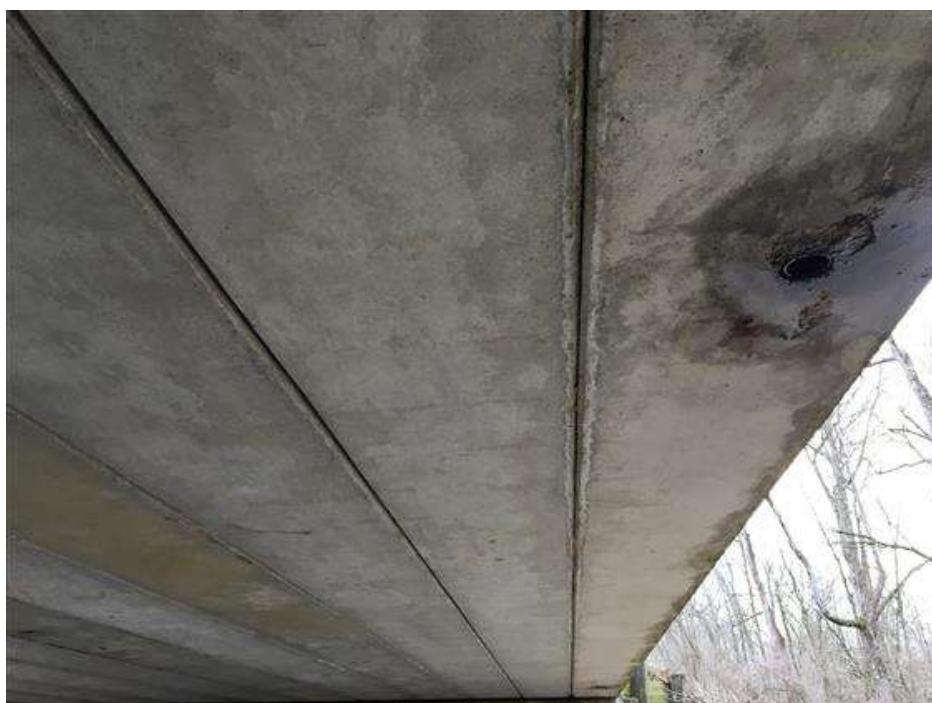
PHOTO 16

Description Box Beam 1 (looking south)

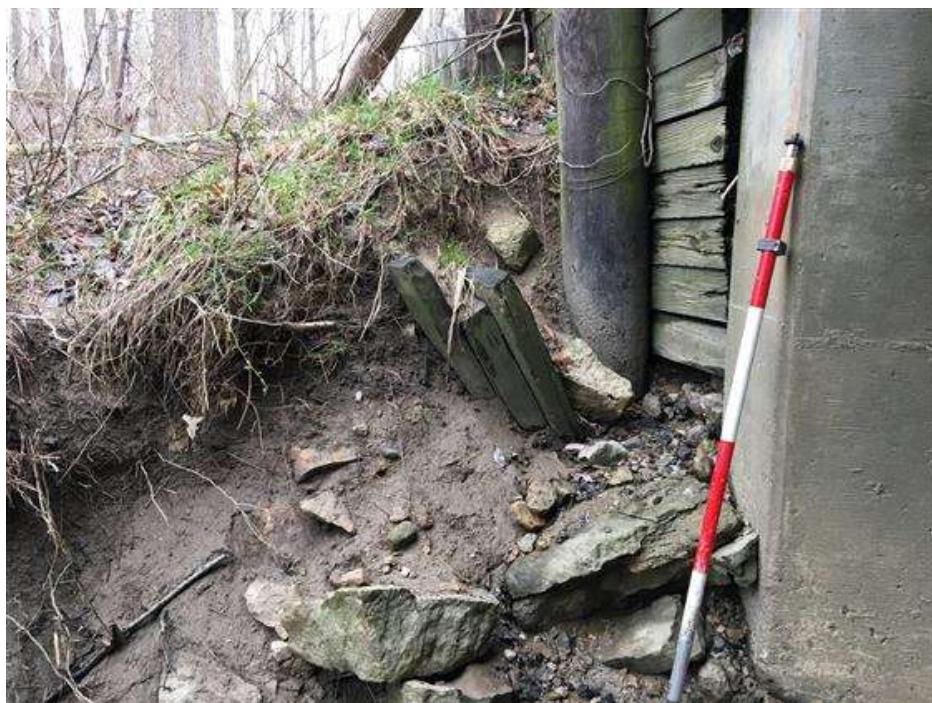
PHOTO 18

Description NW Wing (erosion at base)

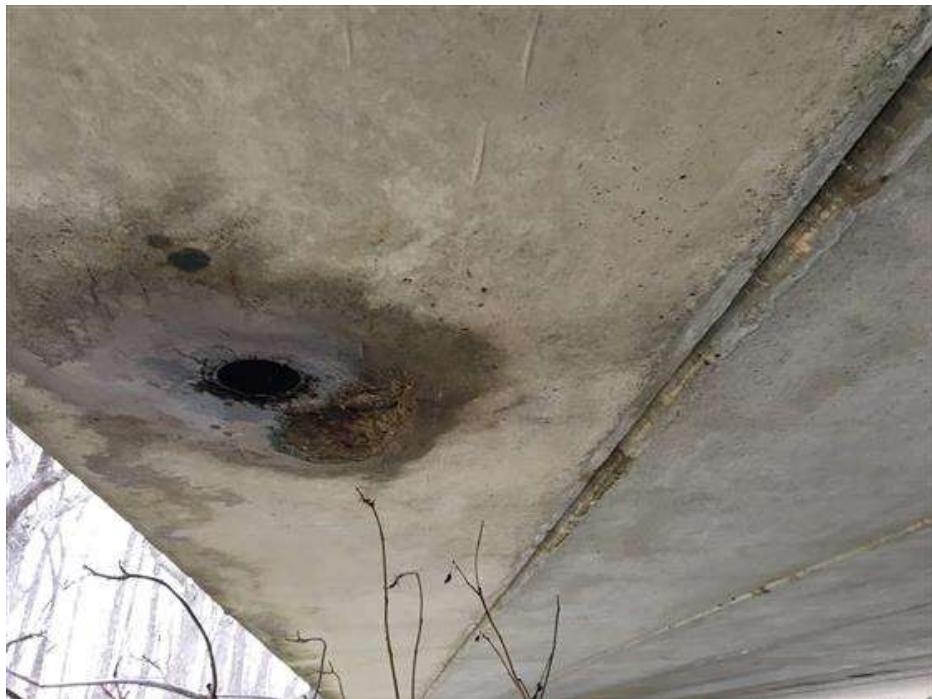
PHOTO 23

Description Box Beam 1 (deterioration at SW drain)

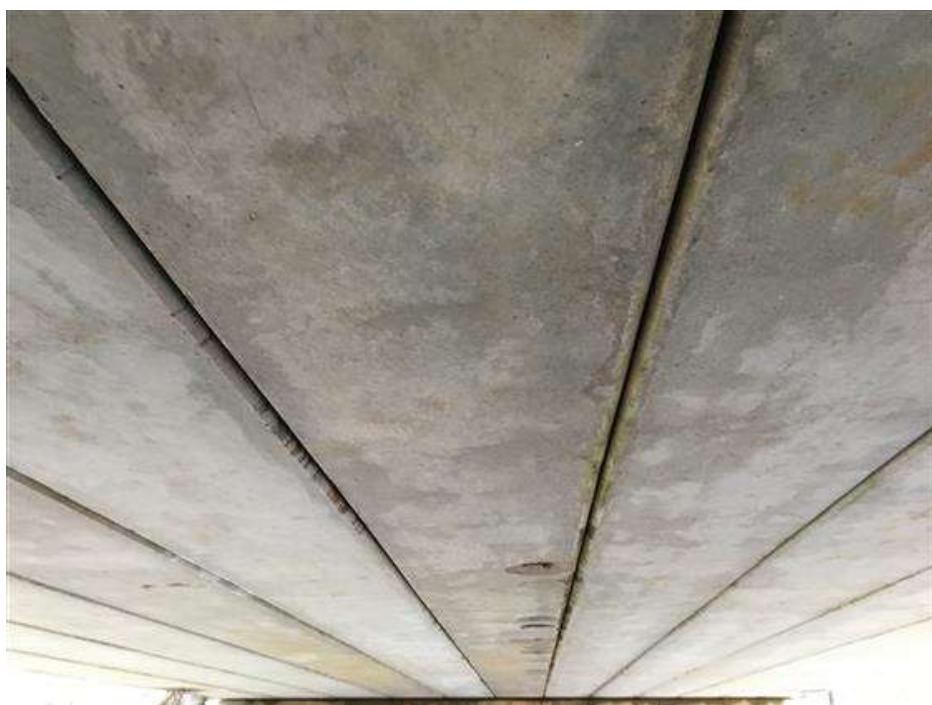
PHOTO 24

Description Box Beam 6 (looking north; spalls on underside)

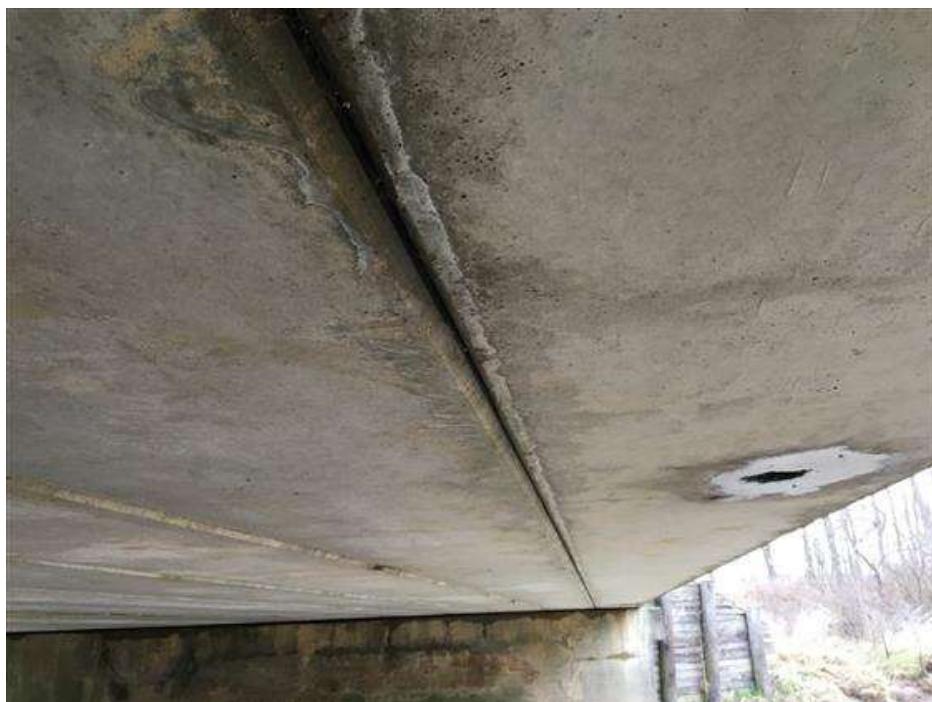
PHOTO 25

Description Box Beam 12 (looking north)
