FHWA-Indiana Environmental Document
CATEGORICAL EXCLUSION / ENVIRONMENTAL ASSESSMENT FORM
GENERAL PROJECT INFORMATION

State Road (SR) 62 / Spencer County

Rehabilitation of Bridge No. 62-74-06164B (National Bridge Inventory (NBI) No. 22130) Carrying SR 62 Over Buckhorn Creek / The project termini for construction extend approximately 105 feet north and south of the center point of the bridge along SR 62. The study limit termini for right-of-way acquisition extend approximately 600 feet north and 540 feet south of the center point of the bridge.

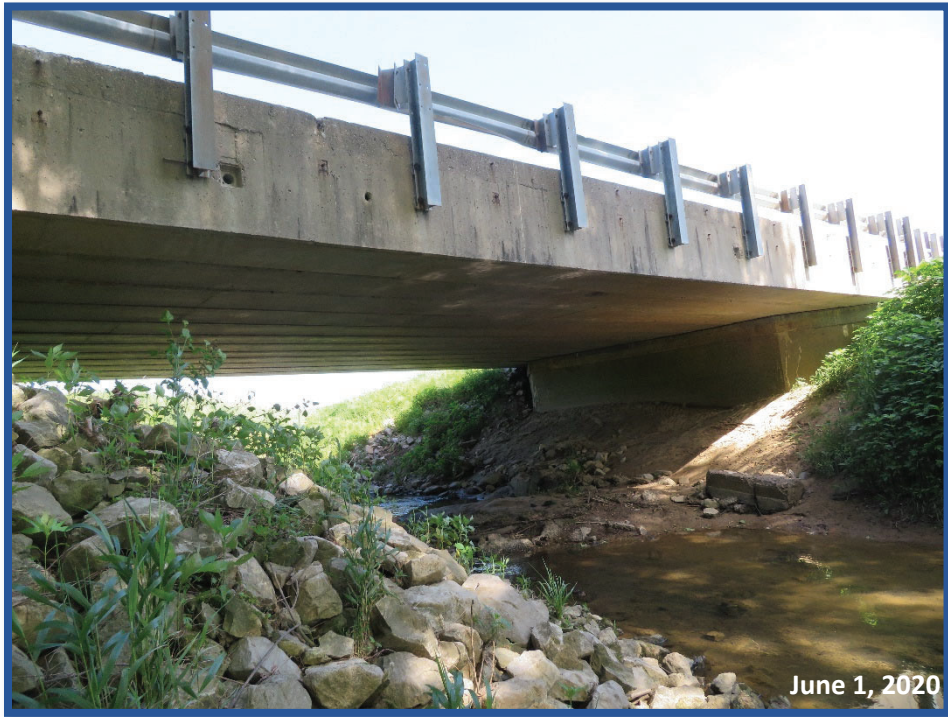
Photo 7: East elevation view of Bridge No. 62-74-06164 B.

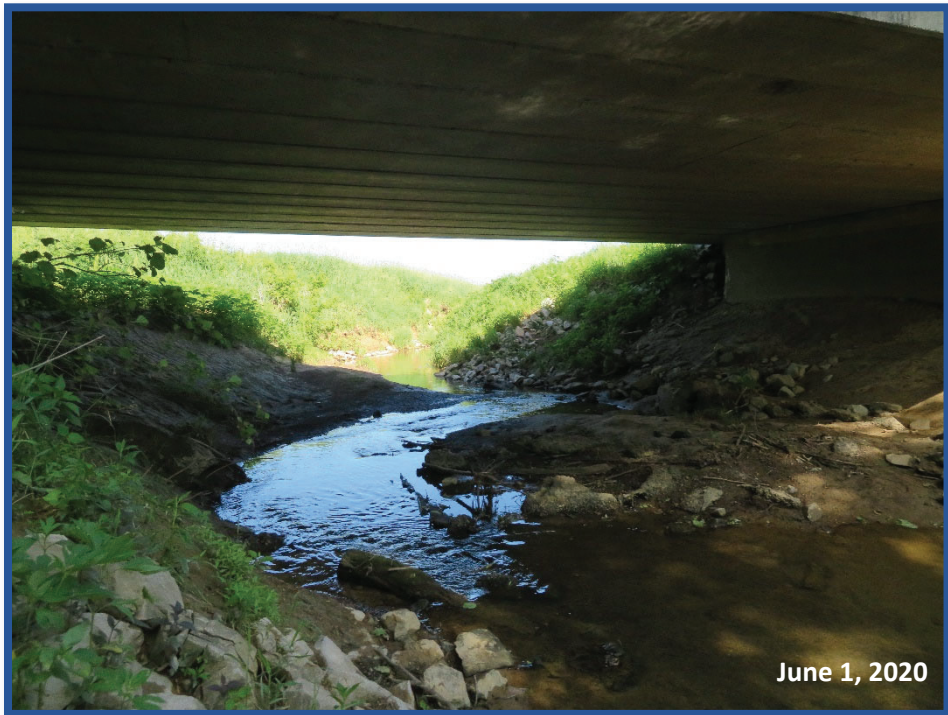
Photo 8: Looking northwest (downstream) along Buckhorn Creek from under Bridge No. 62-74-06164 B.

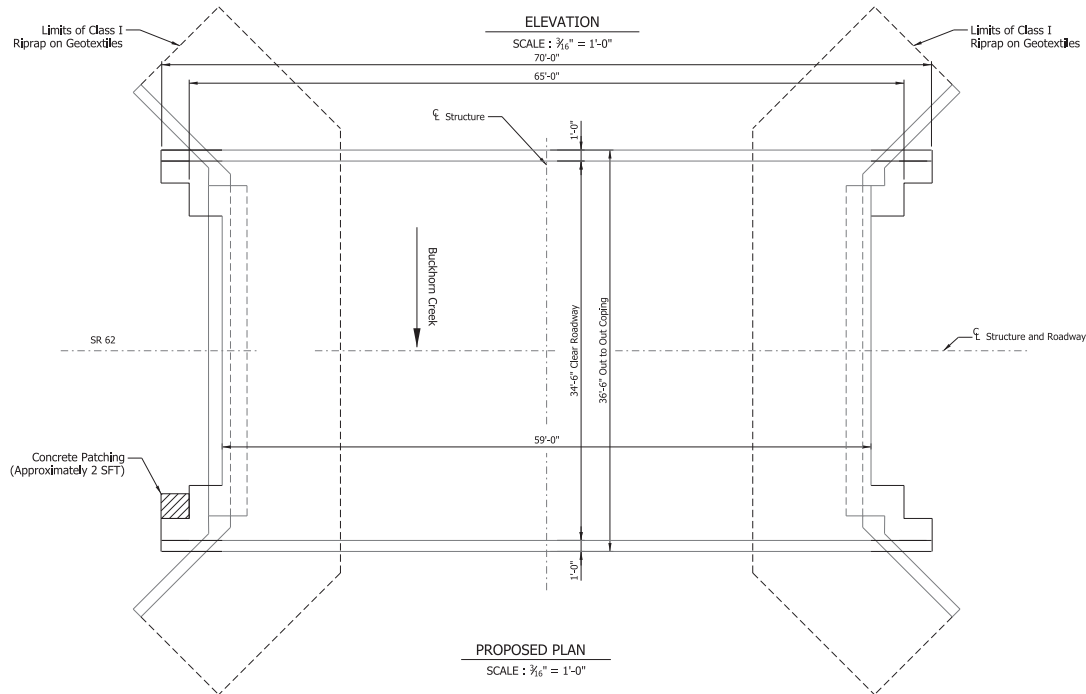
Bridge Deck Overlay on Prestressed Box Beam Bridge
 1 Span @ 56'-0"
 34'-6" Clear Roadway on SR 62
 Over Buckhorn Creek
 In Jackson Township, Spencer County

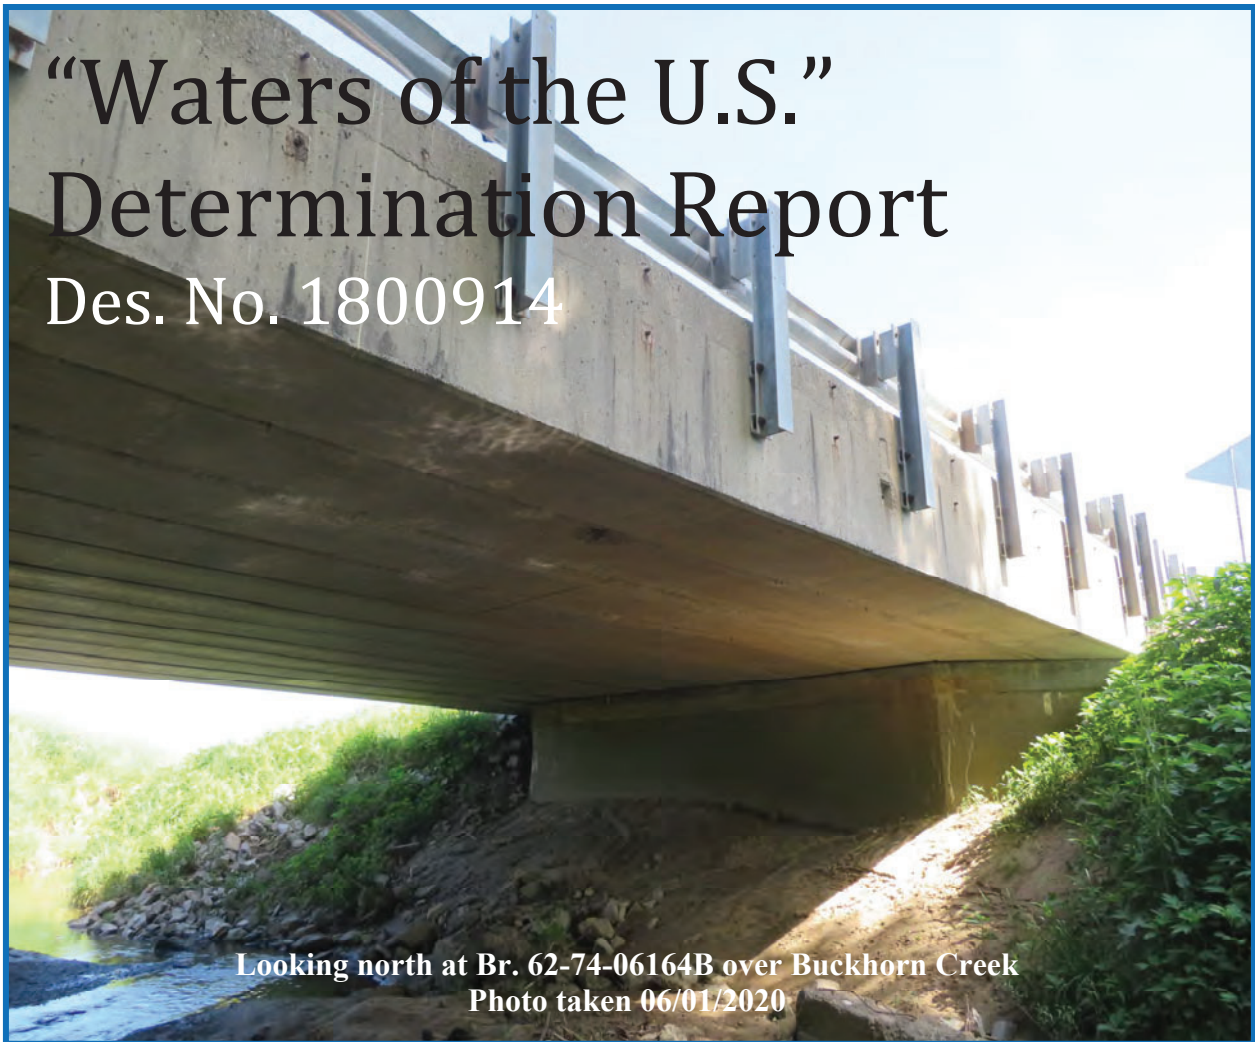
Looking north at Br. 62-74-06164B over Buckhorn Creek
Photo taken 06/01/2020

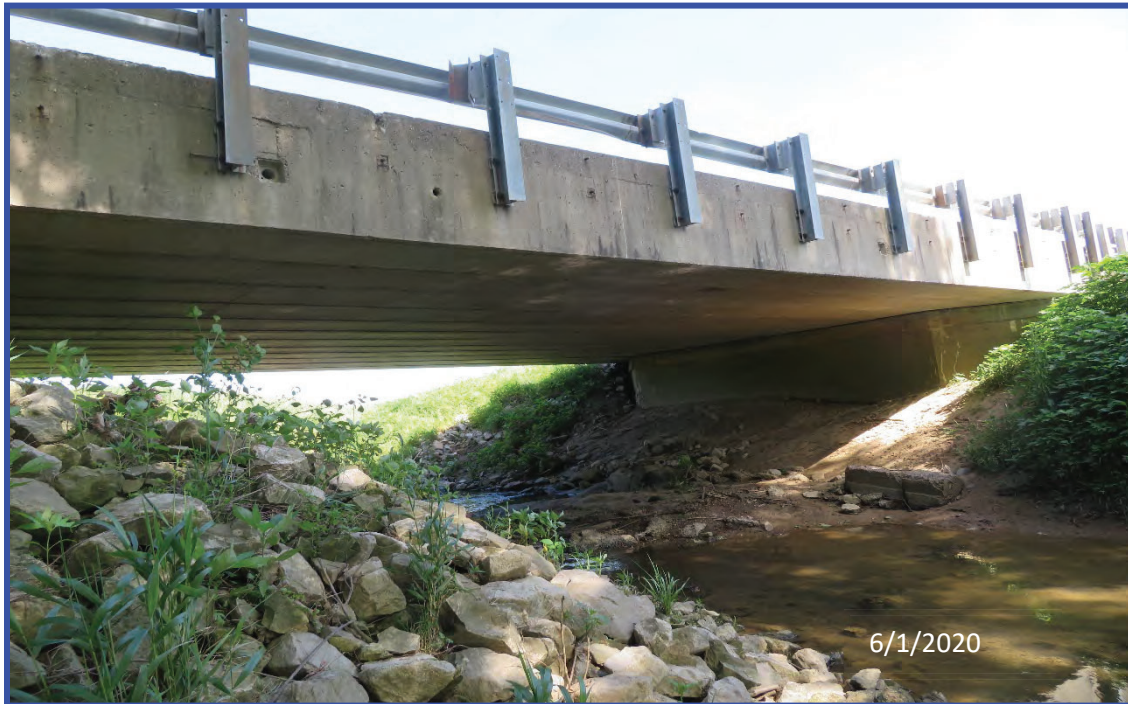
3) Looking northwest at Br. 62-74-06164B from the south bank of Buckhorn Creek

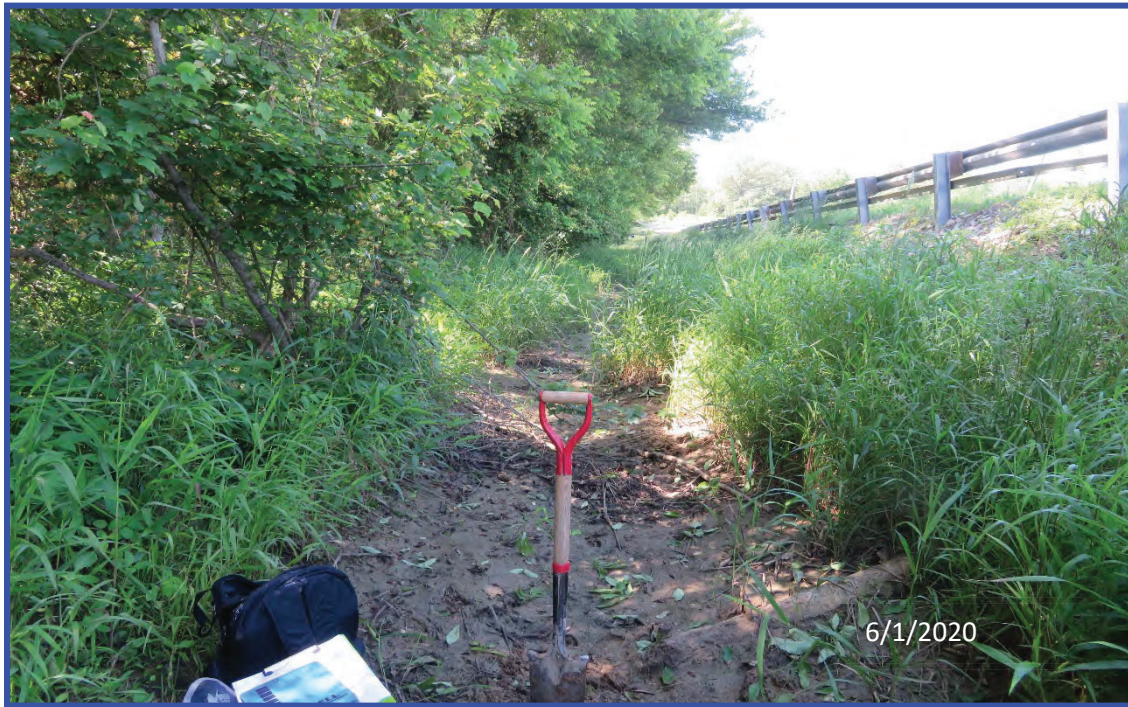
19) Wetland A: Looking south at Sampling Point 1A within RSD1

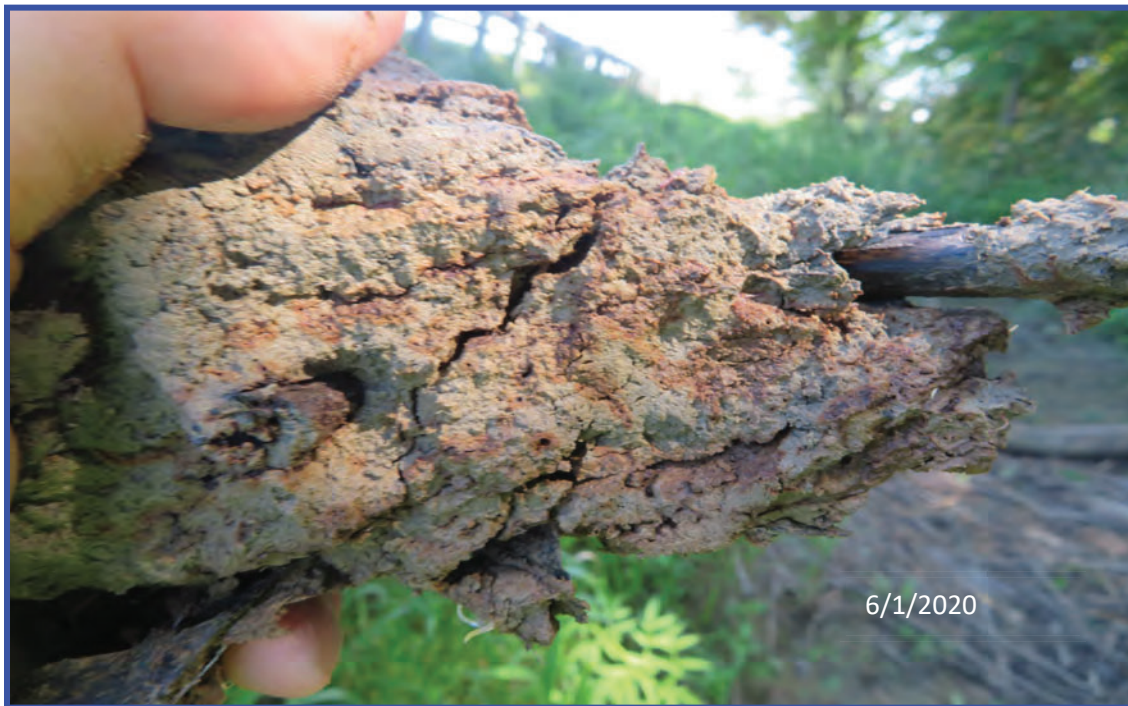
20) Wetland A: Looking at hydric soil field indicators found in soil sample from Sampling Point 1A

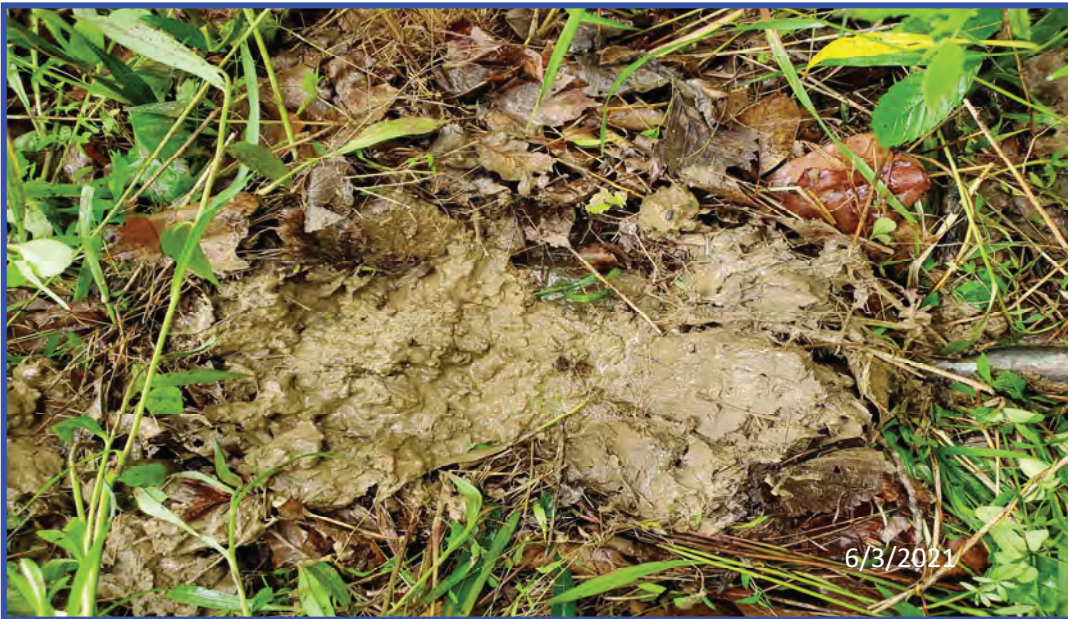
23) Wetland B: View of soil sample collected at SP2A (wetland) in the SE quadrant of Structure 62-74-06164B

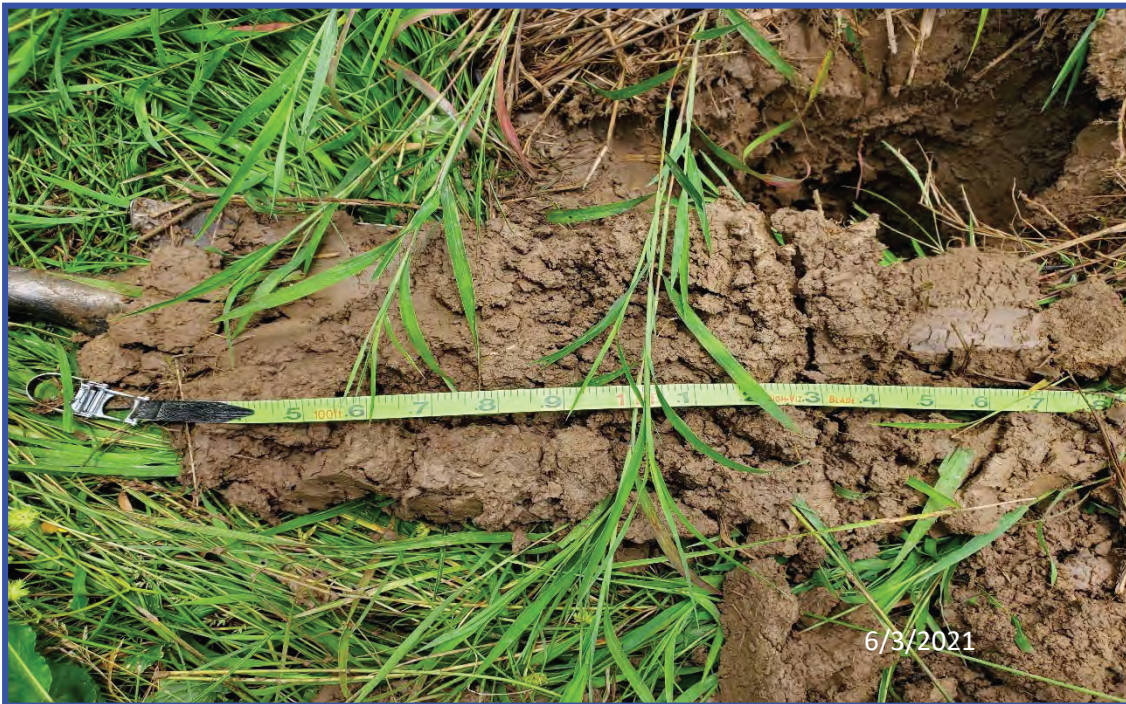
25) View of soil sample collected at SP2B (upland) in the SE quadrant of Structure 62-74-06164B

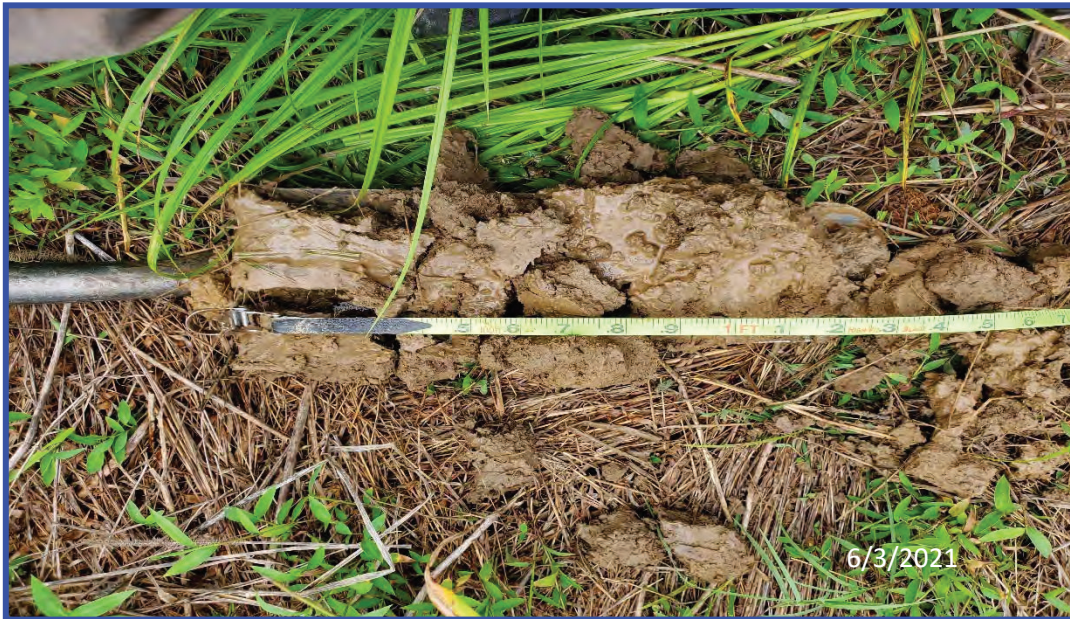
27) View of soil sample collected at SP3 (upland) in the NE quadrant of Structure 62-74-06164B

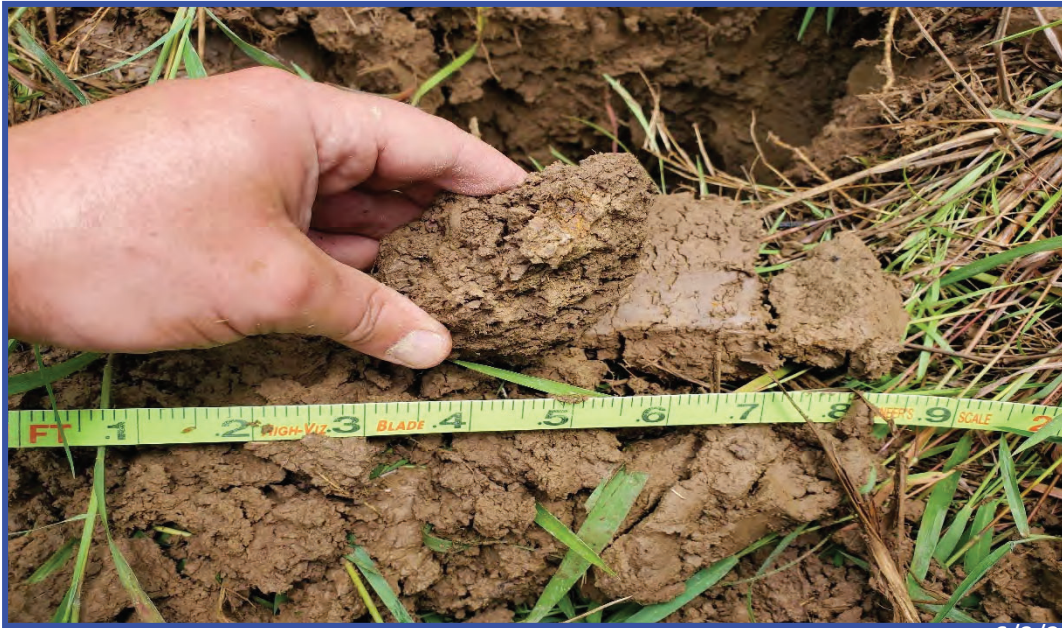
29) View of soil sample collected at SP4 (upland) in the NW quadrant of Structure 62-74-06164B

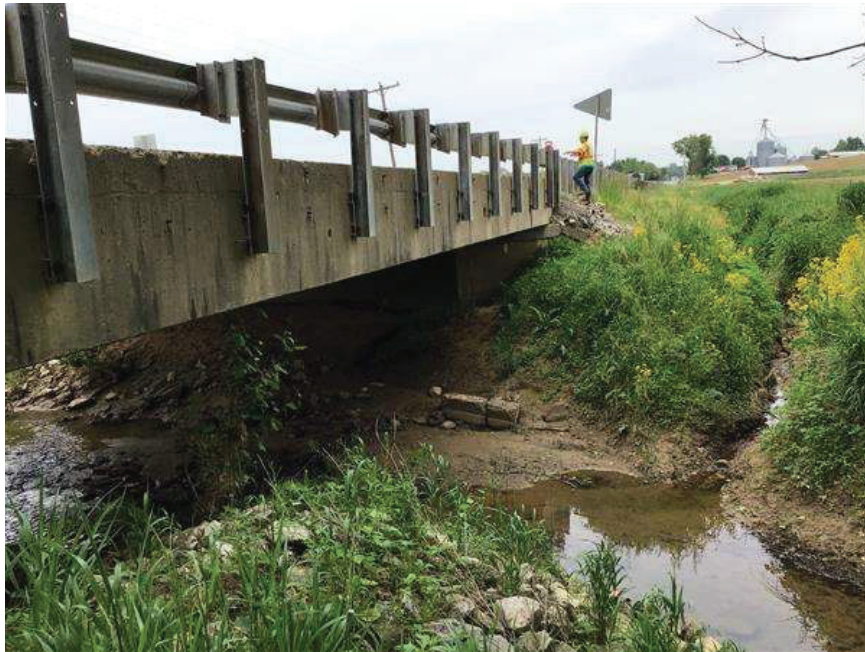
062-74-06164 B
SR 62
over
BUCKHORN CREEK

Inspection Date: 05/17/2021

According to the May 17, 2021 Bridge Inspection Report (Appendix H, H2-H25) for Bridge No. 62-74-06164B (National Bridge Inventory (NBI) No. 022130) carrying SR 62 over Buckhorn Creek 1.4 miles southwest of SR 162 in Spencer County, the bridge deck and wearing surface are deteriorated and have been given ratings of 5 out of 10 (fair condition). In addition, moderate bank erosion at the structure was noted in the report.

the most recent INDOT inspection report, dated May 17, 2021, the structure was given a sufficiency rating of 94.7 out of 100, indicating good condition, while the deck and wearing surface were given ratings of 5 (out of 10), indicating fair condition.
