Environmental Assessment

Appendix J

Section 7 Consultation

Project Name: Des 2001154; SR 11 Roadway Project; Harrison County

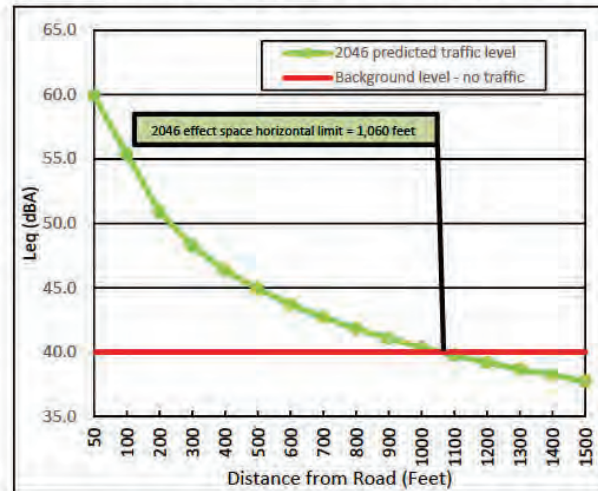
Figure 17 Predicted highway traffic noise effect space limit

Although episodic peaks in noise from loud passing trucks occur, the overall traffic noise levels predicted are considered to be tolerable by Indiana bats, northern long-eared bats, and gray bats and are not expected to result in their exclusion from the Buck Creek floodplain valley and adjacent karst plains under future normal post-construction highway operating conditions.

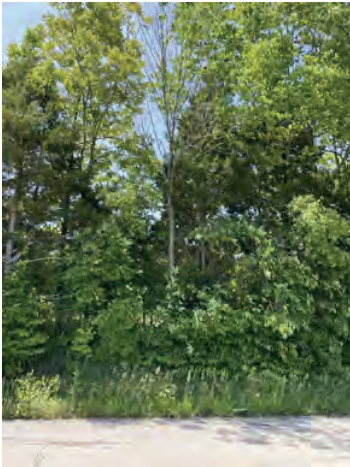
Habitat Area 12: Tree 12.1 - ash, 7-in dia., Stage 3, loose bark but no peeling - Alternative 3 Corridor 5/29/2022

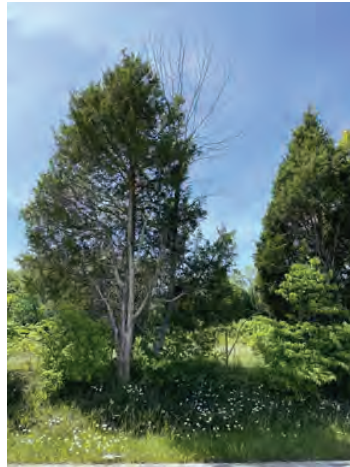
Habitat Area 12: Tree 12.2 - ash, 7-in dia., Stage 3, loose bark but no peeling - Alternative 3 Corridor 5/29/2022

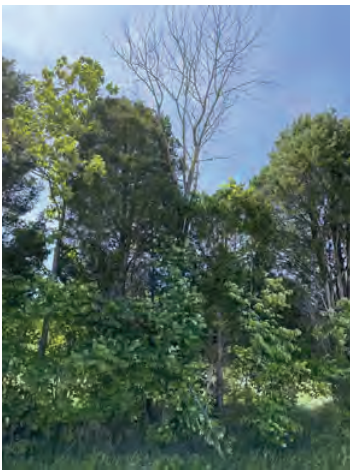
Habitat Area 12: Tree 12.3 - ash, 9-in dia., Stage 3, loose bark but no peeling - Alternative 3 Corridor 5/29/2022

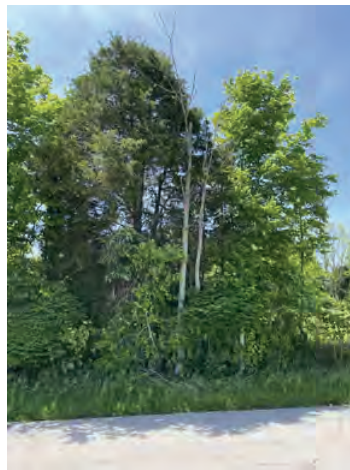
Habitat Area 12: Tree 12.4 - ash, 10-in dia., Stage 3, loose bark but no peeling - Alternative 3 Corridor 5/29/2022

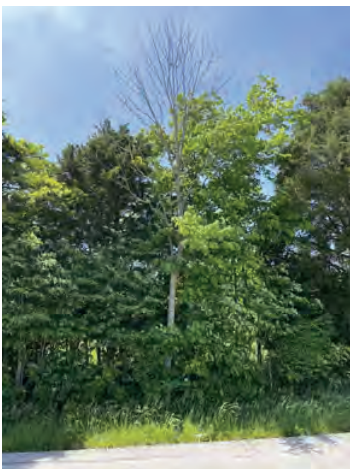
Habitat Area 12: Tree 12.5 - ash, 9-in dia., Stage 3, loose bark but no peeling - Alternative 3 Corridor 5/29/2022

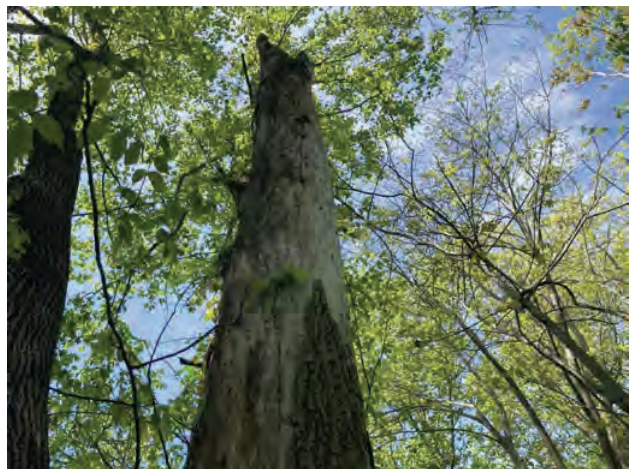
Habitat Area 21: Tree 21.1 - tulip poplar, 13-in dia., Stage 7, hollow snag, cavities - Alternative 3 Corridor 5/6/2021

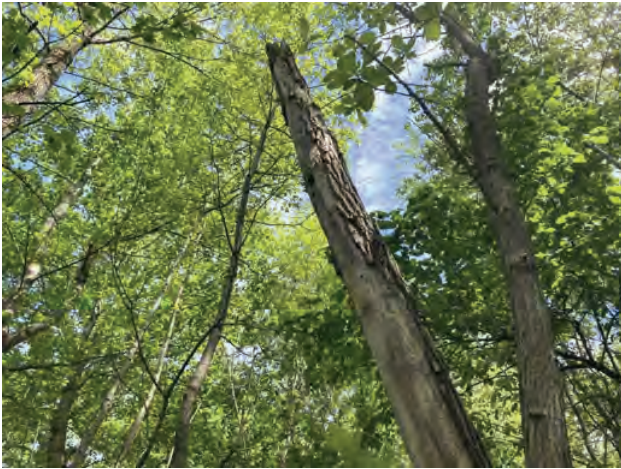
Habitat Area 21: Tree 21.2 - sassafras, 8-in dia., Stage 7, cavities, fissures - Alternative 3 Corridor 5/6/2021

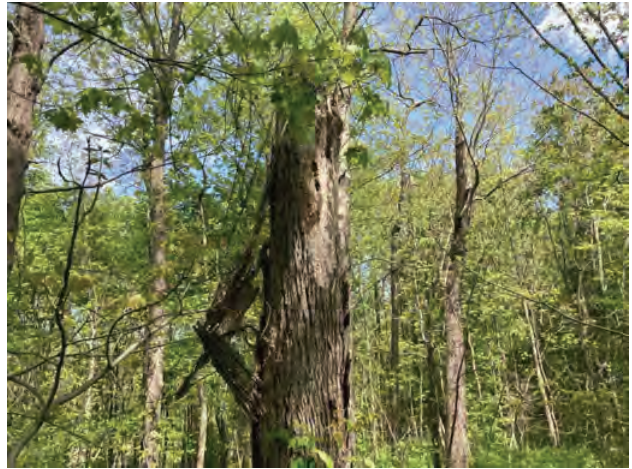
Habitat Area 21: Tree 21.3 - hickory, 19.5-in dia., Stage 7, exfoliating bark, cavities, snag - Alternative 3 Corridor 5/6/2021

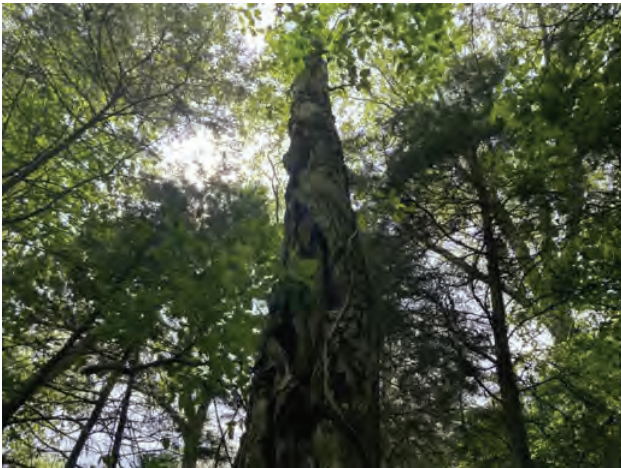
Habitat Area 22: Tree 22.5 - white oak, 14-in dia., Stage 6, cavities, fissure, exfoliating bark - Alternative 3 Corridor and Preliminary Right-of-Way 5/6/2021

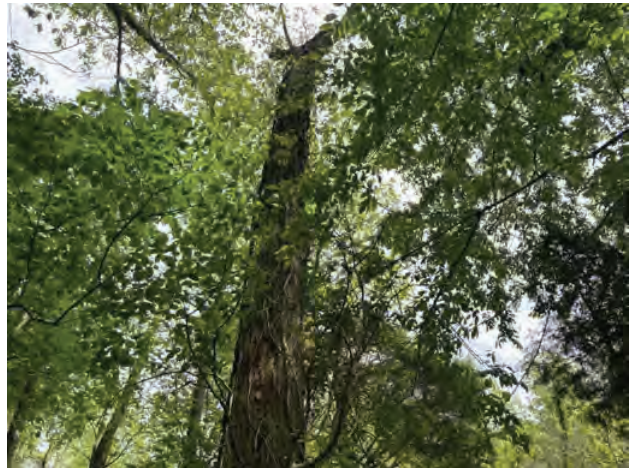
Habitat Area 22: Tree 22.6 - black oak, 29-in dia., Stage 6, exfoliating bark, cavities - Alternative 3 Corridor and Preliminary Right-of-Way 5/6/2021

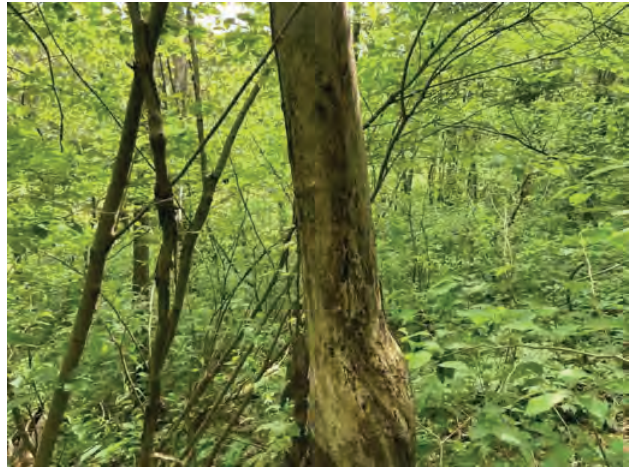
Habitat Area 48A: Tree 48A.4 - elm, 6.5-in dia., Stage 6, cavities, fissures - Alternative Corridor 5/6/2021

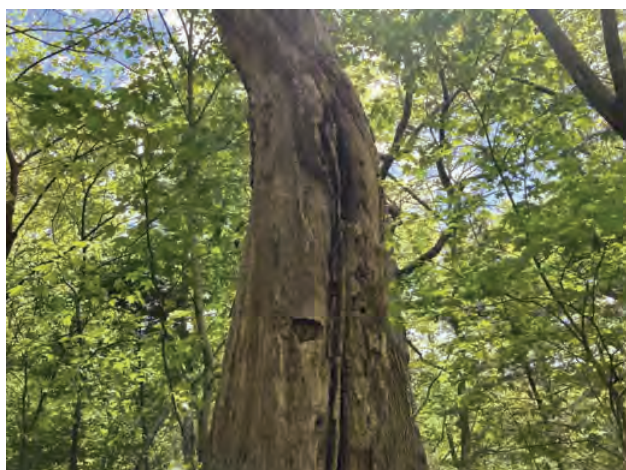
Habitat Area 57G: Tree 57G.6 - white oak, 18 5-in dia., Stage 7, snag, exfoliating bark, fissures - Alternative 3 Corridor and Preliminary Right-of-Way 5/5/2021

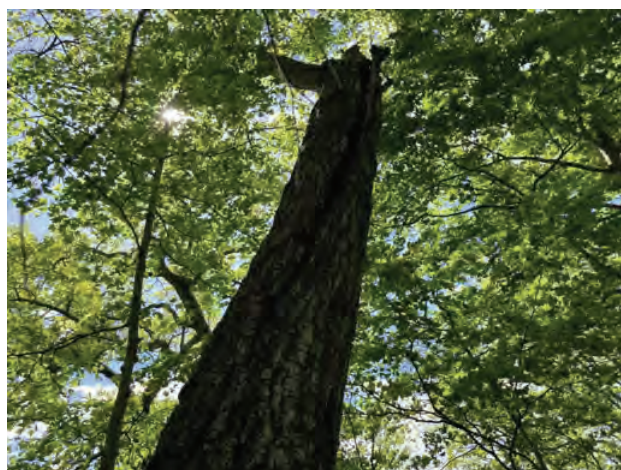
Habitat Area 57G: Tree 57G.7 - black oak, 31-in dia., Stage 2, snag, hollow living branches - Alternative 3 Corridor and Preliminary Right-of-Way 5/5/2021

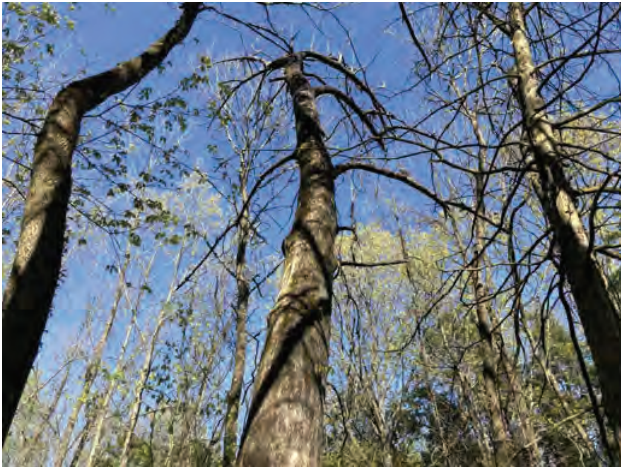
Habitat Area 57H: Tree 57H.1 - black locust, 15-in dia., Stage 4, fissures - 4/22/2021

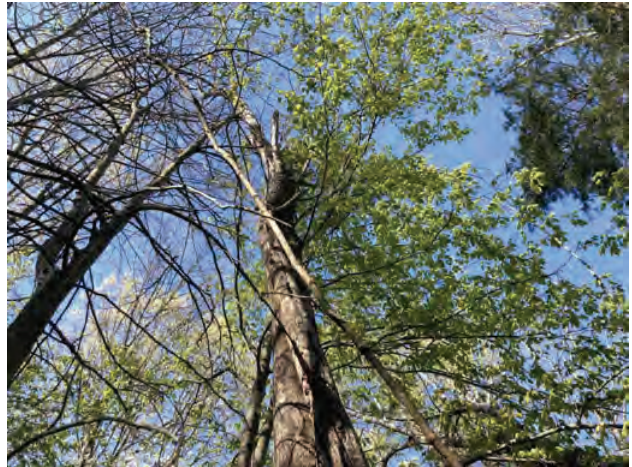
Habitat Area 57H: Tree 57H.2 - black locust, 15.5-in dia., Stage 5, fissures - Alternative Corridor 4/22/2021

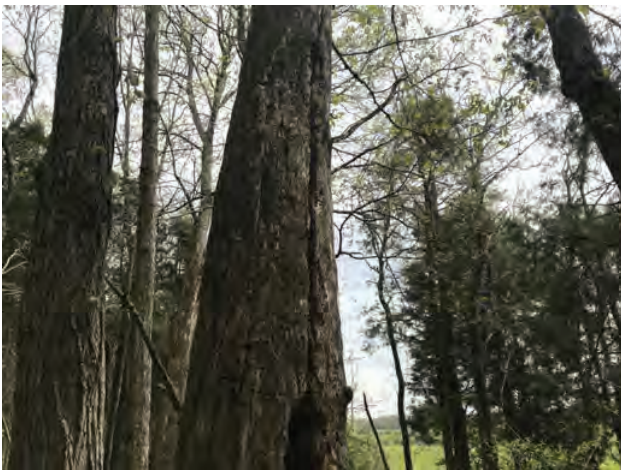
Habitat Area 57H: Tree 57H.3 - black locust, 18-in dia., Stage 4, fissures, cavities - Alternative 3 Corridor and Preliminary Right-of-Way 4/23/2021

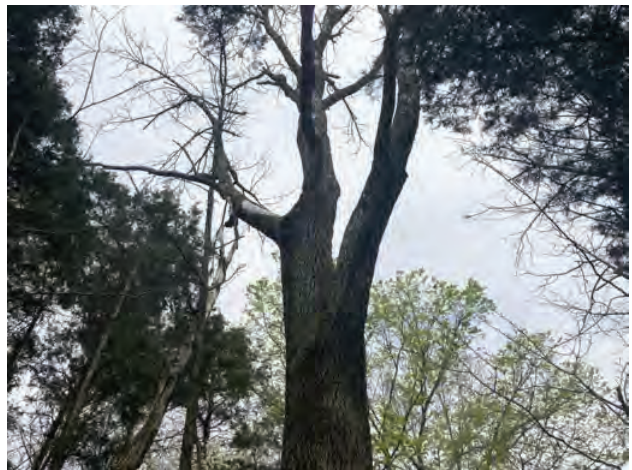
Habitat Area 57H: Tree 57H.5 - white ash, 27.5-in dia., Stage 3, exfoliating bark - Alternative 3 Corridor and Preliminary Right-of-Way 4/23/2021

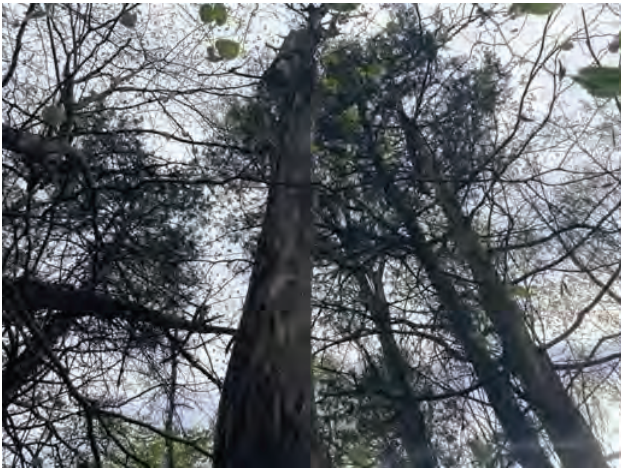
Habitat Area 57H: Tree 57H.10 - black locust, 10-in dia., Stage 4, fissures - Alternative 3 Corridor 4/23/2021

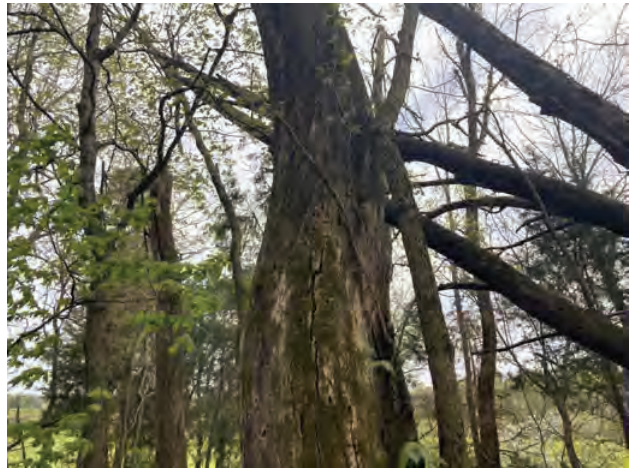
Habitat Area 57H: Tree 57H.11 - black locust, 17.5-in dia., Stage 4, fissures - Alternative 3 Corridor and Preliminary Right-of-Way 4/23/2021

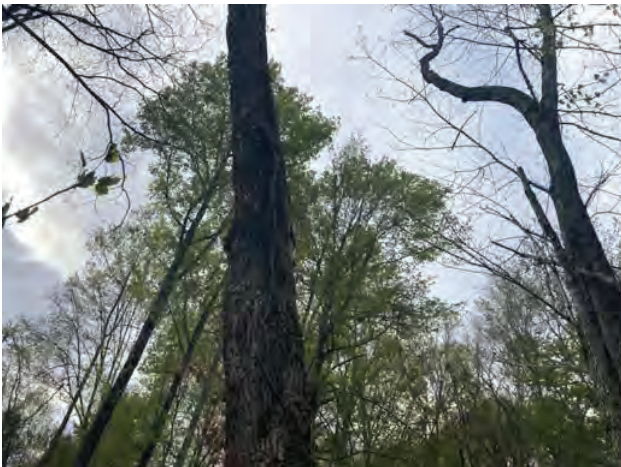
Habitat Area 57H: Tree 57H.12 - ash, 12.5-in dia., Stage 3, exfoliating bark - Alternative 3 Corridor 4/23/2021

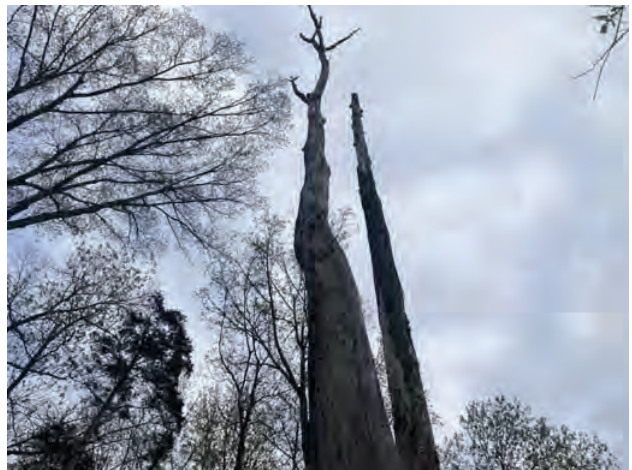
Habitat Area 57H: Tree 57H.17 - unknown, 16.5-in dia., Stage 5, limited exfoliating bark, fissure, cavities - Alternative 3 Corridor 4/23/2021

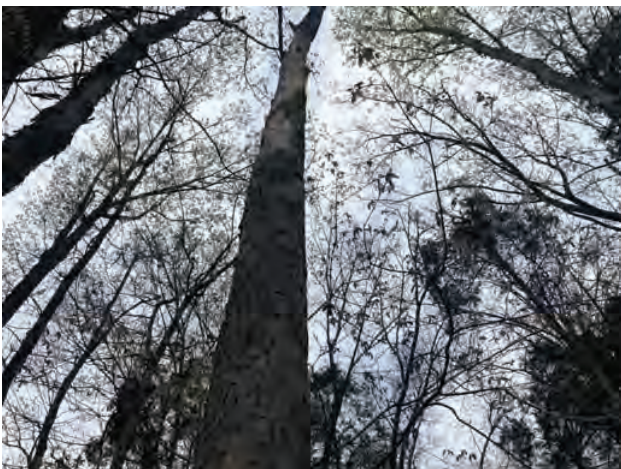
Habitat Area 57H: Tree 57H.18 - sassafras, 12-in dia., Stage 5, cavities, exfoliating bark - Alternative 3 Corridor and Preliminary Right-of-Way 4/23/2021
