CATEGORICAL EXCLUSION LEVEL 1 FORM

United States (U.S.) 12 and Beverly Drive / LaPorte County

2000607 (Lead), 2101096, 2500075

Roadway, small structure project and traffic signal modernization on U.S. 12 and Beverly Drive begins west of Michigan City, from the Porter/LaPorte County line and continues east to the Michigan state line.

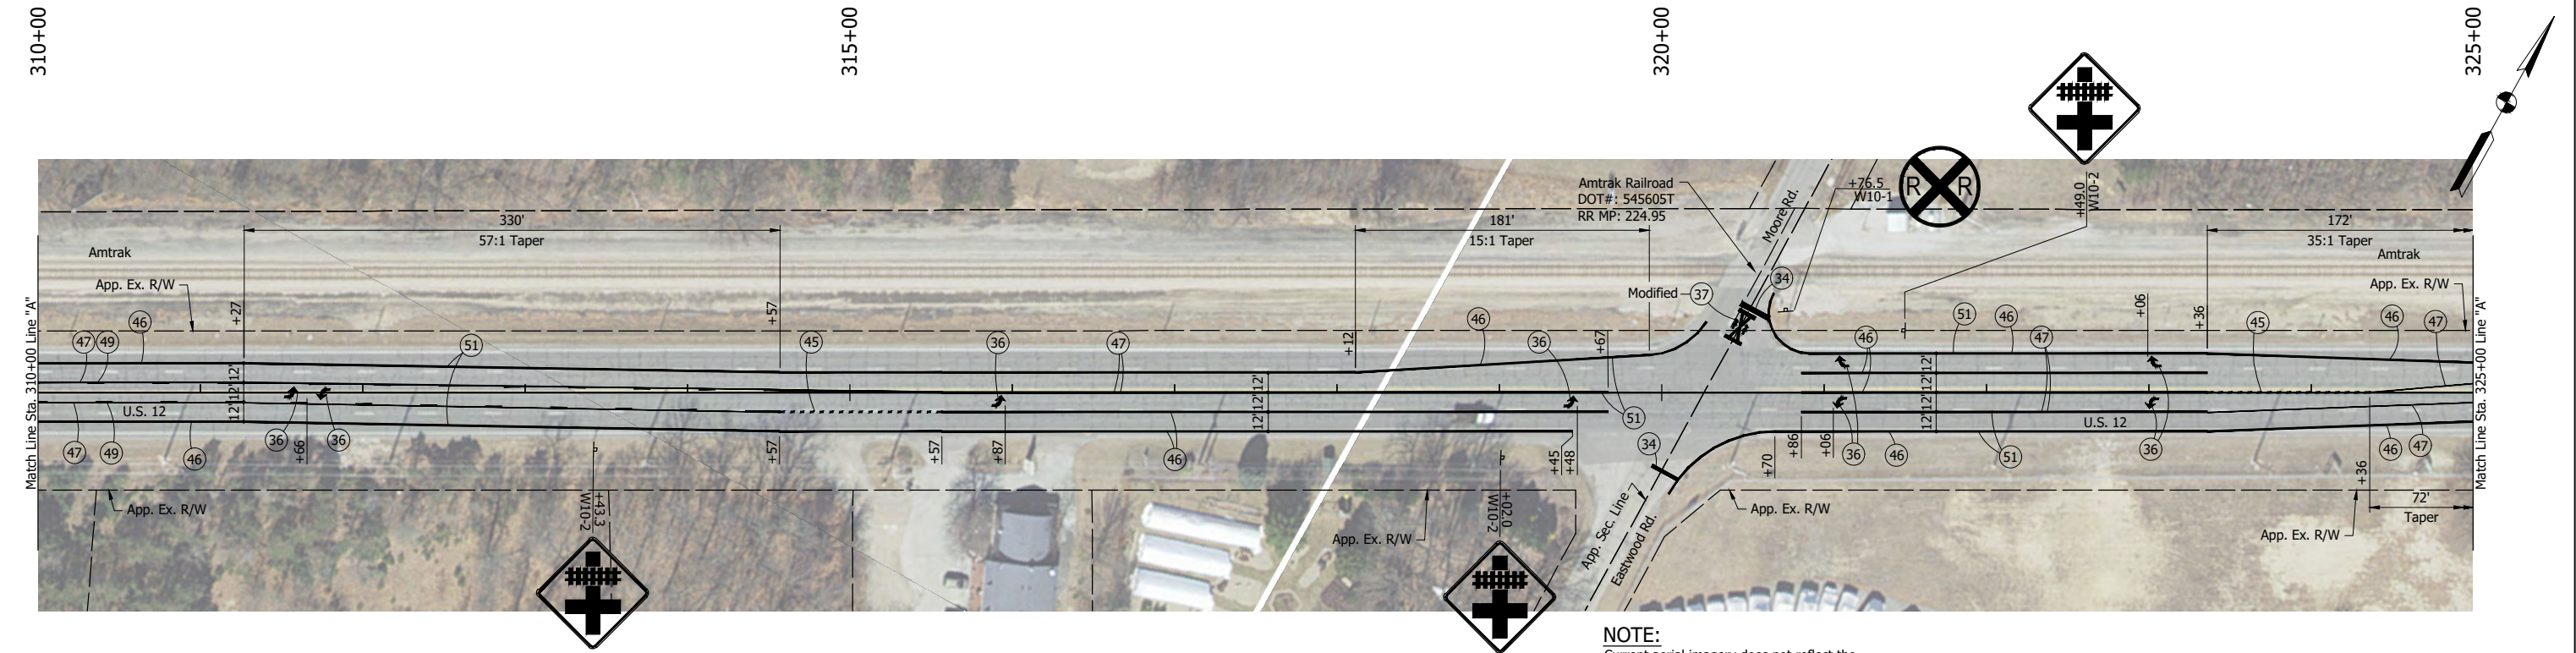
NOTE:
Current aerial imagery does not reflect the
existing condition at Eastwood Rd. / Moore Rd.
of single thru lanes with dedicated left turn lanes.
