# The Good, The Bad, The Ugly!

Midwest Geotech Conference 2025

# Route F over the Sac River Branch Bridge Replacement Southwest Missouri

Highway 60  
Route A/Route N Cross Overs  
Webster County

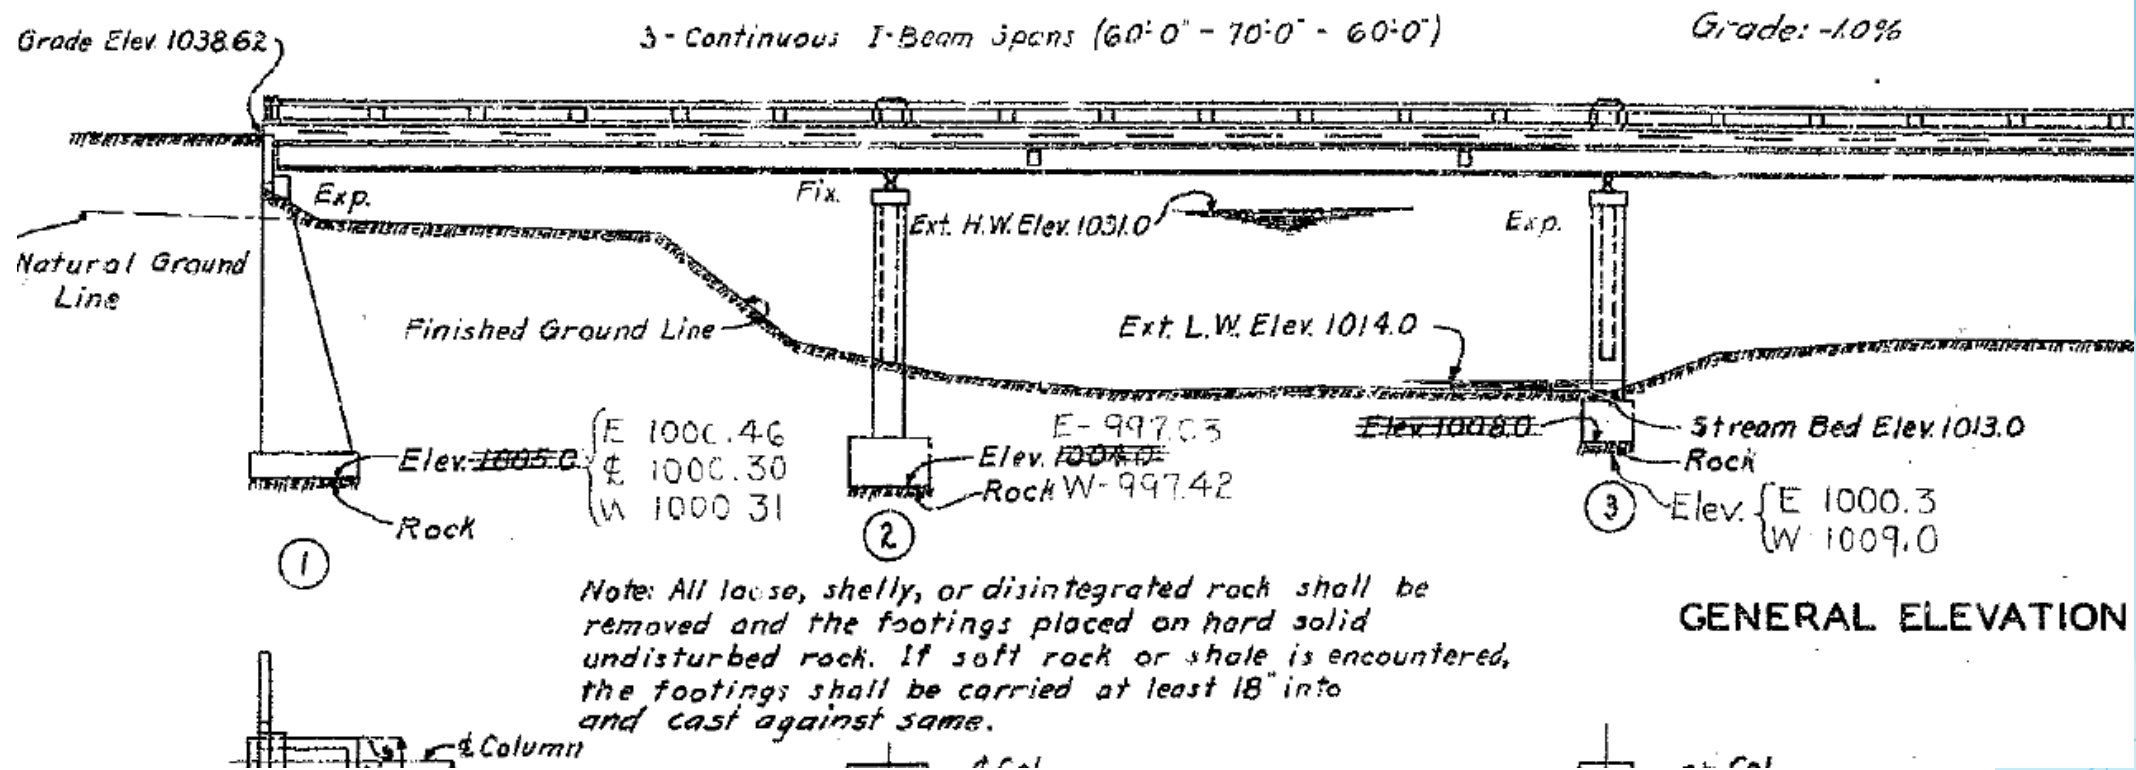
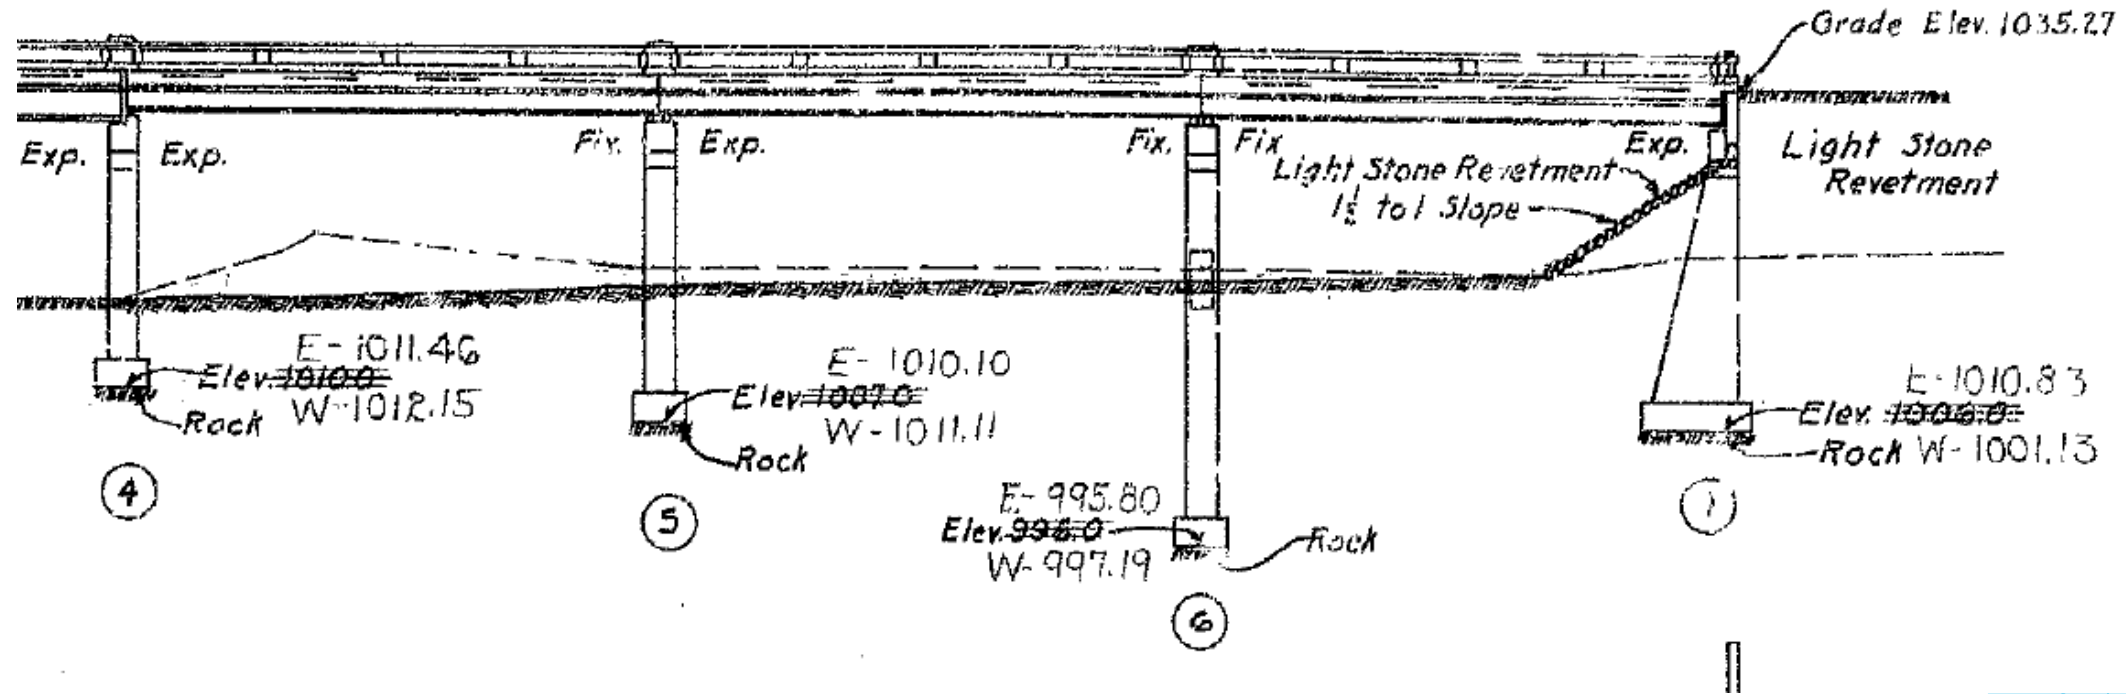
# Existing Structure K0646

3- 45'-0" I-Beam Spans

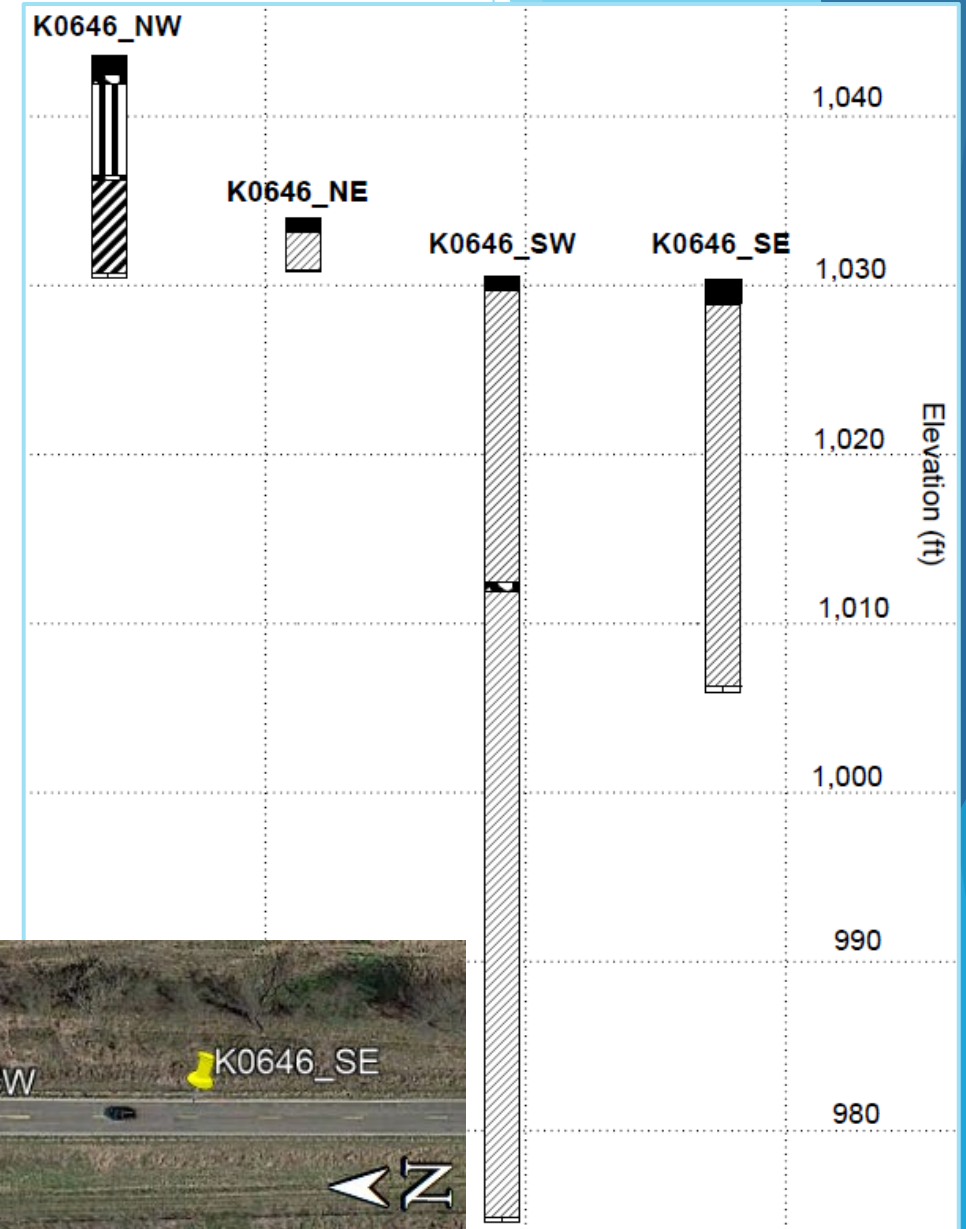
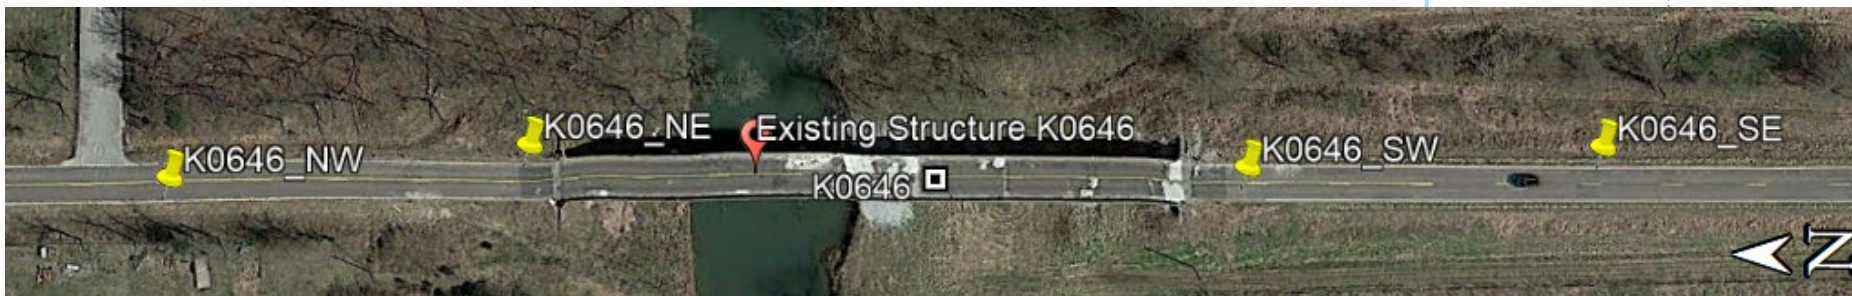
# Preliminary Geotechnical Investigation

- ▶ MoDOT is divided into 7 Districts
- ▶ District Geologists perform PGR's
  - ▶ Auger borings only with limited lab testing of samples
  - ▶ Typically limited to roadway and gentle shoulders
  - ▶ Preliminary planning
- ▶ PGR Findings on this Project:
  - ▶ Larger variation in top of rock than anticipated from the existing plans!
  - ▶ At least auger refusal occurred quickly...

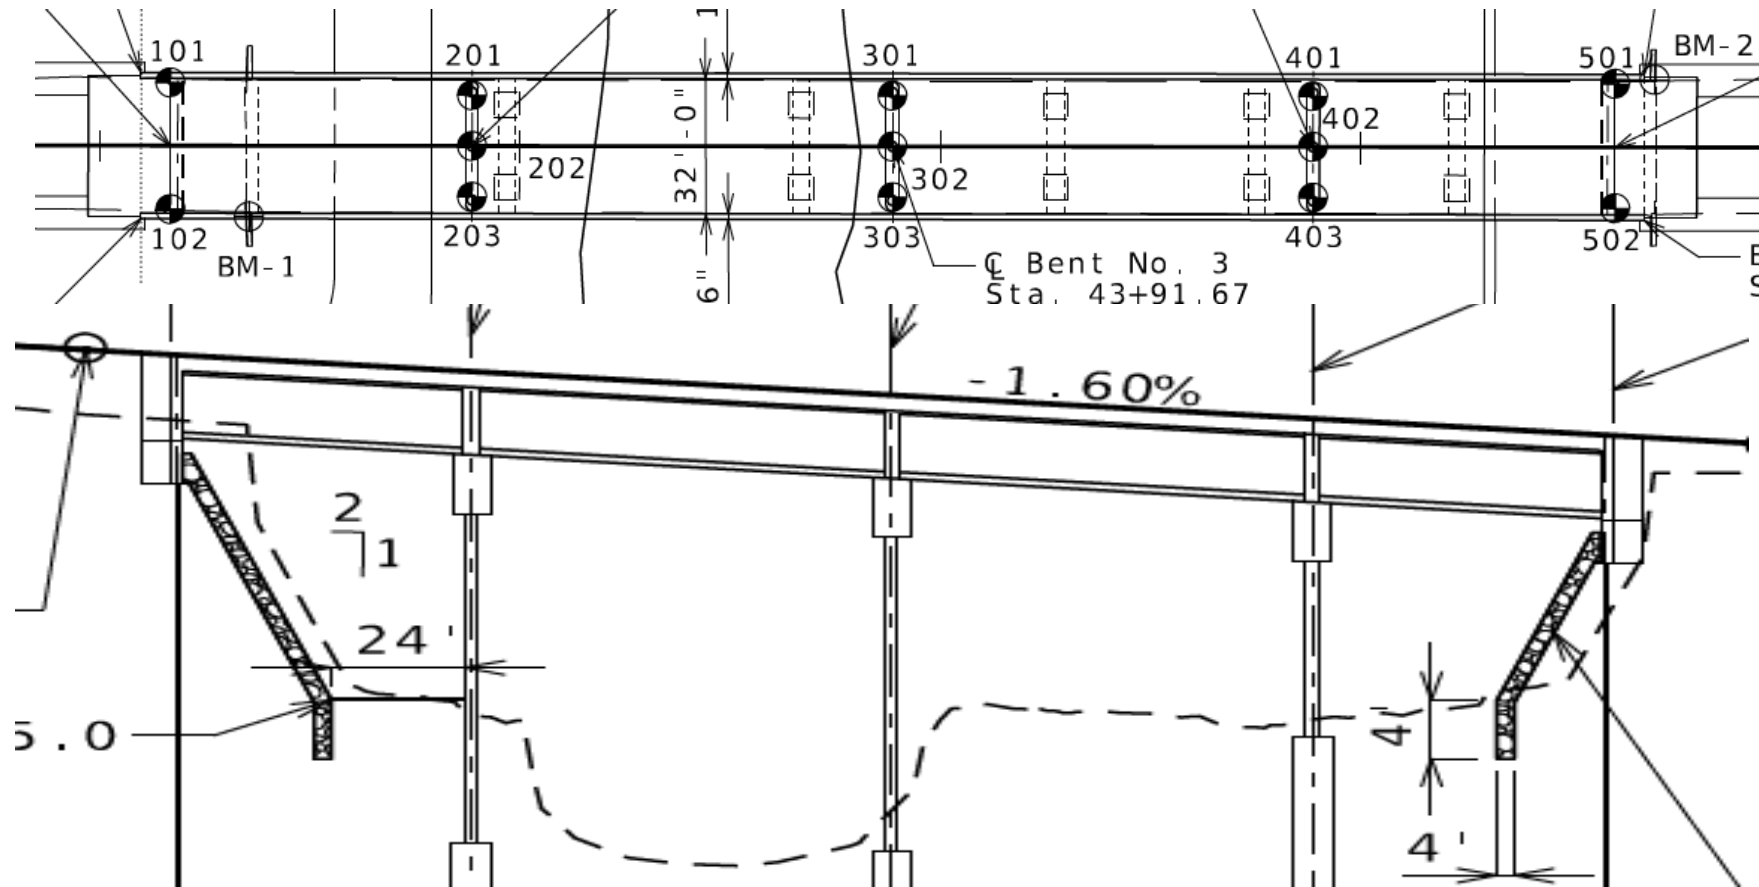
# Replacement Structure A9077

- ▶ H Pile Supported End Bents and Drilled Shaft Supported Intermediate Bents
- ▶ 70'-100'-100'-70' Span Layout

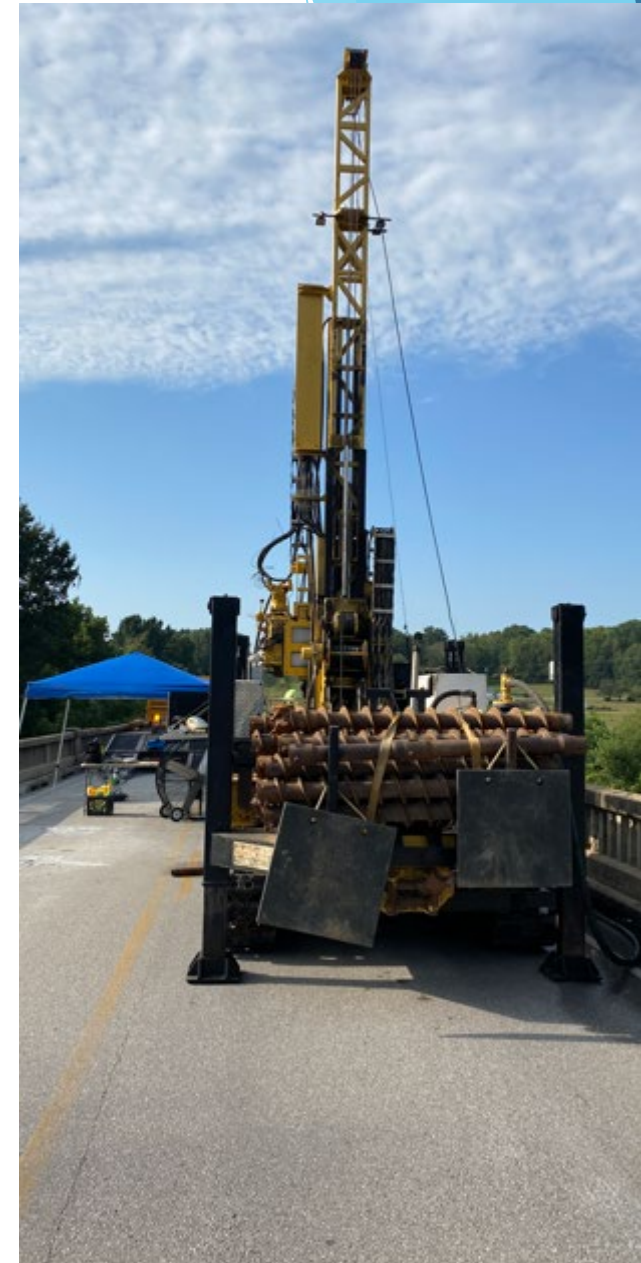
- ▶ Initial plan
  - ▶ Complete 2 borings per bent
    - ▶ Borings on location of outer pile on each end bent
    - ▶ Borings on Left and Right Drilled Shaft Locations on intermediate Bents
- ▶ Adjustments!
  - ▶ Access to requested locations not possible due to steep embankments
  - ▶ Narrow Bridge -> Close the Road
  - ▶ Minor Flooding
  - ▶ Drift Debris
  - ▶ Girders and Bracing
  - ▶ Environmental

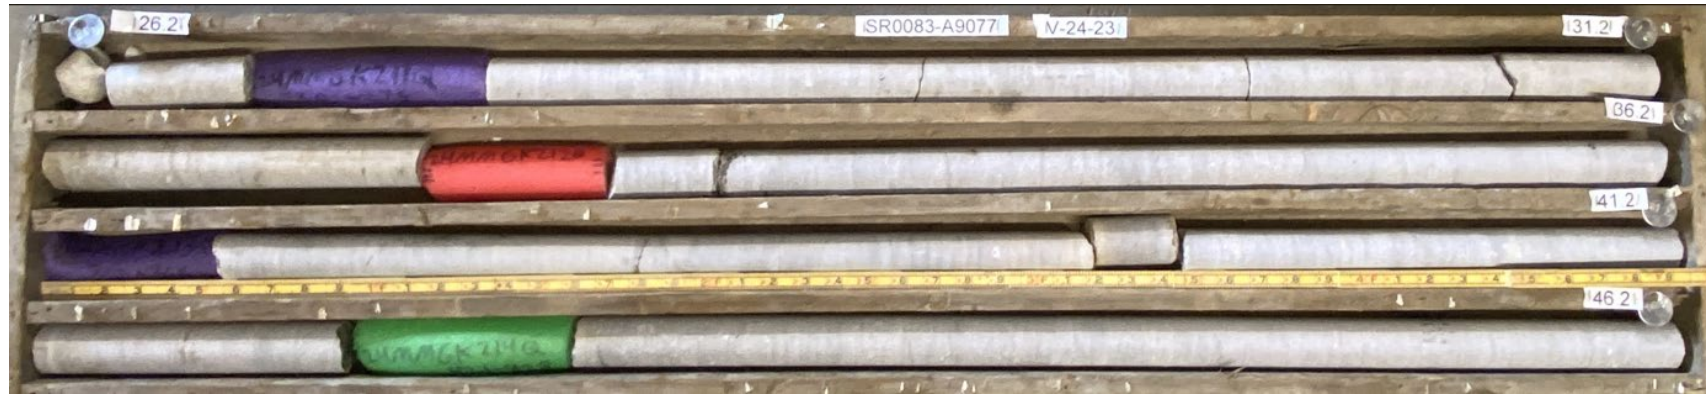
Bent 4 - Boring B-403

- ▶ Great Recovery
- ▶ Great RQD
- ▶ Great Strength

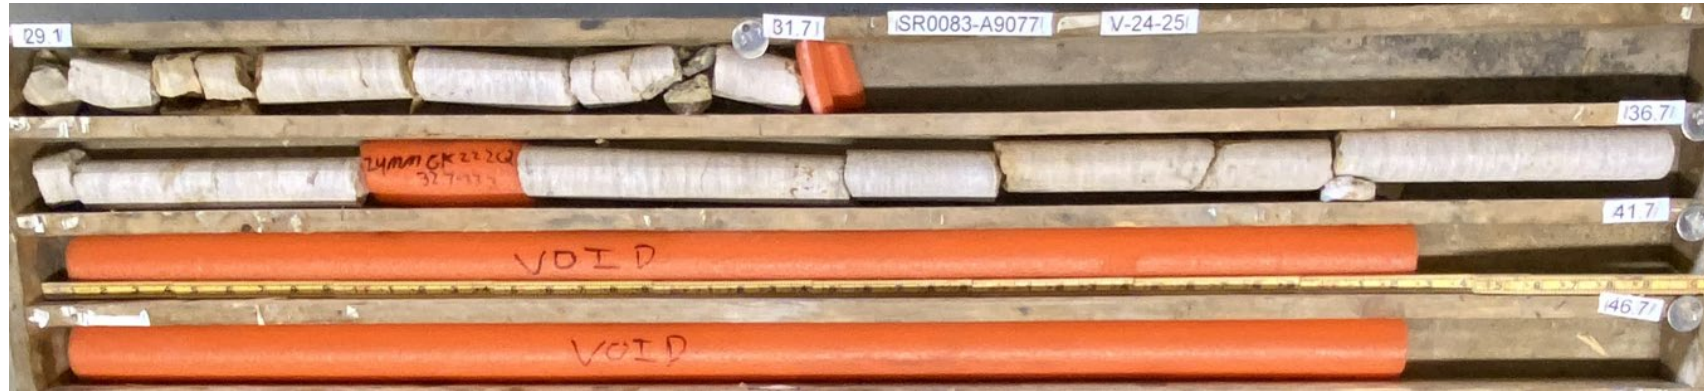
Bent 3 - Boring B-301 Offset

- ▶ Voids
- ▶ Clay Seams
- ▶ Low RQD
- ▶ Poor Recovery
- ▶ Water Current within Void at Bent 1
- ▶ Made Design Team Aware of Conditions

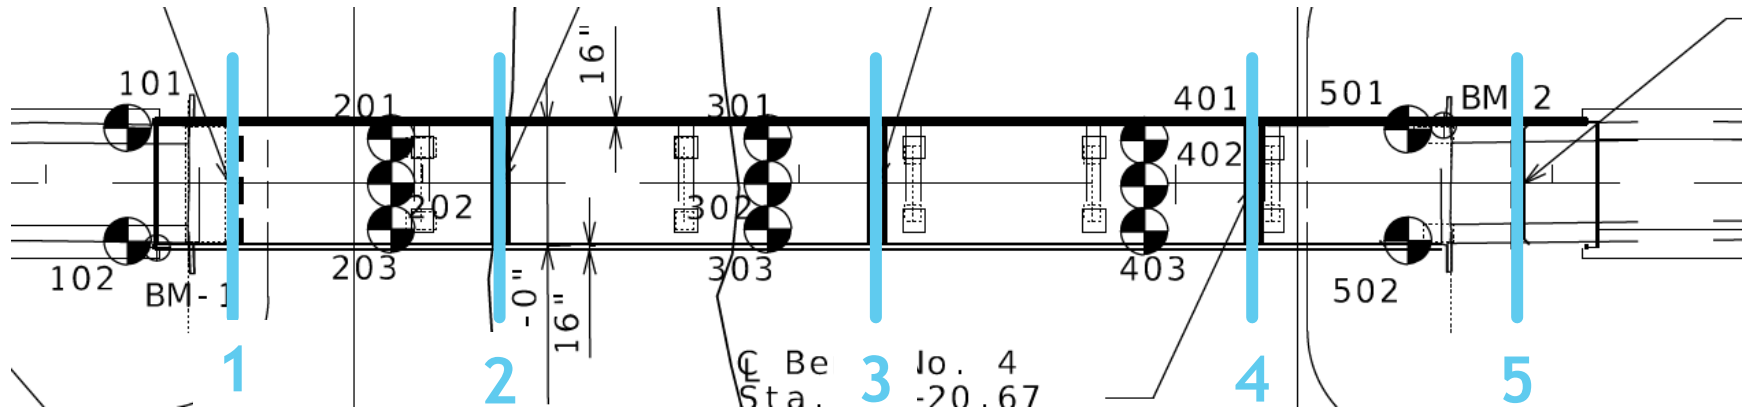
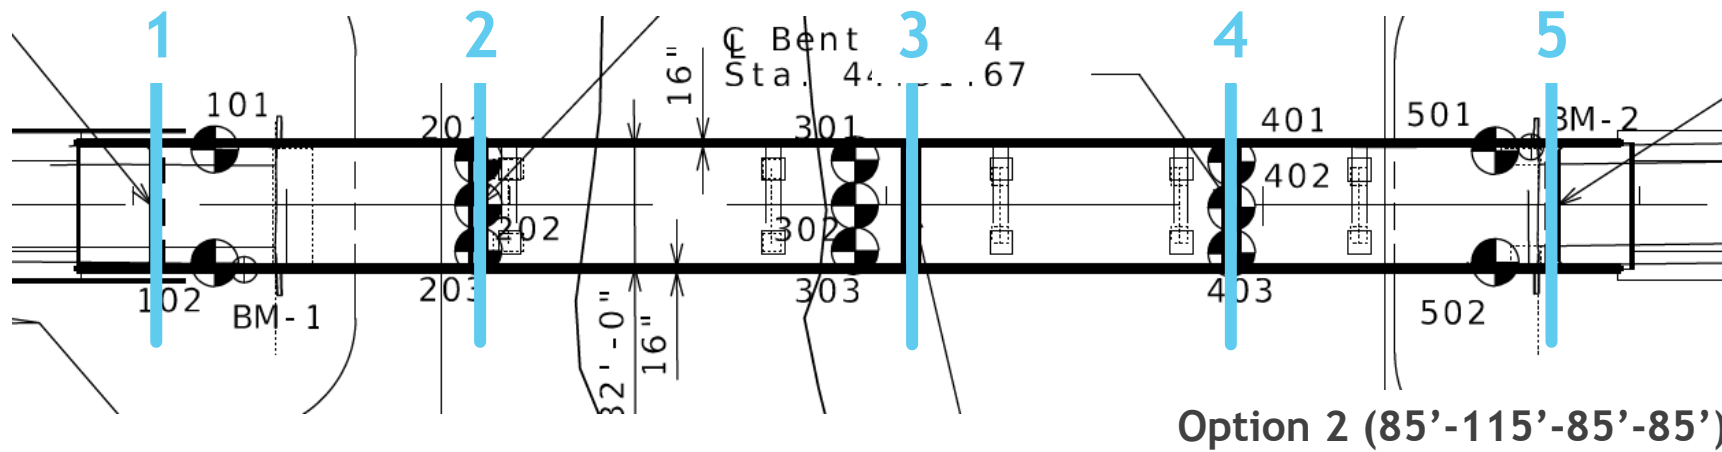
Option 1 (70'-100'-100'-70')

- ▶ Compared Layout Options to Anticipated Subsurface Conditions
  - ▶ Elected to Explore Option 1 First
    - ▶ Preferred Option by Designer
    - ▶ Maintained Span Layout
  - ▶ 1 Boring Per Bent
    - ▶ Prioritize Areas of Highest Concern
    - ▶ Additional Borings if Findings are Favorable
    - ▶ Move on to Option 2 if Findings are Not Favorable
    - ▶ Focus on Rock Conditions and Limit Soil Sampling

- ▶ Elected to utilize Option 1 Layout.
- ▶ Overall Improvement
  - ▶ Reduced karst impact -
    - ▶ 20+ voids and clay seams/filled voids in original investigation to 7 for Option 1
      - ▶ Nearly 50 feet less of encountered voids and clay seams
  - ▶ Complexity of casing through the underground flow avoided
  - ▶ Risk of lost return from additional drilling paid off
    - ▶ Considerable Savings at Bents 1 and 3
  - ▶ Anticipated shorter construction schedule

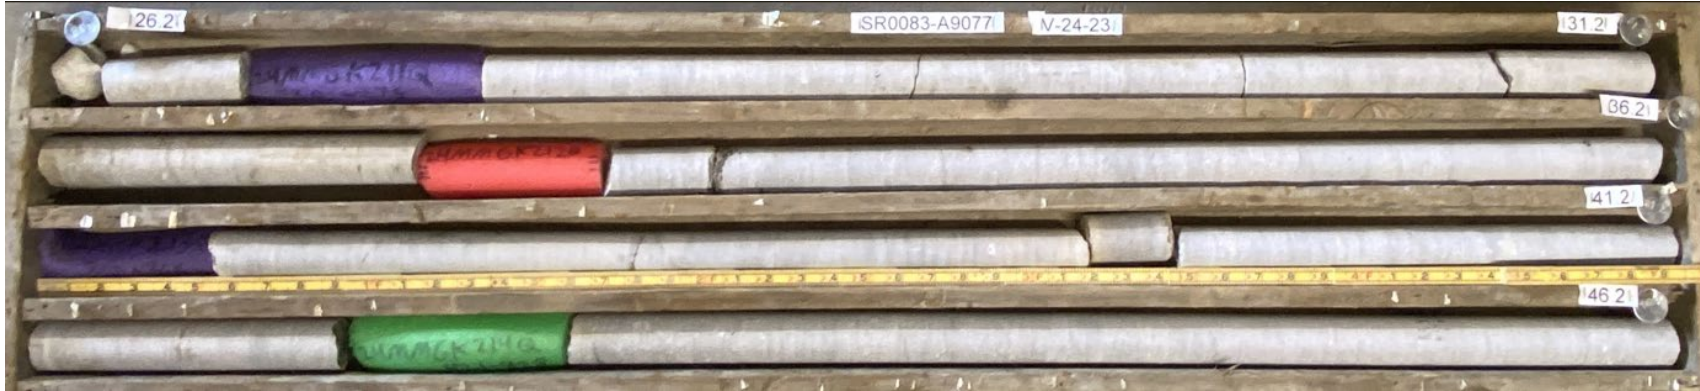
Bent 3 - Boring Opt1 B-302

- ▶ Good Recovery
- ▶ Good RQD
- ▶ Good Rock
- ▶ Few Karst Features

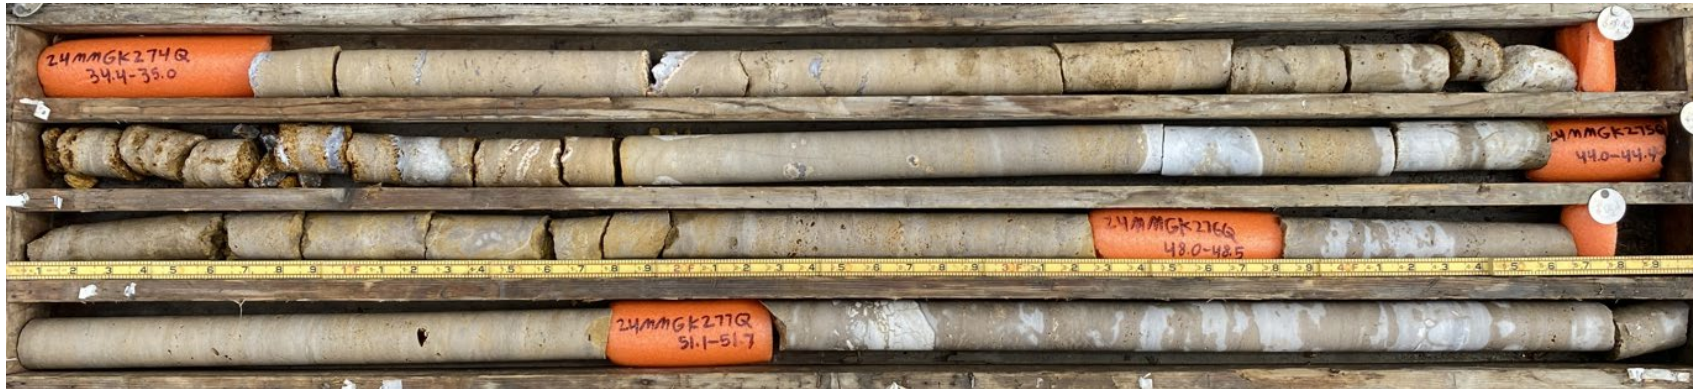
Bent 2 - Boring Opt1 B-201

- And the remaining borings encountered similar conditions

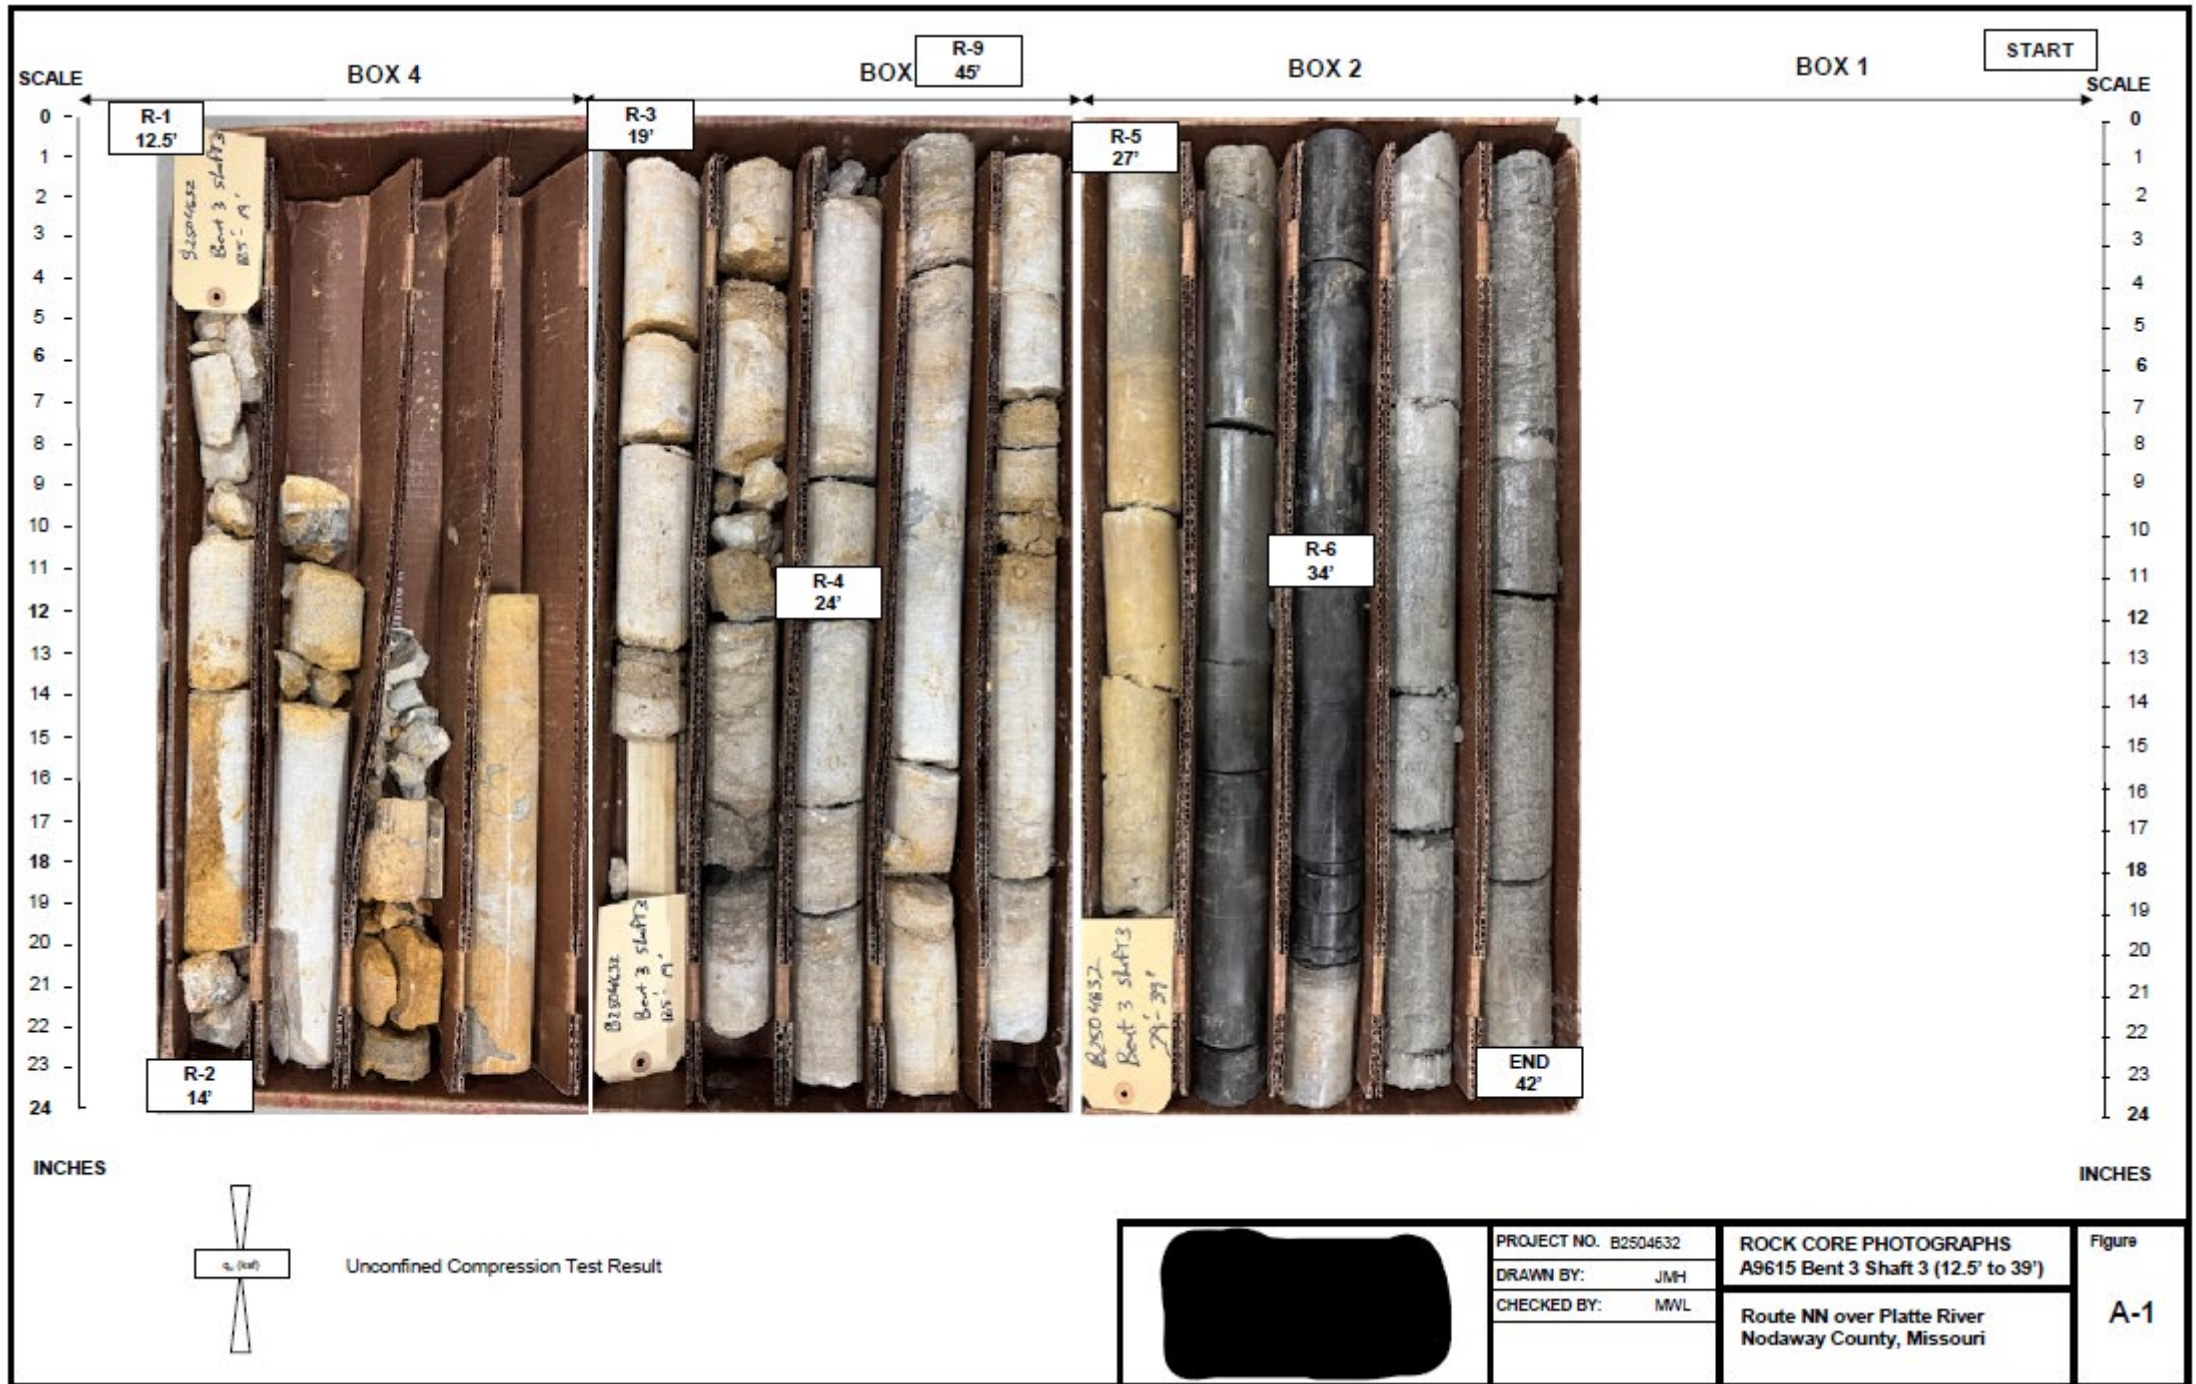
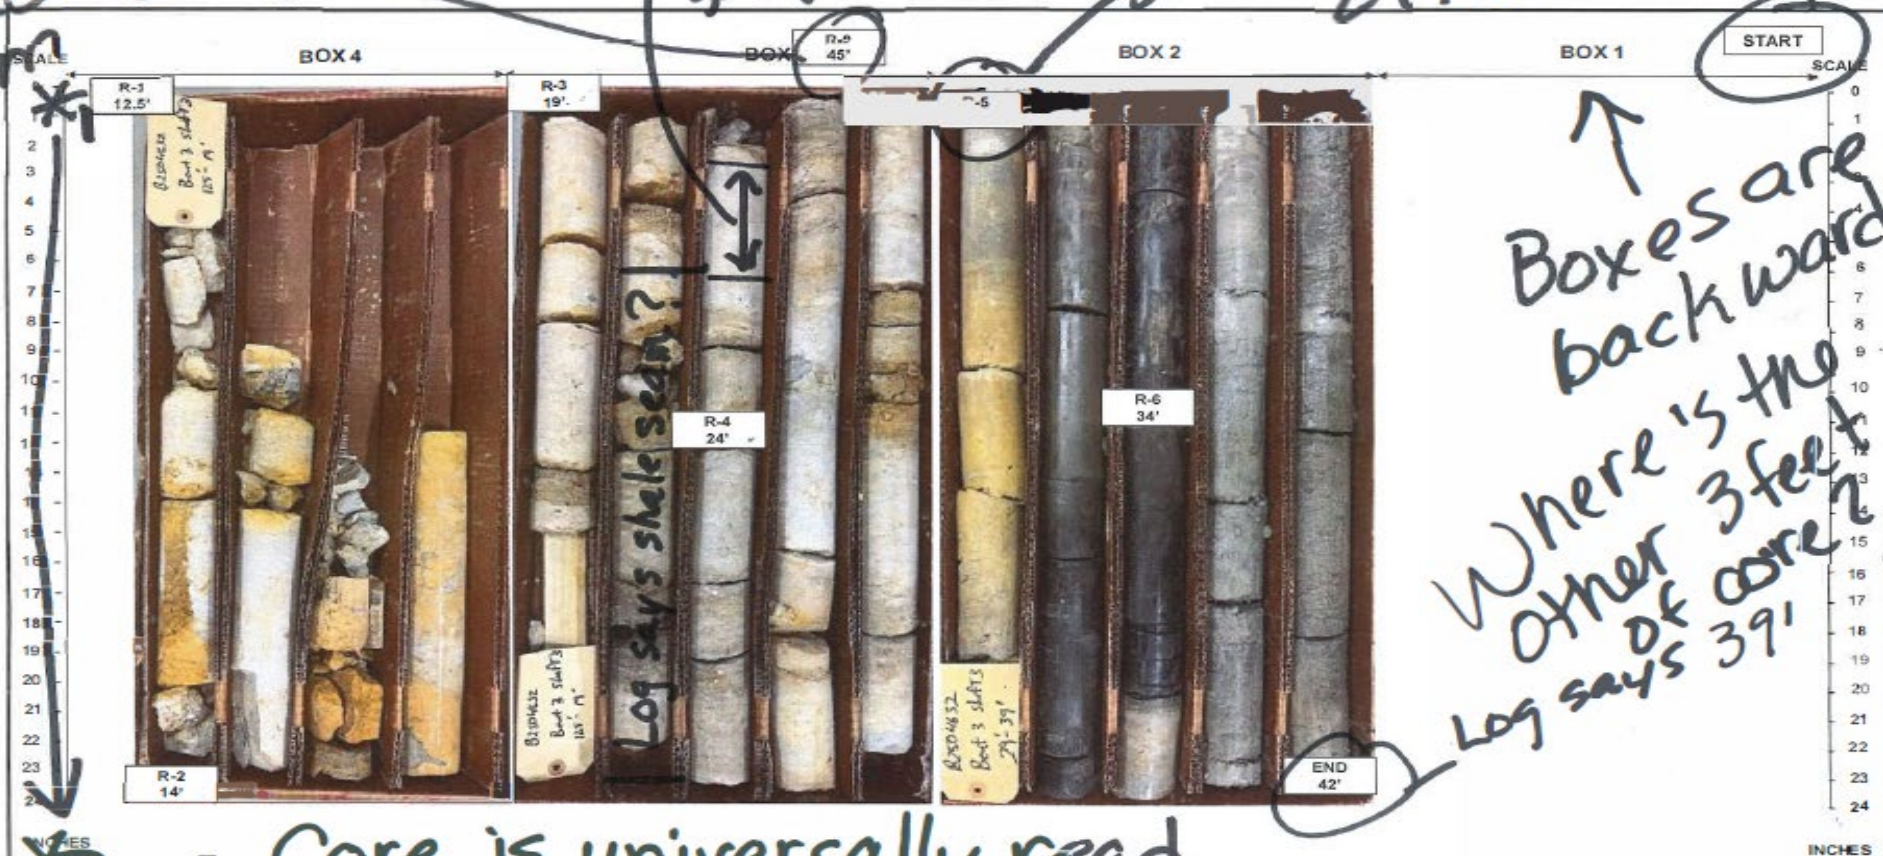
PROJECT NO. B250-4632	ROCK CORE PHOTOGRAPHS A9615 Bent 3 Shaft 3 (12.5' to 39')	Figure
DRAWN BY: JMH		A-1
CHECKED BY: MWL	Route NN over Platte River Nodaway County, Missouri

Are we reading from ~~\*~~

Log skys washout?

Should this be 29 feet?

↑  
Boxes are  
backwards.  
Where is the  
other 3 feet  
of core?  
Log says 39'

Core is universally read  
from left to right  
in a box laying horizontally

- ▶ Not all Consultants are amazing, and some may need a little coaching!
- ▶ It pays to review even if it is sign/sealed by a P.E.
