FHWA-Indiana Environmental Document
CATEGORICAL EXCLUSION / ENVIRONMENTAL ASSESSMENT FORM
GENERAL PROJECT INFORMATION

Road No./County:	United States (US) Route 421, Clinton County
Designation Number(s):	Des. No. 2200665
Project Description/Termini:	Small Structure Culvert Replacement, US 421, 0.67 mile south of SR 26 over a drainage swale. The project extends 227 feet south and 188 feet north of the structure center.

This is page 7 of 21 Project name: US 421 Small Structure Replacement at Drainage Swale Date: March 7, 2025

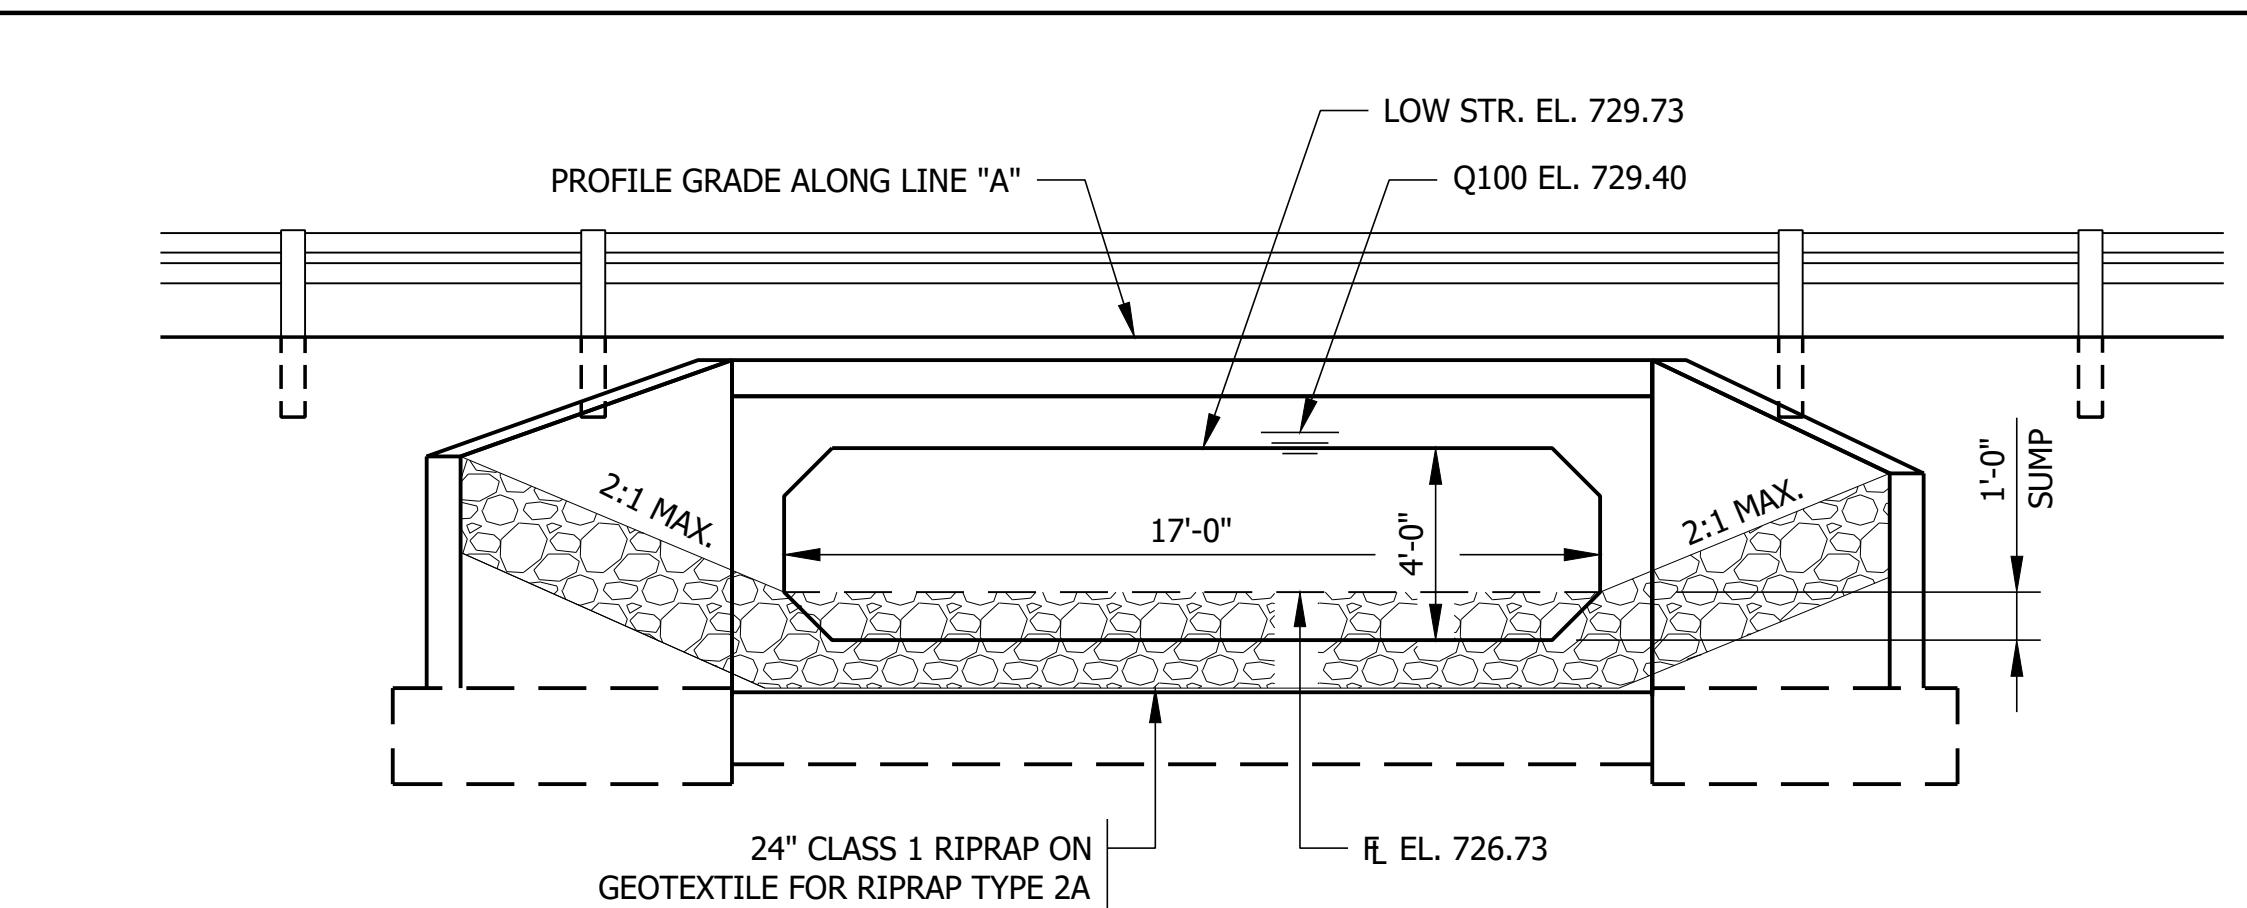
OUTLET ELEVATION

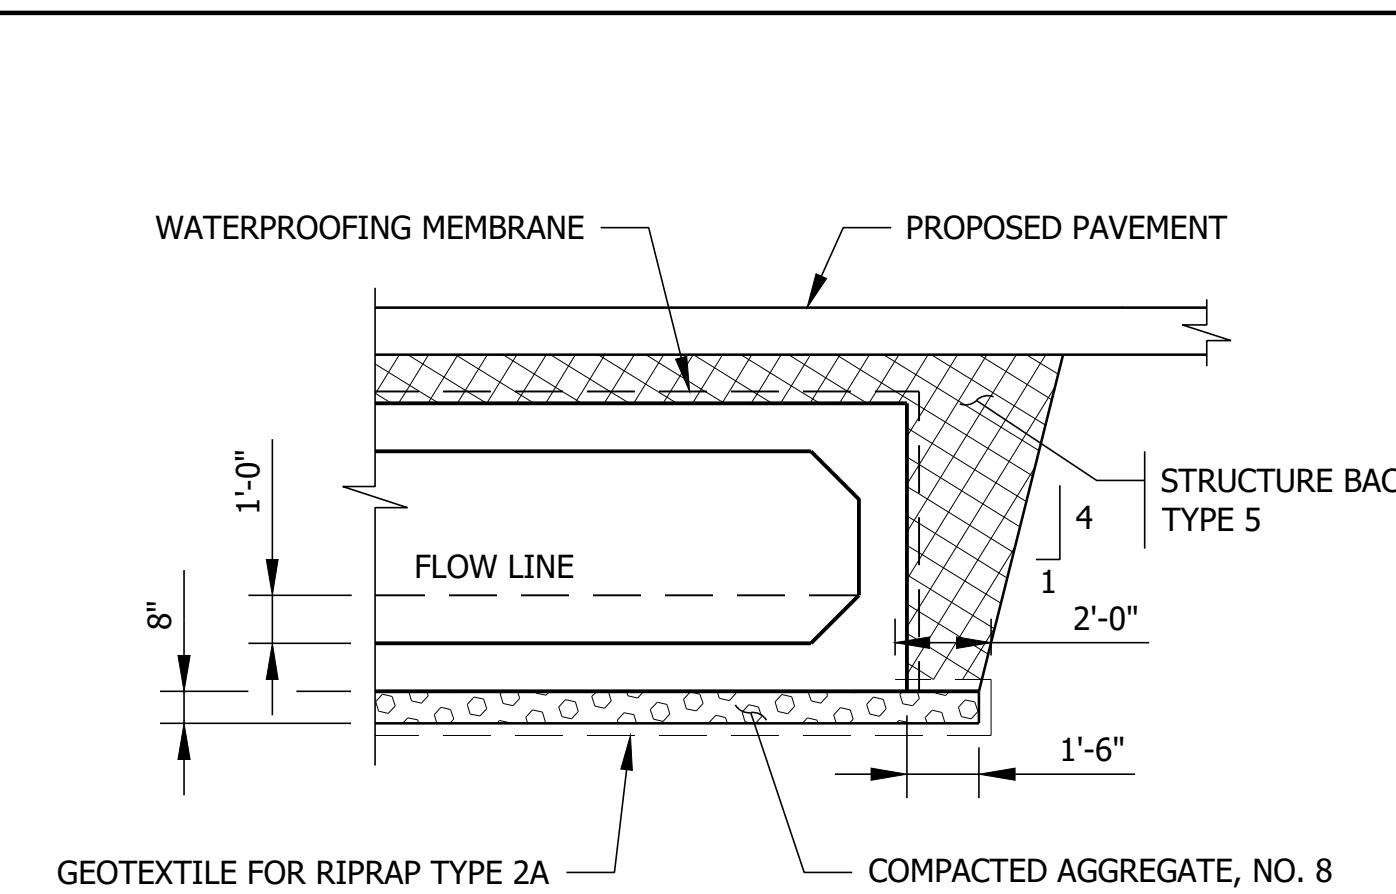
STRUCTURE BACKFILL AT STRUCTURE

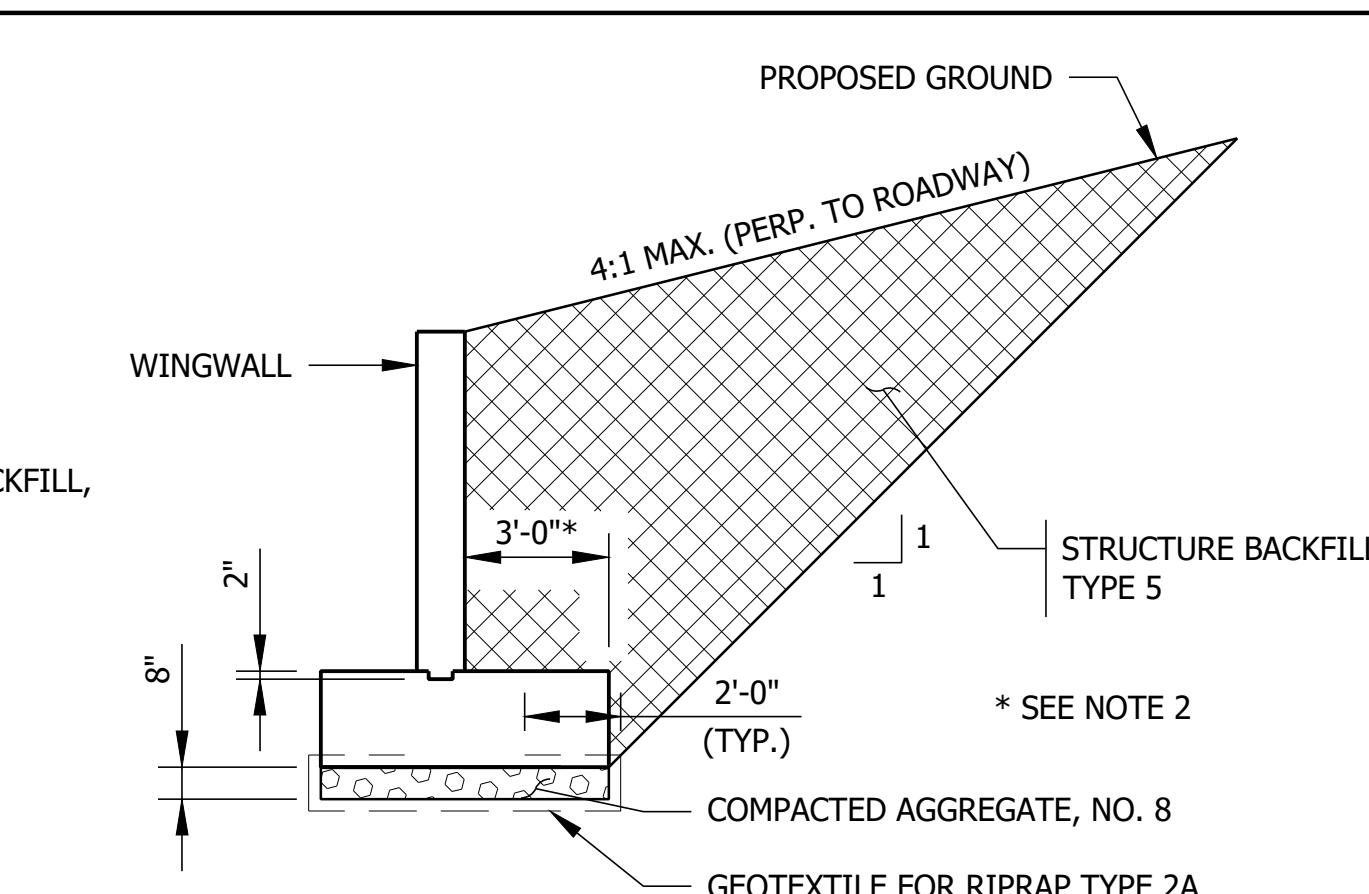
STRUCTURE BACKFILL AT WINGWALL

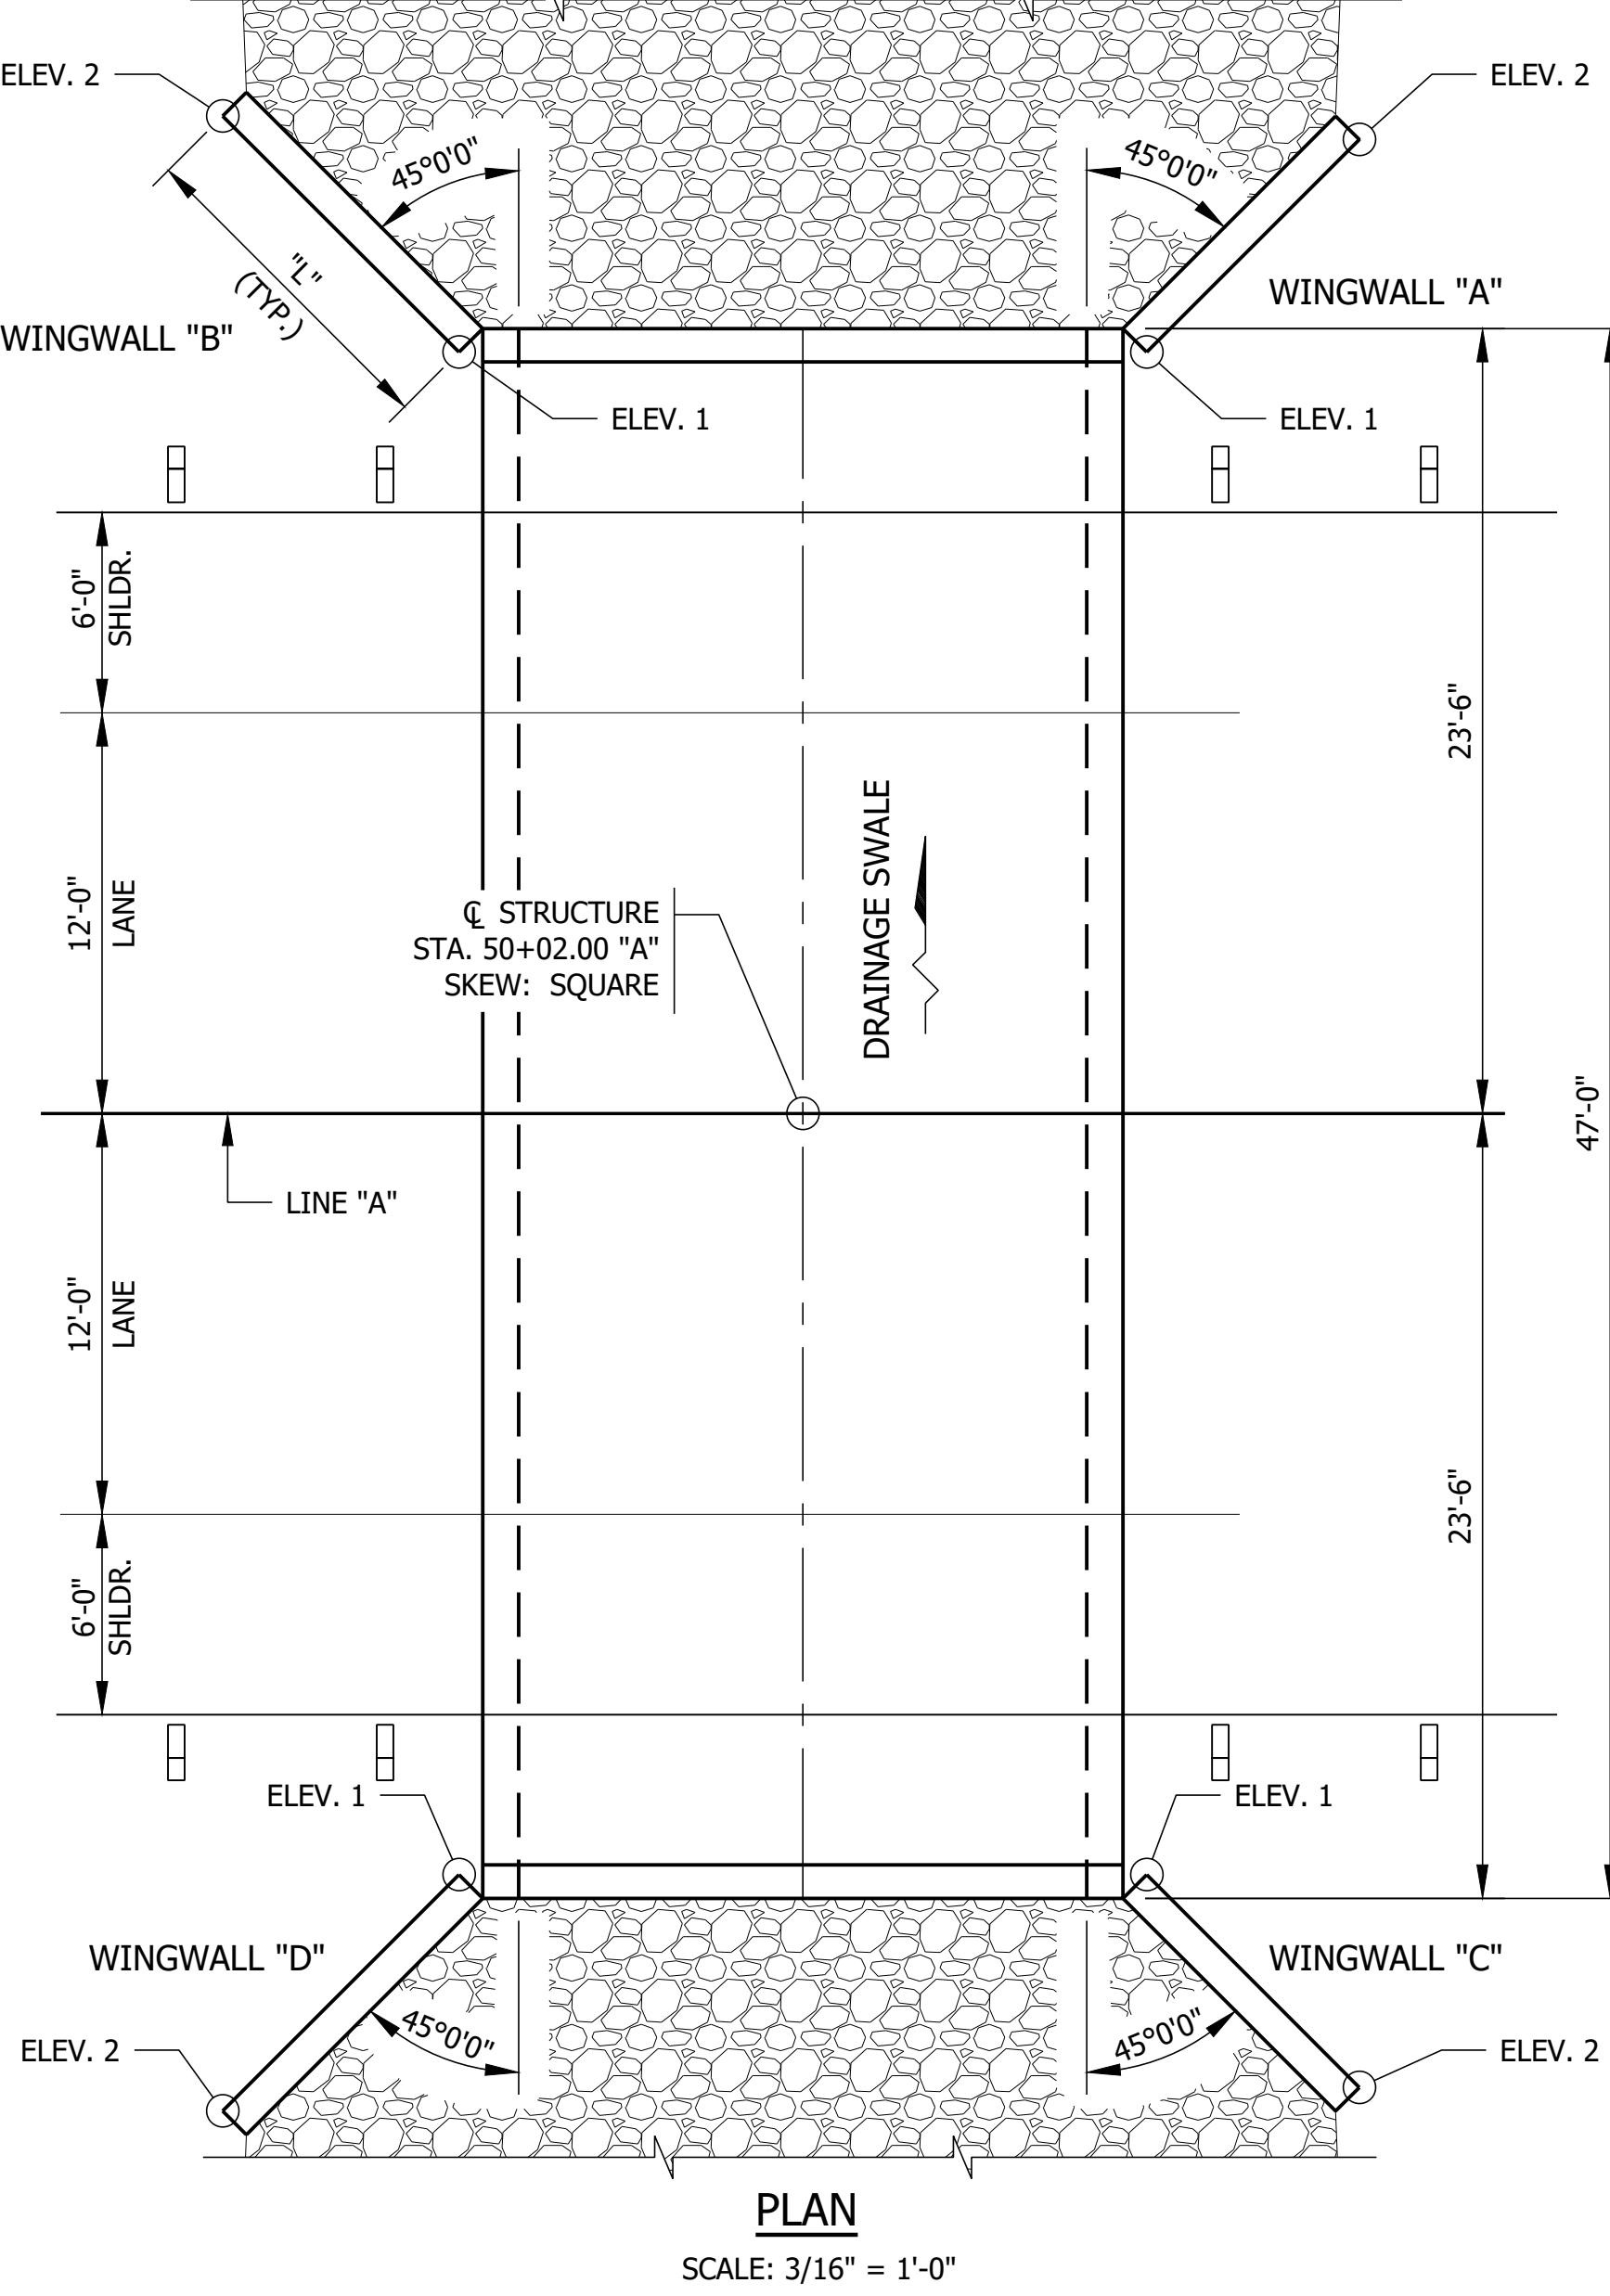
PLAN

The existing structure (CV 421-012-133.62) is an 8-foot span, a 4-foot rise, and a 32-foot length three-sided slab top structure. The project will include the complete removal and replacement of the existing structure. The existing structure will be replaced with a 17-foot span, 4-foot rise, by 47-foot-long reinforced concrete box structure. Riprap on geotextiles will be placed at the inlet and outlet of the new structure.

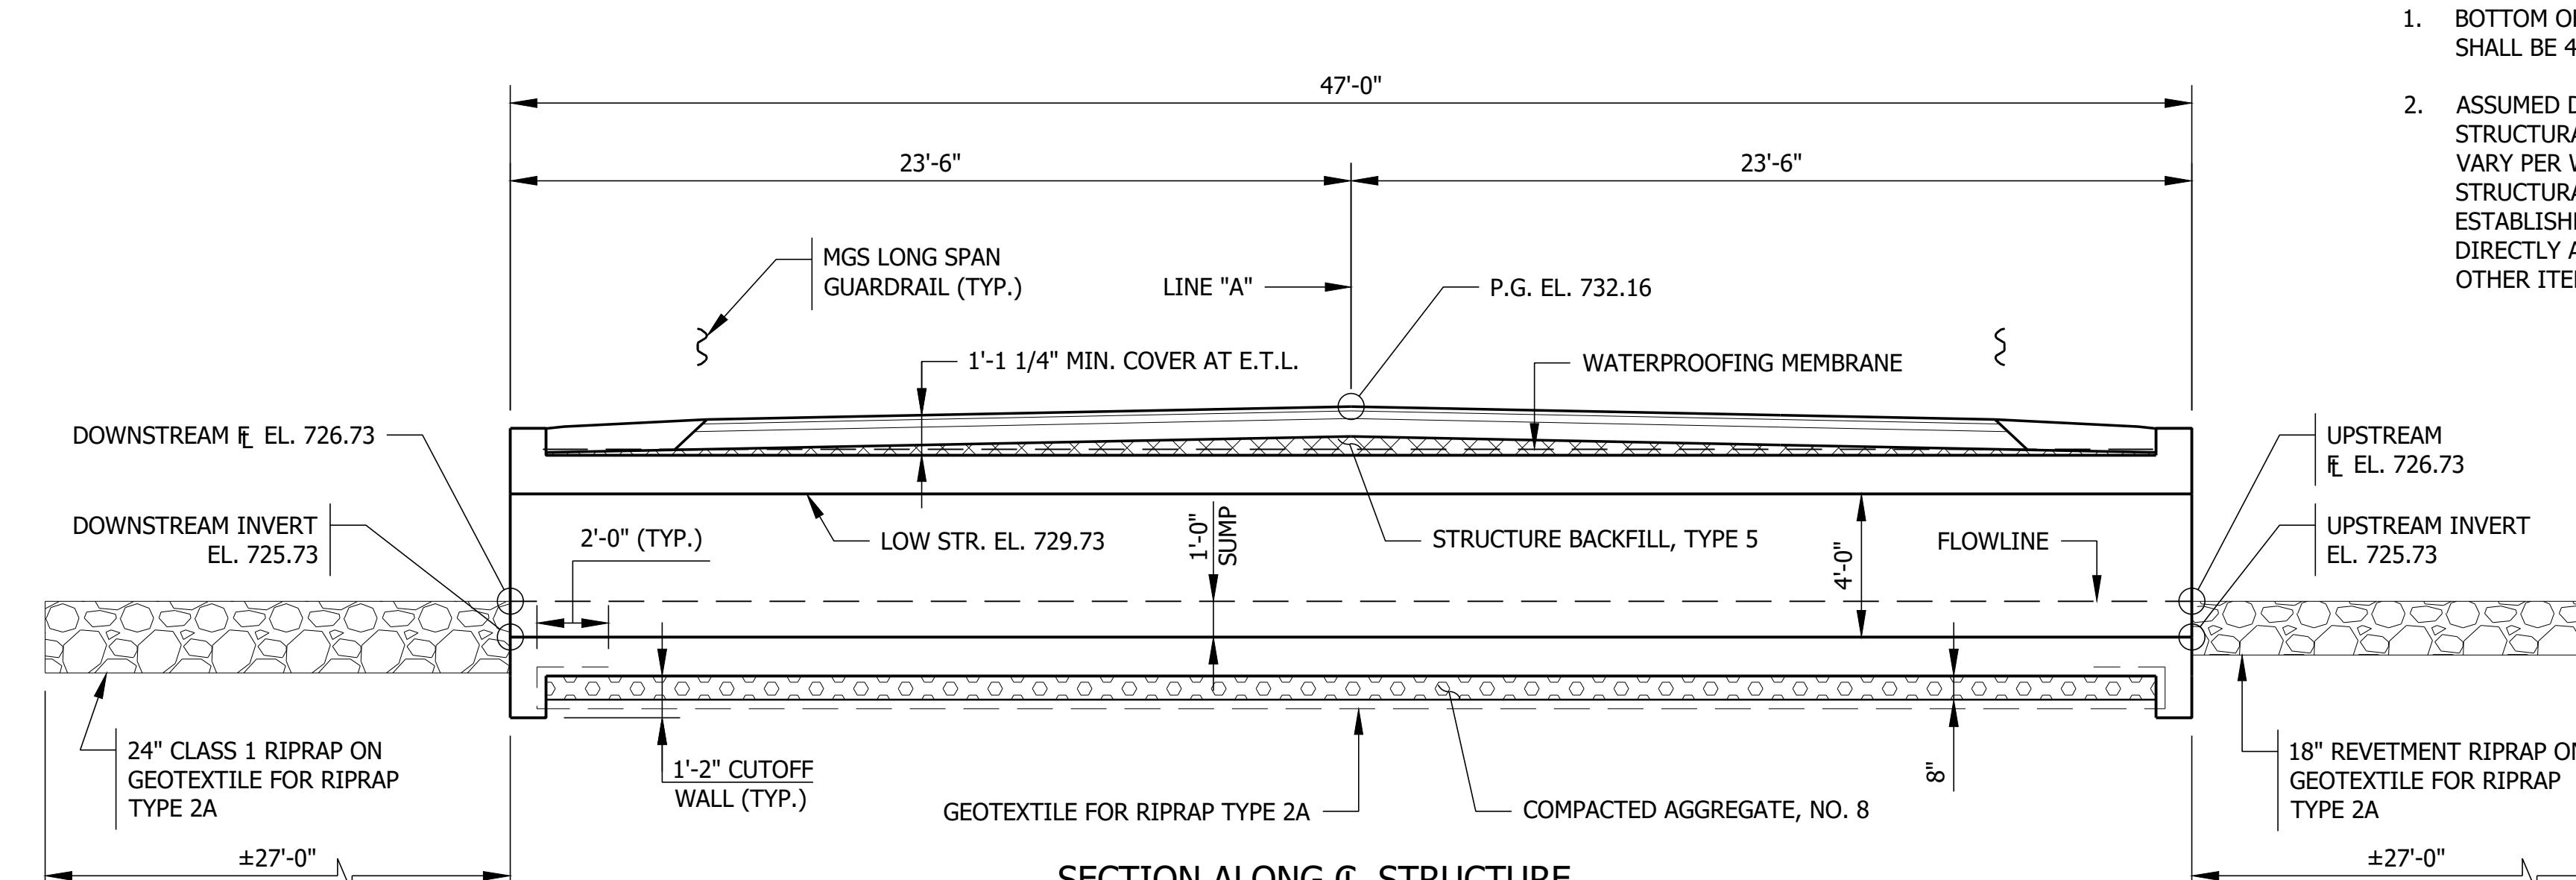
SECTION ALONG C STRUCTURE

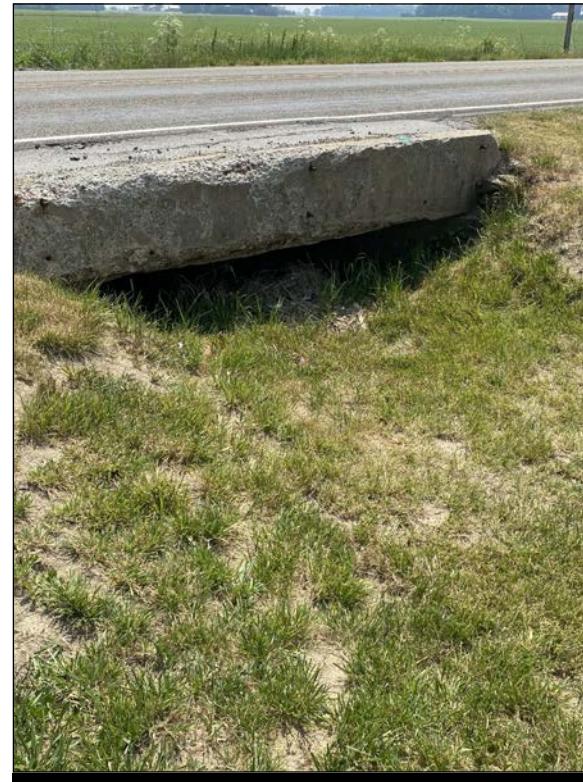
Picture 2—RSD1 project structure outlet, southeast view; 8 JUN 2023.

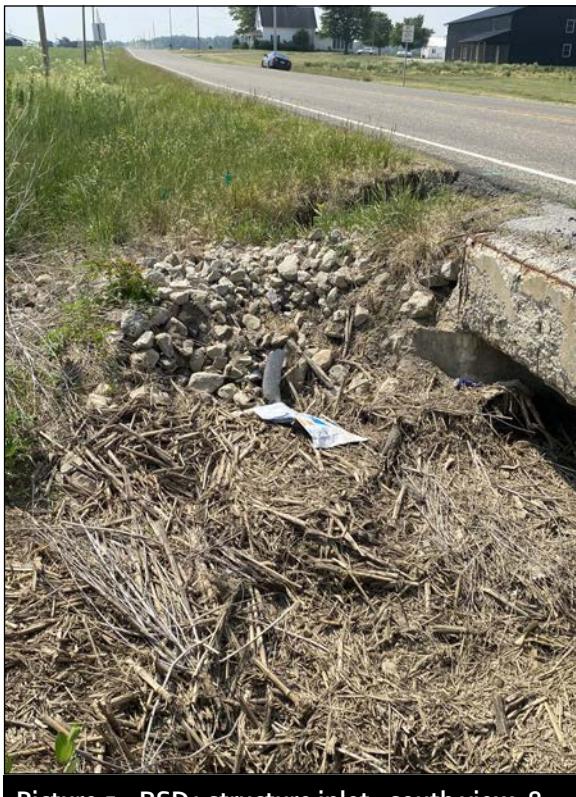
Picture 5—RSD1 structure inlet; south view; 8 JUN 2023.

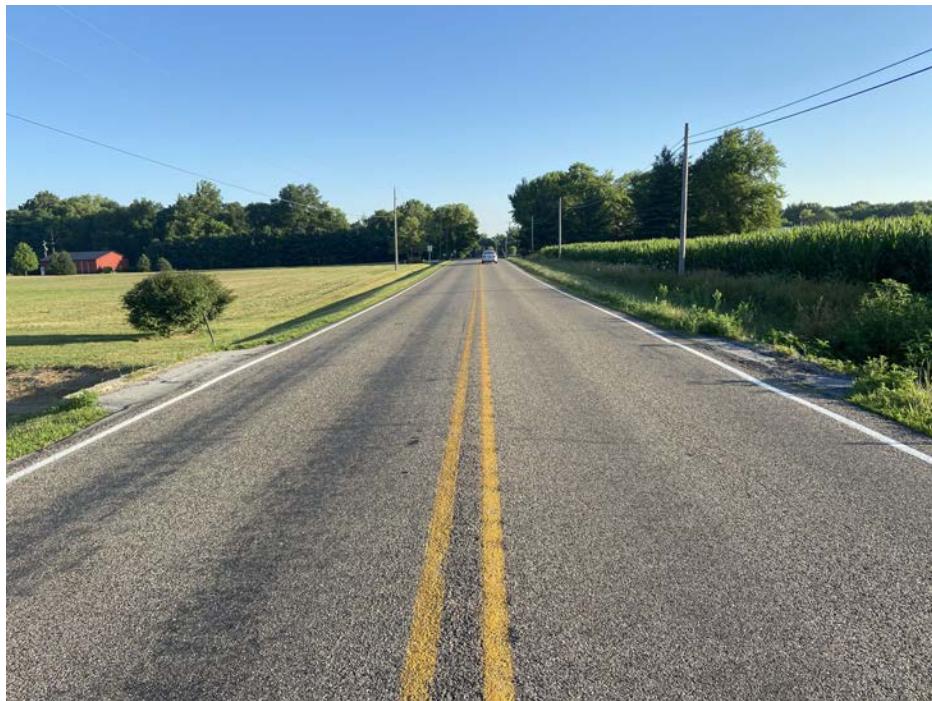
PHOTO 1

Description Alignment Looking North

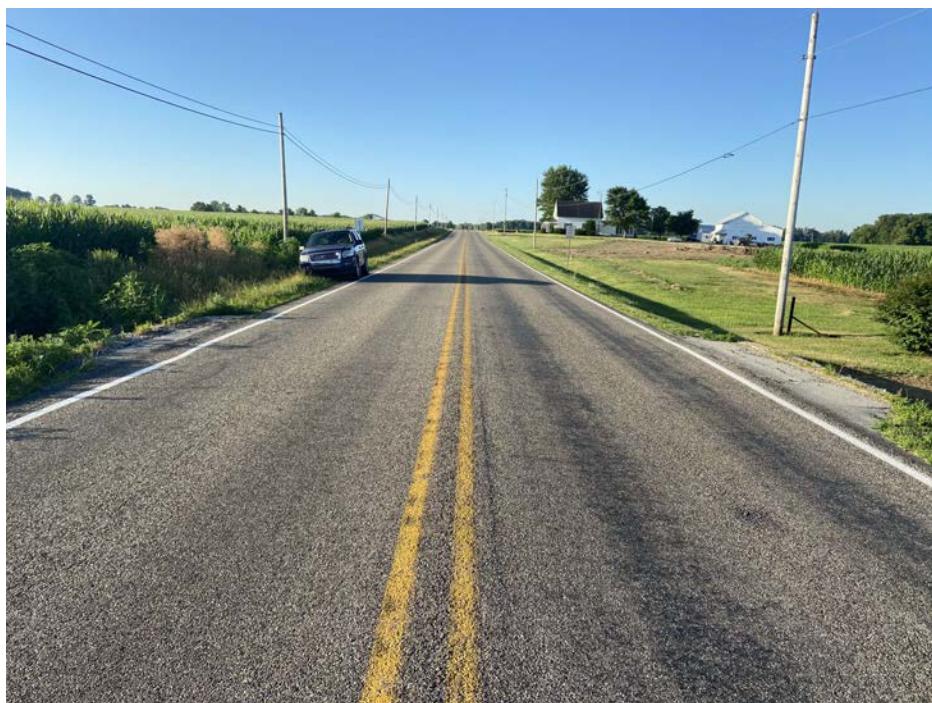
PHOTO 2

Description Alignment Looking South

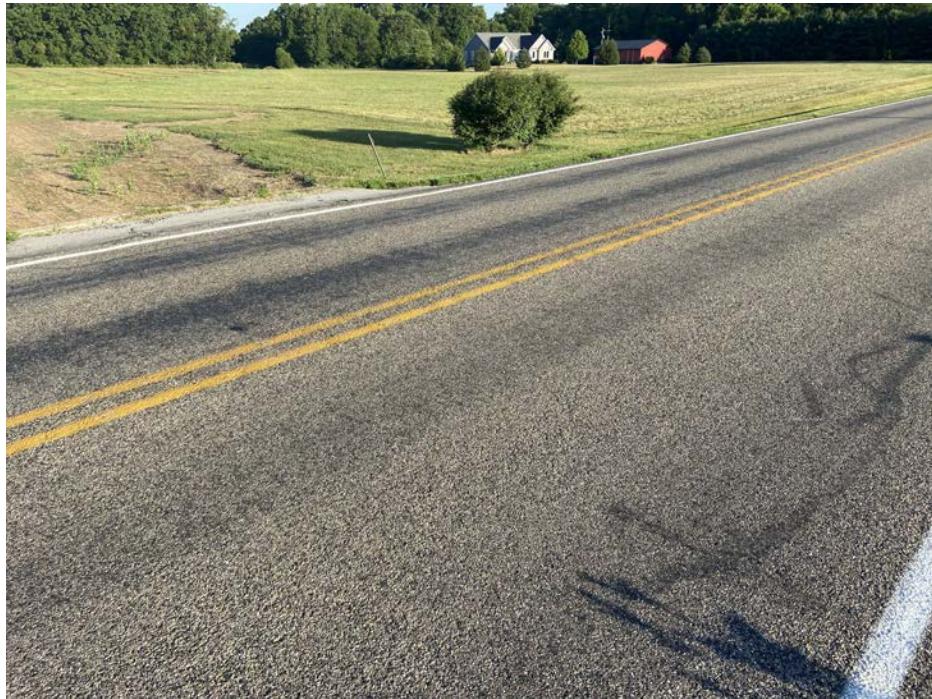
PHOTO 3

Description Wearing Surface

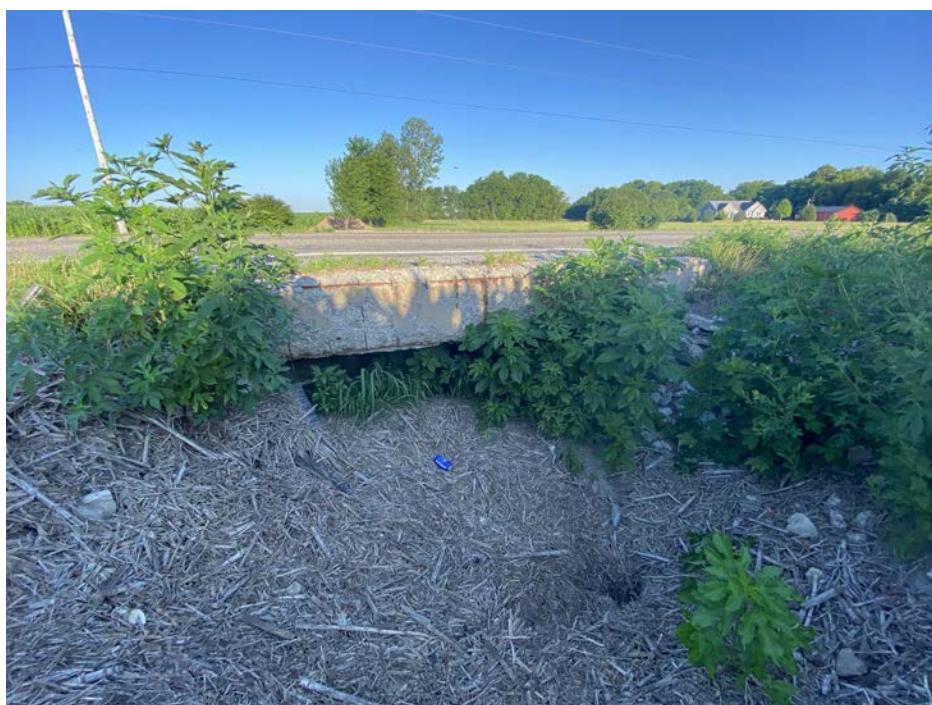
PHOTO 4

Description East Elevation

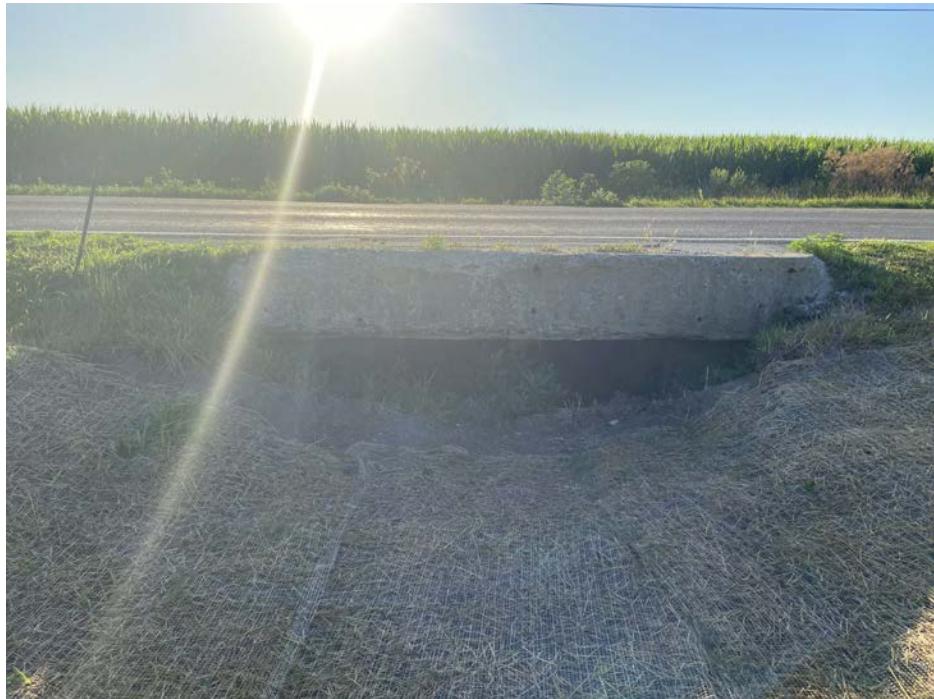
PHOTO 5

Description West Elevation

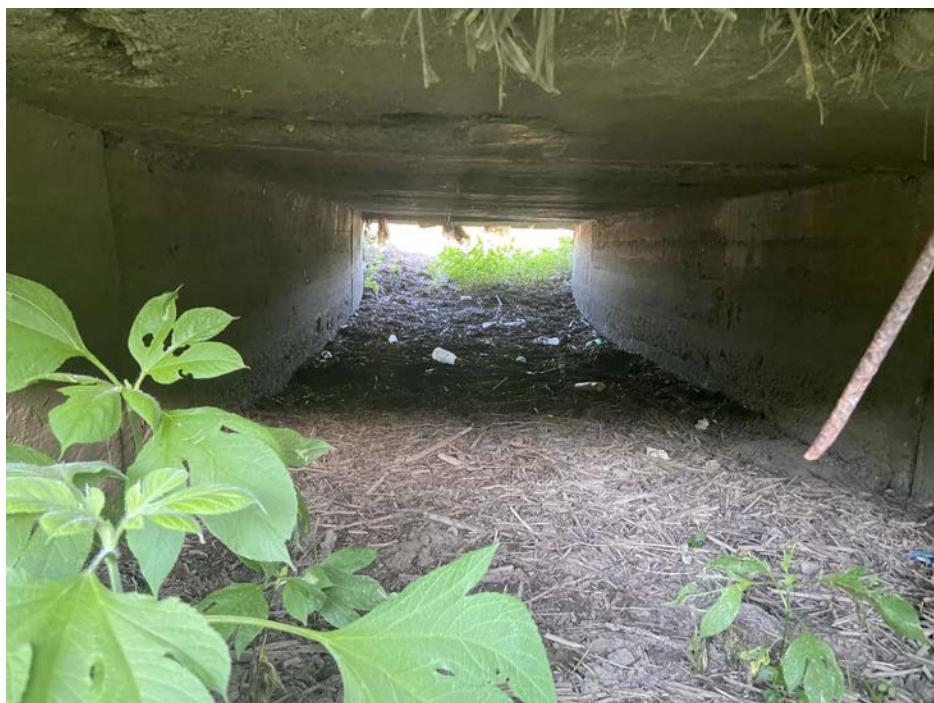
PHOTO 6

Description Interior Looking West

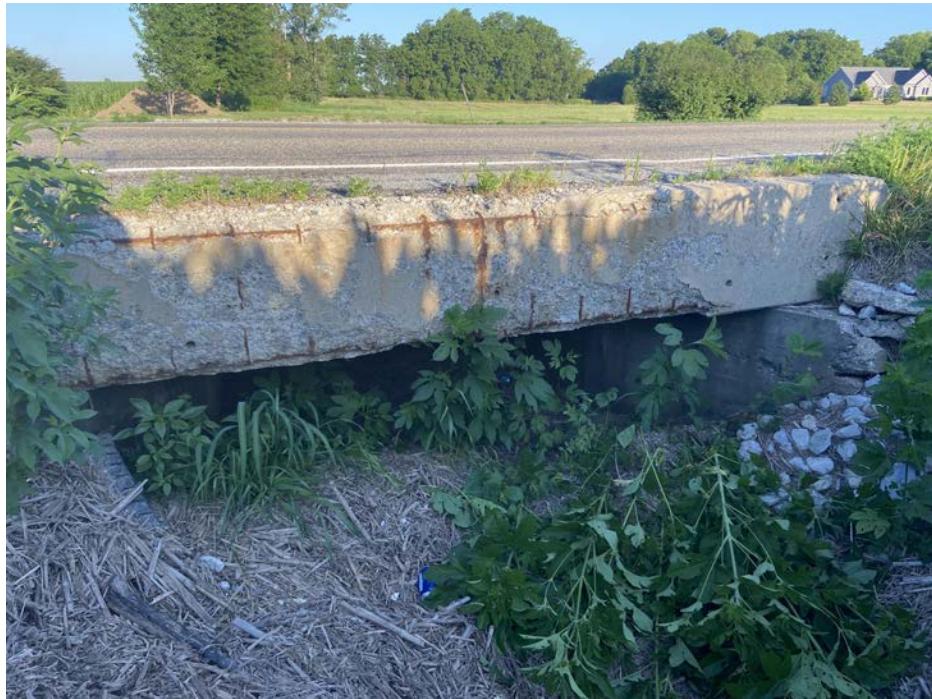
PHOTO 7

Description Heavy Spalling on the East Widening Channel Beam

Need: The need for this project is due to the condition of the existing reinforced concrete box structure (CV 421-012-133.62). There is heavy spalling with exposed rebar and cracking with efflorescence throughout the structure. The structural evaluation rating from the culvert inspection report is a 4 (poor condition) on a scale from 0 (failed condition) to 9 (excellent condition). See the culvert inspection report dated July 13, 2022 for more details (Appendix I-2 to I-18).

Existing Conditions: The existing structure is a three-sided slab top structure with an 8-foot span, a 4-foot rise, and a 32-foot length. Structural deficiencies include heavy spalling with exposed rebar and cracking with efflorescence throughout the structure. The head walls have spalling with exposed rebar. The channel beams have cracks with efflorescence and spalling with exposed rebar. There is bank erosion at the east end of the structure and there is sediment build up at the west end of the structure. Per the inspection, the original slab of the structure has been widened in the past (Appendix I-8). As documented in the Waters of the U.S. Determination report, drainage flows west through a drainage swale served by the small structure and encounters Campbells Run (Appendix F-4 to F-5, WOTUS Report identifies the drainage swale as RSD-1). The small structure is surrounded by rural farmland. Overhead utilities are located within the project area and may be relocated to avoid conflict with the project. The existing US 421 pavement consists of asphalt on the travel lanes and shoulders. The northbound and southbound direction each have one 12-foot travel lane with a 2-foot usable shoulder. The functional class of US 421 is a *Minor Arterial*.

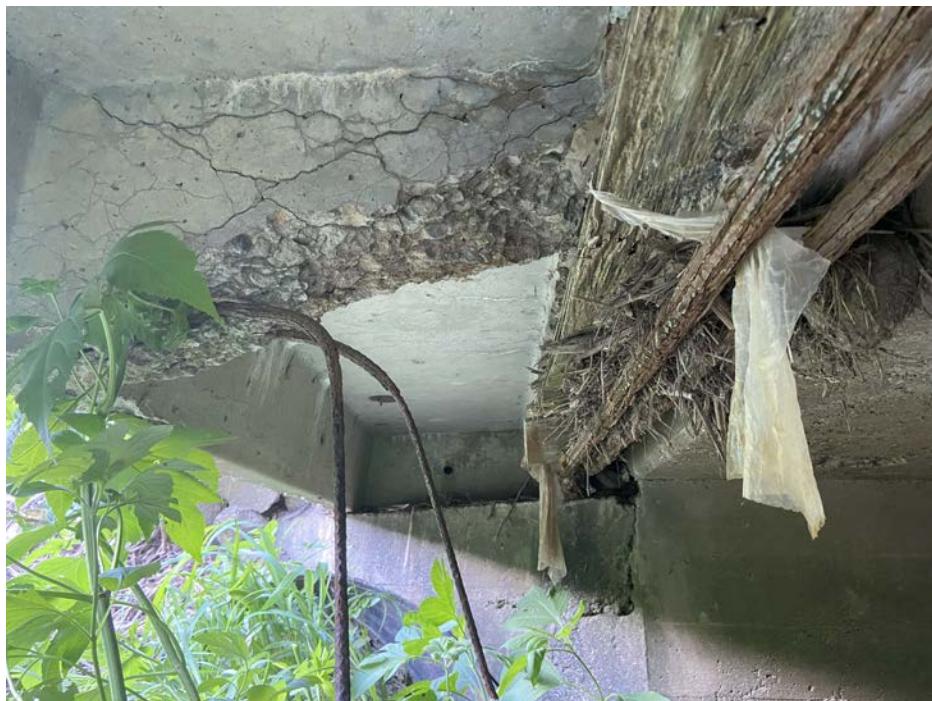
PHOTO 8

Description Heavy Spalling on the East Widening Channel Beam

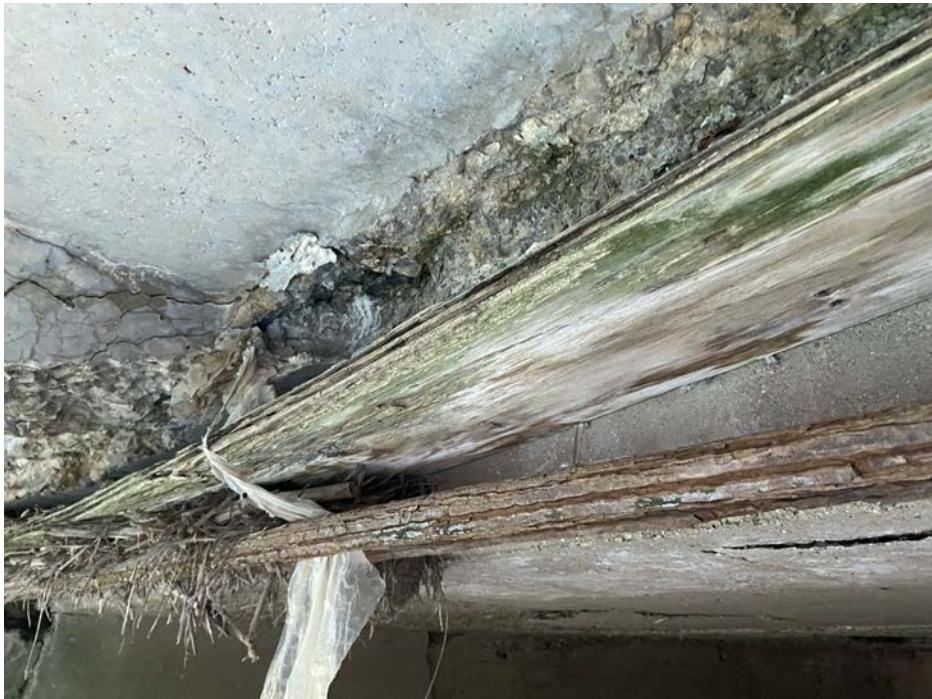
PHOTO 9

Description Heavy Spalling on the East Widening Channel Beam

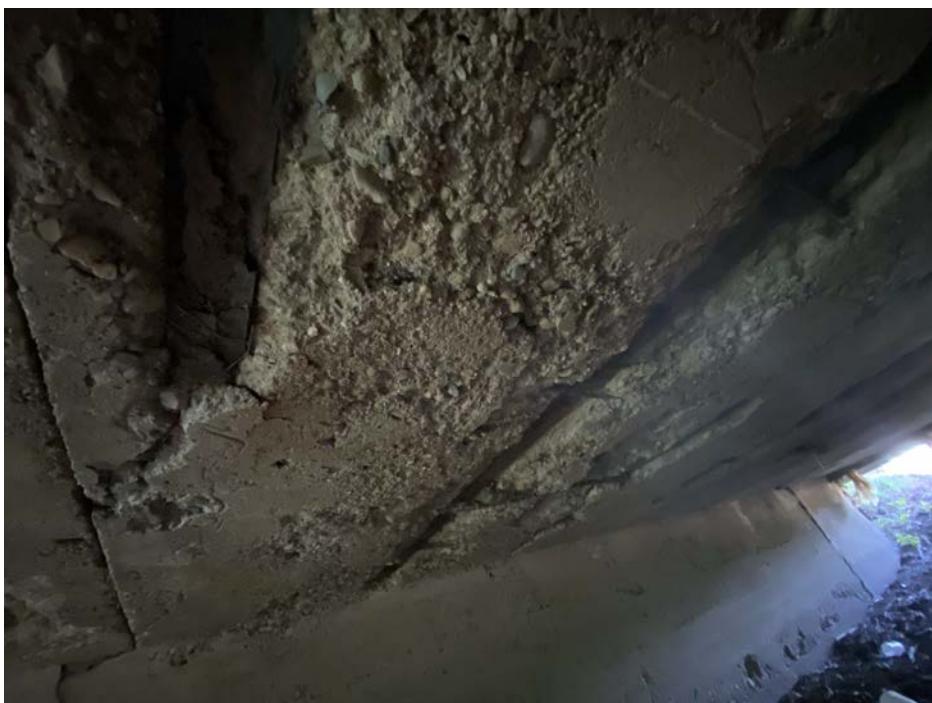
PHOTO 10

Description Heavy Spalling with Exposed Steel on the Original Slab

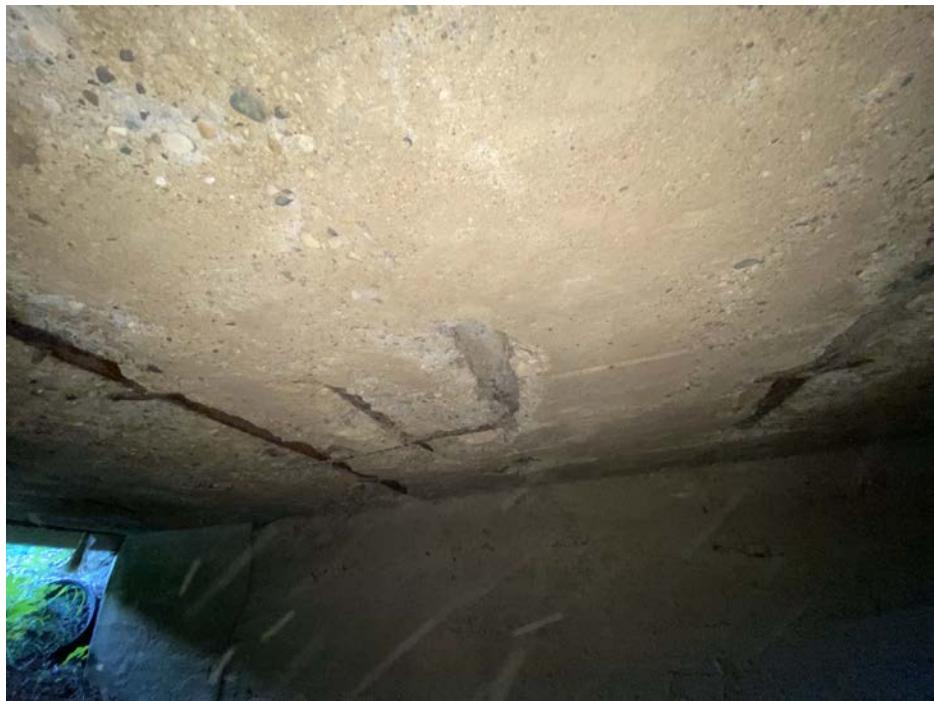
PHOTO 11

Description Heavy Spalling with Exposed Steel on the Original Slab

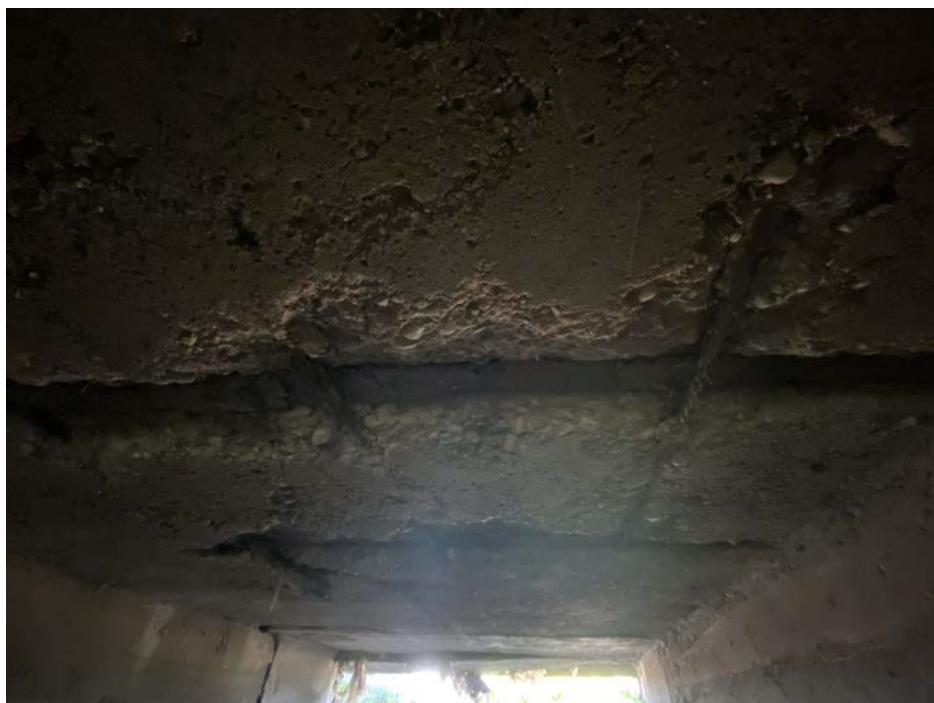
PHOTO 12

Description Heavy Spalling with Exposed Steel on the Original Slab

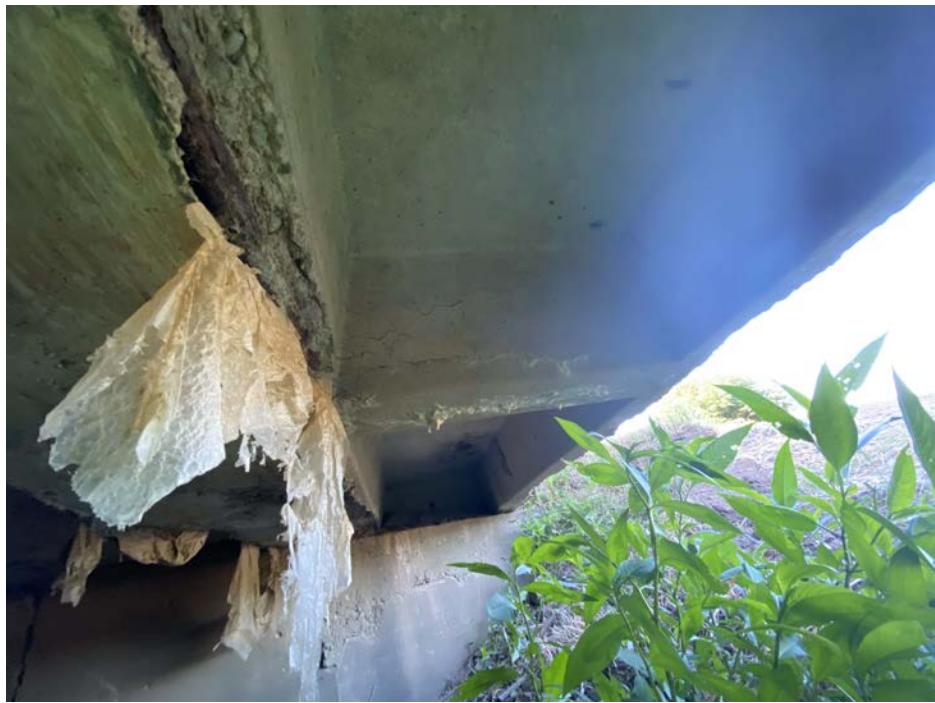
PHOTO 13

Description West Widening Beam

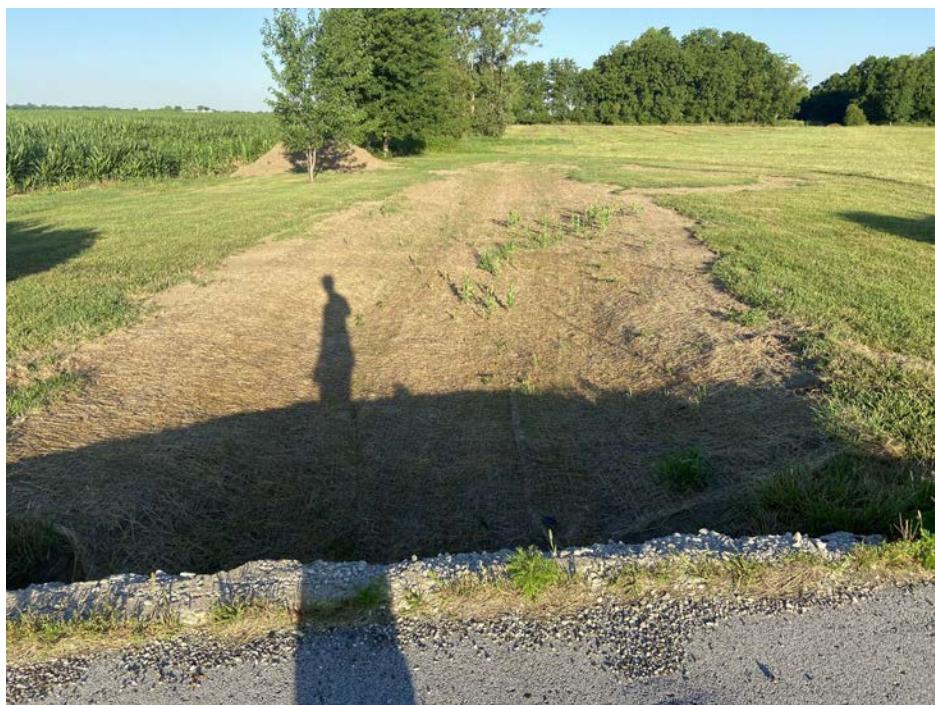
PHOTO 14

Description West Channel

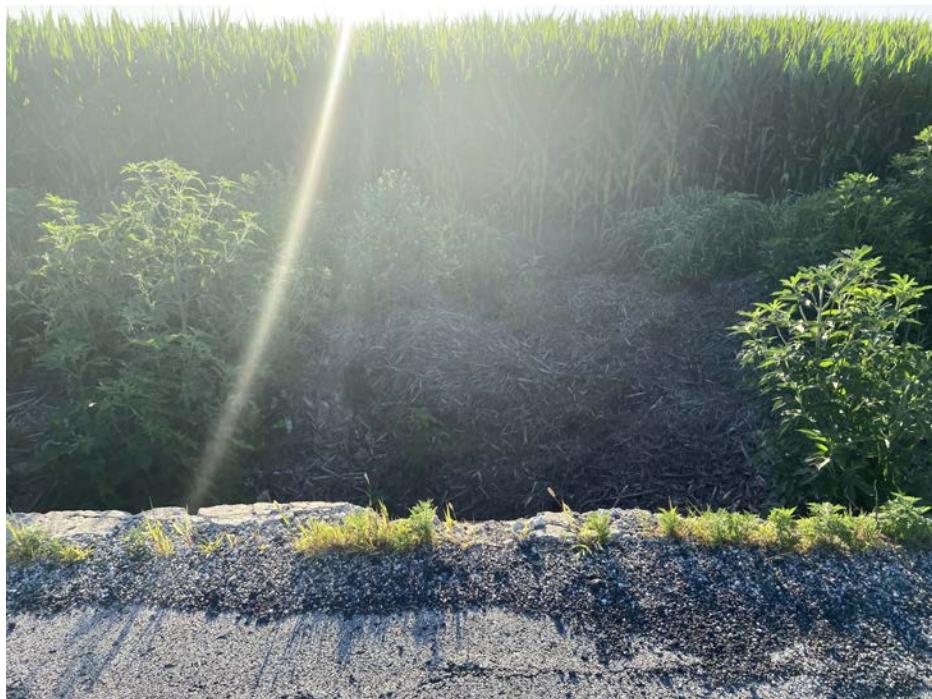
PHOTO 15

Description East Channel
