Inspections Start to Finish: Prep, Access, Safety, & Component Rating

Rob Coop, PE *Bridge Inspection Department Manager, USI*

Jake Gould, PE *Bridge Inspection Area Engineer, Indiana Department of Transportation*

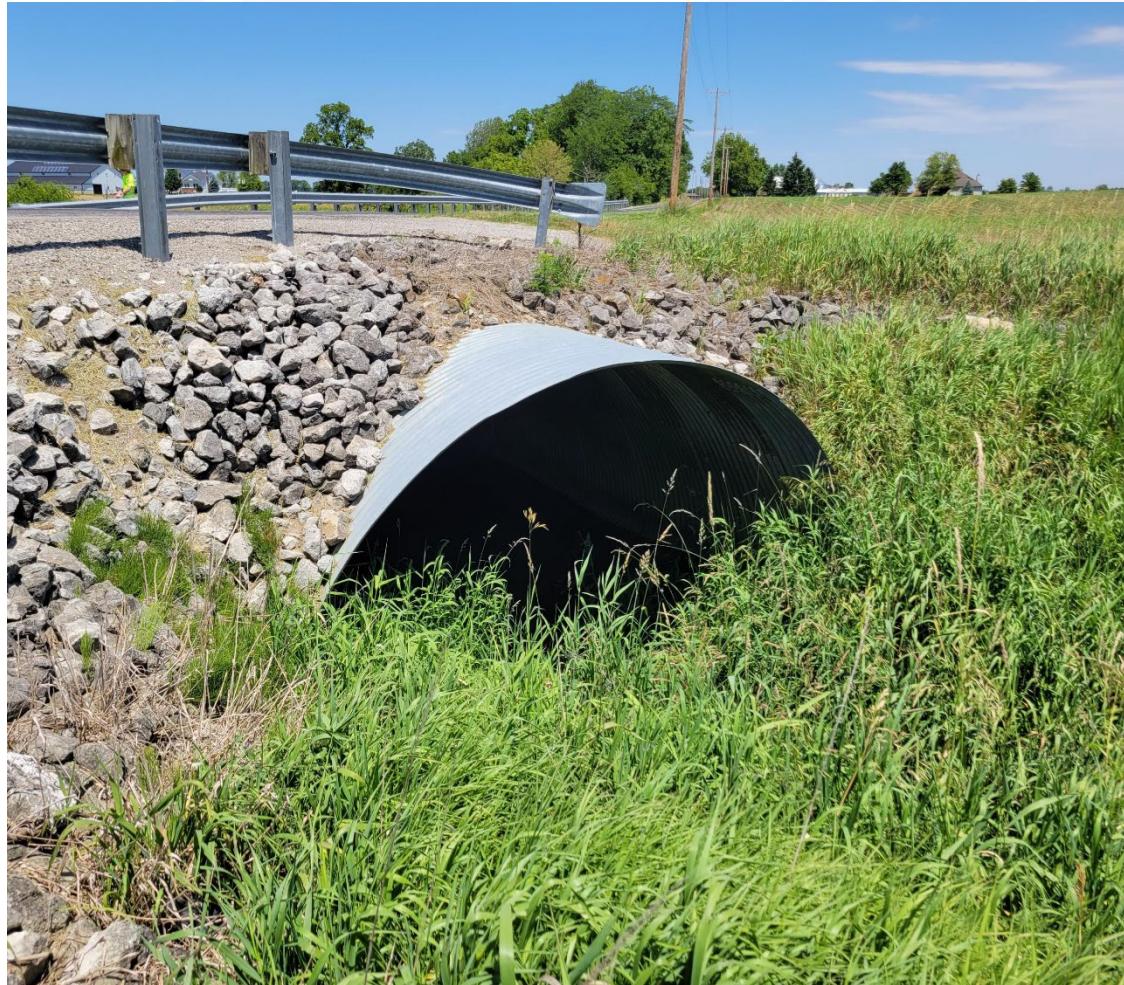
- Single Span Corrugated Metal Pipe

East Elevation

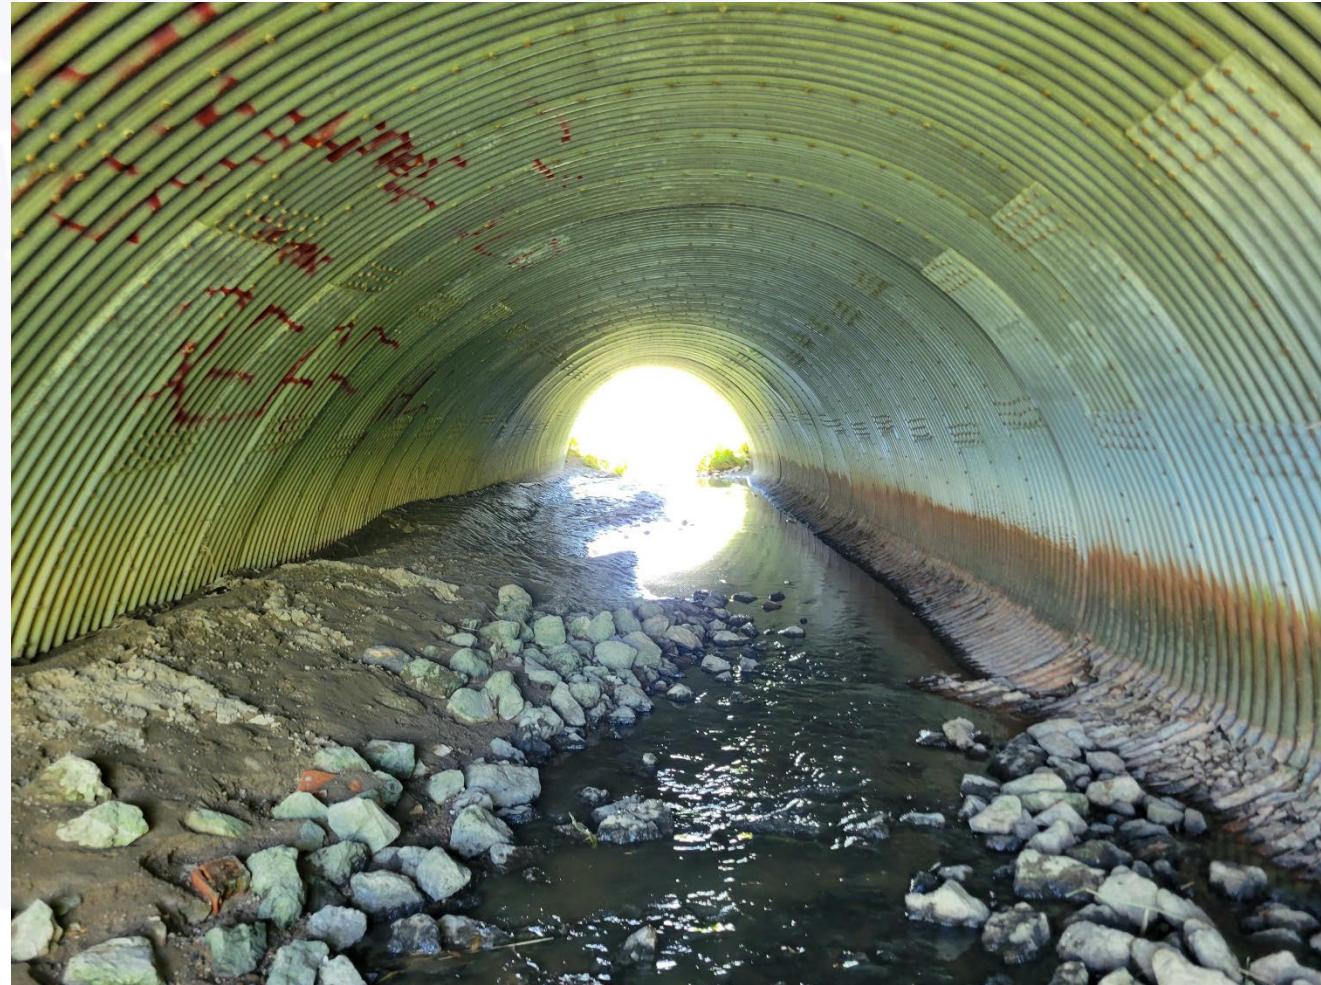
Interior of Structure

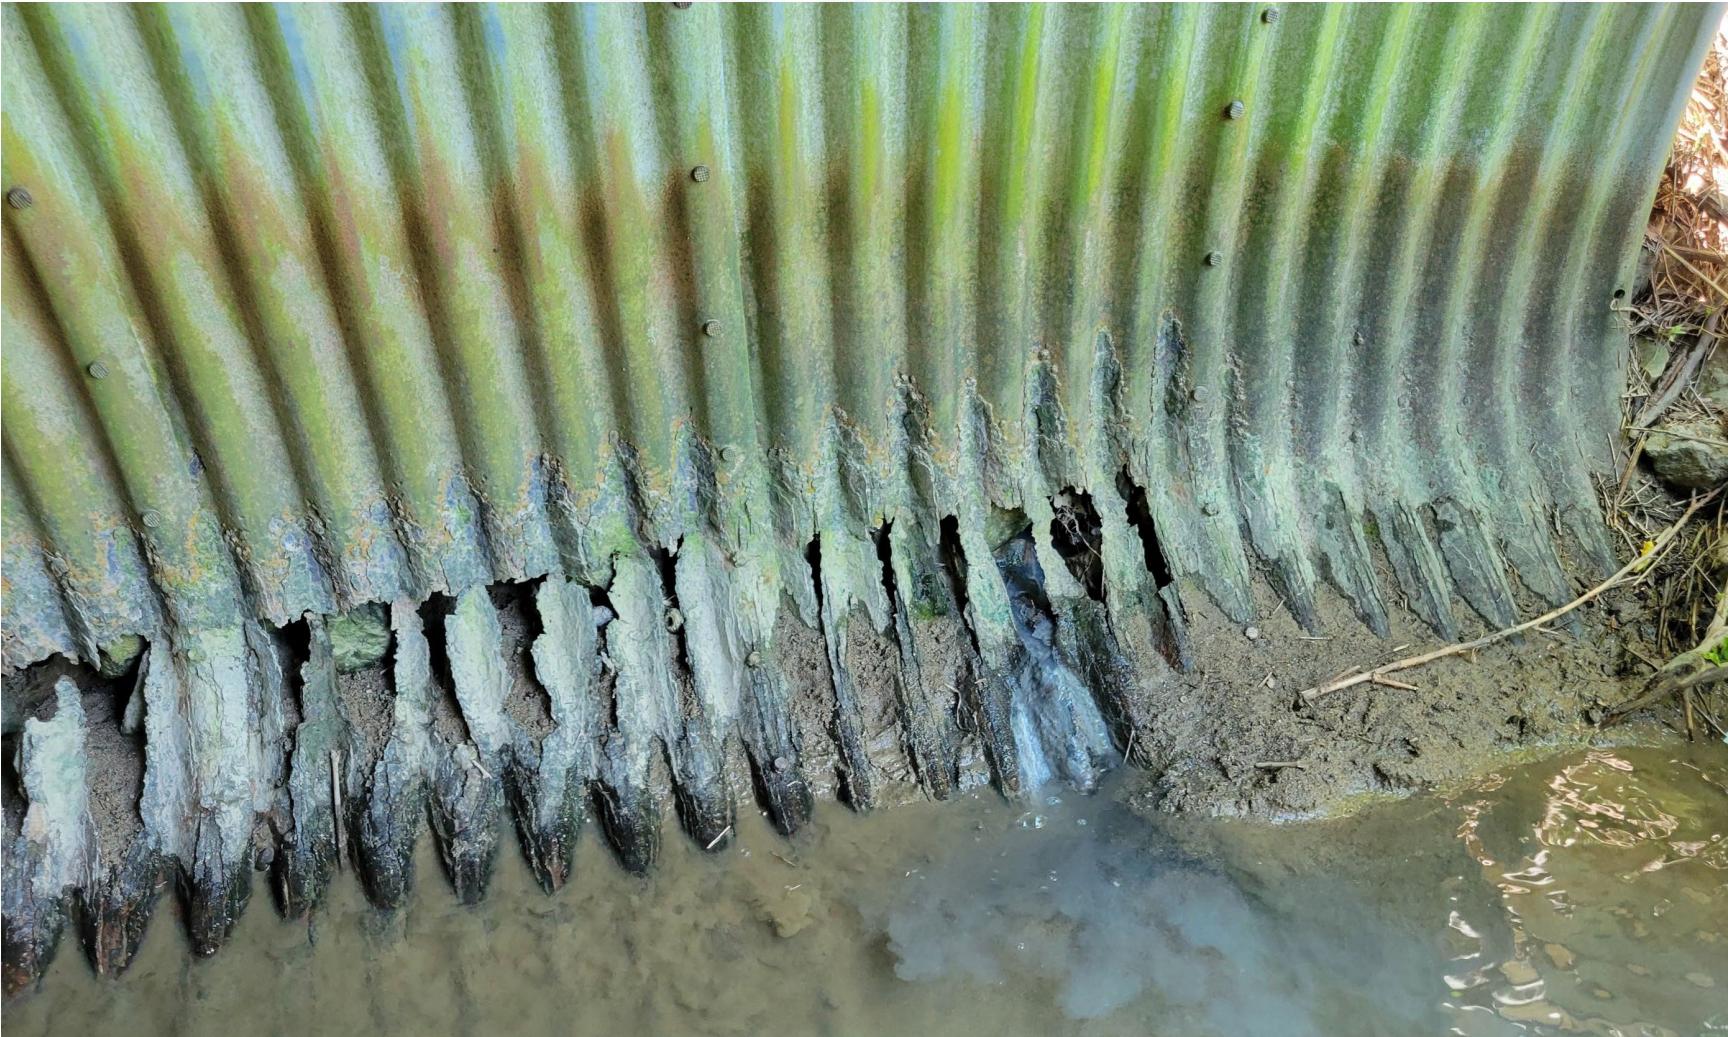
Rust Through at the Waterline

- Previous (62) Culvert rating: ??
- Comments:
 - Rust through (~1/3 the length) along the flow line at the south end of the structure. Backfill is seeping through the holes and riprap has been displaced. Rust through hole through the top of the structure near the outlet. Possible crushing at ~20' from the outlet.

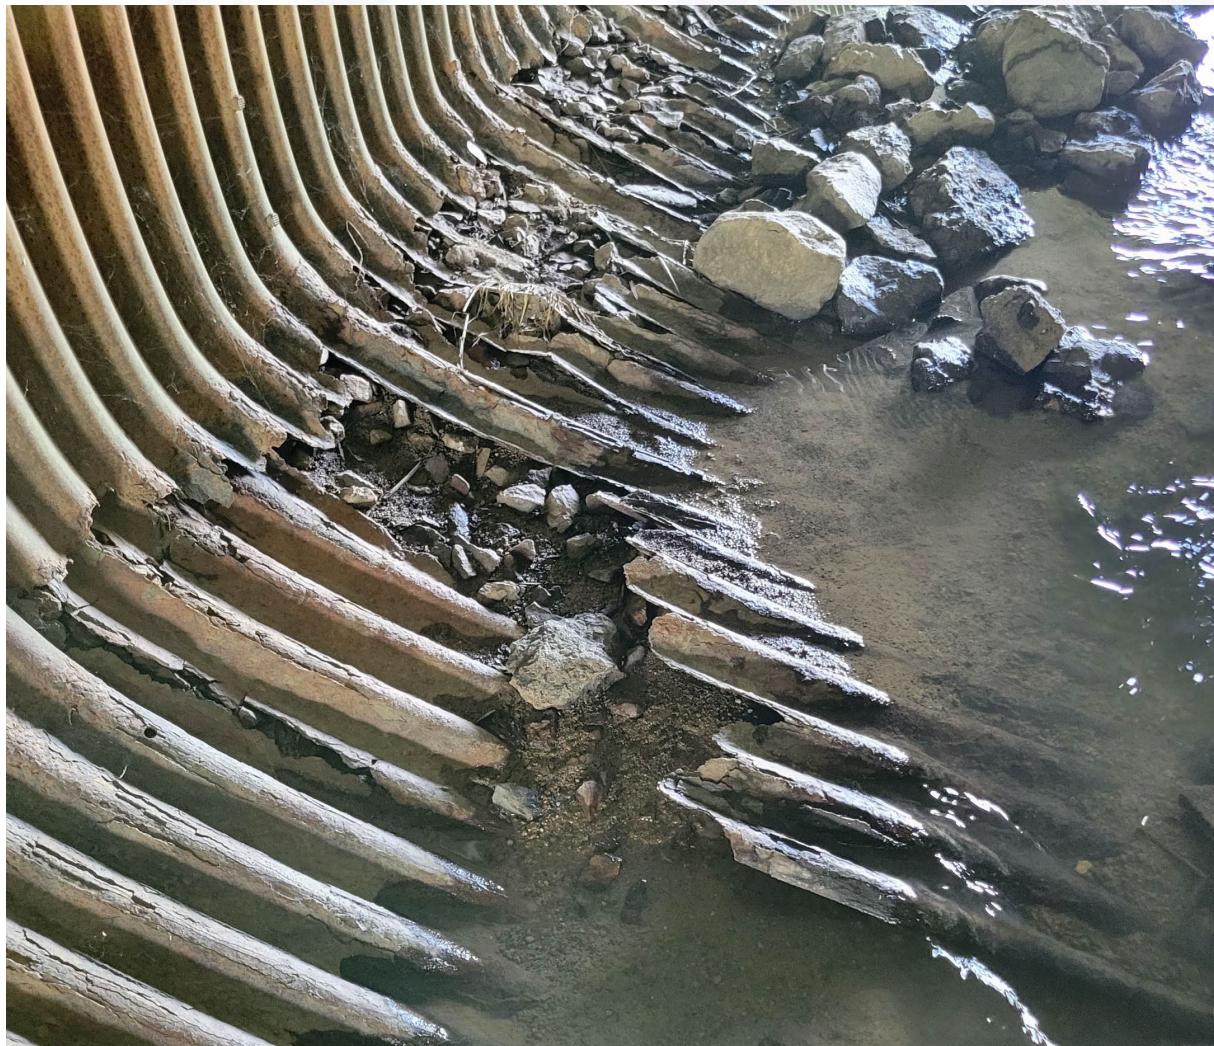
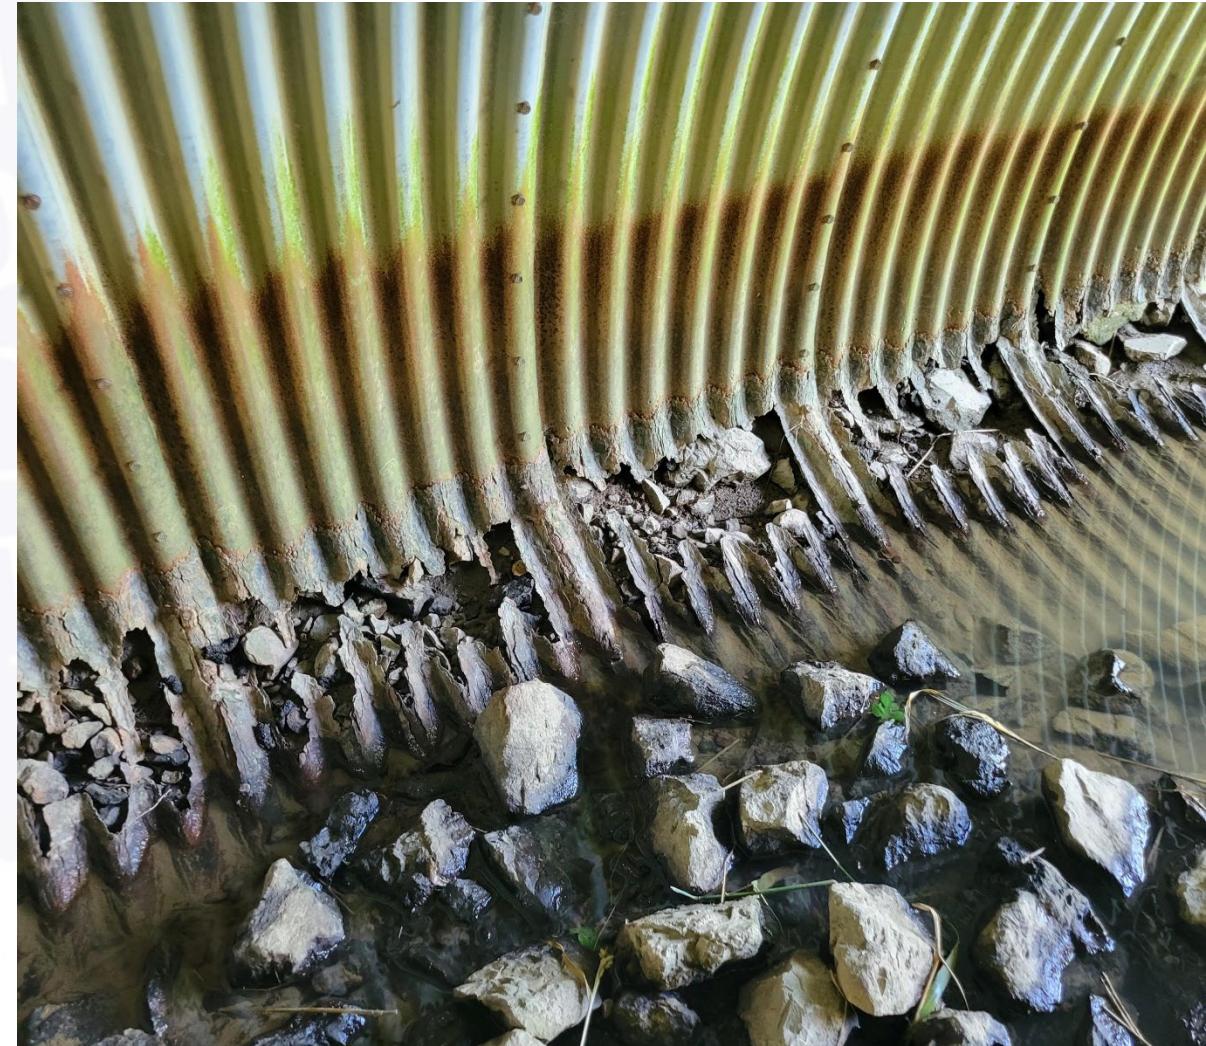
Rust Through at the Waterline

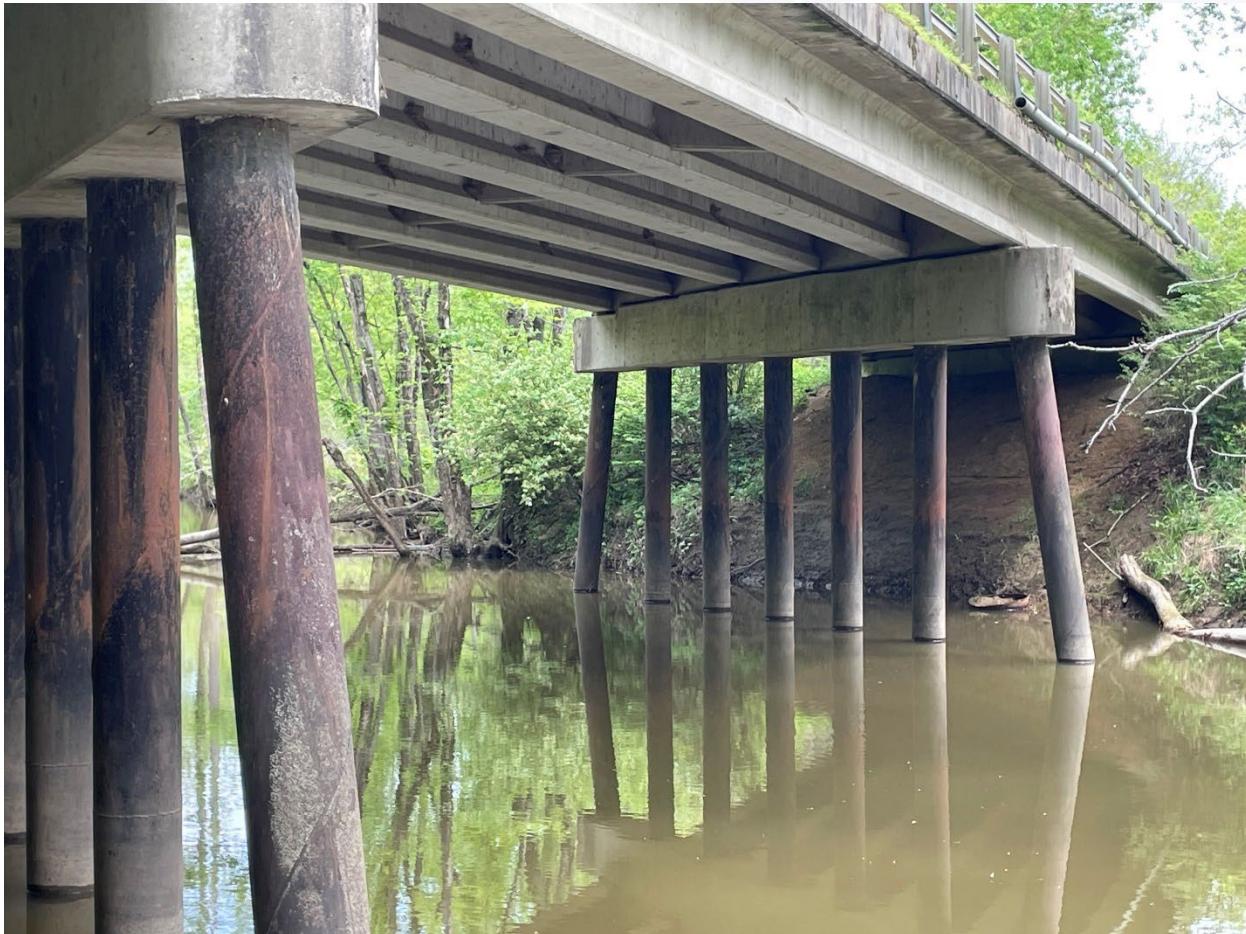
- Three span, prestressed concrete I-Beam (6) bridge with an RC deck
- Posted 10 Tons (Commercial)

Pier 3 and Span B Superstructure

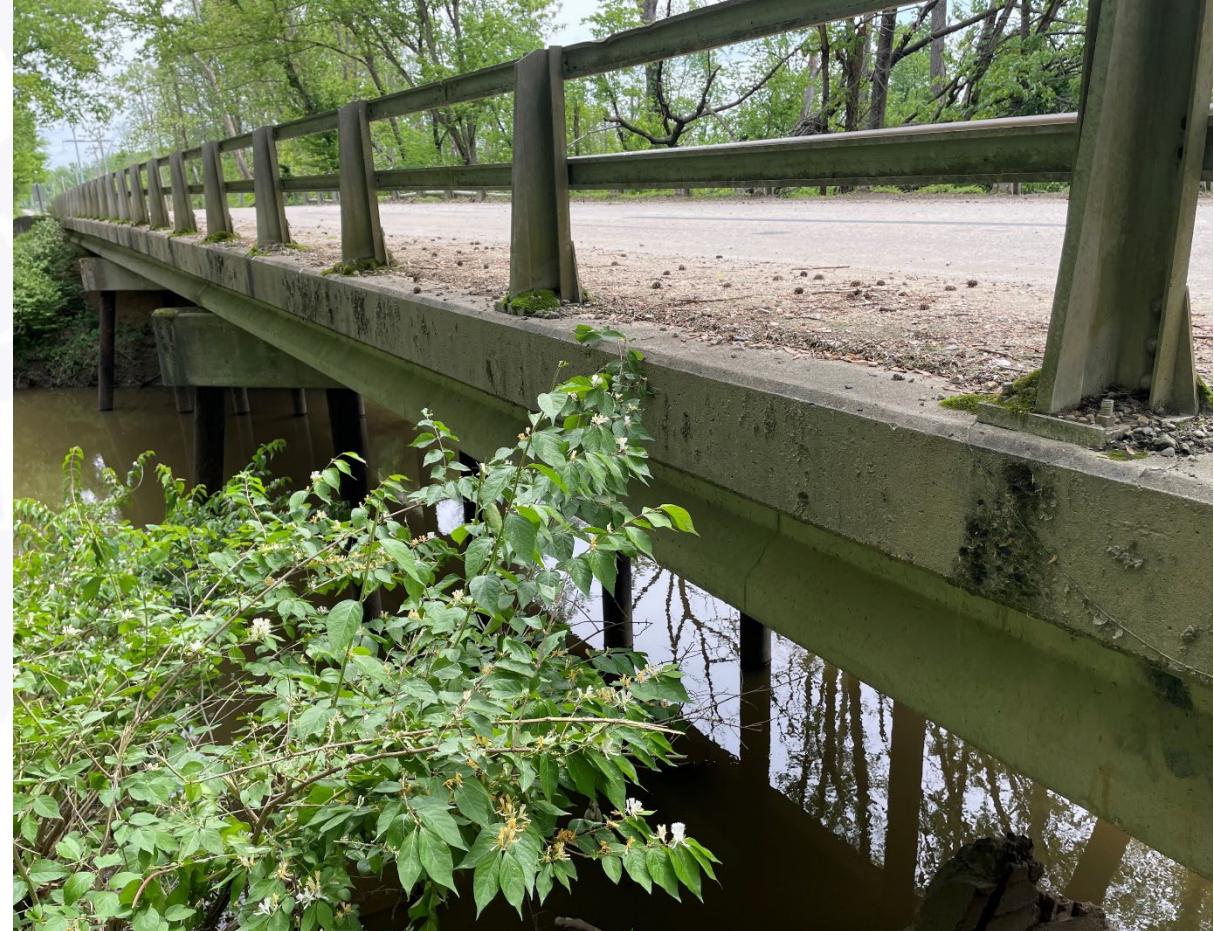
Coping Edge of the Structure

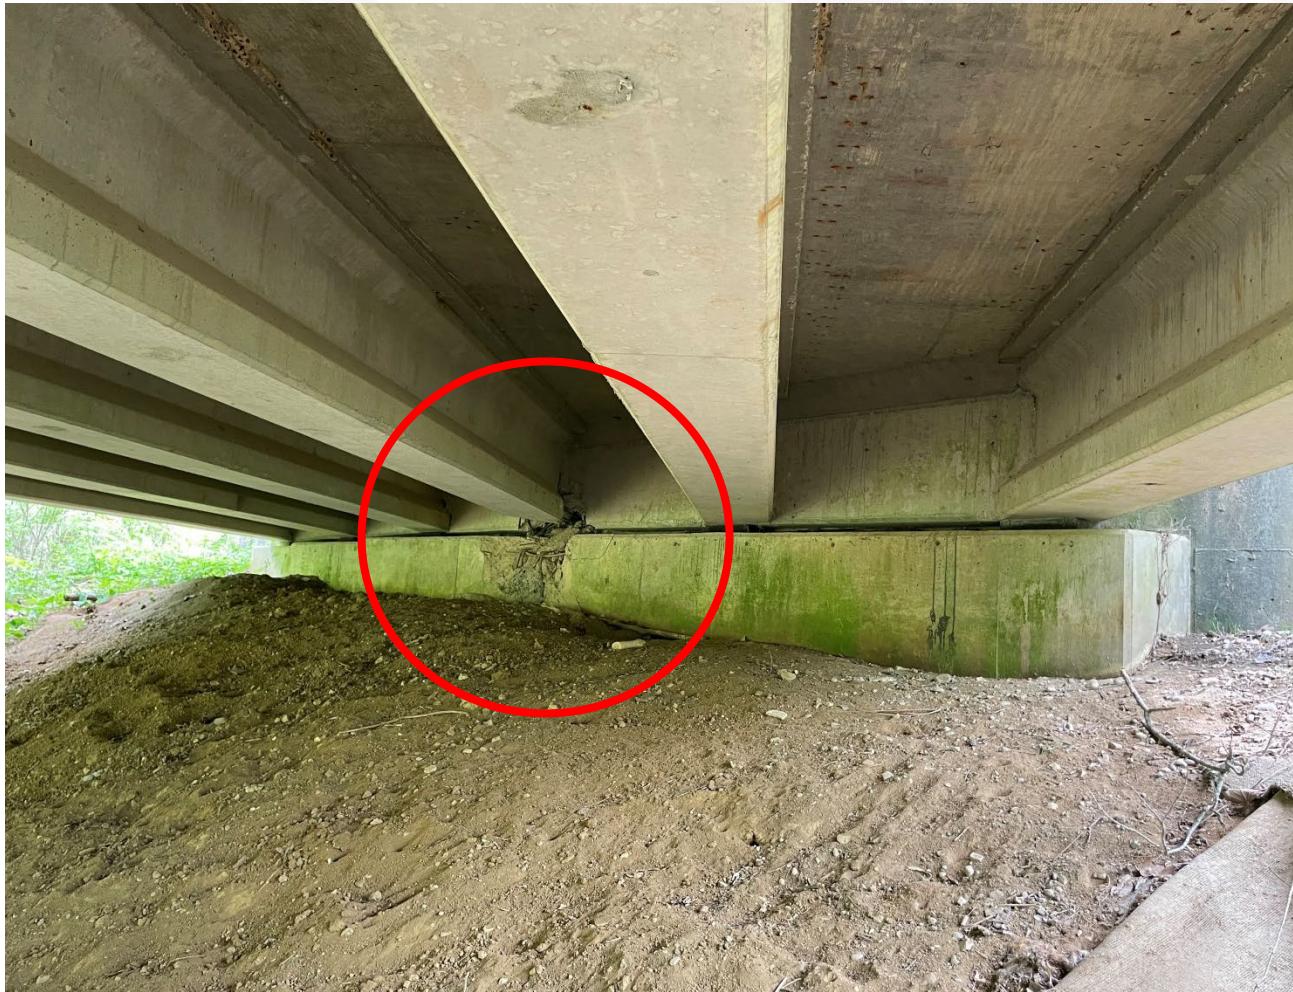
Bent 4 and Span C Superstructure with a Surprise

- Previous (59) Superstructure rating: ??
- Comments:
 - Beam 3 has failed at Bent 4 with heavy spalling (~4' long) that has exposed most of the strands at the end of the beam. The exposed strands and rebar have minor surface rust. The spalling has also occurred at the end diaphragms in this location. No other problems were noted in the other beams.

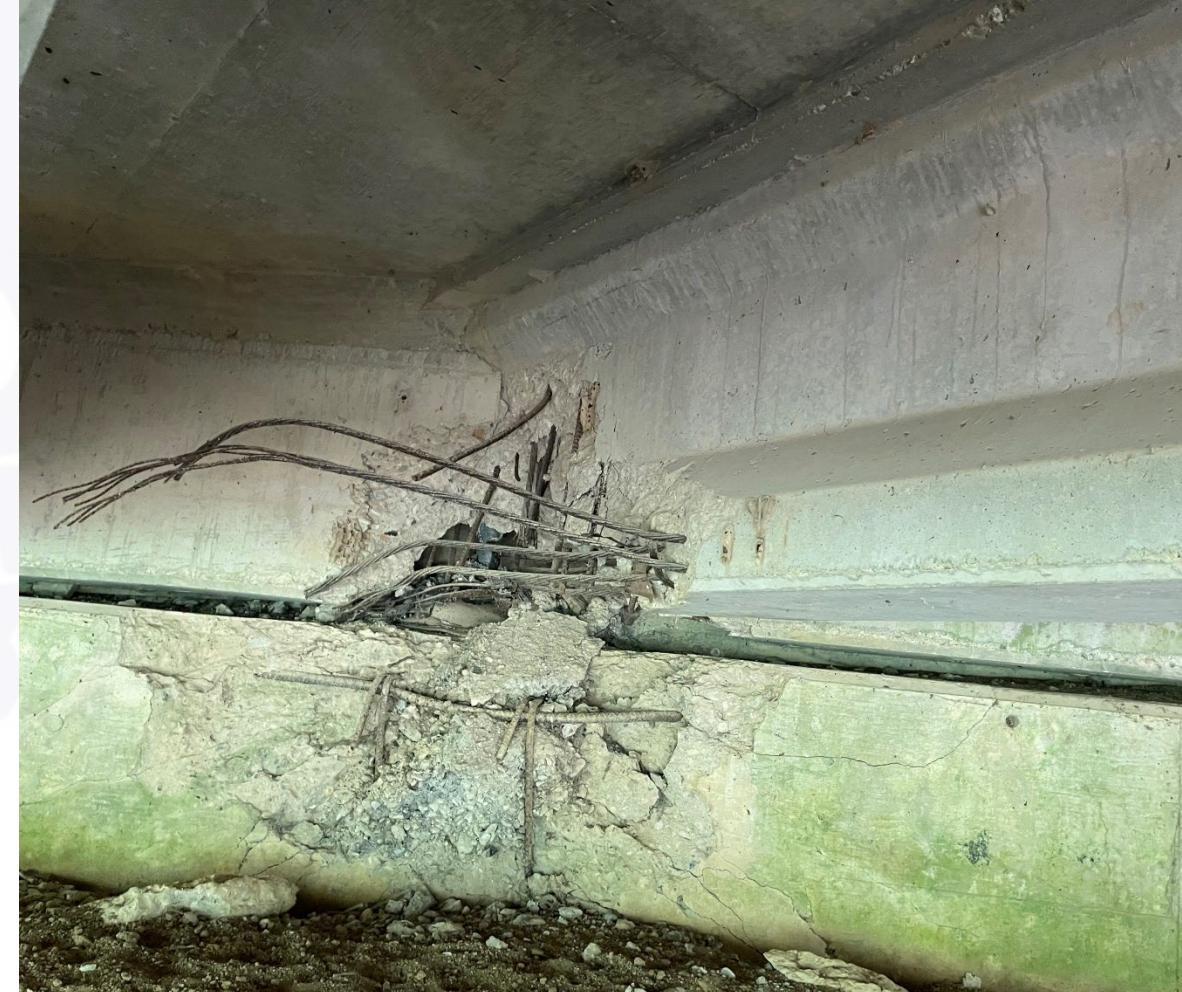
Exposed Strands at Beam 3C (North)

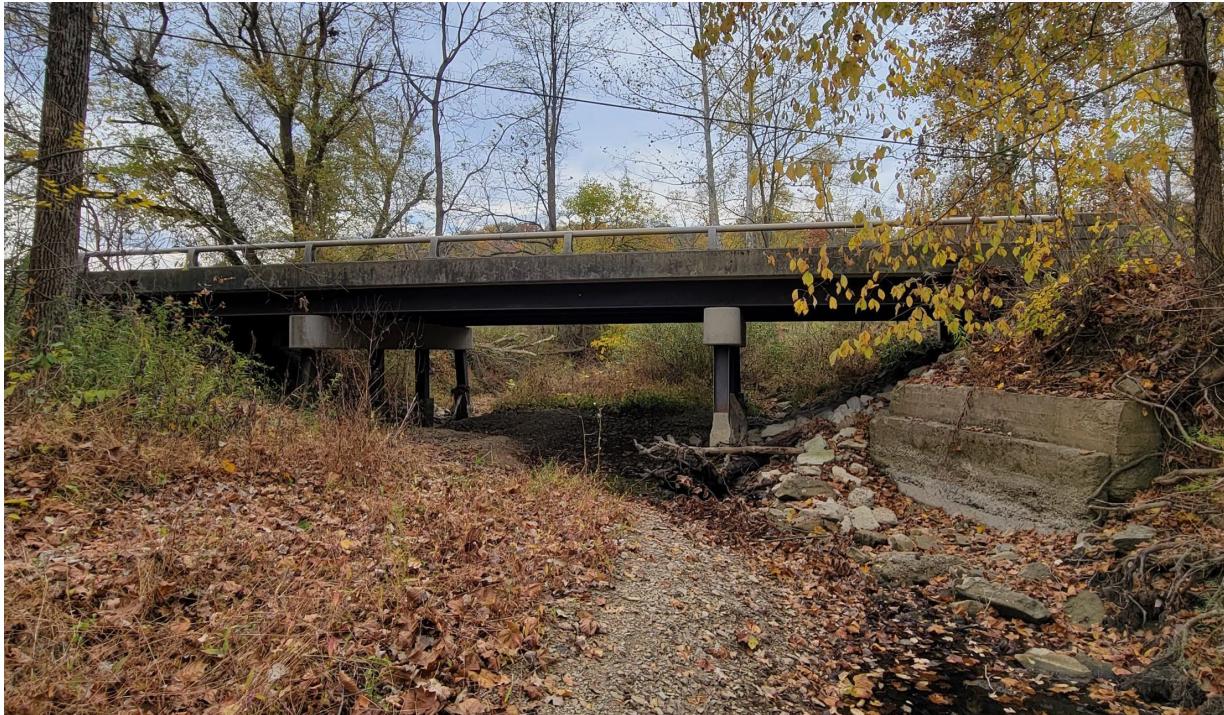
- Three span continuous steel stringer (4) bridge

North Elevation

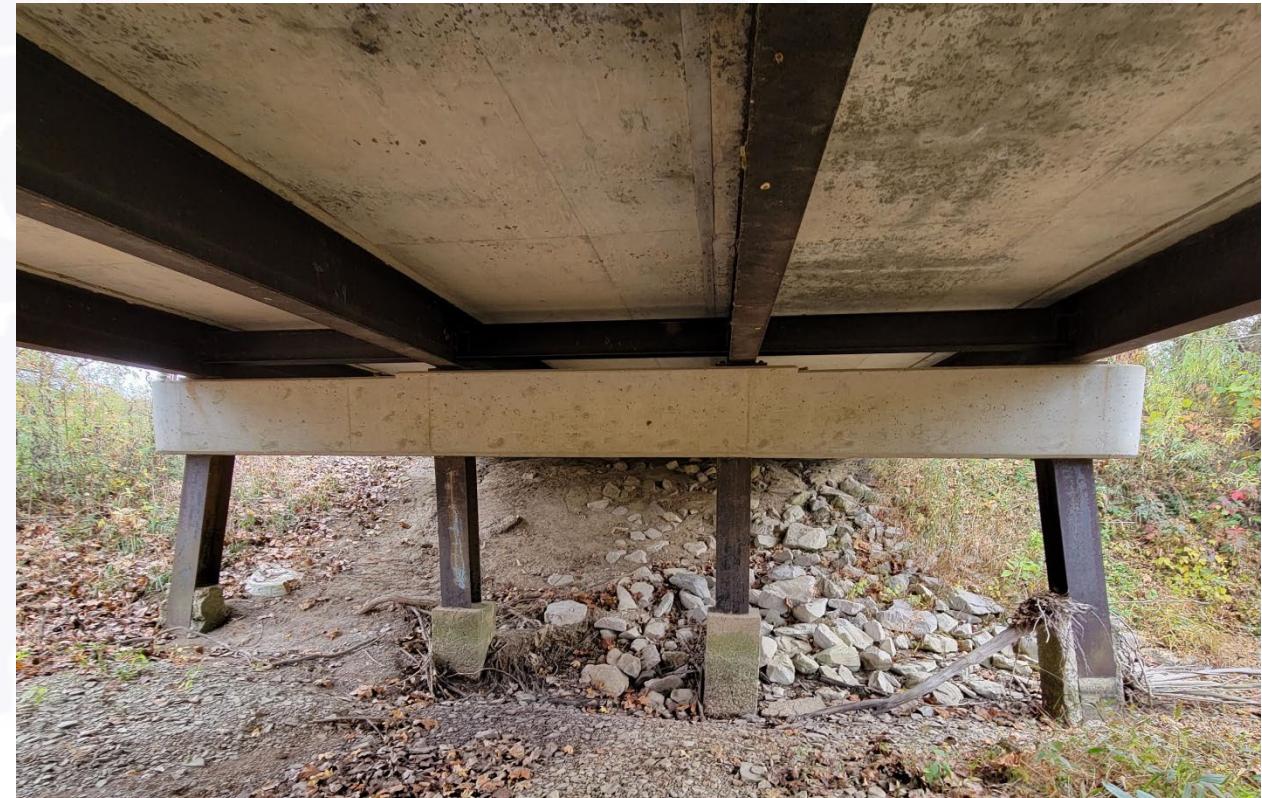
Typical Underside of Structure

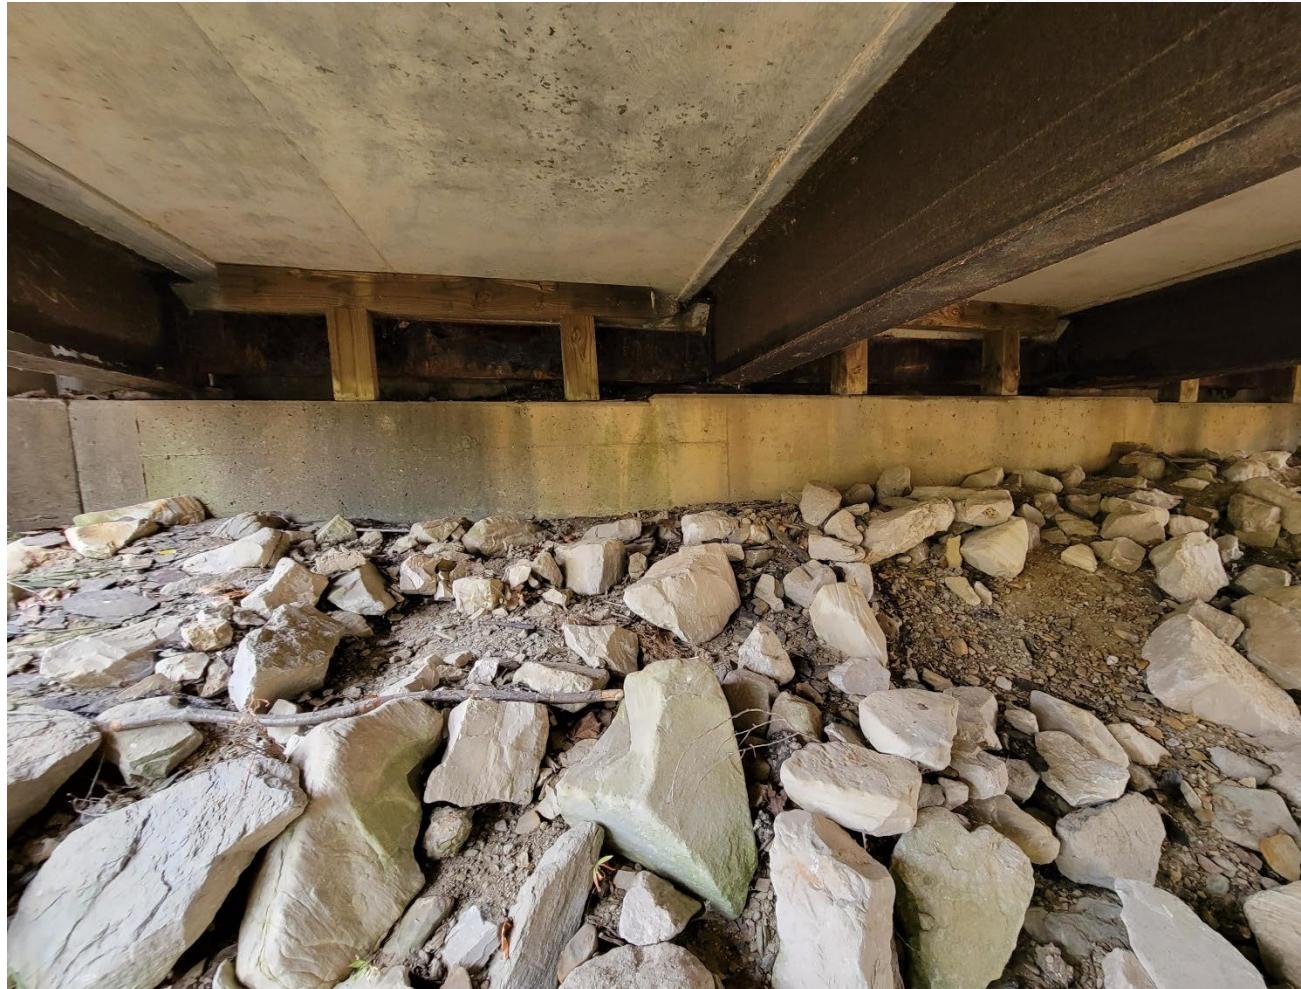
Bent 1 with Retrofit

- Previous (59) Superstructure: ??
- Comments:
 - All beams have rust through along the bottom of the web at each end of the bridge. Rust through is approximately 8' long from the bearings. Diaphragms have also rusted through at the end bents. Moderate pitting is present throughout the remainder of the superstructure. Each end bent has temporary shoring repairs.

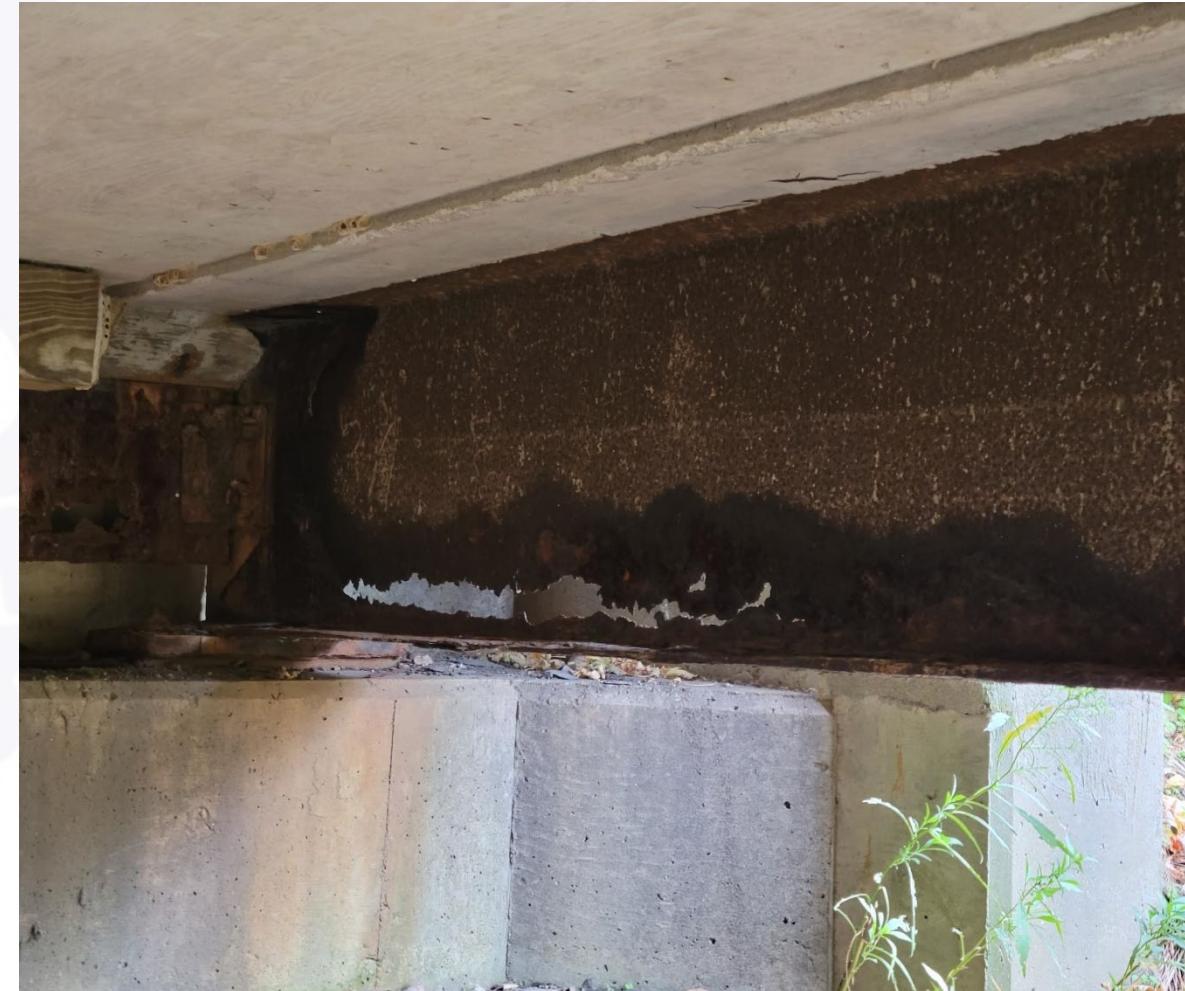
Rust Through of Beam 1A

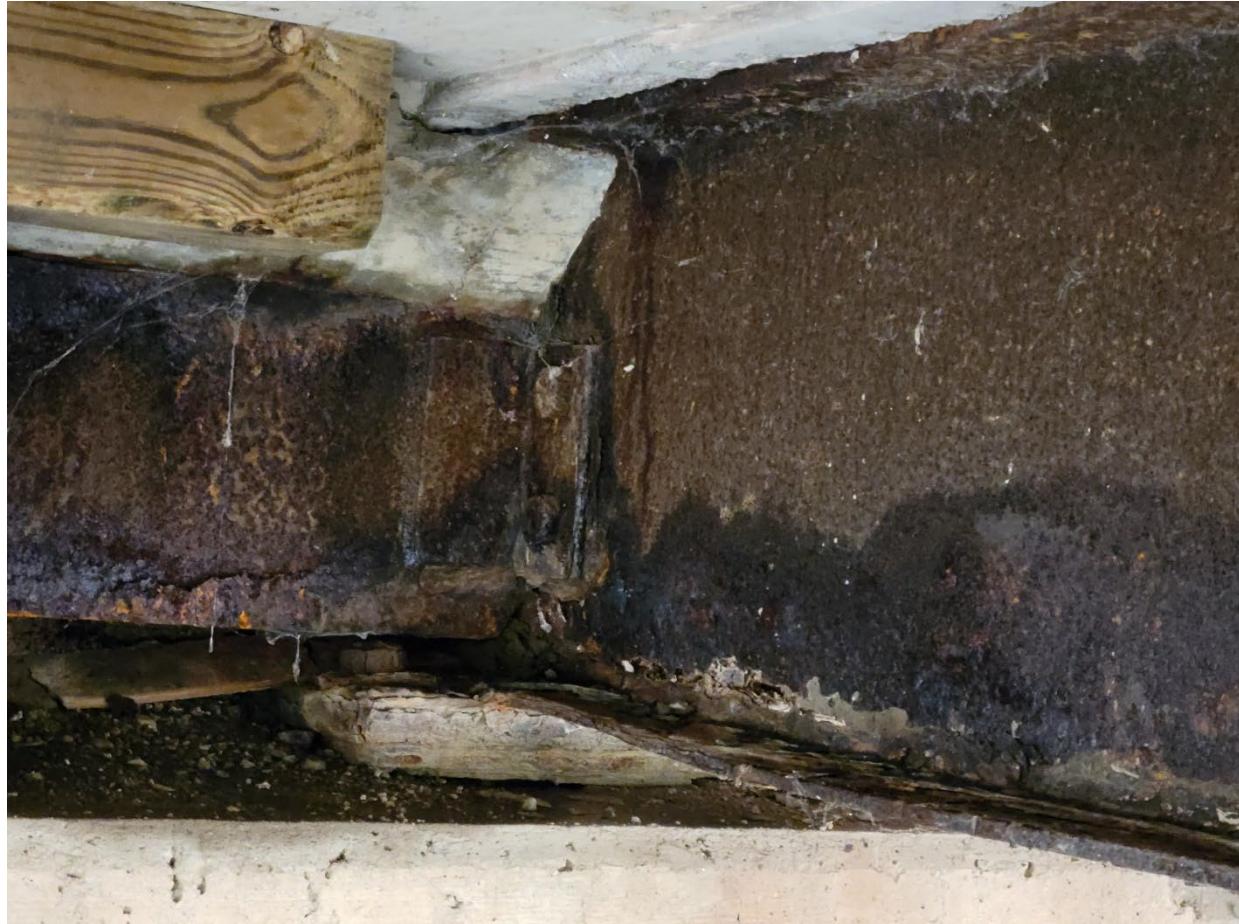
Rust Through of Beam 3C

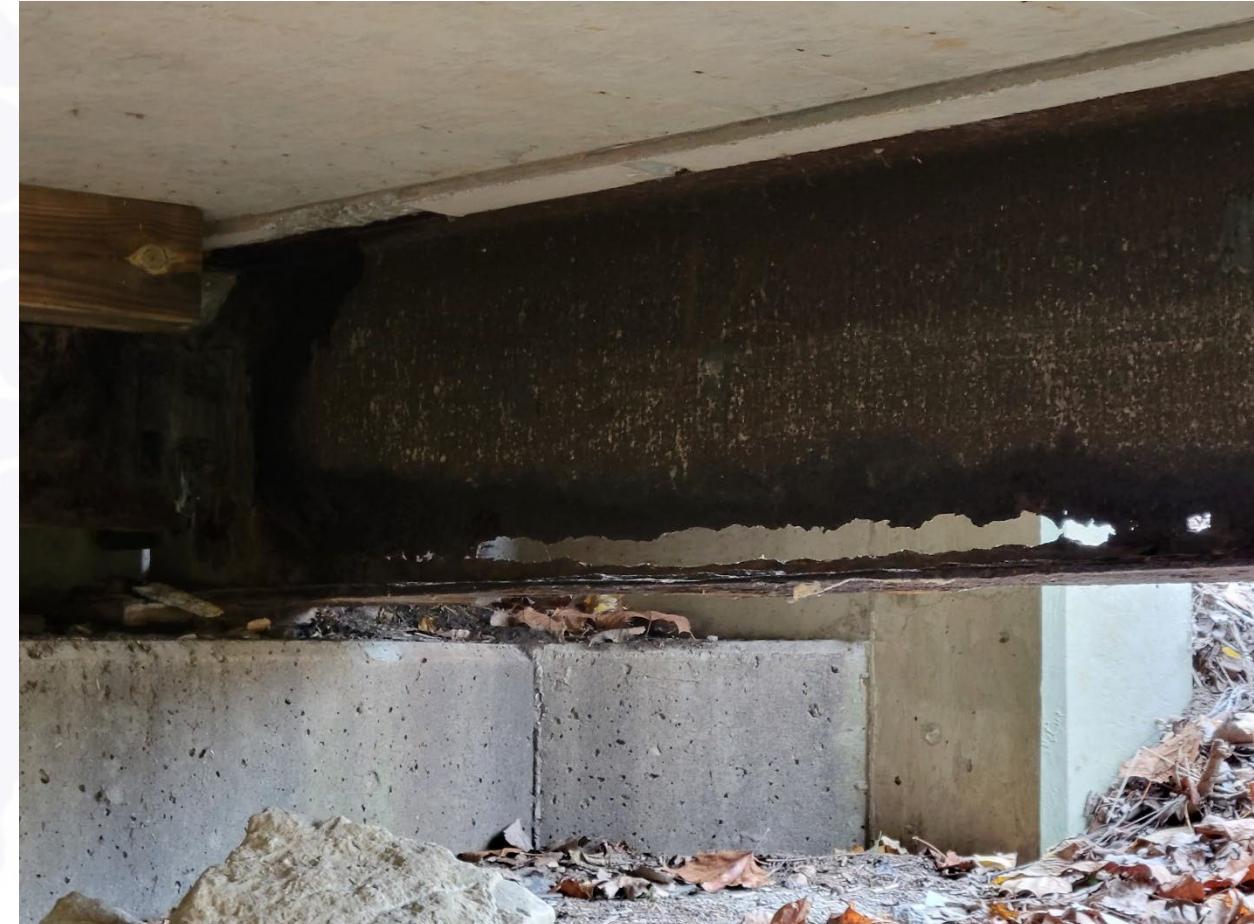
Rust Through of Beam 4C

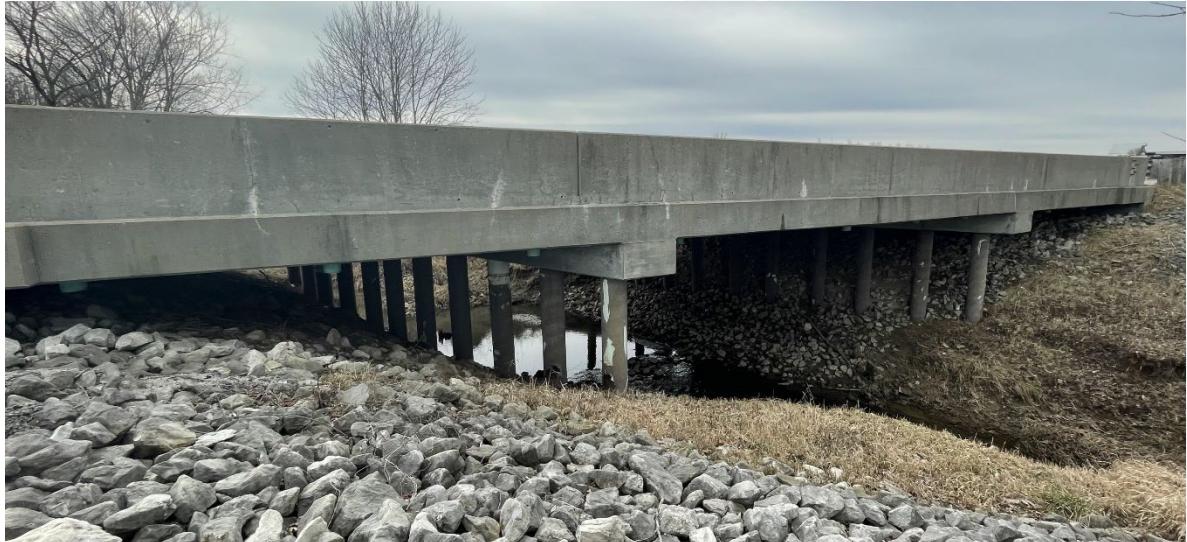
- Three span reinforced concrete slab bridge

North Elevation

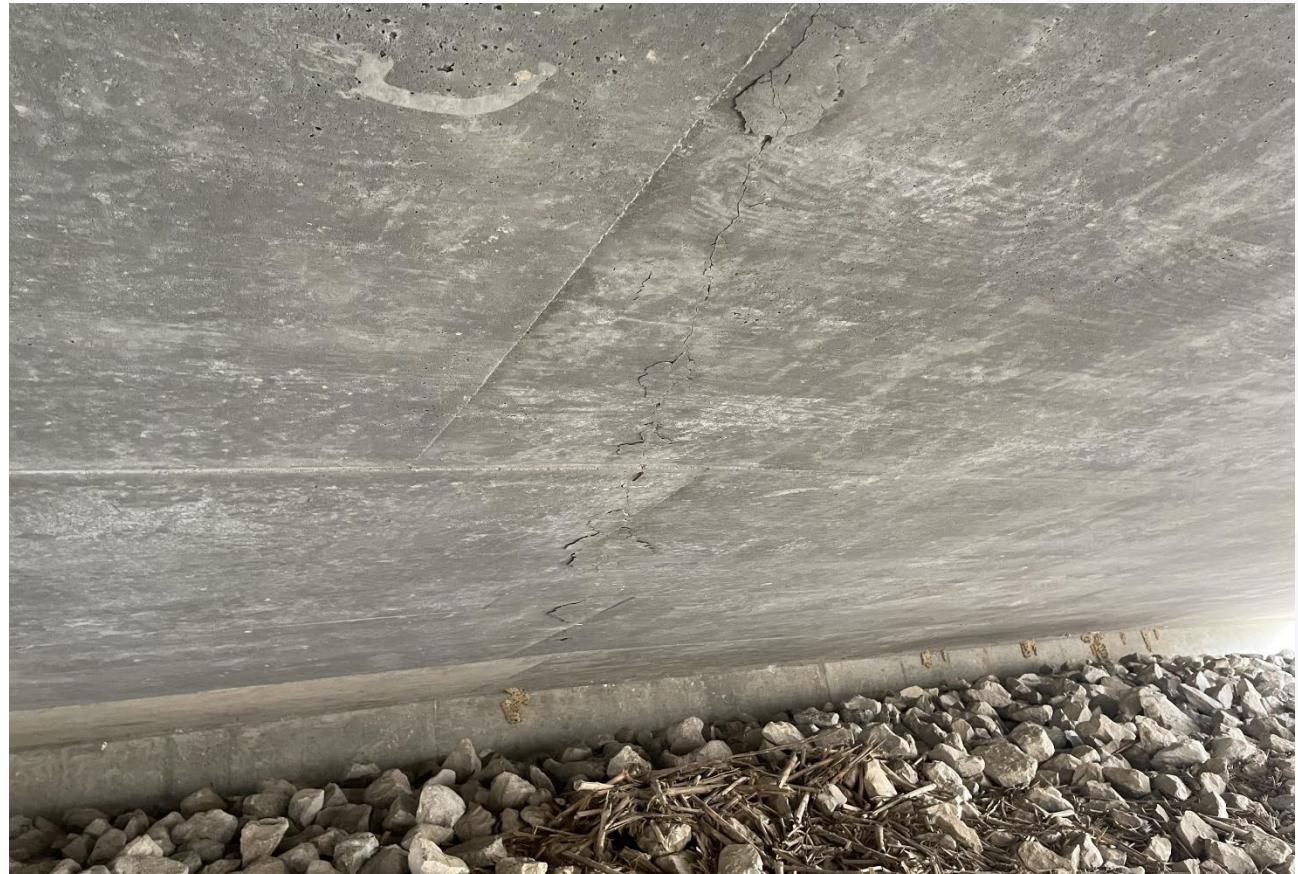
Minor Cracking and Delaminations in the Center of Slab

- Previous (59) Superstructure:
- Comments:
 - The copings of the slab have several areas of delaminations around the drains while there are a few areas with large areas of exposed steel. The interior of the slab has minor longitudinal cracking and/or delaminations.

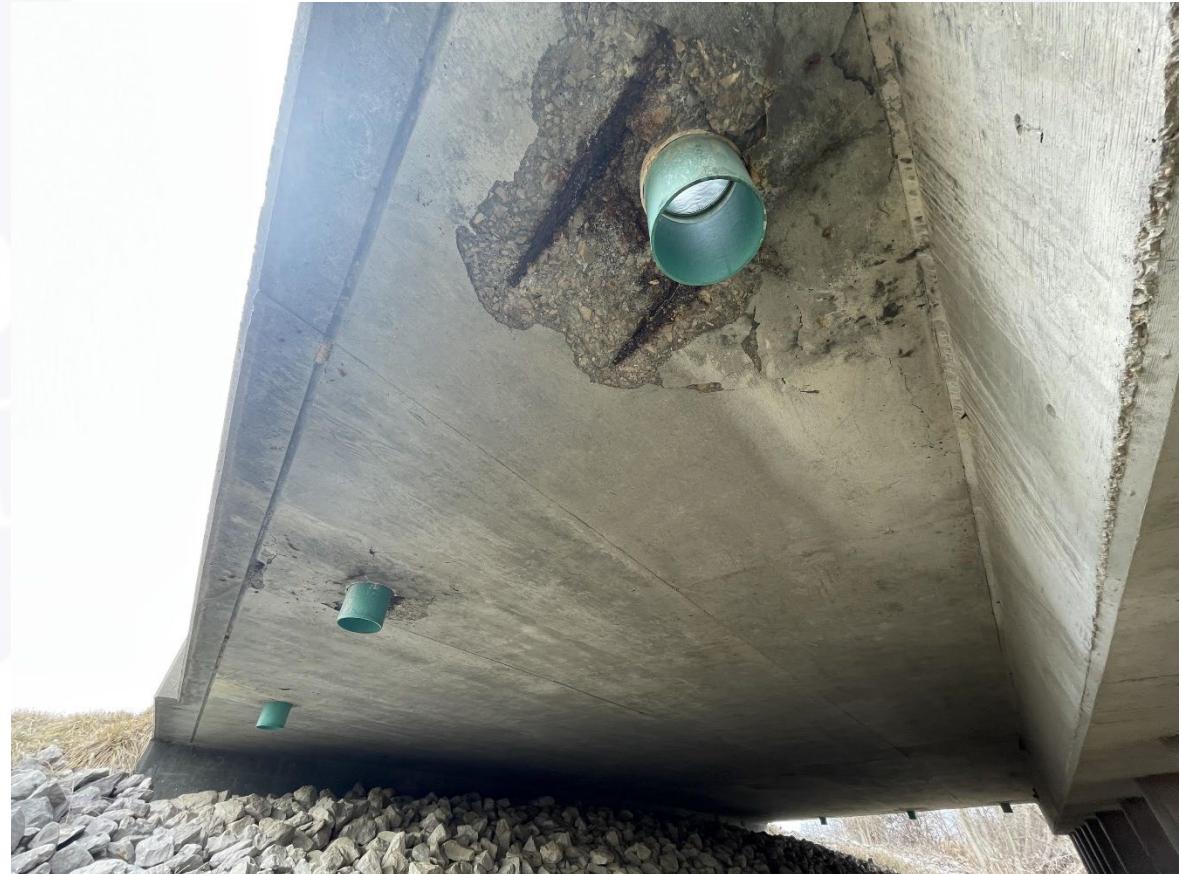
Exposed Steel in Span A, South Coping

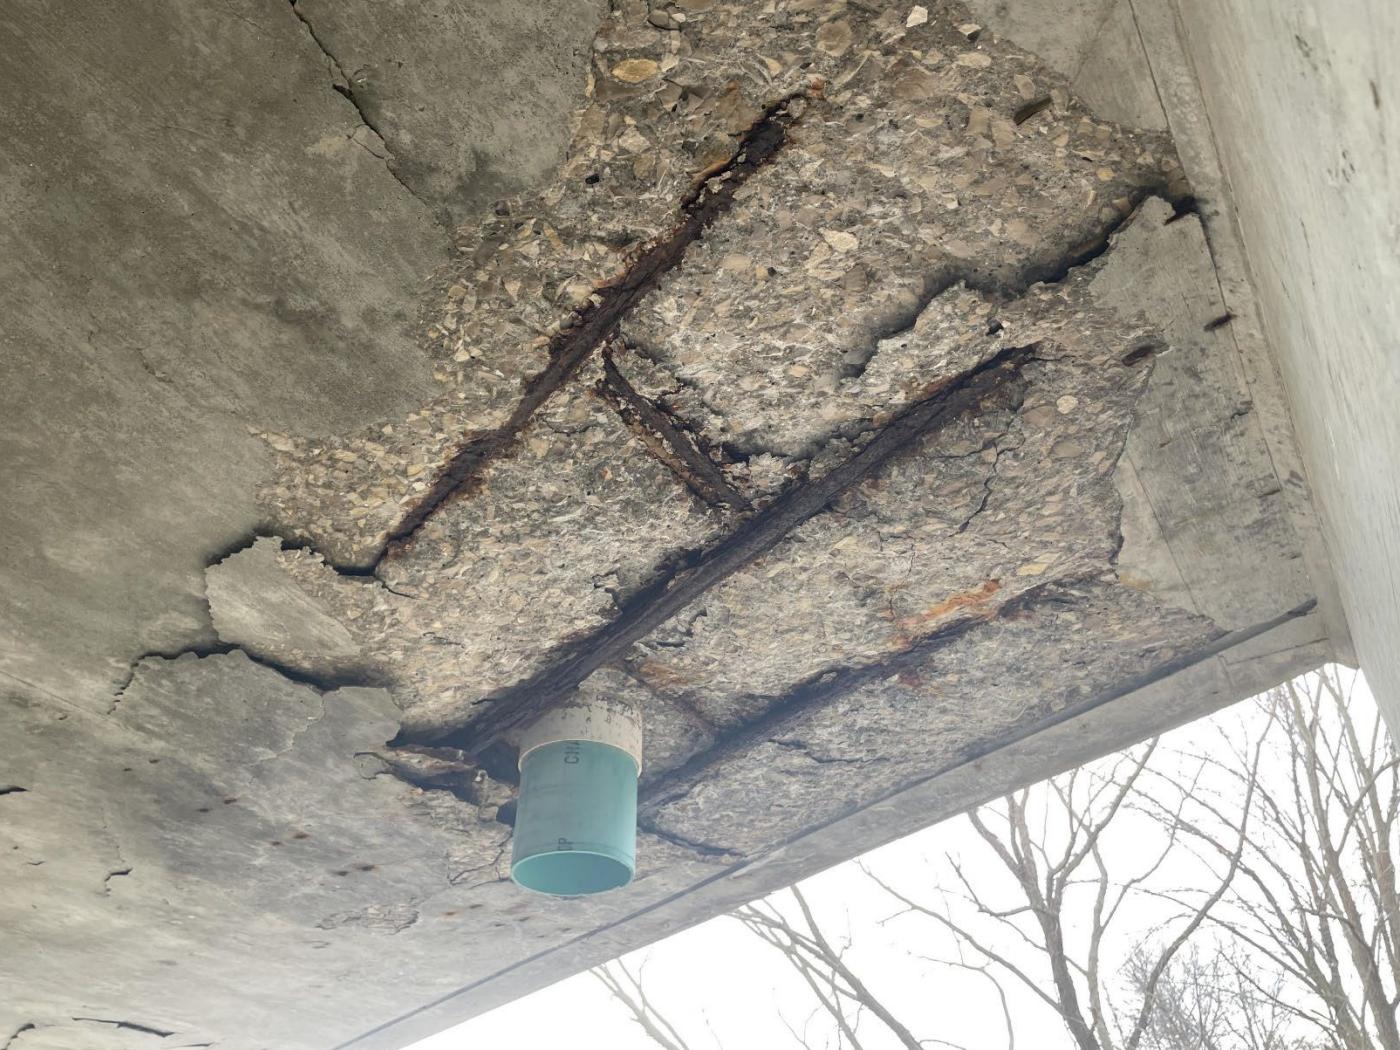
Exposed Steel in Span C, South Coping
