Inspections Start to Finish: Prep, Access, Safety, & Component Rating

Rob Coop, PE *Bridge Inspection Department Manager, USI*

Jake Gould, PE *Bridge Inspection Area Engineer, Indiana Department of Transportation*

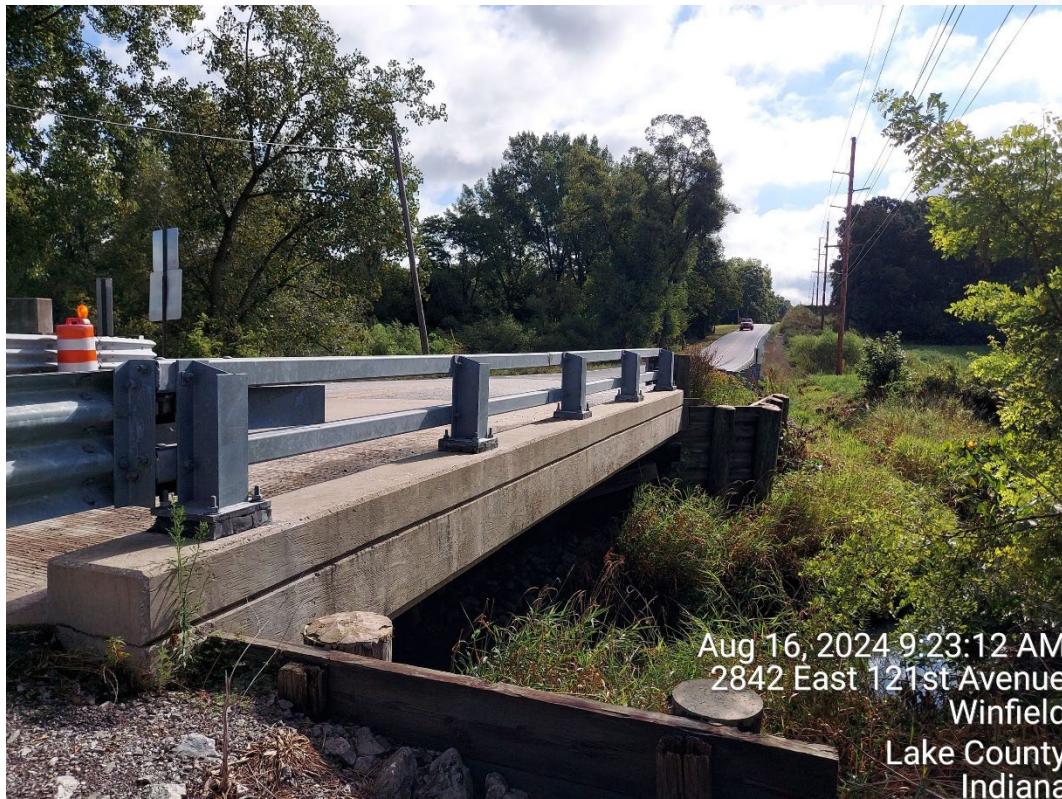
- Single span prestressed concrete box beams on timber pile bents
- Posted 12 Tons Commercial
- Posted 16 Tons, 28 Tons, and 39 Tons for Emergency Vehicles

North Elevation

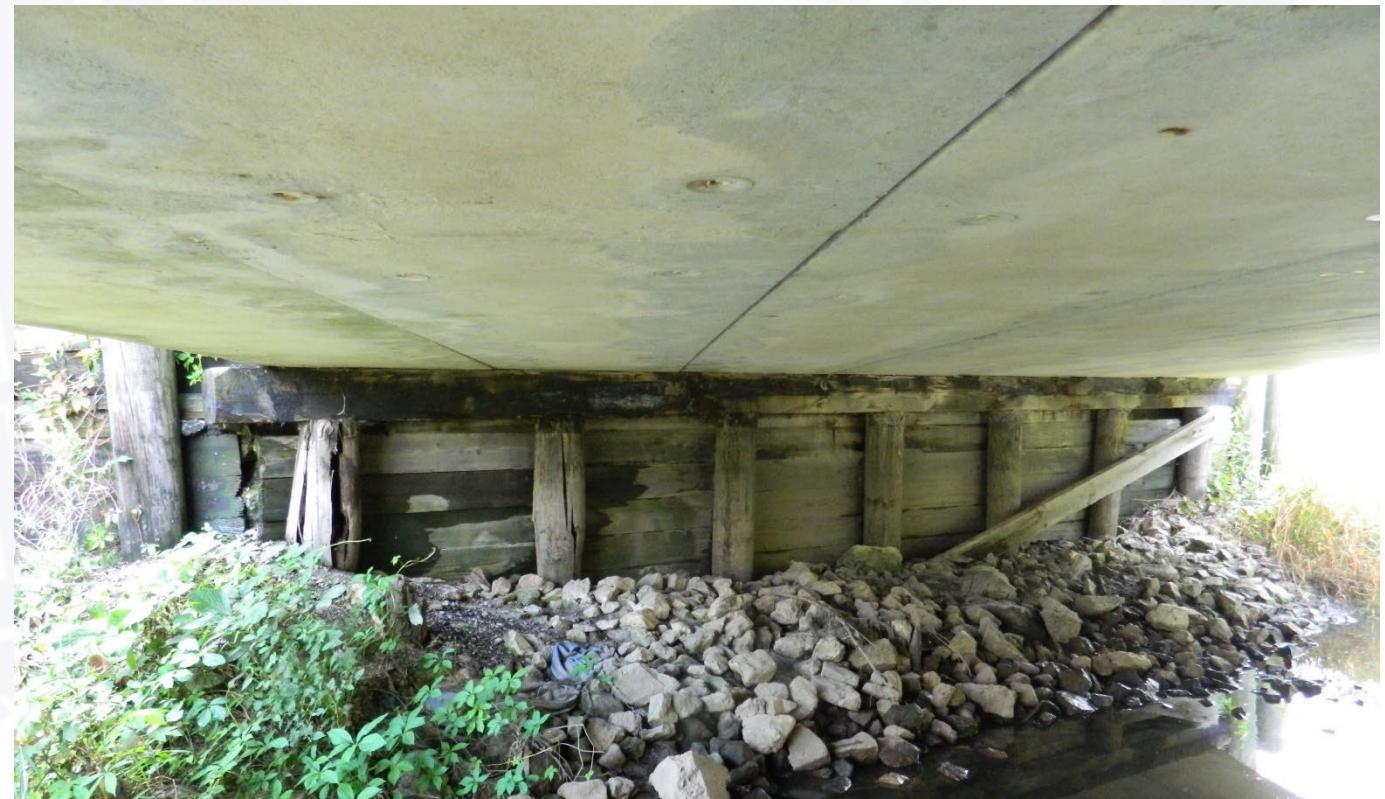
East Bent

- Previous (60) Substructure: ???
- Comments:
 - Both End Bents
 - Temporary supports/sheet piling driven behind backwalls.
 - Rot in backwall planks at ends & ground line

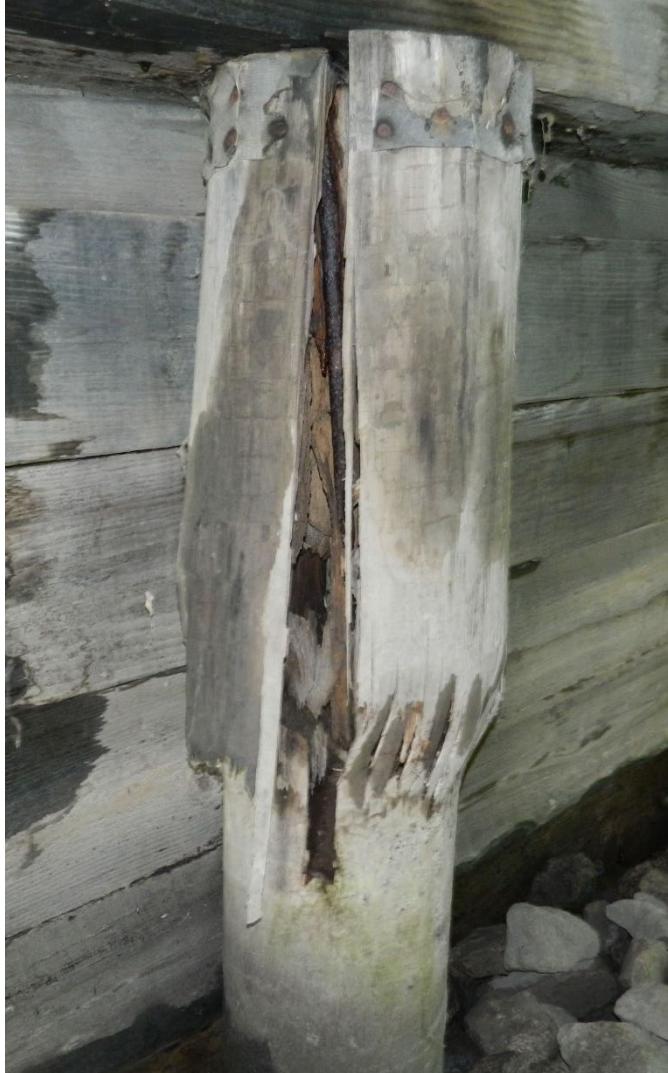
Pile 3 on East Bent

- Pile 2 at has a 2.5" wide split at the top. The rear portion has buckled and the front portion is pushing toward the stream.
 - Pile 3 has failed with 100% section loss at the center and has significant crushing.

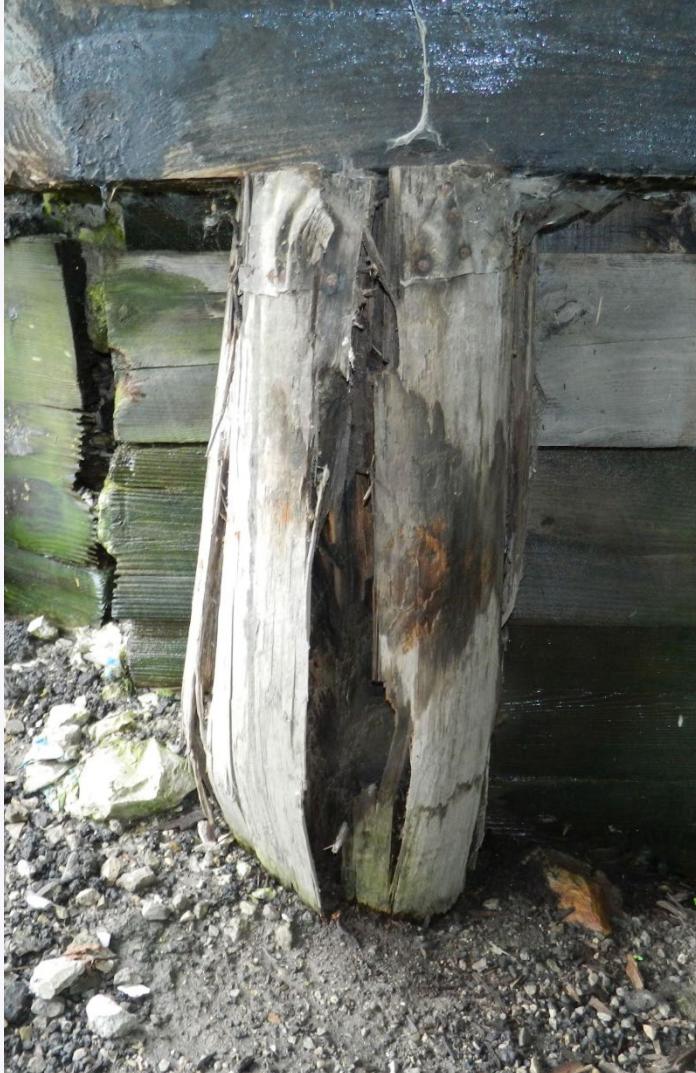
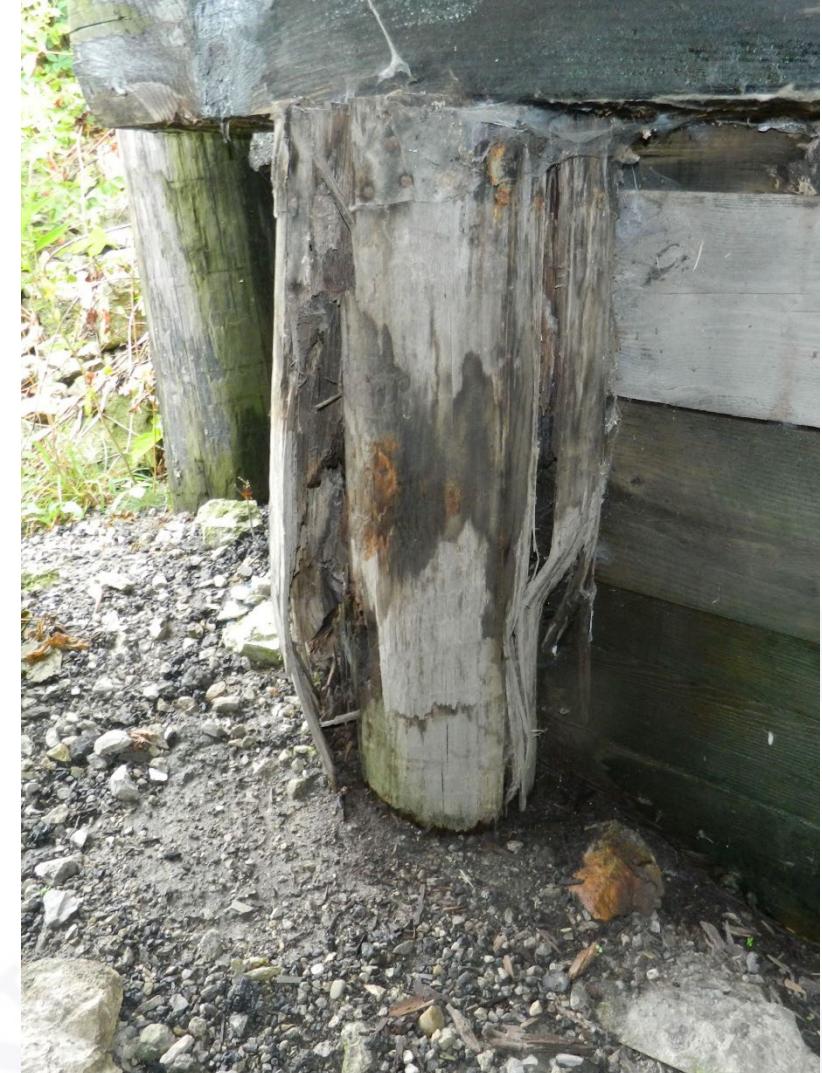
Pile 7 on East Bent

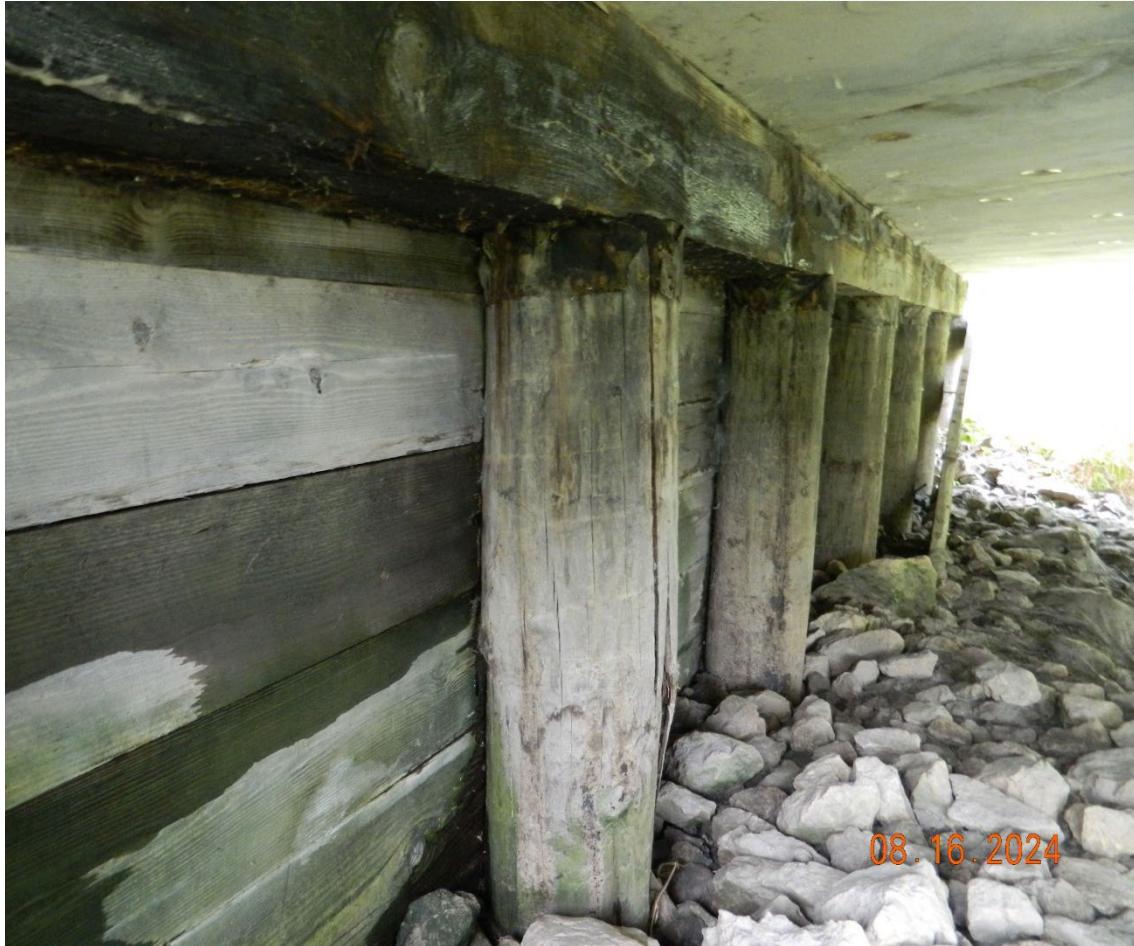
East Bent Piles

- Pile lateral bracing timbers are detached at both end bents.
 - Both end bents have rot in backwall planks & ground line.
 - Minor splitting in piles throughout.

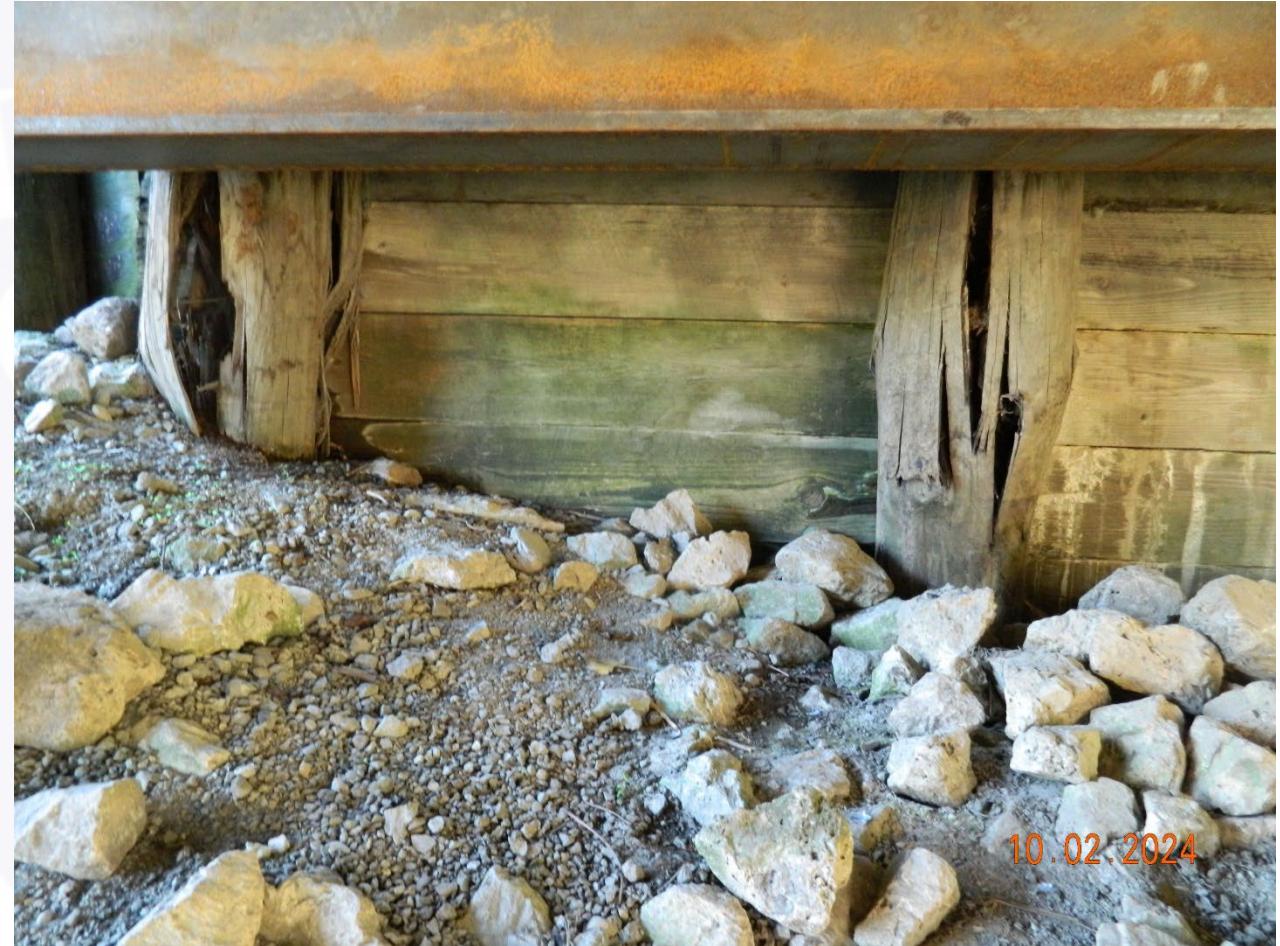
Piles 6 and 7 on East Bent

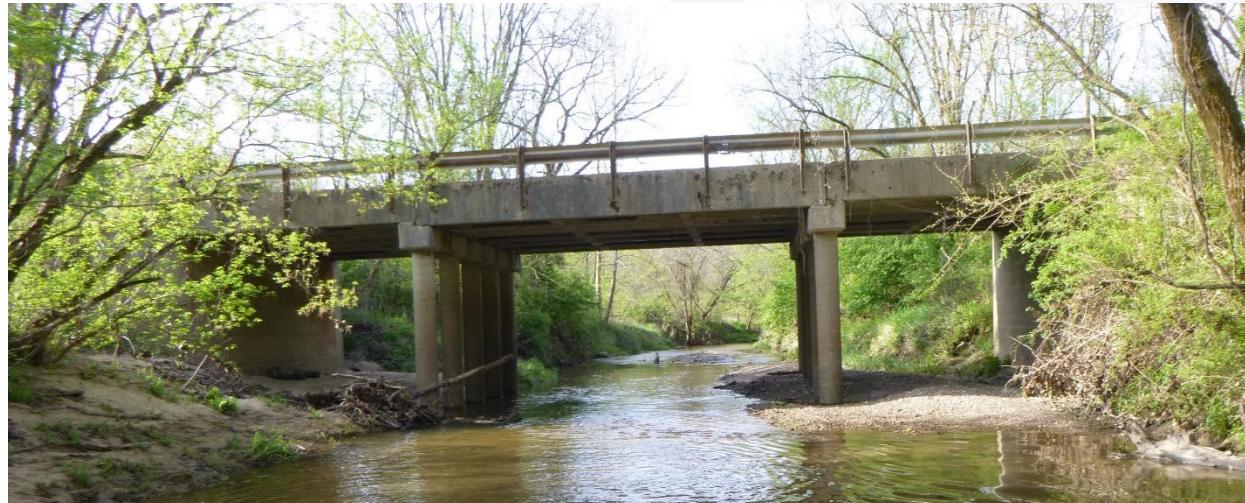
- Three span reinforced concrete channel beam bridge
- Posted 13 Tons

North Elevation

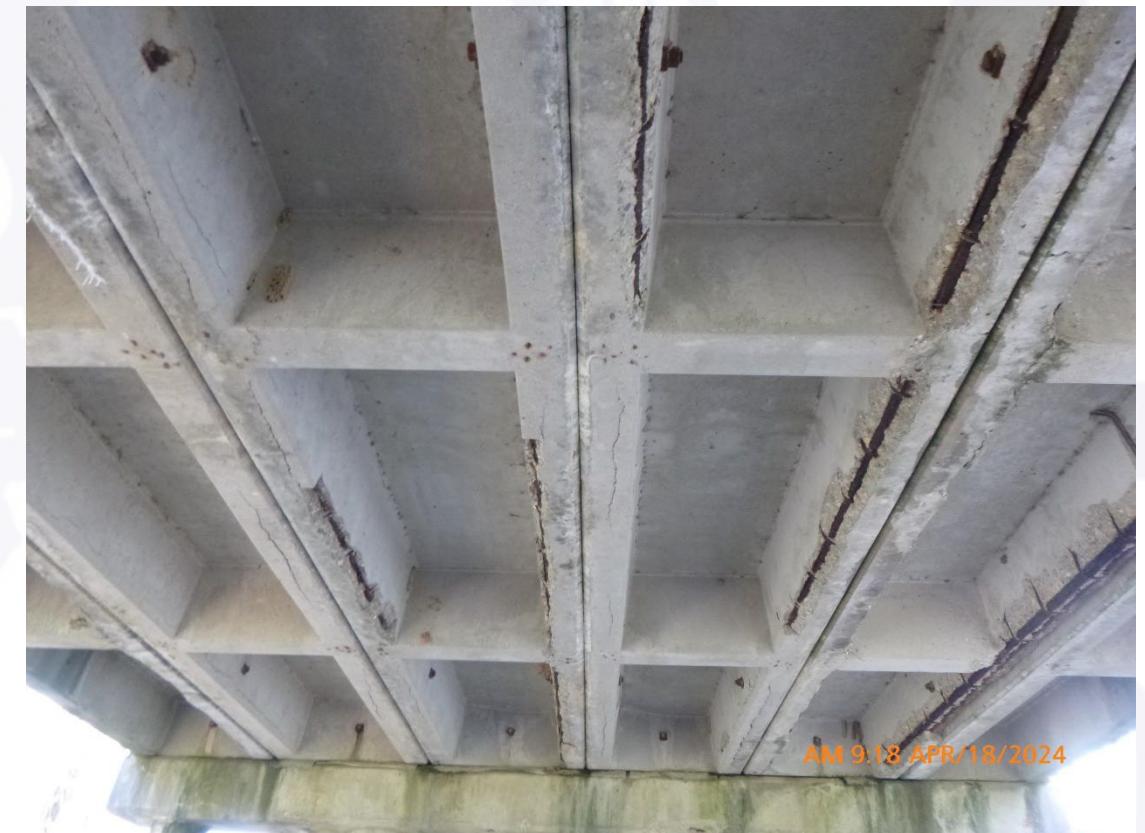
Underside of Deck

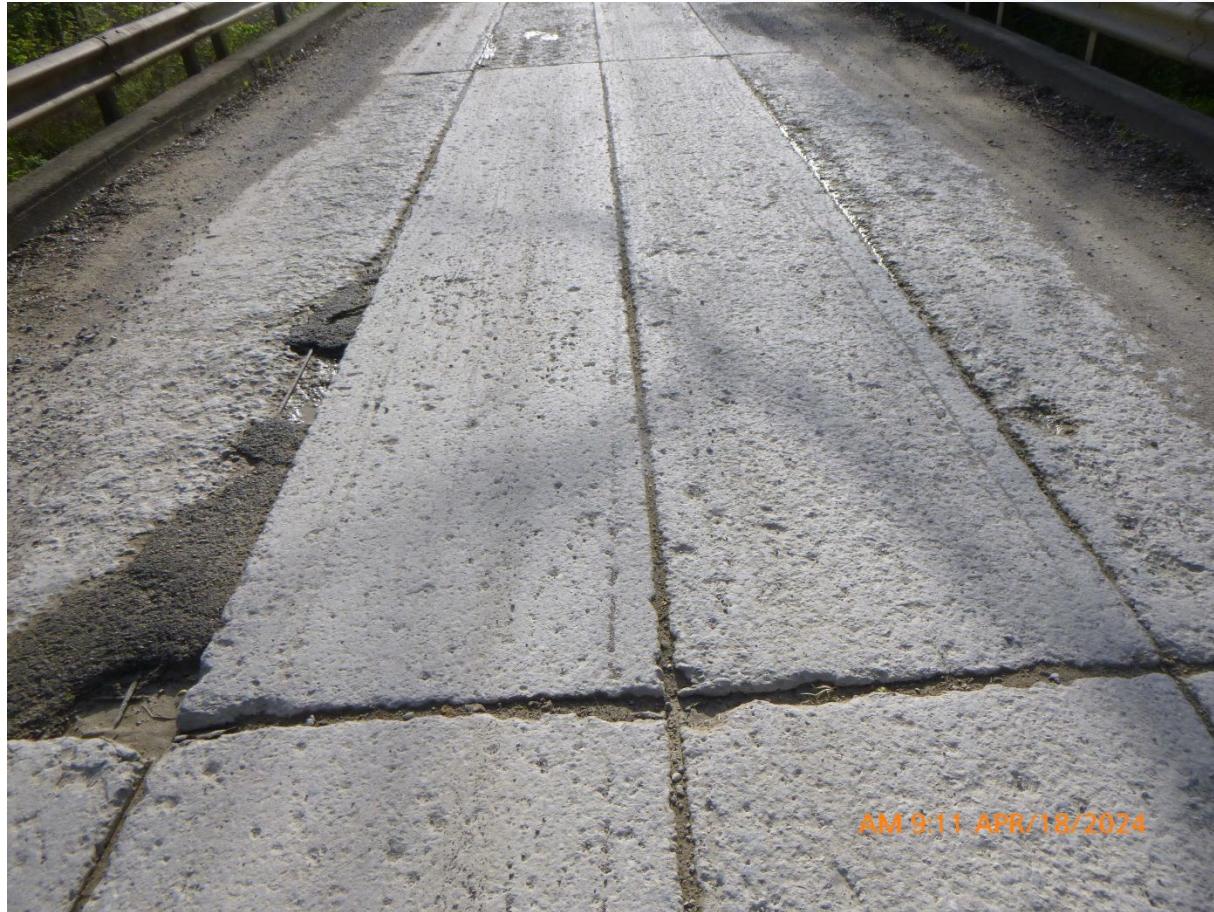
Wearing Surface

- Previous (58) Deck: ???
- Comments:
 - There is debris that has gathered in the gutters and drains. The deck tends to hold water. There is severe abrasion & scaling in top of the beams which covers ~93 SFT (8.2%) of the top of beams. There is heavy spalling with exposed longitudinal and transverse steel on Beams 2B & 3B. The underside of the deck has hairline cracking throughout as well as one minor spall with exposed steel.

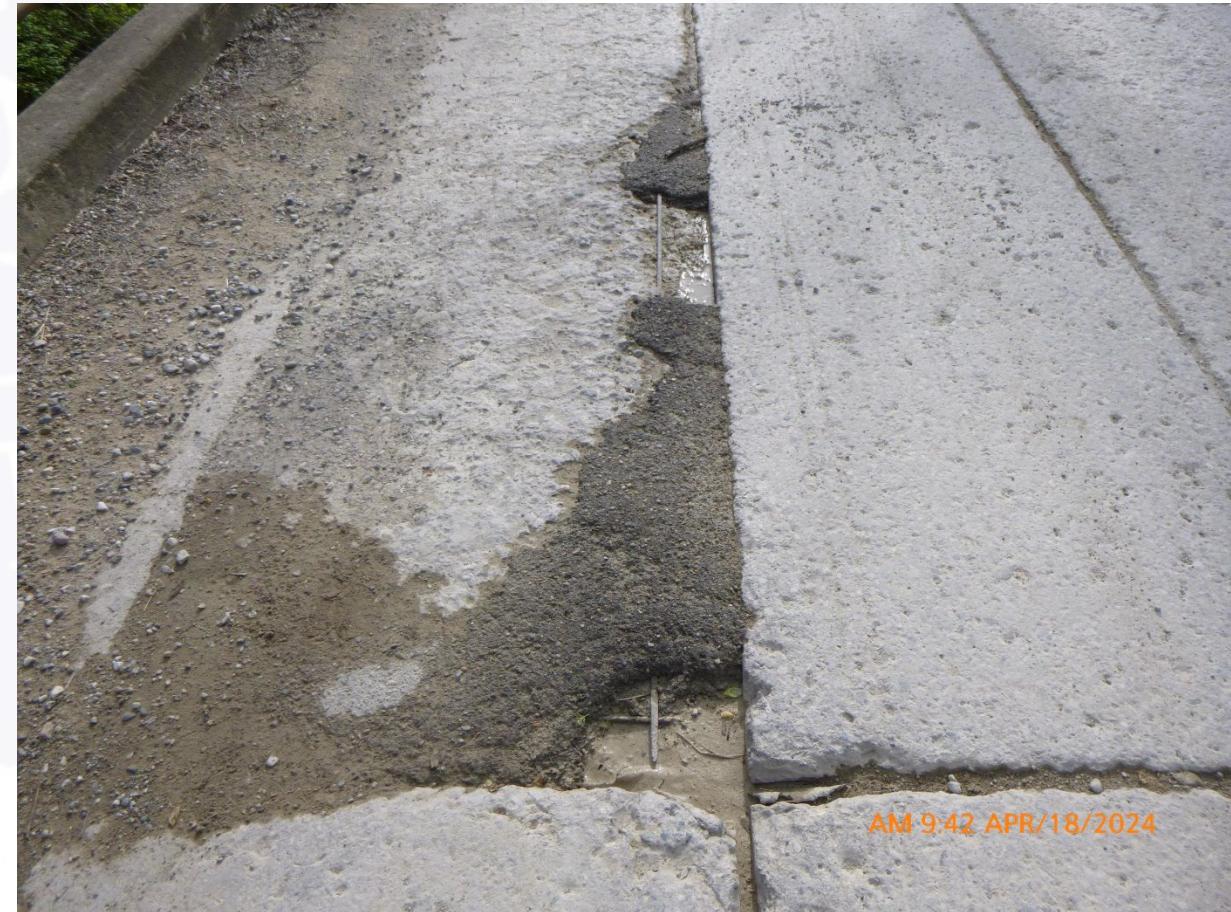
Exposed Steel that has been Partially Repaired

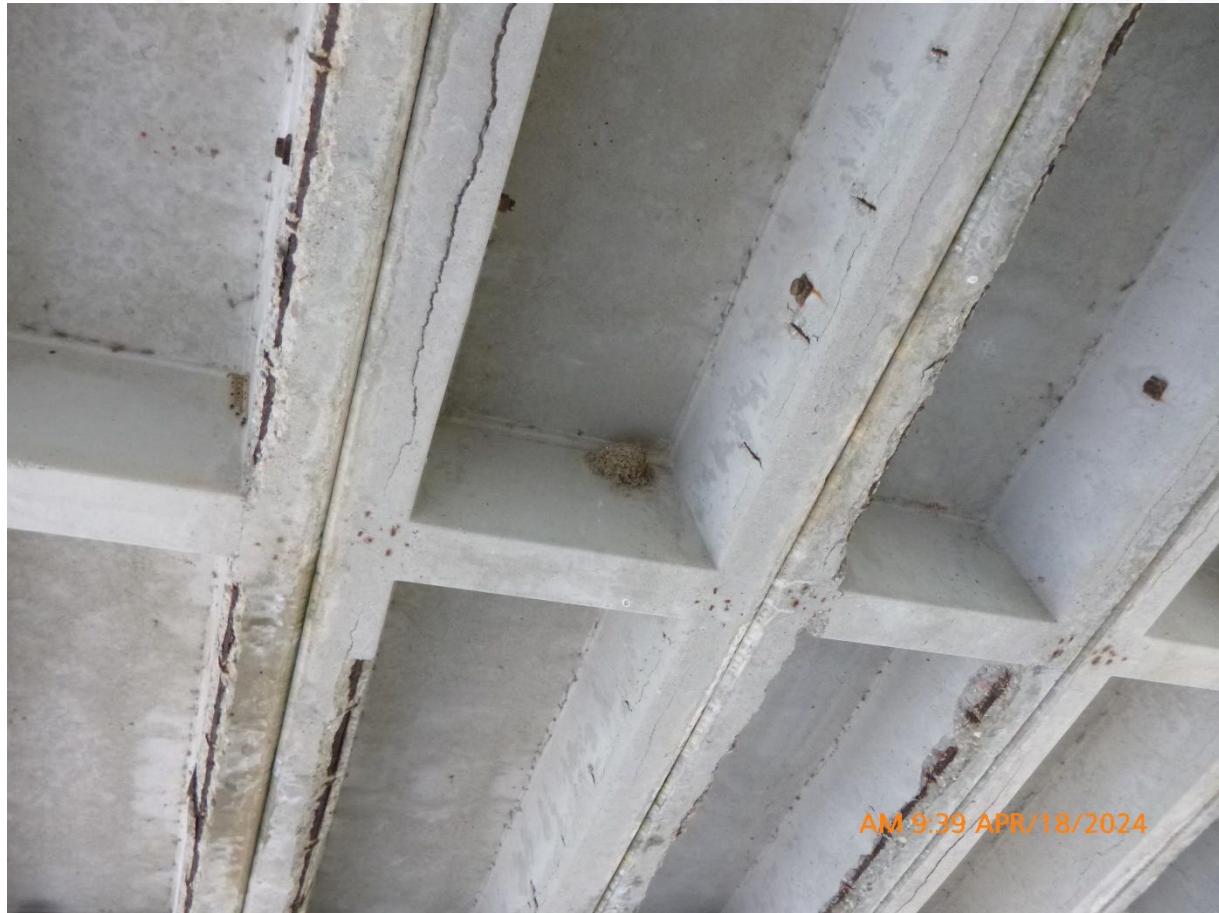
Underside of the Deck

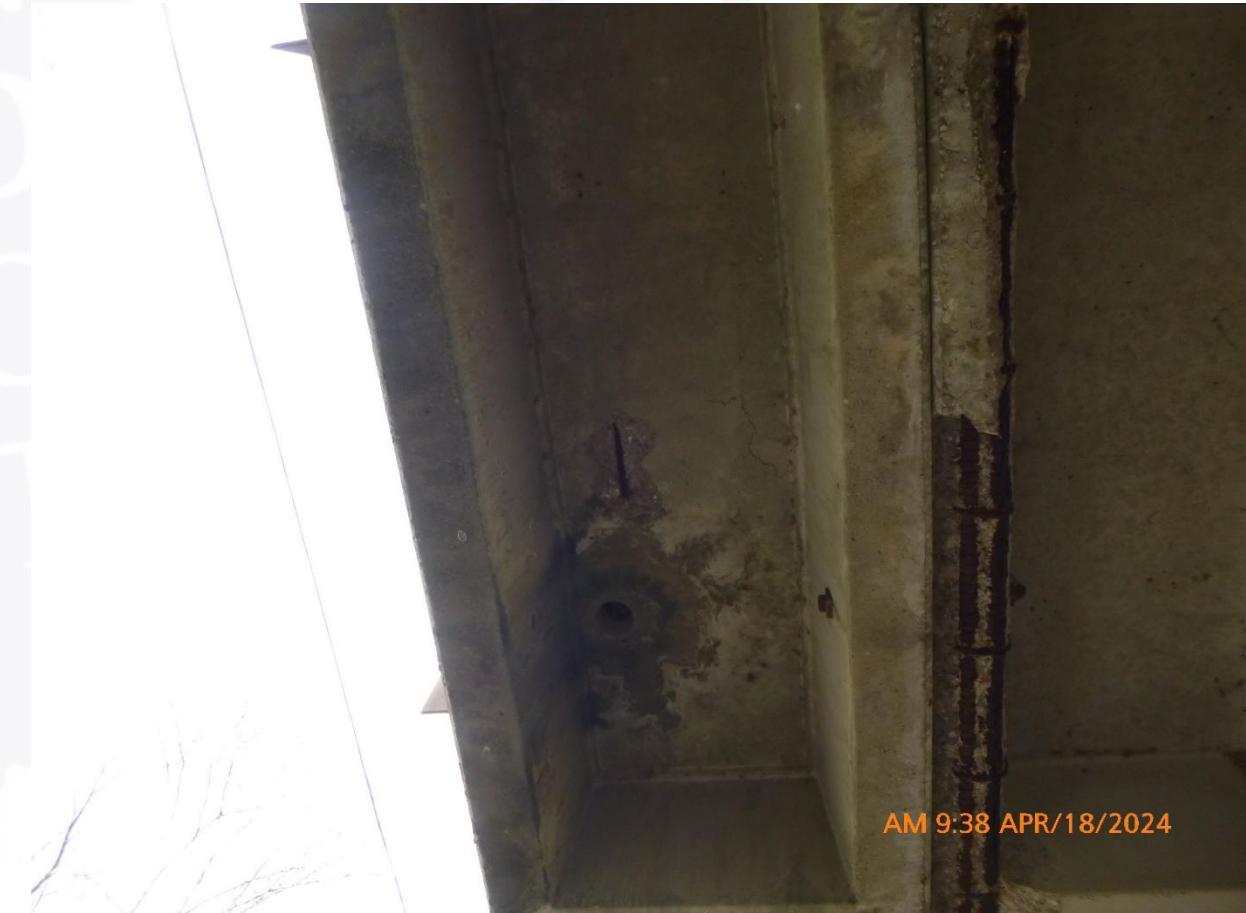
Underside of the Deck with a Minor Spall with Exposed Steel

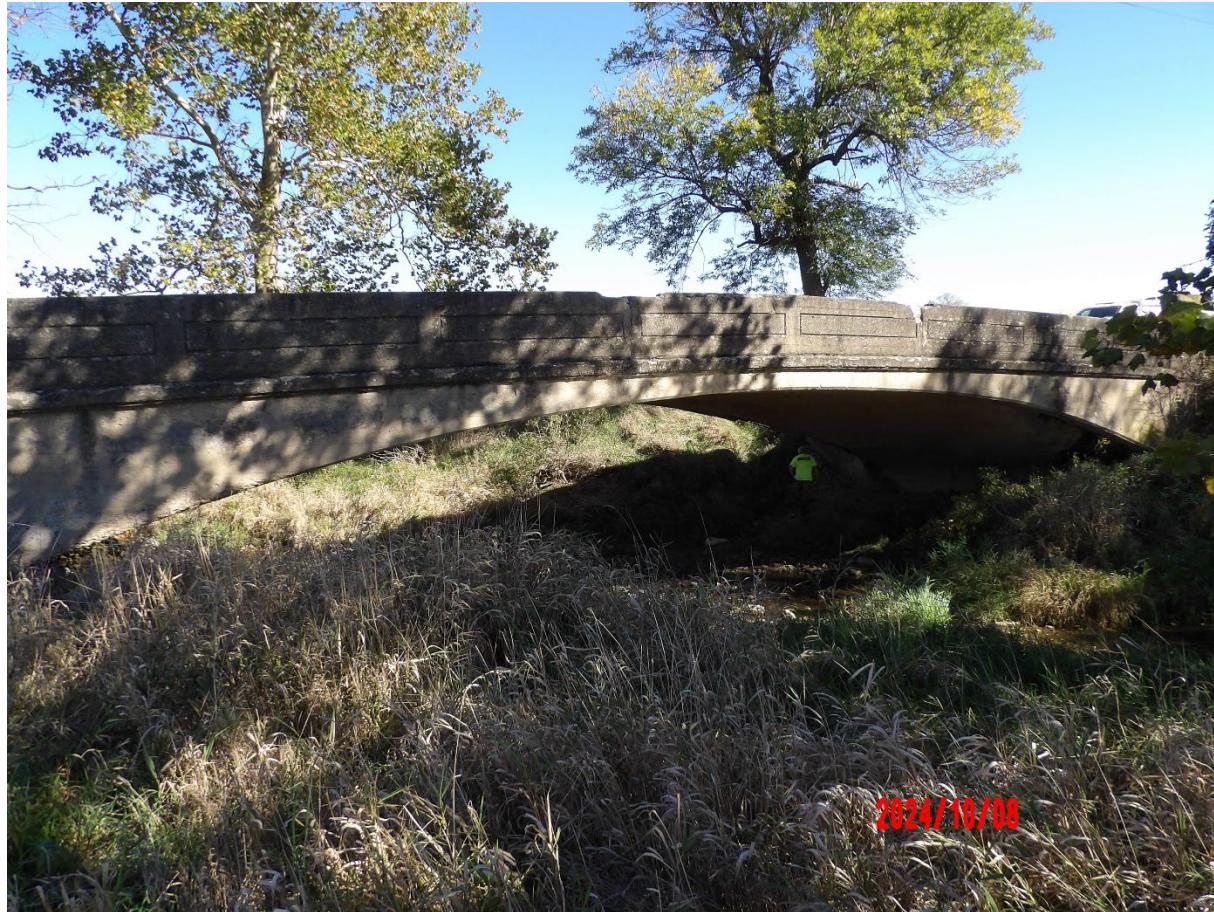
- Single span reinforced concrete under-fill arch

South Elevation

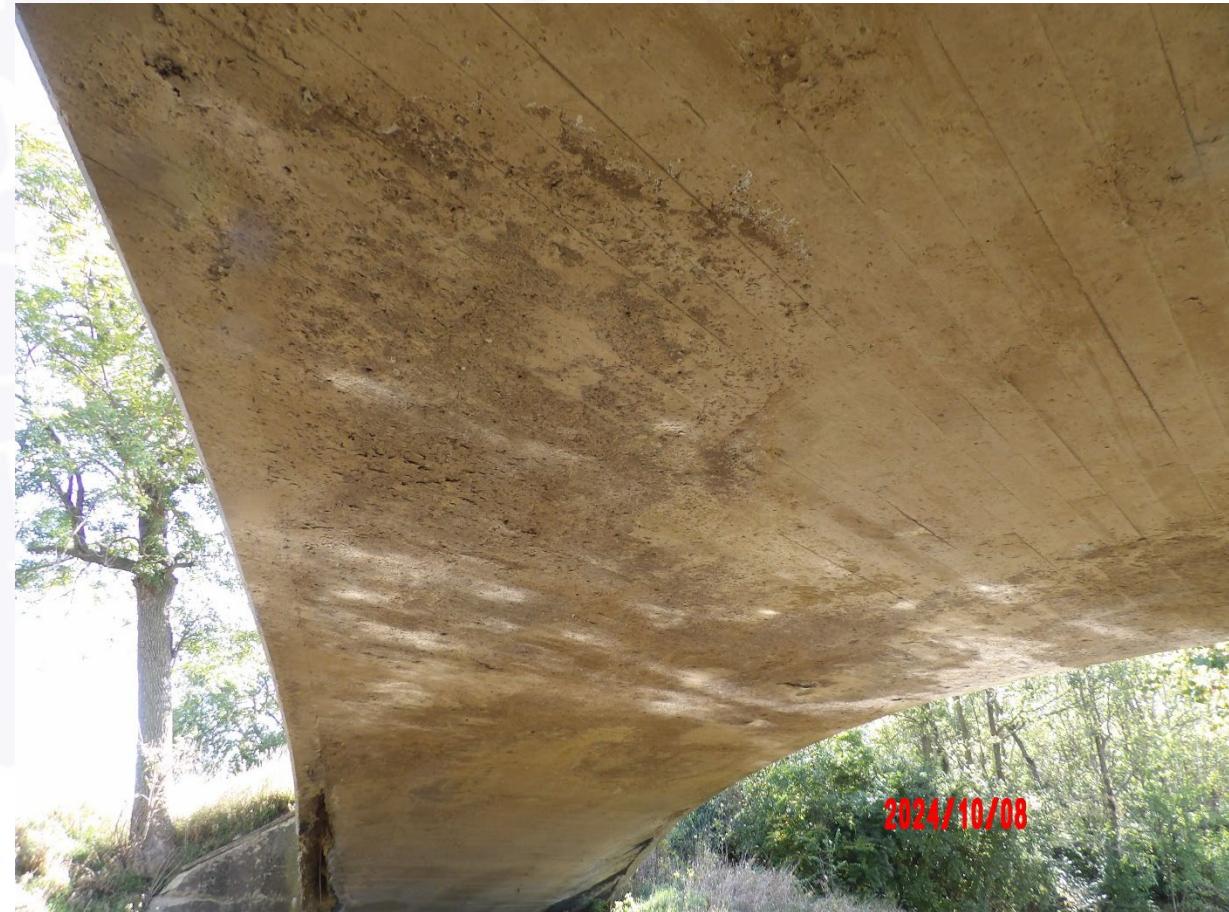
East Abutment

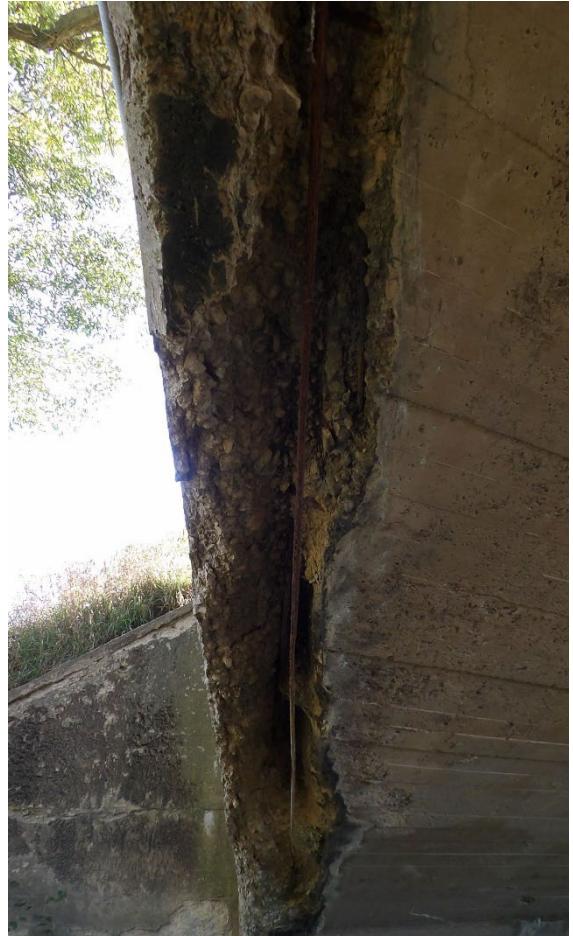
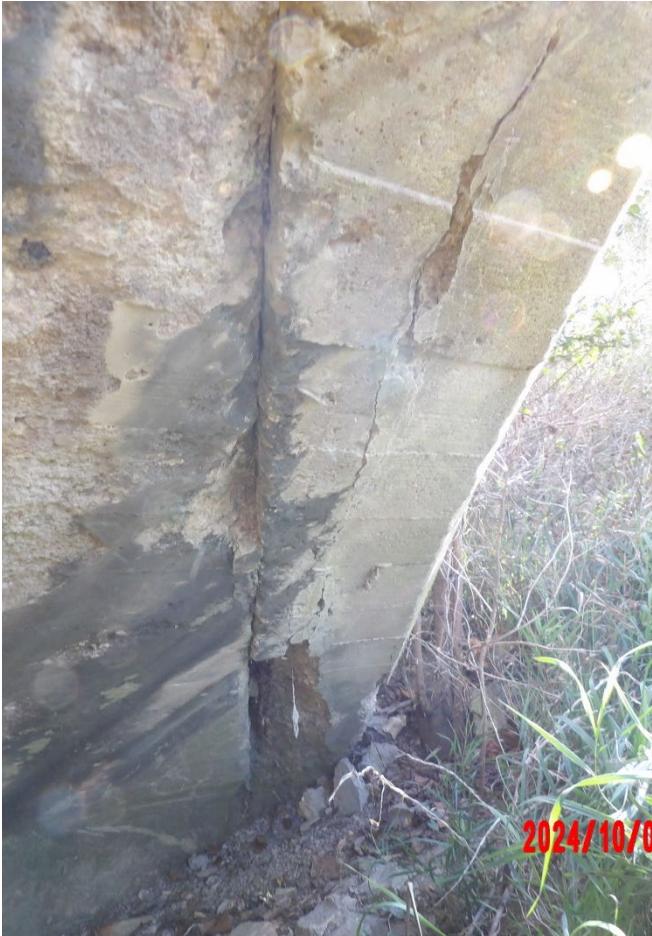
Exposed Steel on NE Coping

- Previous (62) Culvert: ???
- Comments:
 - Northeast interface of the arch ring and spandrel wall has heavily spalled with exposed steel having over 50% section loss. The spall measured 12" deep x 18" wide x 18' long. The southeast corner is spalling with exposed steel. The spall measured 10' long. The center of the arch has minor cracking and spalling. The concrete railing has minor spalling. The copings below the railings have minor spalling.

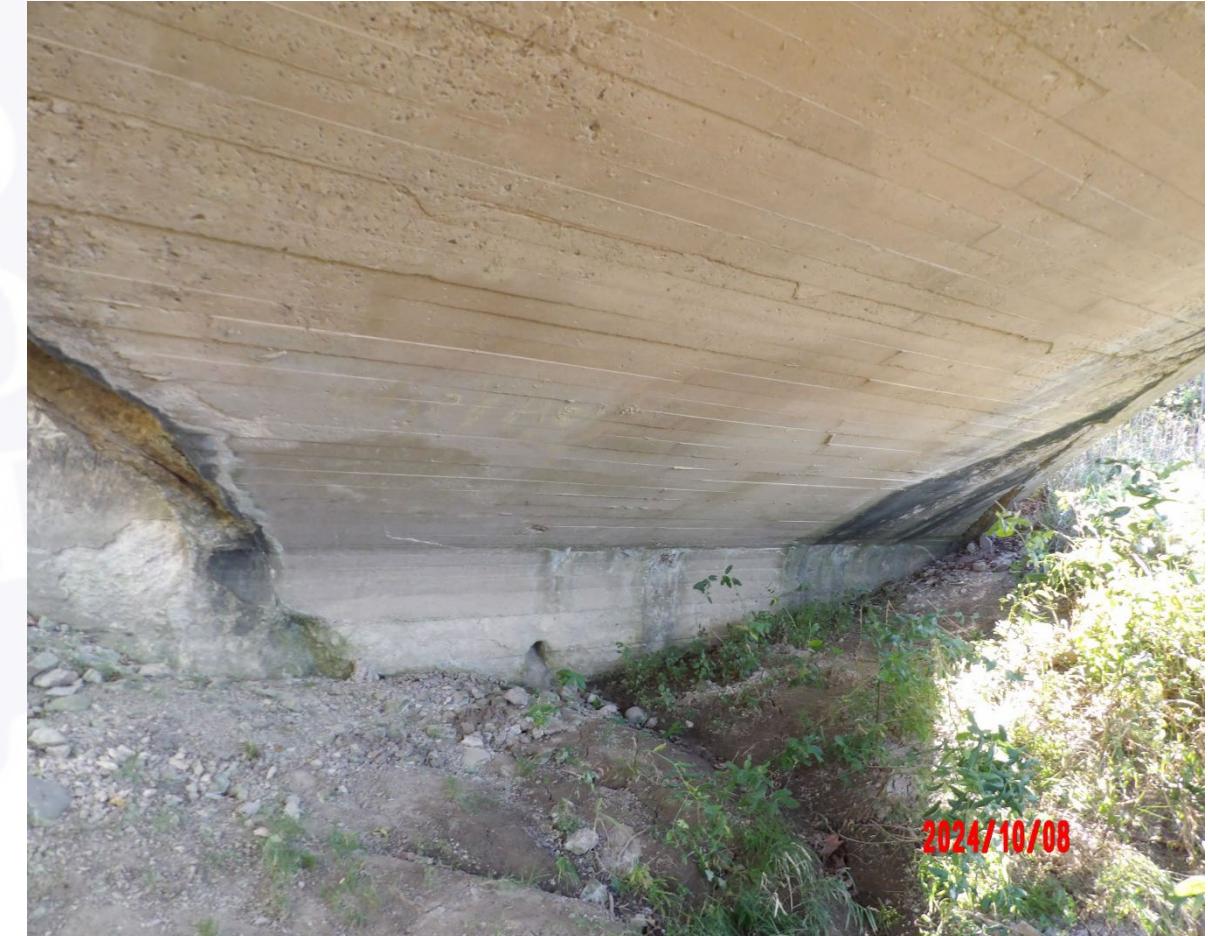
Spalling on the Southeast Coping

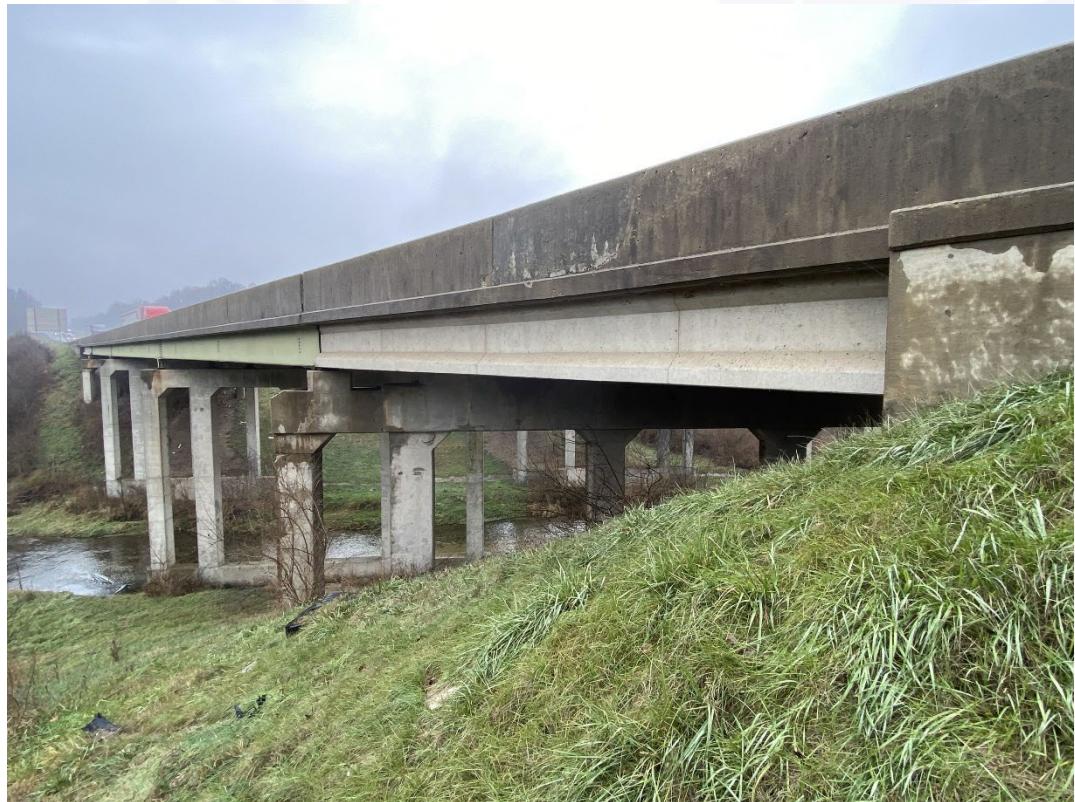
- Five span steel beam / prestressed concrete I-beam bridge with reinforced concrete end bents and reinforced concrete pier columns with bent cap

North Elevation

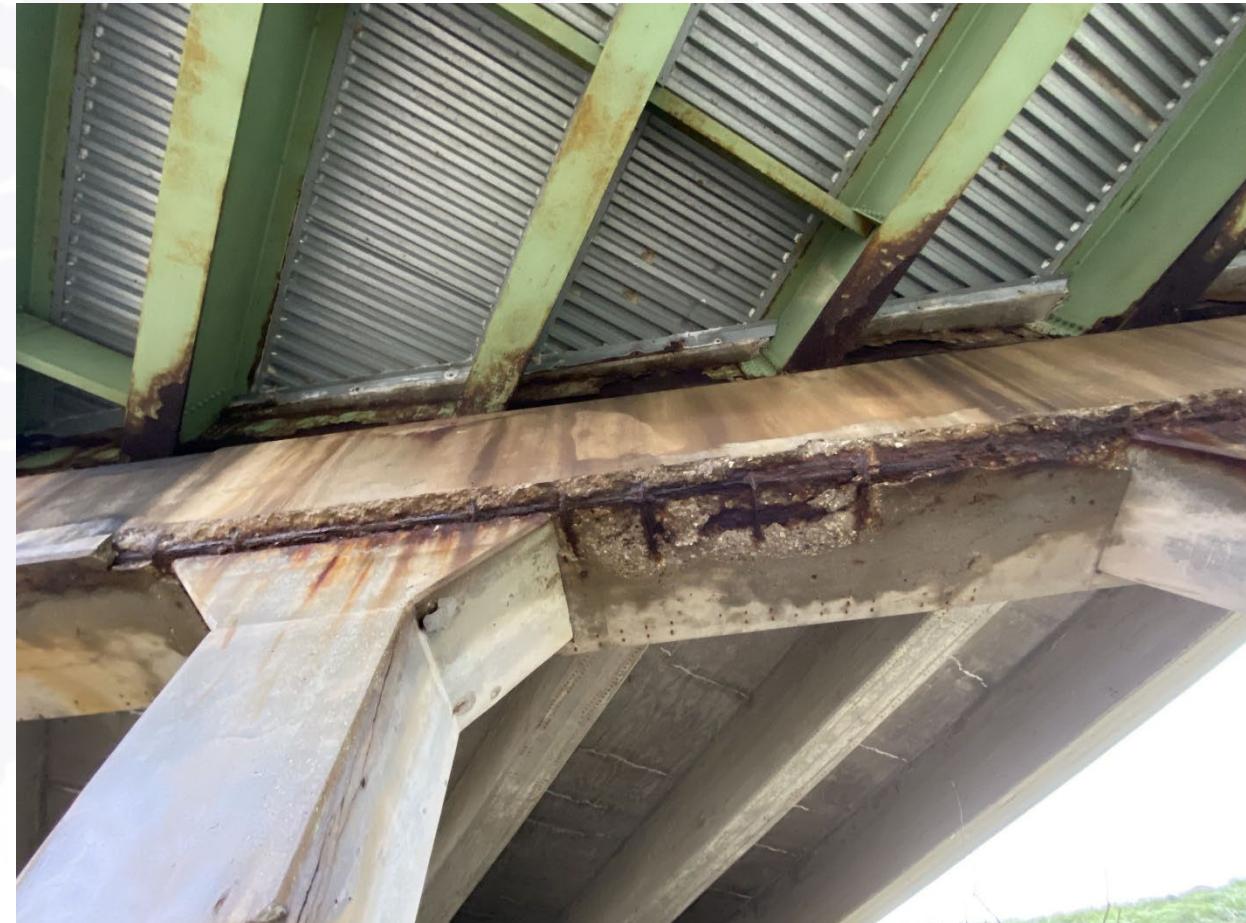
Exposed Steel on the Pier 2 Cap

- Previous (60) Substructure: ???
- Comments:
 - West end bent has moderate horizontal cracks with leaching, delaminations, & minor spalls with exposed steel.
 - Bent #2 cap has heavy spalling with exposed steel as well as heavy cracking on the bottom edge. The columns all have heavy spalling with exposed steel (especially north column that has section loss to the main vertical bar).
 - Bent #5 cap has heavy spalling with exposed steel and delaminations throughout

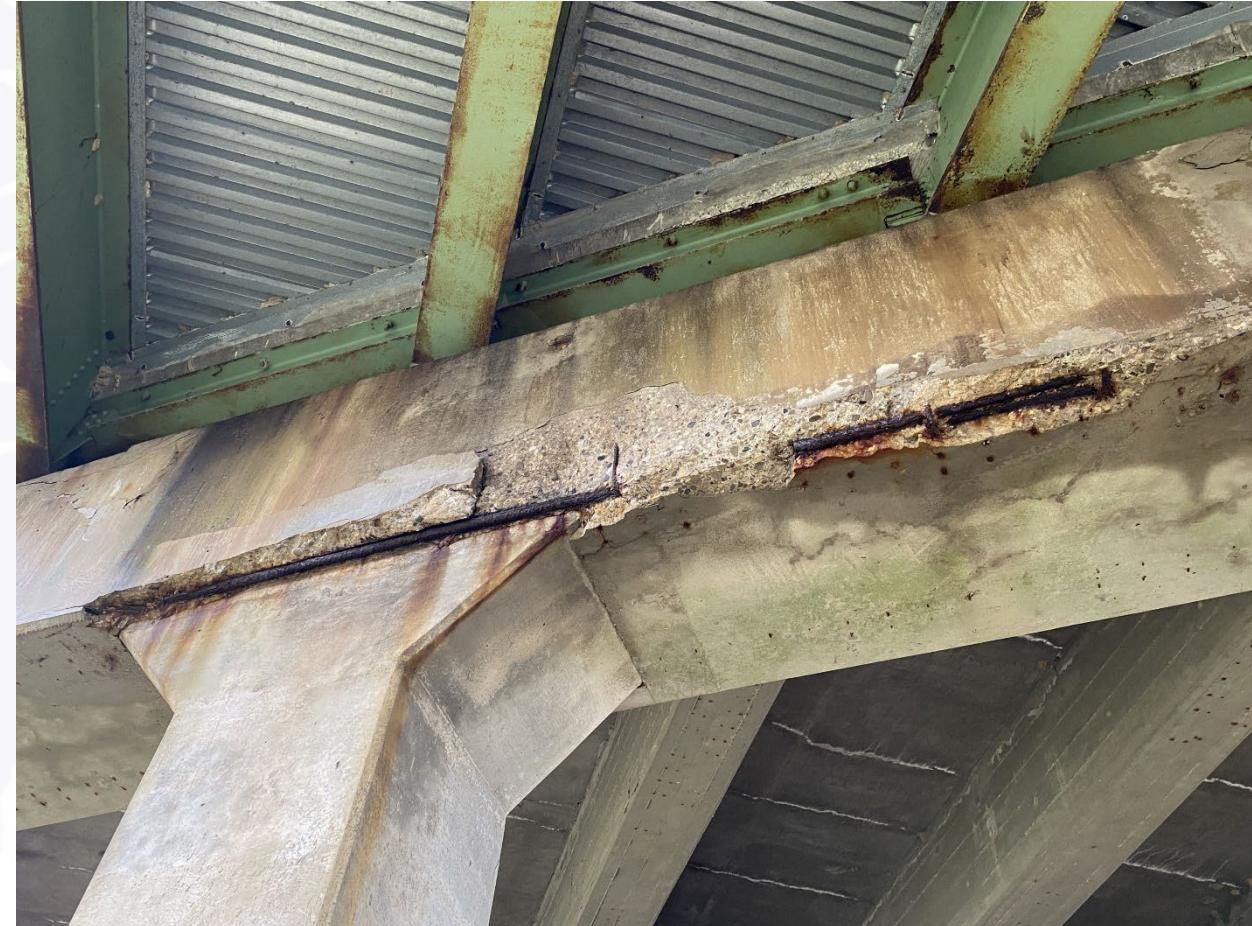
Pier 5 with Exposed Steel
