**“WATERS OF THE U.S.” DETERMINATION REPORT
US 31 in Town of Sellersburg, Clark County, Indiana
Pavement Maintenance
DES. NO. 1700111**

Prepared by: Ryan L. Scott
Contact Information: rscott@bfsengr.com / 317-713-4615
Butler, Fairman & Seufert, Inc.
Completed Date: July 28, 2022

Date(s) of Field Reconnaissance: June 2, 2020, October 28, 2020 and May 17, 2022*

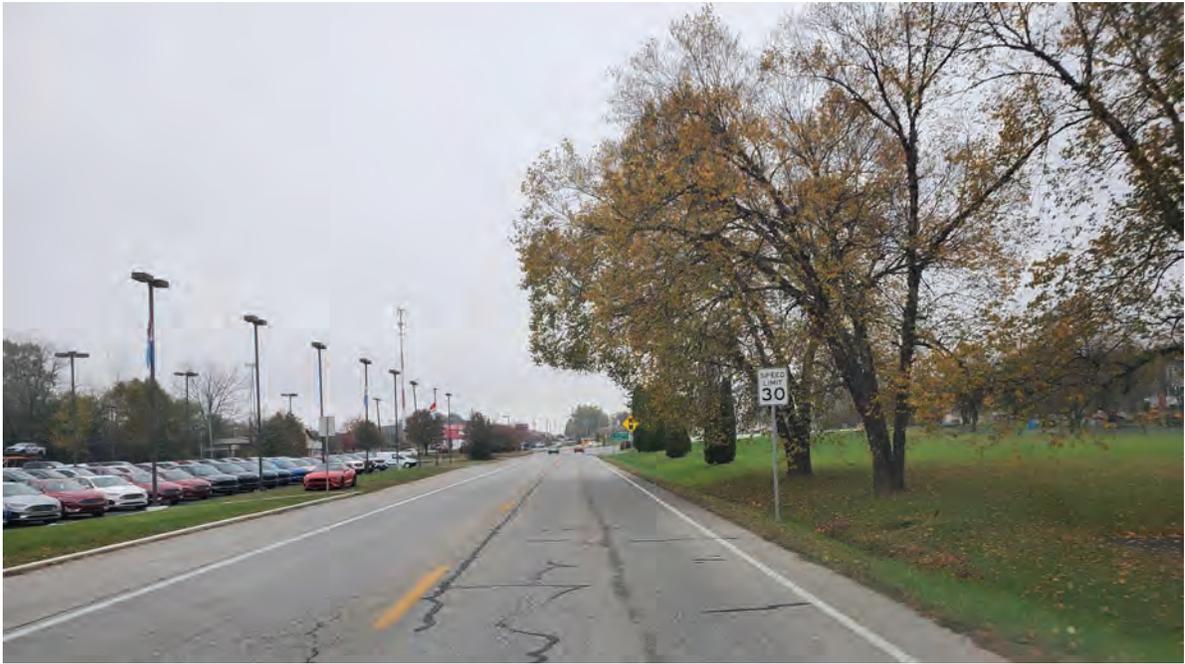
Photo 1: General Project Corridor View; looking northwest along US 31 near the south terminus of the overall project; no roadside drainage features noted

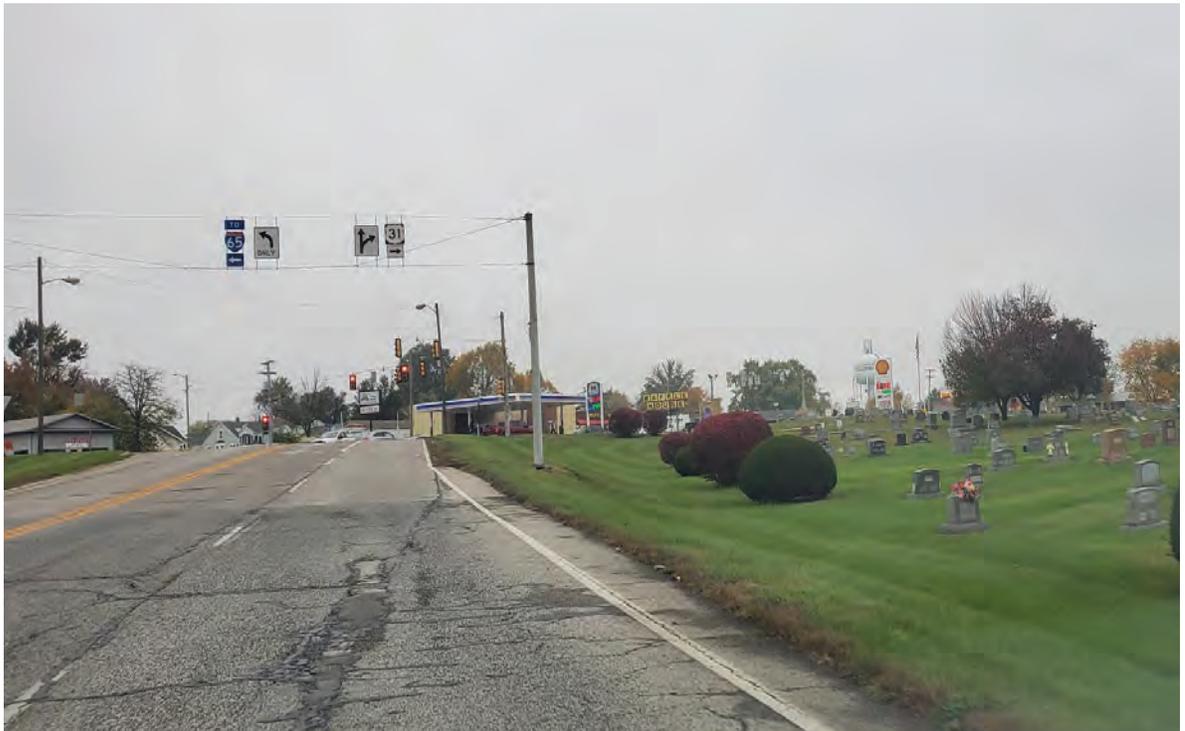
Photo 2: General Project Corridor View; looking northwest along US 31 towards the SR 311 / Charlestown Road Junction; no roadside drainage features noted

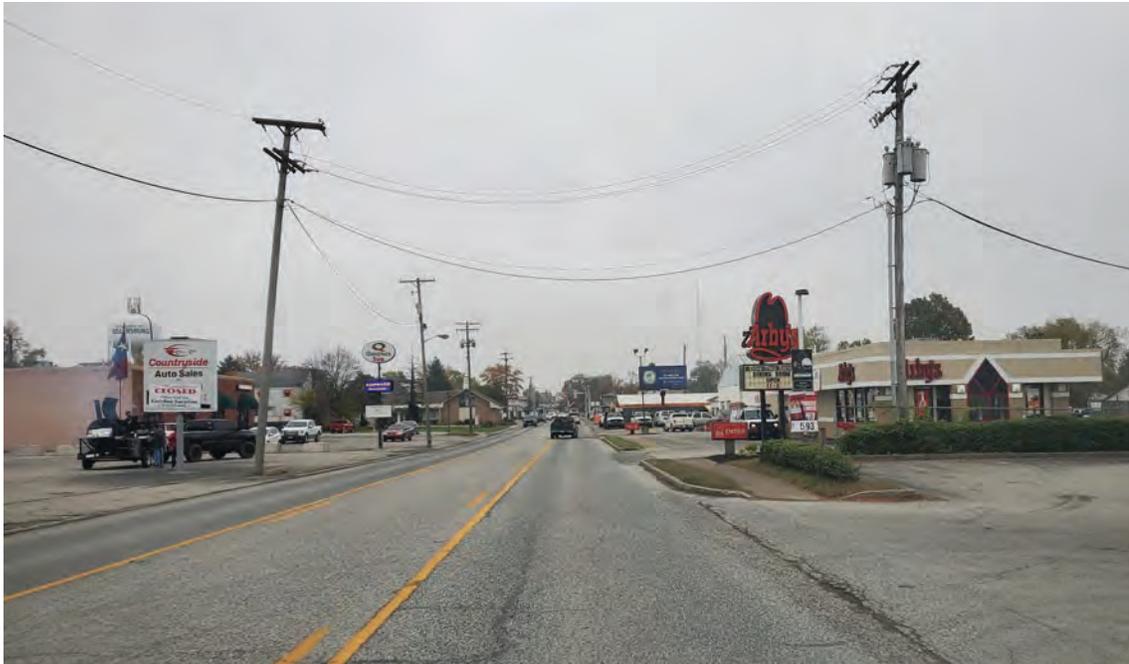
Photo 3: General Project Corridor View; looking northeast along US 31 between the SR 331/Charlestown Road Junction and Utica Street; storm water is managed by existing curb and gutter in this area

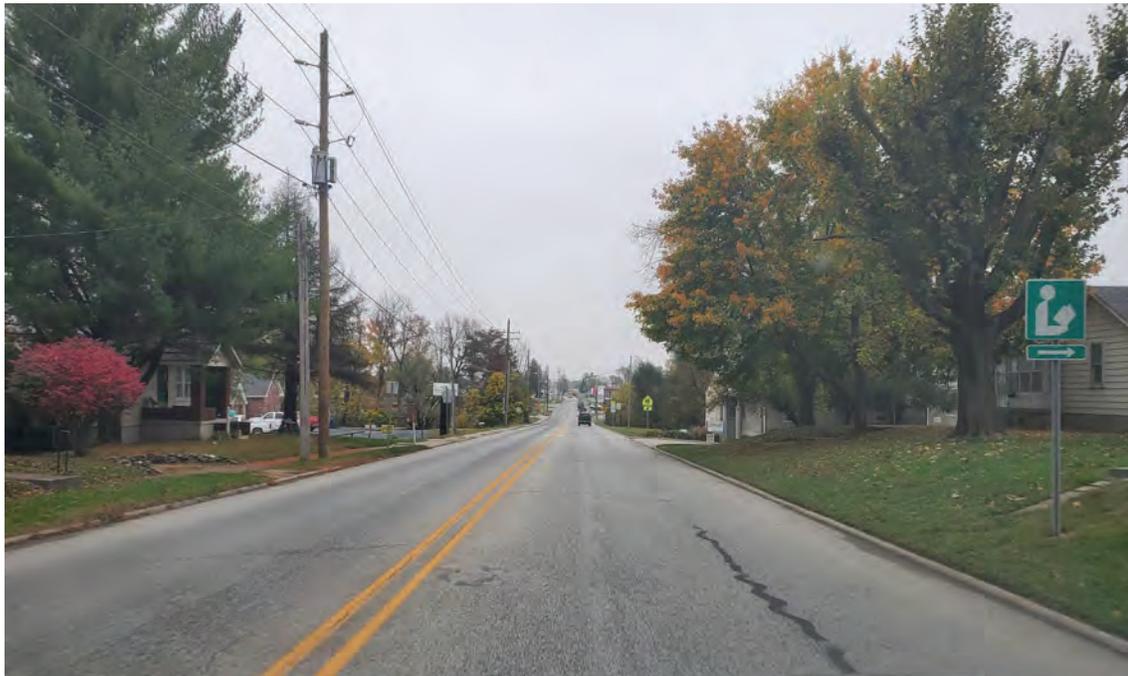
Photo 4: General Project Corridor View; looking northeast along US 31 near Hauss Avenue; storm water is managed by existing curb and gutter in this area

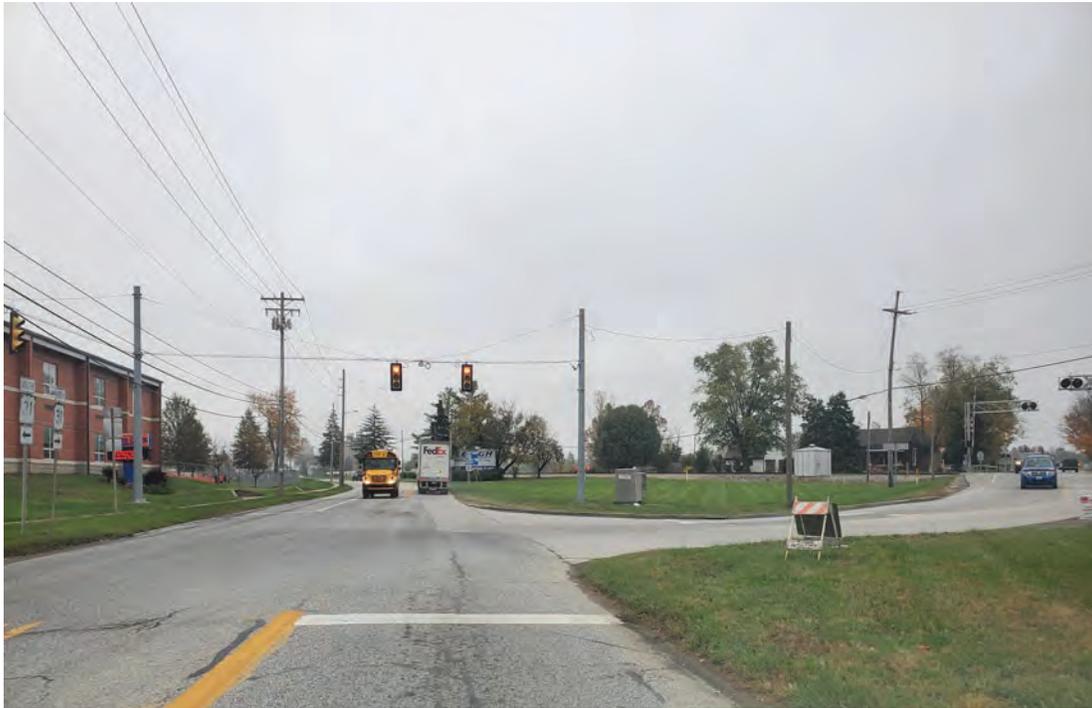
Photo 5: General Project Corridor View; looking northeast along US 31 at the intersection of Old SR 403; no roadside drainage features noted

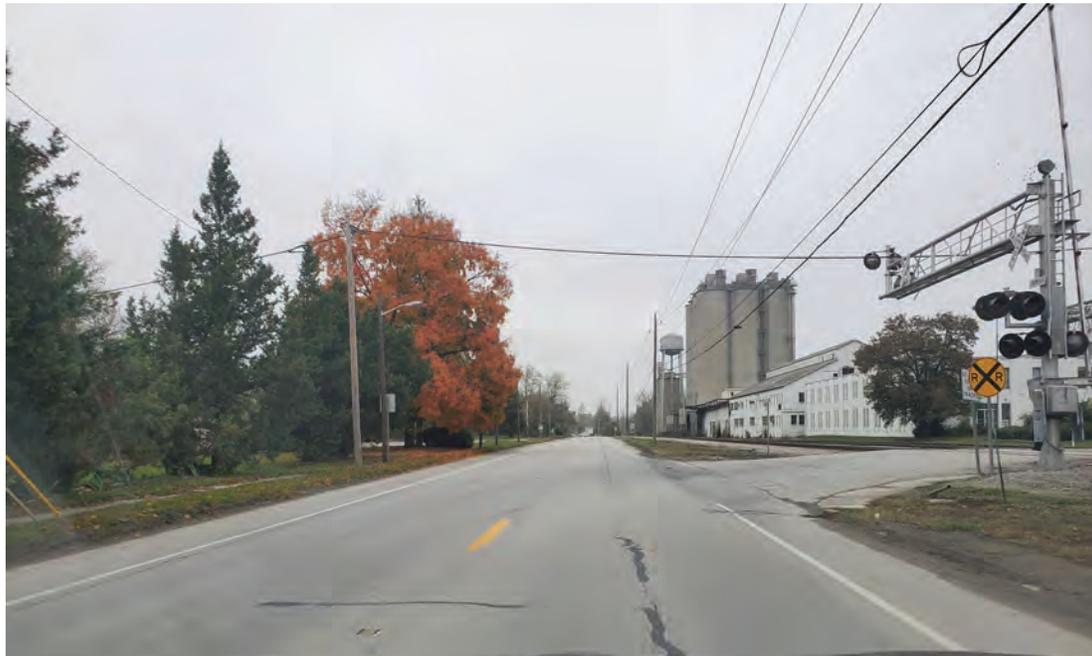
Photo 6: General Project Corridor View; looking north along US 31 near the north project terminus; no roadside drainage features noted

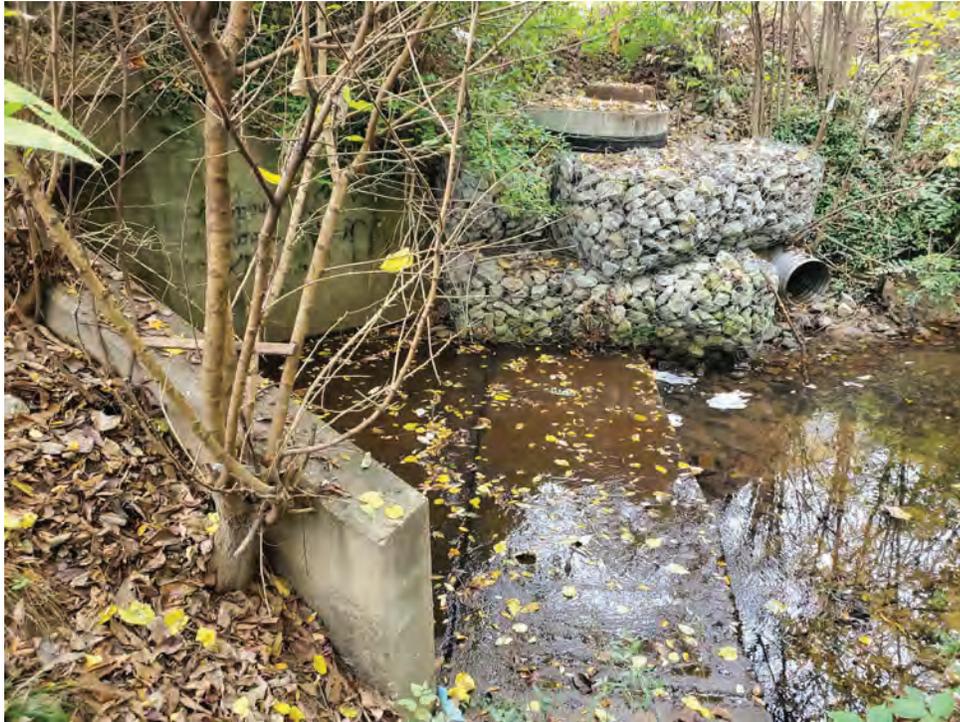
Photo 7: Investigation Area 1; looking northeast along the east side of US 31; culvert shown on the left carries US 31 over UNT to Silver Creek (downstream side pictured); no culvert work is proposed

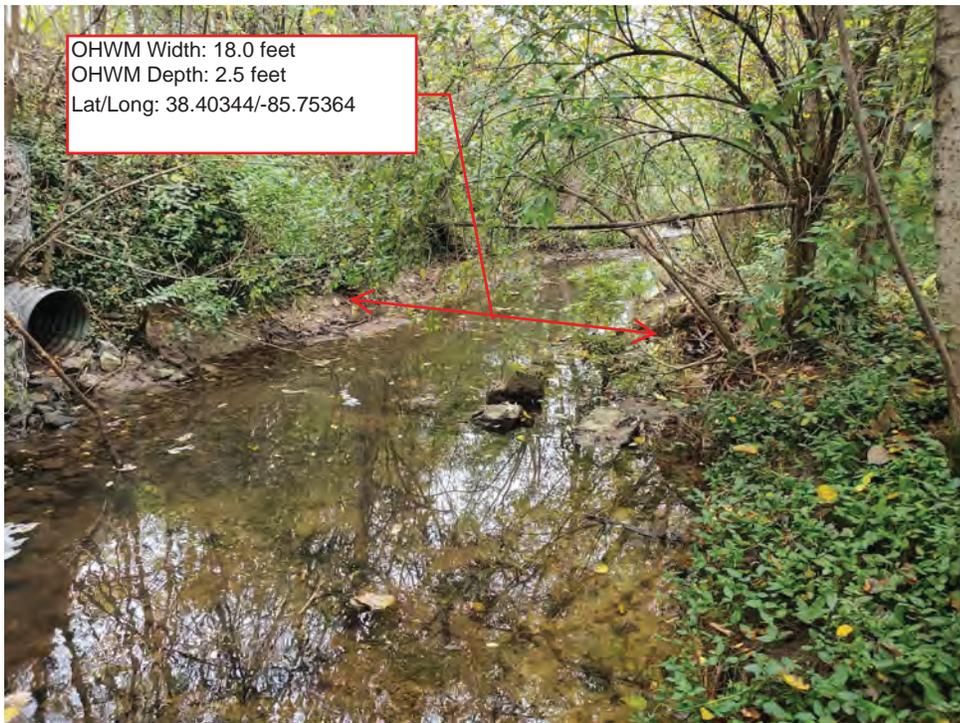
Photo 8: Investigation Area 1; looking east (downstream) along UNT to Silver Creek from the outlet of the US 31 culvert

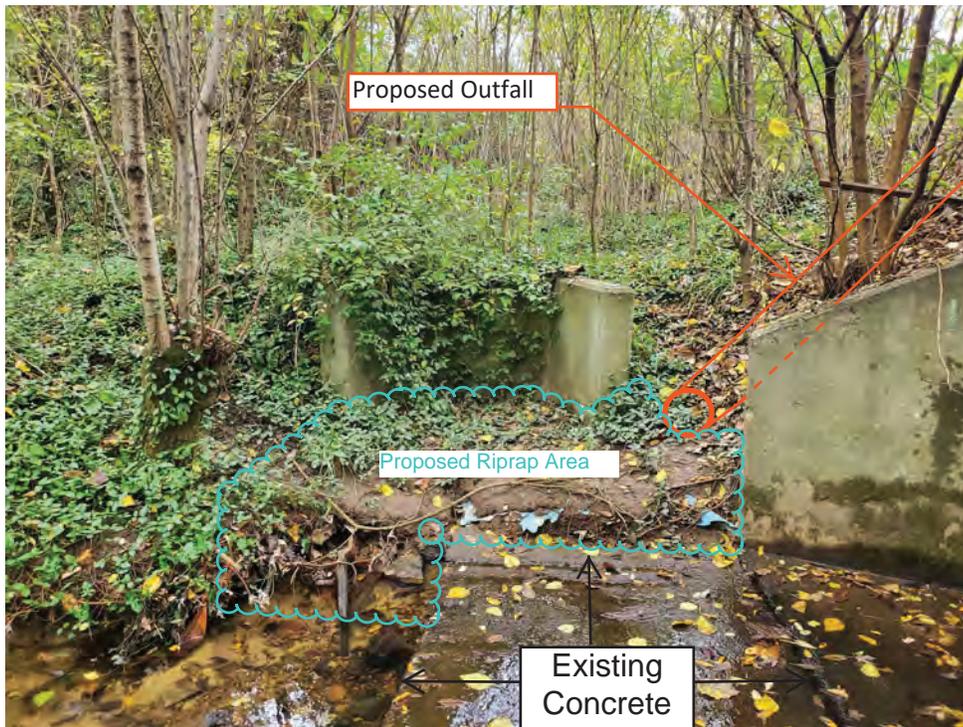
Photo 9: Investigation Area 1; looking southwest at the southeast quadrant of the US 31 crossing of UNT to Silver Creek; proposed new storm water outfall and riprap area noted

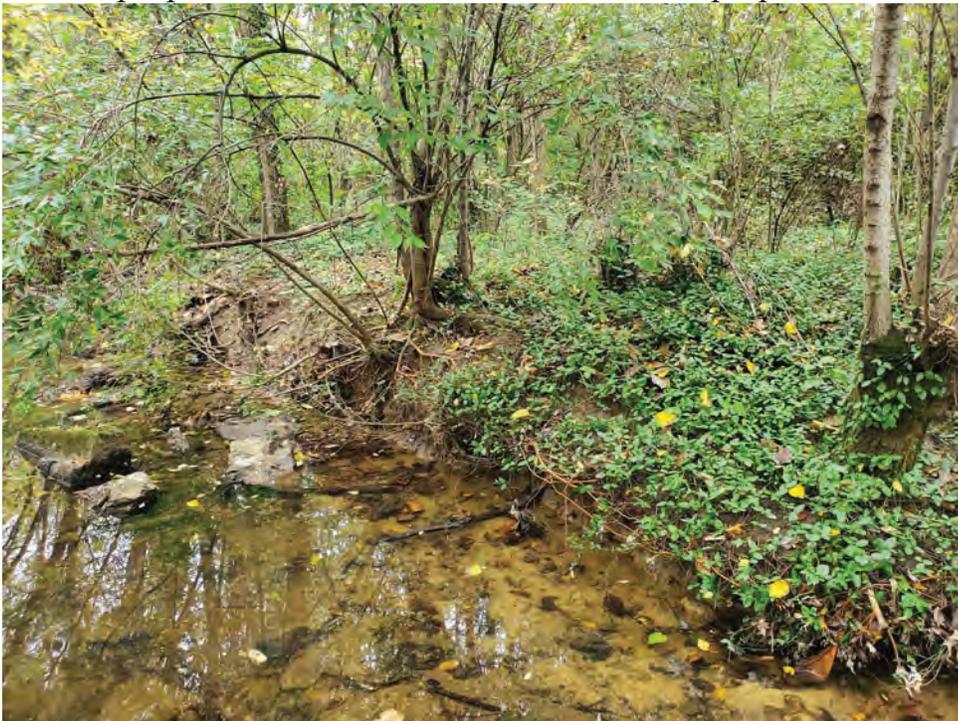
Photo 10: Investigation Area 1; looking southeast at the south bank of UNT to Silver Creek east (downstream) of the proposed outfall/riprap location

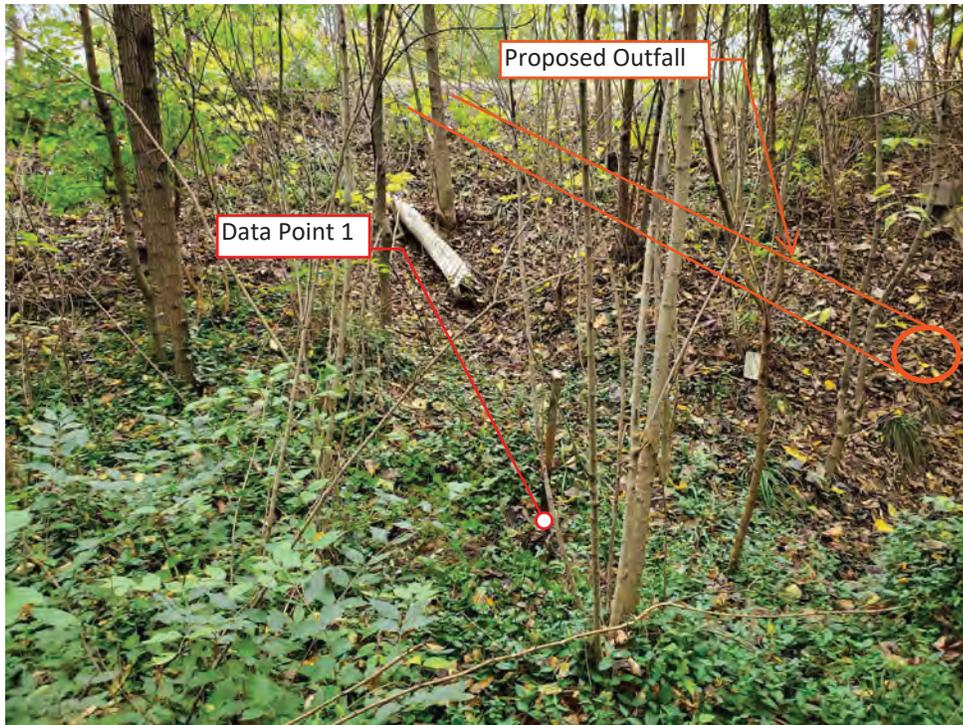
Photo 11: Investigation Area 1; Data Point 1 (non-wetland); looking west towards US 31 and the proposed new storm water outfall structure

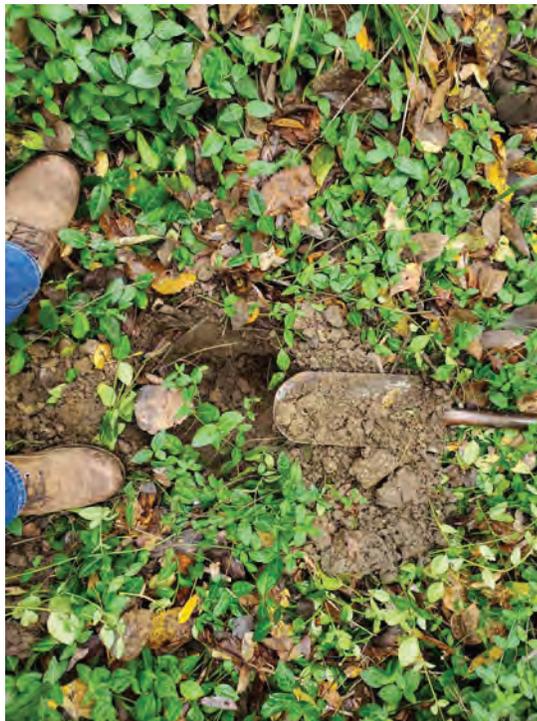
Photo 12: Investigation Area 1; Data Point 1 (non-wetland); view of sample location

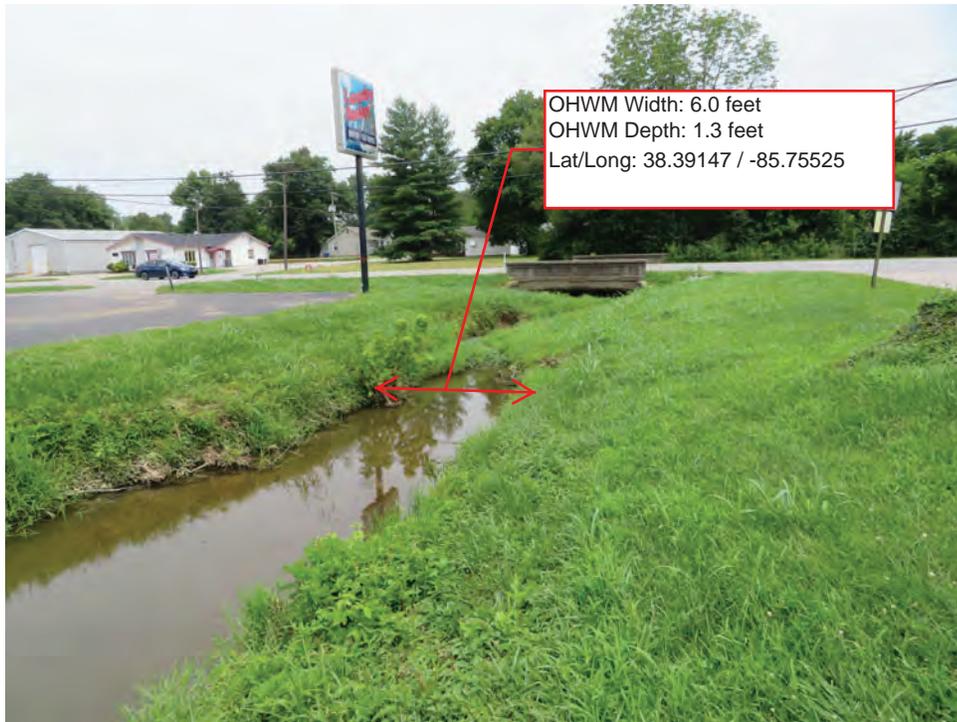
Photo 13: Investigation Area 2; Looking northeast (downstream) along Camp Run (Reach 1); US 31 is carried by the culvert shown in the background

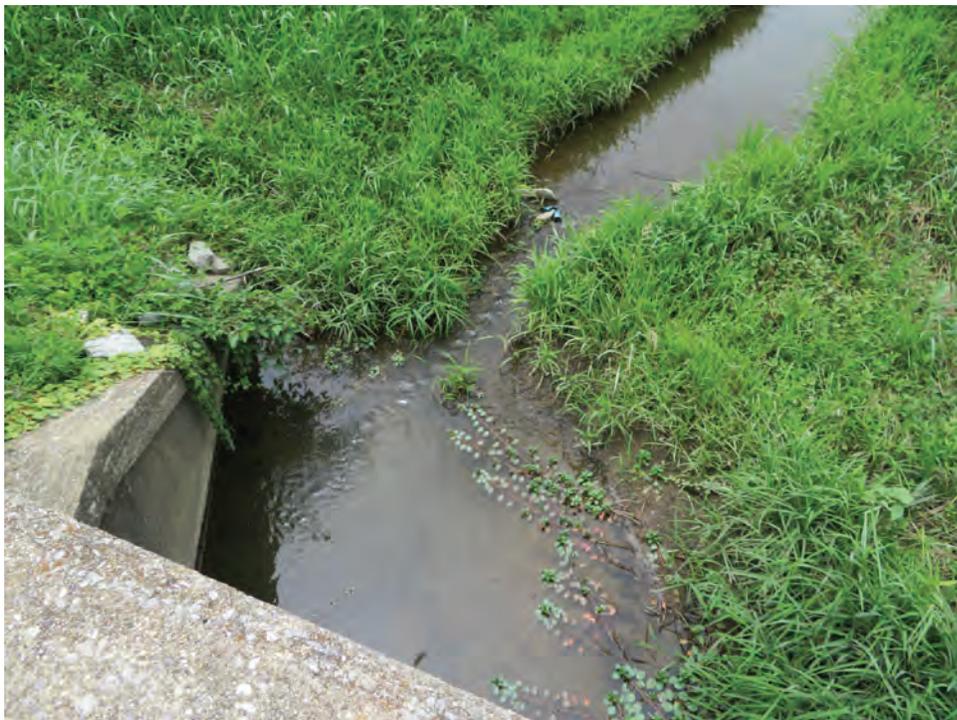
Photo 14: Investigation Area 2; Looking southwest (upstream) along Camp Run (Reach 1) from the US 31 crossing

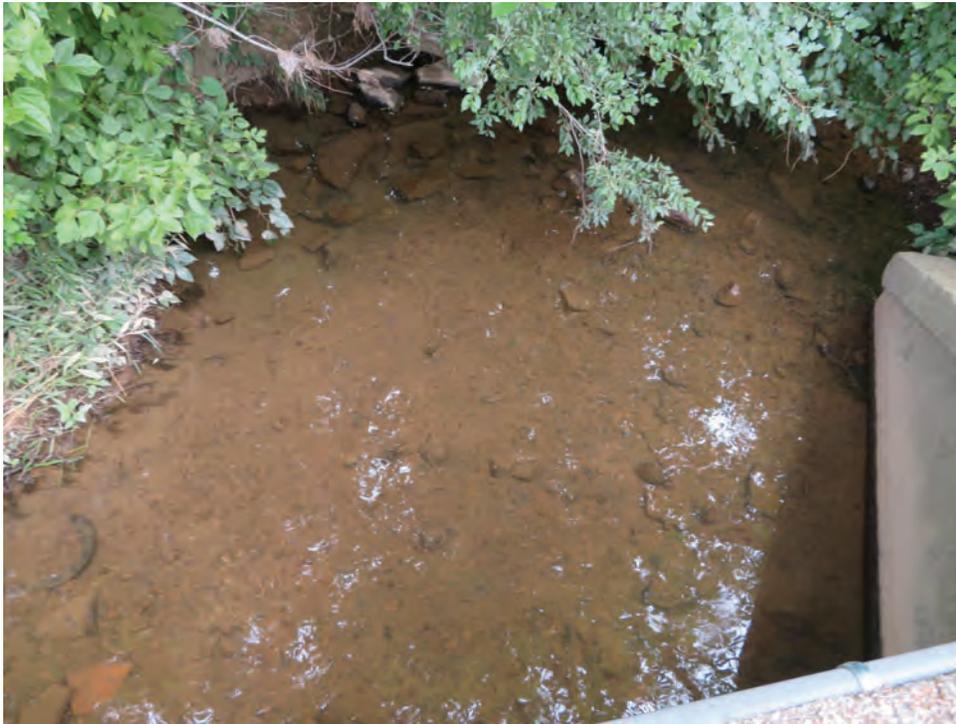
Photo 15: Investigation Area 2; looking northeast (downstream) along Camp Run (Reach 1) from US 31

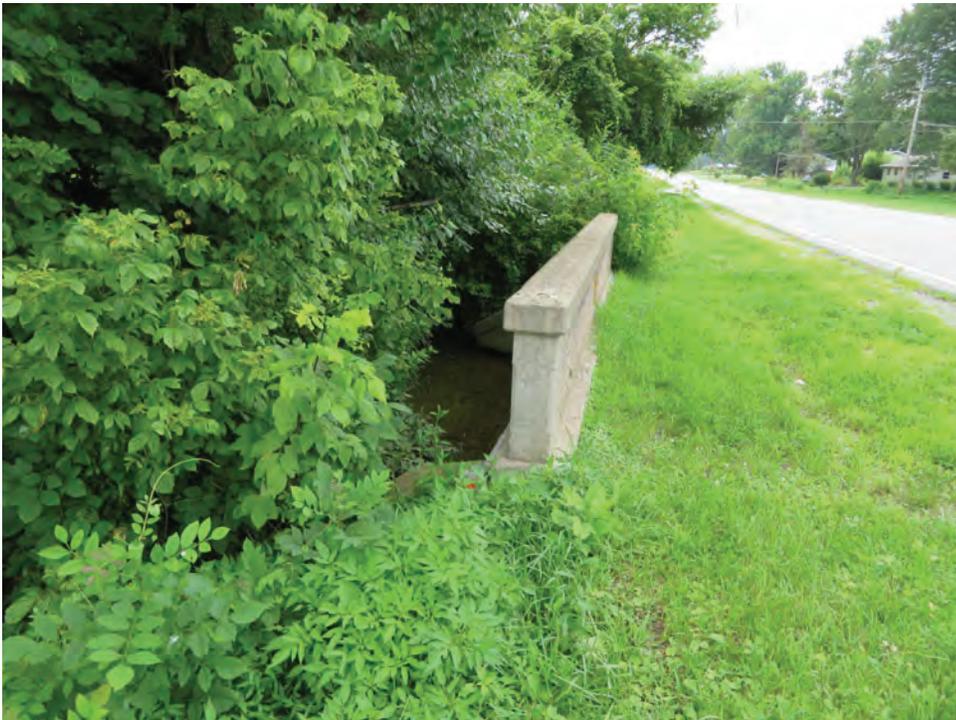
Photo 16: Investigation Area 2; looking southeast along the east side of US 31 towards the outlet of Camp Run (Reach 1)

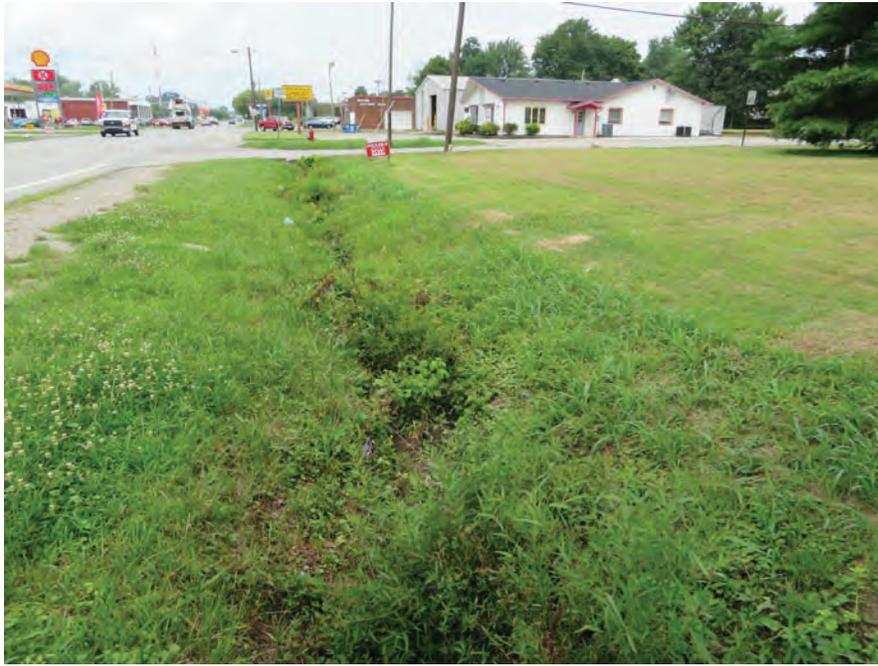
Roadside ditch 1 (RSD1) was observed within Investigation Area 2. Specifically, this feature parallels the east side of US 31 and conveys stormwater runoff south to Camp Run. This feature has a defined channel but does not contain an ordinary high water mark. During the site visit conducted on October 28, 2020, RSD1 did not contain any flowing water. Therefore, it should not be considered a jurisdictional feature.

Photo 17: Investigation Area 2; looking northwest at a roadside ditch (RSD 1) located along the east side of US 31 approximately 50 feet north of Camp Run (Reach 1)

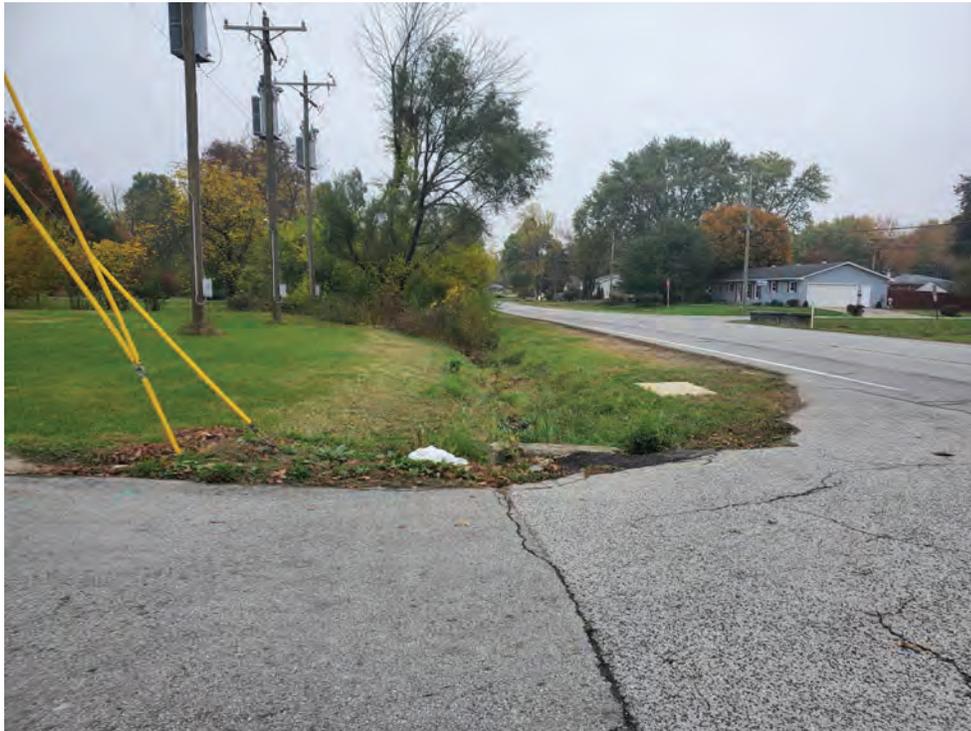
Photo 18: Investigation Area 2; looking southeast from Fern Street at a roadside ditch (RSD1) long the east side of US 31; culvert carrying US 31 over Camp Run (Reach 1) shown in the background

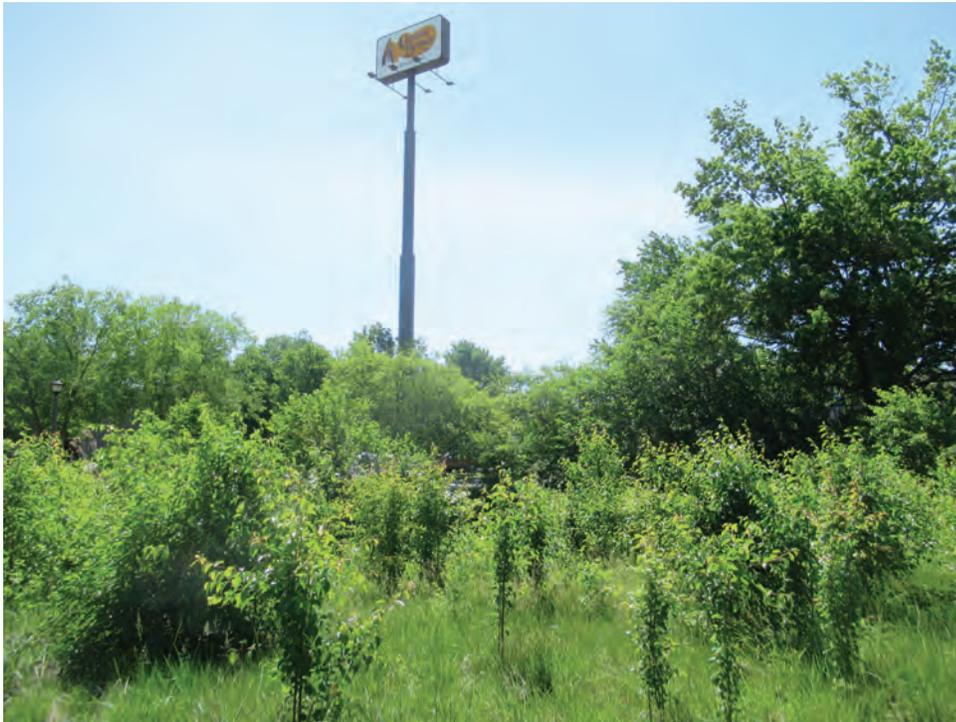
Photo 19: Investigation Area 3; looking southeast north of Camp Run (Reach 2) at upland area dominated by Amur honeysuckle (*Lonicera maackii*, UPL) and field brome (*Bromus arvensis*, FACU)

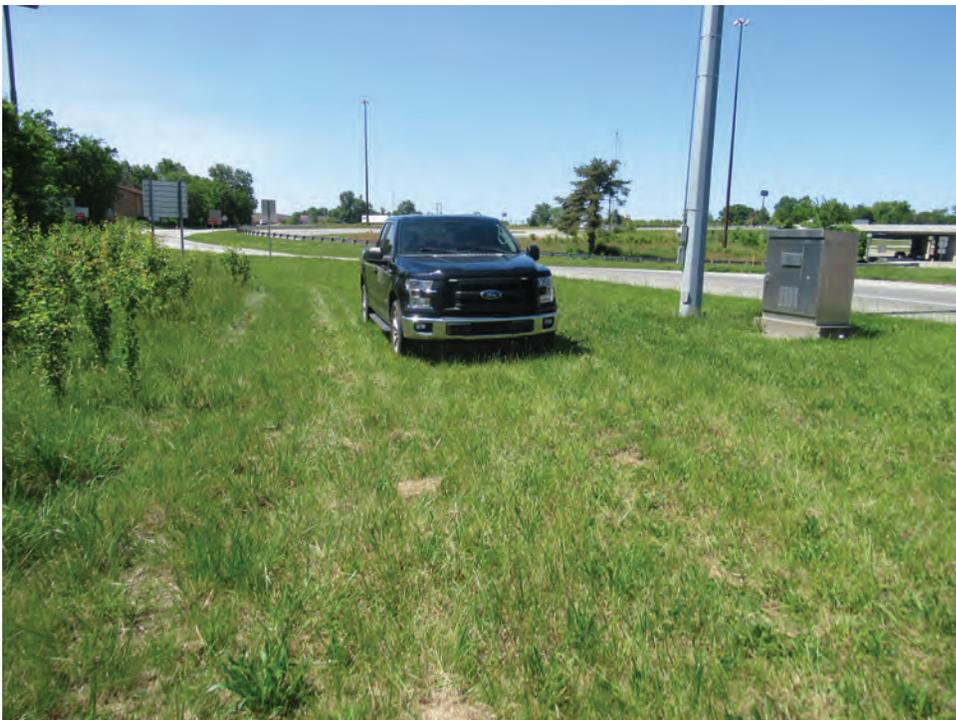
Photo 20: Investigation Area 3; looking southwest north of Camp Run (Reach 2) (not pictured due to being piped)

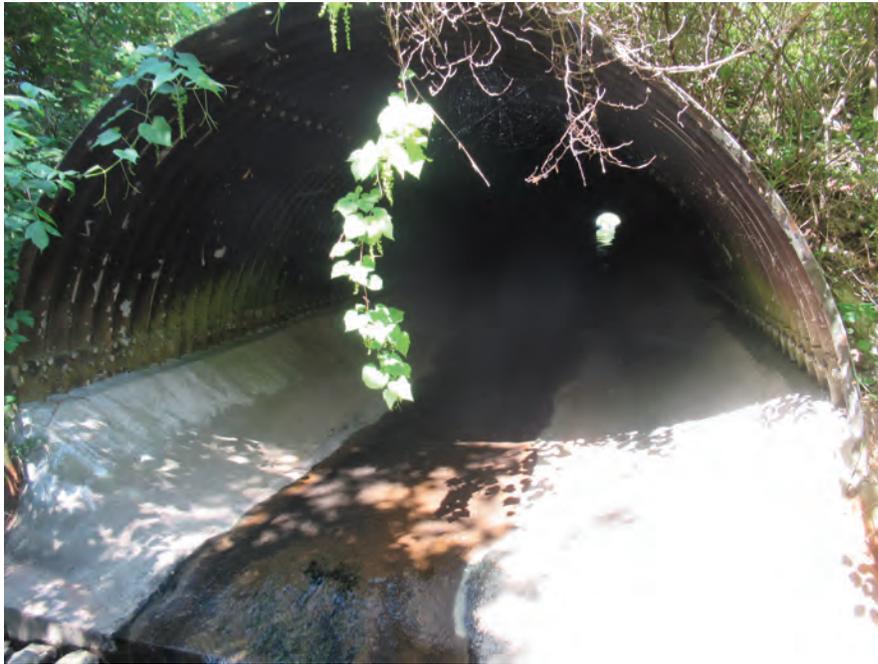
Photo 21: Investigation Area 3; looking southwest at Camp Run (Reach 2) existing pipe outlet under Highway 311.

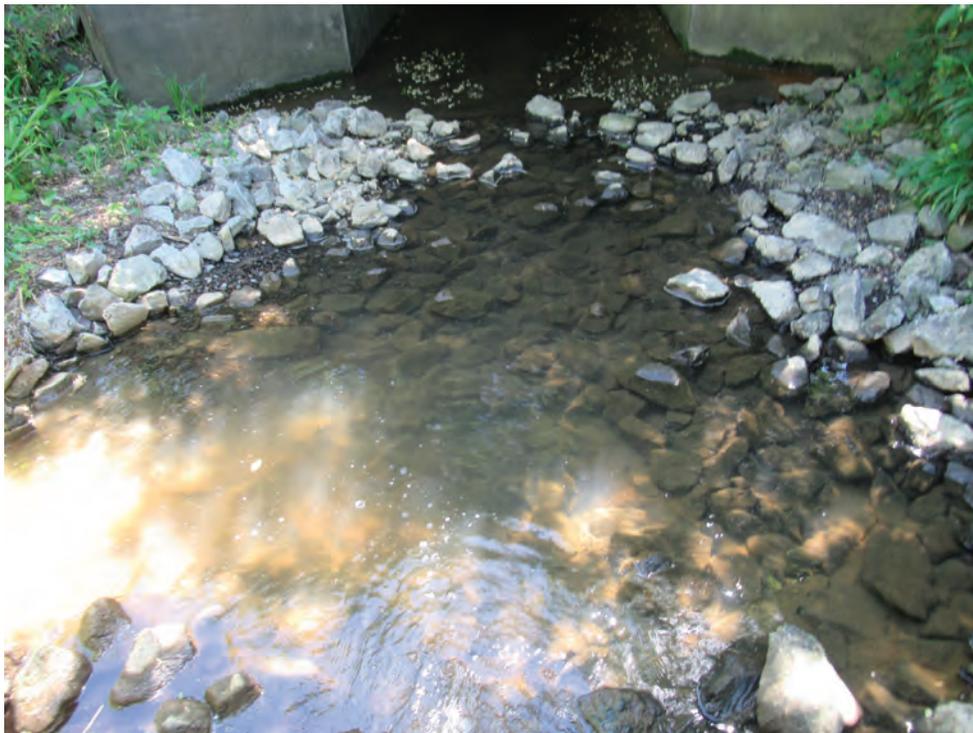
Photo 22: Investigation Area 3; looking southeast (downstream) along Camp Run (Reach 2) from the existing pipe outlet under Highway 311.

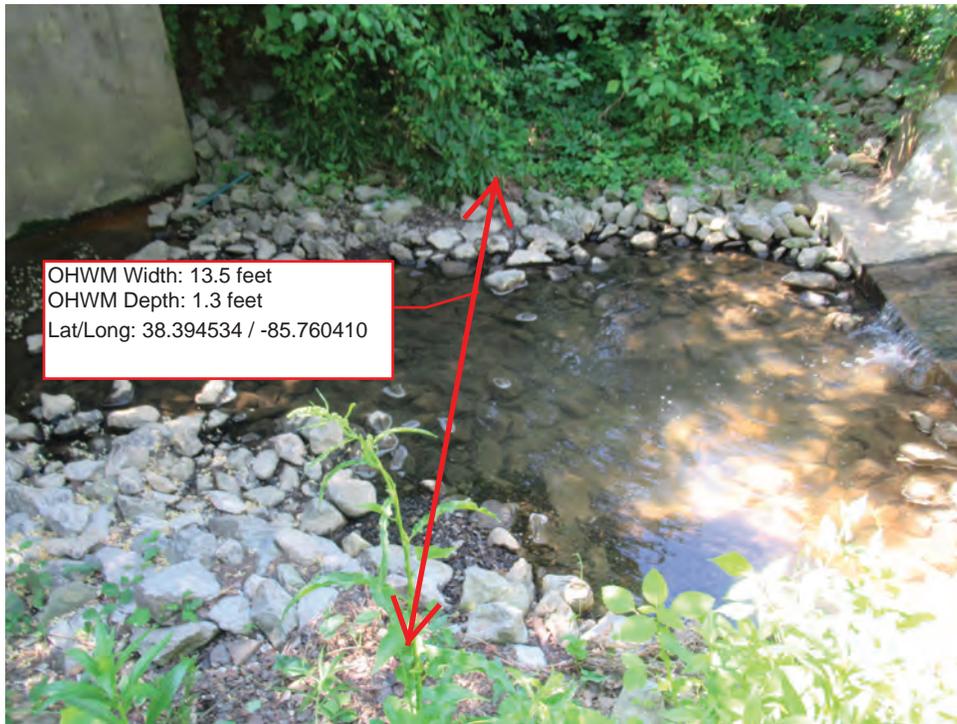
Photo 23: Investigation Area 3; looking southwest across Camp Run (Reach 2) between the Hwy 311 pipe outlet (on right) and a concrete culvert inlet under commercial properties (on left)

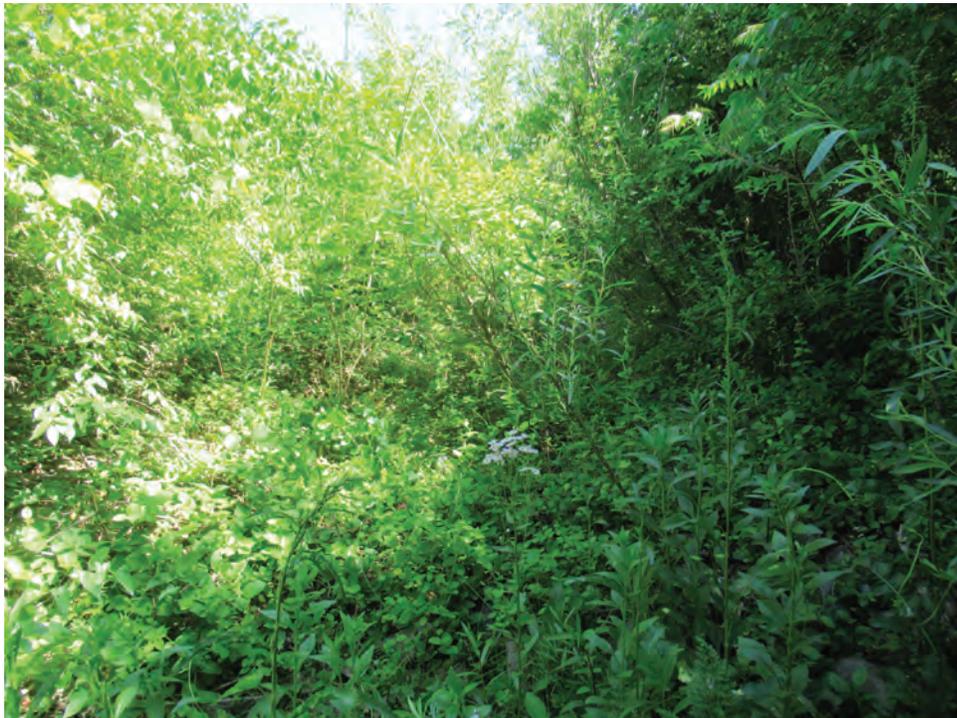
Photo 24: Investigation Area 3; looking northeast from Camp Run (Reach 2) at steeply sloped bank

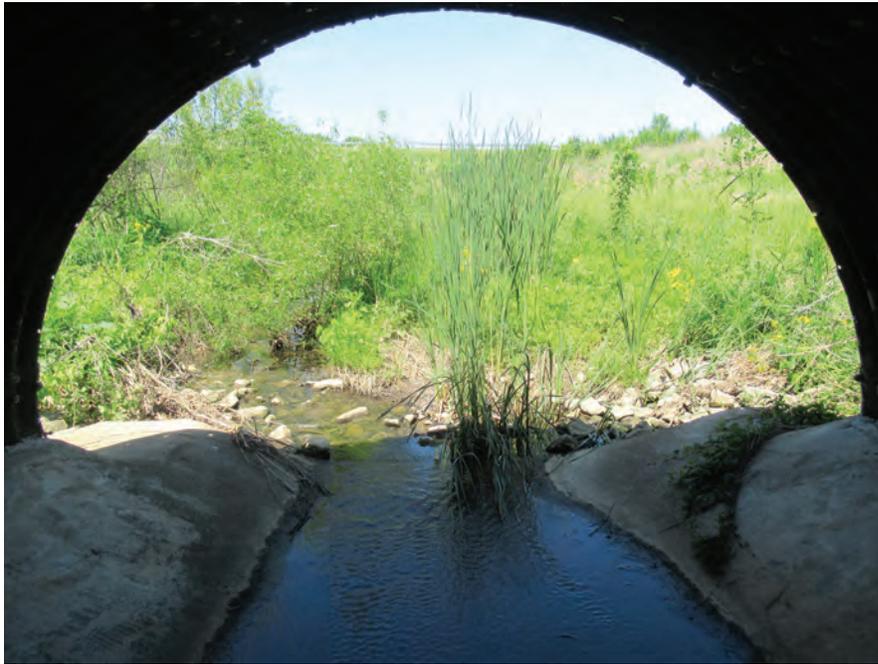
Photo 25: Investigation Area 4; looking northwest (upstream) along Camp Run (Reach 3) from inlet of pipe under Hwy 311

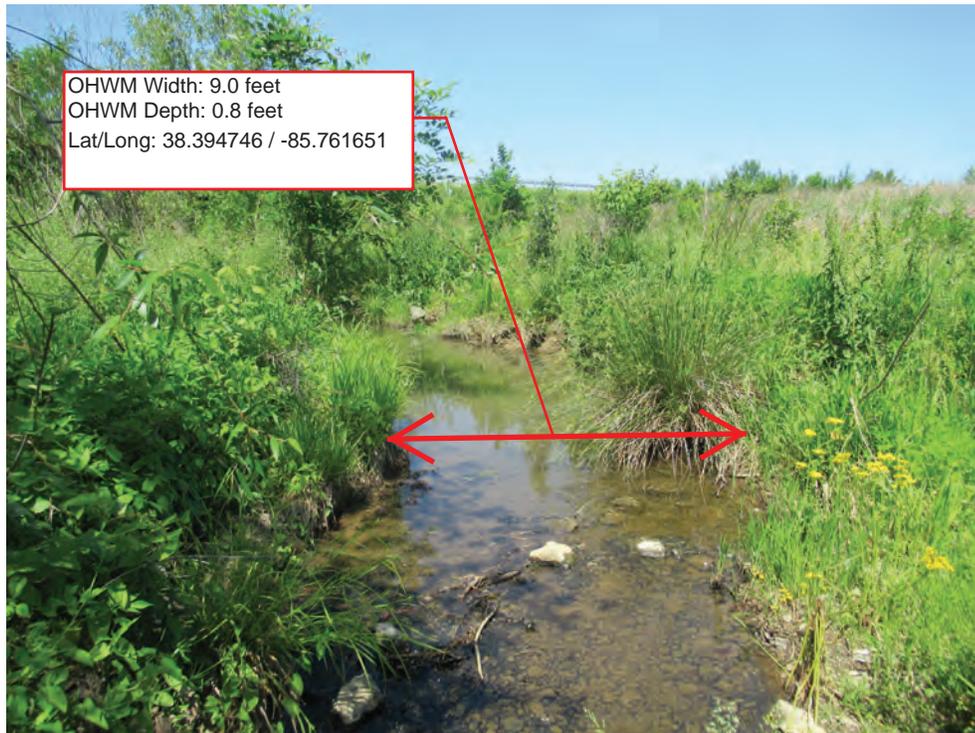
Photo 26: Investigation Area 4; looking northwest (upstream) along Camp Run (Reach 3)

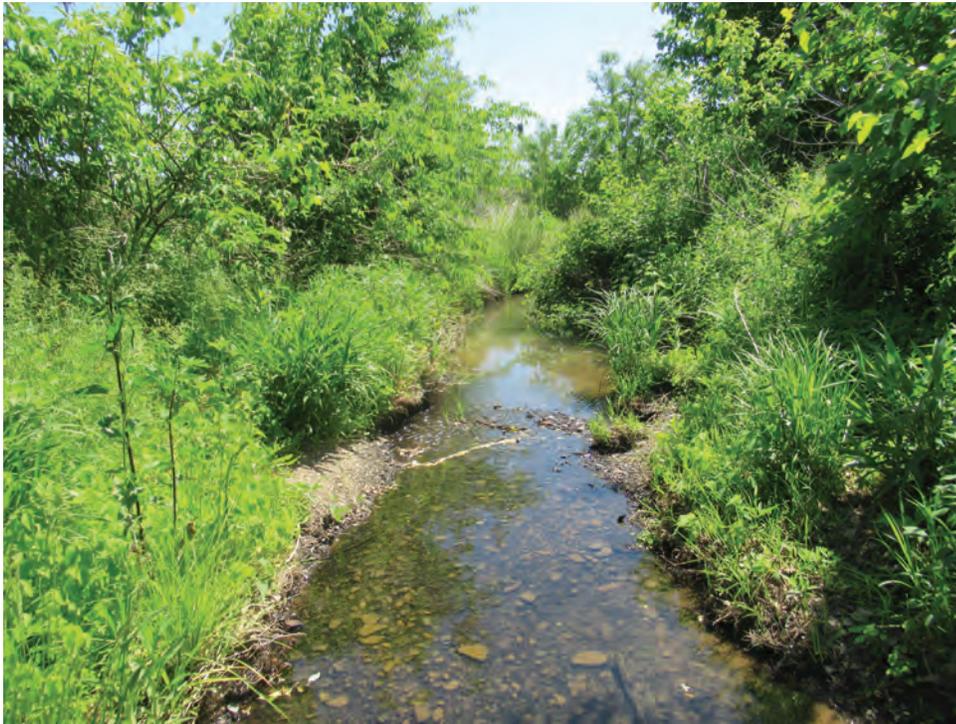
Photo 27: Investigation Area 4; looking southeast (downstream) along Camp Run (Reach 3)

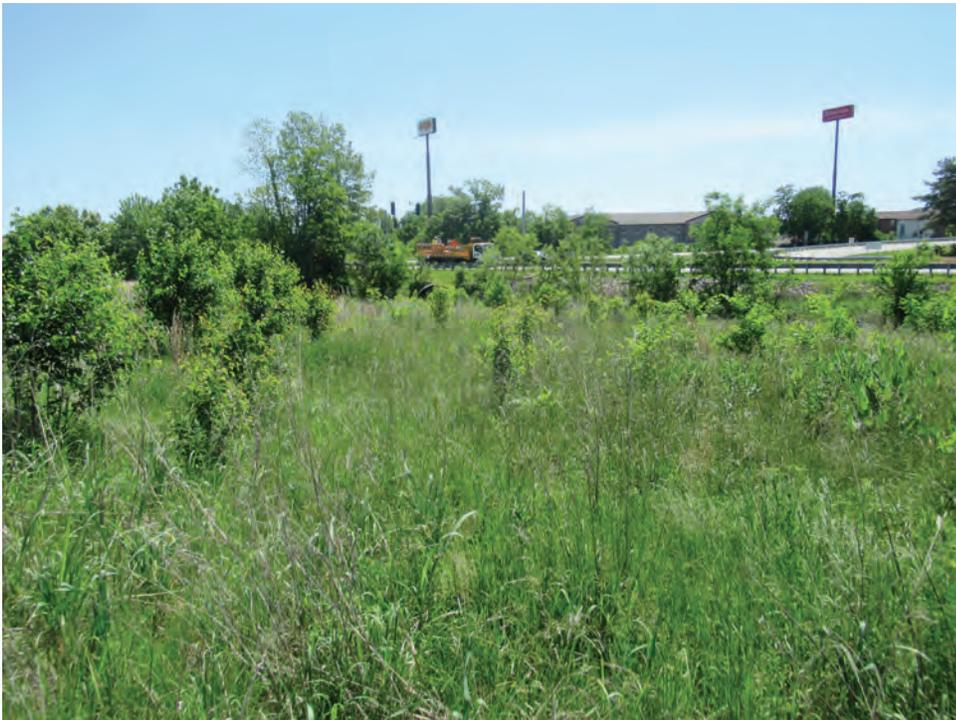
Photo 28: Investigation Area 4; looking southeast north of Camp Run (Reach 3) at upland area dominated by Amur honeysuckle (*Lonicera maackii*, UPL) and field brome (*Bromus arvensis*, FACU)

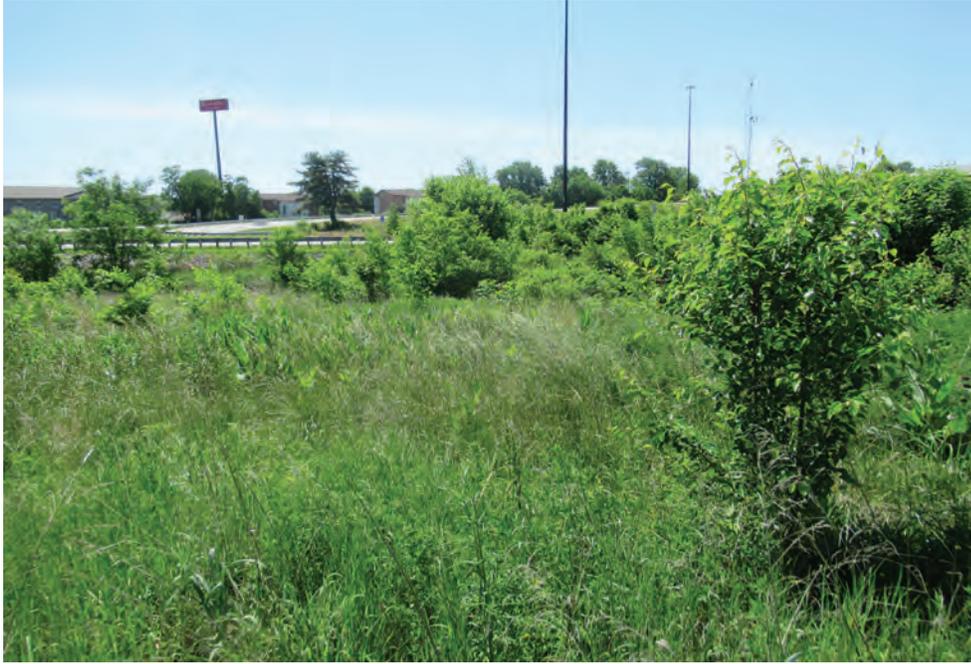
Photo 29: Investigation Area 4; looking south from north of Camp Run (Reach 3) at upland area dominated by Amur honeysuckle (*Lonicera maackii*, UPL) and field brome (*Bromus arvensis*, FACU)

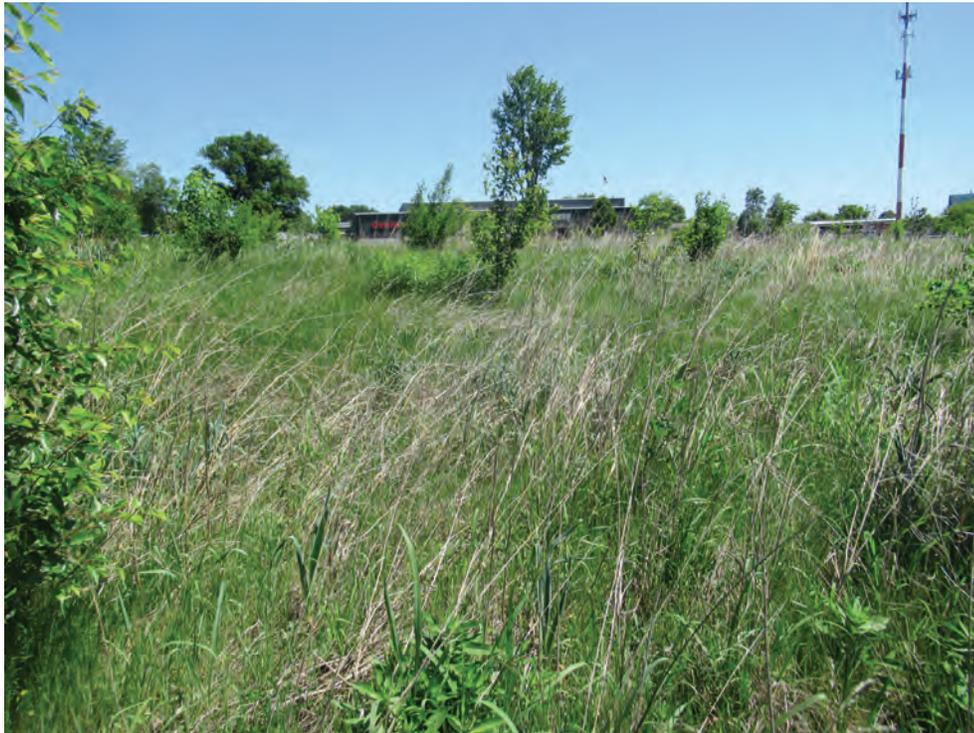
Photo 30: Investigation Area 4; looking northeast from north of Camp Run (Reach 3) at upland area dominated by Amur honeysuckle (*Lonicera maackii*, UPL) and field brome (*Bromus arvensis*, FACU)

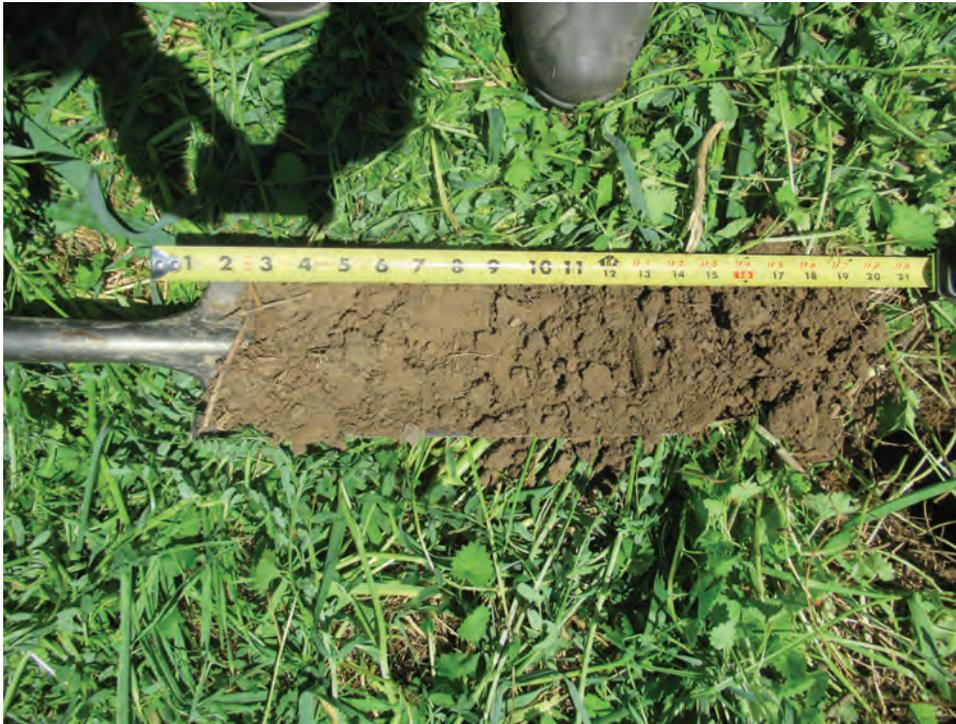
Photo 31: Investigation Area 4; view of soil sample collected for Sample Point 2 (upland) located between Camp Run (Reach 3) and UNT 3 to Camp Run
