**“WATERS OF THE U.S.” DETERMINATION REPORT
US 31 in Town of Sellersburg, Clark County, Indiana
Pavement Maintenance
DES. NO. 1700111**

Prepared by: Ryan L. Scott
Contact Information: rscott@bfsengr.com / 317-713-4615
Butler, Fairman & Seufert, Inc.
Completed Date: July 28, 2022

Date(s) of Field Reconnaissance: June 2, 2020, October 28, 2020 and May 17, 2022*

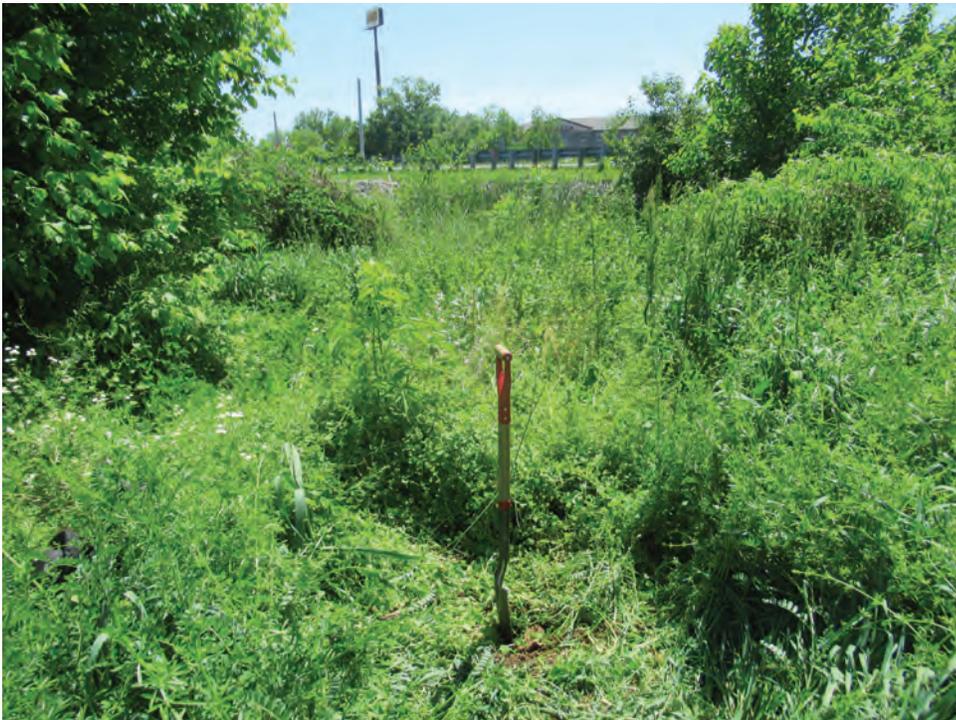
Photo 32: Investigation Area 4; looking southeast at Sample Point 2 (upland) located between Camp Run (Reach 3) and UNT 3 to Camp Run; area is dominated by black elderberry (*Sambucus nigra*, FAC), boxelder (*Acer negundo*, FAC), ground ivy (*Glechoma hederacea*, FACU), meadow garlic (*Allium canadense*, FACU) and stickywilly (*Galium aparine*, FACU)

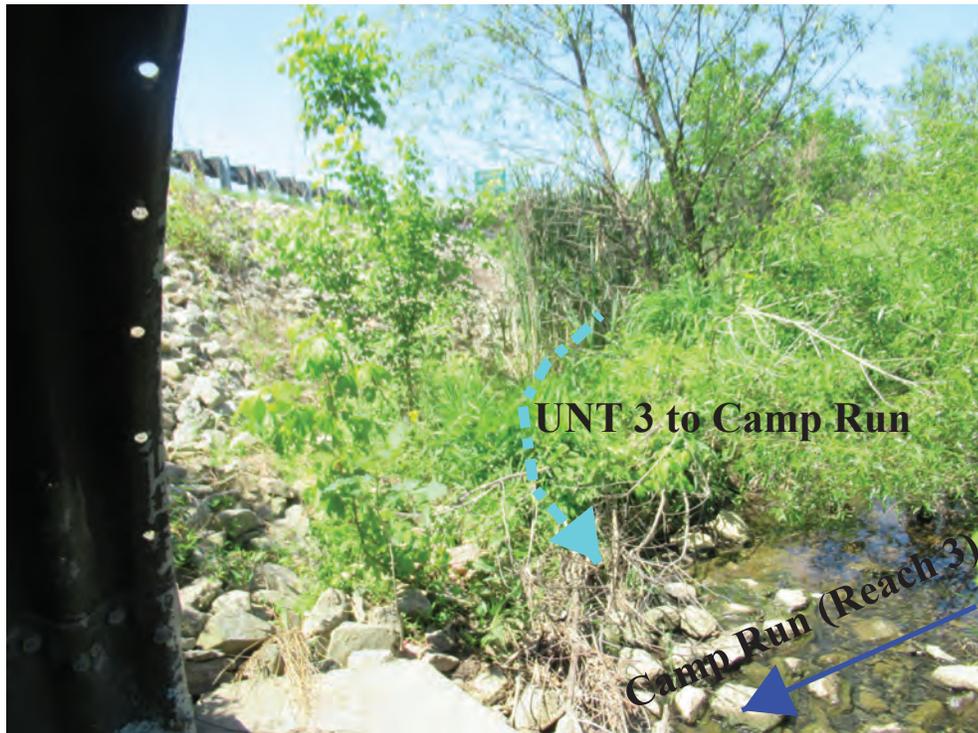
Photo 34: Investigation Area 4; looking southwest at the outlet of UNT 3 to Camp Run

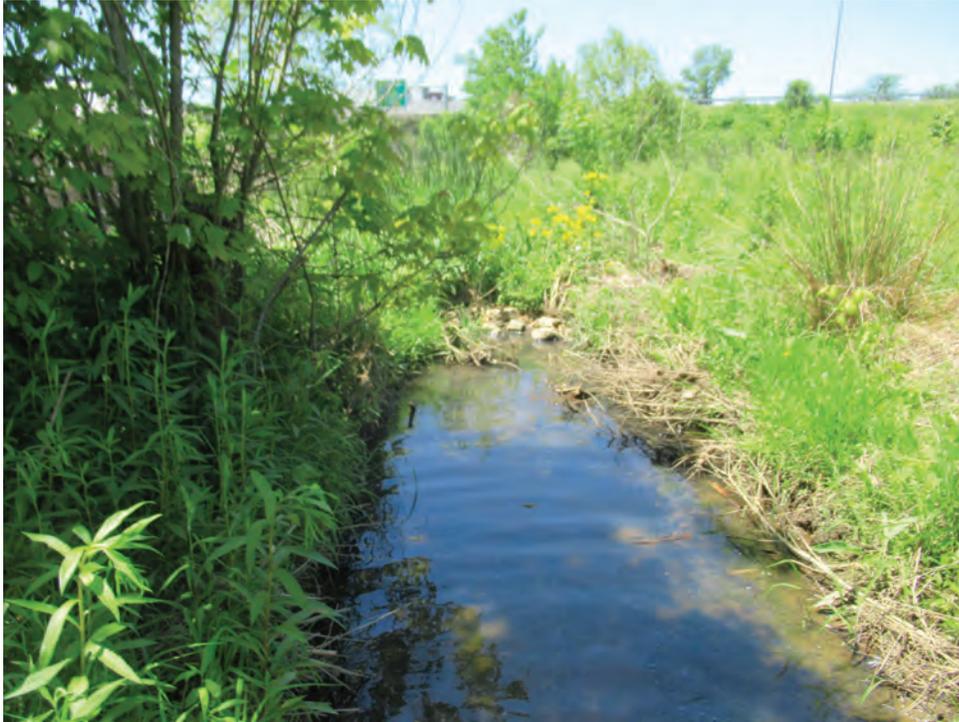
Photo 35: Investigation Area 4; looking southwest (downstream) along UNT 1 to Camp Run (Reach 1)

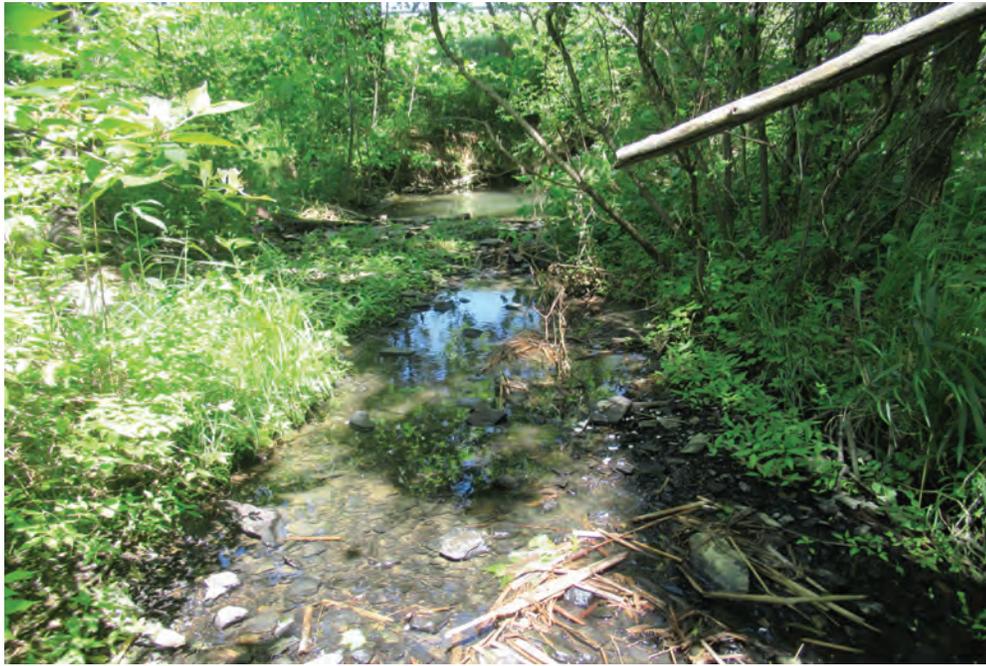
Photo 37: Investigation Area 4; looking northeast (upstream) along UNT 1 to Camp Run (Reach 1)

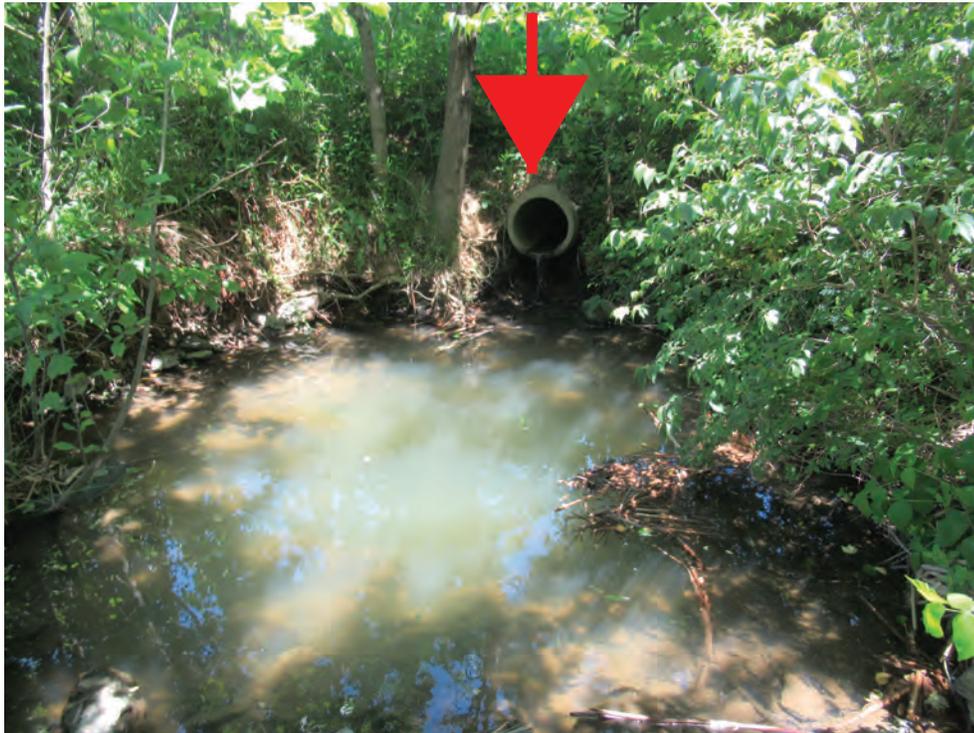
Photo 38: Investigation Area 4; looking northeast (upstream) along UNT 1 to Camp Run (Reach 1); arrow notes pipe outlet from under Hwy 311 exit ramp to northbound I-65

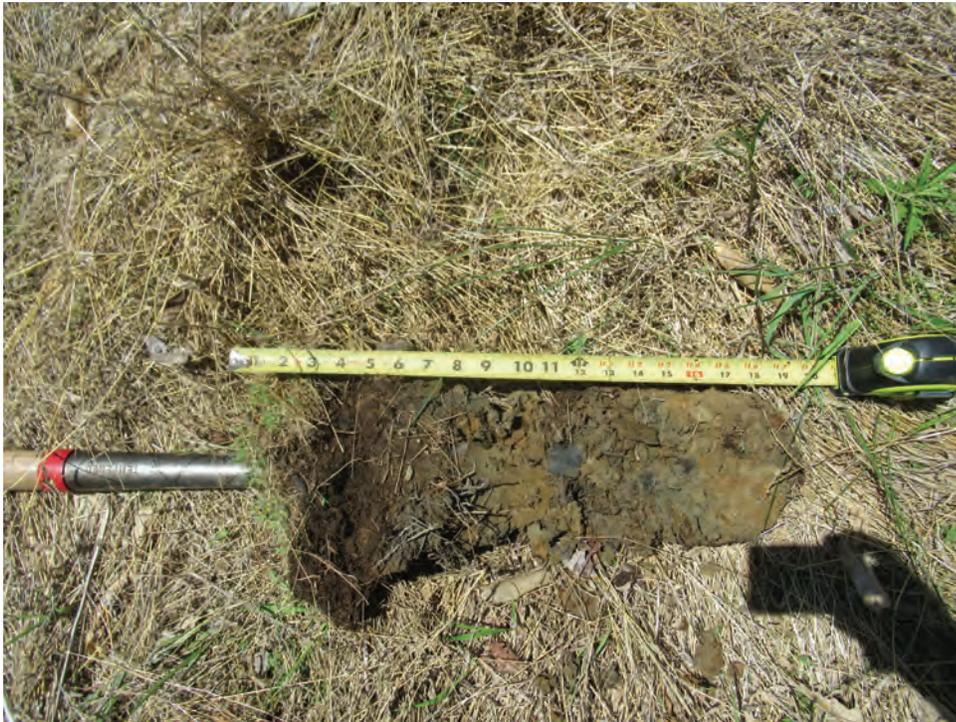
Photo 39: Investigation Area 4; view of soil sample collected at Sample Point 3A (Wetland 1)

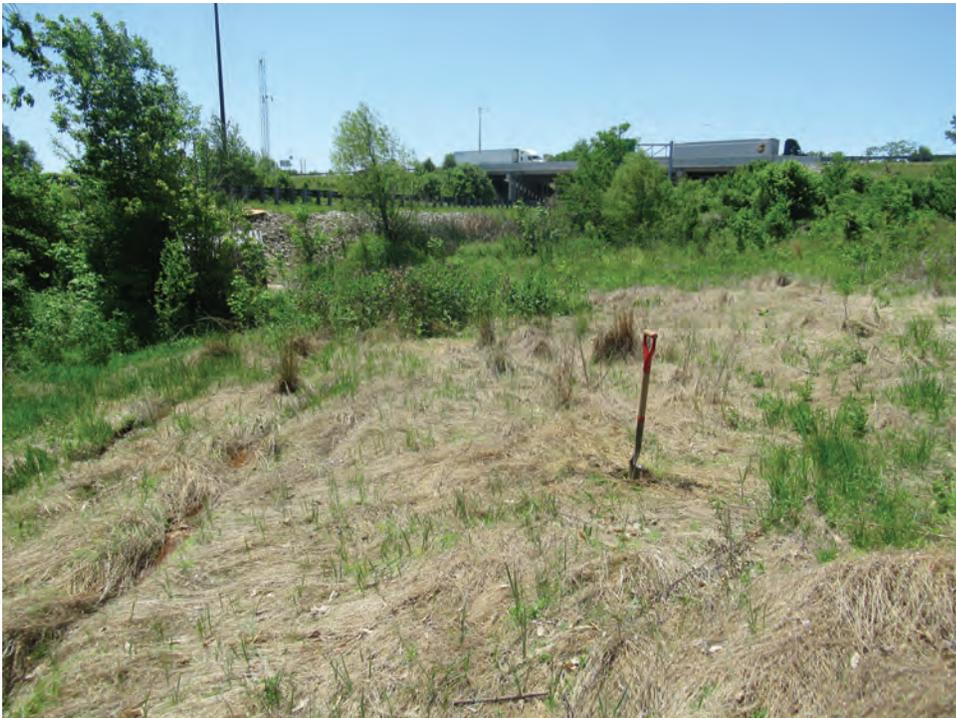
Photo 40: Investigation Area 4; looking southwest at Sample Point 3A; this area is dominated by eastern woodland sedge (*Carex blanda*, FAC), earlyleaf brome (*Bromus latiglumis*, FACW), and Cherokee sedge (*Carex cherokeensis*, FACW)

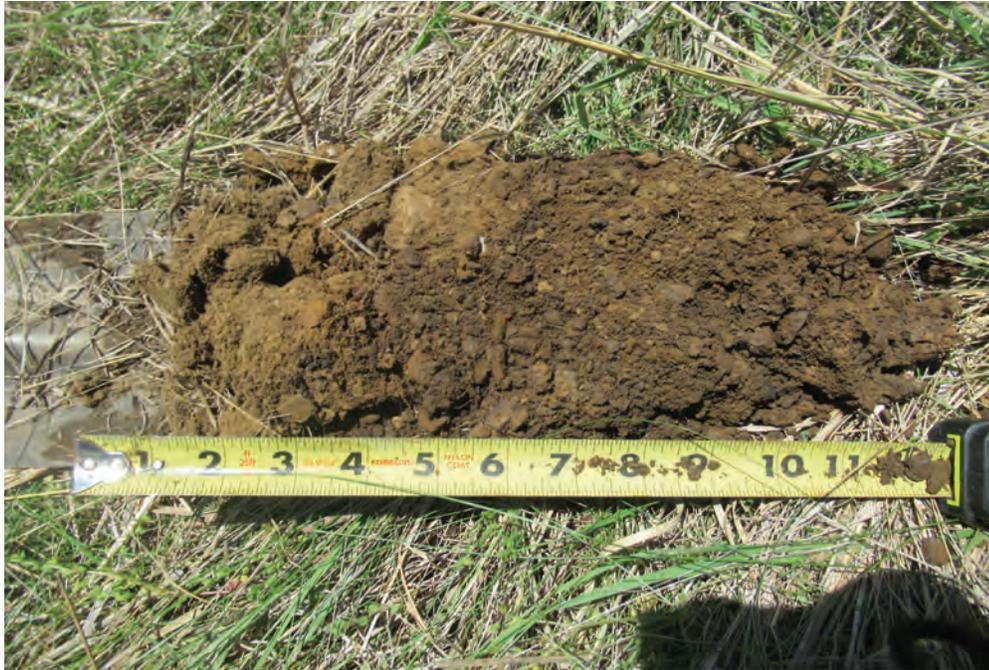
Photo 41: Investigation Area 4; view of soil sample collected at Sample Point 3B (upland)

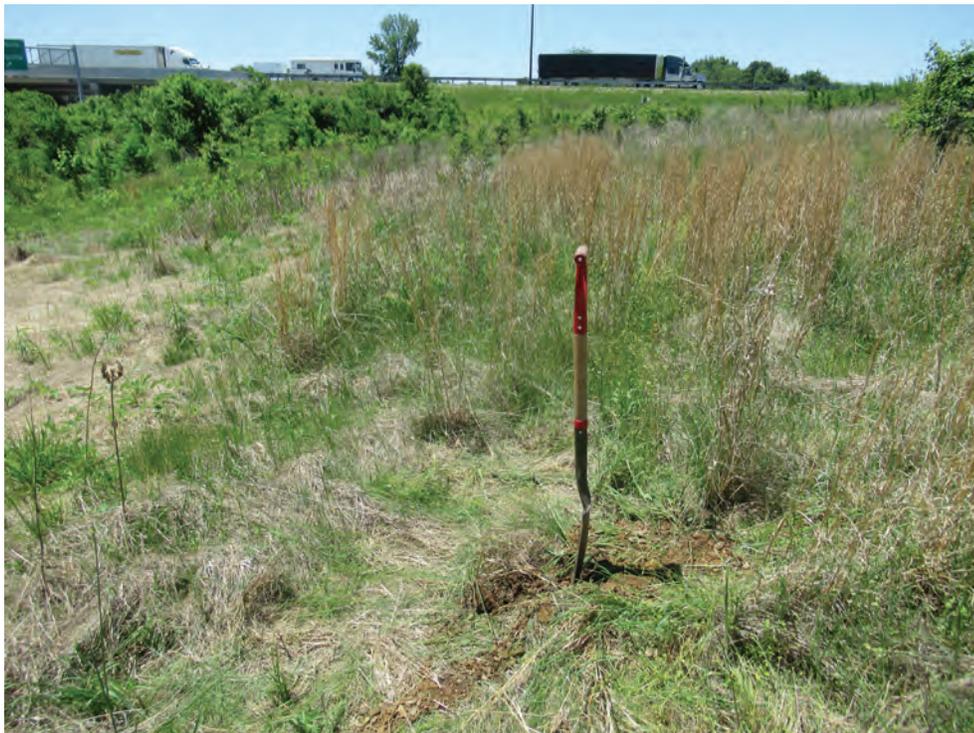
Photo 42: Investigation Area 4; looking west at Sample Point 3B (upland); this area is dominated by strict blue-eyed grass (*Sisyrinchium montanum*, FAC) and broomsedge bluestem (*Andropogon virginicus*, FACU)

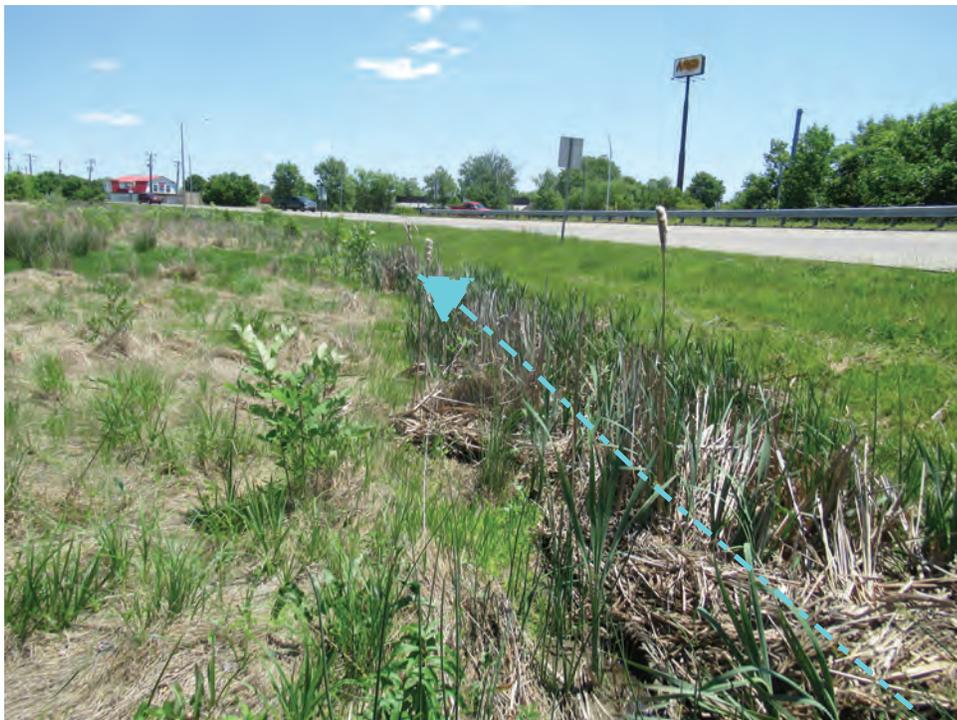
Photo 44: Investigation Area 5; looking southeast (downstream) along UNT 2 to Camp Run

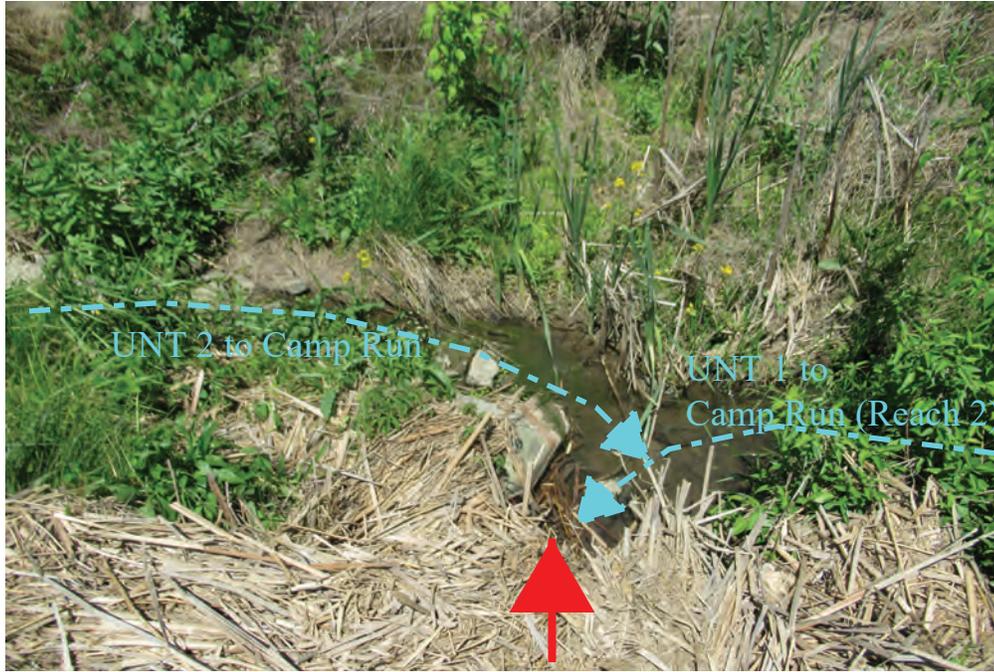
Photo 45: Investigation Area 5; looking north at confluence of UNT 2 to Camp Run and UNT 1 to Camp Run (Reach 2); red arrow notes location of pipe under Hwy 311 exit ramp to northbound I-65

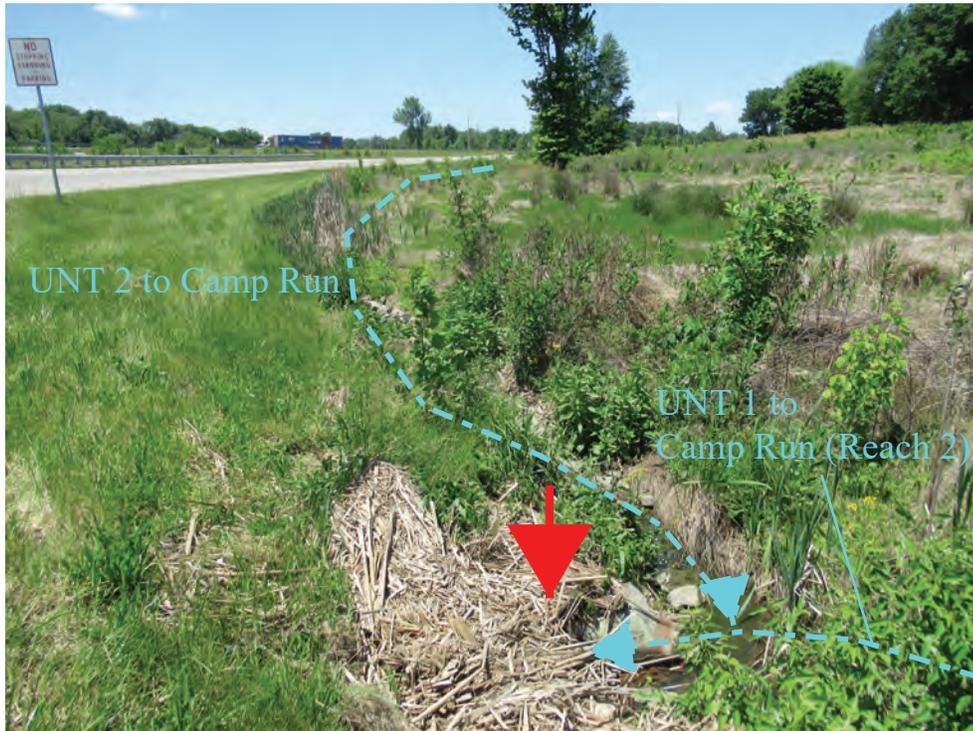
Photo 46: Investigation Area 5; looking northwest at confluence of UNT 2 to Camp Run and UNT 1 to Camp Run (Reach 2); red arrow notes location of pipe under Hwy 311 exit ramp to northbound I-65

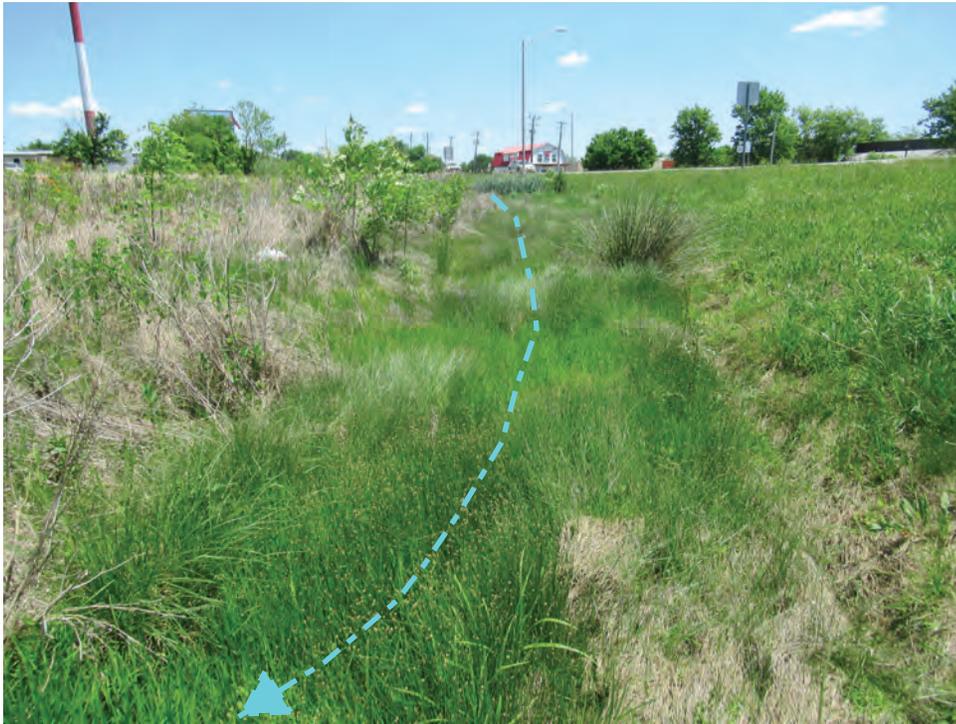
Photo 47: Investigation Area 5; looking northeast (upstream) along UNT 1 to Camp Run (Reach 2)

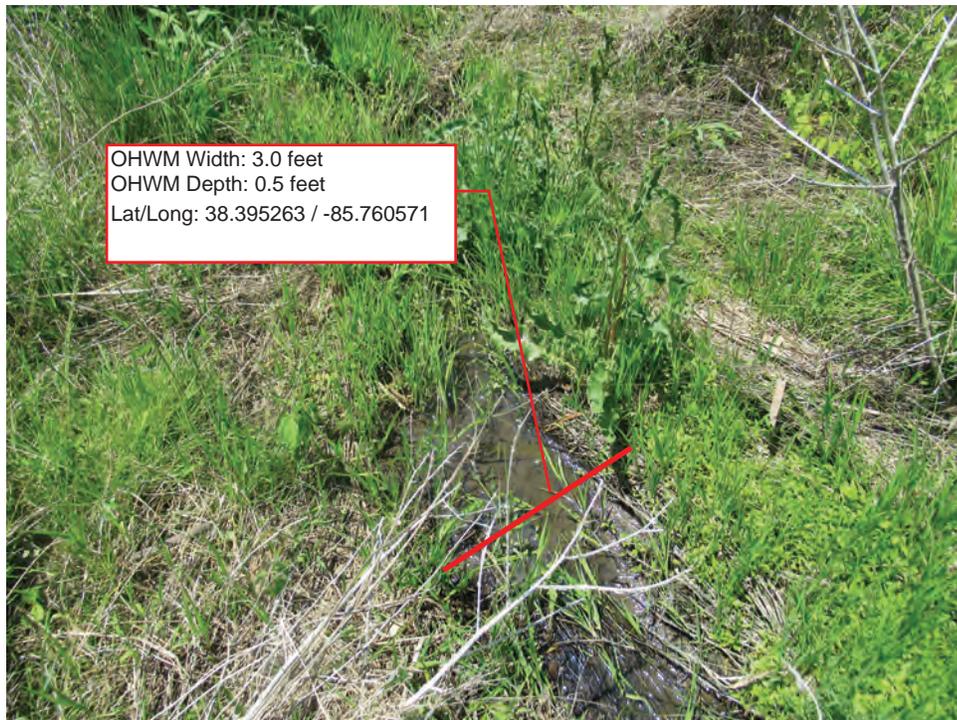
Photo 48: Investigation Area 5; looking southwest (downstream) at UNT 1 to Camp Run (Reach 2)

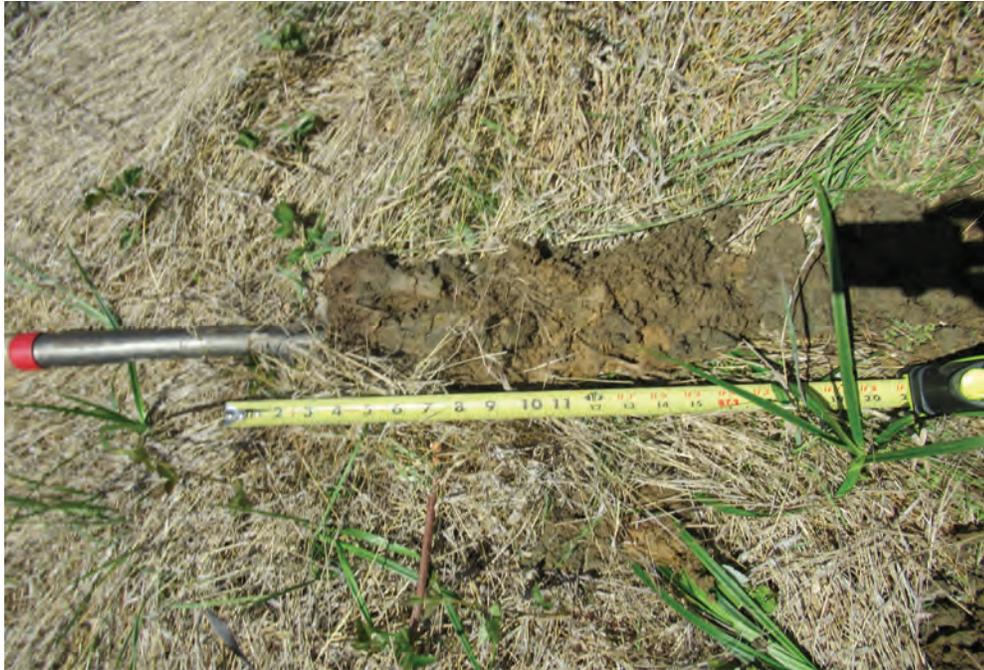
Photo 49: Investigation Area 5; view of soil sample collected at Sample Point 4A (Wetland 2)

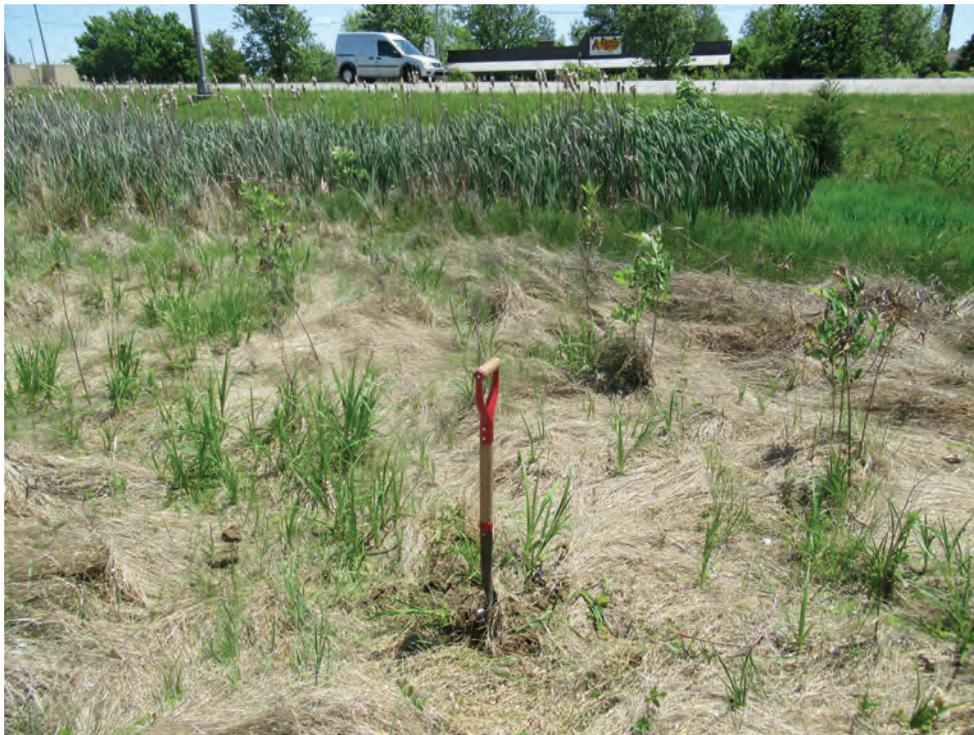
Photo 50: Investigation Area 5; looking southeast at Sample Point 4A (Wetland 2); the area is dominated by sweet flag (*Acorus calamus*, OBL) and Indian hemp (*Apocynum cannabinum*, FACW)

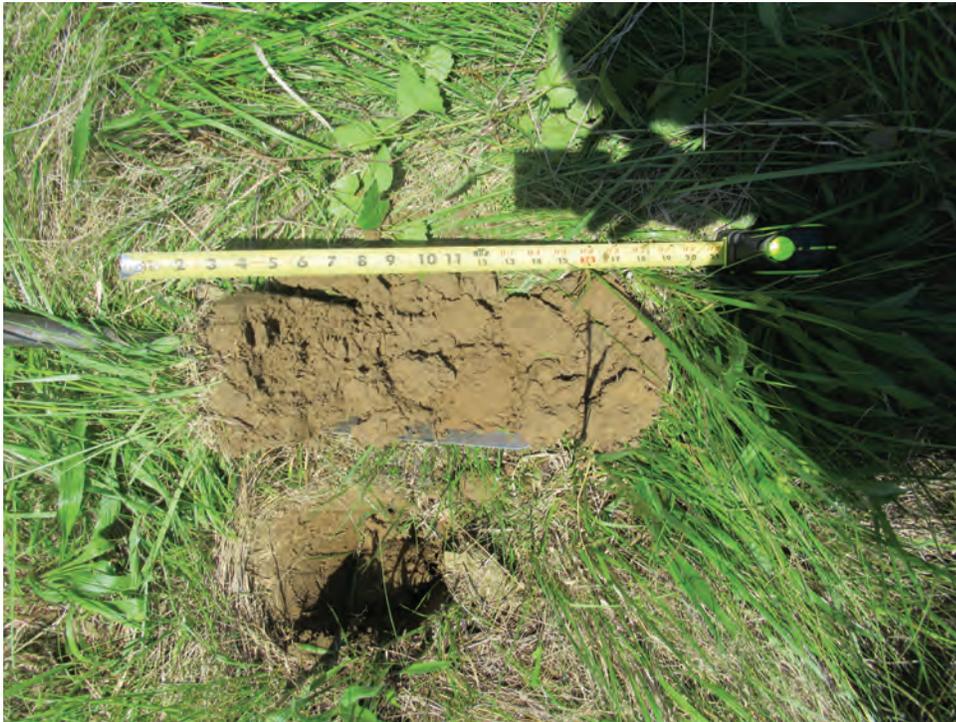
Photo 51: Investigation Area 5; view of soil sample collected at Sample Point 4B (upland)

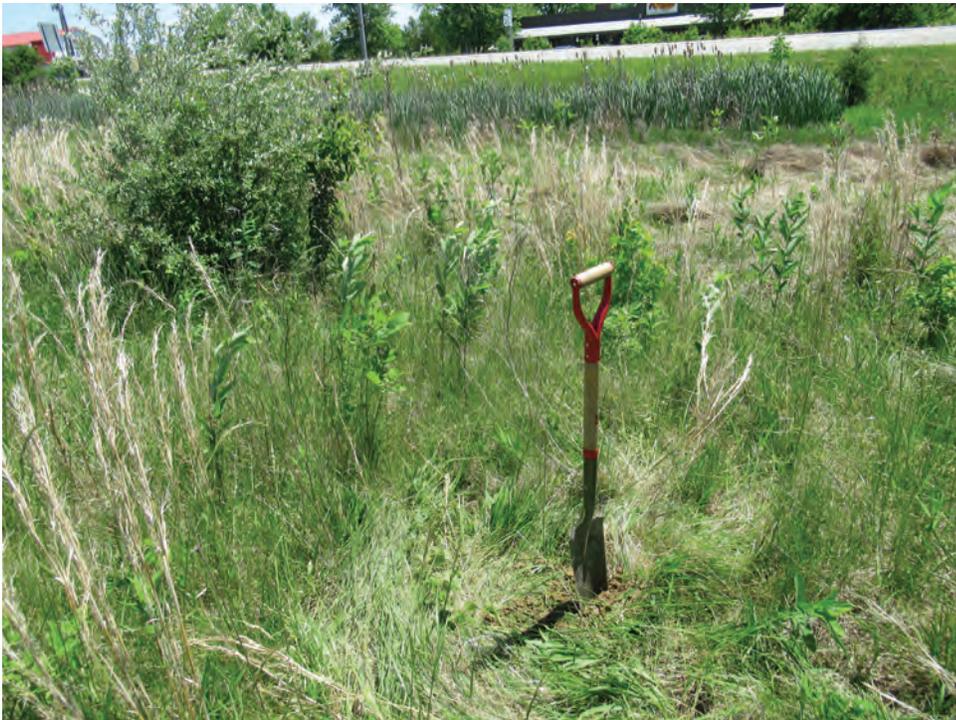
Photo 52: Investigation Area 5; looking southeast at Sample Point 4B (upland); area is dominated by Russian olive (*Elaeagnus angustifolia*, FACU) and broomsedge bluestem (*Andropogon virginicus*, FACU)

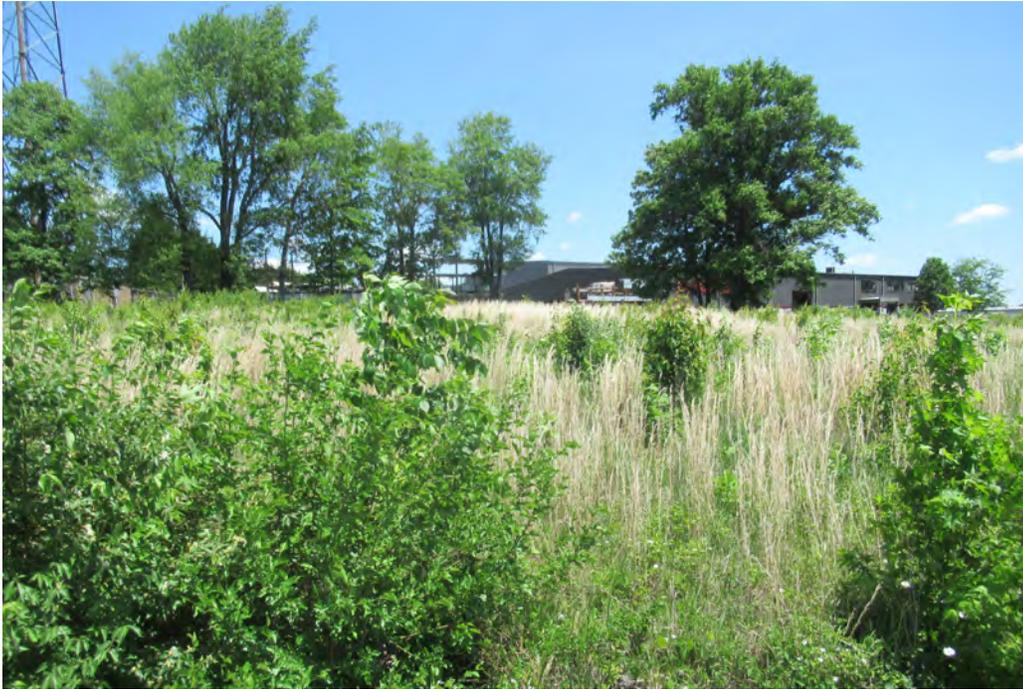
Photo 53: Investigation Area 5; looking northeast at upland area is dominated by Japanese honeysuckle (*Lonicera japonica*, FACU) and broomsedge bluestem (*Andropogon virginicus*, FACU)

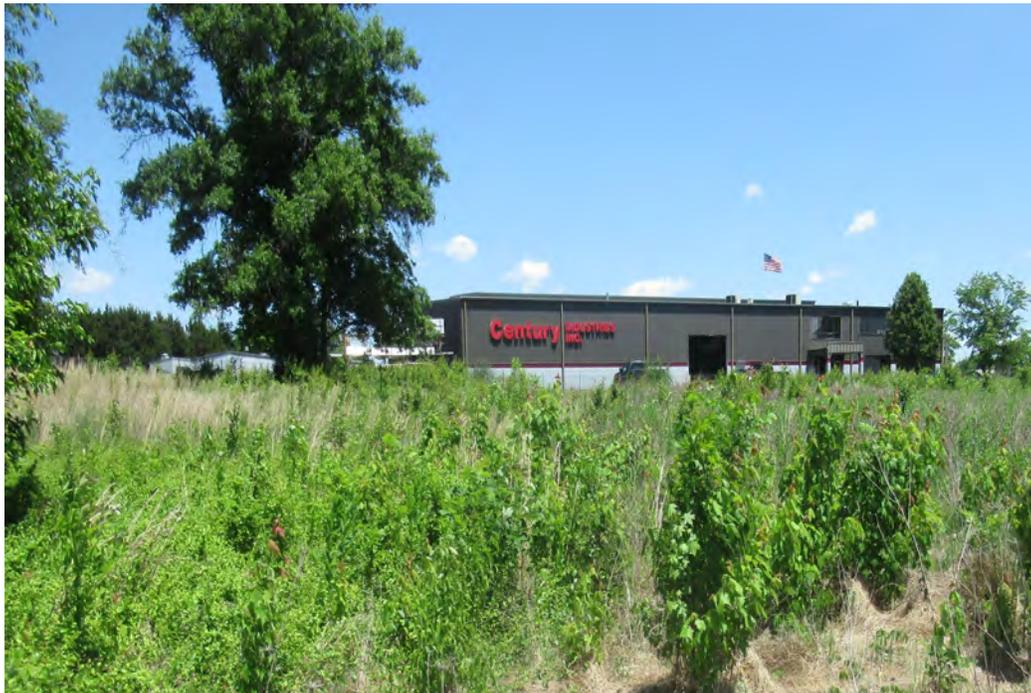
Photo 54: Investigation Area 5; looking northeast at upland area is dominated by Japanese honeysuckle (*Lonicera japonica*, FACU) and broomsedge bluestem (*Andropogon virginicus*, FACU)
