**DESCRIPTION AND DELINEATION OF KARST FEATURES IN THE VICINITY OF U.S. HIGHWAY 150/STATE ROAD 56 BETWEEN WEST BADEN SPRINGS AND PAOLI, ORANGE COUNTY, INDIANA, AND STATE ROAD 37 BETWEEN PAOLI AND MITCHELL, ORANGE AND LAWRENCE COUNTIES, INDIANA, AND RECOMMENDATIONS FOR THEIR PROTECTION**

This report is prepared by Earth Tech for the Indiana Department of Transportation (INDOT) to assist the Department in complying with the terms and conditions of a 1993 Memorandum of Understanding (MOU) between INDOT, the Indiana Department of Natural Resources, the Indiana Department of Environmental Management, and the U. S. Fish and Wildlife Service regarding guidelines for construction of highway transportation projects in the karst areas of the State of Indiana. This report summarizes the results of field investigations of karst features within and near the existing right-of-ways of portions of U.S. Highway (US) 150/State Road (SR) 56, and SR 37 between West Baden Springs and Paoli in Orange County, Indiana, and SR 37 between Paoli, and Mitchell in Lawrence and Orange Counties, Indiana.

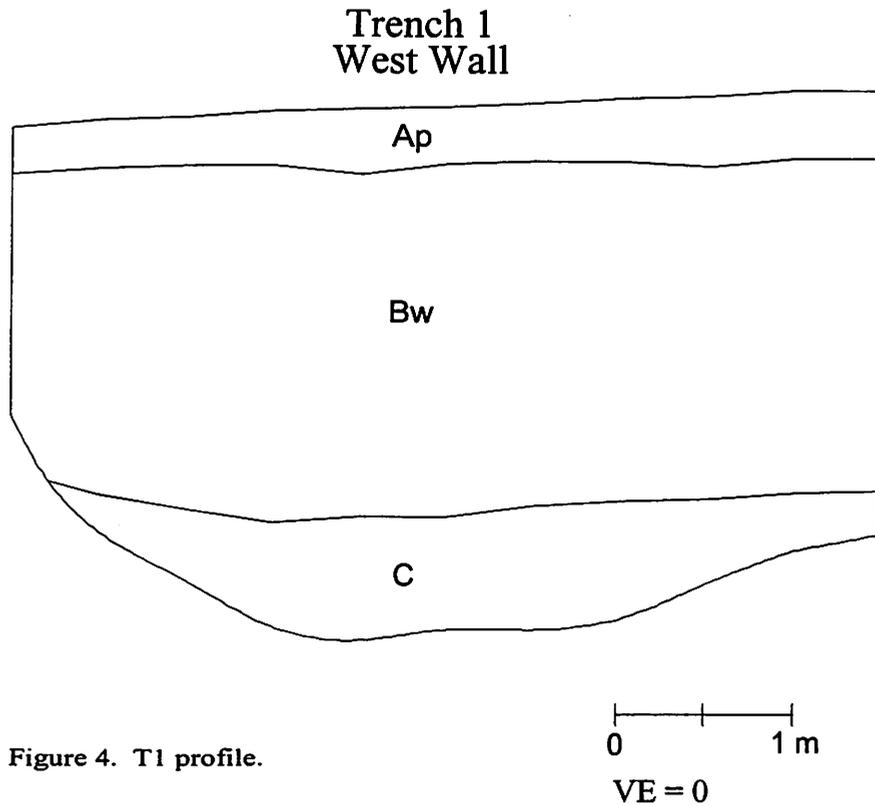
Figure 4. T1 profile.

Trench 1 (Figure 4) and Trench 2 (Figure 5) were excavated west of the main excavations to confirm generally poor drainage conditions as observed during an earlier geoarchaeological assessment for this project (Holycross, Cantin & Stafford 2003). Although, cambic B (Bw) horizons are thicker and solum depths are more extensive than descriptions (Soil Survey Staff 1984) for a typical Haymond silt loam pedon, trenches 1 and 2 display profiles that generally correlate with those of the Haymond silt loam, frequently flooded. Sedimentological differences exist between these two

trenches, but differences in the amount of sand and presence of loam and sandy loam strata are noted in the aforementioned descriptions. Bw horizons could be subdivided, but this was not practical in the field and they are represented in profile maps as a single entity. No cultural materials were identified in trenches 1 and 2. Formal descriptions are provided for these two trenches in Table 2 and Table 3.

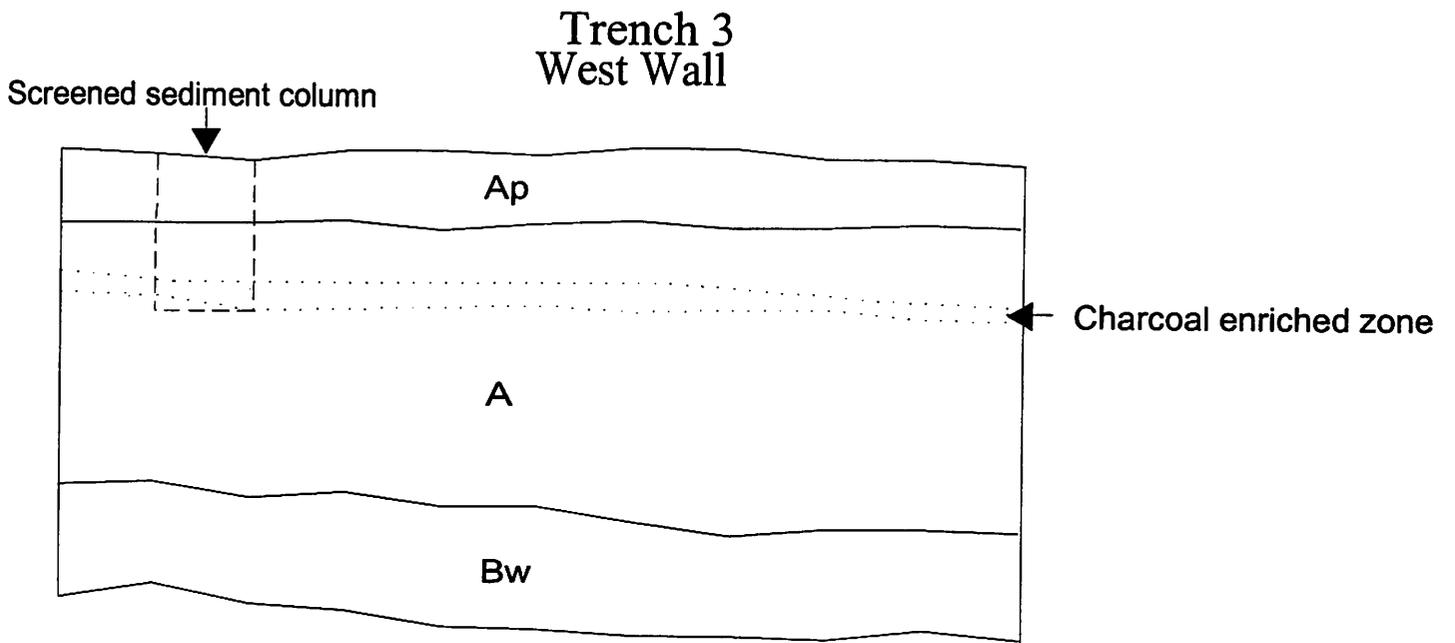
Figure 6. T3 profile.

A layer of moderate charcoal concentration was observed in the trench wall ranging from ca. 55 cm to 65 cm below ground surface and extending about 10 cm beyond these depths. No other inclusions (e.g., rock etc.) were associated with this zone, but due to limited artifact recovery from Trenches 4 and 7, an approximate 70 cm-75 cm sediment column was screened. This sediment column, extending to the base of the charcoal enriched zone, was removed from the south end of the

trench. No cultural materials were recovered associated with Trench 3. A formal description for Trench 3 is provided in Table 4.

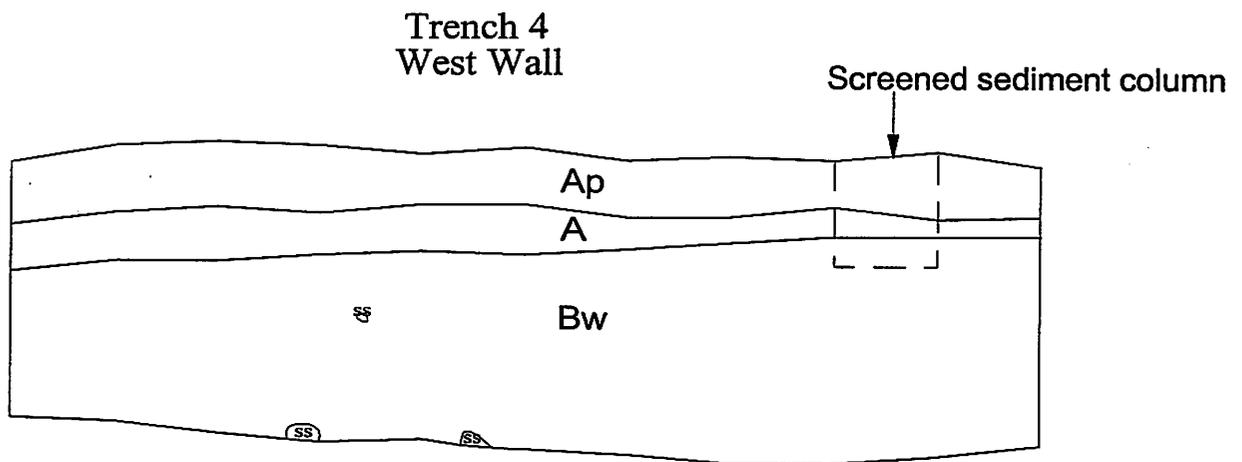
Figure 7. T4 profile.

A few, very fine pieces of wood charcoal were observed within these trench walls in the A and Bw horizons, but no discreet zones of enrichment were definable. Also, a small number of oxidized and deteriorating pieces of sandstone were noted in the walls and along the floor (Bw horizon) of these trenches (n=4). The clasts are not interpreted as cultural. This is due to a lack of any discernable patterning (concentrations or traceable zones), evidence of in-place burning and lack of association with other more definitive cultural materials. The sandstone has likely oxidized due to natural processes prior to deposition and burial.

Cultural material from these two trenches consist of a single Holland chert secondary flake recovered from Trench 4 during the stepping of the trench's east wall. While the flake was not recovered in-situ, it was recovered during mechanical excavation near the base of the plowzone. In an attempt to provide more definitive definition of the occupation associated with the recovered flake, 50 cm sediment columns were screened from the north end of both trenches. These columns penetrated beyond the base of the plowzone, but no additional cultural materials were recovered. Formal descriptions are provided for these two trenches in Table 5 and Table 6.

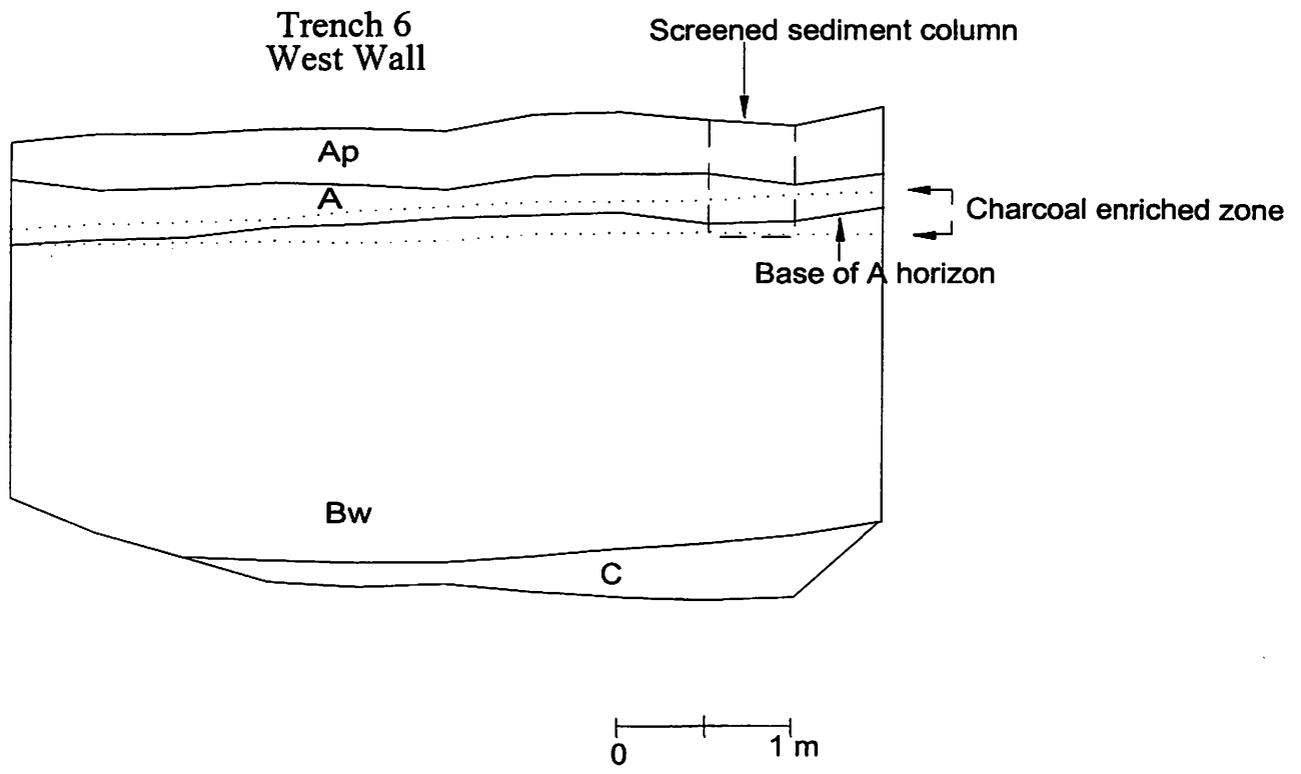
Figure 9. T6 profile.

As was the case with Trench 3, a layer of moderate charcoal concentration was observed in the wall of Trench 6. Occurring at depths of approximately 40 cm-45 cm below surface, this zone was 10 cm-20 cm in thickness and extended into the Bw horizon. No other inclusions were associated with this charcoal zone that is possibly contemporaneous with that encountered in Trench 3.

Cultural material recovered during excavating, scraping and mapping of Trenches 6 and 7 consisted of a single Indian Creek chert secondary flake. This artifact was recovered from Trench 7 during the stepping of the trench's east wall, near the base of the plowzone.

50 cm-60 cm sediment columns were screened from the north end of both trenches. These columns penetrated beyond the base of A horizons and the charcoal enriched strata of Trench 6. This screening resulted in the recovery of one Indian Creek chert tertiary flake from the plowzone of Trench 7 (ca. 15 cm below surface). Formal descriptions are provided for these two trenches in Table 7 and Table 8.

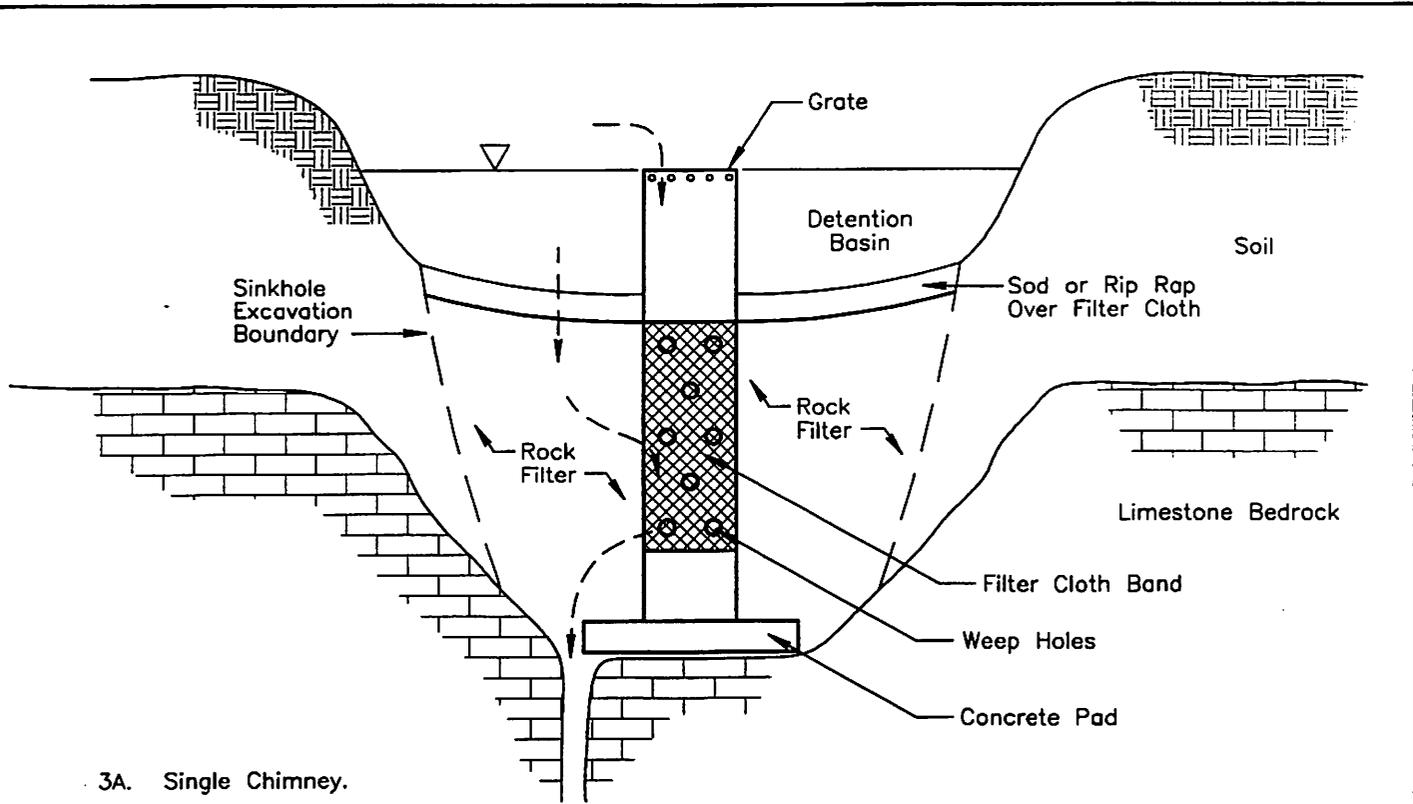
3A. Single Chimney.

DIAGRAM OF A DETENTION BASIN/  
 HAZARDOUS MATERIALS TRAP  
 INDOT S.R. 56/U.S. 150 AND S.R. 37  
 KARST INVESTIGATION  
 ORANGE AND LAWRENCE COUNTIES, INDIANA

Detention Basin/Hazardous Materials Trap a basin of appropriate size to provide detention and settling of highway runoff prior to its entry into the subsurface. This is coupled with a trap for hazardous materials, which in most cases would consist of a siphon outfall to temporarily retain petroleum spills. As an option, this may be coupled with a secondary basin/sphagnum peat filter to remove dissolved metals and some dissolved organic compounds.

Features that possess an eye or an active slump, and that receive highway runoff, provide a direct route for runoff to the subsurface without the benefit of natural soil filtering or settling of particulates. The use of detention basin/hazardous materials traps (Figure 3) should be considered if the feature will not be significantly filled as a result of highway construction, a detention basin/hazardous materials trap should be installed upslope of the feature to intercept all runoff, provide for settling of particulates, provide additional retention of highway spills, and provide a measure of filtration/adsorption of dissolved contaminants.
