INDIANA ROAD SAFETY AUDIT GUIDELINES

For State and Local Governments in Indiana

INDOT Office of Traffic Safety &
Indiana LTAP HELPERS Program

Smith Pike Road at Forrest Park Drive

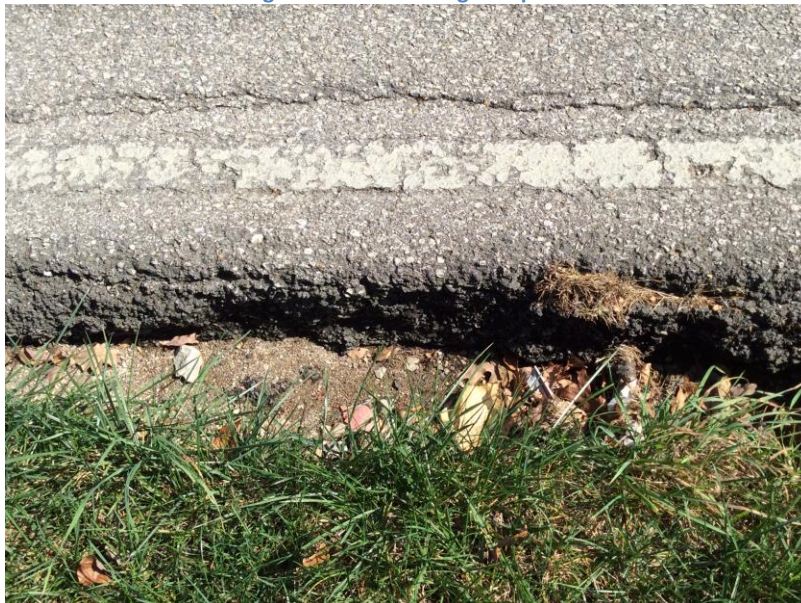
Figure 1: Shoulder edge drop-off

There is not much usable or consistent shoulder in the analyzed section of Smith Pike Road. There is significant shoulder drop-off on both sides of the road, which can cause crashes if errant vehicles get a wheel off the pavement. Figure 1 shows the pavement edge drop-off.

Shoulder Edge Drop-off/Roadside hazards: Shoulder edge drop-offs can cause errant vehicles to lose control.

- Add shoulder stone
- Add safety edge as part of any pavement rehab project
- Install object markers for existing roadside hazards if vehicles do run off the road

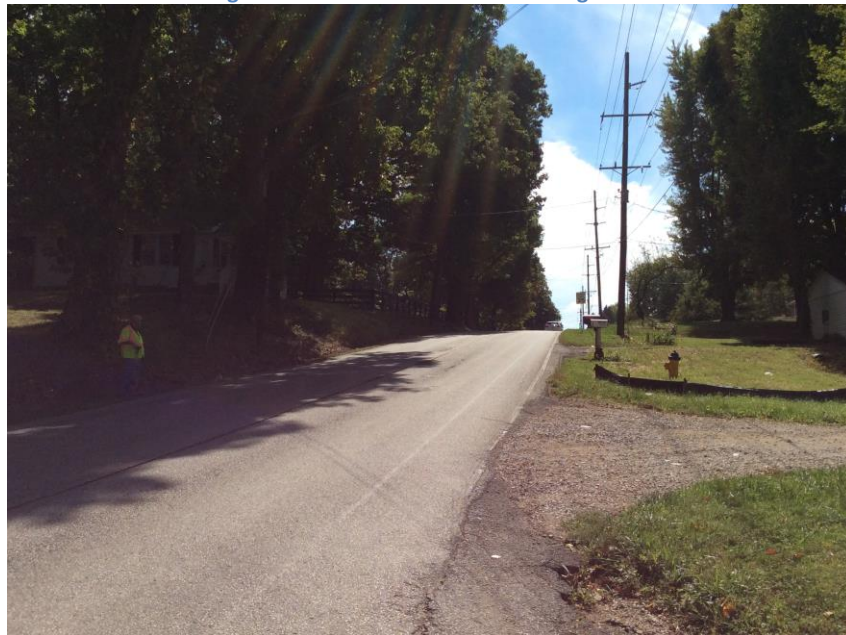
Figure 2: At Forrest Park Drive looking south

The analyzed intersection is north of a crest vertical curve, which may limit stopping sight distance for northbound traffic. A northbound vehicle waiting to turn left onto Forrest Park Drive may surprise a northbound driver coming over the hill, especially when a queue is present. The SR 46 intersection may also cause a queue back to the analyzed intersection. This is consistent with the significant number of rear-end crashes occurring at the analyzed intersection. The operating speeds on Smith Pike Road also exacerbate the limited sight distance condition at the vertical curve. Figure 2 shows the view at the intersection looking south along Smith Pike Road.

Limited Sight Distance: The County's options here include increasing the sight distance through geometric improvements and/or removing the left turn conflicts. These improvements should decrease the significant number of rear-end crashes at the intersection.

- Cut down hill
- Passing blister or left-turn lane
- Contact INDOT District to look at signal timing to address queues on Smith Pike Road

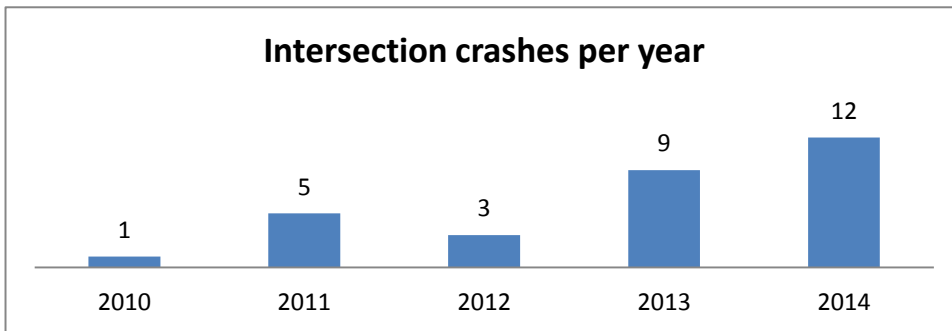
Smith Pike @ Forrest Park Intersection crash summary

# of crashes	% of total
Total crashes	30	
Injury crashes	5	17%
NB rear-end crashes (and ROR's to avoid RE's)	24	80%
Wet pvmt crashes (no snow/ice)	26	87%
Dark crashes	3	10%

Smith Pike Rd has a history of rear-end crashes during wet weather in the vicinity of Forrest Park Drive in the northbound direction. This section of roadway has averaged six intersection-related crashes per year from 2010-2014. Of the 30 total intersection-related crashes reported, 17% were injury crashes, 80% were northbound rear-end crashes, and 87% were wet weather crashes (not including snow/ice). A summary of the crash data is included in the Appendix.

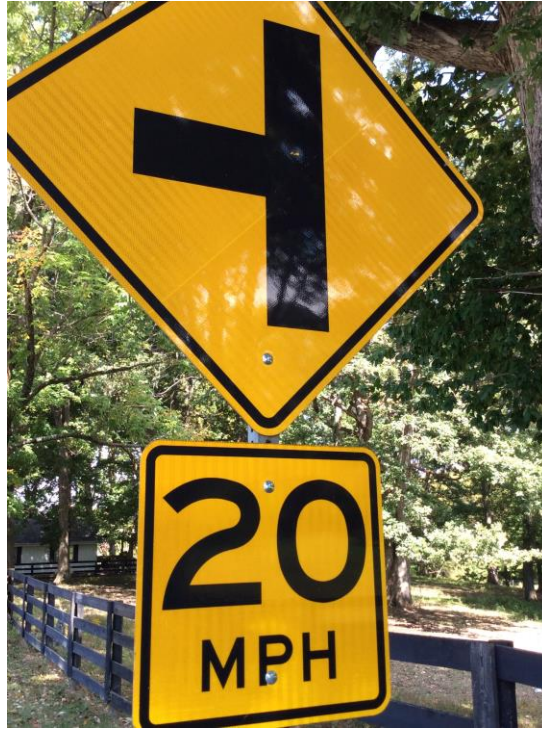
Existing warning signs in good condition

There is an intersection warning sign with an advisory speed of 20 mph on the northbound approach to the intersection. 35-mph speed limit signs are also present in the vicinity of the intersection. All of these signs appear to be in good condition. There are also transverse rumble strips on the northbound approach that help alert drivers to the upcoming intersection.

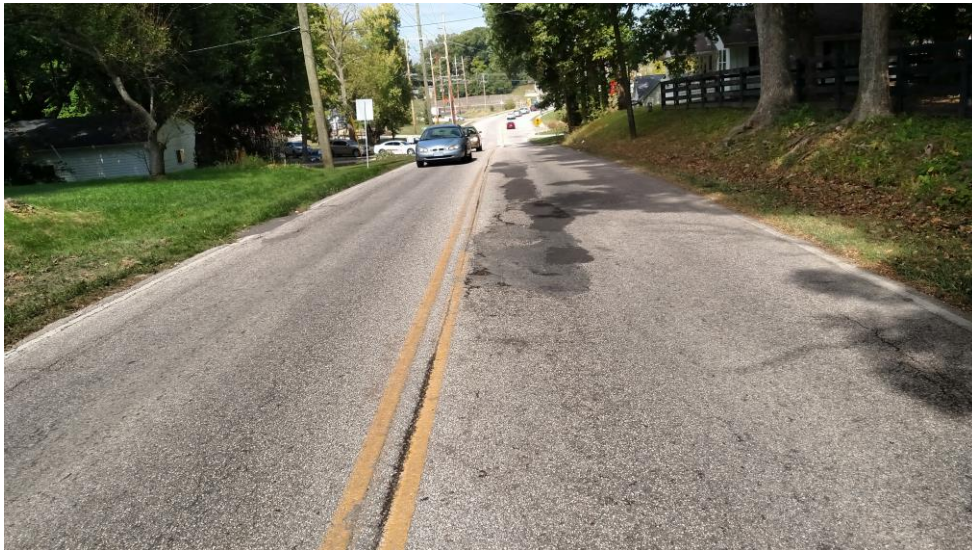
Pavement condition and worn markings

The roadway cross section is well-crowned and other than a few spots, the pavement appears to be in fair condition. There is some raveling and minimal wheel rutting in the northbound lane, which appears to be the product of the tree canopy over that side of the road. Some polishing is also present, lowering the pavement's skid resistance. This is consistent with the significant number of wet-weather crashes. Centerline and edgeline pavement markings are present, but appear worn and lacking sufficient retroreflectivity.

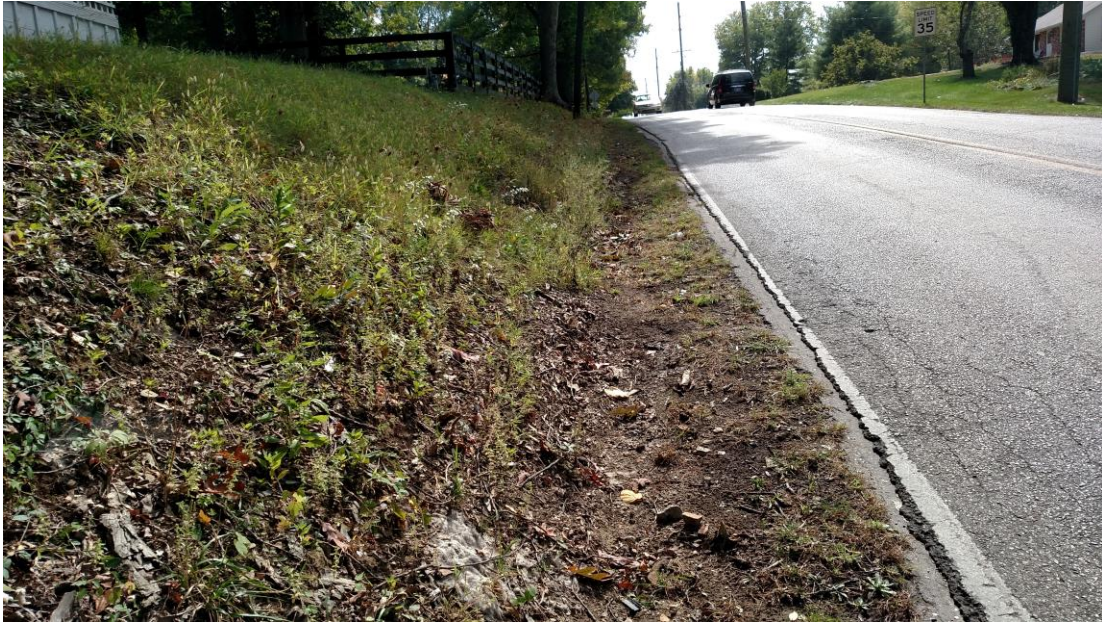
Shallow roadside ditch

- Add underdrain behind shoulder in ditch line, fill with stone
- Add curb and gutter with gutter turn-outs
- Pave driveways back to right-of-way line
- Clean out and deepen roadside ditches
- Resize and replace driveway drainage pipe on east side of intersection
- Contain driveway run-off to private properties

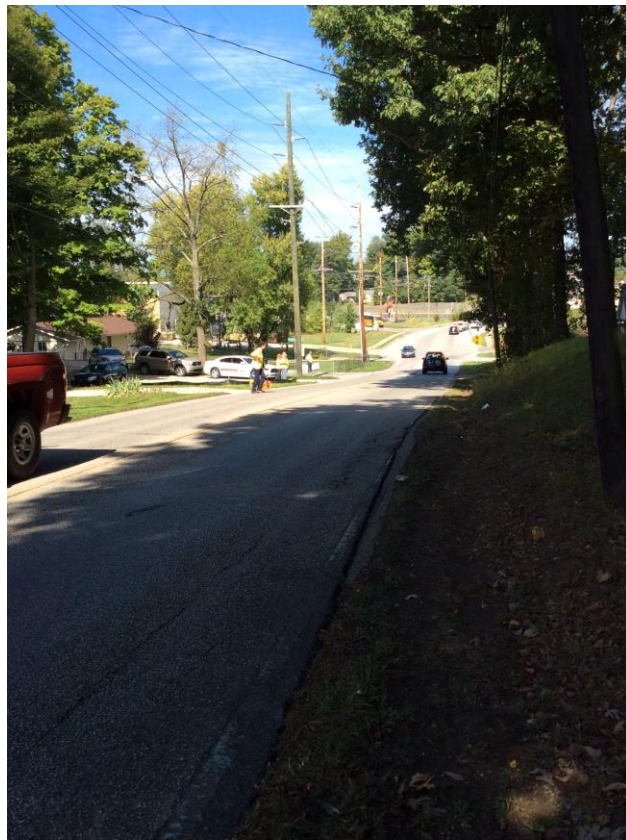
Tree canopy on Smith Pike Rd

There is no roadway lighting present. There are hazards present within the clear zone, including power poles, trees, ditches, and drainage devices. There is a tree canopy present, mostly in the northbound lane, which may throw leaves in the roadway in fall and cause icing problems in winter.
