Red Flag Investigation - Site Location
SR26 from 0.33mi E of SR55 E Junction to 8.57mi E of SR55 E Junction
Des. 1700114 HMA Overlay Minor Structure
Warren and Tippecanoe County, Indiana

Exhibit 3 – Wetland and Floodplain Map Index Wetland and Waterways Delineation

State Road 26 Improvements
 Warren and Tippecanoe County, Indiana
 Project No: 18-022 DES 1400249

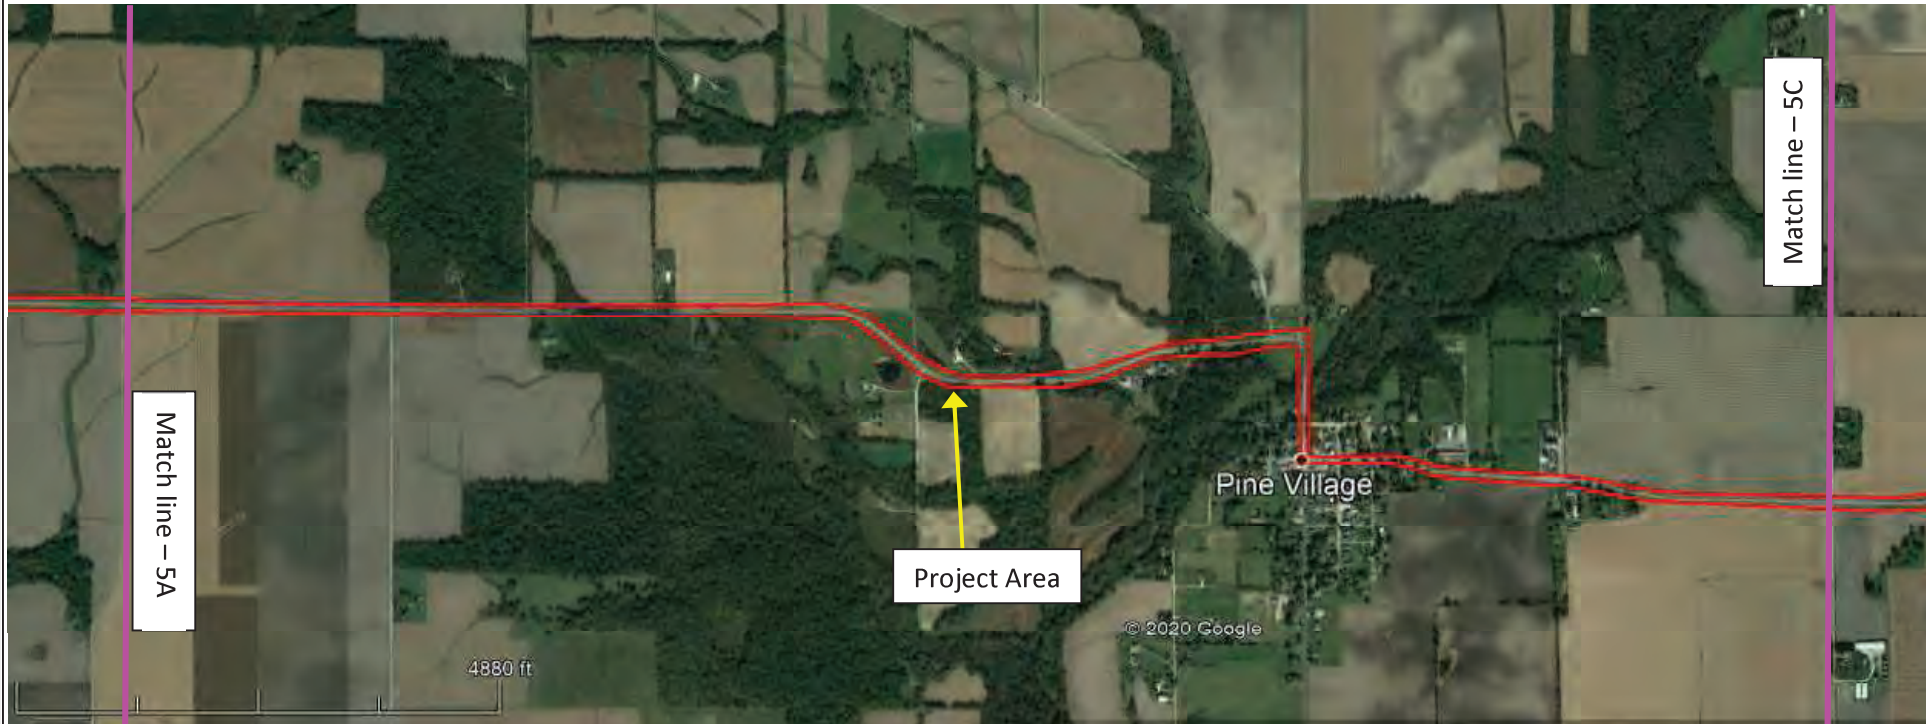
Exhibit 5B – Aerial Photograph Wetland and Waterways Delineation

Land use in the vicinity of the project is primarily agricultural with low density residential and occasional small woodlots. Within Pine Village, land use is a mix of high density residential and commercial. Aerial photography showing land use within the project limits and immediate vicinity can be found on Exhibit 5.
