**FHWA-Indiana Environmental Document
CATEGORICAL EXCLUSION / ENVIRONMENTAL ASSESSMENT FORM
GENERAL PROJECT INFORMATION**

Road No./County:	State Road (SR 156)/Switzerland County
Designation Number:	1600616
Project Description/Termini:	Slide Correction Project 1.5 miles west of the SR 56/SR 156 east junction

This is page 1 of 24 Project name: SR 156 Slide Correction Project Date: March 25, 2021

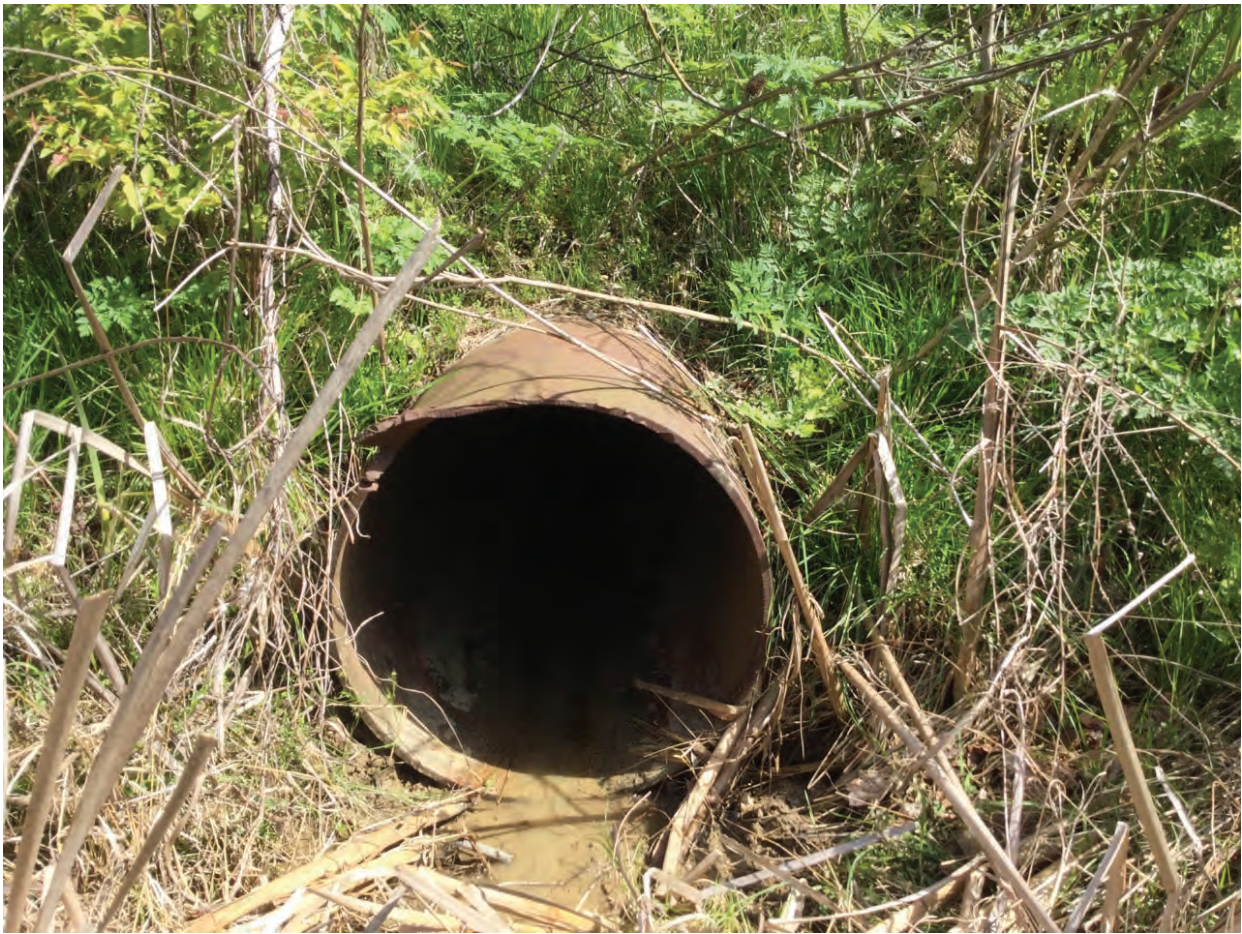
3. Looking northeast at culvert below State Road 156 – 4/21/2020

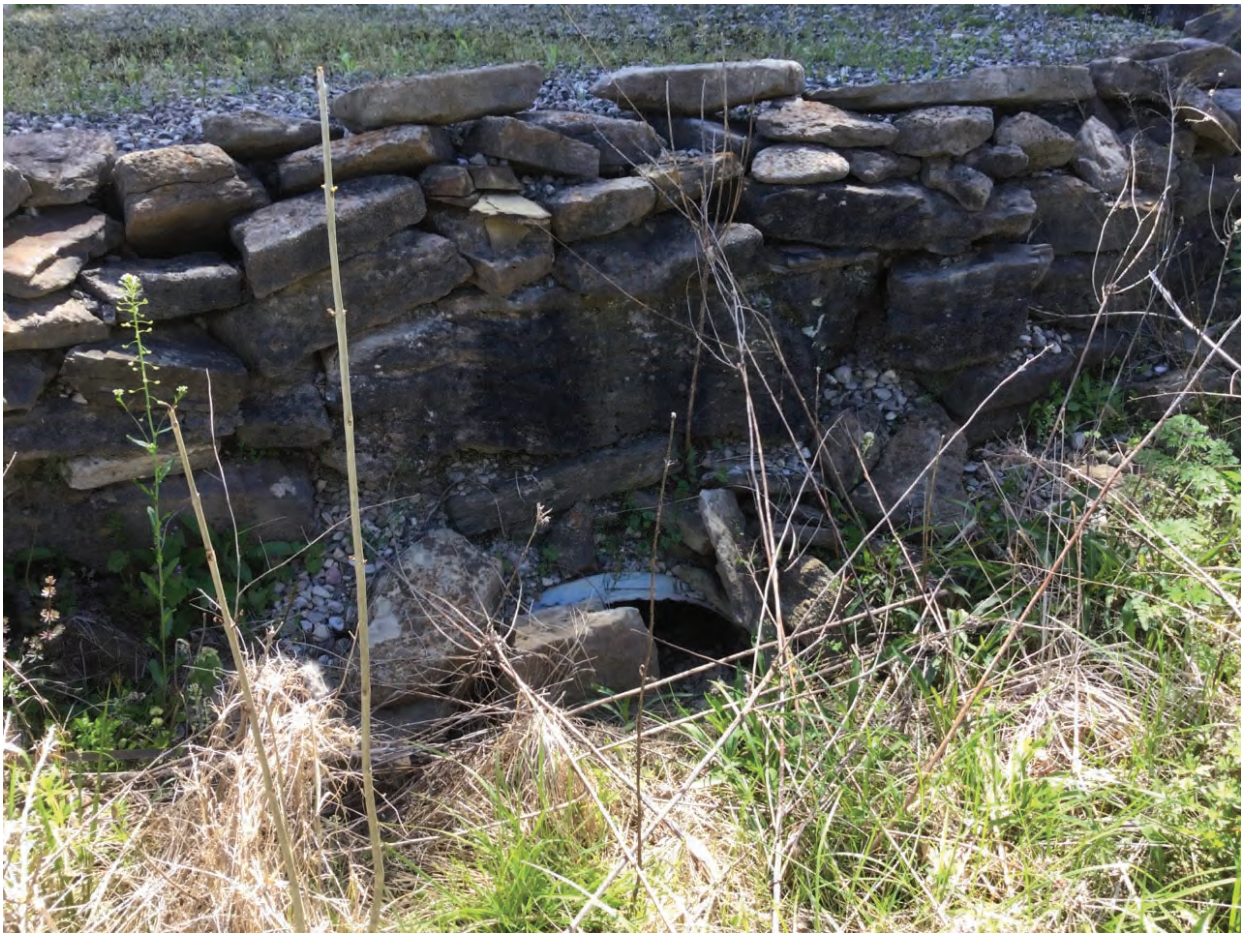
5. Looking south at culvert below residential drive – 4/21/2020

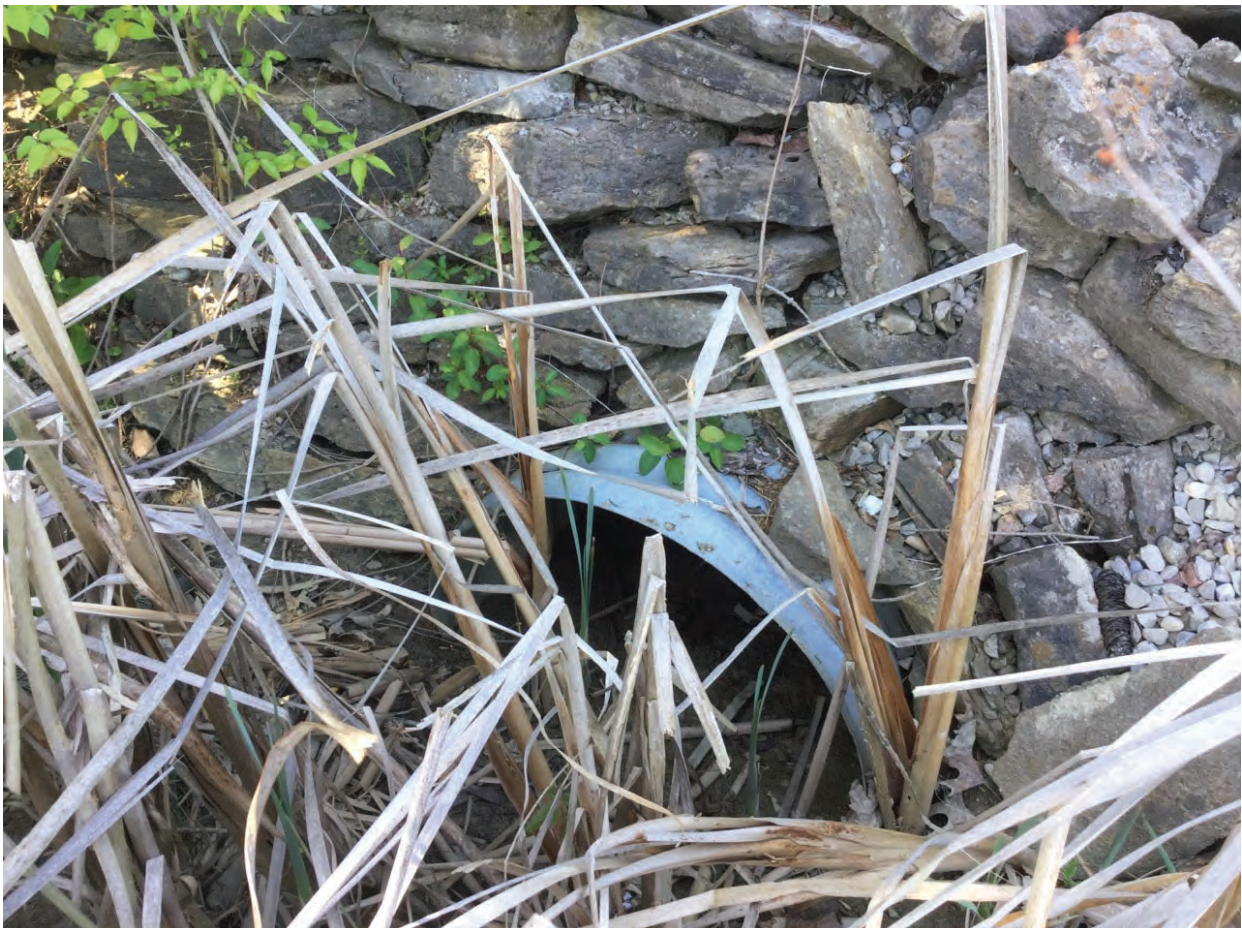
6. Looking west at culvert conveying drainage between Wetland A and Wetland B – 4/21/2020

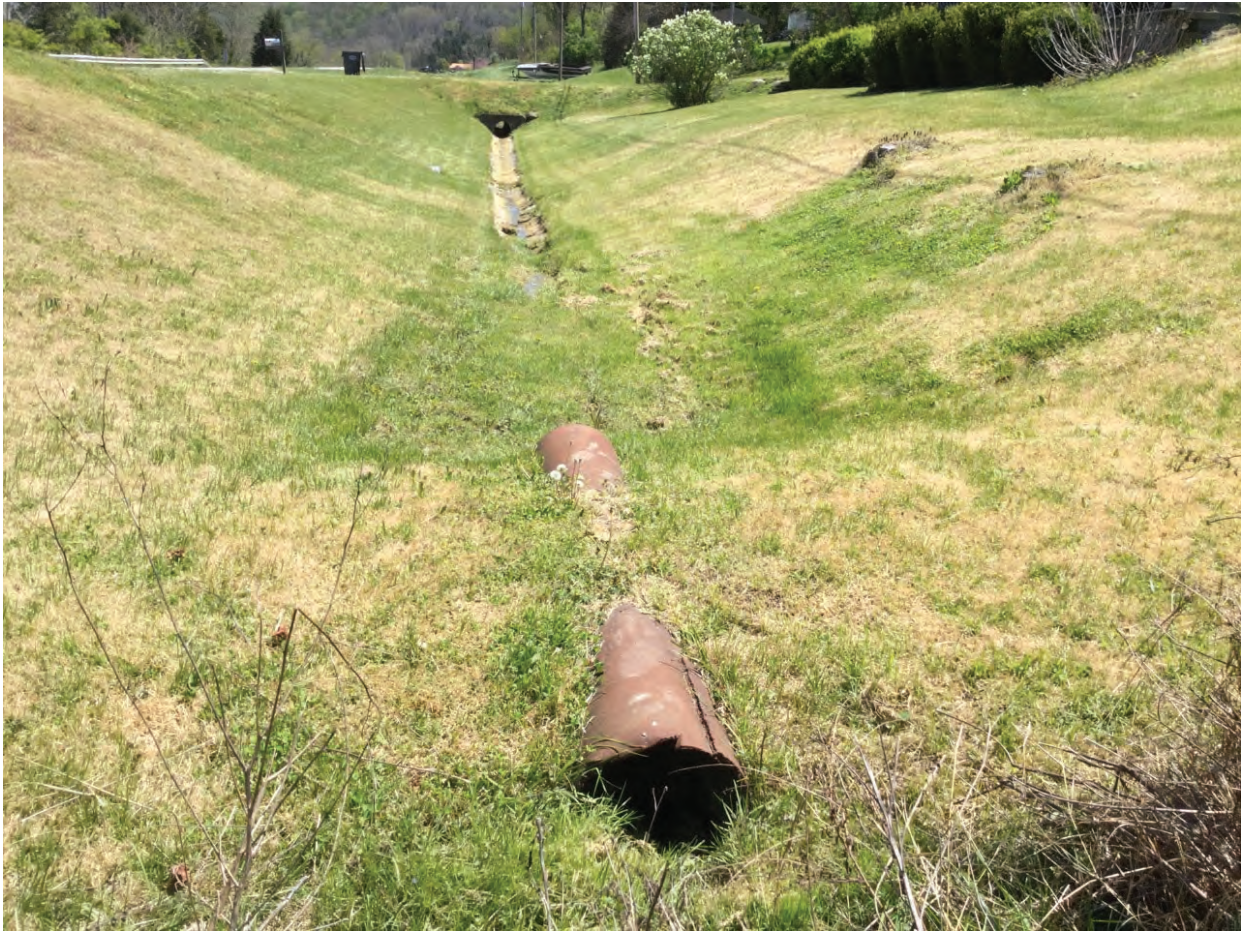
7. Looking southeast at metal pipe culverts and concrete lined drainage area – 4/21/2020

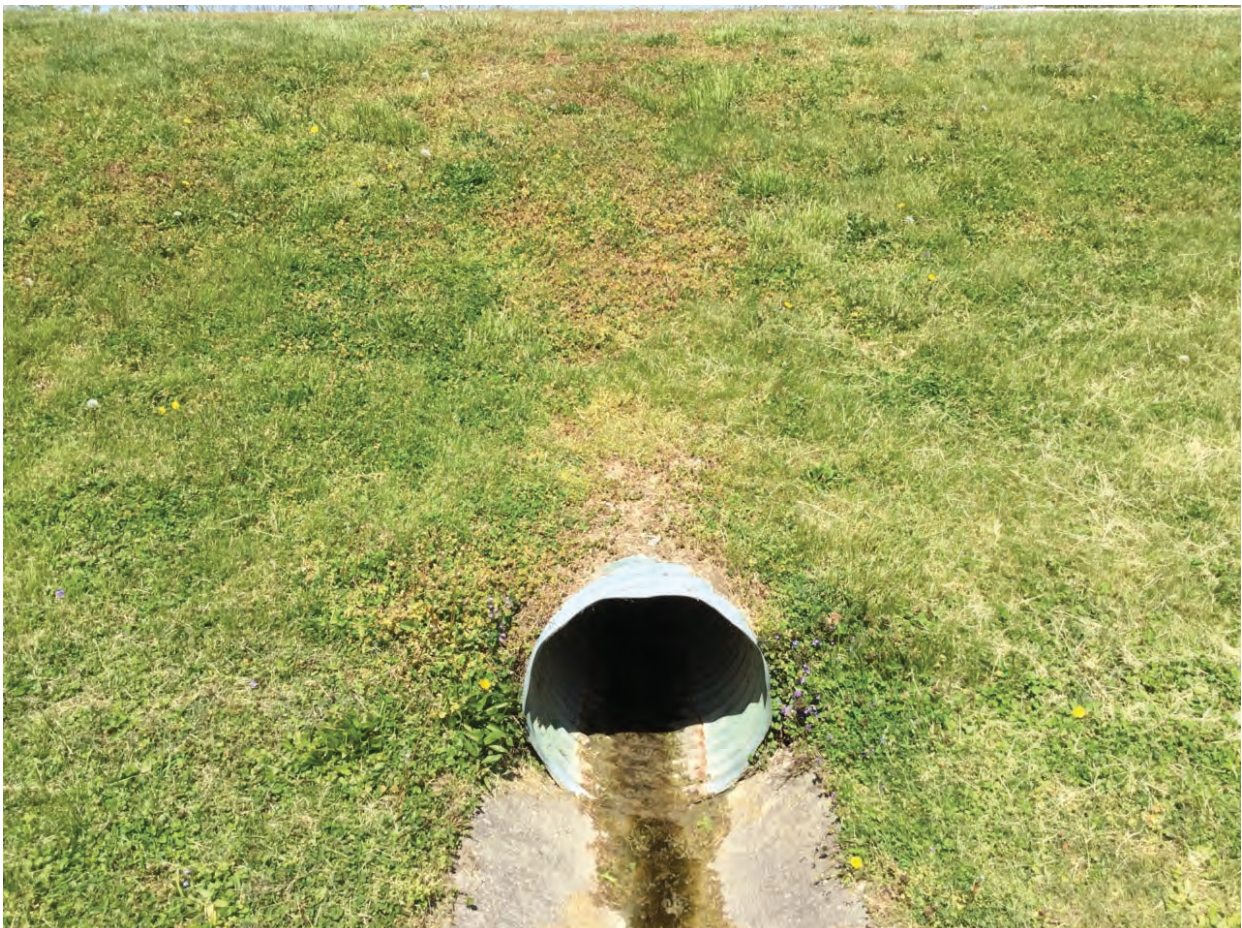
8. Looking northeast at culvert below State Road 156 – 4/21/2020

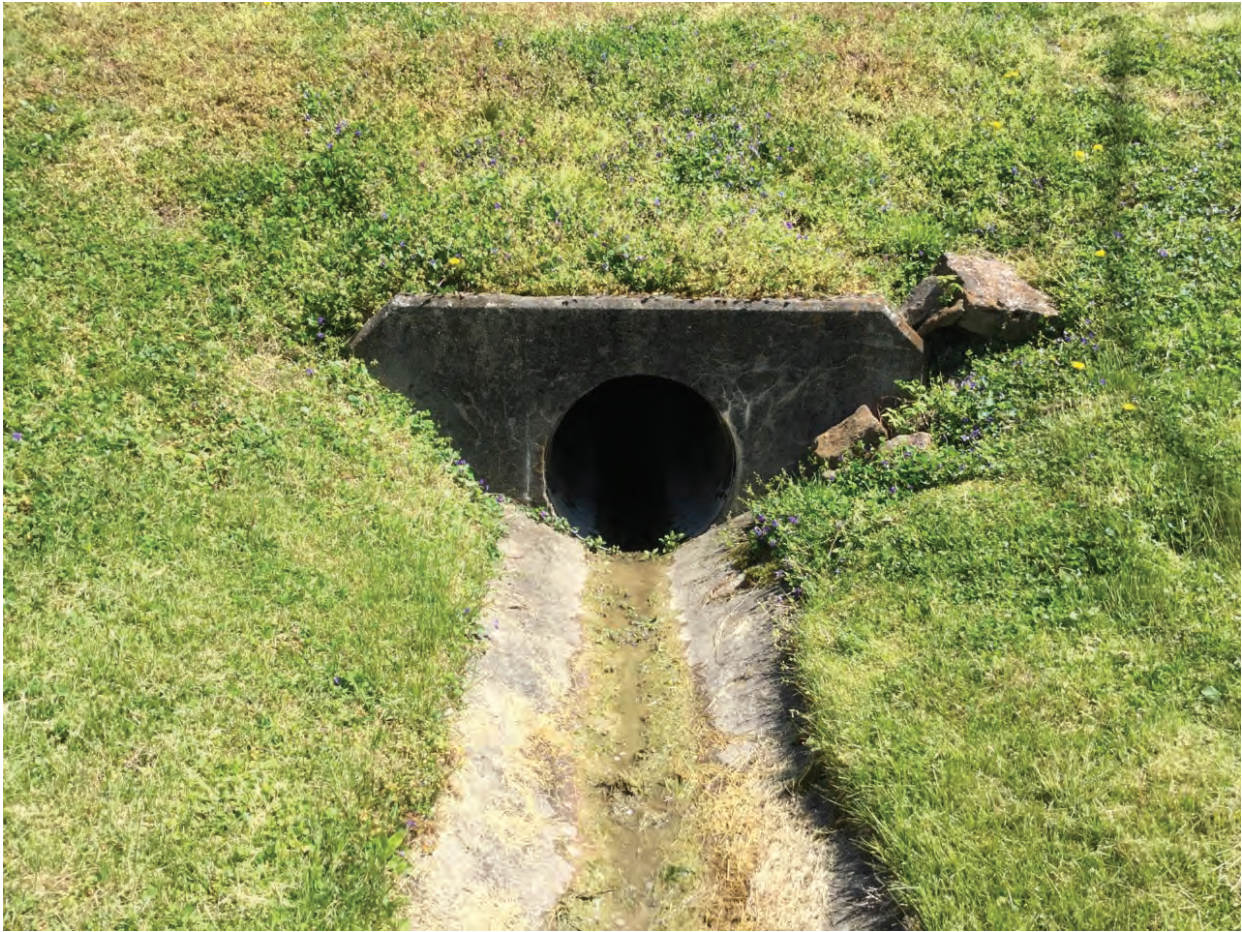
9. Looking southeast at culvert below residential driveway – 4/21/2020

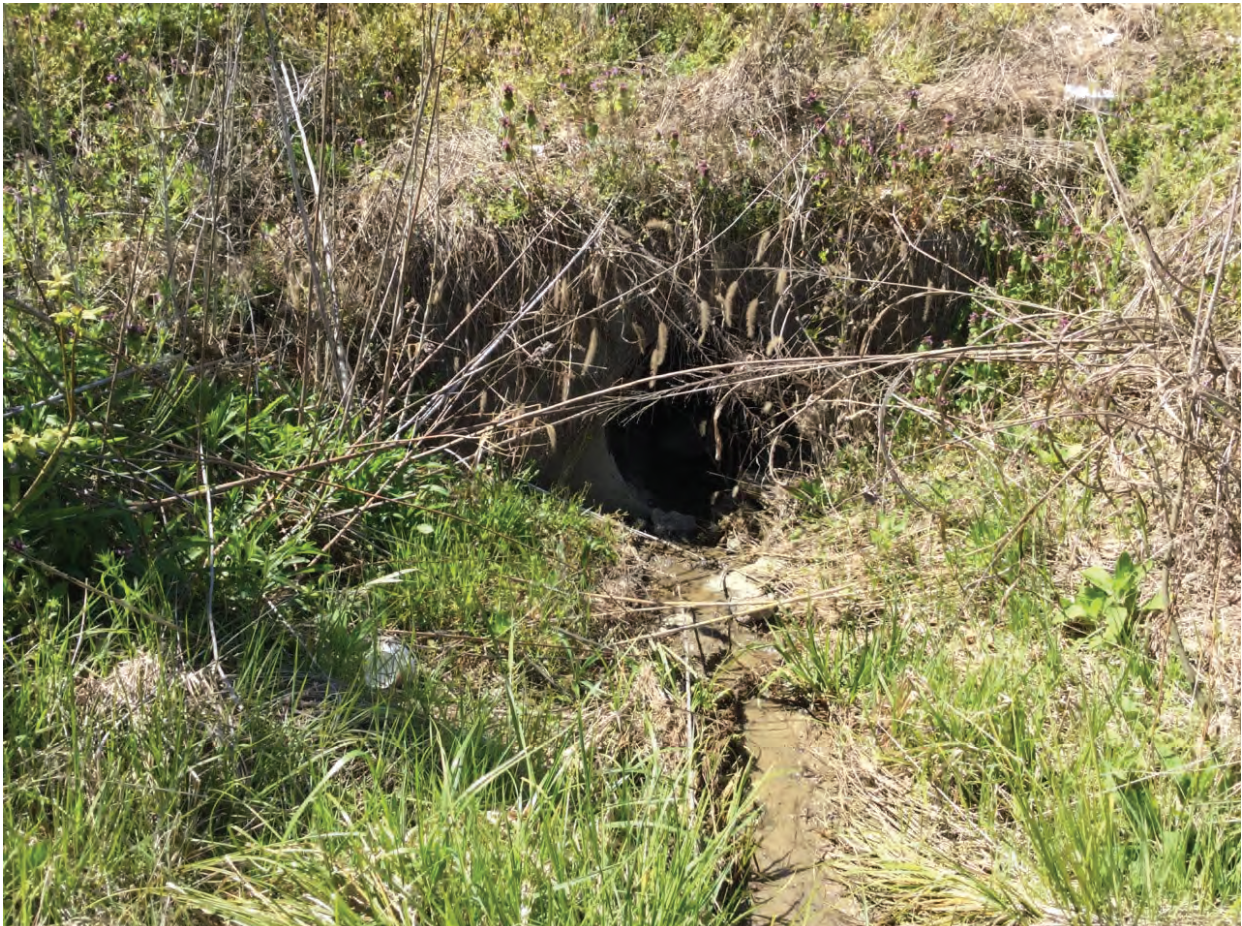
10. Looking southeast at culvert below residential driveway – 4/21/2020

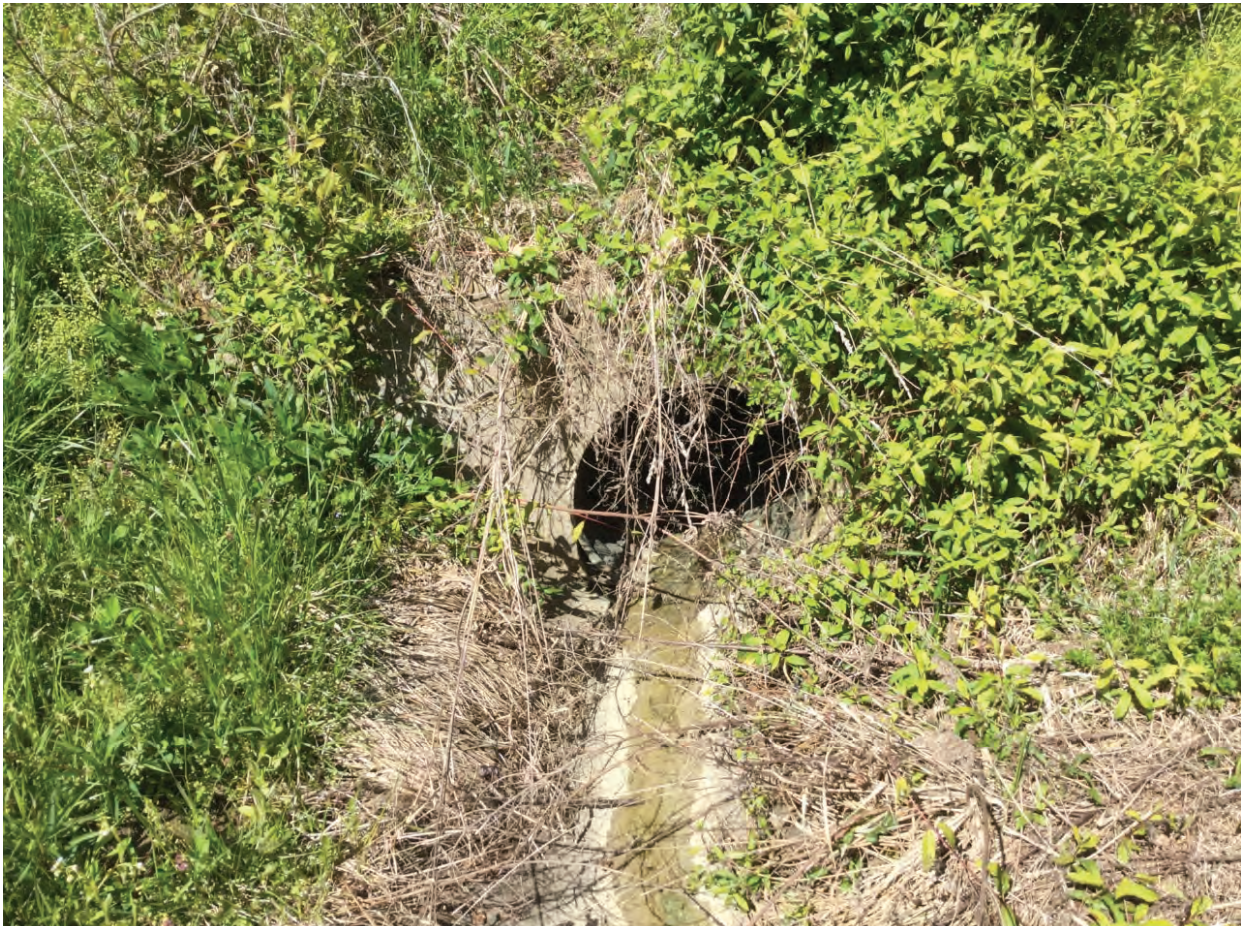
12. Looking northeast at culvert below State Road 156 – 4/21/2020

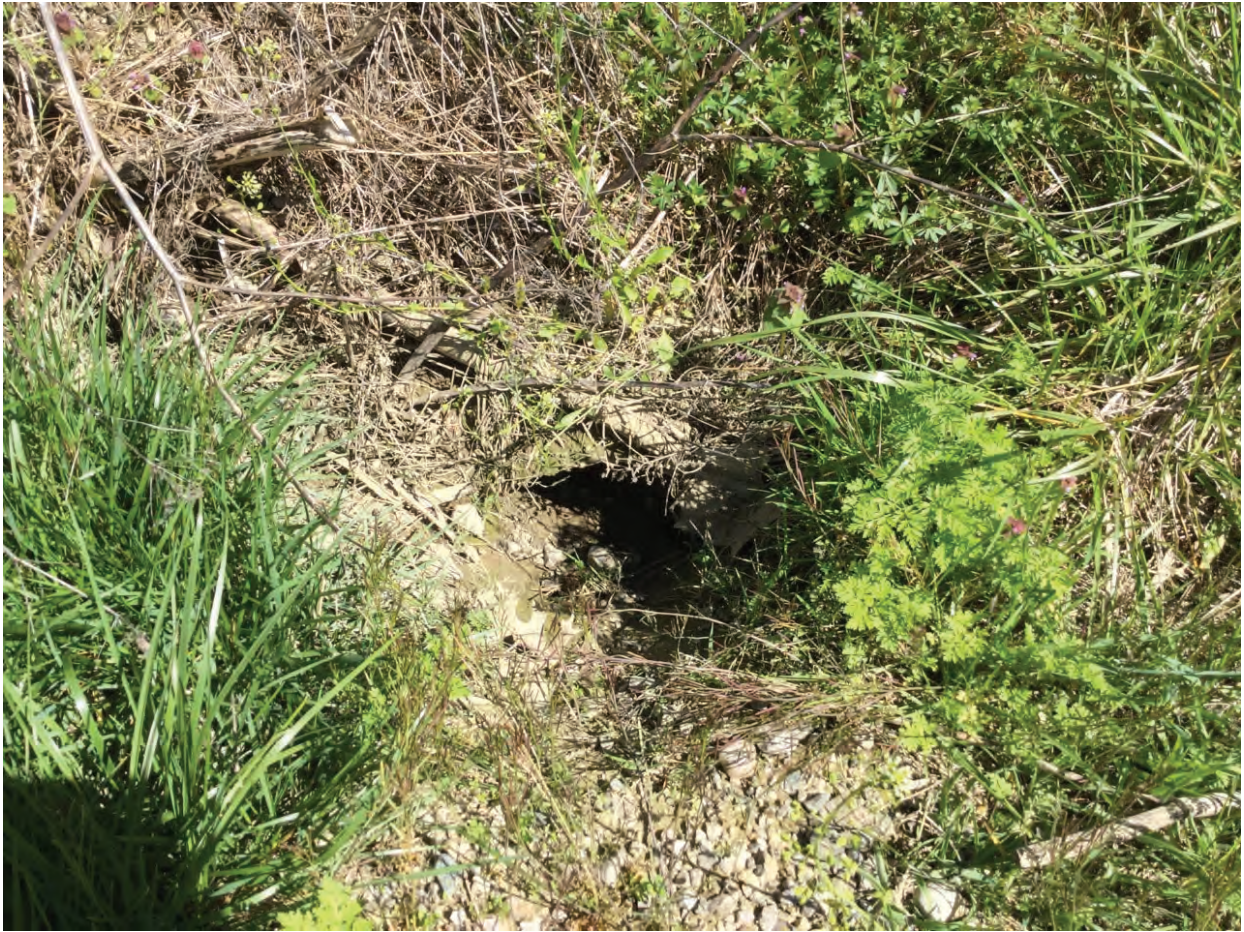
13. Looking southeast at culvert below residential driveway – 4/21/2020

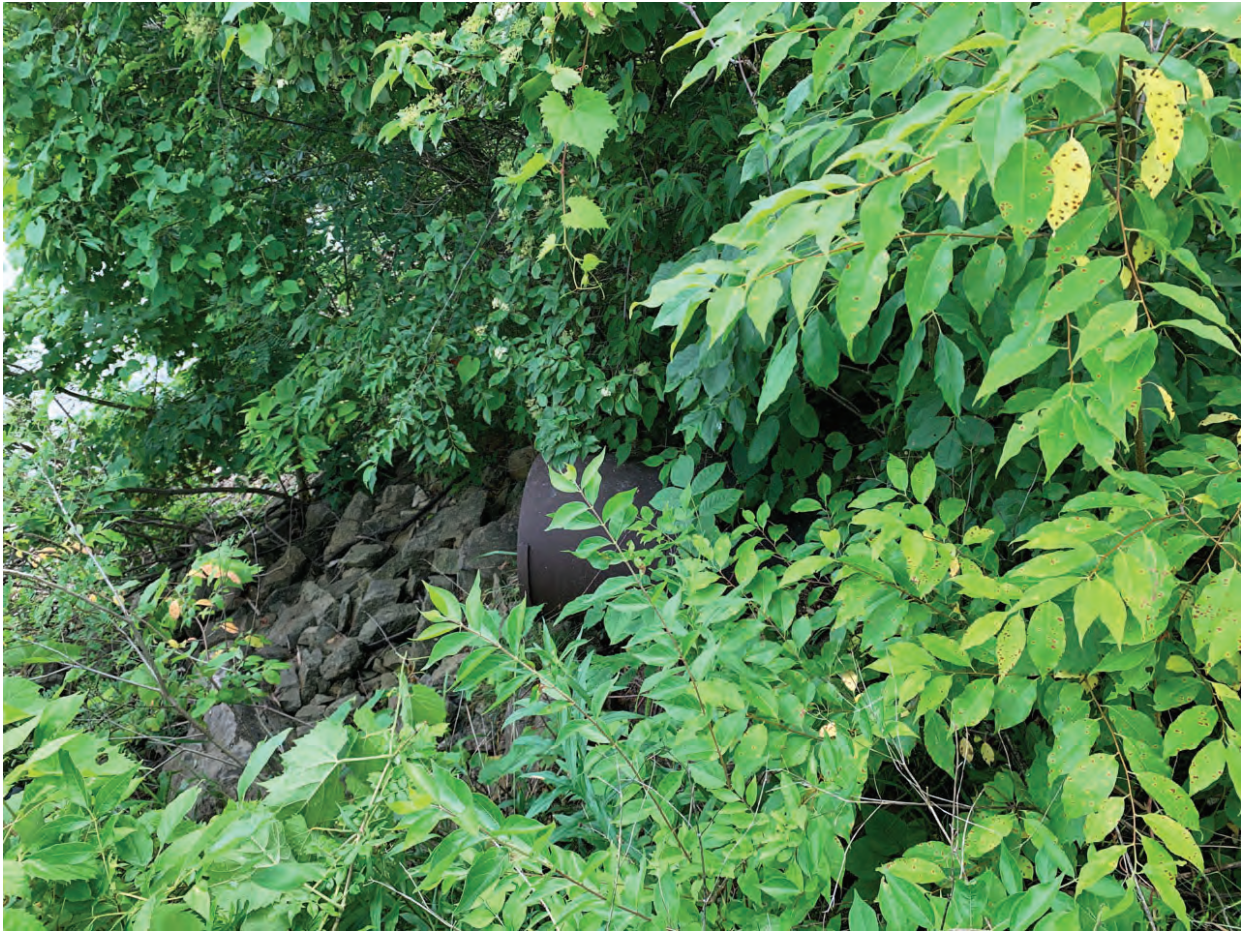
15. Looking northeast at culvert outlet below State Road 156 – 6/22/2020

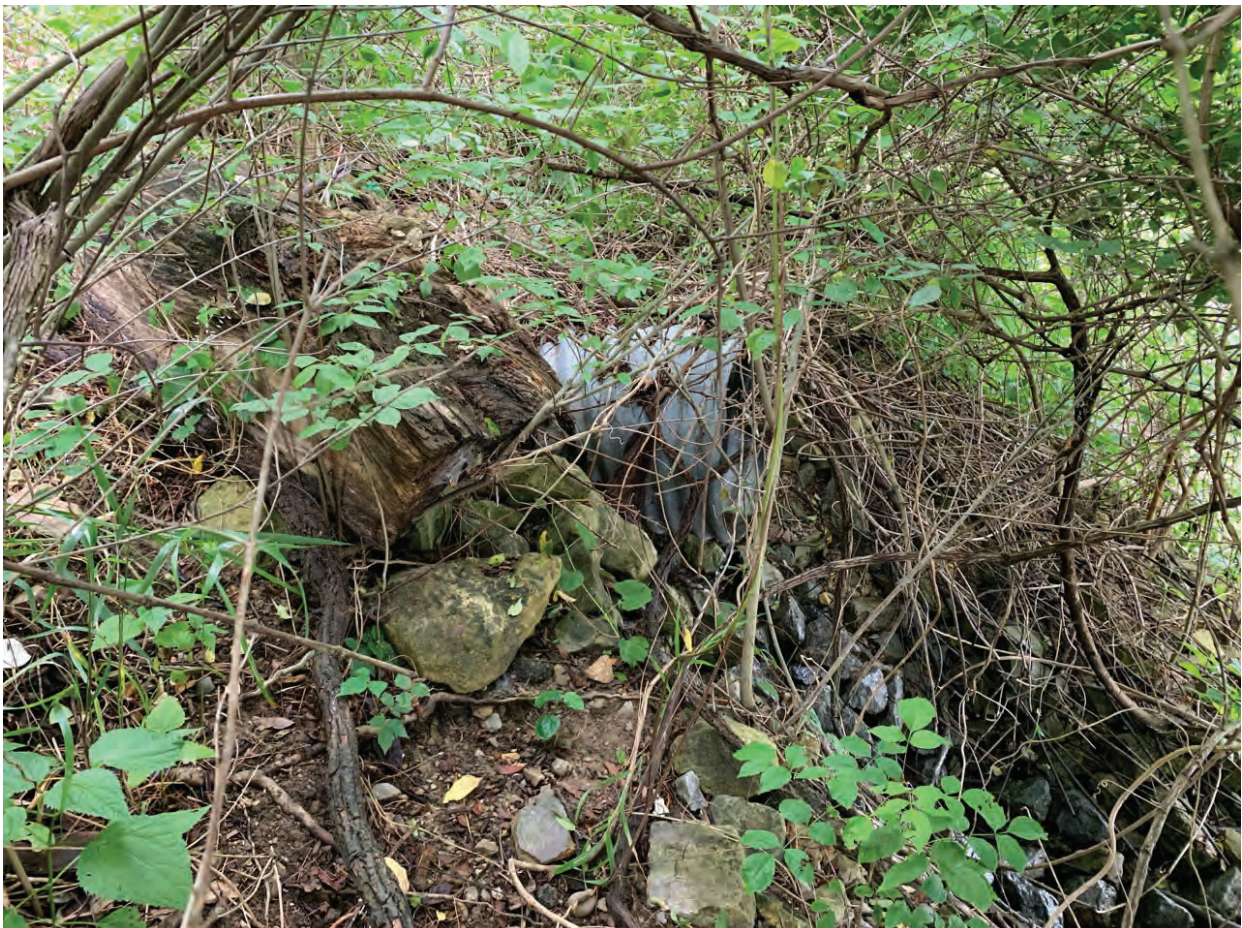
18. Looking northwest at culvert below State Road 156 – 6/22/2020

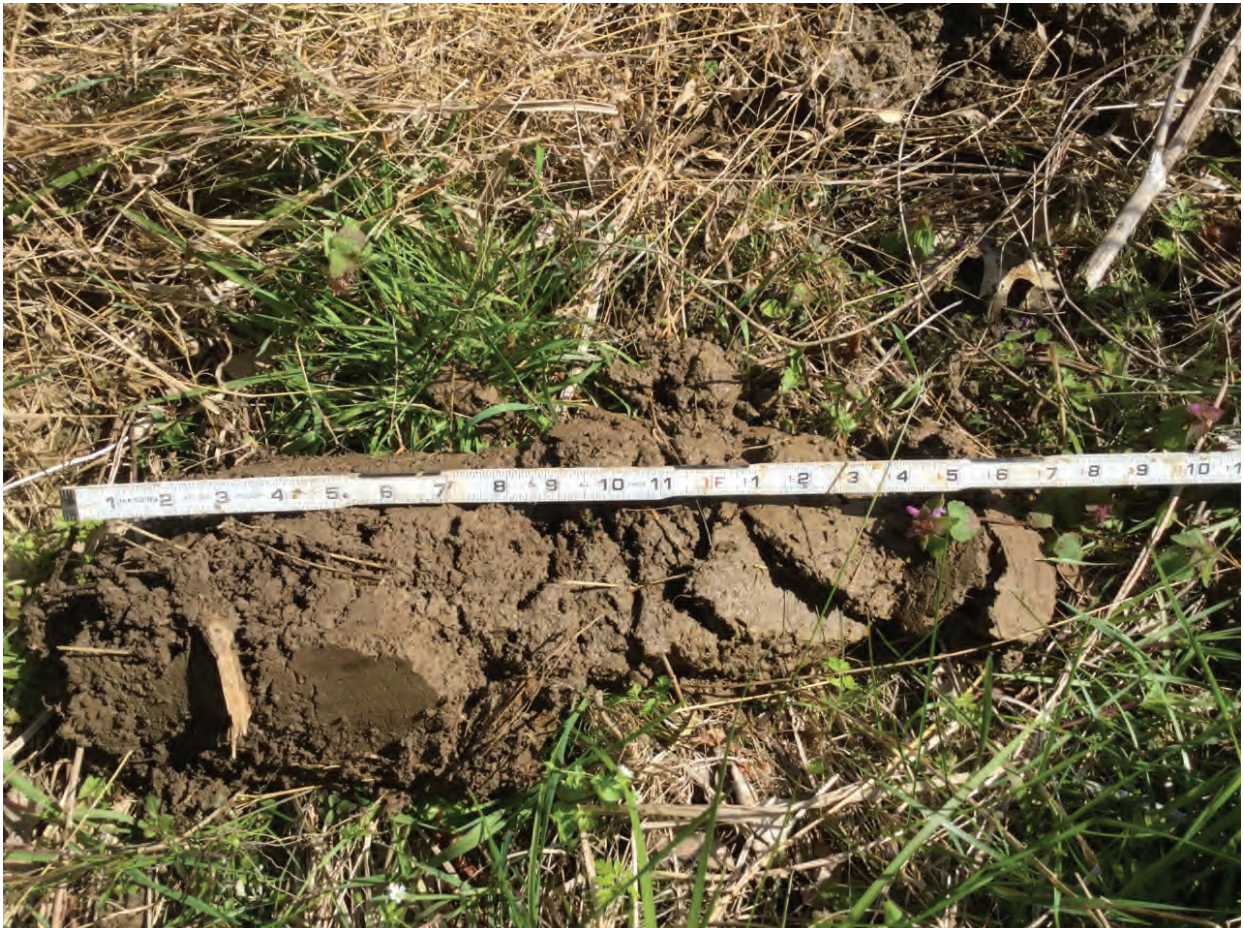
AW1 soil profile

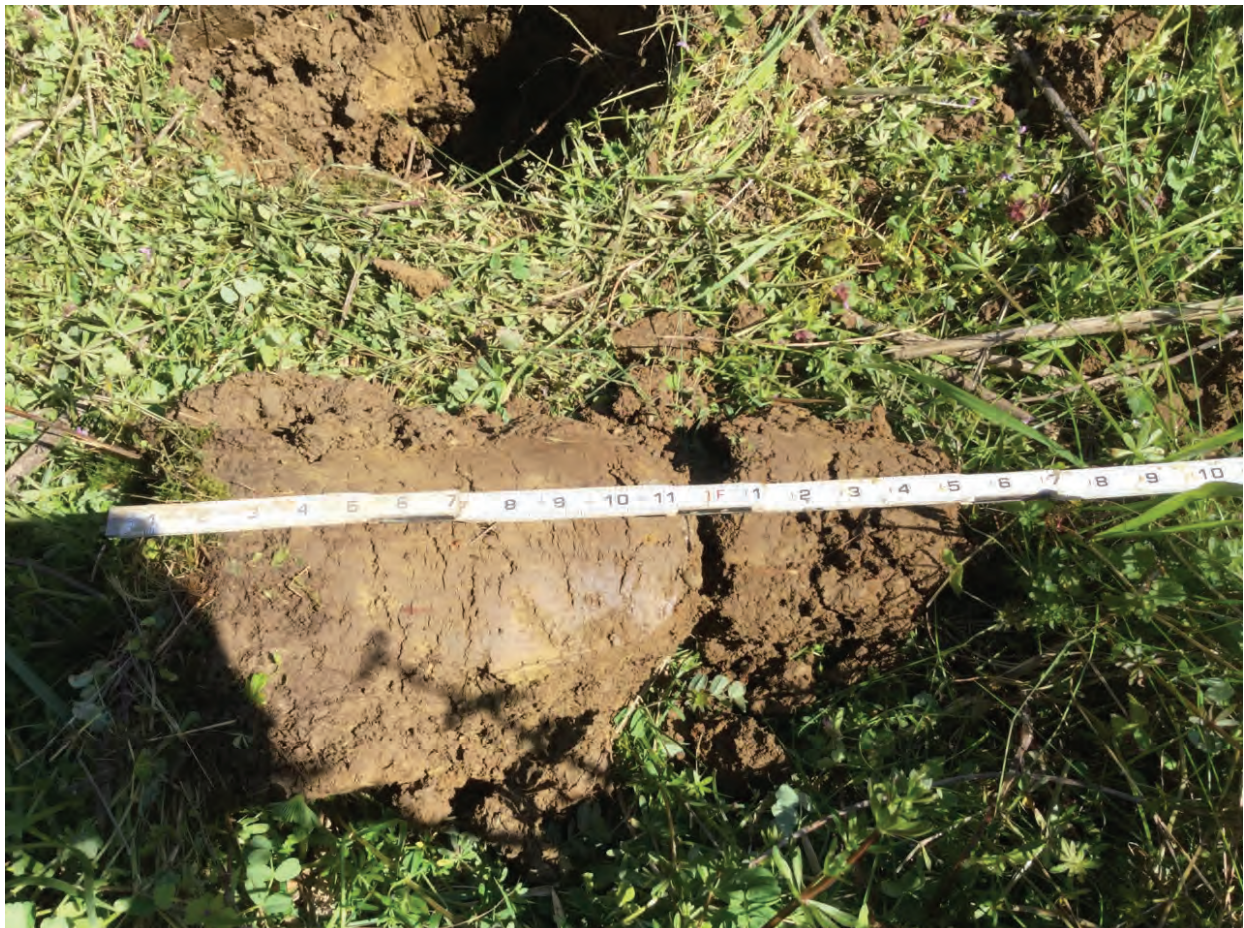
AD1 soil profile

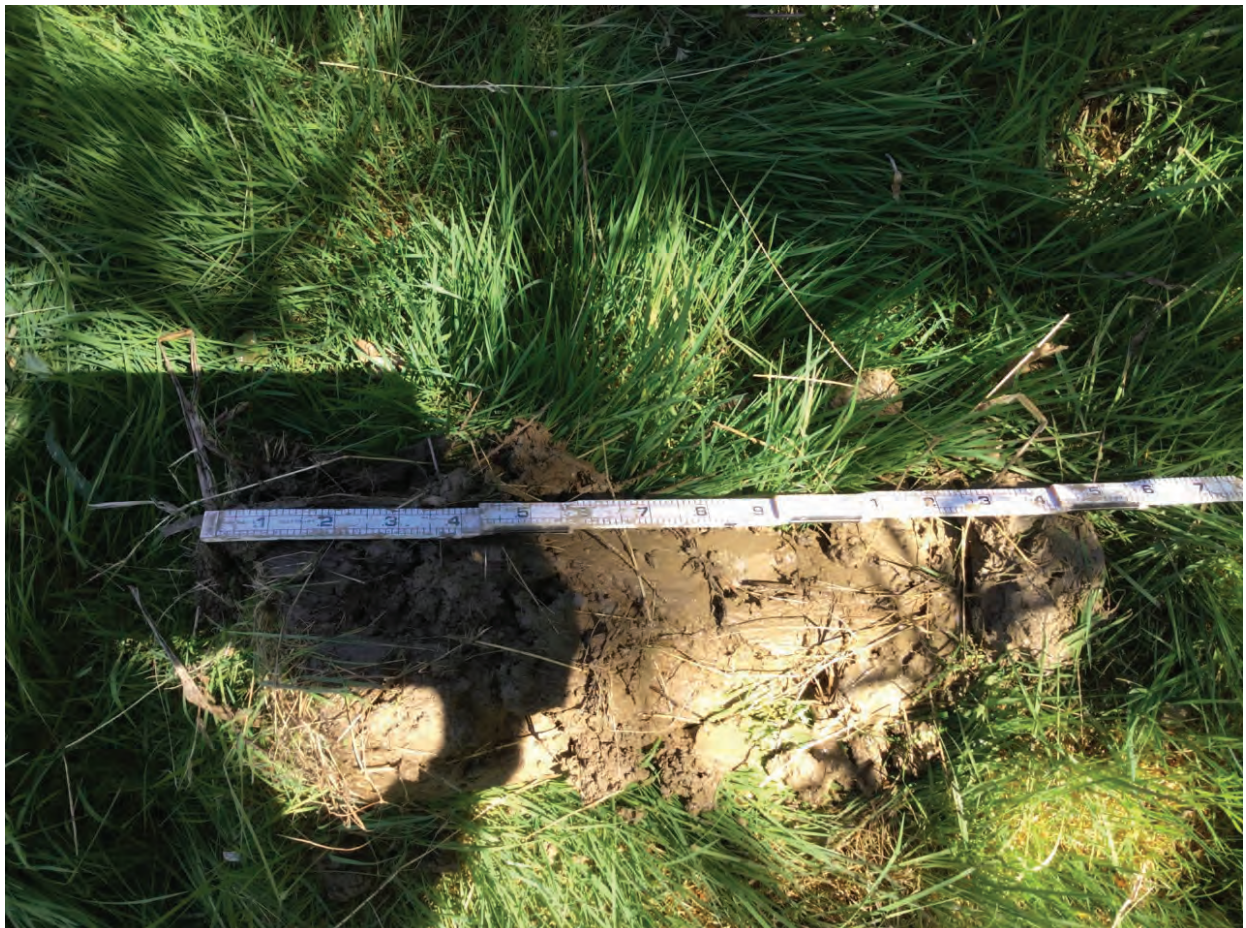
BW1 soil profile

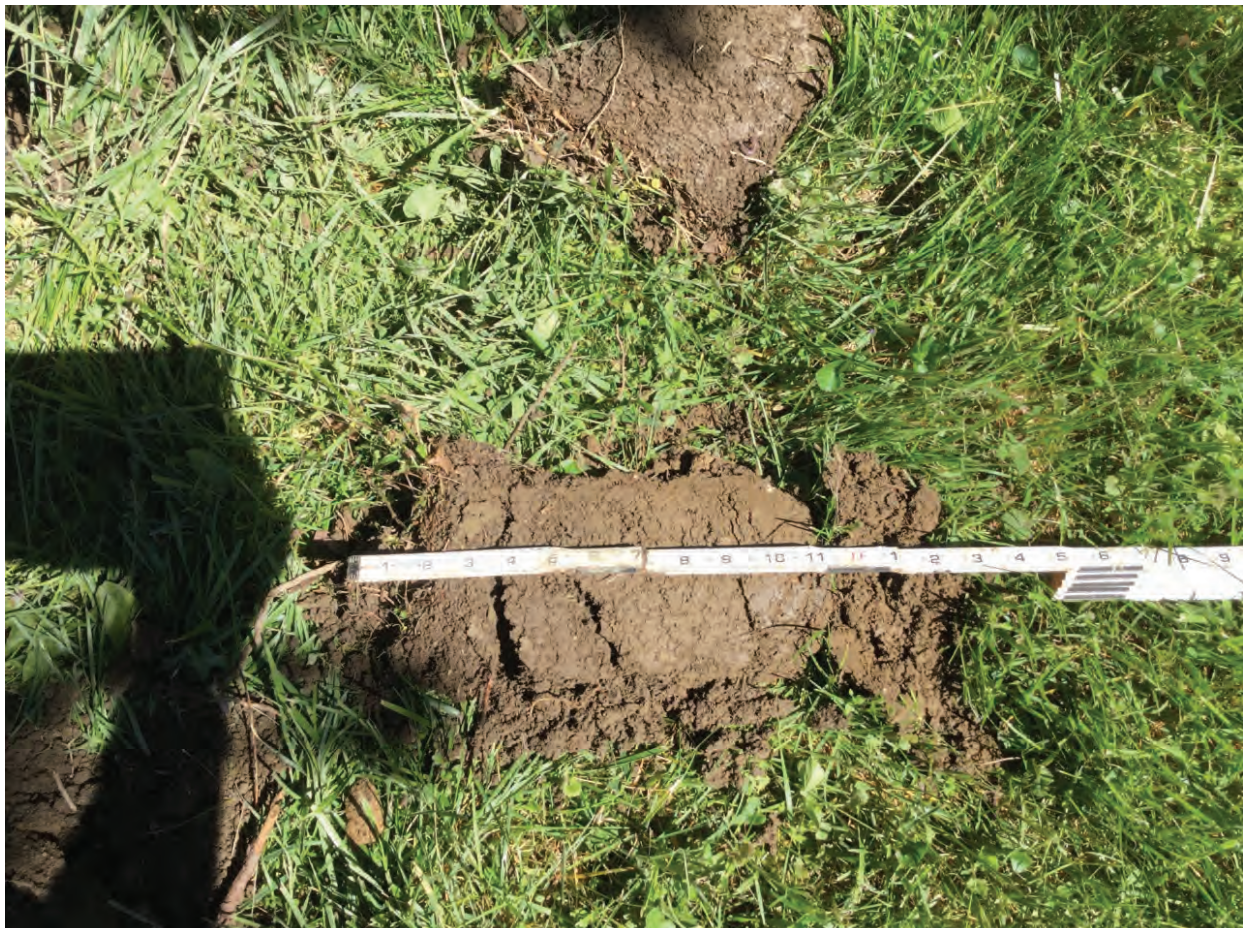
BD1 soil profile

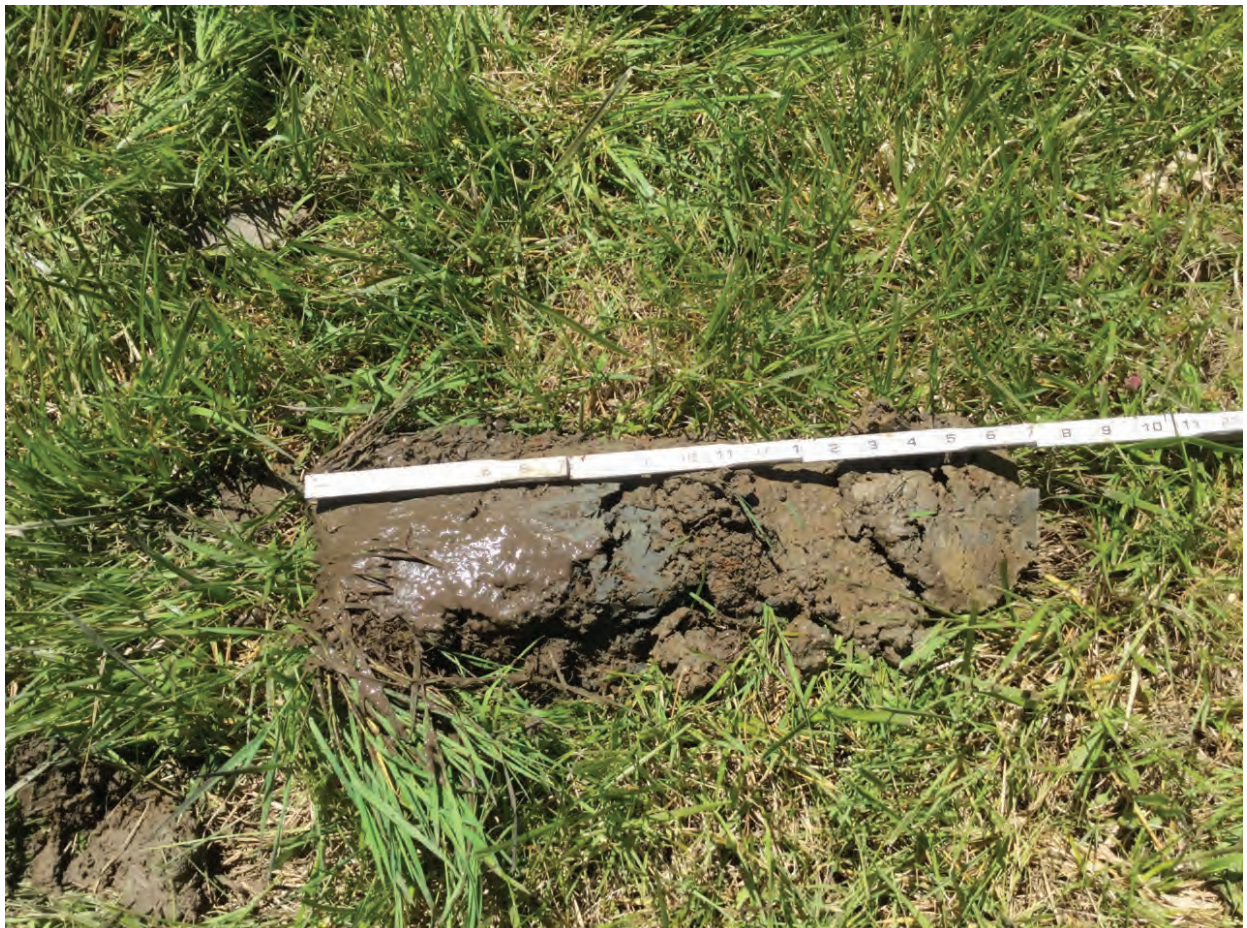
CW1 soil profile

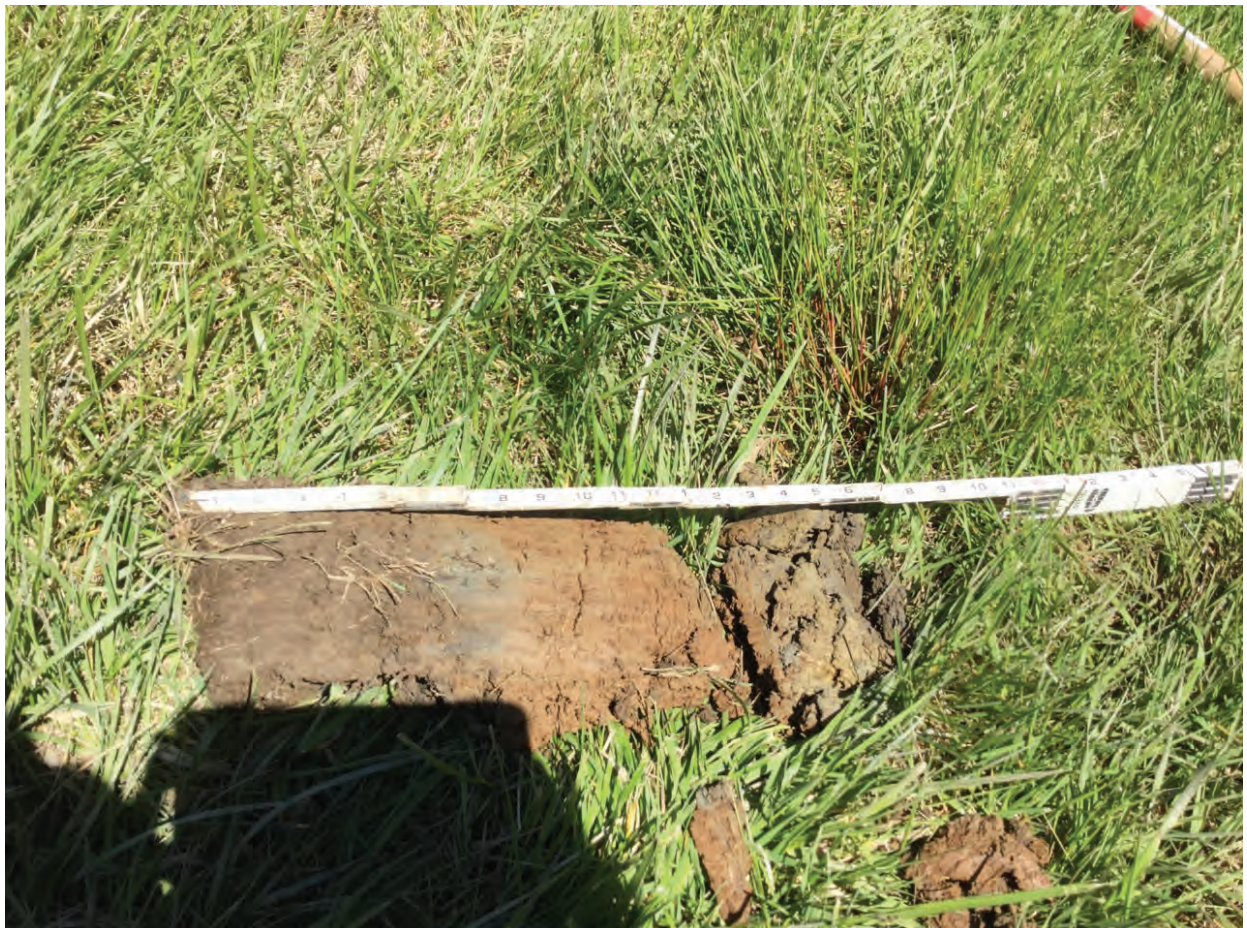
CD1 soil profile
