Categorical Exclusion
Appendix C
Early Coordination

Re: Agencies Coordination
Designation (Des.) Number 1700091
Road Project
US 231, from 0.27 miles north of I-70 to 1.05 miles north of I-70
Putnam County, Indiana

Red Flag Investigation - Infrastructure
 US 231, From 0.27 Mile North to 1.05 Miles North of I-70
 Des. No. 1700091, Added Travel Lanes
 Putnam County, Indiana

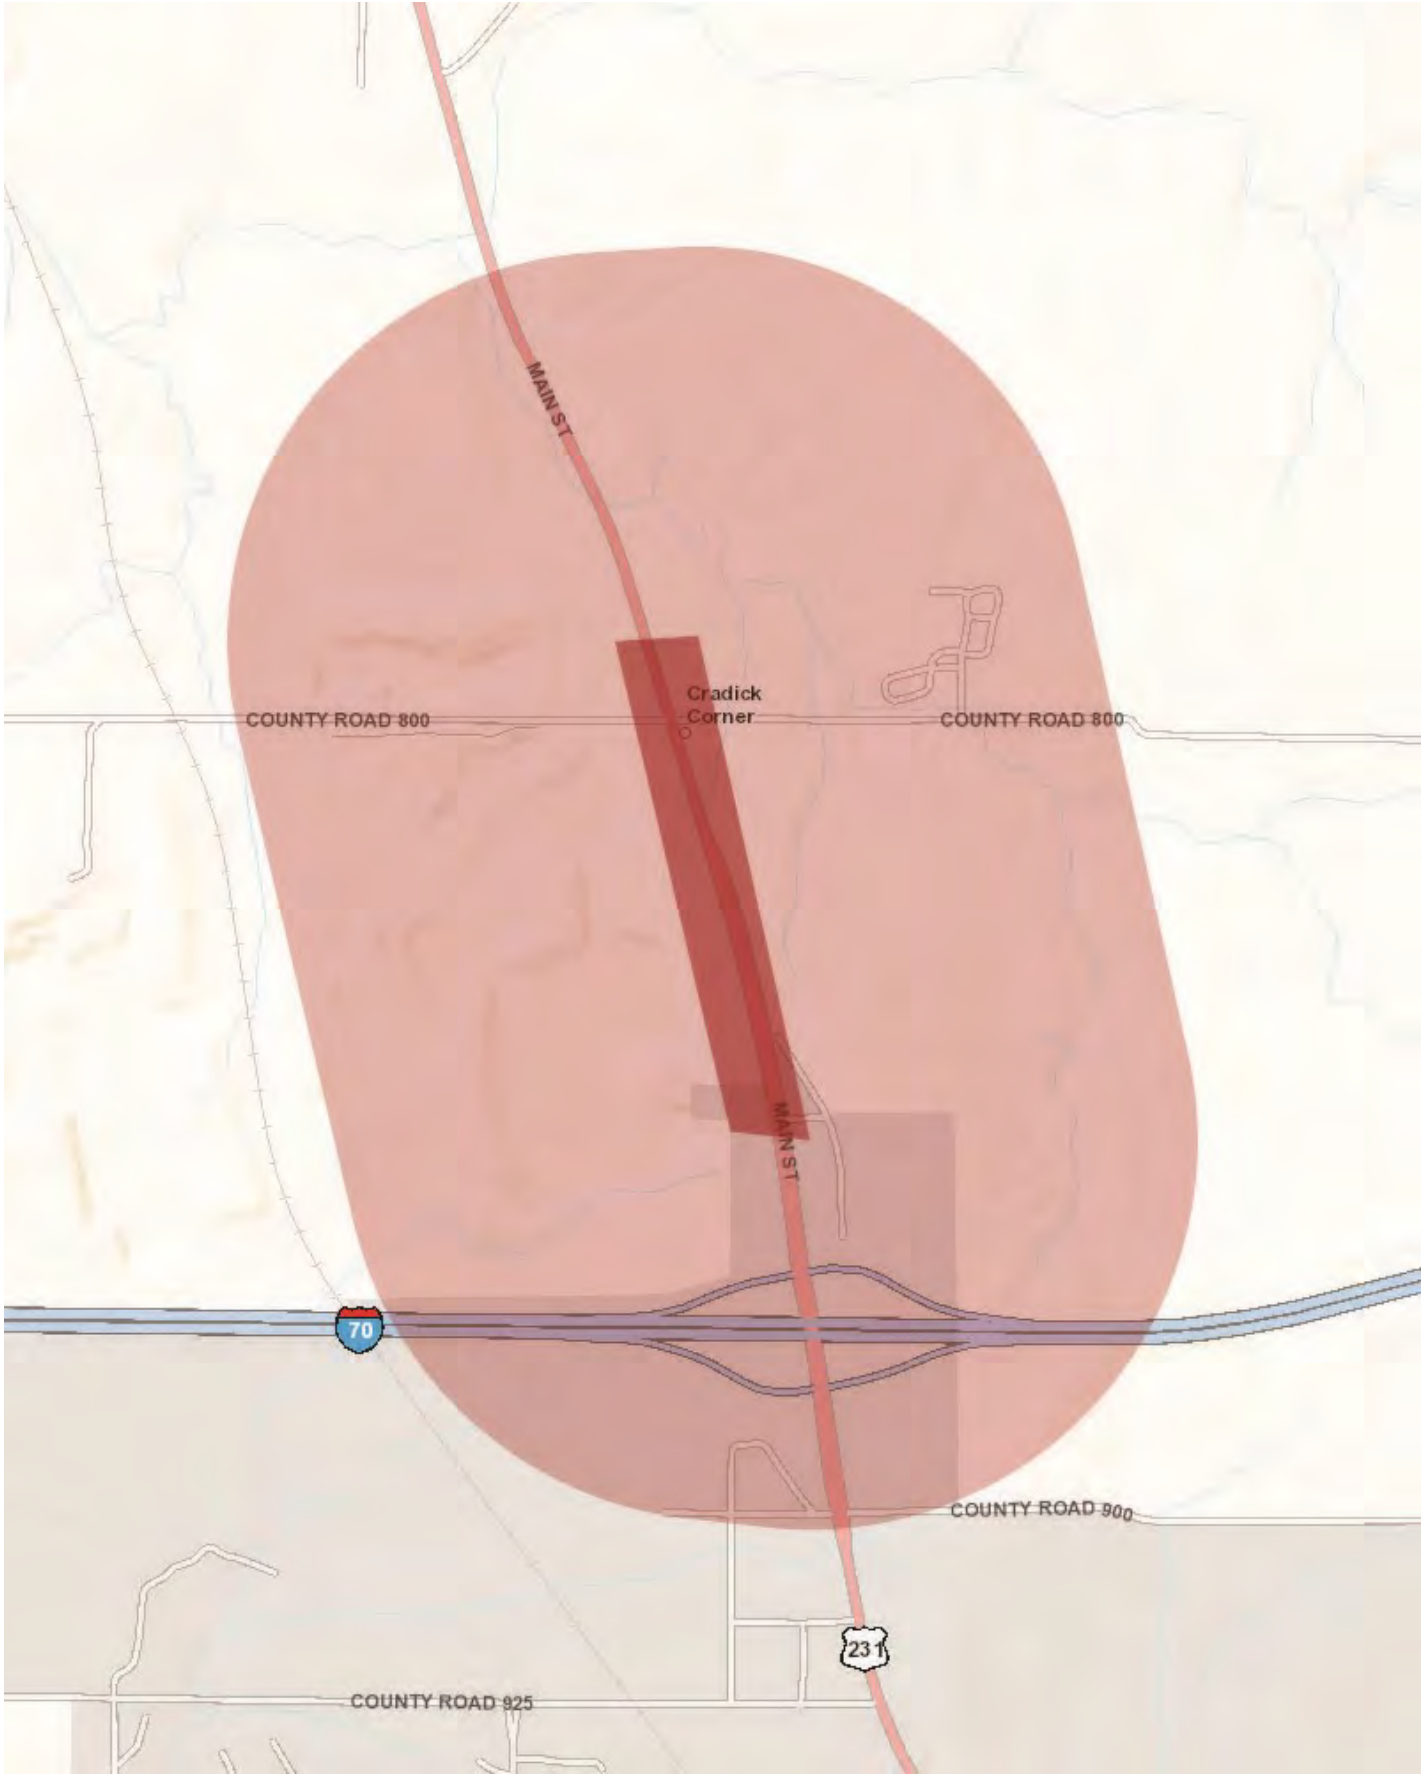
1. Geological Hazards:
 - Potential Karst
 - Moderate liquefaction potential
 - 1% Annual Chance Flood Hazard
2. Mineral Resources:
 - Bedrock Resource: High Potential
 - Sand and Gravel Resource: None documented in the area
3. Active or abandoned mineral resources extraction sites:
 - None documented in the area

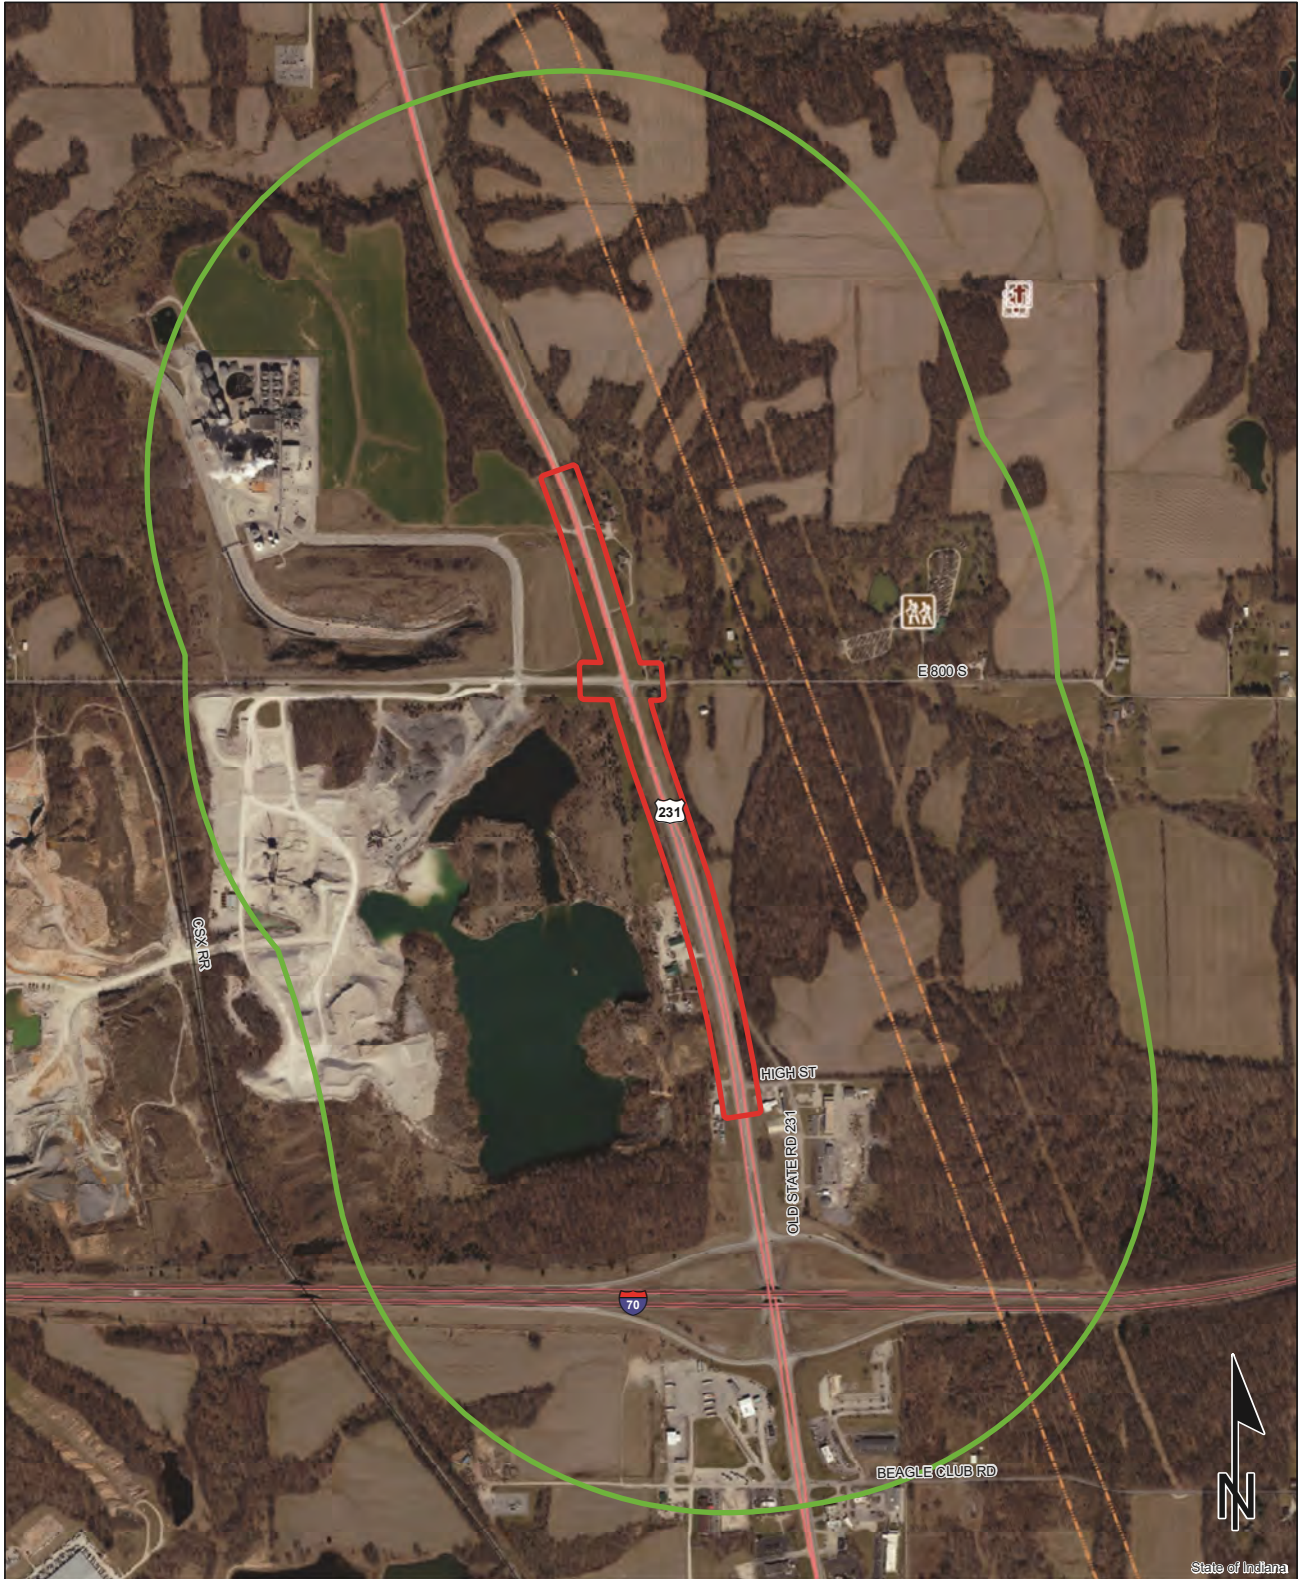
Infrastructure			
Indicate the number of items of concern found within the 0.5 mile search radius. If there are no items, please indicate N/A:			
Religious Facilities	N/A	Recreational Facilities	1
Airports ¹	N/A	Pipelines	2
Cemeteries	N/A	Railroads	N/A
Hospitals	N/A	Trails	N/A
Schools	N/A	Managed Lands	N/A

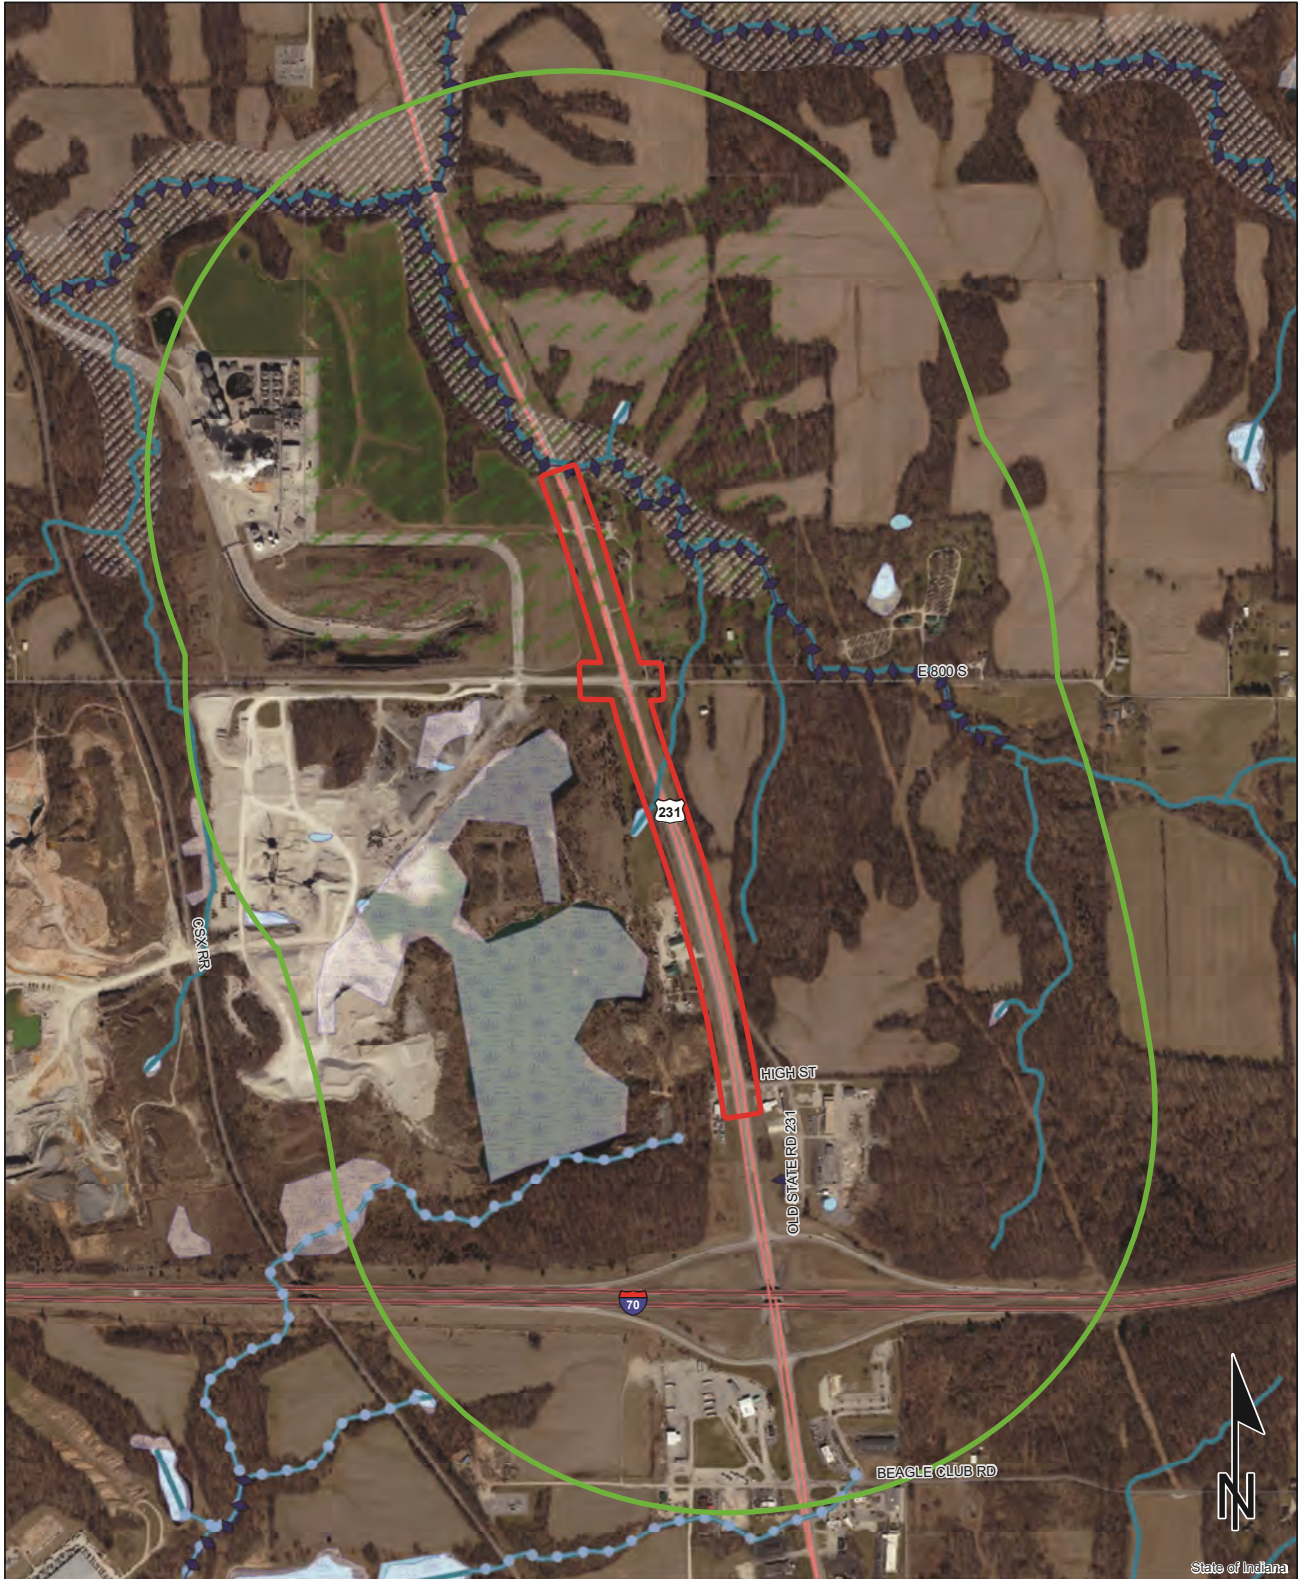
Red Flag Investigation - Water Resources
 US 231, From 0.27 Mile North to 1.05 Miles North of I-70
 Des. No. 1700091, Added Travel Lanes
 Putnam County, Indiana

Water Resources			
Indicate the number of items of concern found within the 0.5 mile search radius. If there are no items, please indicate N/A:			
NWI - Points	N/A	Canal Routes - Historic	N/A
Karst Springs	N/A	NWI - Wetlands	8
Canal Structures – Historic	N/A	Lakes	11*
NPS NRI Listed	N/A	Floodplain - DFIRM	1
NWI-Lines	5	Cave Entrance Density	1
IDEM e303d Listed Streams and Lakes (Impaired)	2	Sinkhole Areas	N/A
Rivers and Streams	20	Sinking-Stream Basins	N/A

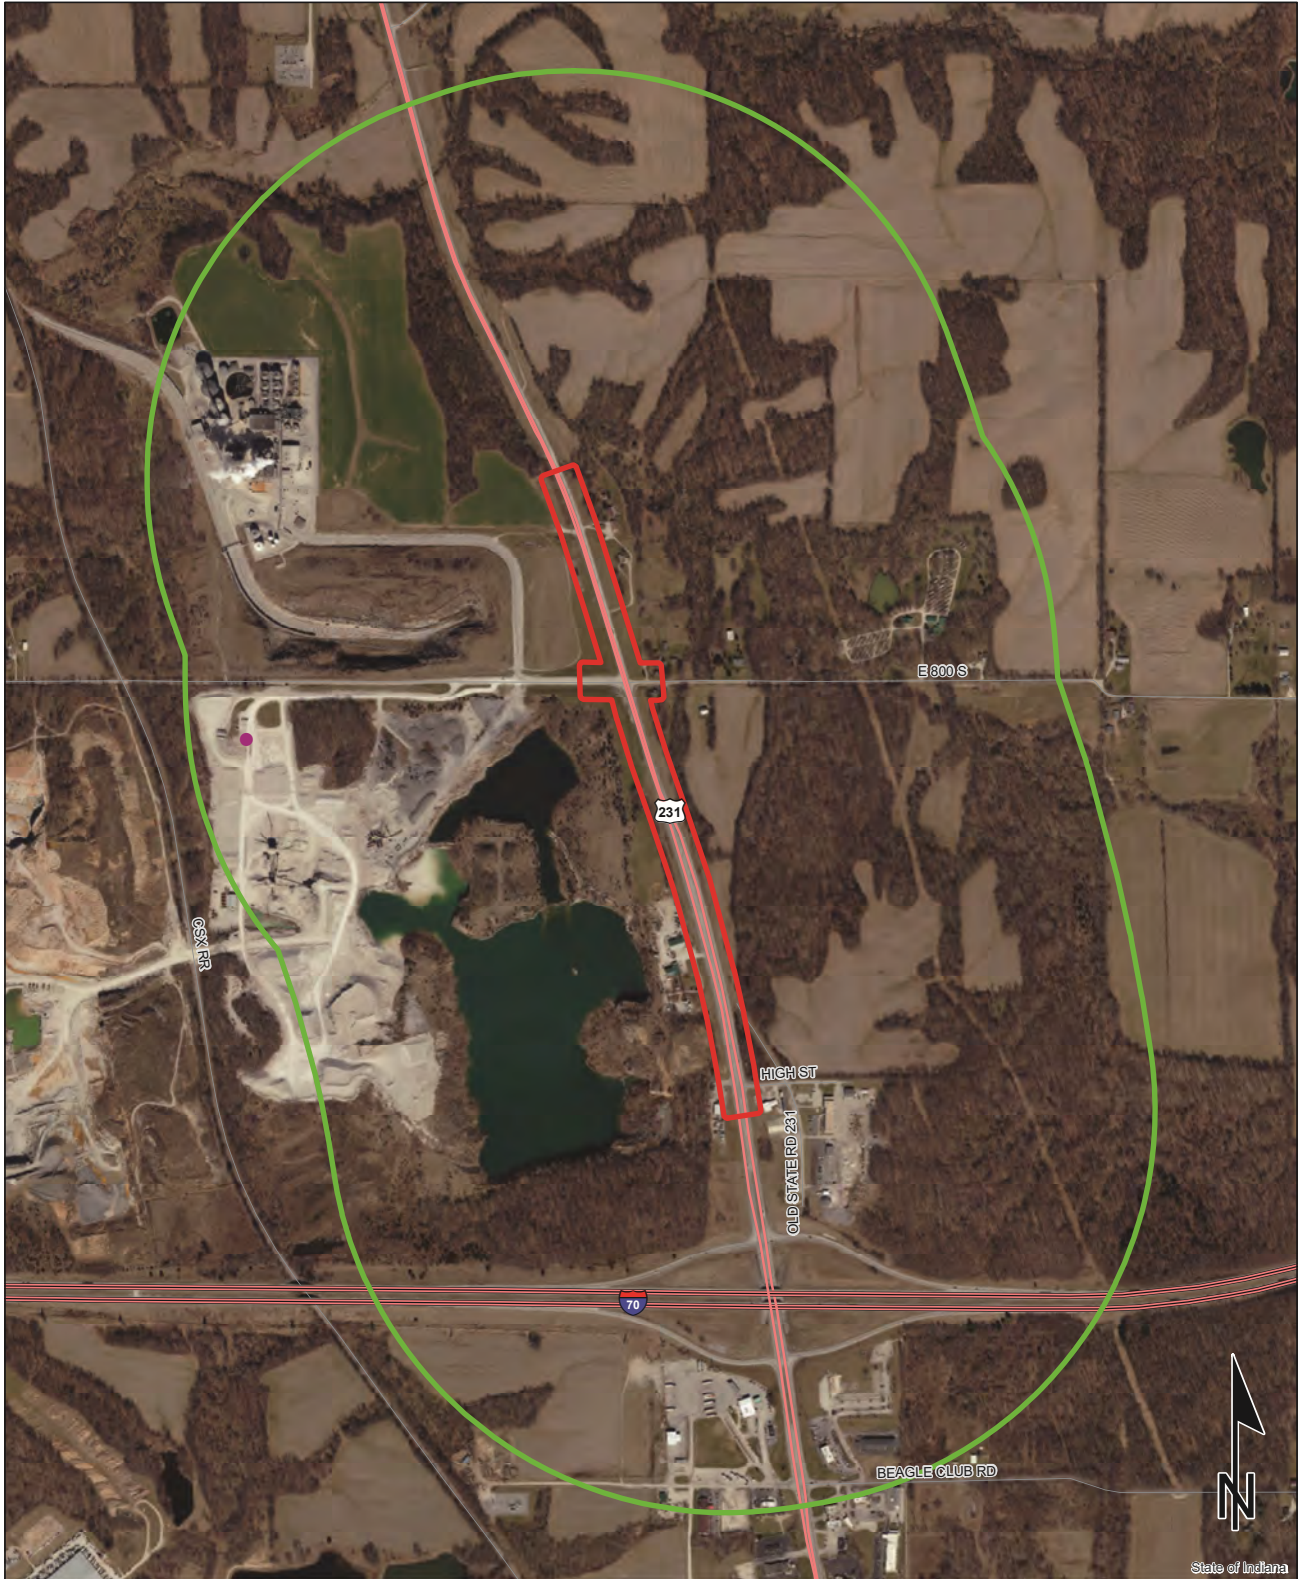
Red Flag Investigation - Mining and Mineral Exploration
 US 231, From 0.27 Mile North to 1.05 Miles North of I-70
 Des. No. 1700091, Added Travel Lanes
 Putnam County, Indiana

Mining/Mineral Exploration			
Indicate the number of items of concern found within the 0.5 mile search radius. If there are no items, please indicate N/A:			
Petroleum Wells	N/A	Mineral Resources	1
Mines – Surface	N/A	Mines – Underground	N/A

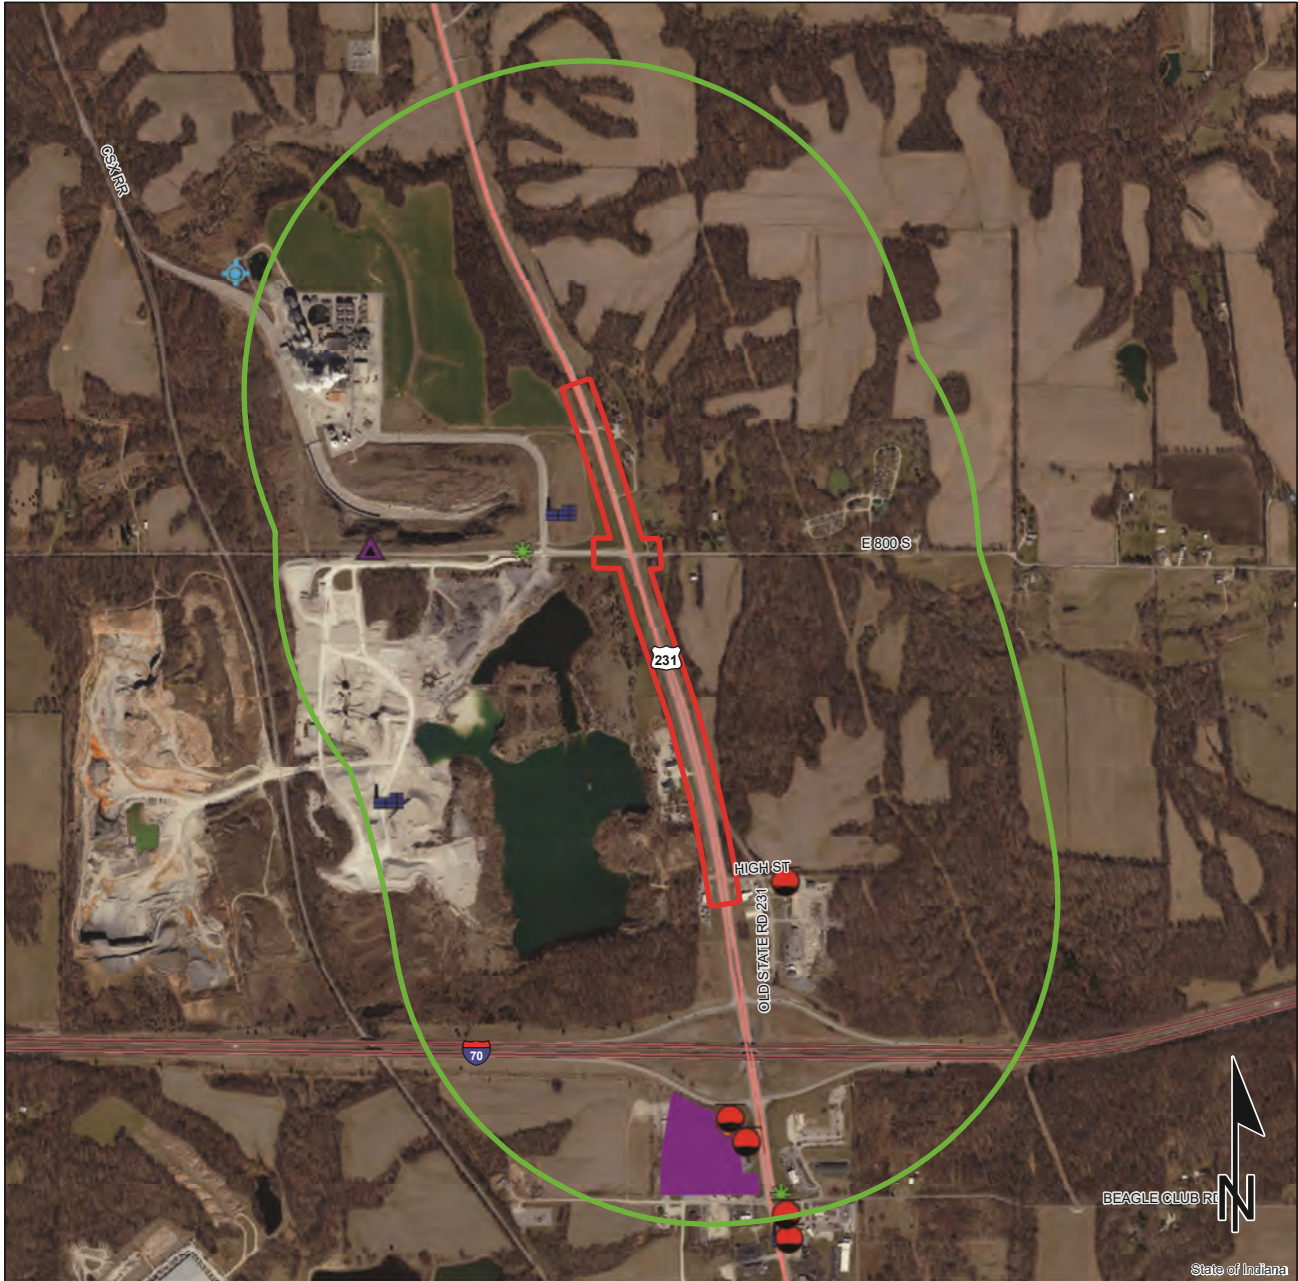
Red Flag Investigation - Hazardous Material Concerns
 US 231, From 0.27 Mile North to 1.05 Miles North of I-70
 Des. No. 1700091, Added Travel Lanes
 Putnam County, Indiana

Hazardous Material Concerns			
Indicate the number of items of concern found within the 0.5 mile search radius. If there are no items, please indicate N/A:			
Superfund	N/A	Manufactured Gas Plant Sites	N/A
RCRA Generator/ TSD	2*	Open Dump Waste Sites	N/A
RCRA Corrective Action Sites	N/A	Restricted Waste Sites	N/A
State Cleanup Sites	1	Waste Transfer Stations	N/A
Septage Waste Sites	N/A	Tire Waste Sites	N/A
Underground Storage Tank (UST) Sites	N/A	Confined Feeding Operations (CFO)	N/A
Voluntary Remediation Program	N/A	Brownfields	2
Construction Demolition Waste	N/A	Institutional Controls	1
Solid Waste Landfill	N/A	NPDES Facilities	3
Infectious/Medical Waste Sites	N/A	NPDES Pipe Locations	1
Leaking Underground Storage (LUST) Sites	4	Notice of Contamination Sites	1

INDOT Cloverdale Subdistrict, (10 High Street Cloverdale, IN 46120, AI# 59861), is located approximately 0.05 mile east of the southernmost portion of the project area. The INDOT Cloverdale Subdistrict site is not mapped as being a RCRA Generator; however, the IDEM VFC contained documents referring to the site as a Conditionally Exempt Generator, dating back to 1994. This site is also listed as a Leaking Underground Storage (LUST) site. Refer to LUST site section for more details. No impact is expected.

Leaking Underground Storage Tank (LUST) Sites: Four (4) LUST sites are located within the 0.5 mile search radius. The nearest LUST site, INDOT Cloverdale Subdistrict, (10 High Street Cloverdale, IN 46120, AI# 59861), is located approximately 0.05 mile east of the southernmost portion of the project area. According to the UST Closure Report dated May 18, 1998, three (3) underground storage tanks (USTs), and 75 cubic yards of soil, were removed from the site. Soil samples collected from the excavation after the tanks, and impacted soils, were removed failed to detect any

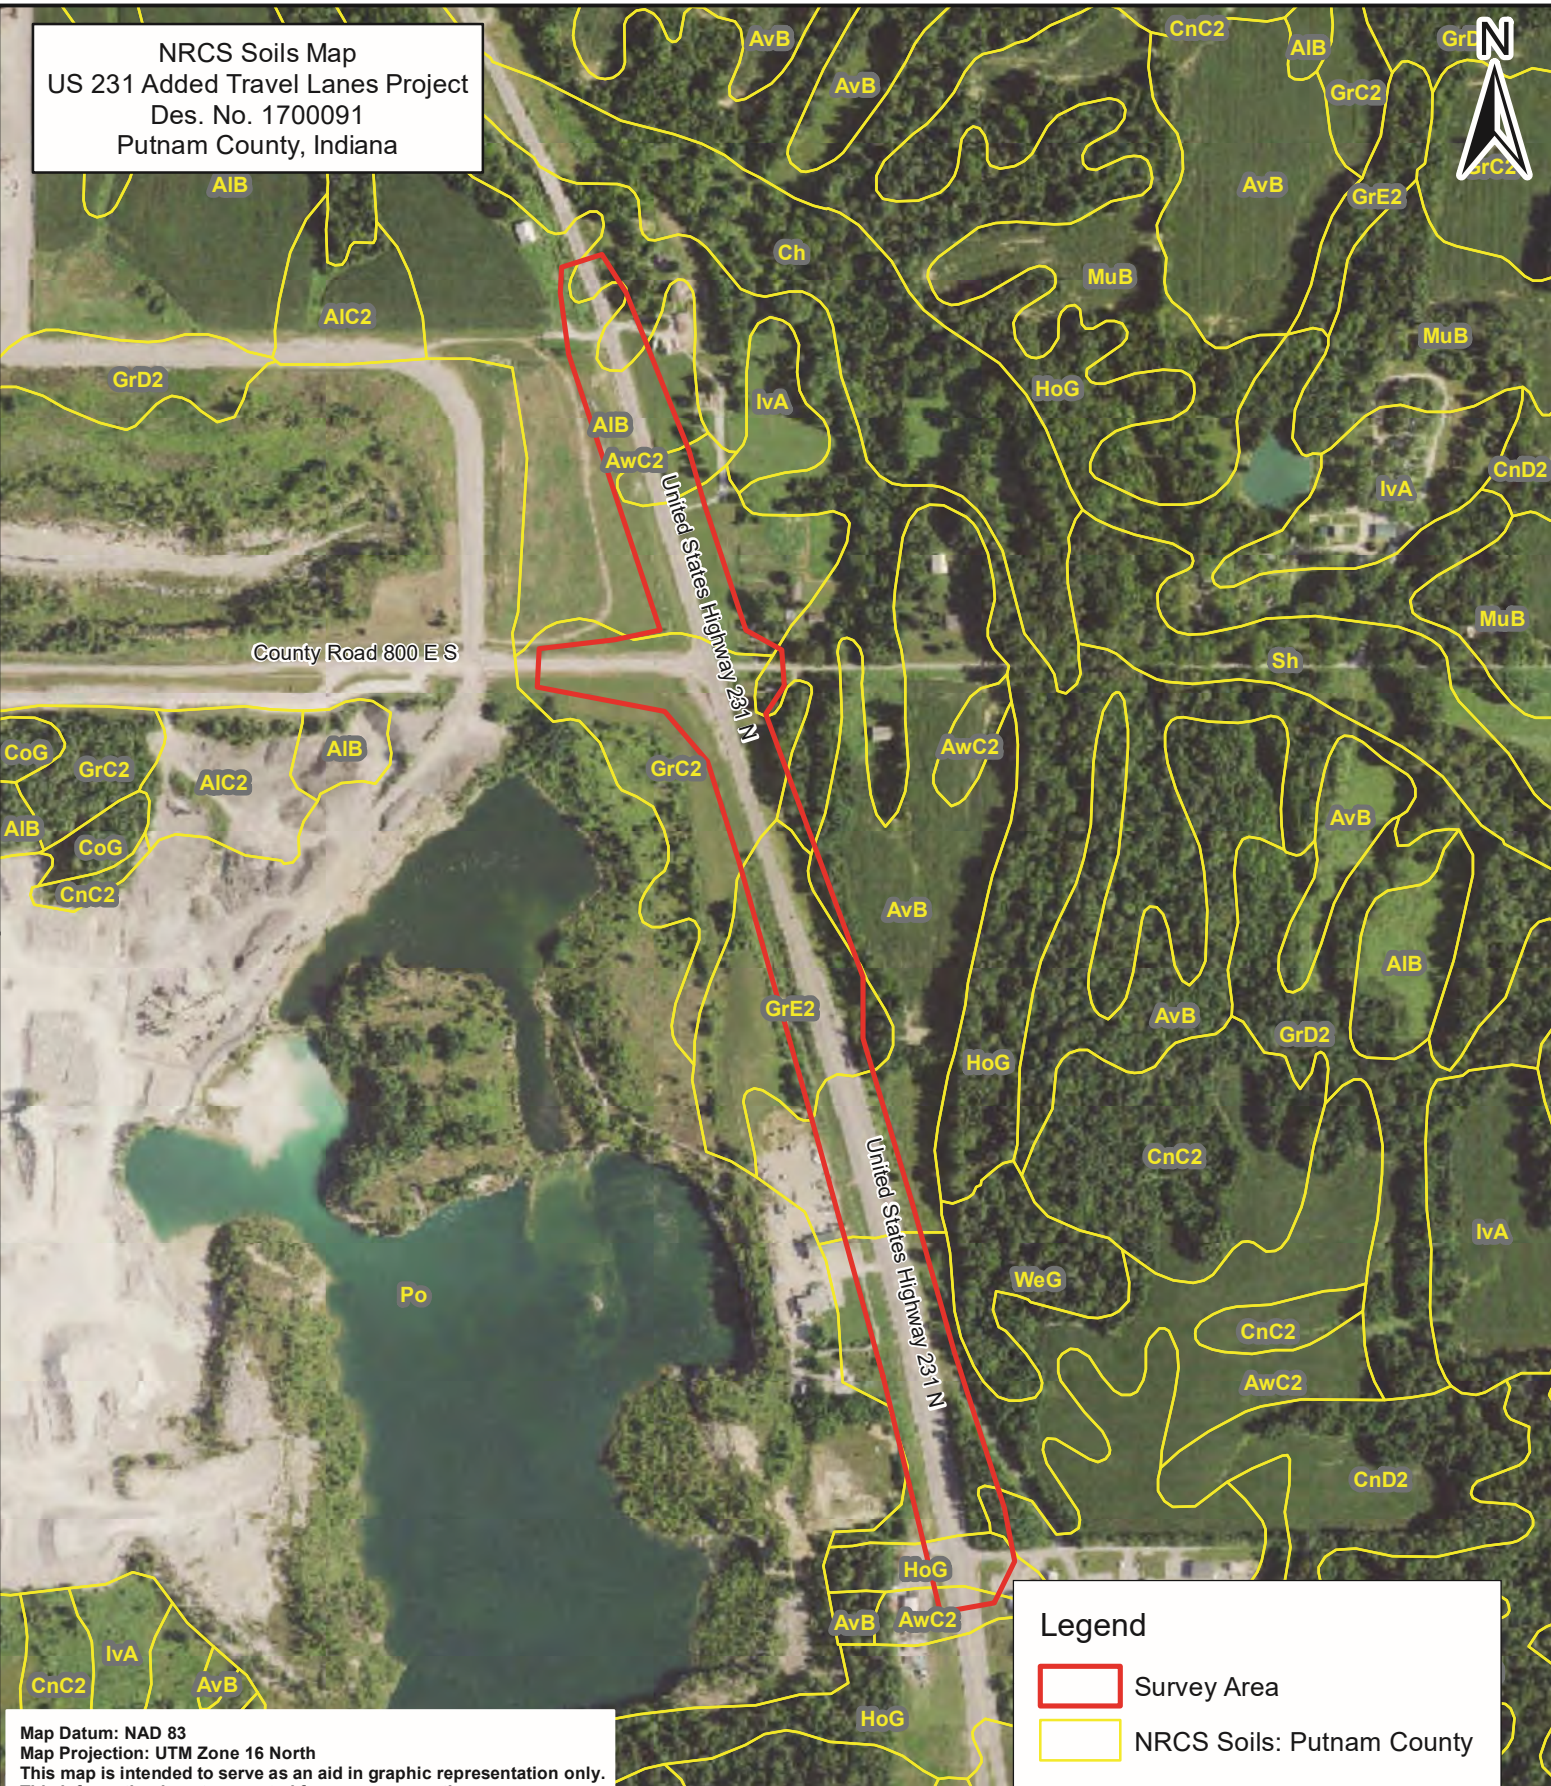
NRCS Soils Map
 US 231 Added Travel Lanes Project
 Des. No. 1700091
 Putnam County, Indiana

Soil Survey Area: Putnam County, Indiana
 Survey Area Data: Version 21, Sep 16, 2019
