**Wetland Delineation and Waters of the US Report**  
**SR 3 and SR 46 North Junction**  
**Washington Township, Decatur County, Indiana**  
**Des. No. 1700050**

**Report Completed: March 31, 2020**

SR 46 and SR 3 Intersection Improvement  
Decatur County, Indiana

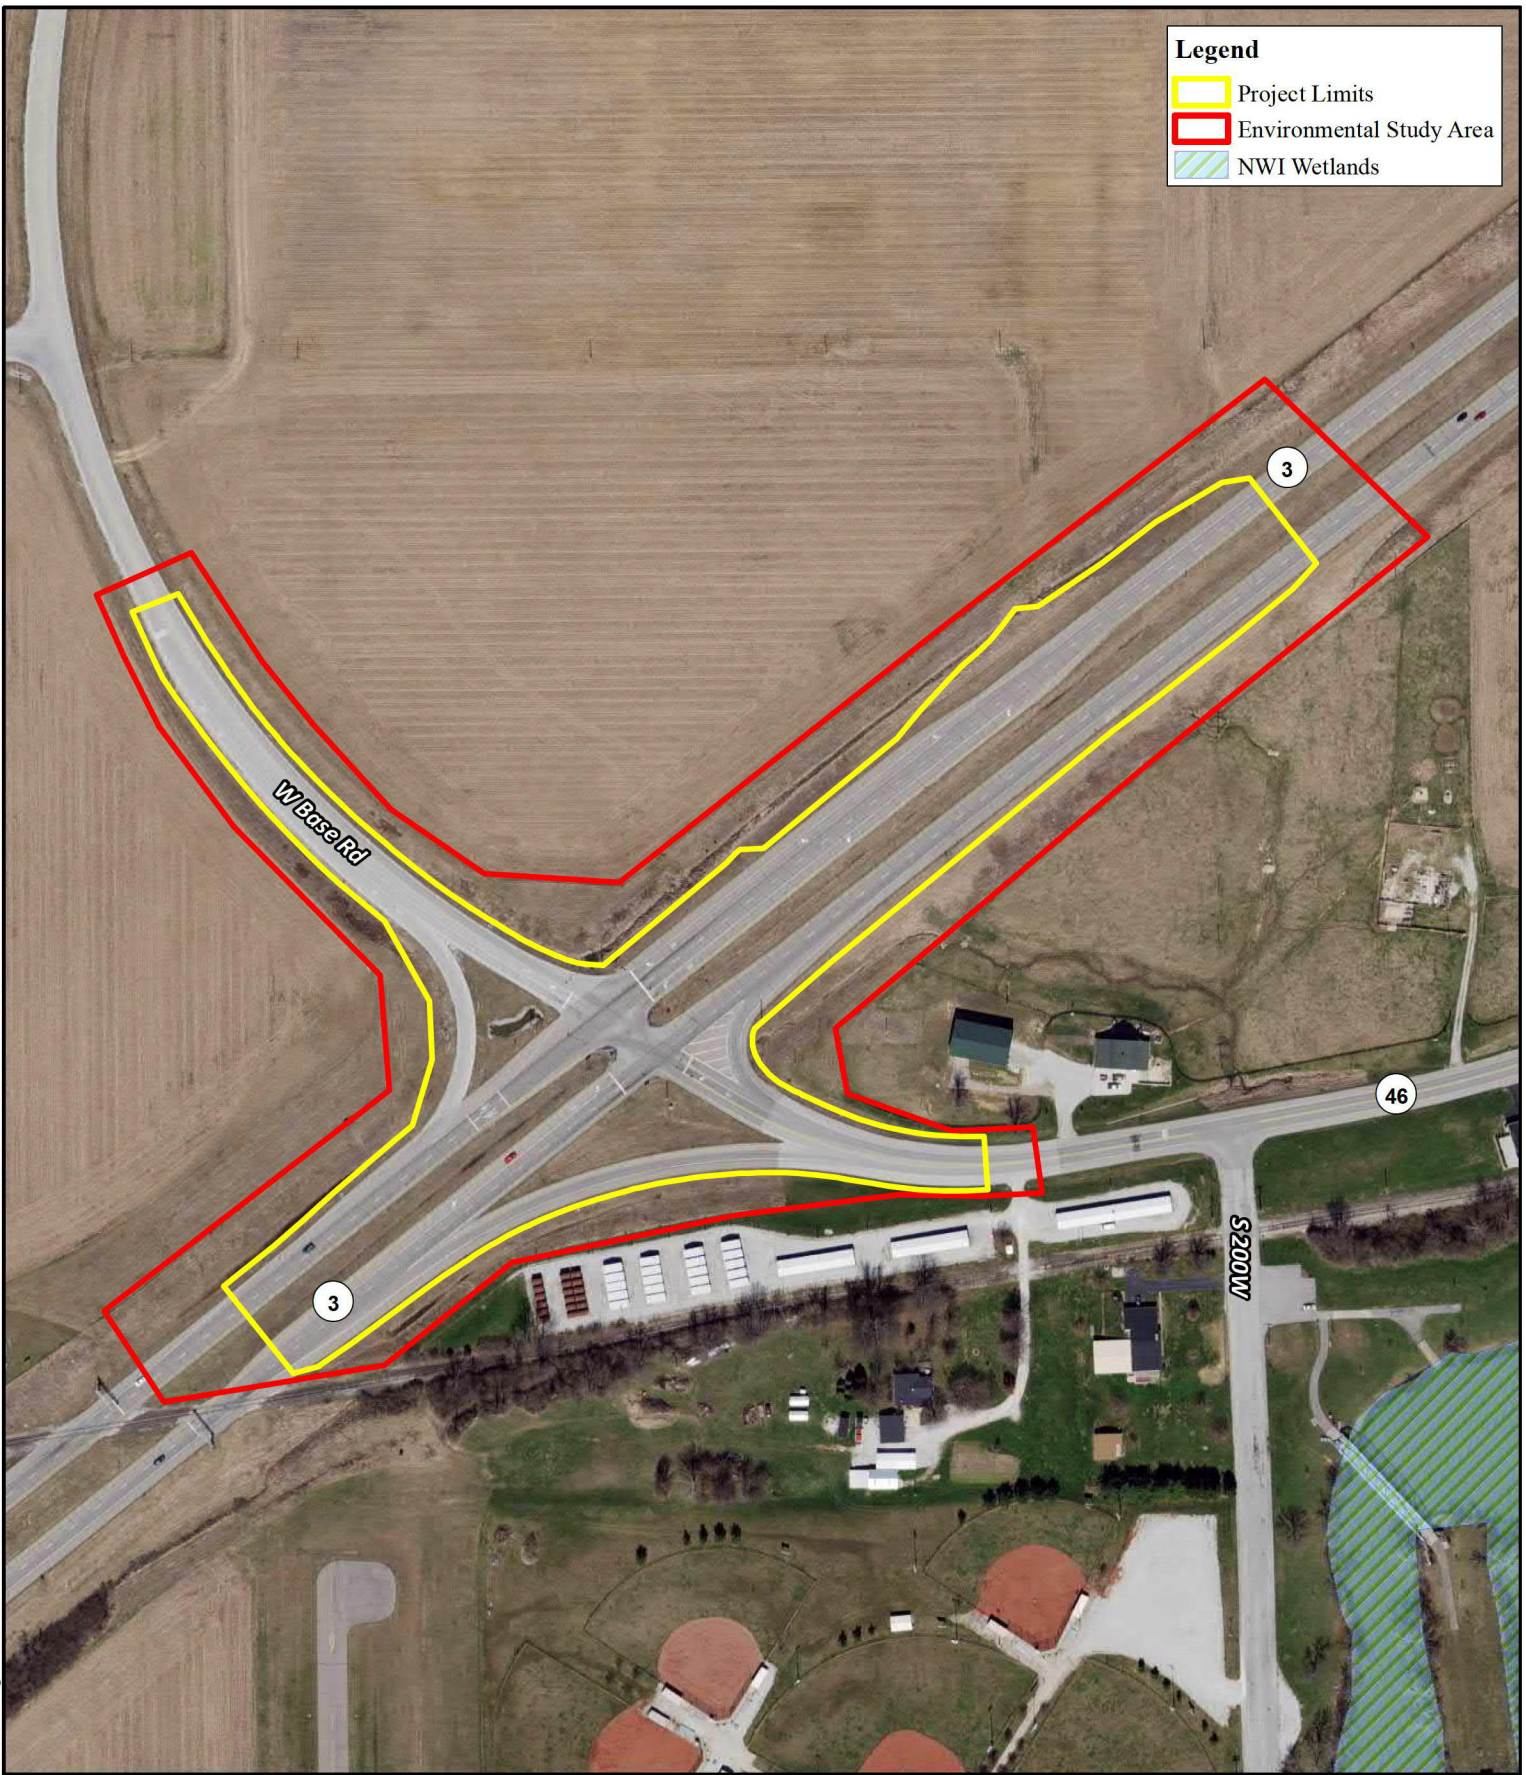
## NWI Wetlands Map

The U.S. Fish and Wildlife Service (USFWS) NWI maps identify potential wetlands based on high-level imagery interpretation. The wetlands are then classified by type utilizing the Cowardin classification system. The classification system provides information on wetland vegetation type, water regime, and any relevant alterations. This level of mapping does not determine regulatory boundaries. The NWI map was evaluated for the presence of potential jurisdictional wetlands within the project area (Attachment A, NWI Wetlands Map). No NWI wetlands are mapped within the study area. The nearest NWI is mapped 0.11-mile southeast of the project area, identified as a PUBGh, freshwater pond, palustrine, unconsolidated bottom, intermittently exposed, dike/impounded.

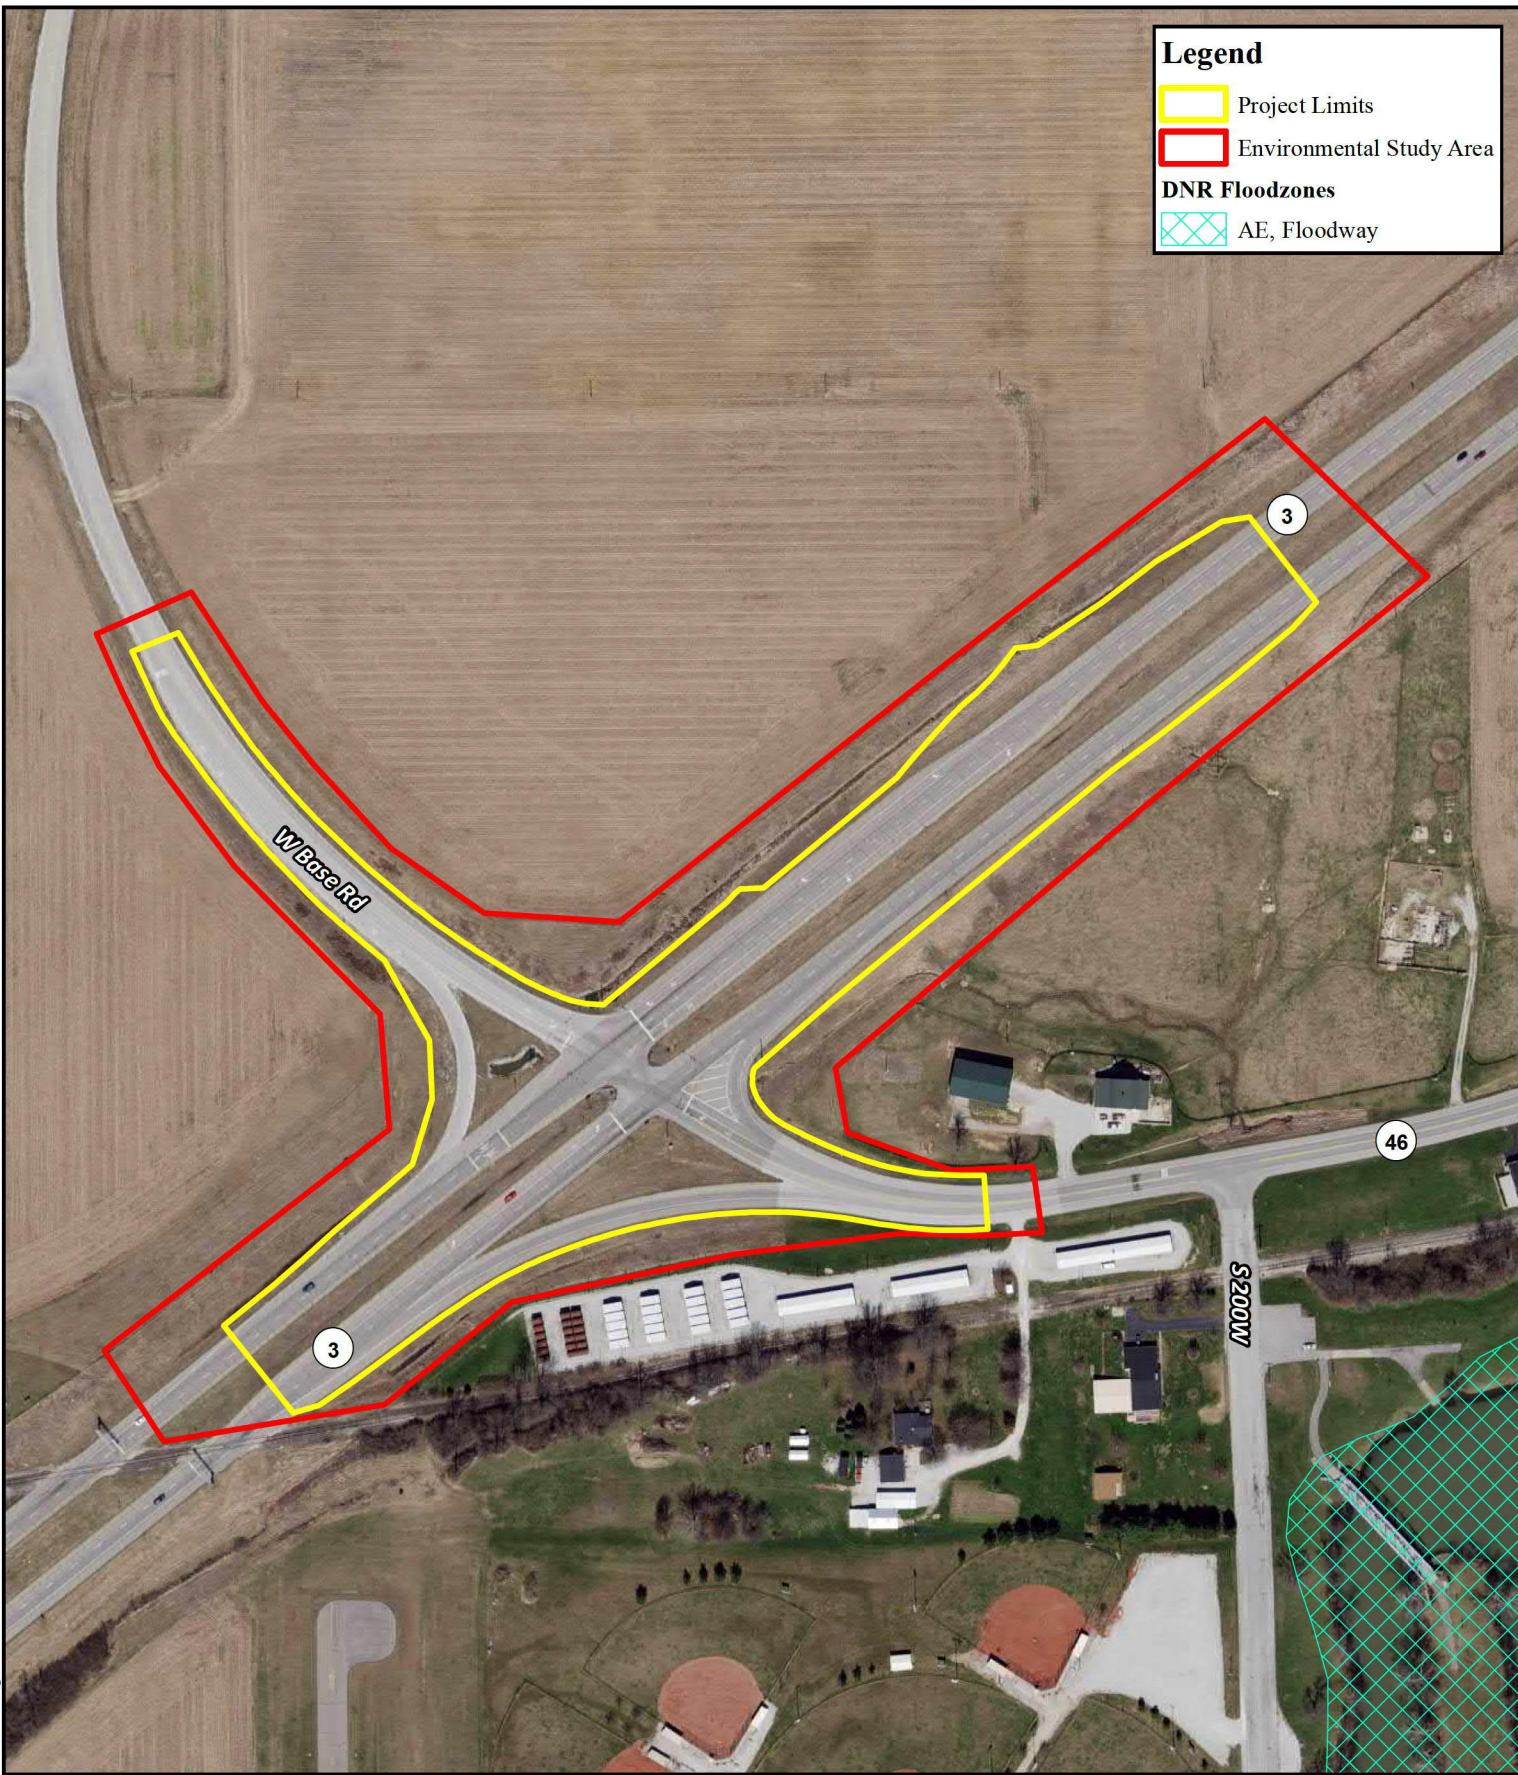
**IDNR Floodzones Map**

The Indiana Department of Natural Resources (IDNR) Best Available Floodzone Mapping was reviewed for the presence of the Special Flood Hazard Areas. The project is not located within any designated floodplains.

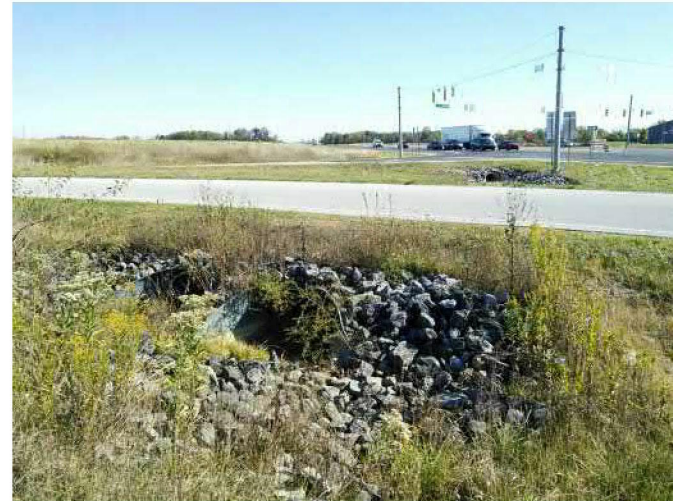
PP-6: Looking northeast at the culverts under the SR 46 junction to SR 3 on the northwest side of the project area (2019-10-14)

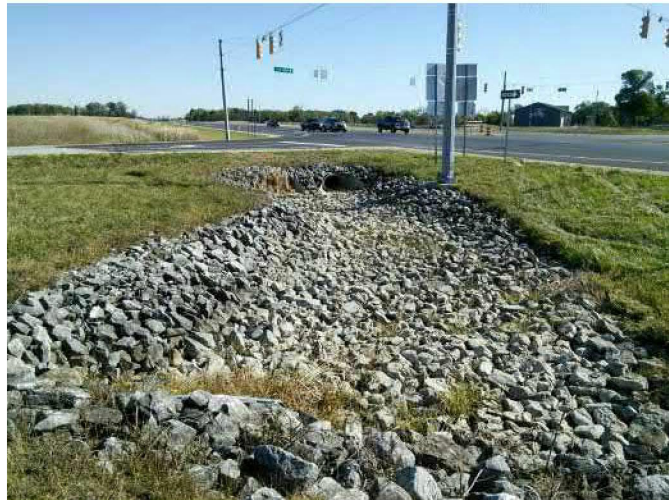
PP-7: Looking northeast at the riprap and culverts on the northwest side of the project area (2019-10-14)

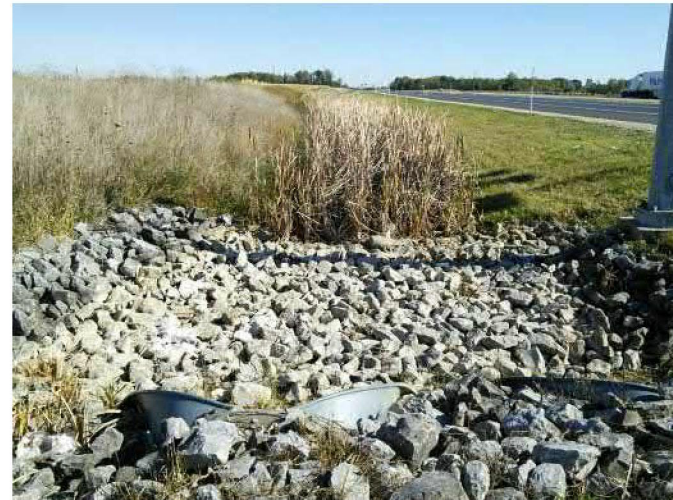
PP-8: Looking northeast at the culverts and riprap at the west side of the Wetland A (2019-10-14)

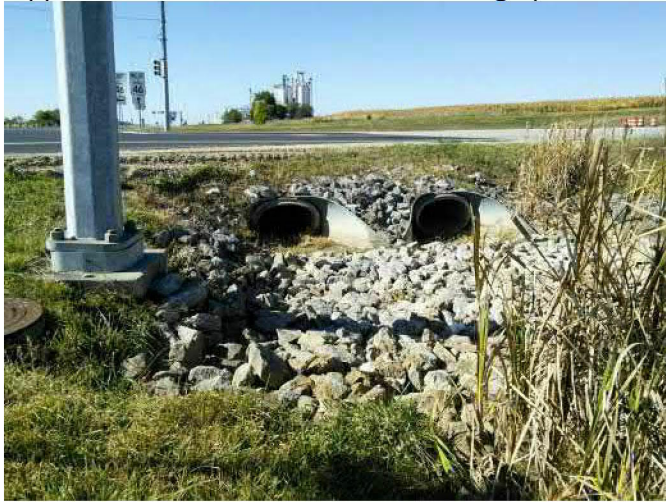
PP-8: Looking southwest at the culverts and riprap at the south end of Wetland A (2019-10-14)

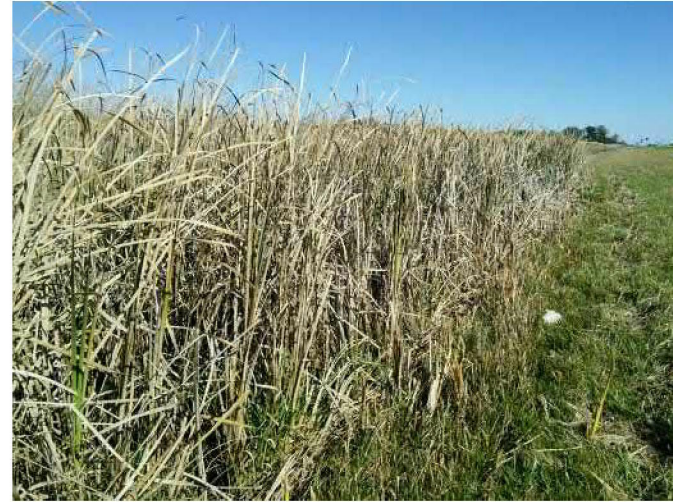
*Data Point 1* was located within Wetland A. The dominant species at this data point was *Typha X glauca* (hybrid cattail, OBL). This data point passed the Rapid Test for Hydrophytic Vegetation, Dominance Test, and Prevalence Index, therefore; meeting the hydrophytic vegetation criterion. The soil profile, from 0 to 3 inches, was silty clay loam that had a color of 10YR 4/1 (90%) with 7.5YR 4/6 (10%) redox concentrations in the matrix. From 3-18 inches, the soil profile was a silty clay loam that had a color of 10YR 5/1 (75%) with 10YR 6/8 (25%) redox concentrations in the matrix. The hydric soil indicator Depleted Matrix (F3) was observed at this data point, indicating that hydric soils are present. Geomorphic position (D2) and FAC-Neutral Test (D5) were the observed secondary hydrology indicators, signifying that wetland hydrology was present. As all three required criteria were considered met, DP-1 was located within a wetland.

PP-9: Looking northeast from DP-1 along Wetland A (2019-10-14)

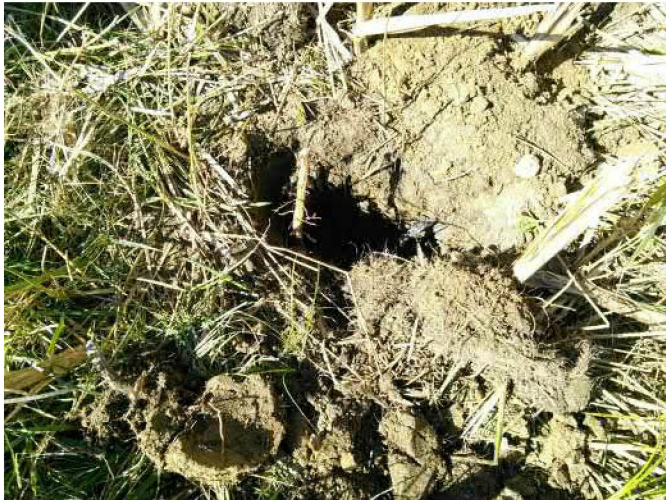
PP-9: Looking down at the soil profile for DP-1 in Wetland A (2019-10-14)

Depth (inches)	Matrix			Redox Features					Texture	Remarks
	Color (moist)		%	Color (moist)	%	Type <sup>1</sup>	Loc <sup>2</sup>			
0-3	10YR	4/1	90	7.5YR	4/6	10	C	M	Silty Clay Loam	
3-18	10YR	5/1	75	10YR	6/8	25	C	M	Silty Clay Loam

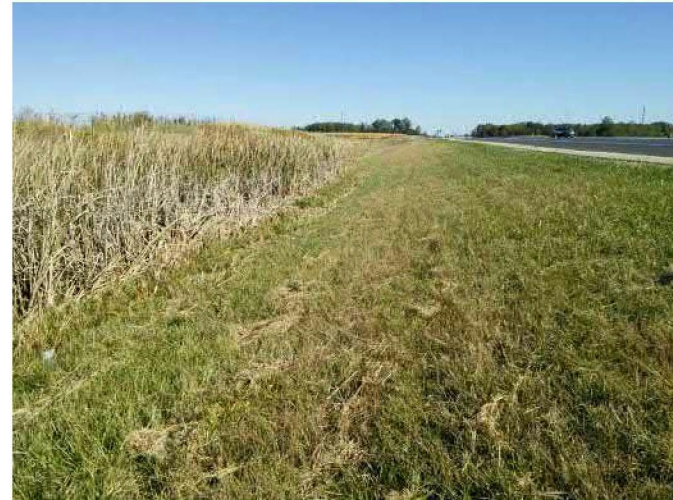
*Data Point 2* was located in an upland area adjacent to Wetland A. The dominant species at this data point was *Festuca arundinacea* (tall fescue, FACU). Data point 2 did not meet the hydrophytic vegetation criterion, due to no hydrophytic vegetation being present. The soil sample, from 0-5 inches, was silty clay loam that had a color of 10YR 4/3 (100%). From 5-18 inches, the soil profile was a silty clay loam that had a color of 10YR (5/3) (100%). There were no hydric soil indicators observed for data point 2, therefore no hydric soil was present. No hydrology indicators were noted, consequently there was no wetland hydrology at this data point. As the required criteria were not met, data point 2 is not located within a wetland.

PP-10: Looking at the upland area northeast adjacent to Wetland A from DP-2 (2019-10-14)

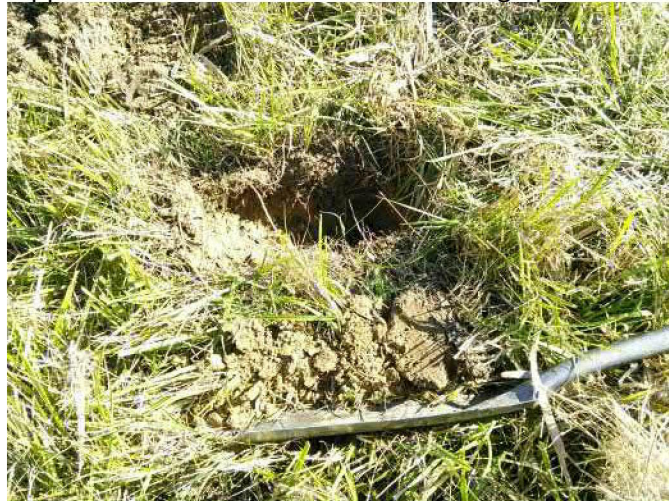
PP-10: Looking down at the upland soil profile of DP-2 adjacent to Wetland A (2019-10-14)

Depth (inches)	Matrix		Redox Features				Texture	Remarks
	Color (moist)	%	Color (moist)	%	Type <sup>1</sup>	Loc <sup>2</sup>		
0-5	10YR	4/3	100				Silty Clay Loam	
5-18	10YR	5/3	100				Silty Clay Loam

Remarks:  
 No hydric soils indicators were observed

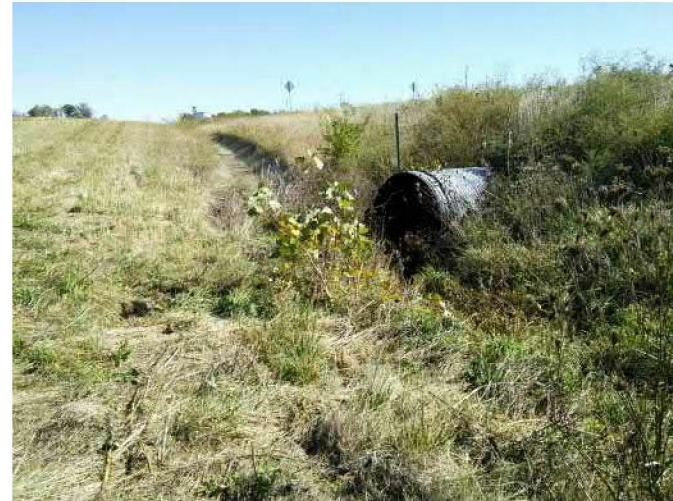
PP-11: Looking west at the culvert located east of Wetland A (2019-10-14)

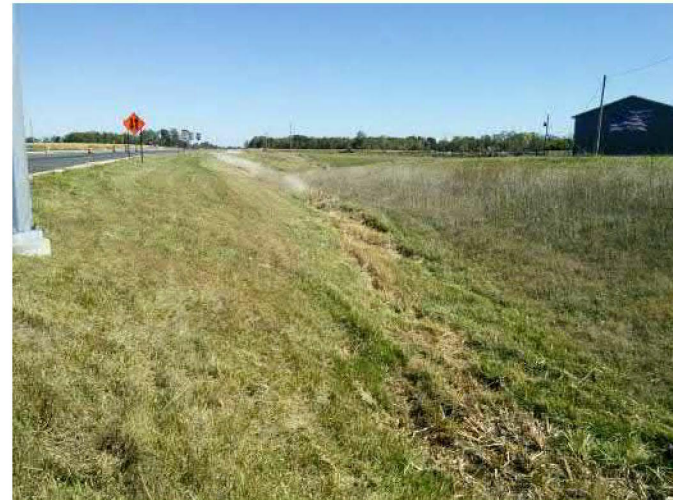
UNT 1 is an ephemeral stream located adjacent to SR 3 on the southeast side of the highway with an ordinary high-water mark (OHWM), exhibiting bed and bank at approximately 1 foot wide and 0.25 feet deep, with a drainage area of 0.04 square miles. UNT 1 starts east of the SR 46 junction to SR 3, flows northeast parallel with SR 3, and then heads southeast out of the project area. UNT 1 appears to be connected through an impounded pond to the southeast of the project area that outlets to Muddy Fork Sand Creek, a Relatively Permanent Water (RPW) and Waters of the U.S. Substrate consisted of silt. UNT 1 possesses a narrow riparian corridor, and no excess erosion along the bank. The stream is considered to be in poor condition due to surrounding agricultural land use, narrow riparian buffer, and little aquatic habitat. UNT 1 would likely be considered a Waters of the US.

PP-13: Looking northeast at UNT 1 along SR 3 downstream (2019-10-14)
