Categorical Exclusion
Appendix F
Water Resources

SR 66 INTERSECTION IMPROVEMENT AT EPWORTH ROAD VANDERBURGH & WARRICK COUNTY, IN

*December 29, 2021
Waters of the U.S. Report
Prepared by: Peter Putzier*

**Des. No.: 1400195
Contract No.: R-39921**

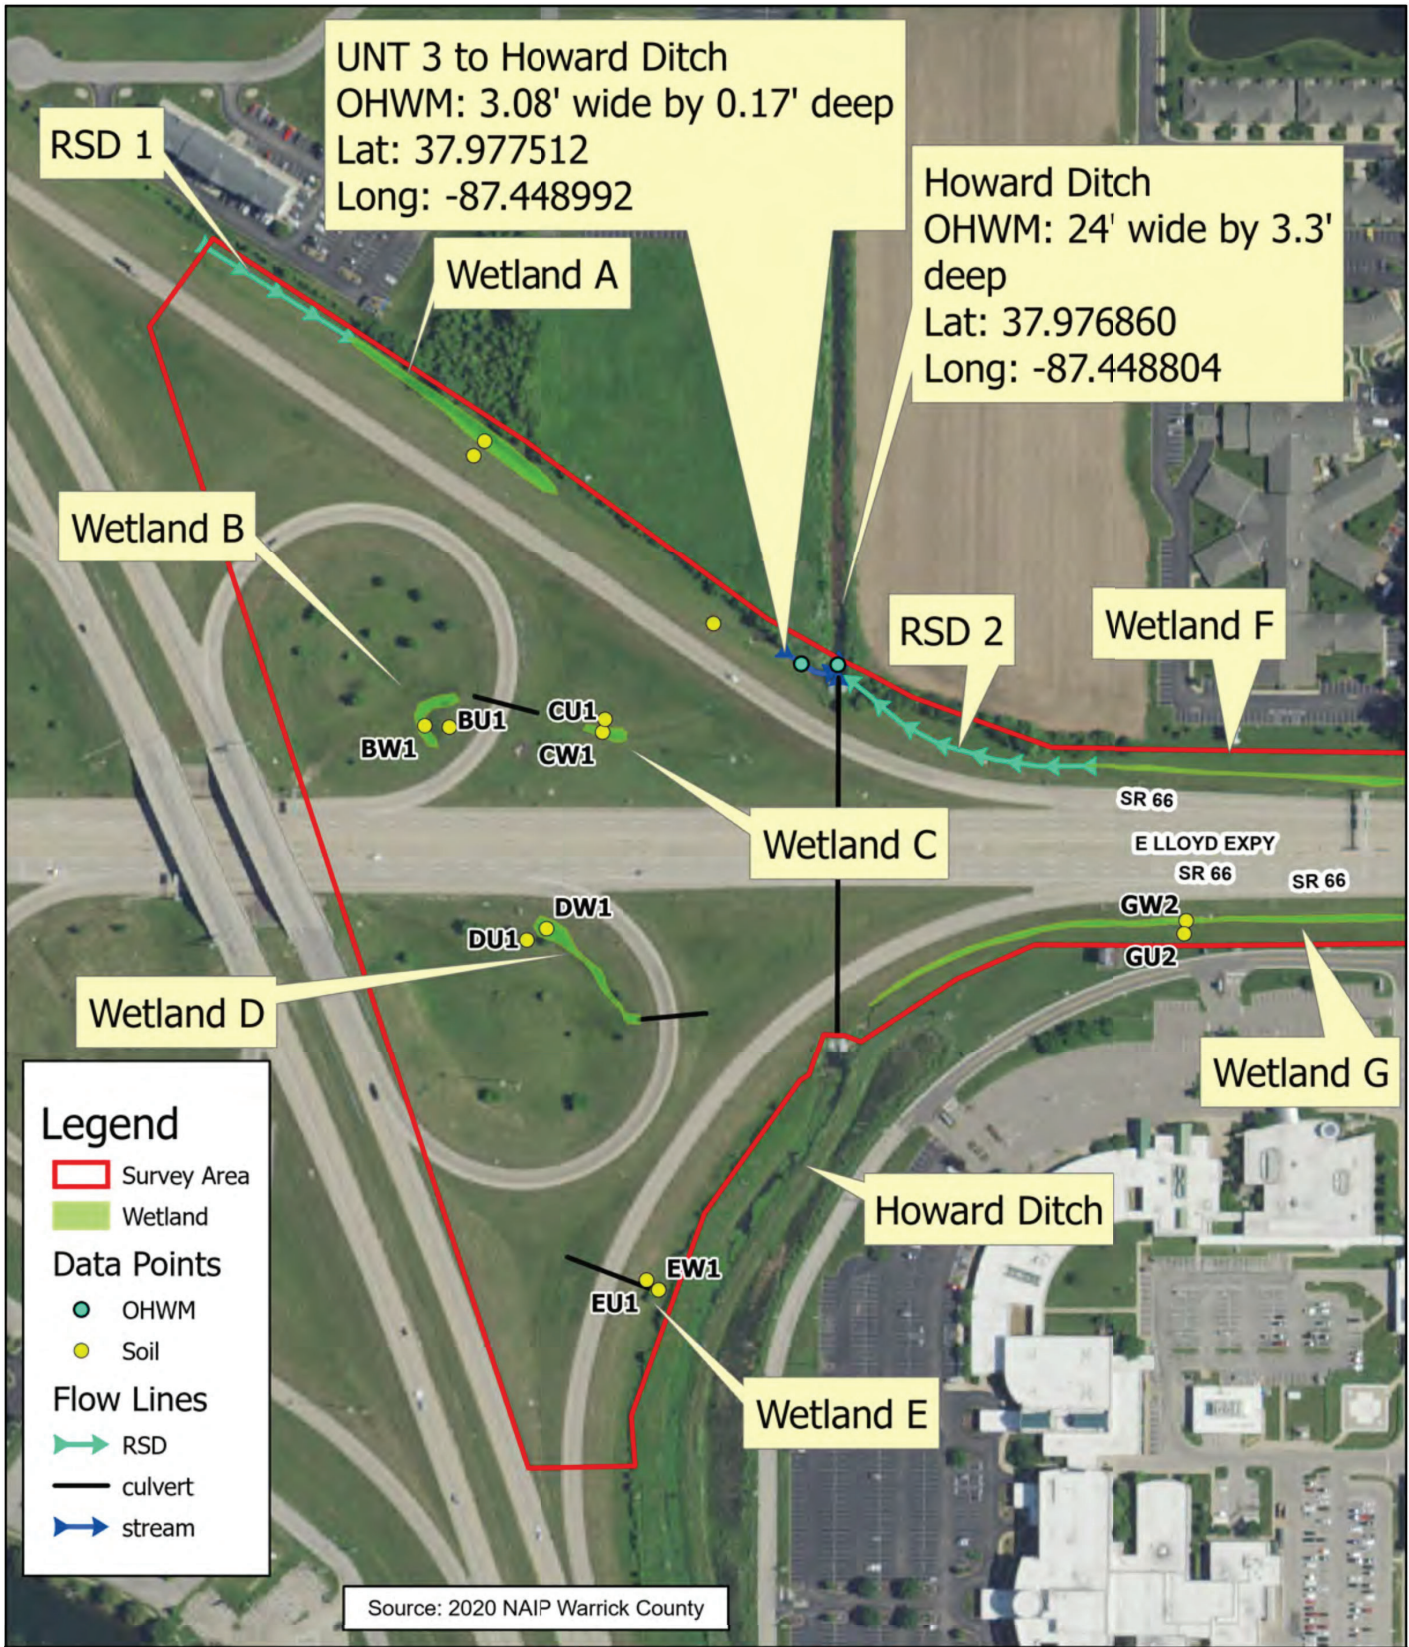
Best Available Flood Hazard Map
 Des. No. 1400195
 Waters of the U.S. Report

SR 66 Intersection Improvement at Epworth Road
 Created: 12/29/2021, P.Putzier

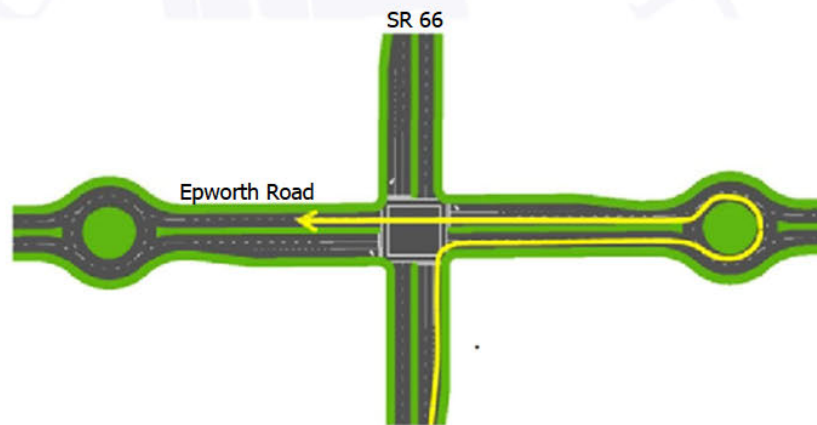
- No Build – did not reduce crashes
- Hybrid Boulevard Left / Displaced Left Turn Intersection
 - 24% Overall Crash Reduction
 - 29 second Delay Reduction
- Bowtie Intersection
 - 36% Overall Crash Reduction
 - 9.5 second Delay Reduction
