Aerial photograph showing the wetlands, RSDs, sample points, and photograph locations for the US 41 and SR 352 Intersection Improvement Project (INDOT Des. No. 2100058) investigation area. (2 Sheets)

US 41 and SR 352 Intersection Improvement (INDOT Des. No. 2100058)

Grant Township, Benton County, Indiana

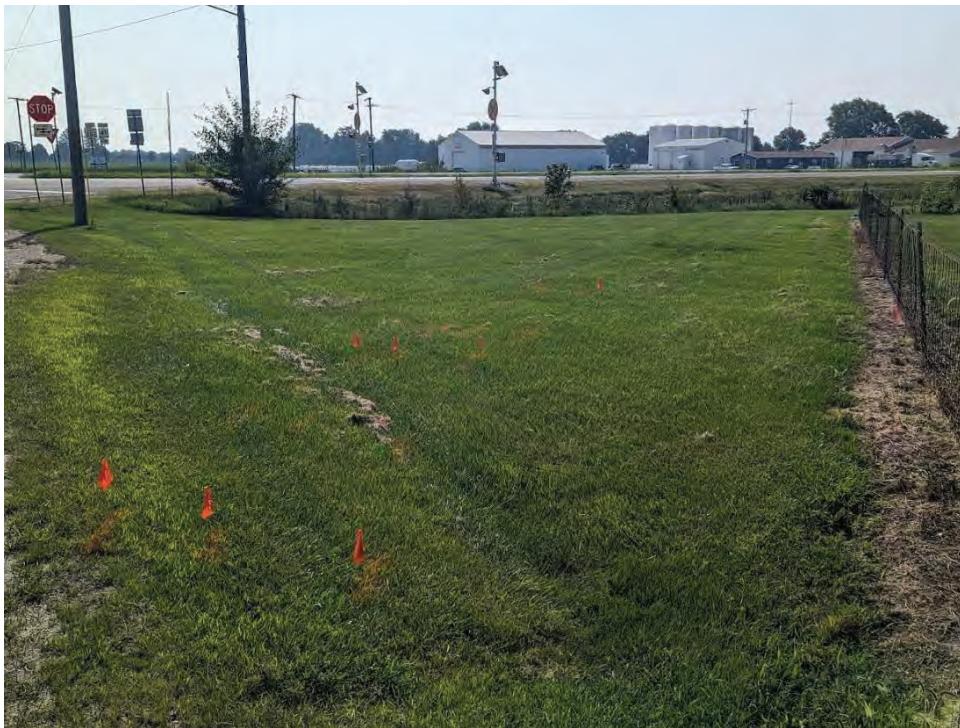
Photograph 1. The right-of-way (ROW) with the southwestern quadrant of the intersection between US 41 and SR 352 with Wetland B in the background, looking east.

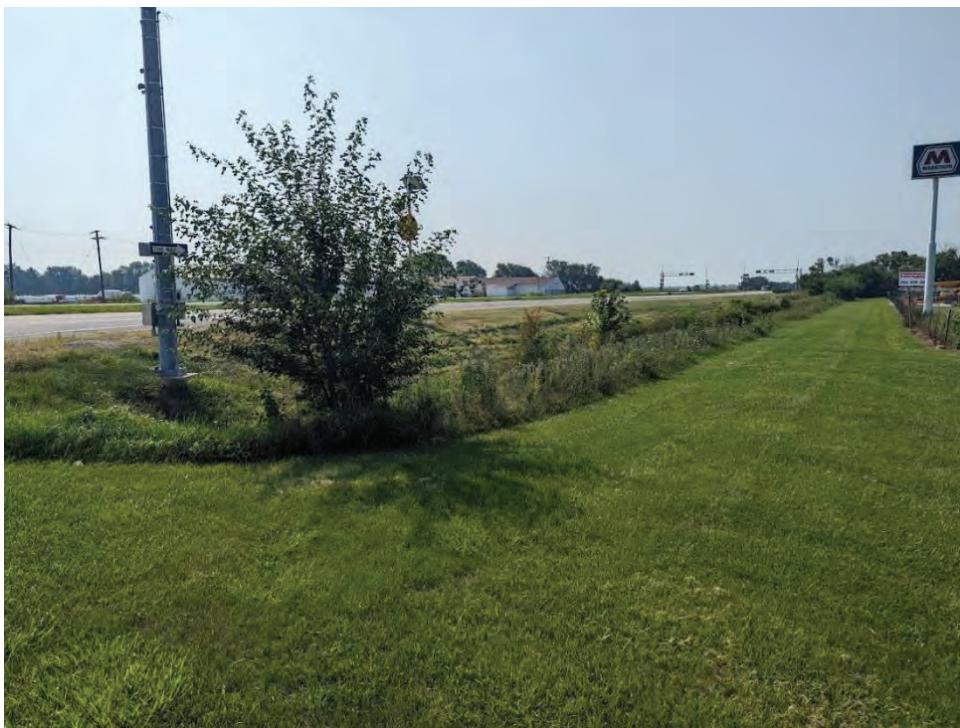
Photograph 2. View of the typical roadway swale and Wetland B, within the ROW adjacent to west of US 41, south of SR 352, looking southeast.

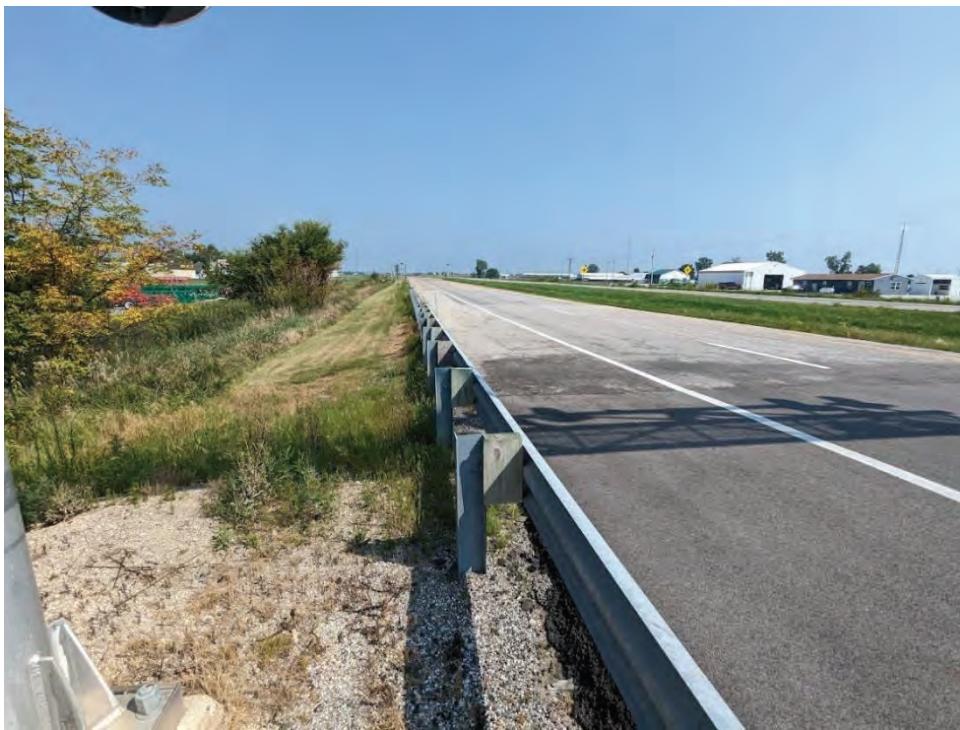
Photograph 3. View from the southern boundary of the investigation area, west of US 41, looking north.

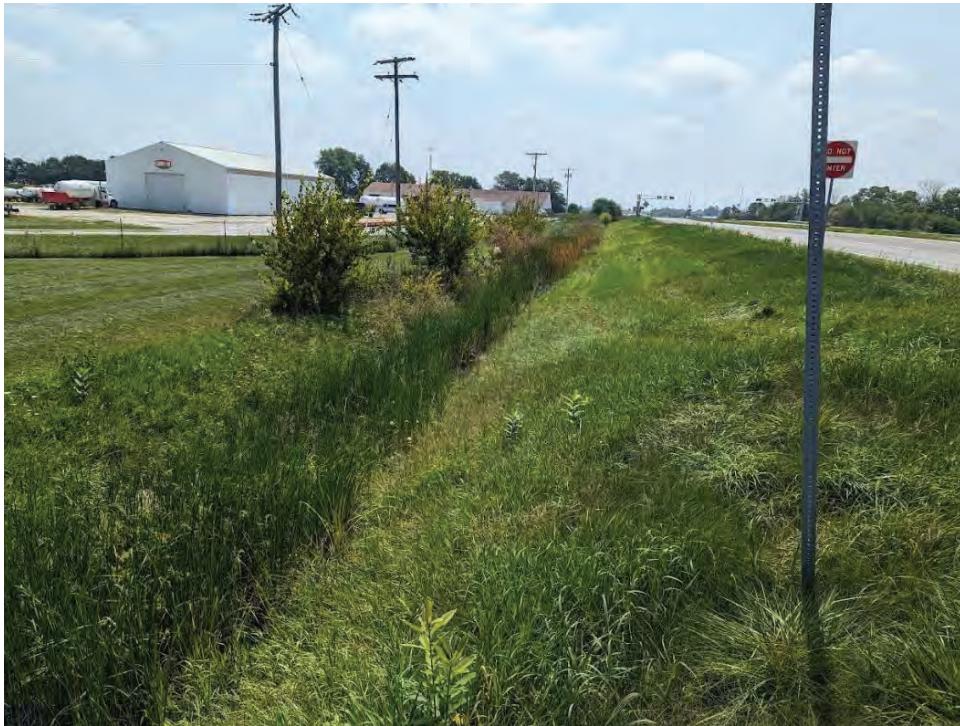
Photograph 5. View of the eastern US 41 roadway swale and Wetland D adjacent to US 41 and south of the SR 352 intersection, looking south.

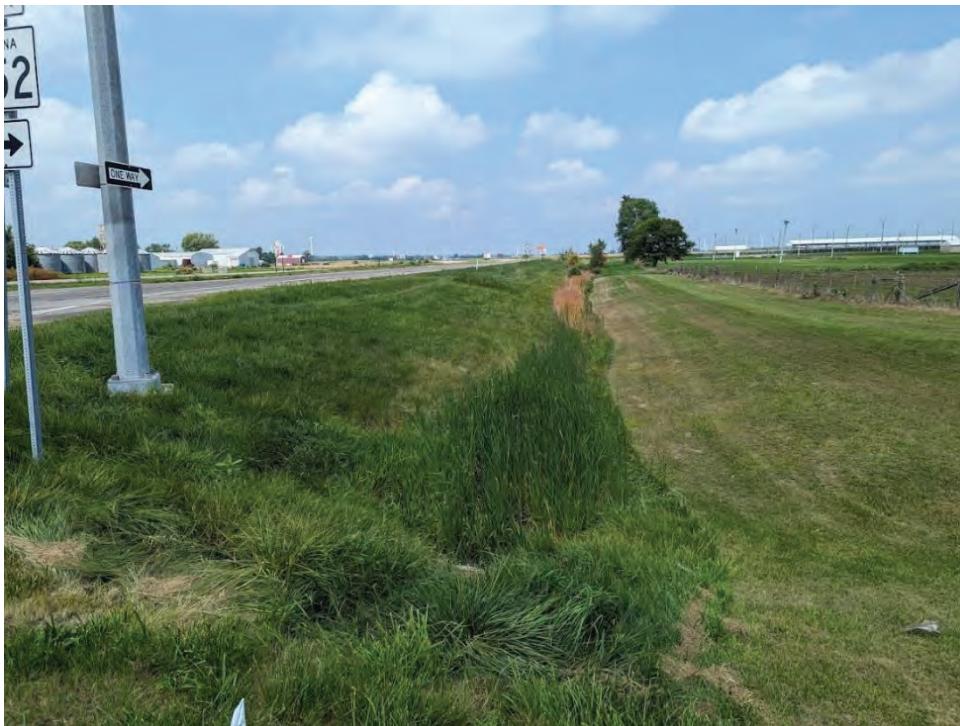
Photograph 6. View of the eastern roadway swale and Wetland C adjacent to US 41 and north of the SR 352 intersection, looking northwest.

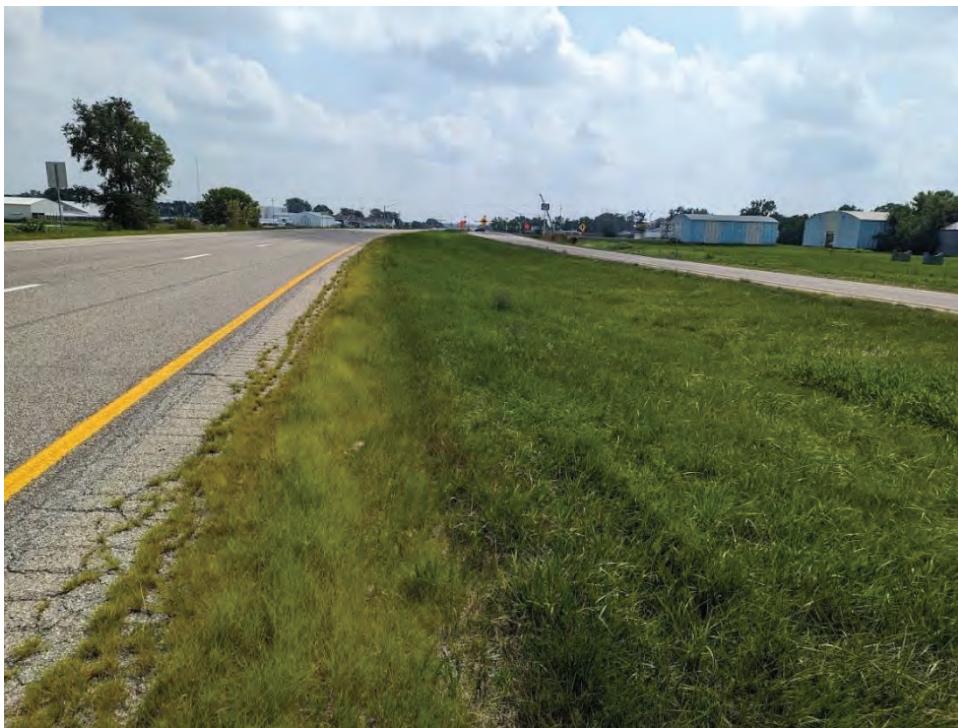
Photograph 7. View from the northern boundary of the investigation area within the US 41 roadway median and RSD3, looking south.

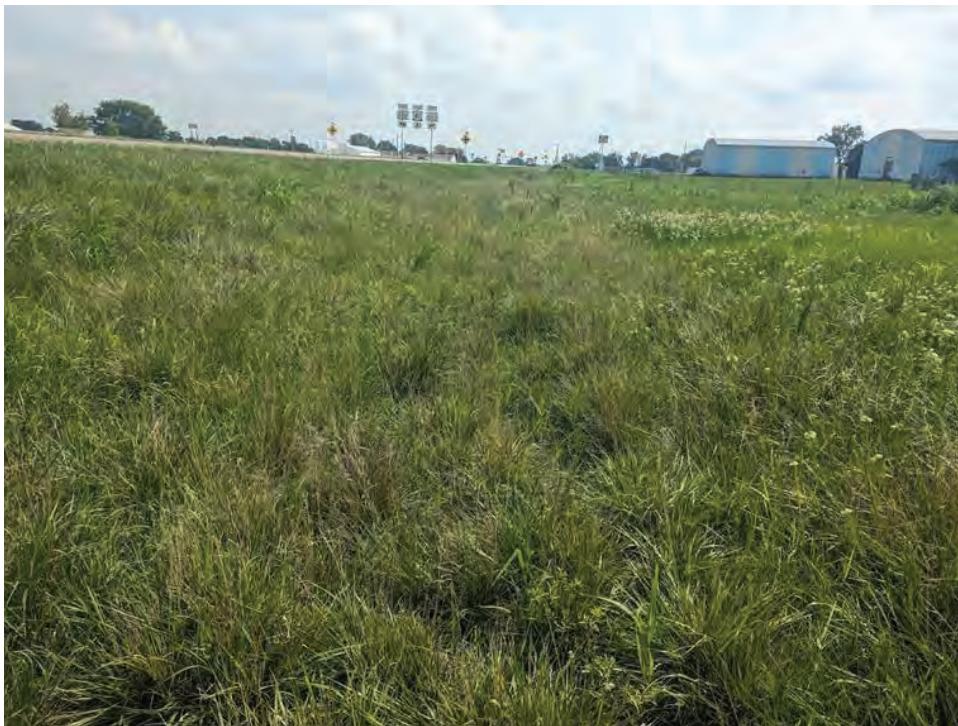
Photograph 8. View of the western roadway swale and RSD2 adjacent to US 41 near the northern investigation boundary, looking south.

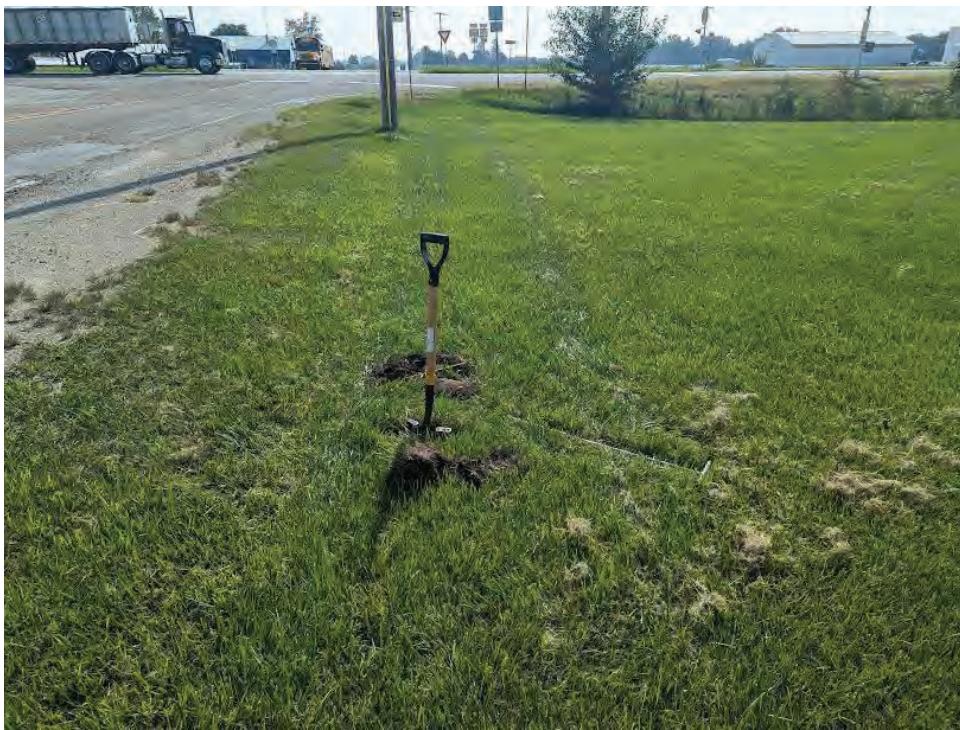
Photograph 9. View of upland SP1 which describes the top slope mowed and maintained lawns within the US 41 and SR 352 ROW, looking east.

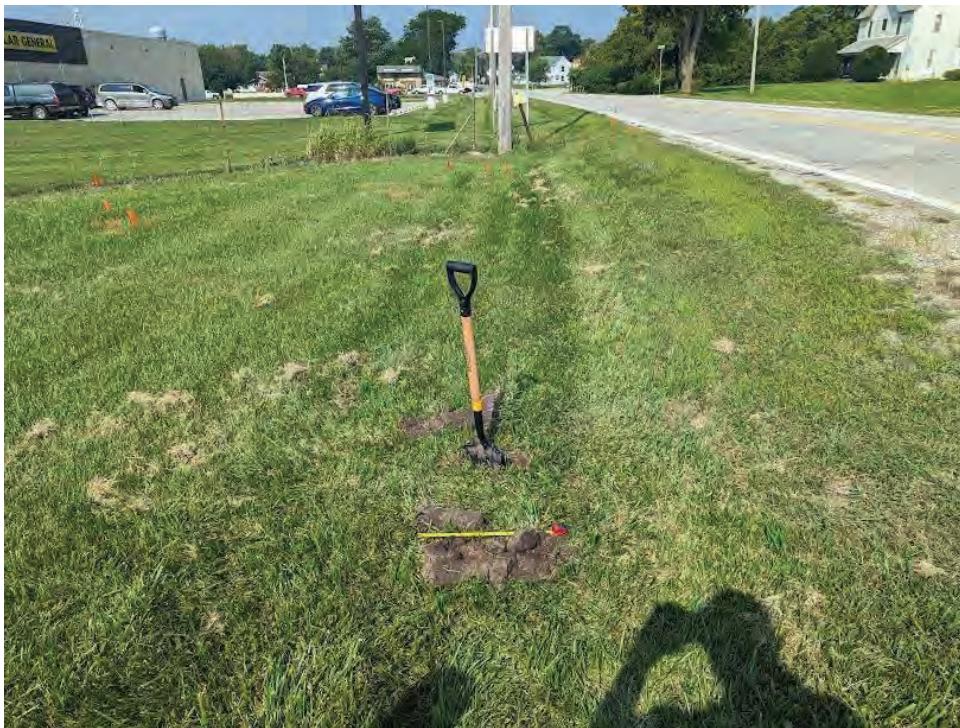
Photograph 11. View of SP1 where no evidence of wetland vegetation or hydrology were observed, looking west.

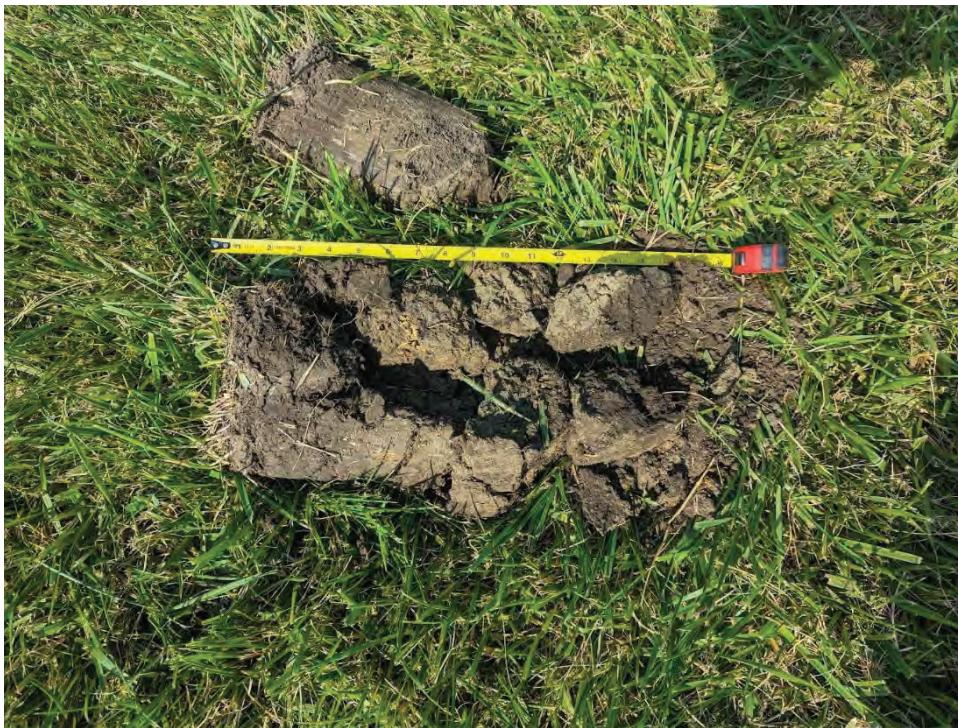
Photograph 13. View of upland SP1 soils.

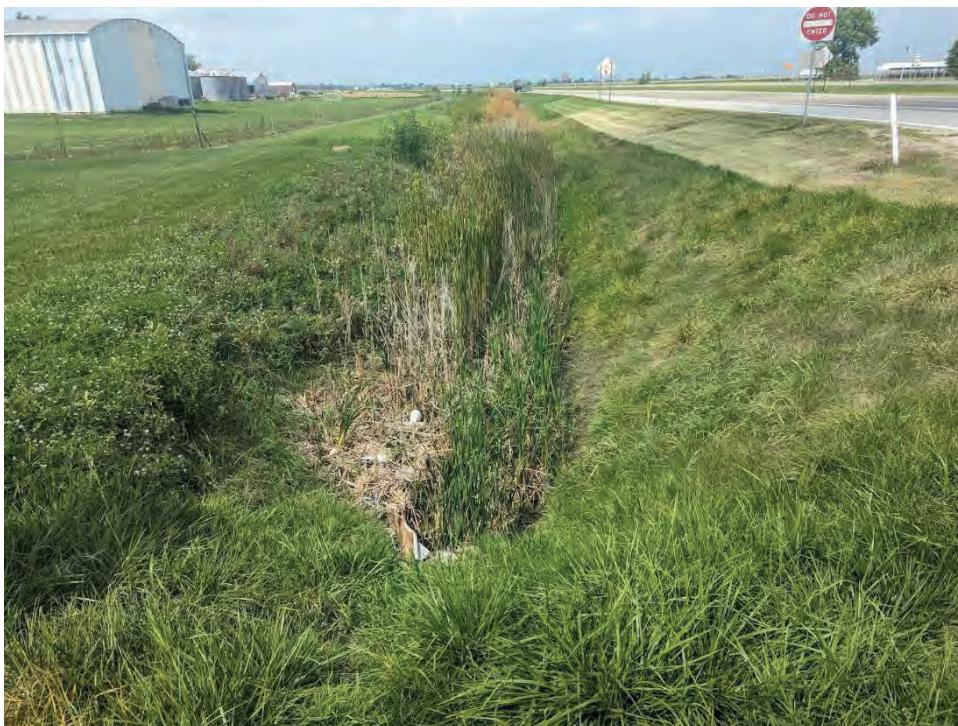
Photograph 14. View of Wetland A within the western roadway swale of US 41 from the culvert inlet at SR 352, looking north.

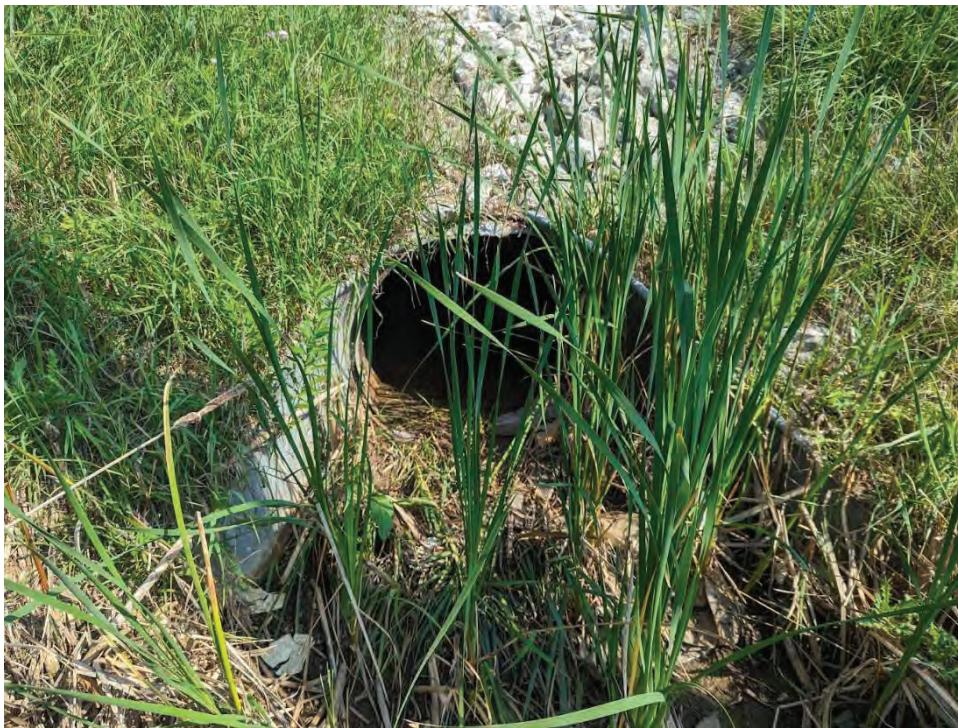
Photograph 15. View of Wetland A and the culvert inlet which flows south under SR 352 leading to Wetland B, looking southwest.

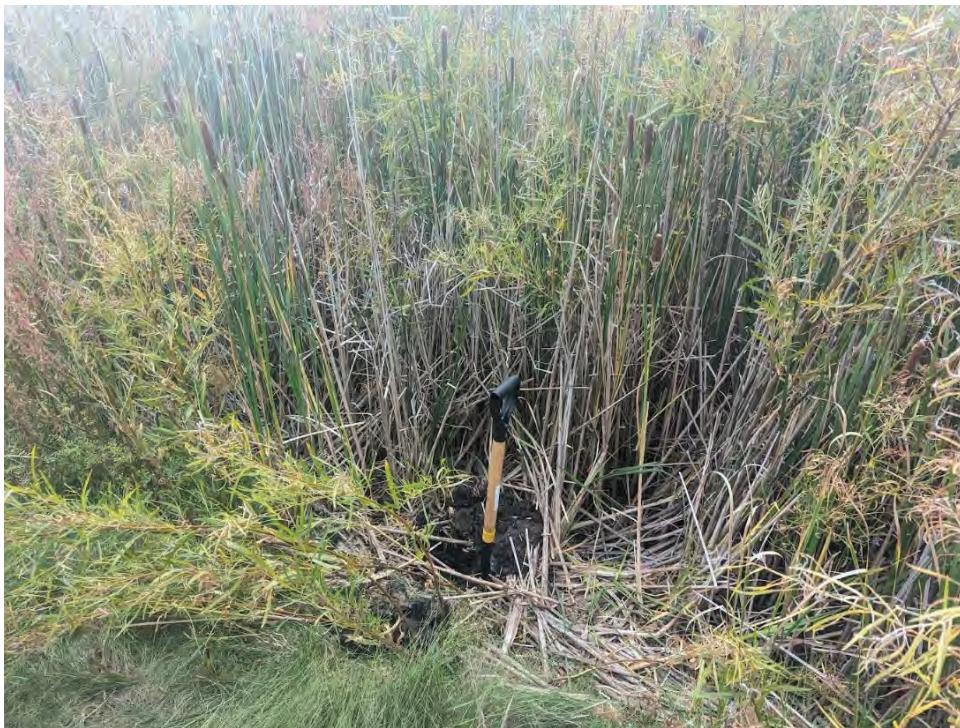
Photograph 17. View of SP2 (Wetland A) dominated by hydrophytic narrowleaf cattail (*Typha angustifolia*) and sandbar willow (*Salix interior*), looking west.

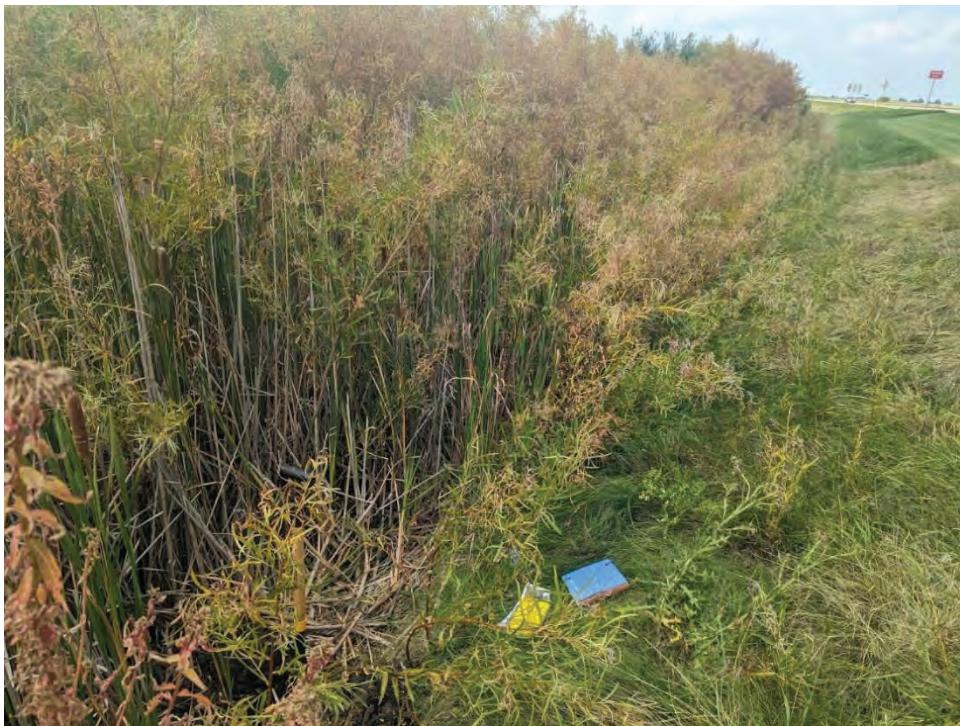
Photograph 18. View of SP2 (Wetland A) which is part of the US 41 roadway swale and conveys stormwater runoff to the south, looking north.

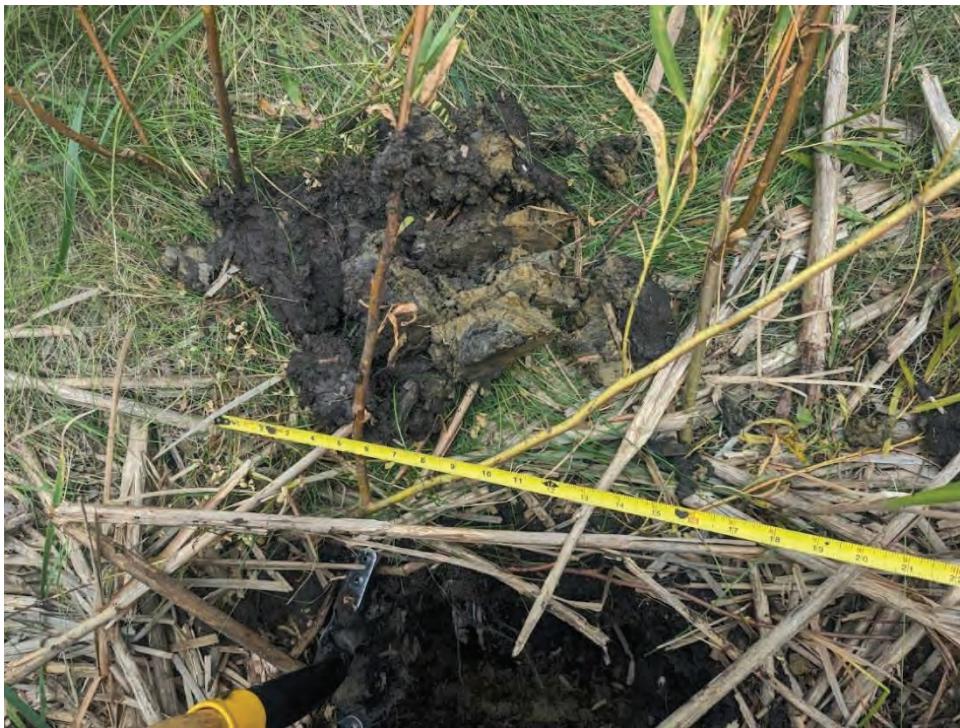
Photograph 19. View of the soil profile of SP2 (Wetland A) which met the Depleted Below Dark Surface (A11) and Depleted Matrix (F3) hydric soil indicators.

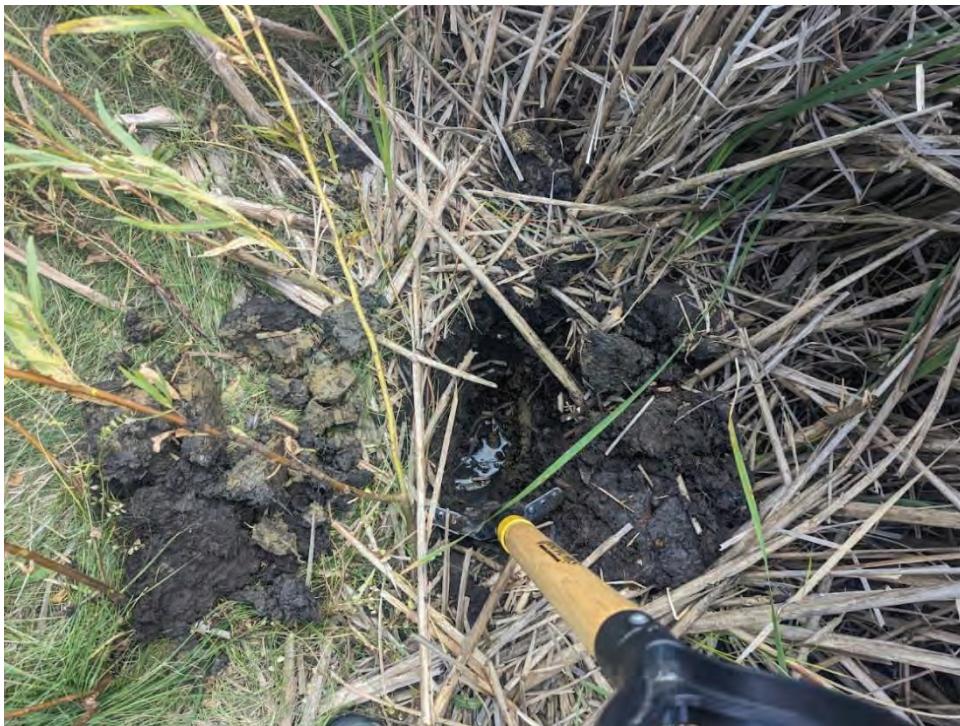
Photograph 20. Water was observed within the SP2 (Wetland A) soil pit indicating a Dry-Season Water Table (C2) wetland hydrology indicator.

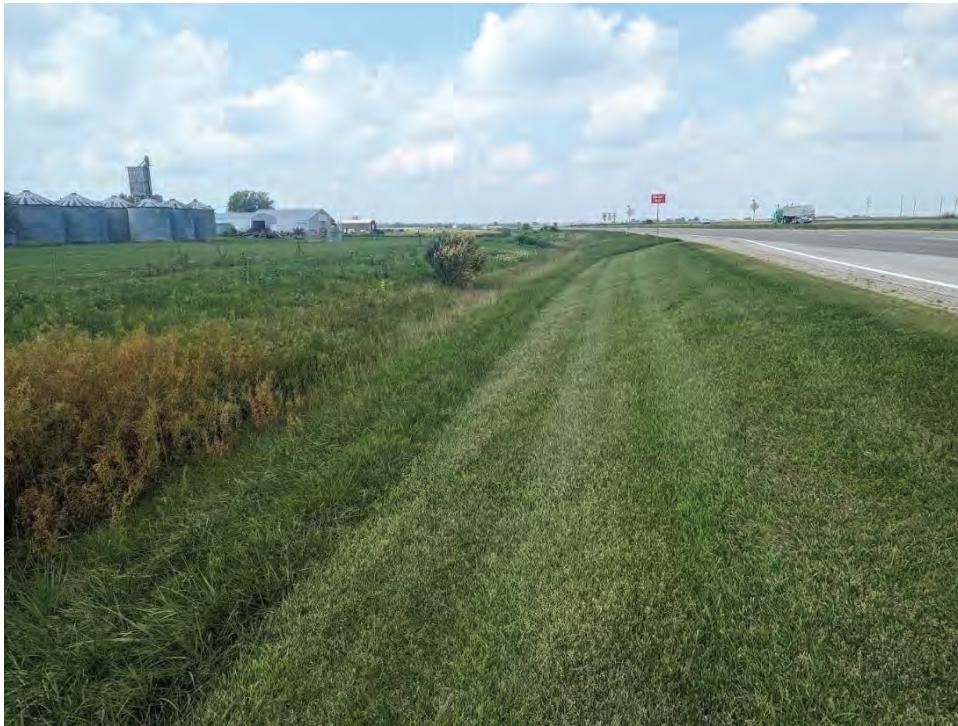
Photograph 21. View of the wetland-upland edge of Wetland A (TP1) and RSD2 (TP2) where an abrupt change in vegetation communities was observed, north of SP2 and west of US 41, looking north.

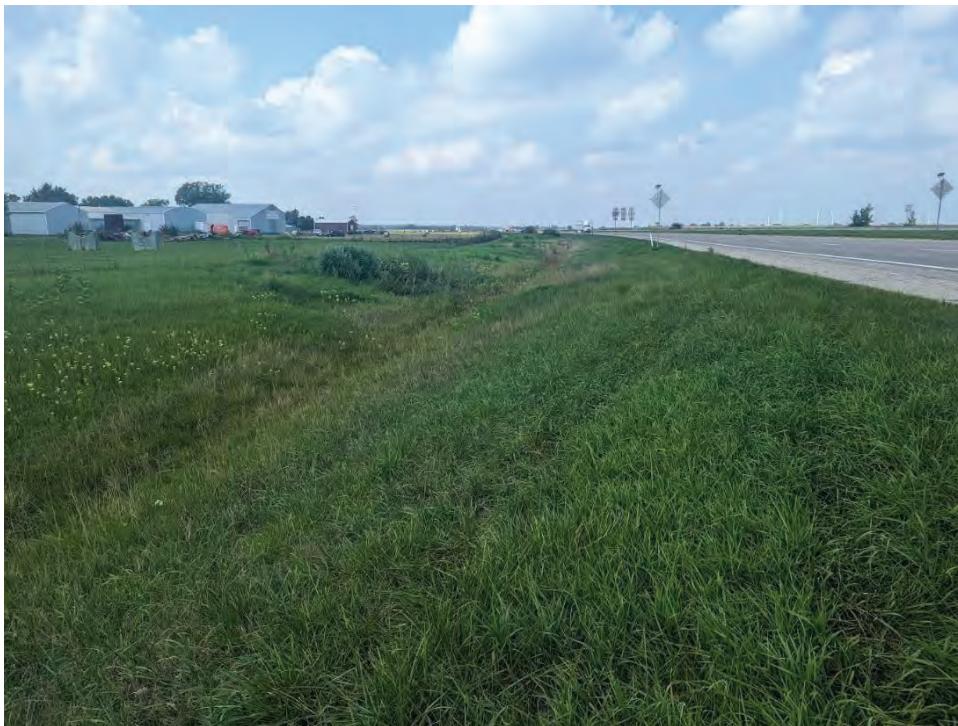
Photograph 22. Typical view of the western US 41 roadside swale documented in SP3 and recorded as RSD2, which provides hydrology for Wetland A, looking north.

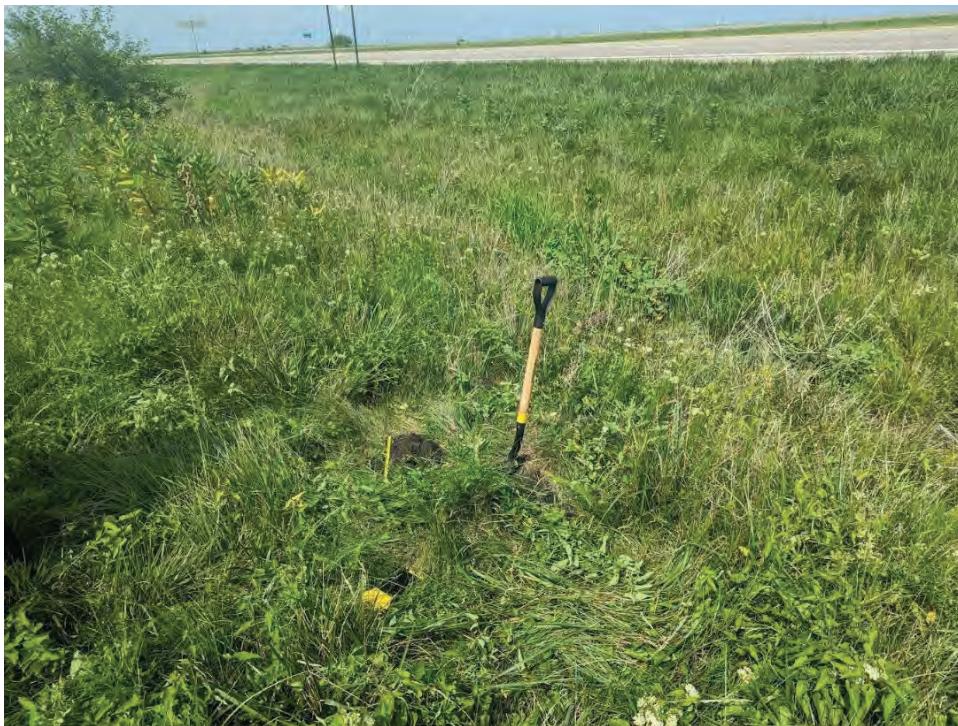
Photograph 24. View of SP3 within the concave roadway swale of RSD2 and dominated by barnyard grass (*Echinochloa crus-galli*), perennial ryegrass (*Lolium perenne*), and whorled milkweed (*Asclepias verticillata*), looking northeast.

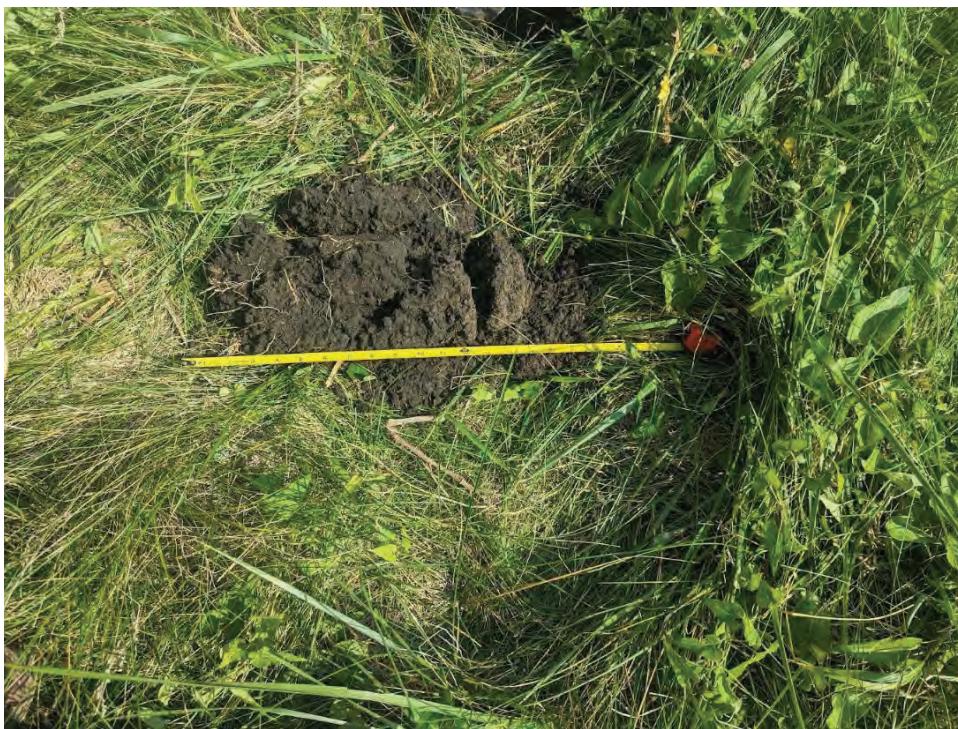
Photograph 25. View of the soils of SP3 (RSD2) which did not meet any hydric soil indicator.

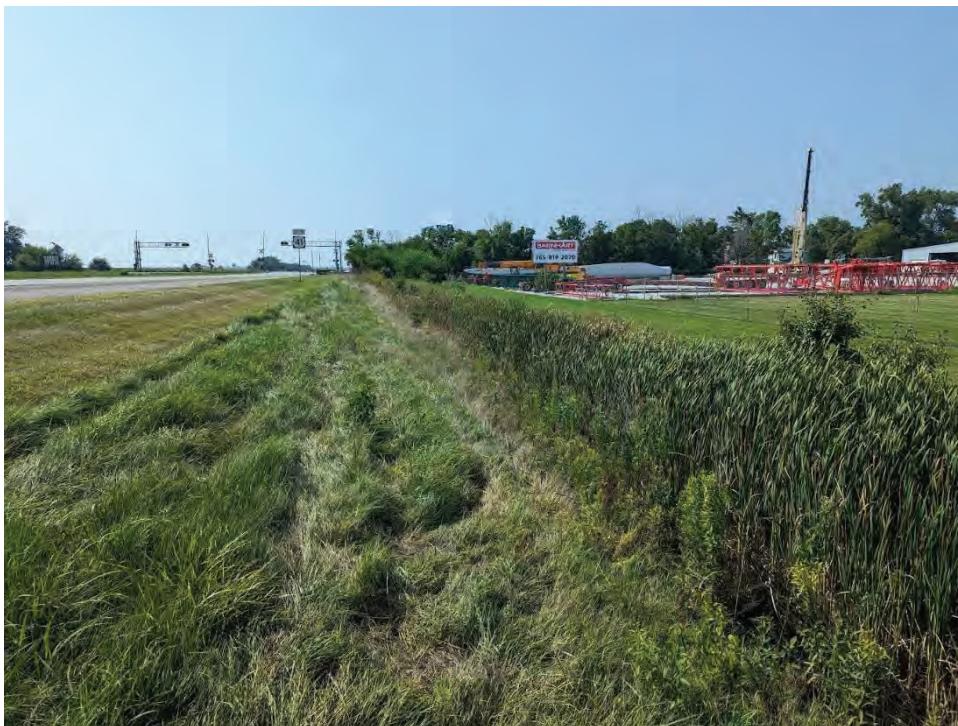
Photograph 26. View of Wetland B dominated by narrowleaf cattail (*Typha angustifolia*) near the southern and downstream outlet of the SR 352 road culvert west of US 41, looking south.

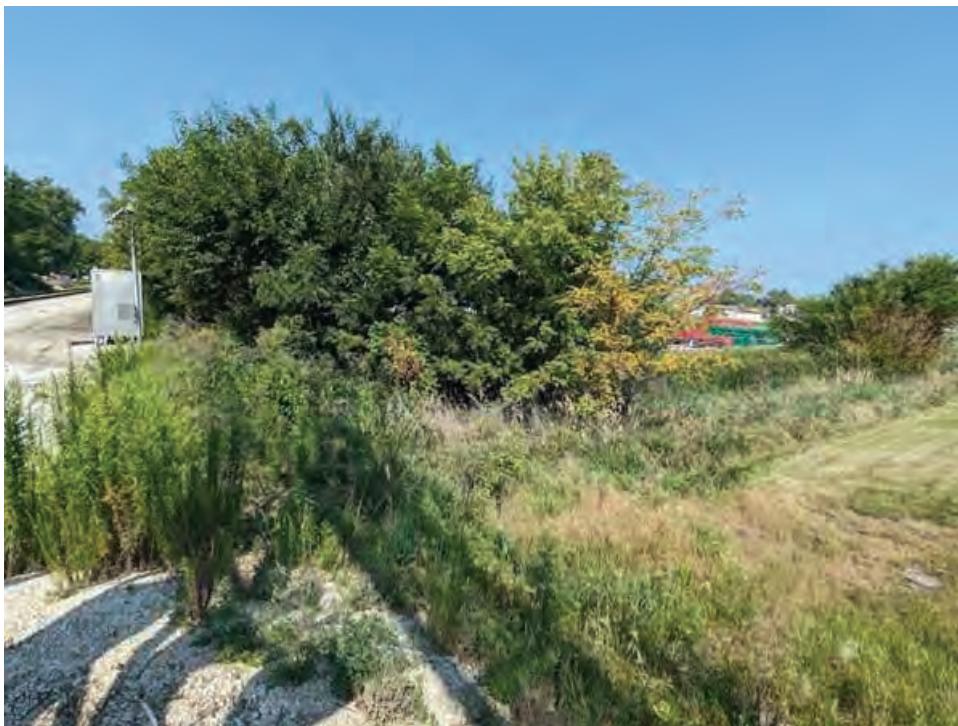
Photograph 28. View of the southern terminus of Wetland B where hydrology enters a culvert under the train tracks, looking west.

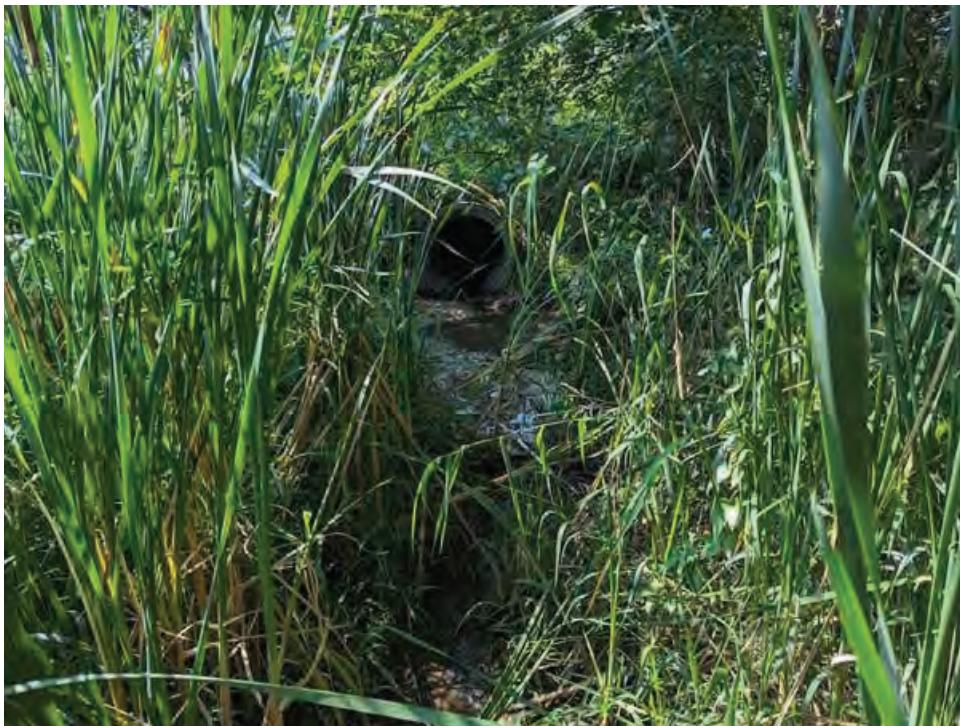
Photograph 29. View of the culvert inlet for Wetland B at its southern terminus within the investigation area, looking south.

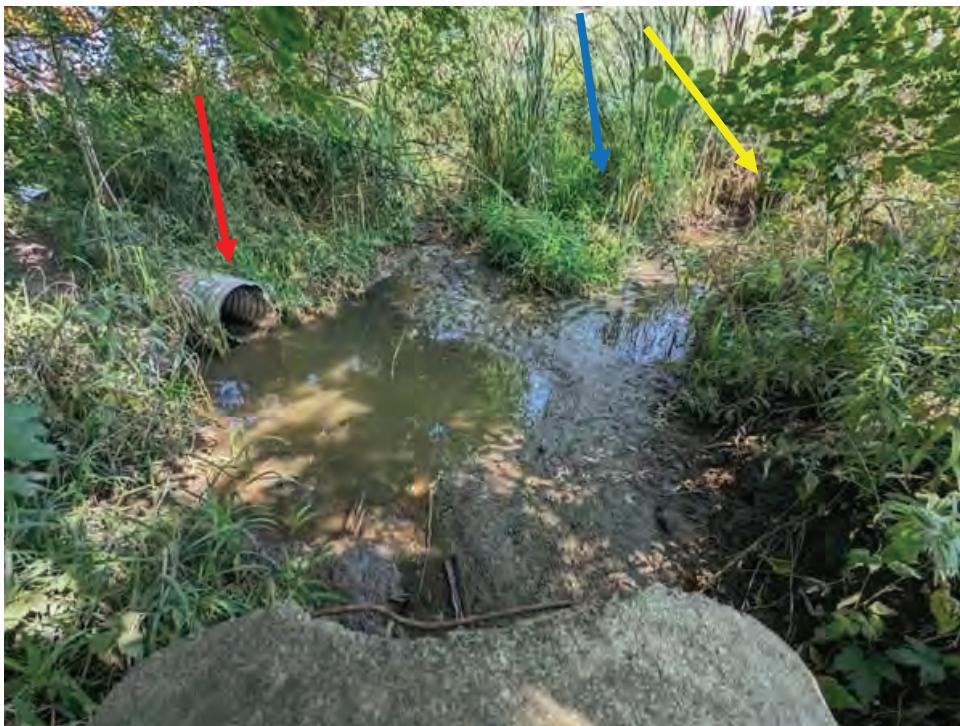
Photograph 30. View of Wetland B TP3 (blue arrow), an unknown (red arrow) culvert outlet, and the southern US 41 culvert outlet (yellow arrow) from southern culvert inlet, looking north.

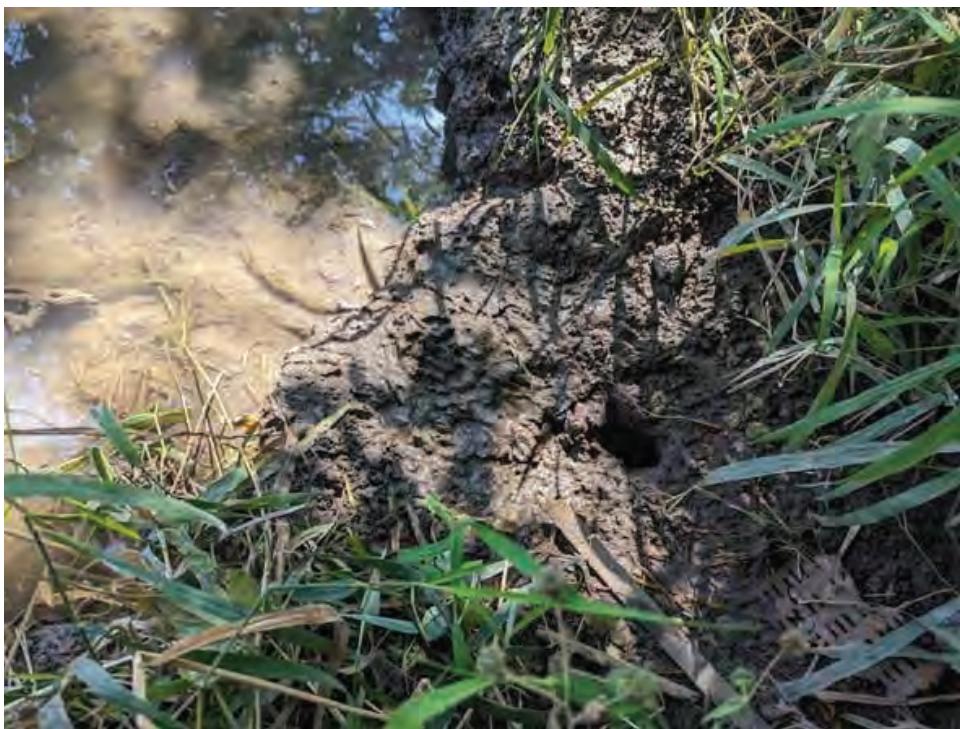
Photograph 31. View of the evidence in the form of tracks, indicating possible wildlife habitat at the southern culvert cluster.

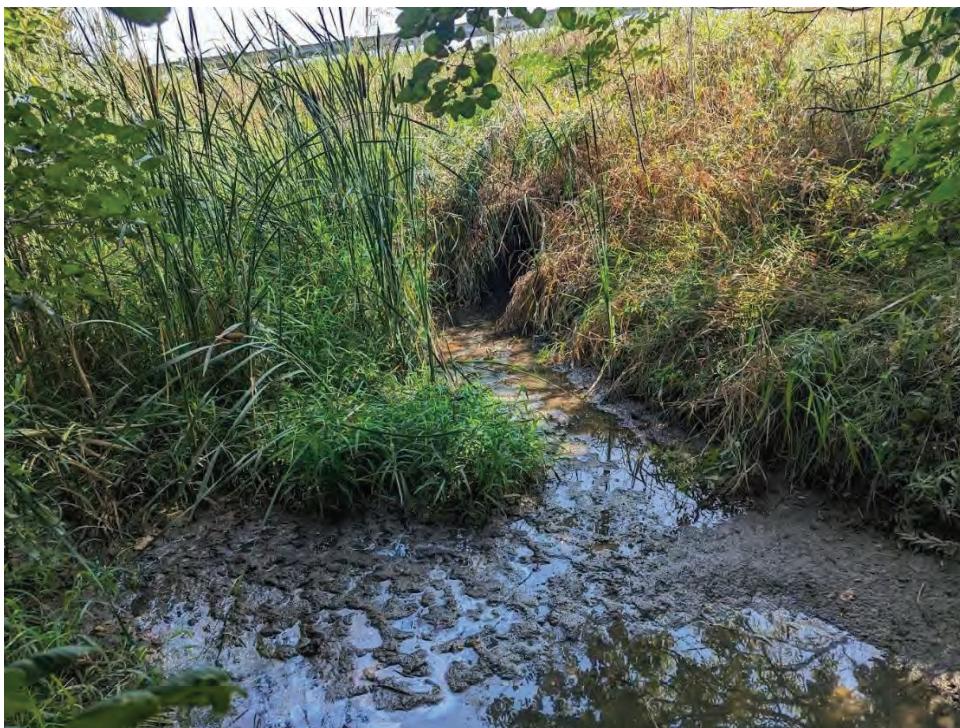
Photograph 32. View of the southern US 41 culvert outlet which captures flow from the eastern and median roadside swales, looking southeast.

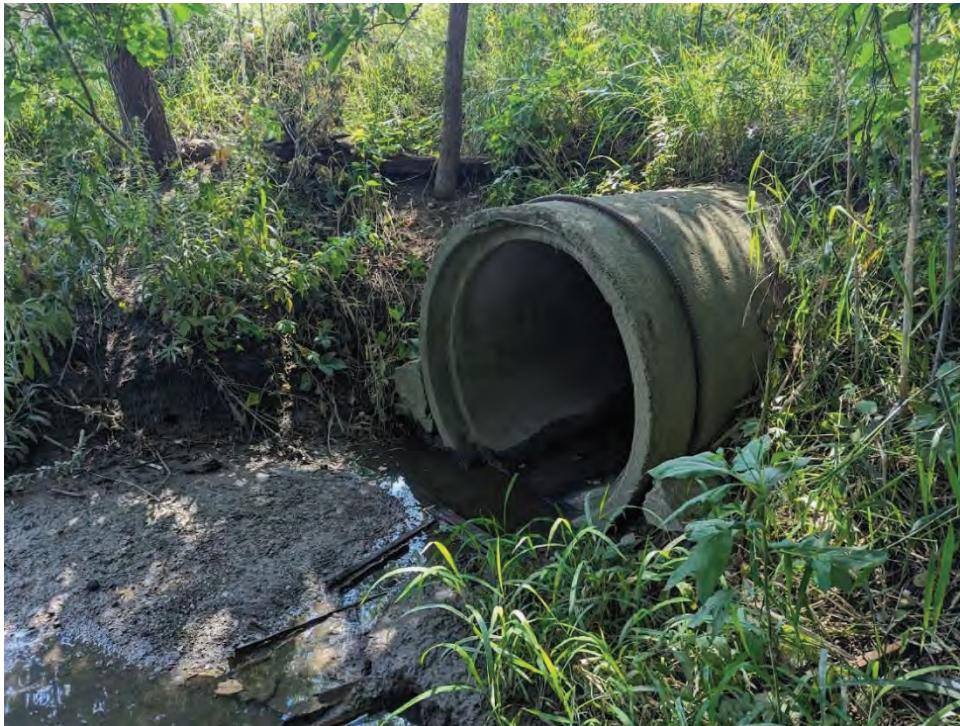
Photograph 33. View of the southern culvert inlet which collects hydrology from Wetland B, an unknown outlet, and the southern US 41 road culvert, looking southeast.

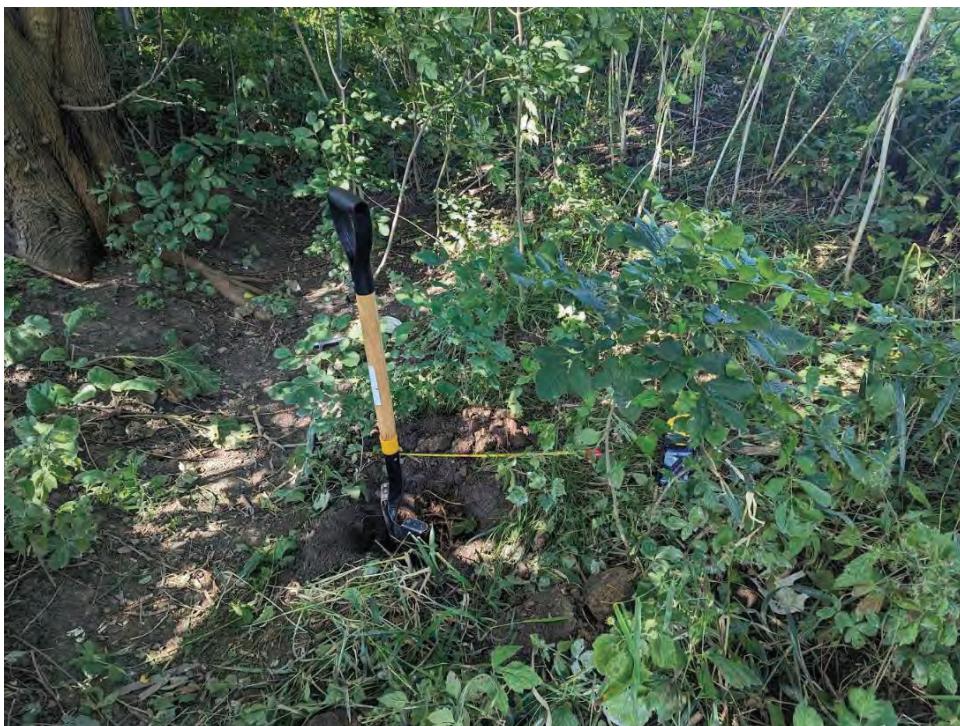
Photograph 36. View of SP4 which was dominated by white ash (*Fraxinus americana*), poison ivy (*Toxicodendron radicans*), and orchard grass (*Dactylis glomerata*), looking west.

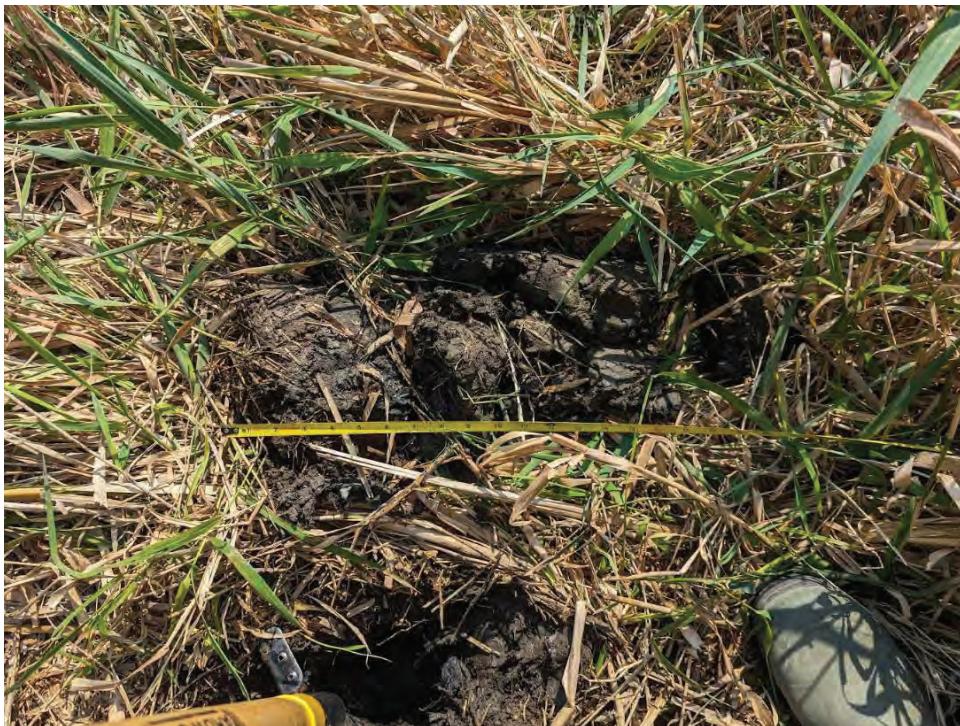
Photograph 39. View of the soil profile found at upland SP5 upslope from Wetland B, which met the Redox Dark Surface (F6) hydric soil indicator.

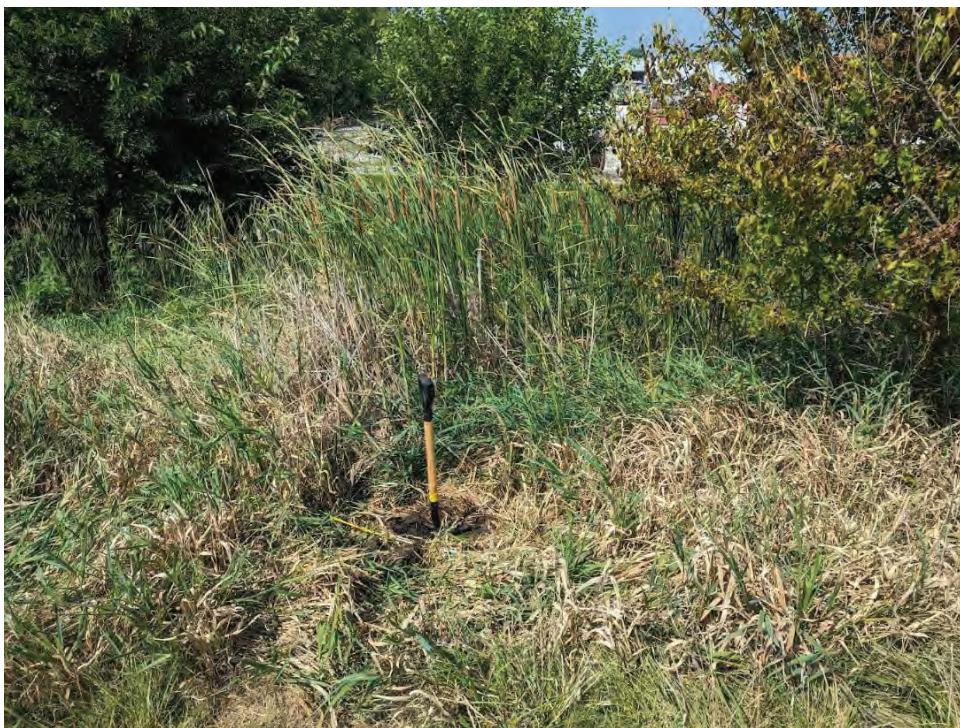
Photograph 40. View of SP5 which documents the sloped embankment which contains hydrophytic vegetation reed canary grass (*Phalaris arundinacea*) and narrowleaf cattail (*Typha angustifolia*) but met no other wetland criterion, looking west.

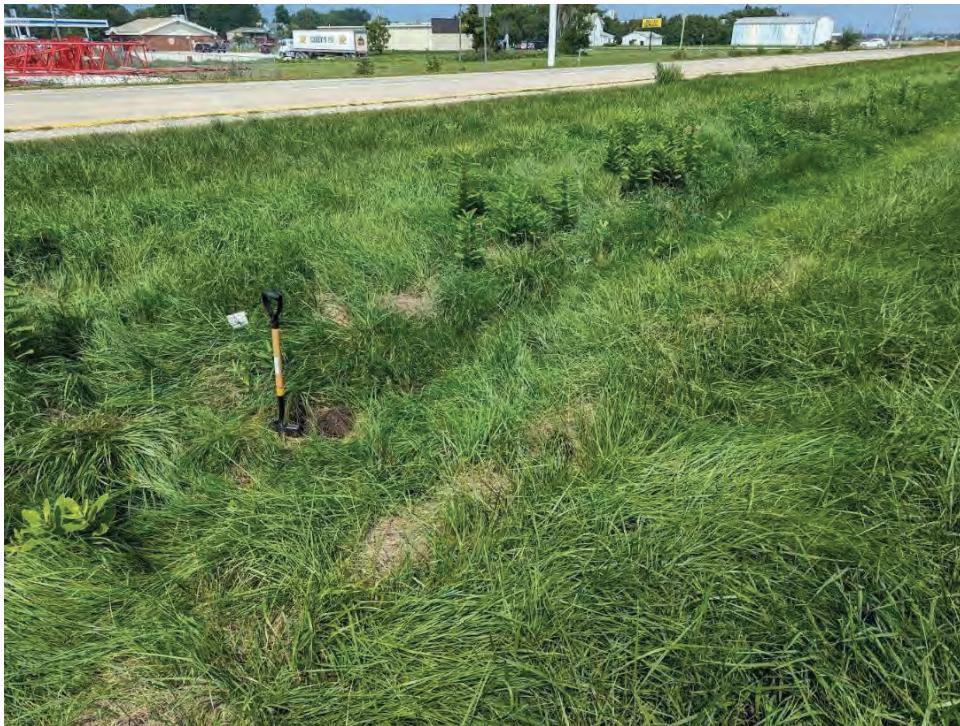
Photograph 44. View of SP6 within the concave US 41 roadway swale (RSD1) where vegetation was dominated by reed canary grass (*Phalaris arundinacea*), smooth brome (*Bromus inermis*), and tall fescue (*Schedonorus arundinaceus*), looking northwest.
