Aerial photograph showing the wetlands, RSDs, sample points, and photograph locations for the US 41 and SR 352 Intersection Improvement Project (INDOT Des. No. 2100058) investigation area. (2 Sheets)

US 41 and SR 352 Intersection Improvement (INDOT Des. No. 2100058)

Grant Township, Benton County, Indiana

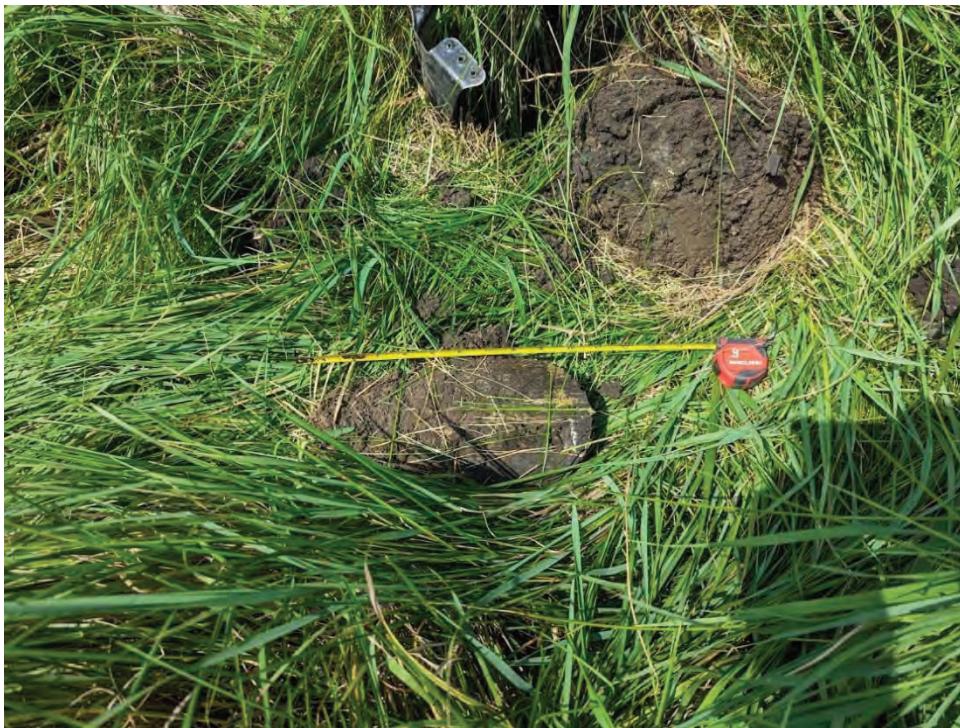
Photograph 45. View of the soils of SP6 (RSD1) which did not meet any hydric soil indicator and where coarse fragment refusal as observed at 12-inches.

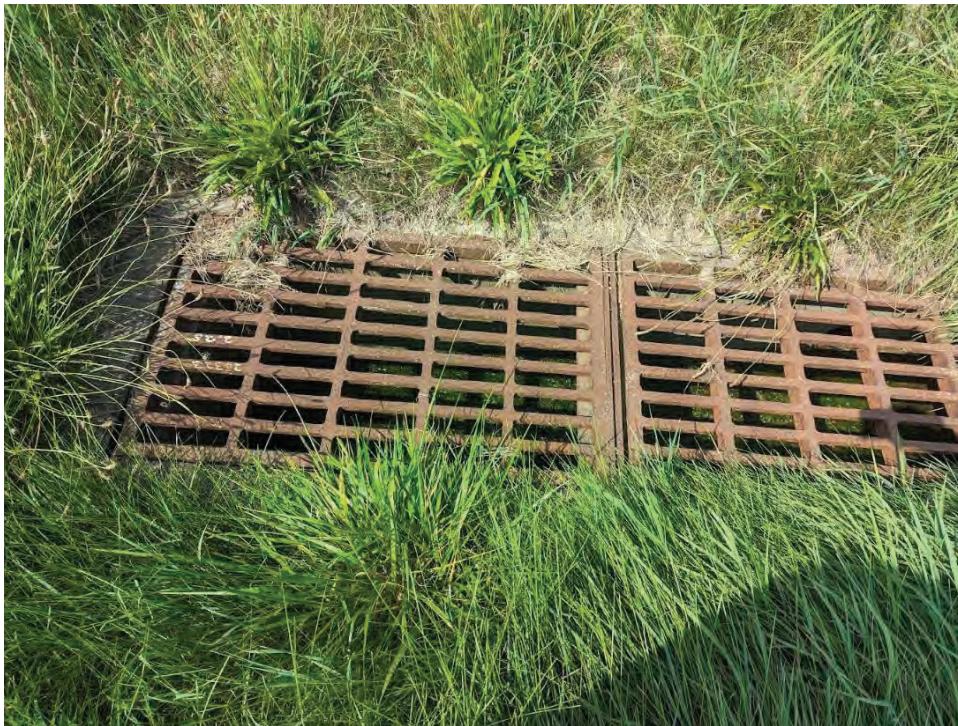
Photograph 48. View of the stormwater inlet basin found at the southern terminus of RSD1. This basin captures flow from RSD1 and outlets to the west into Wetland B.

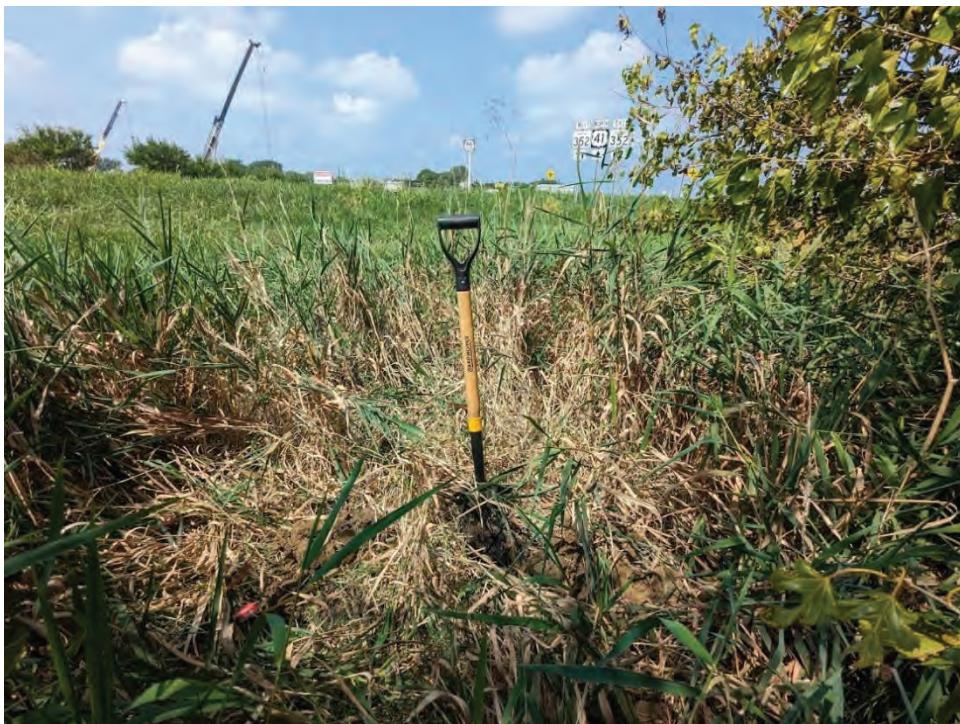
Photograph 50. View of upland SP7, adjacent to Wetland D, which was taken on the top slope terrace where hydrophytic vegetation, reed canary grass (*Phalaris arundinacea*) was found to be dominant but met no other wetland criteria, looking northwest.

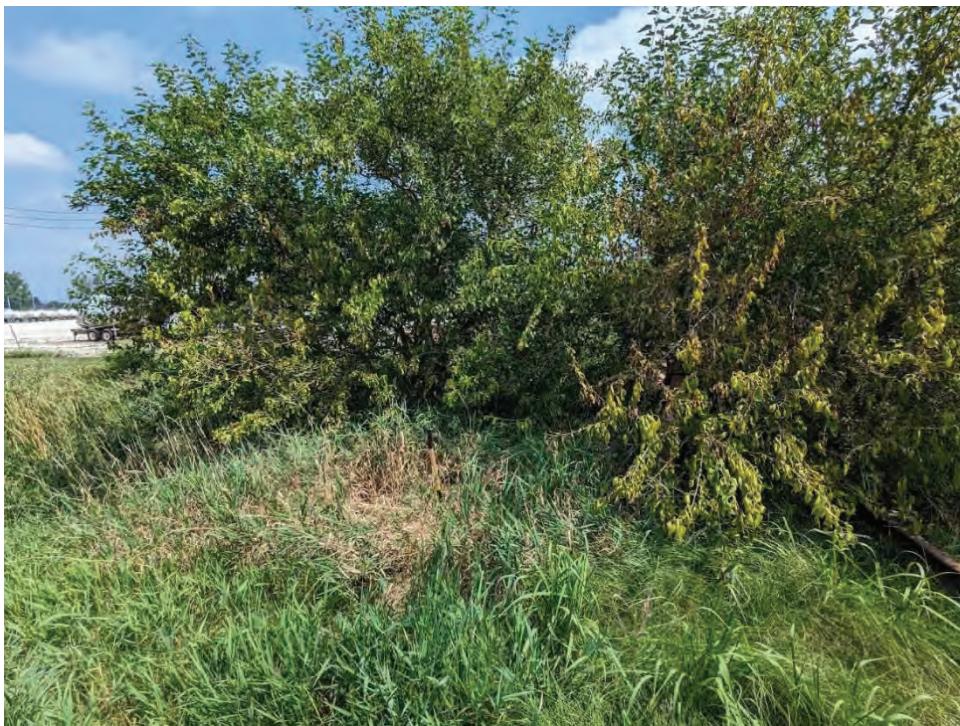
Photograph 52. View of SP7 which did not meet the wetland hydrology or hydric soil criteria, but did contain hydrophytic vegetation, looking east.

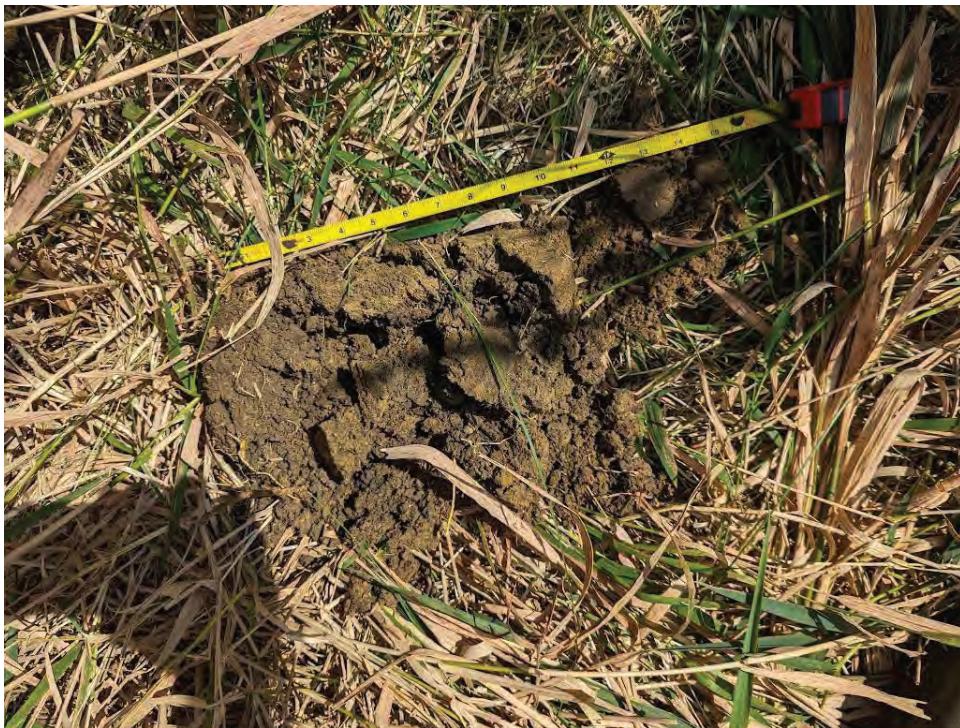
Photograph 53. View of the soil profile found at SP7 which do not meet any hydric soil indicators.

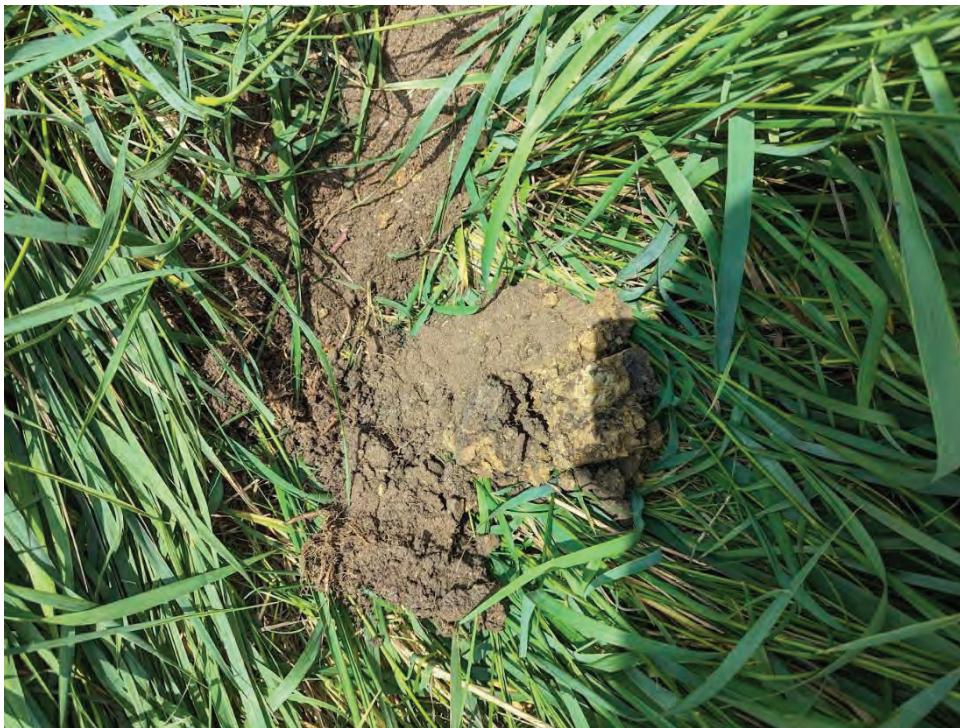
Photograph 55. View of the SP8 soil profile which did not meet any hydric soil indicator.

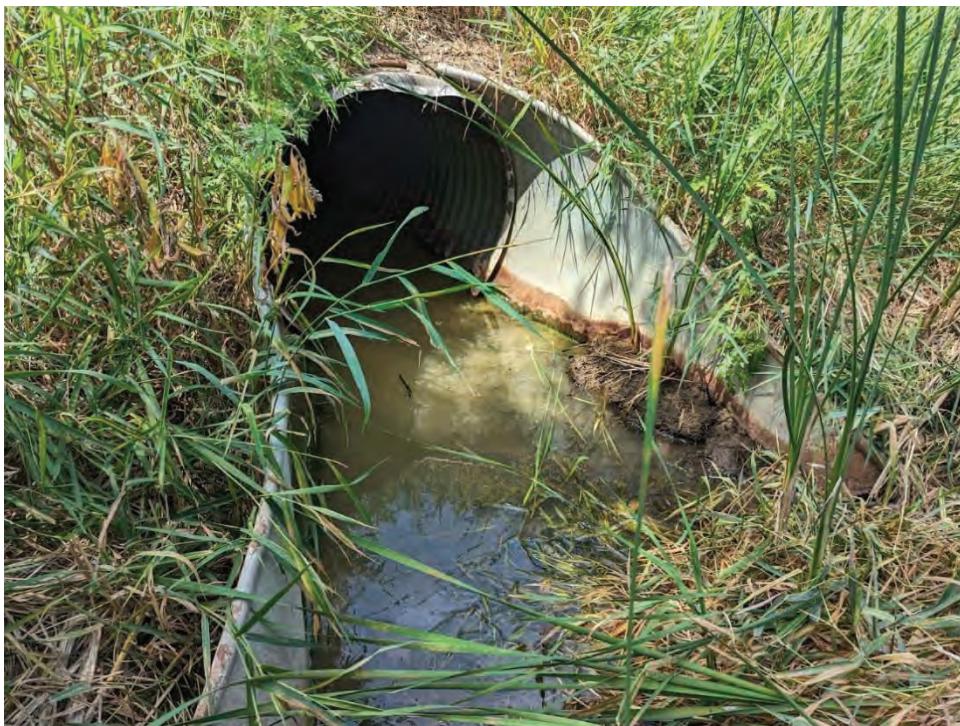
Photograph 60. View of the culvert outlet within Wetland D which divides hydrology between Wetland C and D found at the southeastern quadrant of the intersection between US 41 and SR 352, looking southwest.

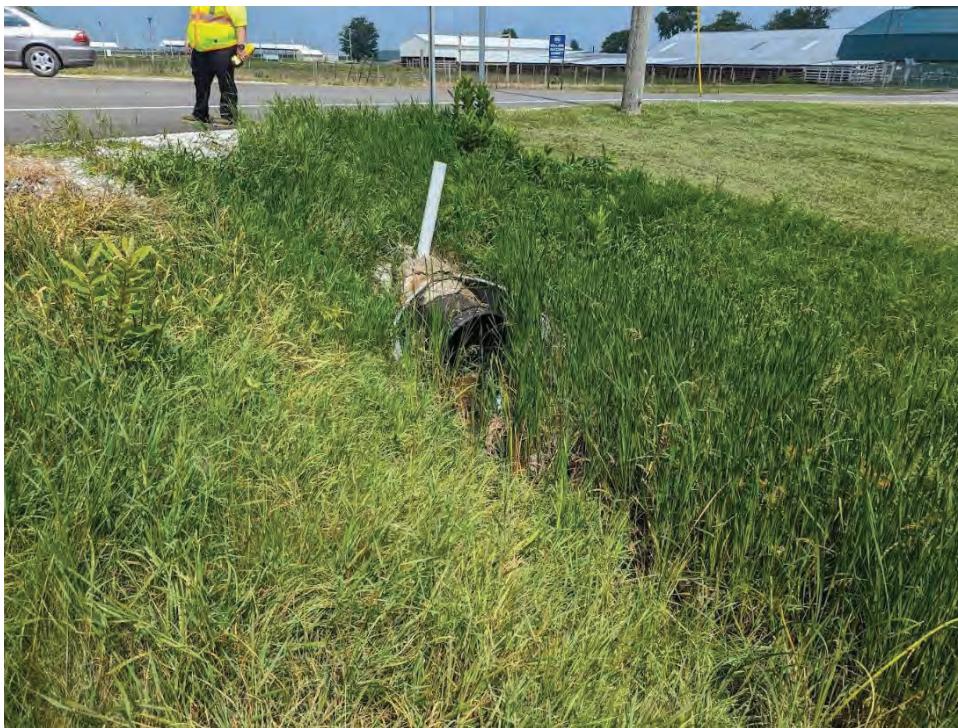
Photograph 61. View of the culvert outlet within Wetland D found at the southeastern quadrant of the intersection between US 41 and SR 352 which divides Wetland C and D, looking northeast.

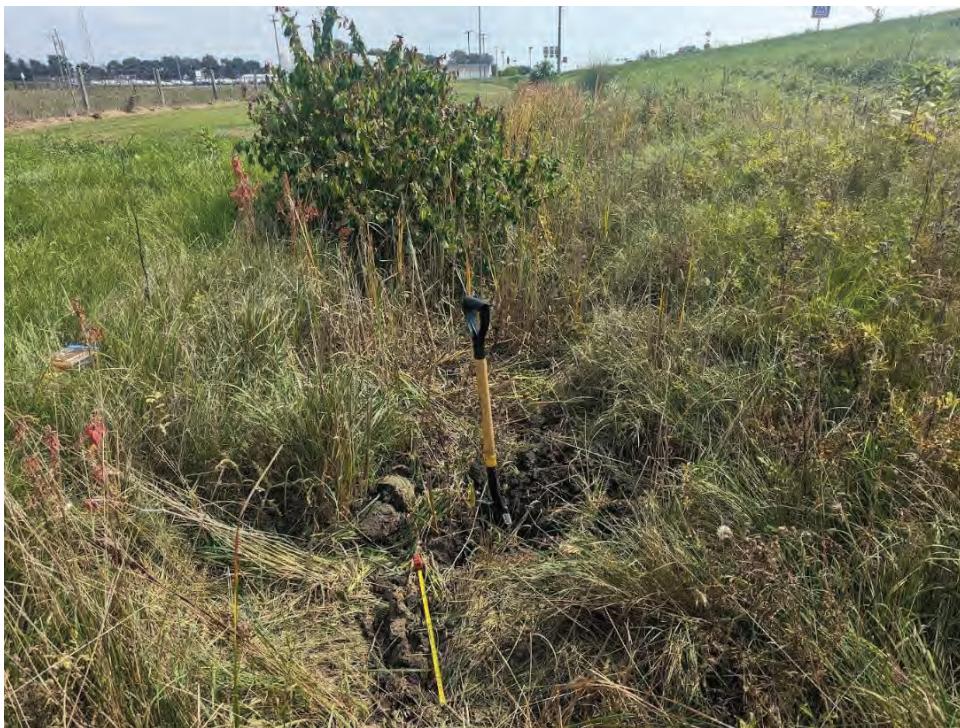
Photograph 63. View of SP9 documenting Wetland C and Wetland D within the eastern US 41 roadway swale which was dominated by silky dogwood (*Cornus amomum*) and reed canary grass (*Phalaris arundinacea*), looking south.

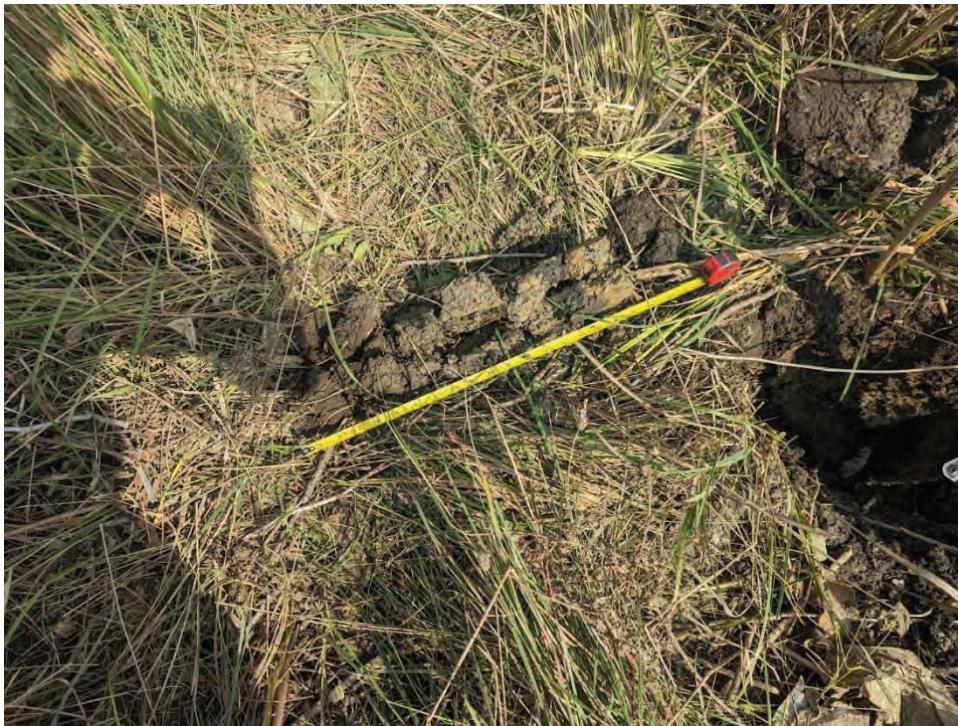
Photograph 65. View of the soil profile found at SP9 which met Depleted Below Dark Surface (A11) and Depleted Matrix (F3) hydric soil indicators.

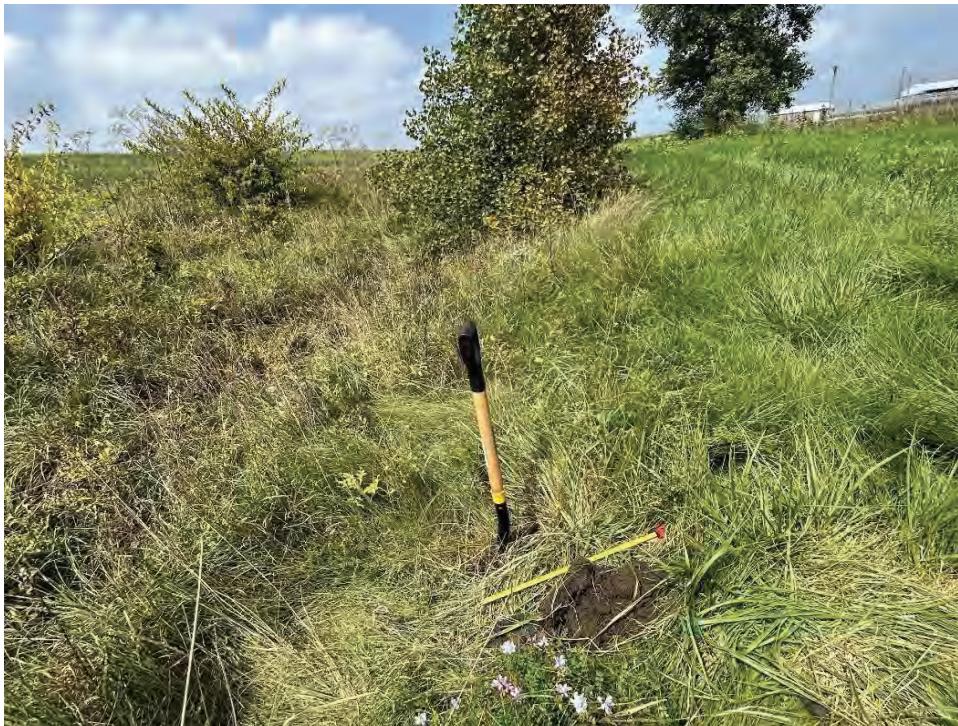
Photograph 67. View of upland SP10 taken in RSD4, upslope from SP9 and Wetland C, where no indicators of wetland vegetation were observed, looking north.

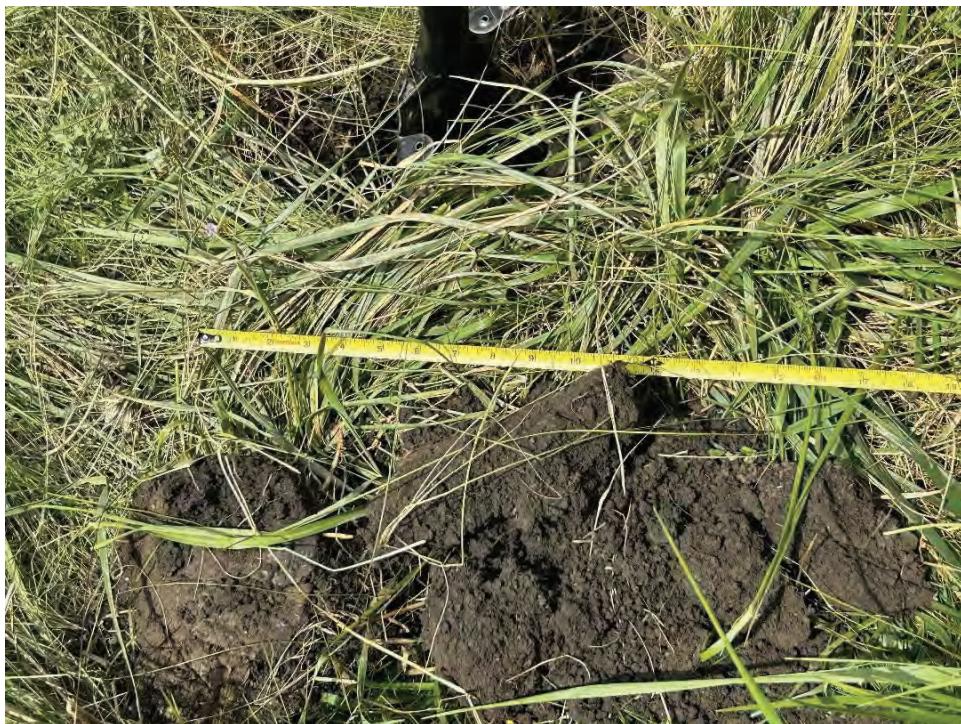
Photograph 69. View of the soil profile found at SP10 (RSD4) which met the Depleted Below Dark Surface (A11) and Depleted Matrix (F3) hydric soil indicators.

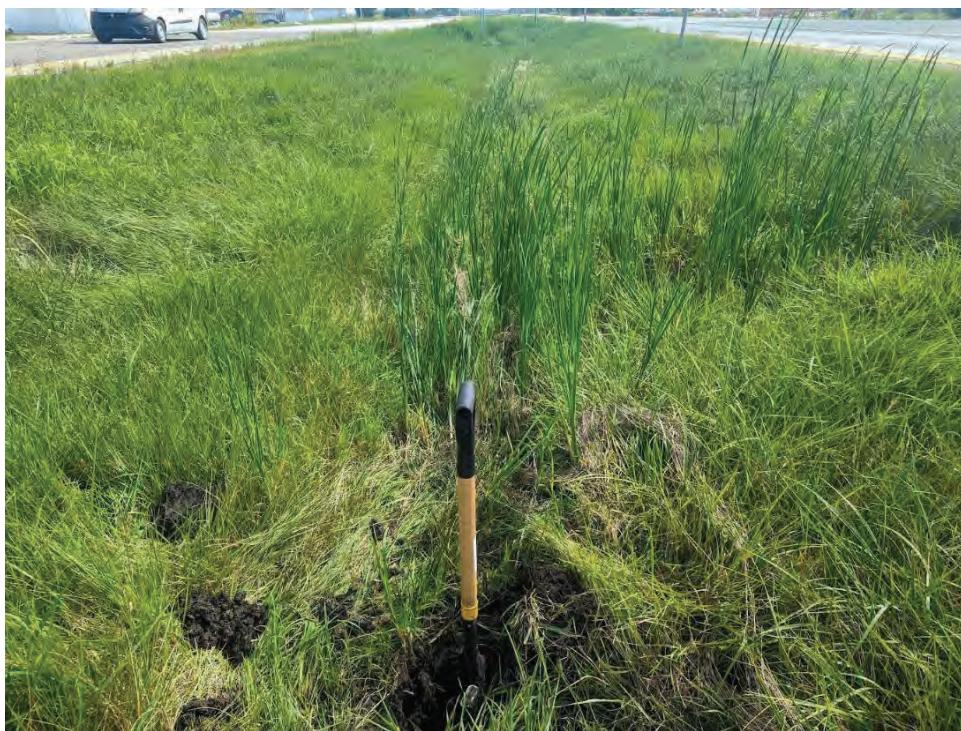
Photograph 70. View of SP11 representing Wetland E within the US 41 roadway median swale which contained hydrophytic vegetation narrowleaf cattail (*Typha angustifolia*) north of SR 352, looking

south.

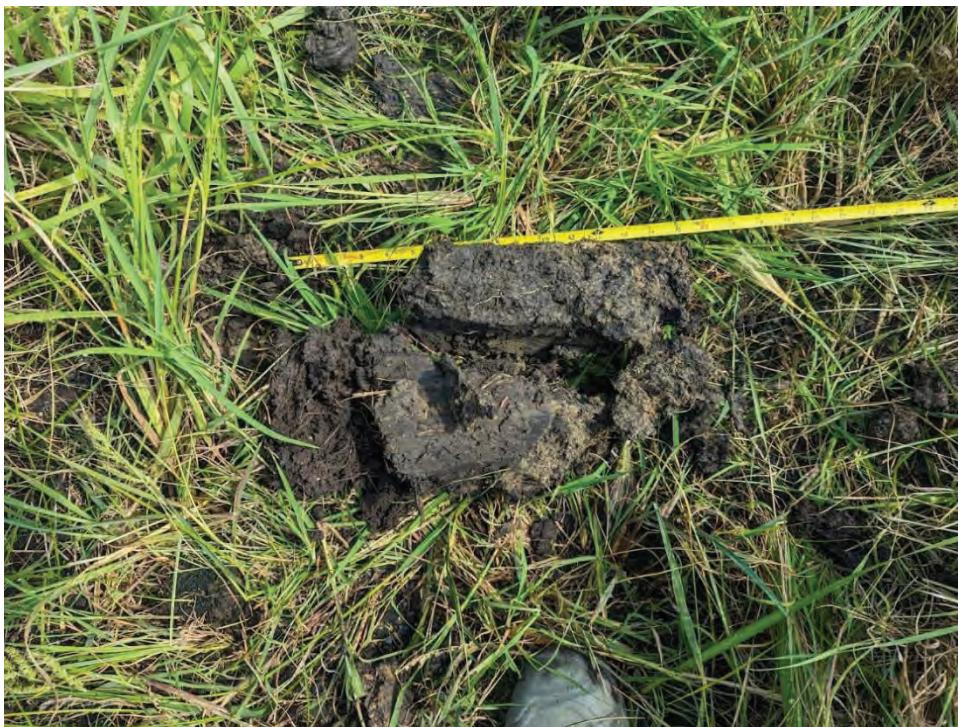
Photograph 72. View of the soil profile of Wetland E found at SP11 which met the Redox Dark Surface (F6) hydric soil indicator.
