US 41 and SR 352 Intersection Improvement (INDOT Des. No. 2100058)

Grant Township, Benton County, Indiana

Photographs taken on August 22, 2023

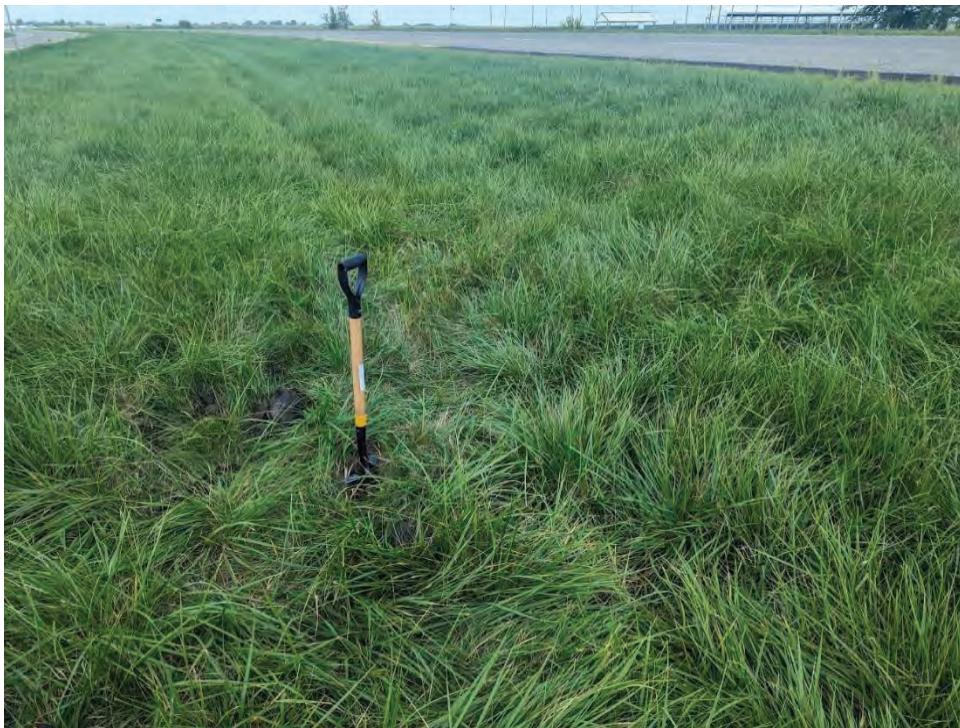
Photograph 73. View of upland SP12, upslope from Wetland E, which was taken to document RSD3 and did not meet the wetland vegetation or hydrology criteria, looking north.

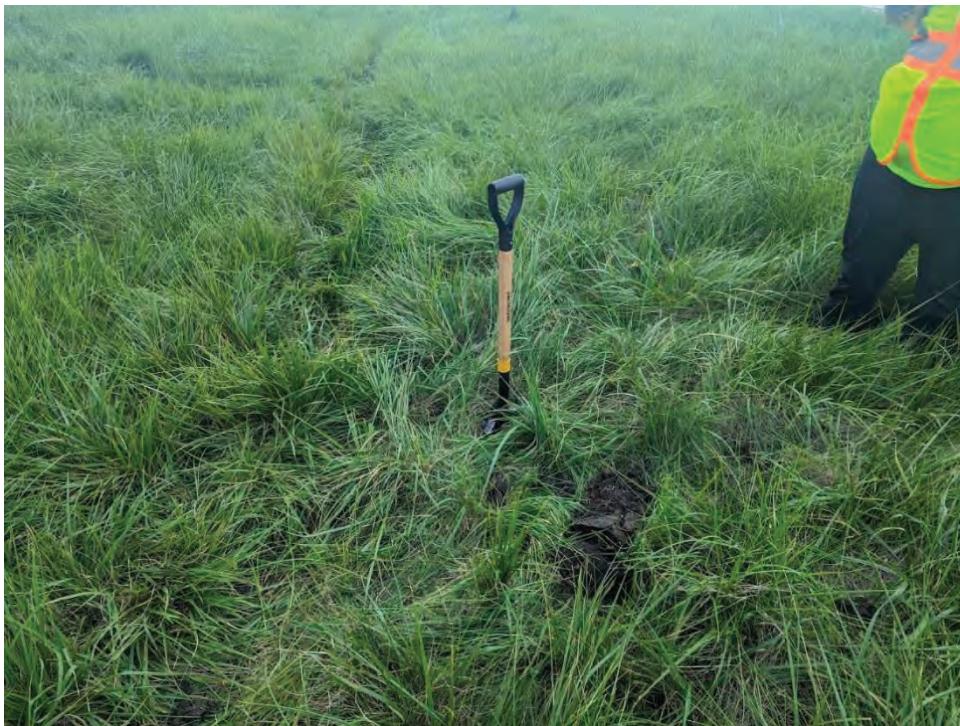
Photograph 74. View of SP12 within the concave roadway swale (RSD3) and dominated by tall fescue (*Schedonorus arundinaceus*) and smooth brome (*Bromus inermis*), looking south.

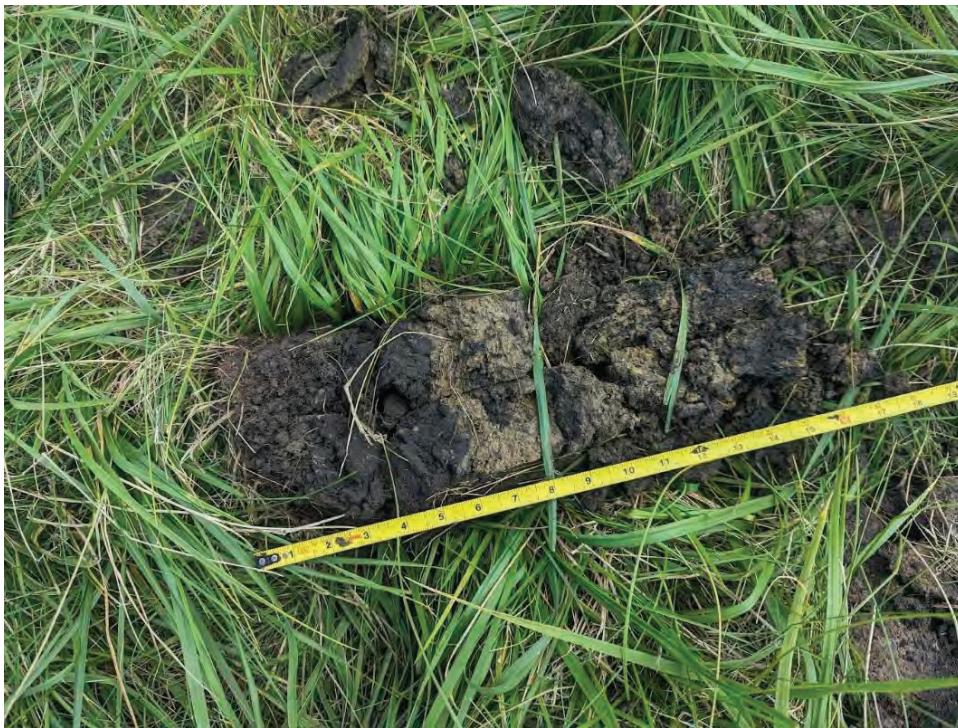
Photograph 75. View of the soil profile found at SP12 (RSD3) which met the Redox Dark Surface (F6) hydric soil indicator.

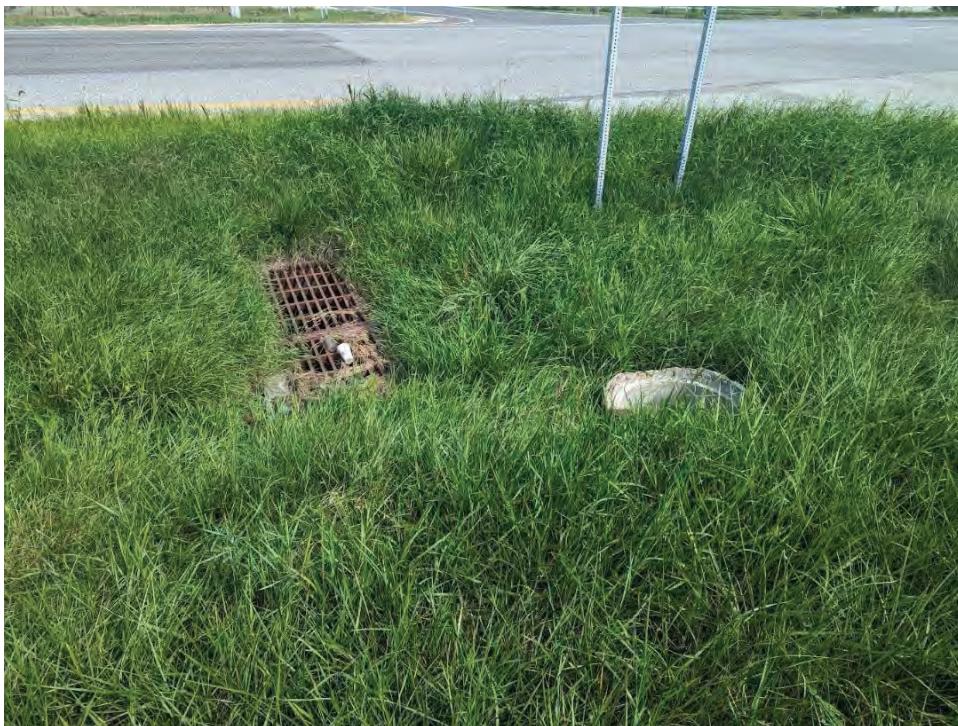
Photograph 76. View of the stormwater inlet basin within the US 41 median, north of SR 352 which captures hydrology from Wetland E.

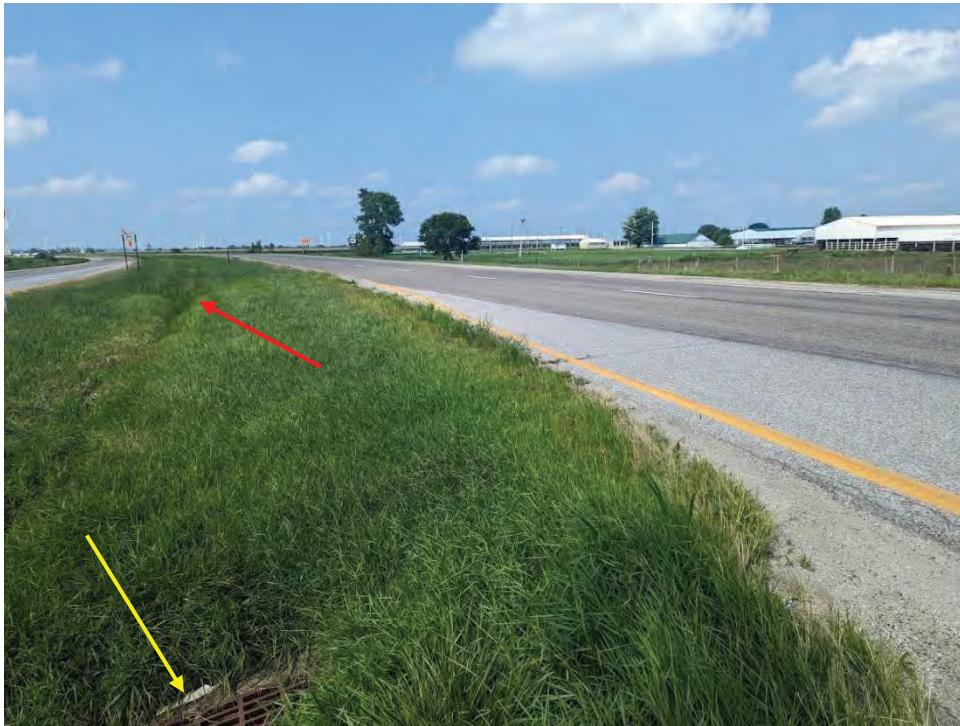
Photograph 77. View US 41 median roadway swale, the stormwater inlet basin (yellow arrow) and Wetland E (SP11)-upland RSD3 (TP5) transition (red arrow), north of SR 352.

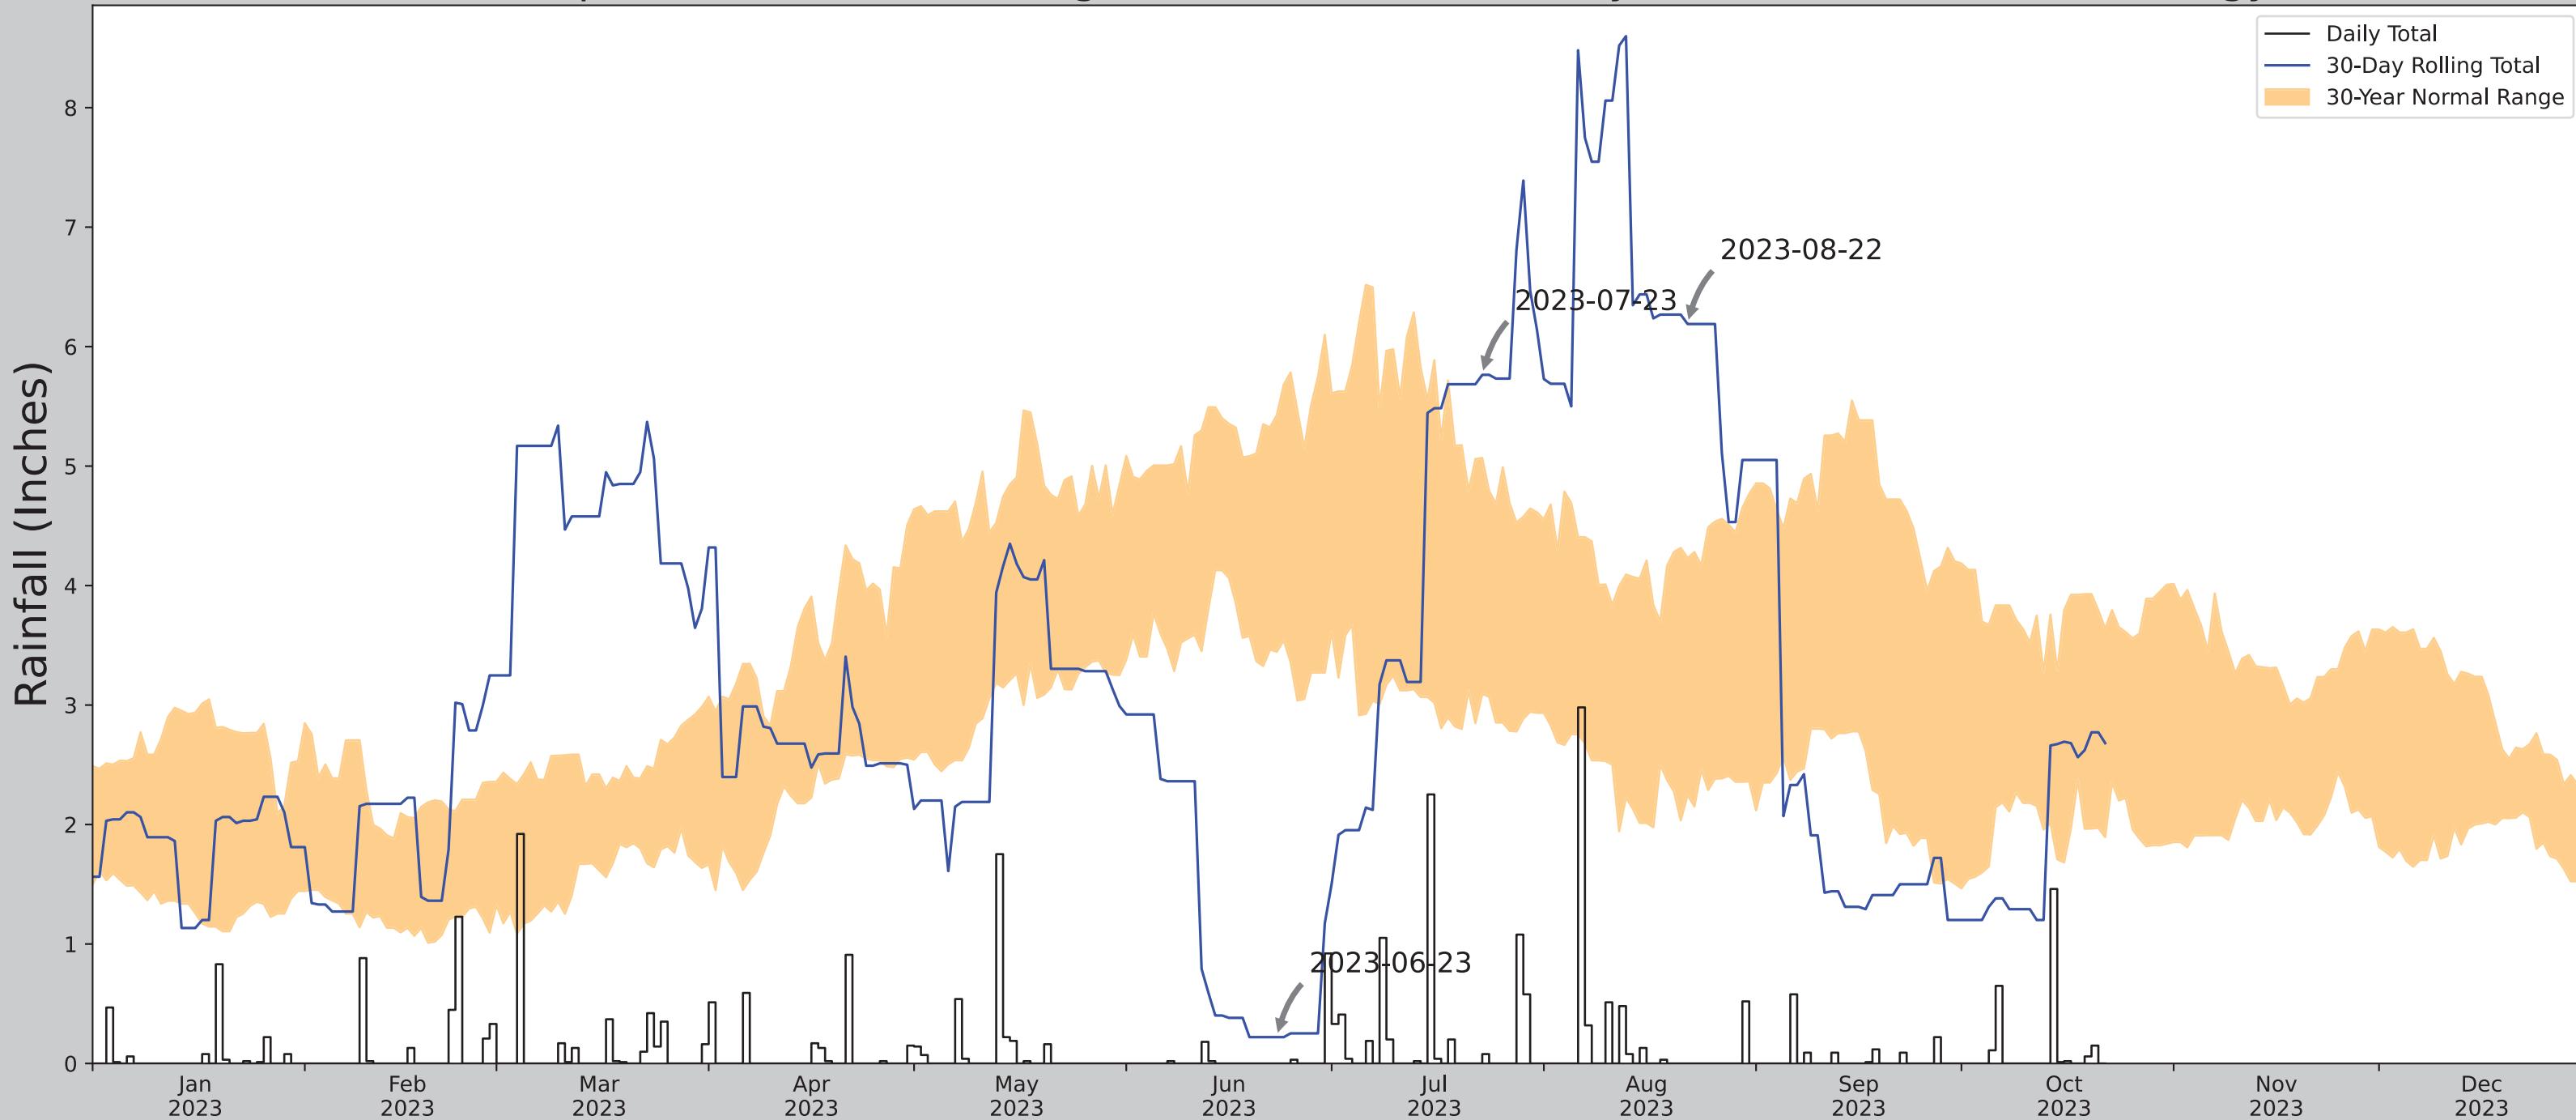
Antecedent Precipitation vs Normal Range based on NOAA's Daily Global Historical Climatology Network

Coordinates	40.521141, -87.375943
Observation Date	2023-08-22
Elevation (ft)	757.863
Drought Index (PDSI)	Mild drought
WebWIMP H ₂ O Balance	Dry Season

30 Days Ending	30 th %ile (in)	70 th %ile (in)	Observed (in)	Wetness Condition	Condition Value	Month Weight	Product
2023-08-22	2.246457	4.230709	6.188977	Wet	3	3	9
2023-07-23	3.09252	5.068504	5.76378	Wet	3	2	6
2023-06-23	3.446457	5.427953	0.220472	Dry	1	1	1
Result							Wetter than Normal - 16

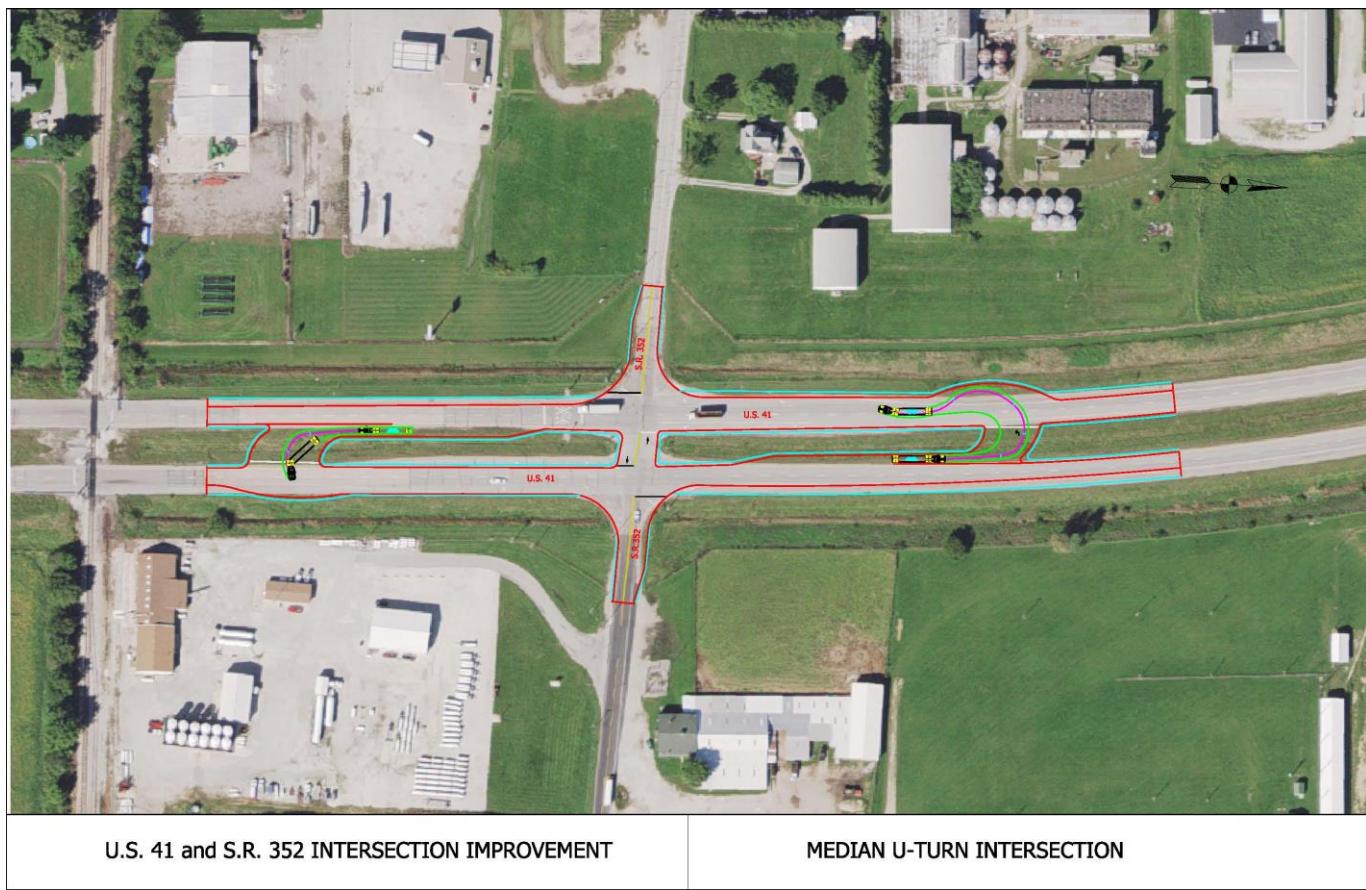
Figure 2: Median U-Turn

The Median U-Turn (MUT) Intersection is also known as the Median U-Turn Crossover and sometimes referred to as a Michigan Left Turn. The MUT refers to an intersection replacing direct left turns at an intersection with indirect left turns using a U-turn movement in a wide median. The MUT intersection requires drivers on SR 352 to turn right onto the main road and then make a U-turn maneuver at a one-way median opening at least 400 feet after the intersection. The MUT intersection also eliminates left turns on SR 352 from US 41 and thus reduces the number of conflict points at the main crossing intersection, resulting in improved safety at the intersection. Right turn lanes were incorporated in the design, but they are not required; this would separate the through vehicles from the turning vehicles. The addition of the right turning lanes are included in the cost estimate. This alternative would be un-signalized. US 41 and SR 352 will be milled and resurfaced after the completion of adding the median U-turns.

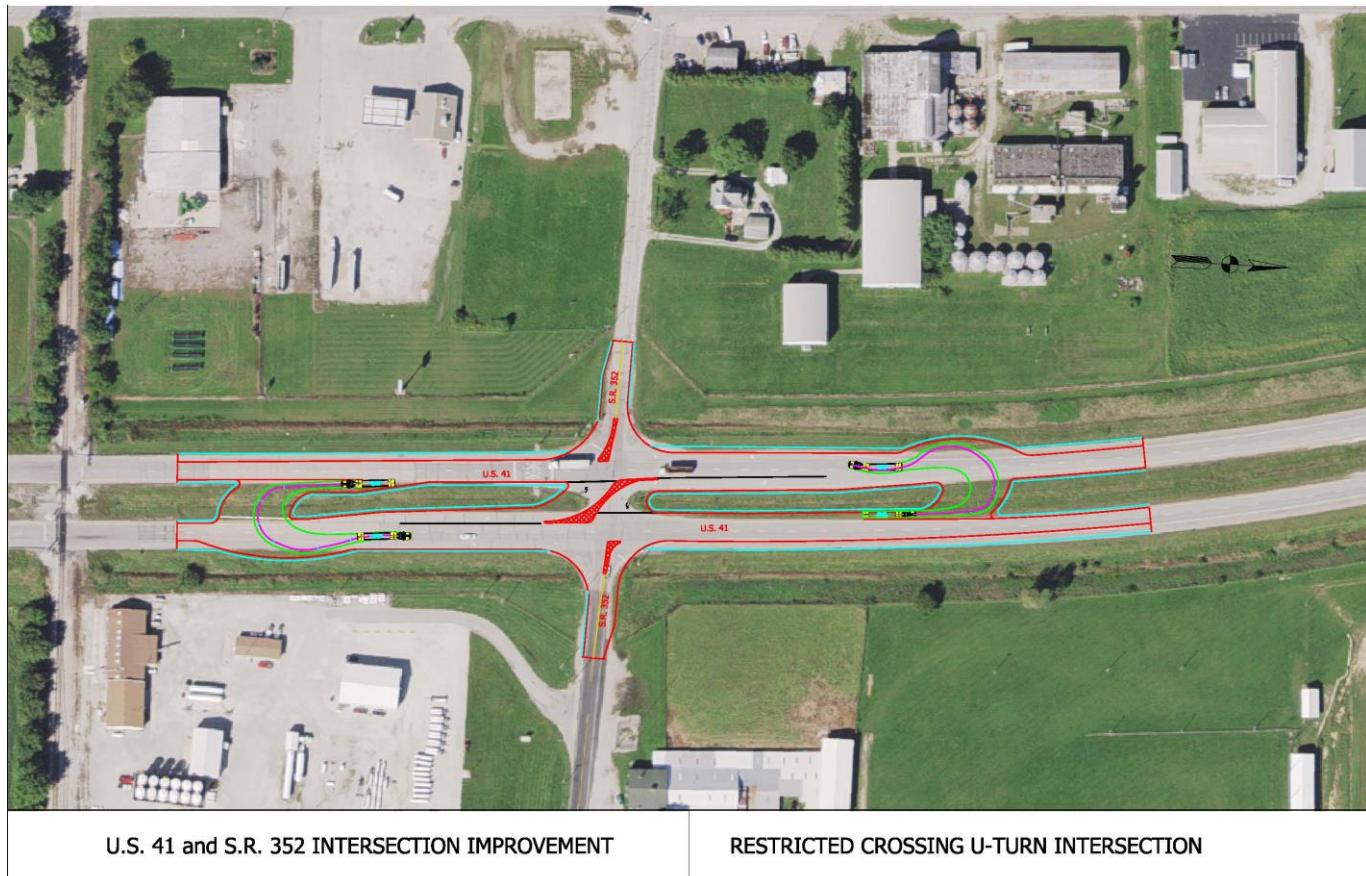
Figure 3: Restricted Crossing U-Turn

The Restricted Crossing U-Turn (RCUT) Intersection is also known as a superstreet intersection, a J-turn intersection, and synchronized street intersection. The RCUT intersection differs from a conventional intersection by eliminating the left-turn and through movements from cross street approaches. To accommodate these movements, the RCUT intersection requires SR 352 drivers to turn right onto the main road and then make a U-turn maneuver at a one-way median opening at least 400 feet after the intersection. US 41 traffic will still be allowed to turn left on SR 352. RCUT intersections can have either three or four legs. In the case of a four-legged RCUT intersection, there are two U-turn crossovers, and minor street left-turn and through movements are not allowed to be made directly at the intersection. A stop-controlled RCUT intersection is used as a safety treatment at an isolated intersection on a four-lane divided arterial in a rural area. This alternative would be un-signalized and the turns (both the right and U-turns) would be stop controlled. US 41 and SR 352 will be milled and resurfaced after the completion of adding the median U-turns and center medians.

After considering the reconstruction alternatives, even though the cost of the MUT intersection is the smallest, it has been determined that the Restricted Crossing U-Turn Intersection (Reconstruction Alternative 2) is the recommended alternative for how effectively it meets the Project Purpose and Need and not that much more in cost.

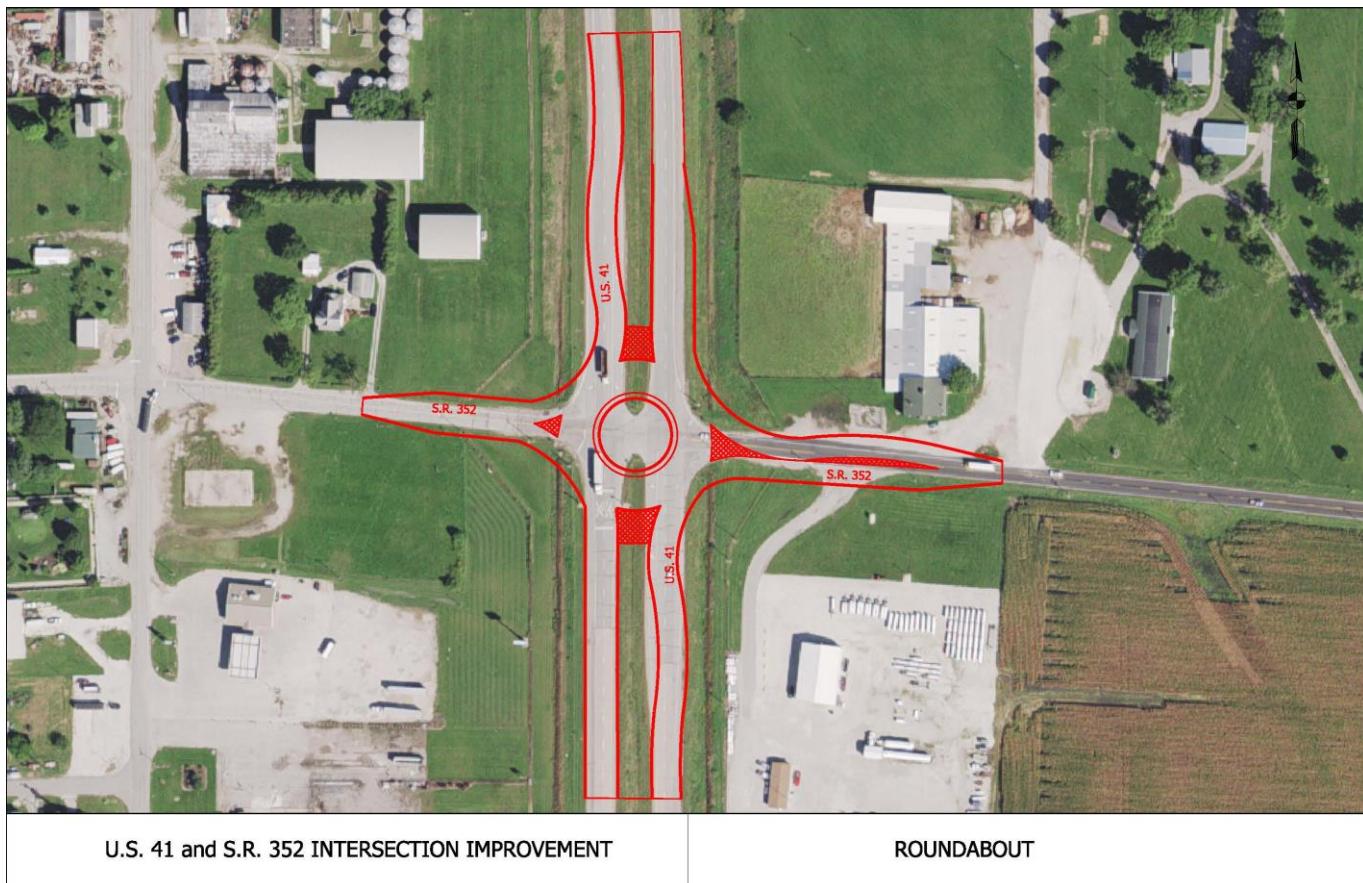
Figure 4: Multi-Lane Roundabout

This alternative will consist of a multi-lane roundabout that follows the design standards per NCHRP 672 and the IDM. Multi-lane roundabouts have at least one entry with two or more lanes. SR 352 will be widened to two entry lanes to allow more vehicles to enter the roundabout. The geometric design will include raised spitter islands, truck apron, non-traversable central island, and appropriate entry path deflection. Since US 41 and the east leg of SR 352 are high speed roadways, a series of curves will be designed leading up to the roundabout to reduce the speed of vehicles. US 41 and SR 352 will be milled and resurfaced after the completion of the roundabout.
