Red Flag Investigation, DES # 1800060 and 1900361

Red Flag Investigation - Infrastructure SR 32, 3.69 Miles West of SR 75 to 0.5 Mile West of I-65 Des. No. 1800060 and 1900361, Passing Lane and Minor Structure Overlay Boone County, Indiana

Brief Description of Project: The Federal Highway Administration (FHWA) and Indiana Department of Transportation (INDOT), Crawfordsville District propose to proceed with a passing lanes and minor structural overlay project on SR 32 from 3.69 miles west of SR 75 to 0.5 mile west of I-65 in Boone County, Indiana. The proposed project will involve a Hot Mix Asphalt (HMA) Minor Structural Overlay (from 0.05 mile west of the SR 75 junction to 0.5 mile west of I-65), the construction of four (4) passing lane locations, replacement of drainage pipes within the four (4) passing lane areas, and drainage ditch regrading. Refer to the RFI Part 1 of 2 for full project description. Coordination with INDOT SAM occurred on May 7, 2021, and it was determined that a limited RFI should be prepared for the drainage ditch work portion of this project.

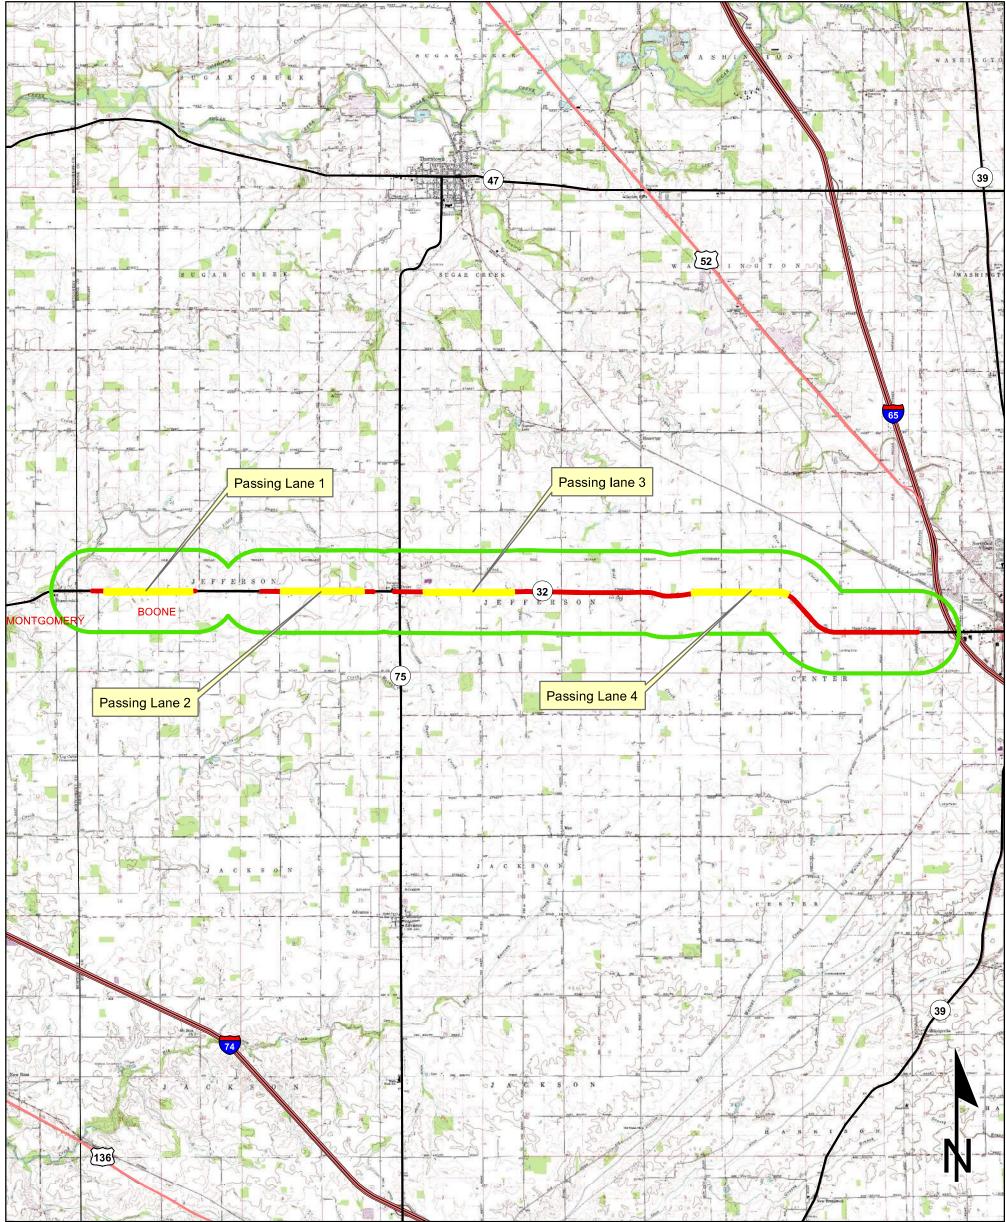
Recreational Facilities: One (1) recreational facility, Western Boone Junior-Senior High School, is located adjacent to the north of the Passing Lane 3 project area in the northeast quadrant of the SR 32 and SR 75 intersection. Coordination with Western Boone Junior-Senior High School will occur.

Cemeteries: One (1) cemetery, Dover Cemetery, is located approximately 0.05 mile west of the Passing Lane 3 project area, in the northeast quadrant of the SR 32 and SR 75 intersection. A Cemetery Development Plan may be required if this project is within 100 feet of the cemetery. Coordination with INDOT Cultural Resources will occur.

Schools: One (1) school, Western Boone Junior-Senior High School, is located adjacent to the north of the Passing Lane 3 project area, in the northeast quadrant of the SR 32 and SR 75 intersection. Coordination with Western Boone Junior-Senior High School will occur.

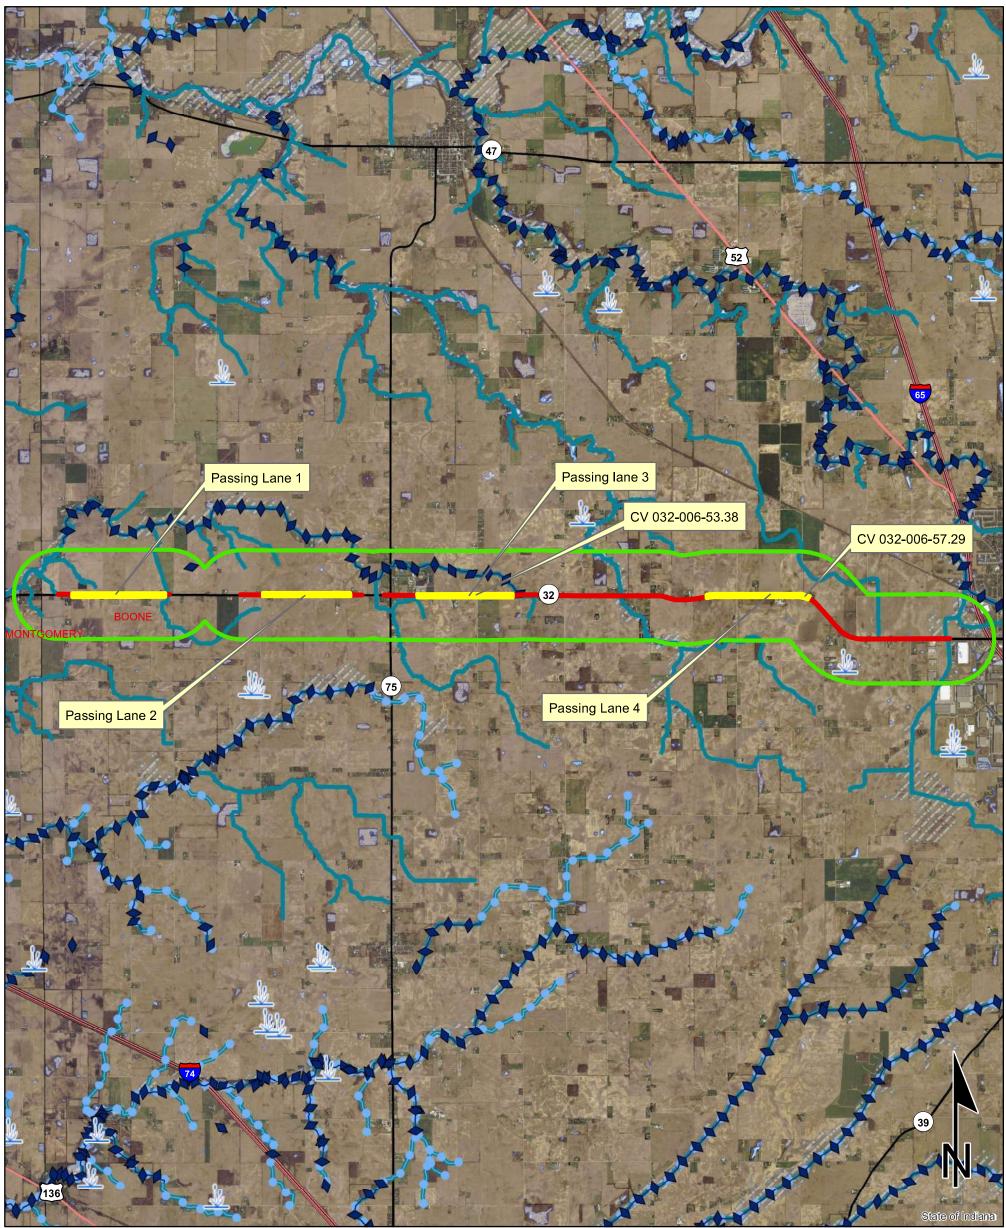
Red Flag Investigation - Water Resources SR 32, 3.69 Miles West of SR 75 to 0.5 Mile West of I-65 Des. No. 1800060 and 1900361, Passing Lane and Minor Structure Overlay Boone County, Indiana

WATER RESOURCES: The presence of the following water resources will require the preparation of a Waters of the US Report and coordination with INDOT ESD Ecology and Waterway Permitting.

- Three (3) NWI-Wetland polygons are located adjacent to the project area; One (1) NWI-Wetland polygon is located adjacent to the south of the Passing Lane 1 project area, and two (2) NWI-Wetland polygons are located adjacent to the south of the Passing Lane 3 project area.
- Three (3) stream segments are located adjacent to the Passing Lane project areas; One (1) stream segment is located adjacent to the east of the Passing Lane 1 project area, and two (2) stream segments are located adjacent to the Passing Lane 3 project area (one (1) to the east and one (1) to the west).
- Due to the presence of the two (2) culverts and various drainage pipes, there is a potential for unmapped water features within the project area (coordination only).

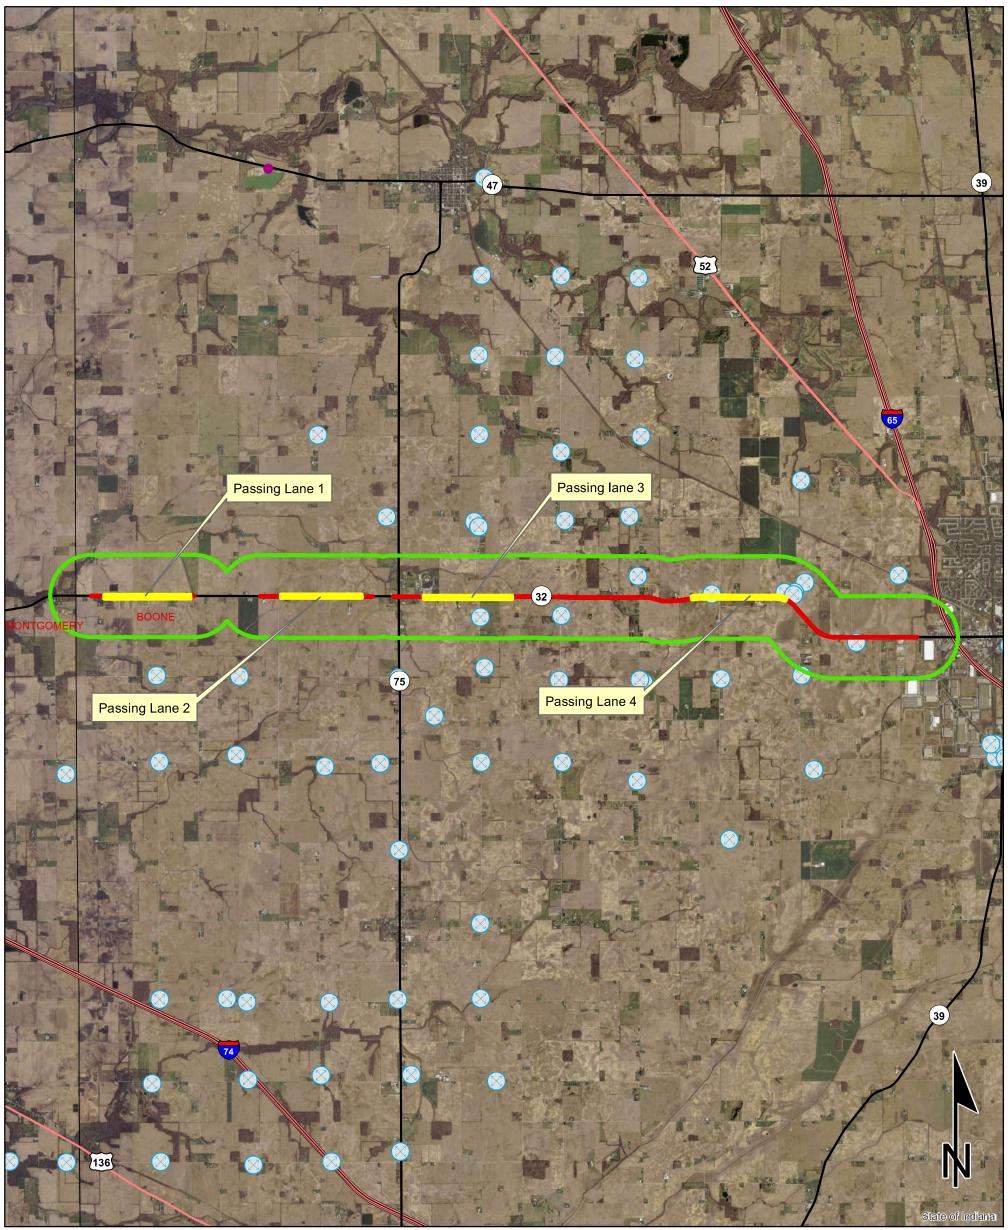
Red Flag Investigation - Mining and Mineral Exploration SR 32, 3.69 Miles West of SR 75 to 0.5 Mile West of I-65 Des. No. 1800060 and 1900361, Passing Lane and Minor Structure Overlay Boone County, Indiana

Petroleum Wells: One (1) petroleum well (presumed plugged) is located adjacent to the north of the Passing Lane 4 project area. Coordination with Indiana Department of Natural Resources (IDNR) Oil and Gas Division will occur.

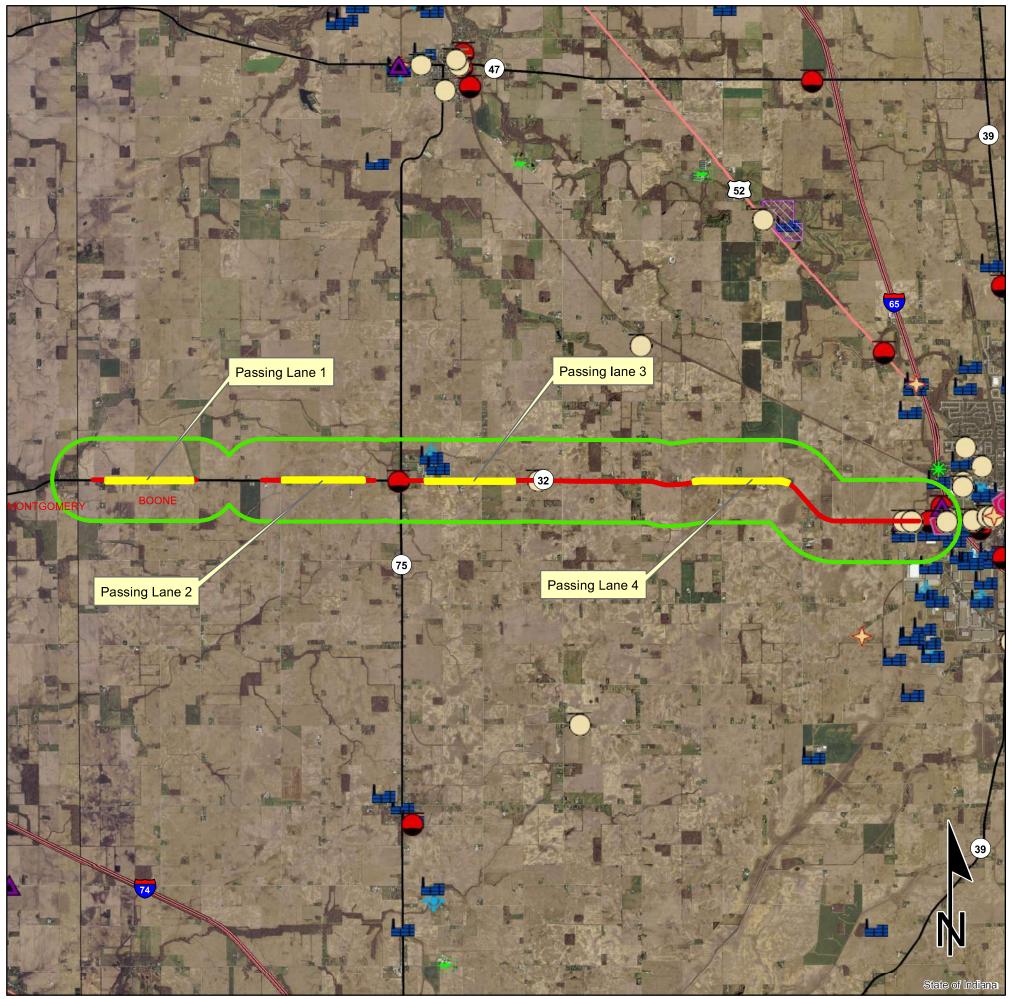
Red Flag Investigation - Hazardous Material Concerns SR 32, 3.69 Miles West of SR 75 to 0.5 Mile West of I-65 Des. No. 1800060 and 1900361, Passing Lane and Minor Structure Overlay Boone County, Indiana

NPDES Facility: Western Boone Junior-Senior High School Track and Renovations, 1205 SR 75 (AI ID 123849), is located adjacent to the north of the Passing Lane 3 project area. The permit is in effect until April 8, 2024. Coordination with Western Boone Junior-Senior High School will occur.

NPDES Pipe Locations: Western Boone Junior-Senior High School is located approximately 0.30 mile north of the Passing Lane 3 project area. Coordination with Western Boone Junior-Senior High School will occur.

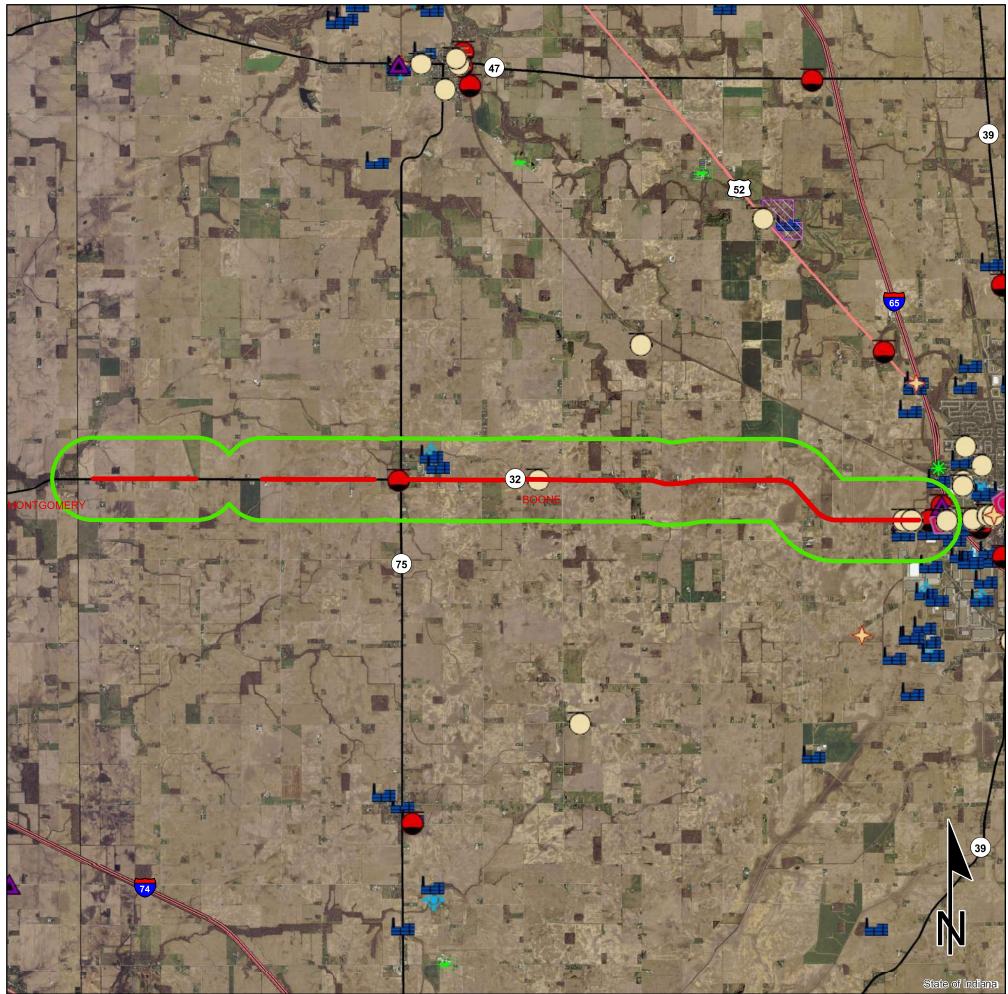
Limited Red Flag Investigation - Hazardous Material Concerns SR 32, 3.69 Miles West of SR 75 to 0.5 Mile West of I-65 Des. No. 1800060 and 1900361, Passing Lane and Minor Structure Overlay Boone County, Indiana

Shell Oil Lebanon Westside Station, 1230 West SR 32 (AI ID 2543), is incorrectly mapped within the east portion of the project area. The site is actually located approximately 0.30 mile east of the project area. IDEM issued a UST Inspection on December 1, 2020, and the facility was found to be out of compliance with equipment, operating, and maintenance requirements set forth in Indiana's UST Rule 329 IAC 9. IDEM issued a Return to Compliance Letter for the site on January 28, 2021. No impact is expected.

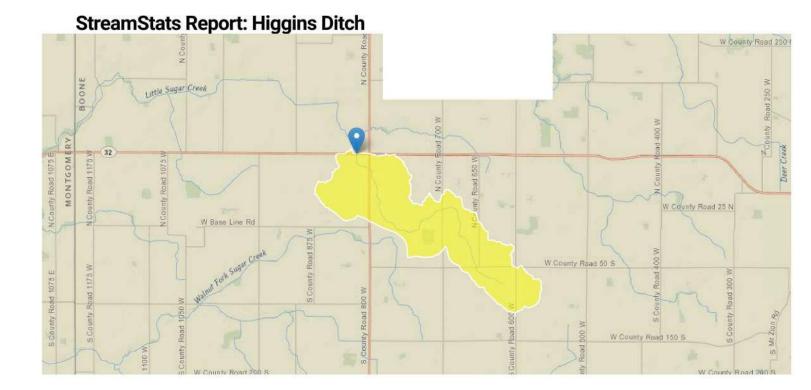
Basin Characteristics

Parameter Code	Parameter Description	Value	Unit
CONTDA	Area that contributes flow to a point on a stream	2.425	square miles
DRNAREA	Area that drains to a point on a stream	2.425	square miles
K2INDNR	Average hydraulic conductivity (ft/d) for the full depth of unconsolidated deposits from InDNR well database.	11	ft per day
T2INDNR	Average transmissivity (ft2/d) for the full depth of unconsolidated deposits from InDNR well database.	1046	square feet per day
