LOUISVILLE - SOUTHERN INDIANA
OHIO RIVER BRIDGES PROJECT

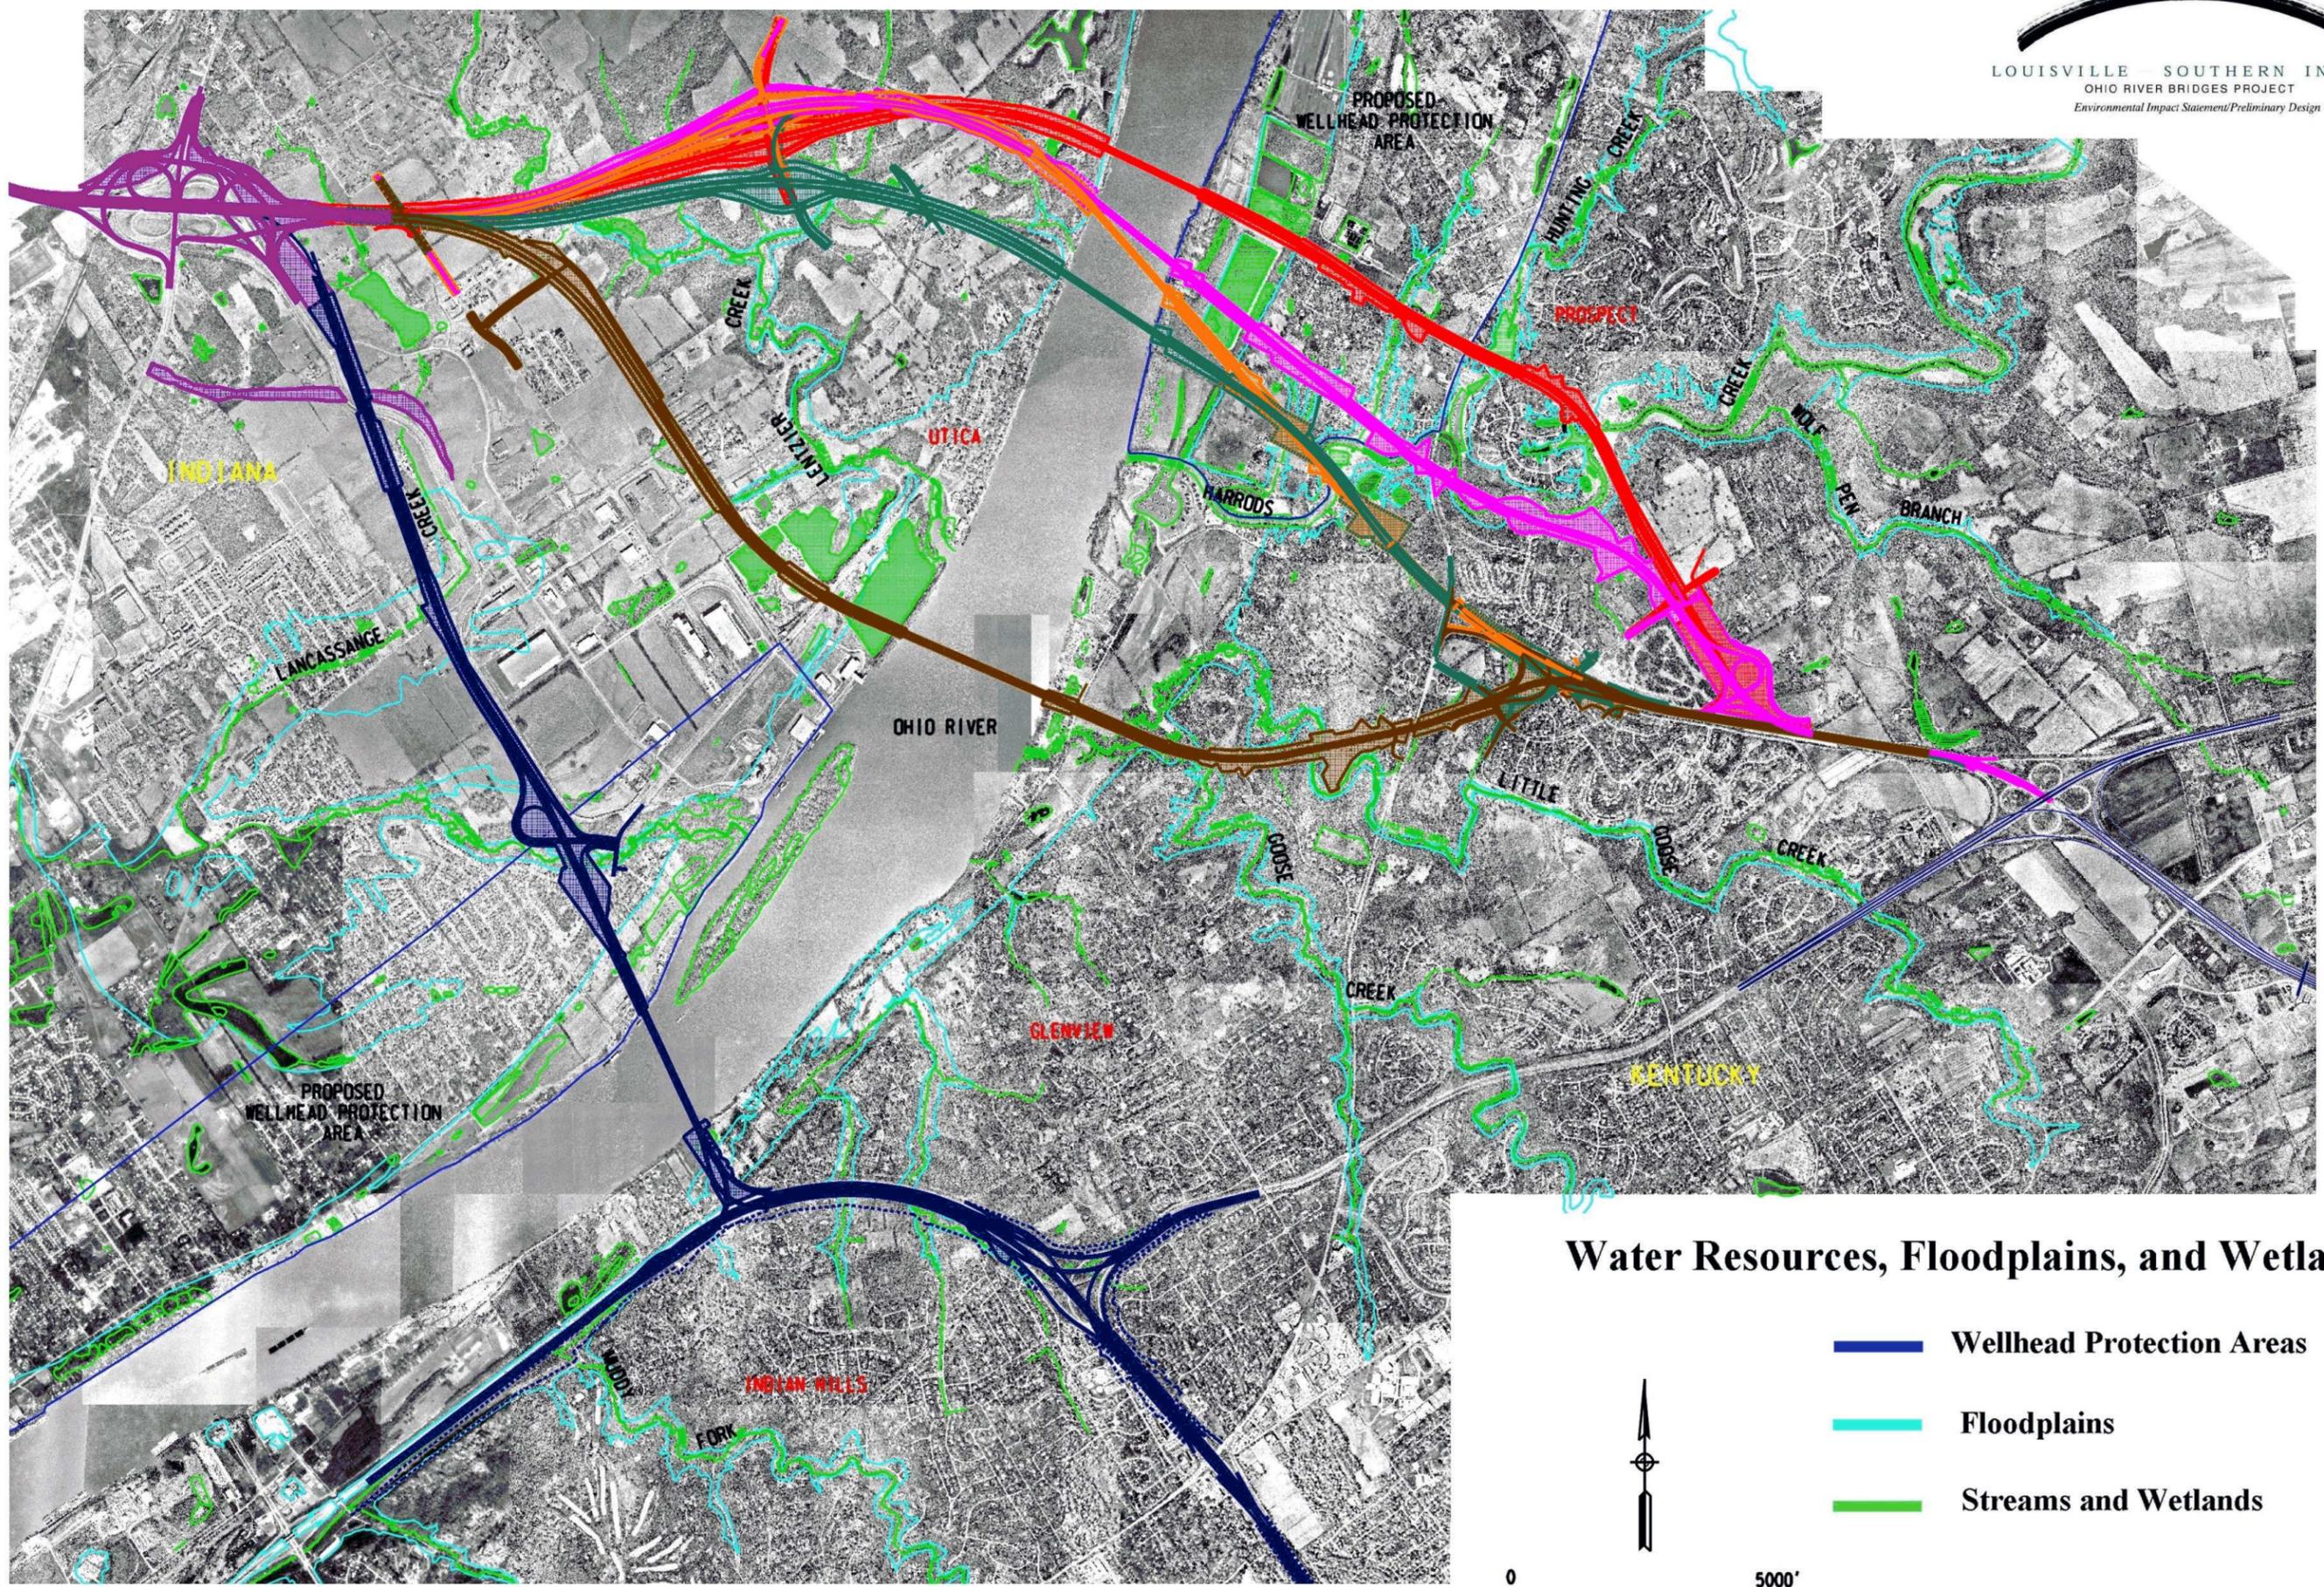
Figure 4.8-1a

Water Resources, Floodplains, and Wetlands

- Wellhead Protection Areas
- Floodplains
- Streams and Wetlands

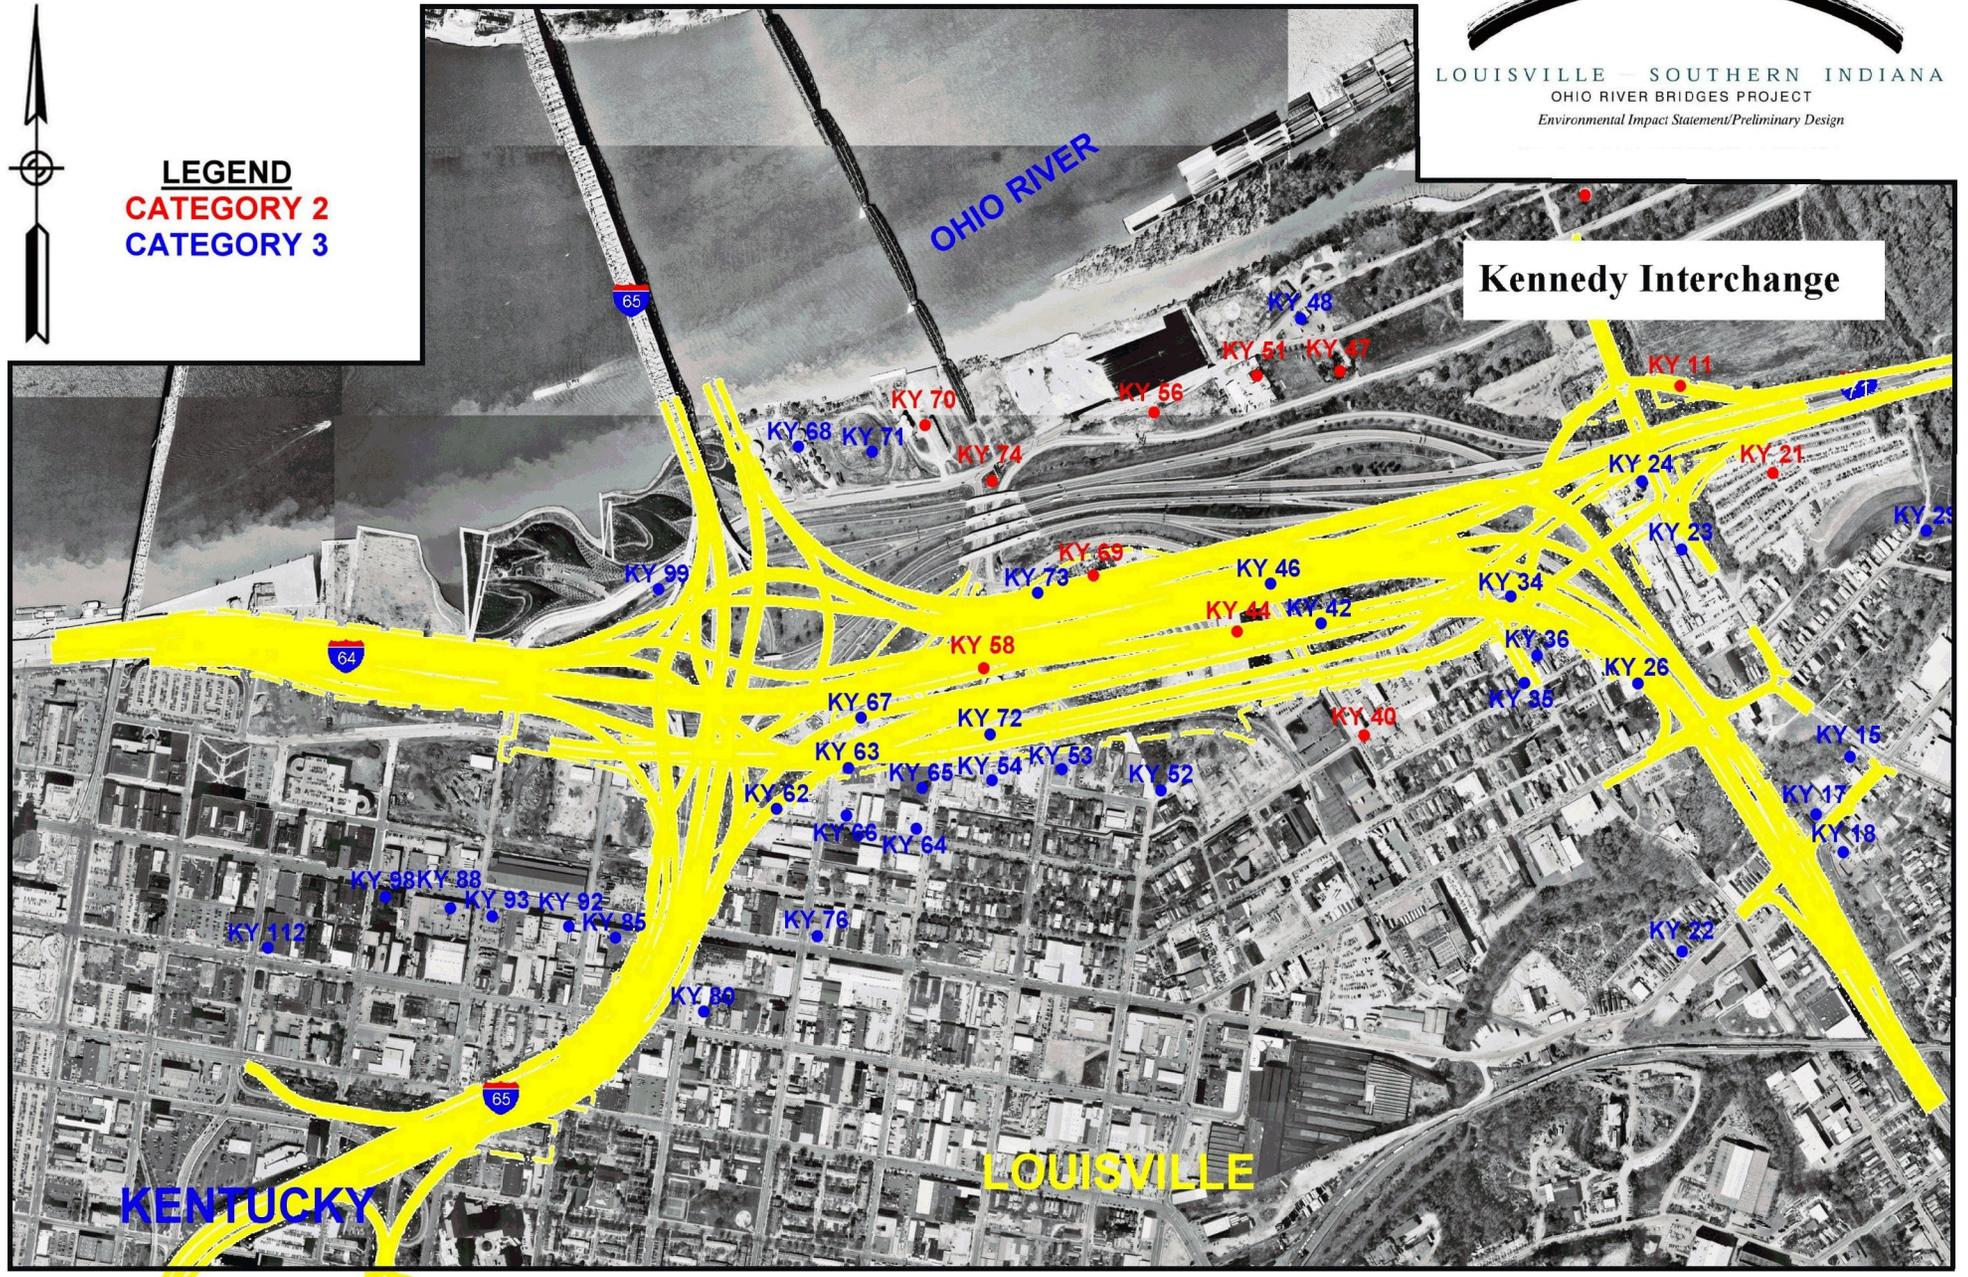
Figure 4.12-1b

Hazardous Materials Sites

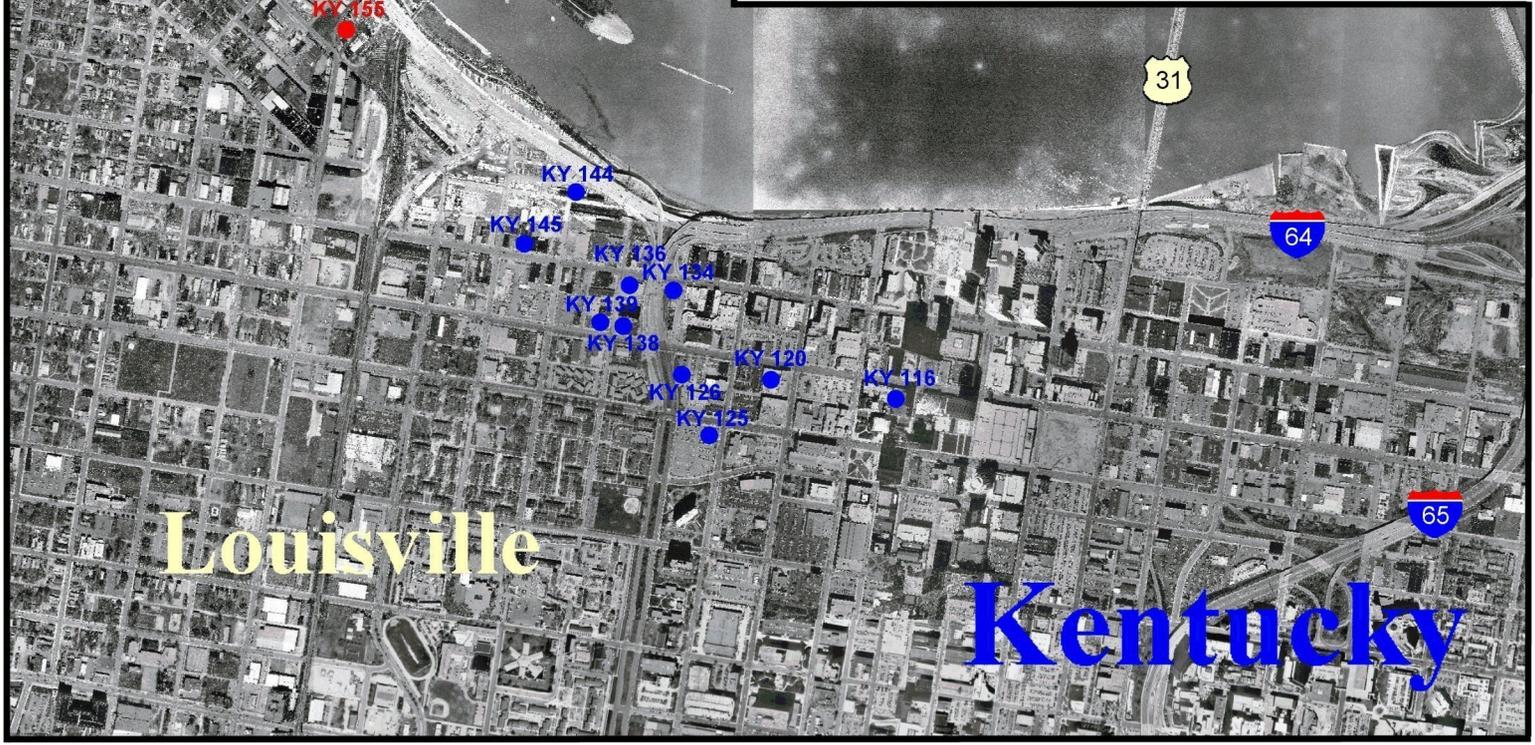
Figure 4.12-1c

Hazardous Materials Sites

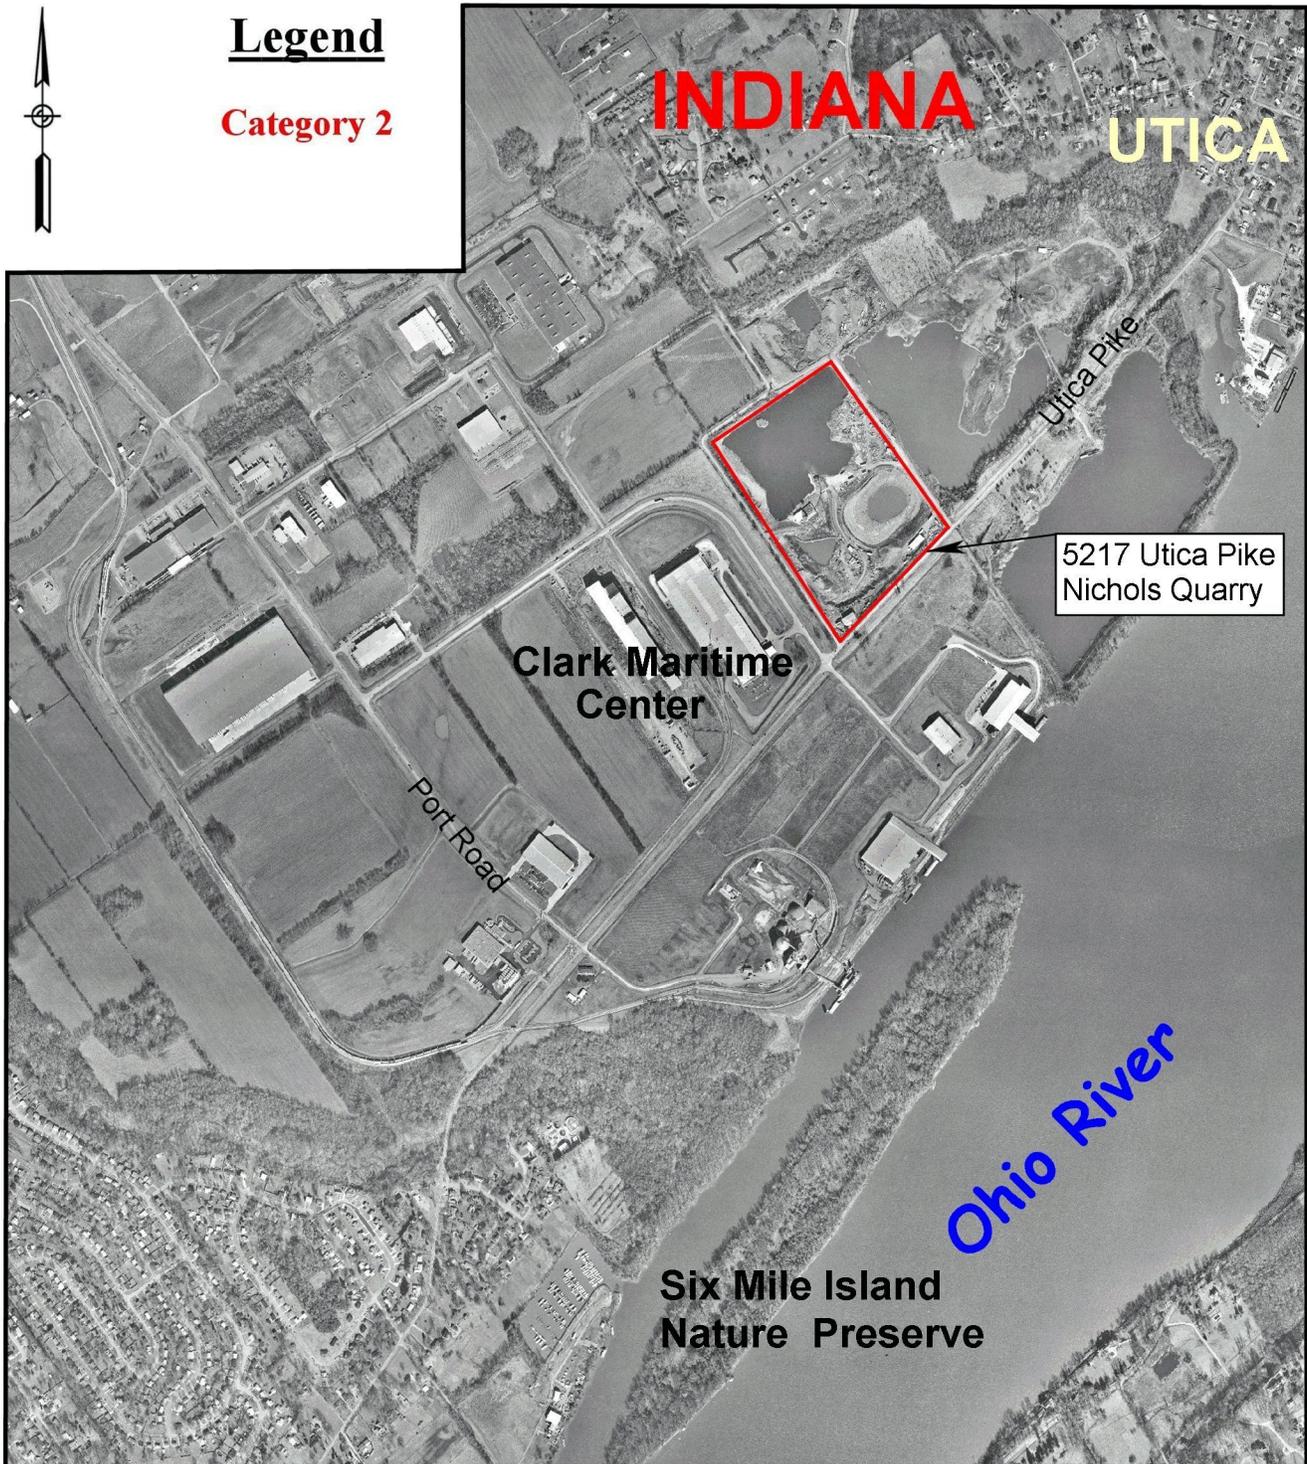
Figure 4.12-1d

Hazardous Materials Sites
