# Deep River-Portage Burns Waterway Initiative

Public Meeting  
Hobart Community Ctr.  
July 15, 2014

# Deep River-Portage Burns Waterway Baseline Assessment & TMDL Study

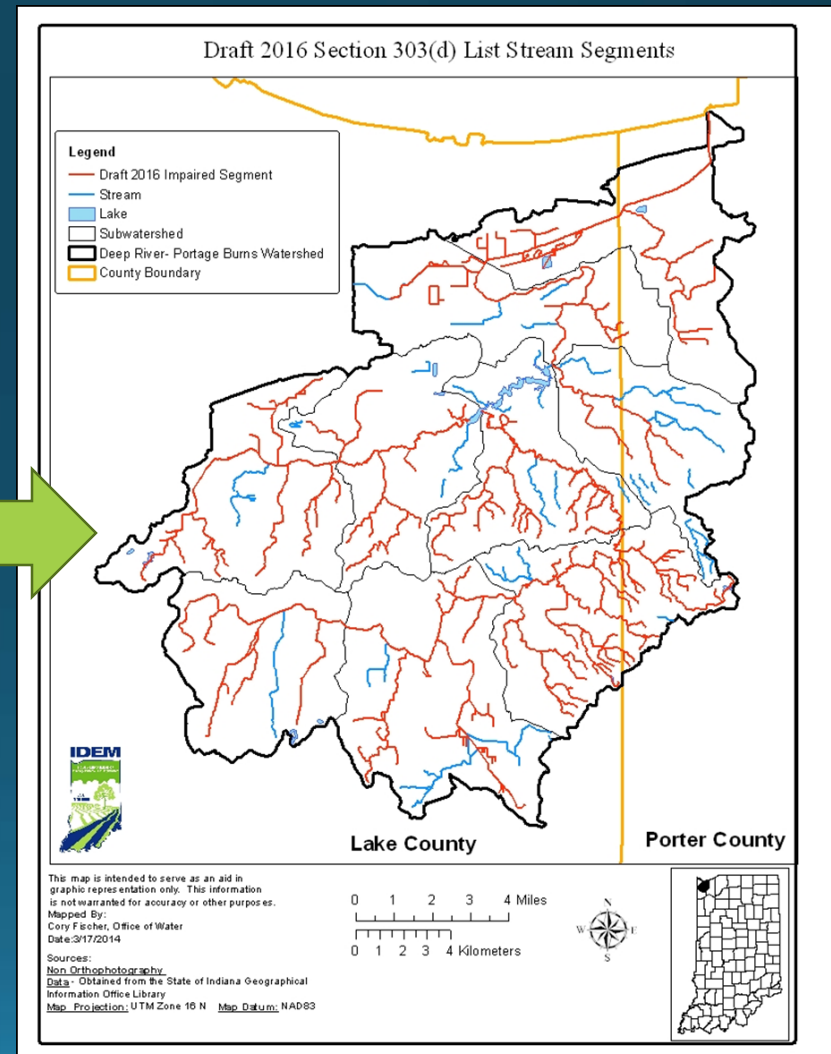
# Impaired Waterbodies

Impairment	2012 Impaired Miles	2016 Impaired Miles	Impaired Stream Miles Changed
IBC	92	225	+133
E. coli	51	210	+159
Nutrients	0	61	+61
Dissolved Oxygen	15	97	+82
PCBs Fish Tissue	34	34	0
Siltation	12	12	0
Free Cyanide	9	9	0

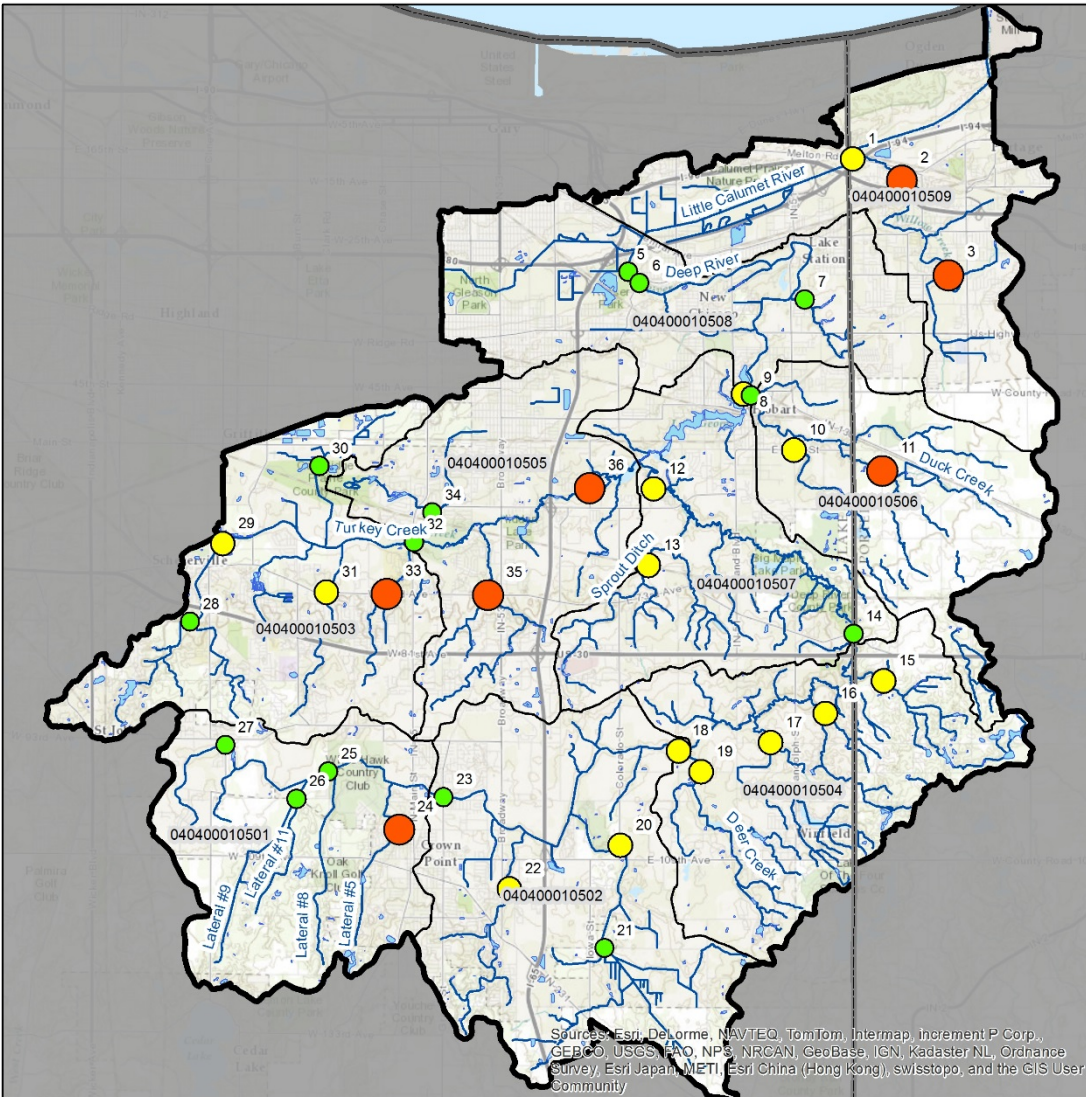
# E. coli

**Median Concentration**

**E. coli**

- 73 - 285
- 286 - 613
- 614 - 1,300

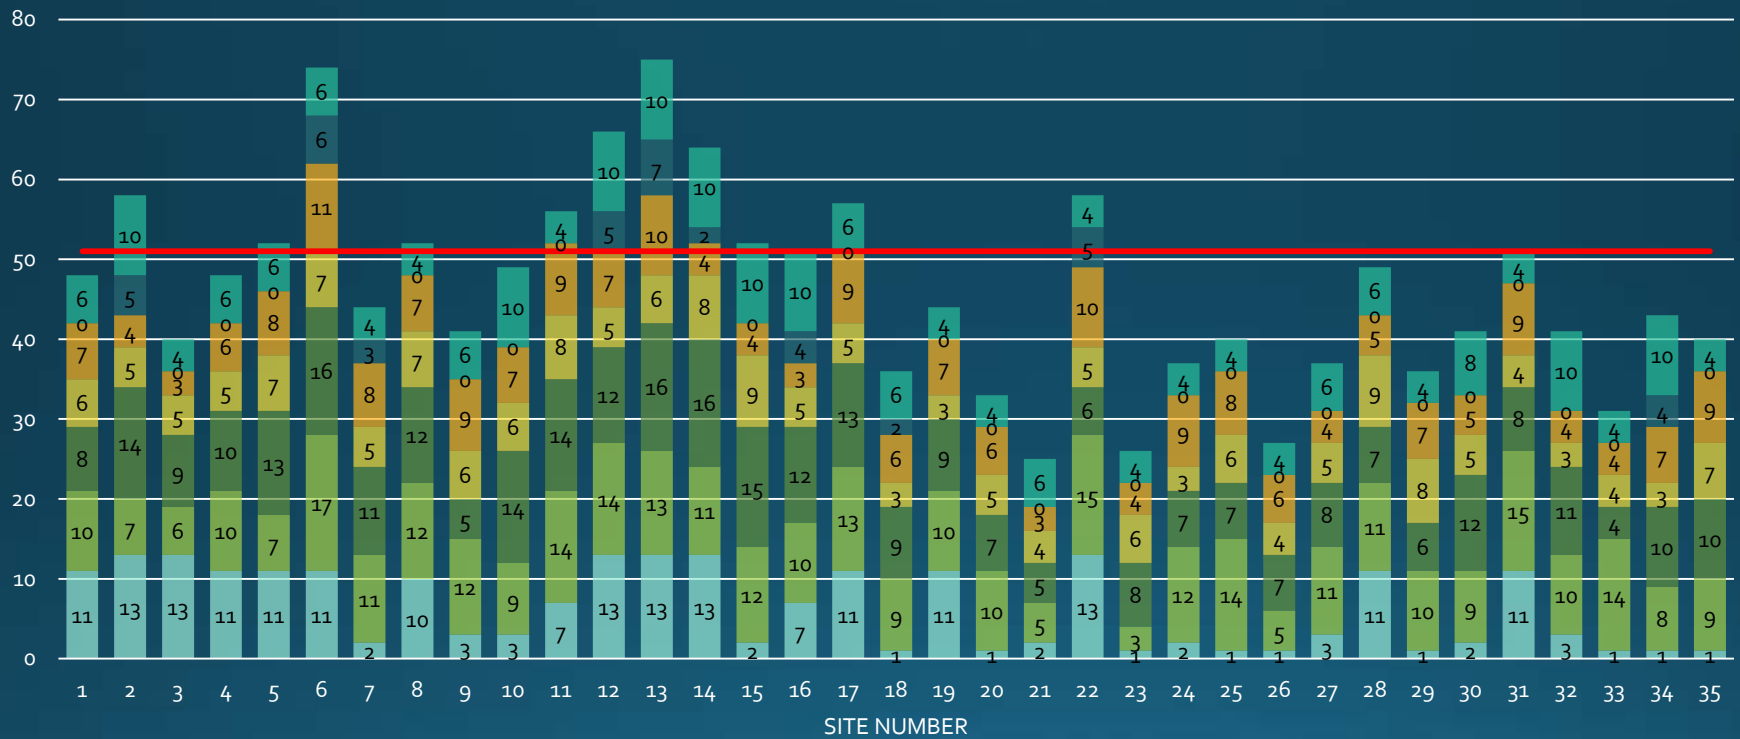
# Habitat Evaluation Scoring

■ Substrate  
 ■ Cover  
 ■ Channel  
 ■ Riparian  
 ■ Pool/Current  
 ■ Riffle/Run  
 ■ Gradient  
 — Minimum
