HAZARDOUS AND REGULATED MATERIALS INSPECTION REPORT

Genesis Convention Center
401 Adams Street
Parcel ID: 45-08-282-001
Gary, IN 46402

Egis
48797 Alpha Drive, Suite 130
Wixom, MI 48393
Egis Project ID: 240100
August 12, 2025

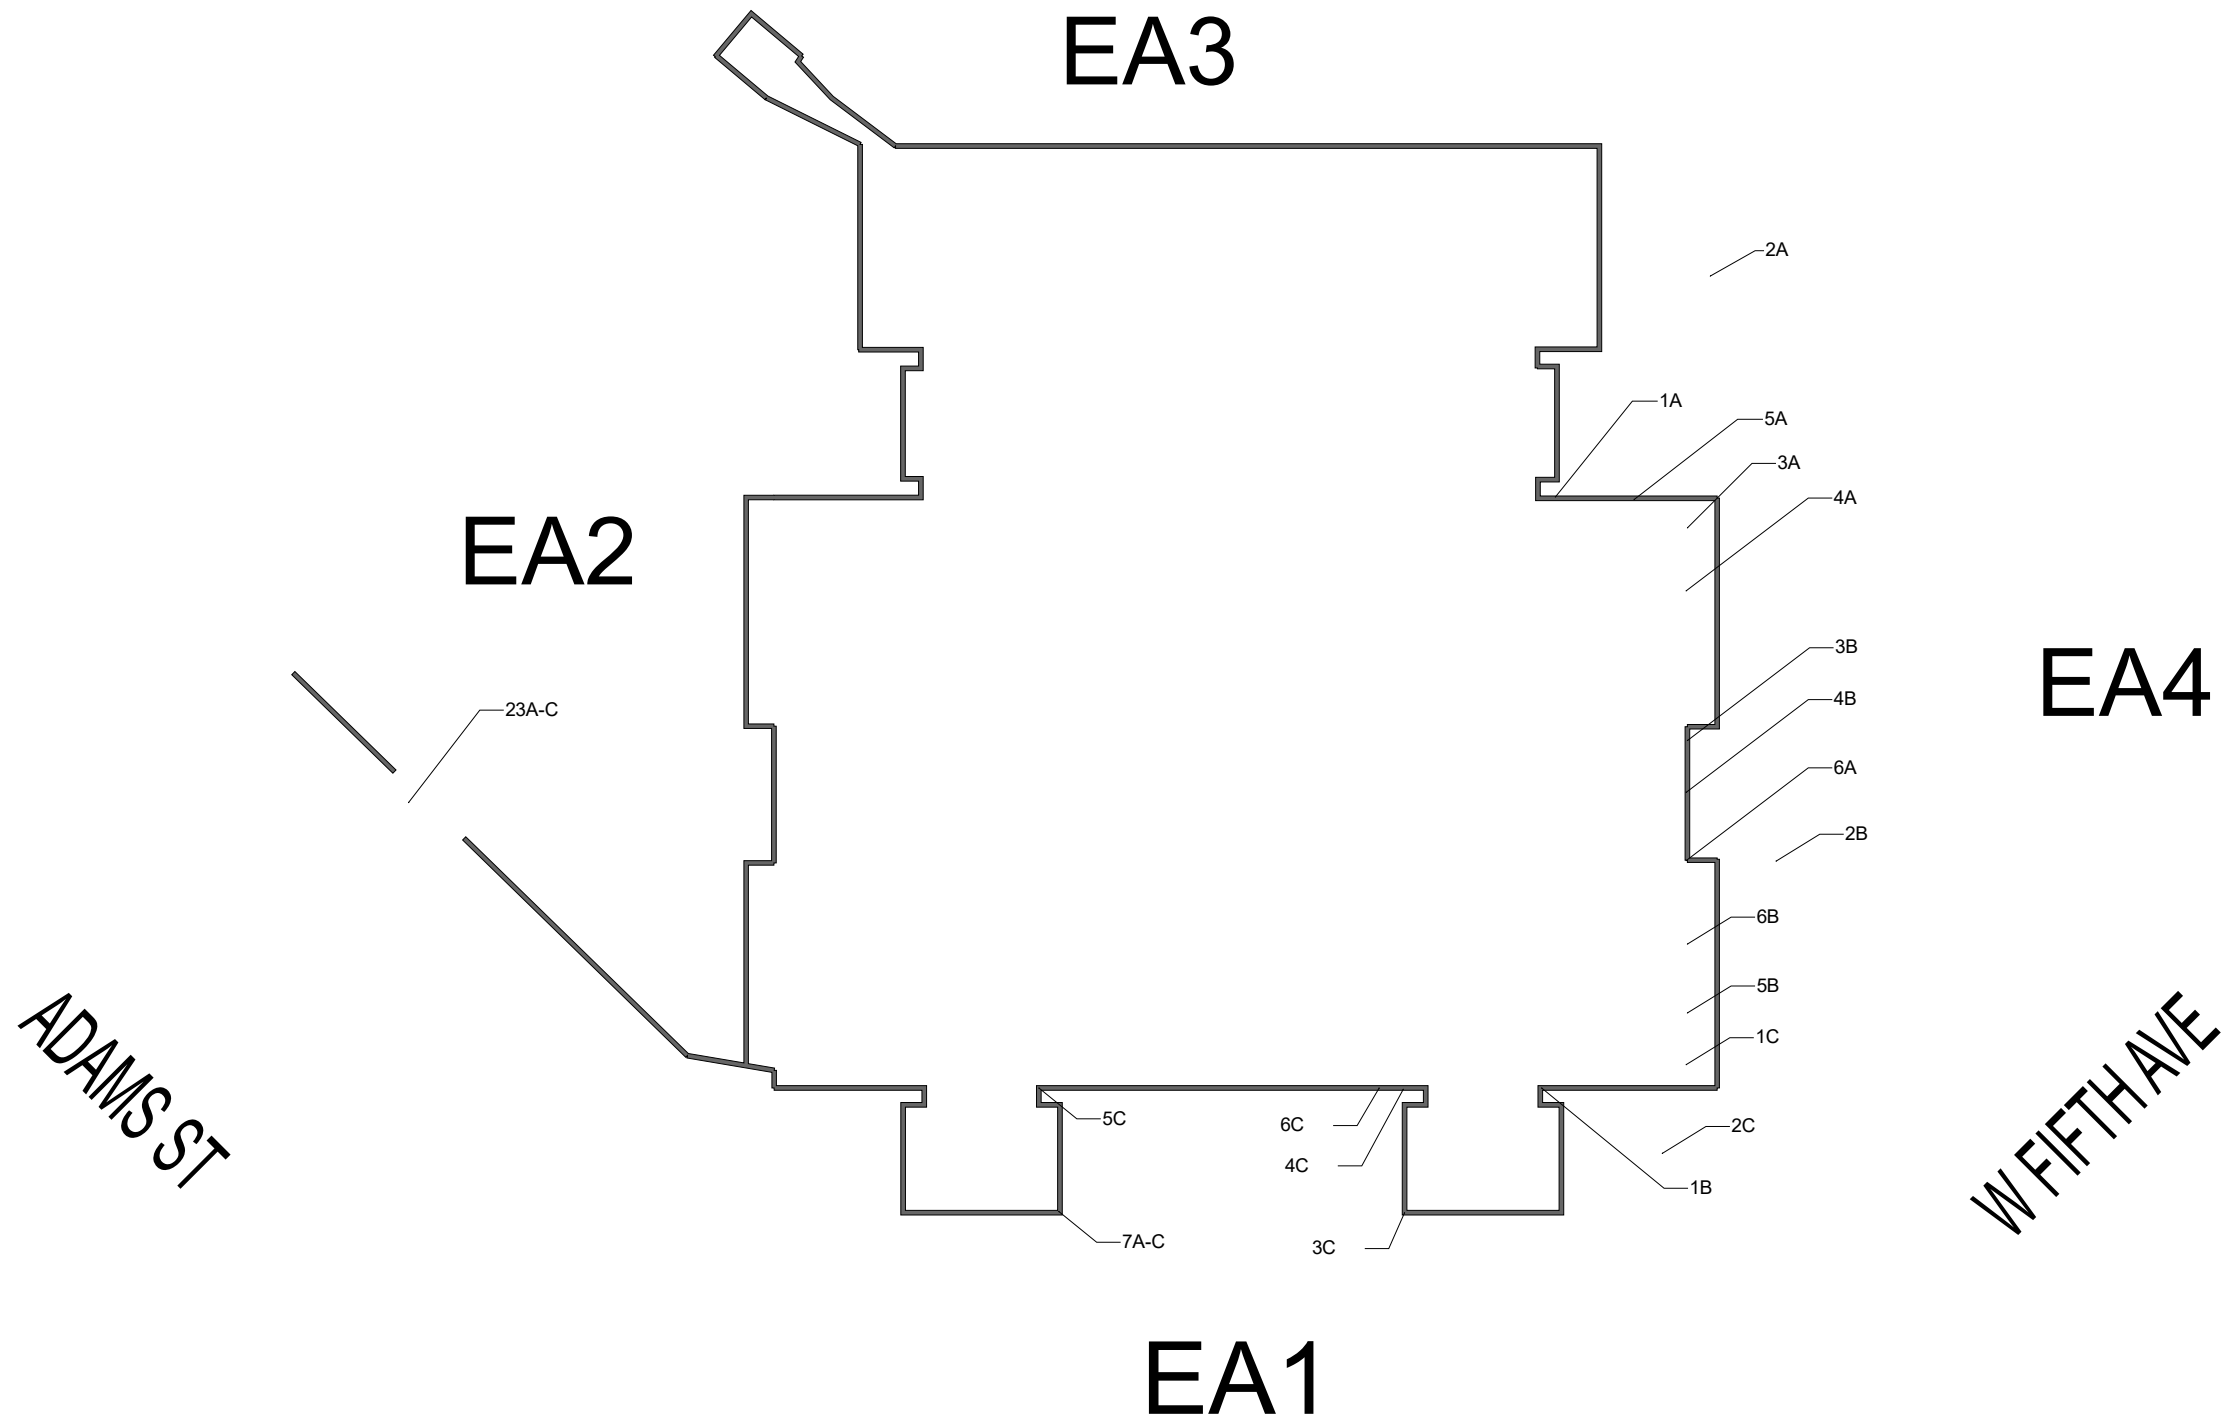
Figure 1- Exterior
 401 Adams St - Genesis Convention
 Center
 Gary, Indiana 46402

Approximate Building Area 90,390 SF

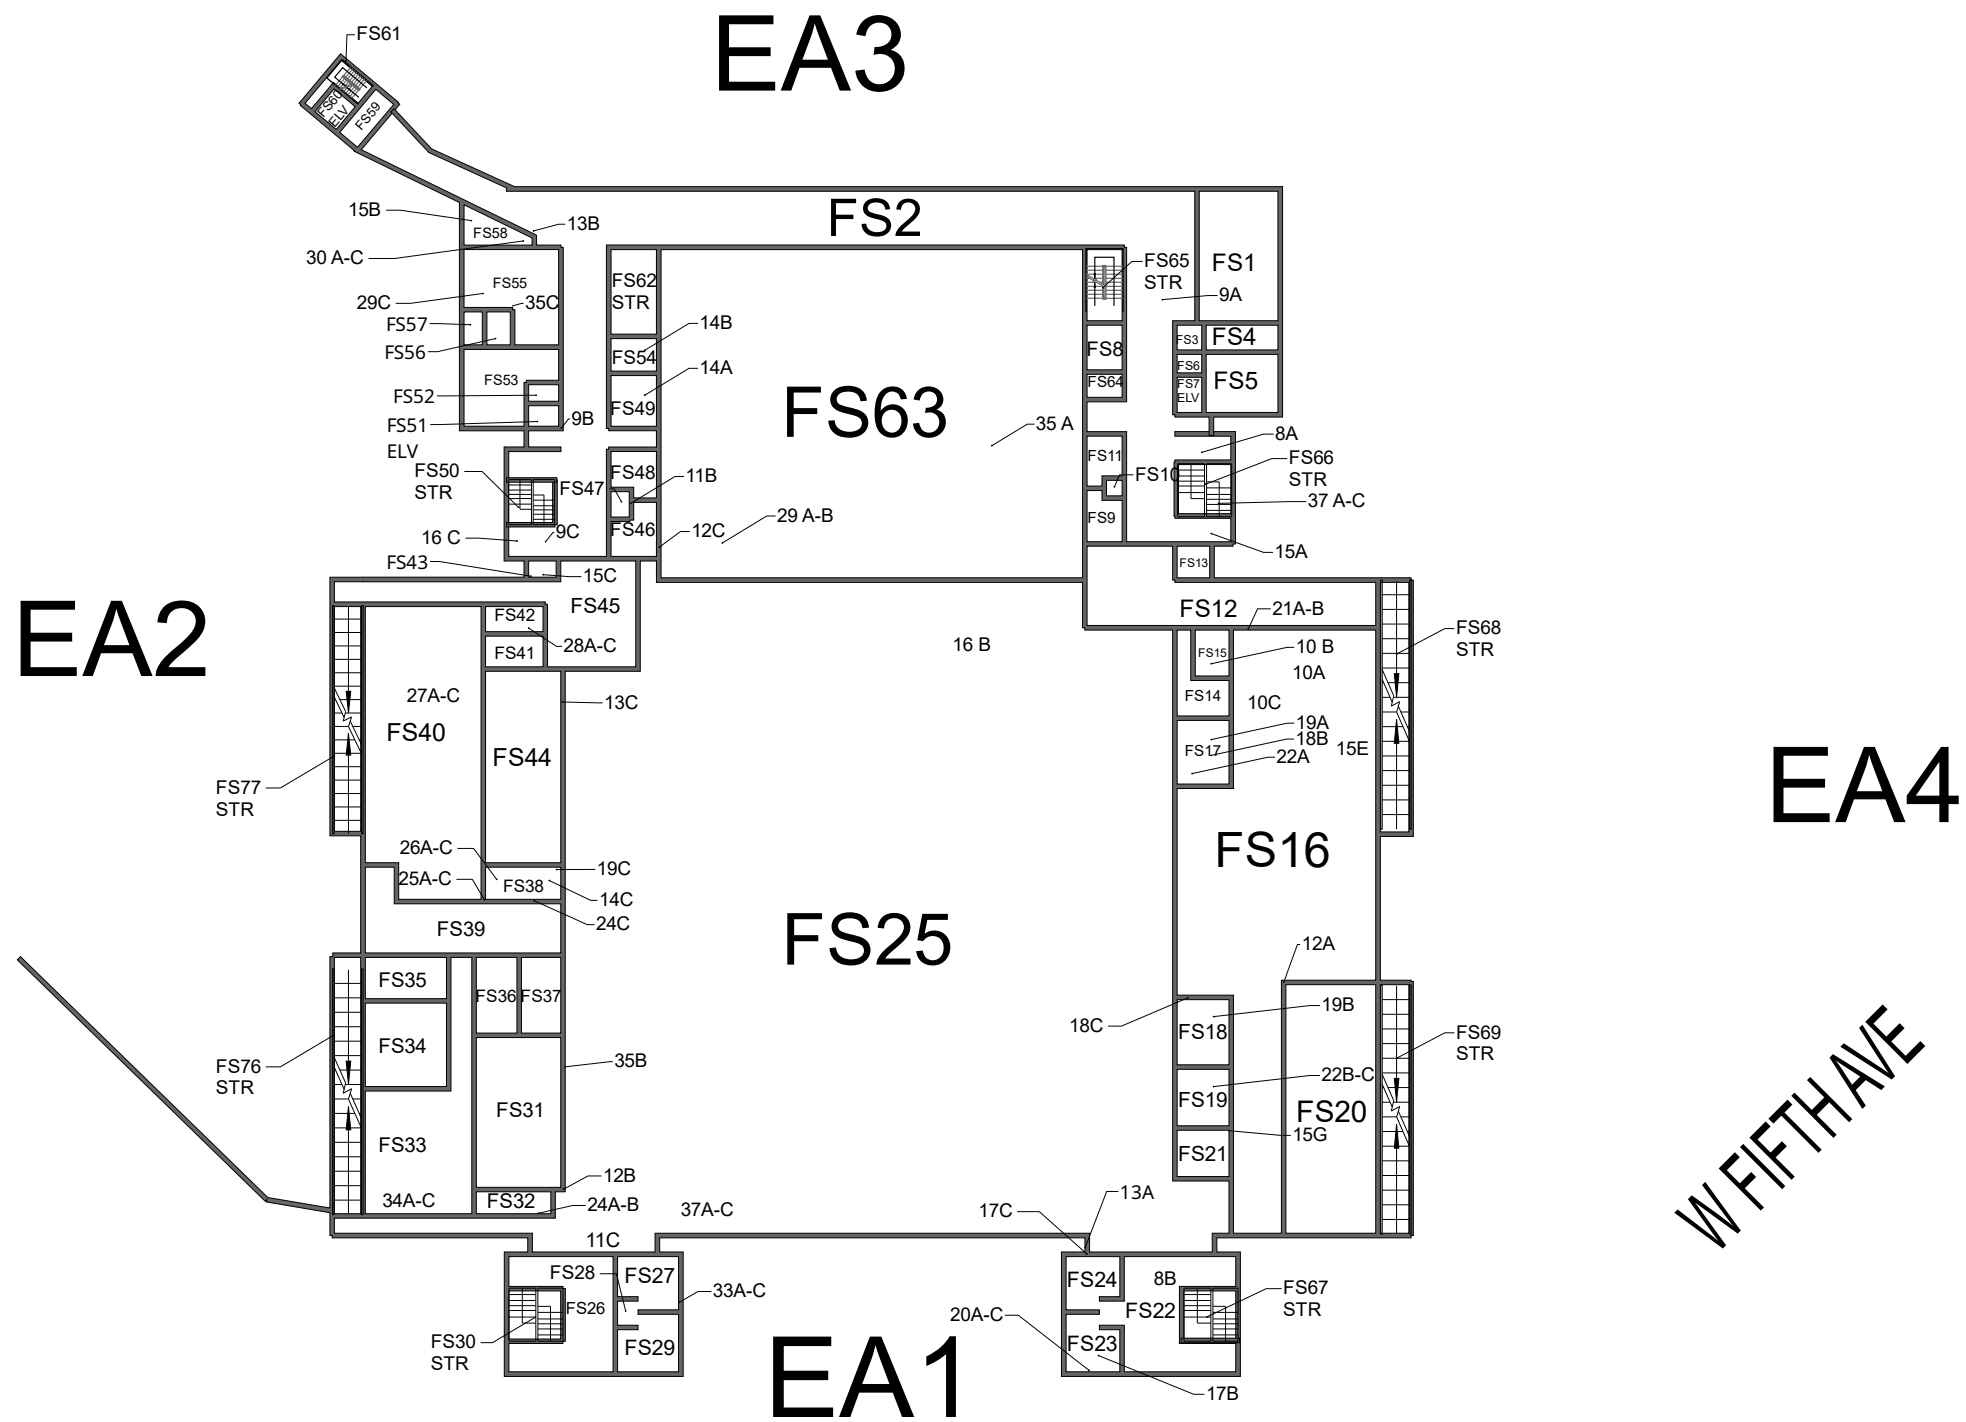
Figure 2- First Floor
 401 Adams St - Genesis Convention Center
 Gary, Indiana 46402

- Sample location
- ACM Sample Location
-

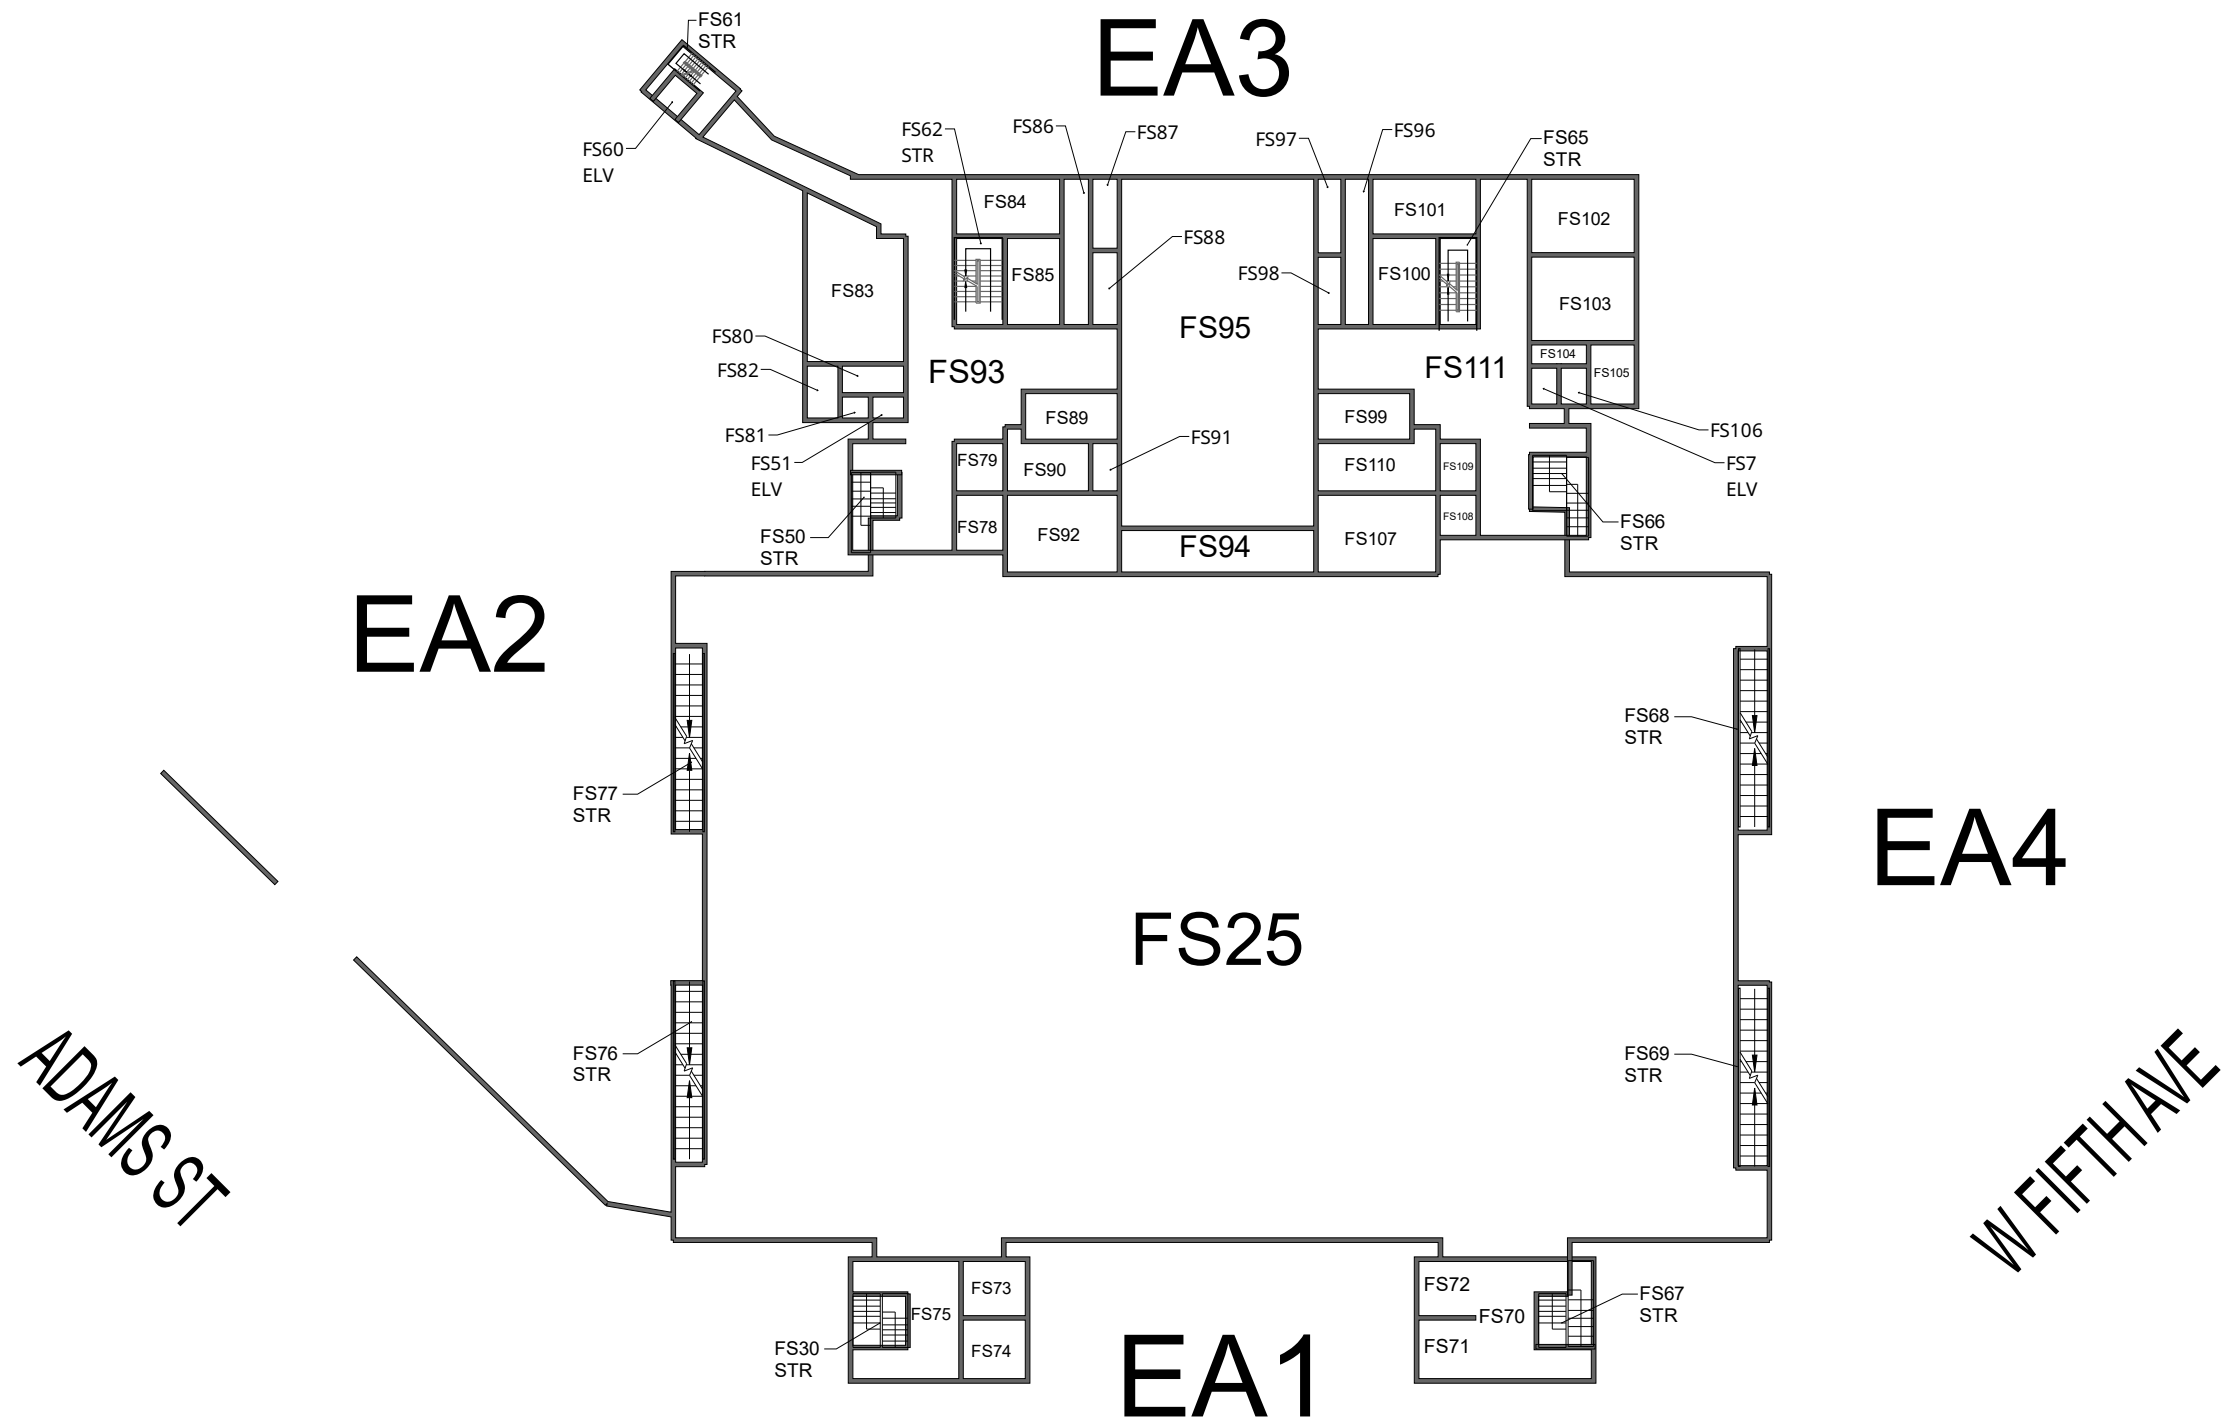
Figure 3 - Second Floor
401 Adams St - Genesis Convention Center
Gary, Indiana 46402

Approximate Building Area 90,390 SF

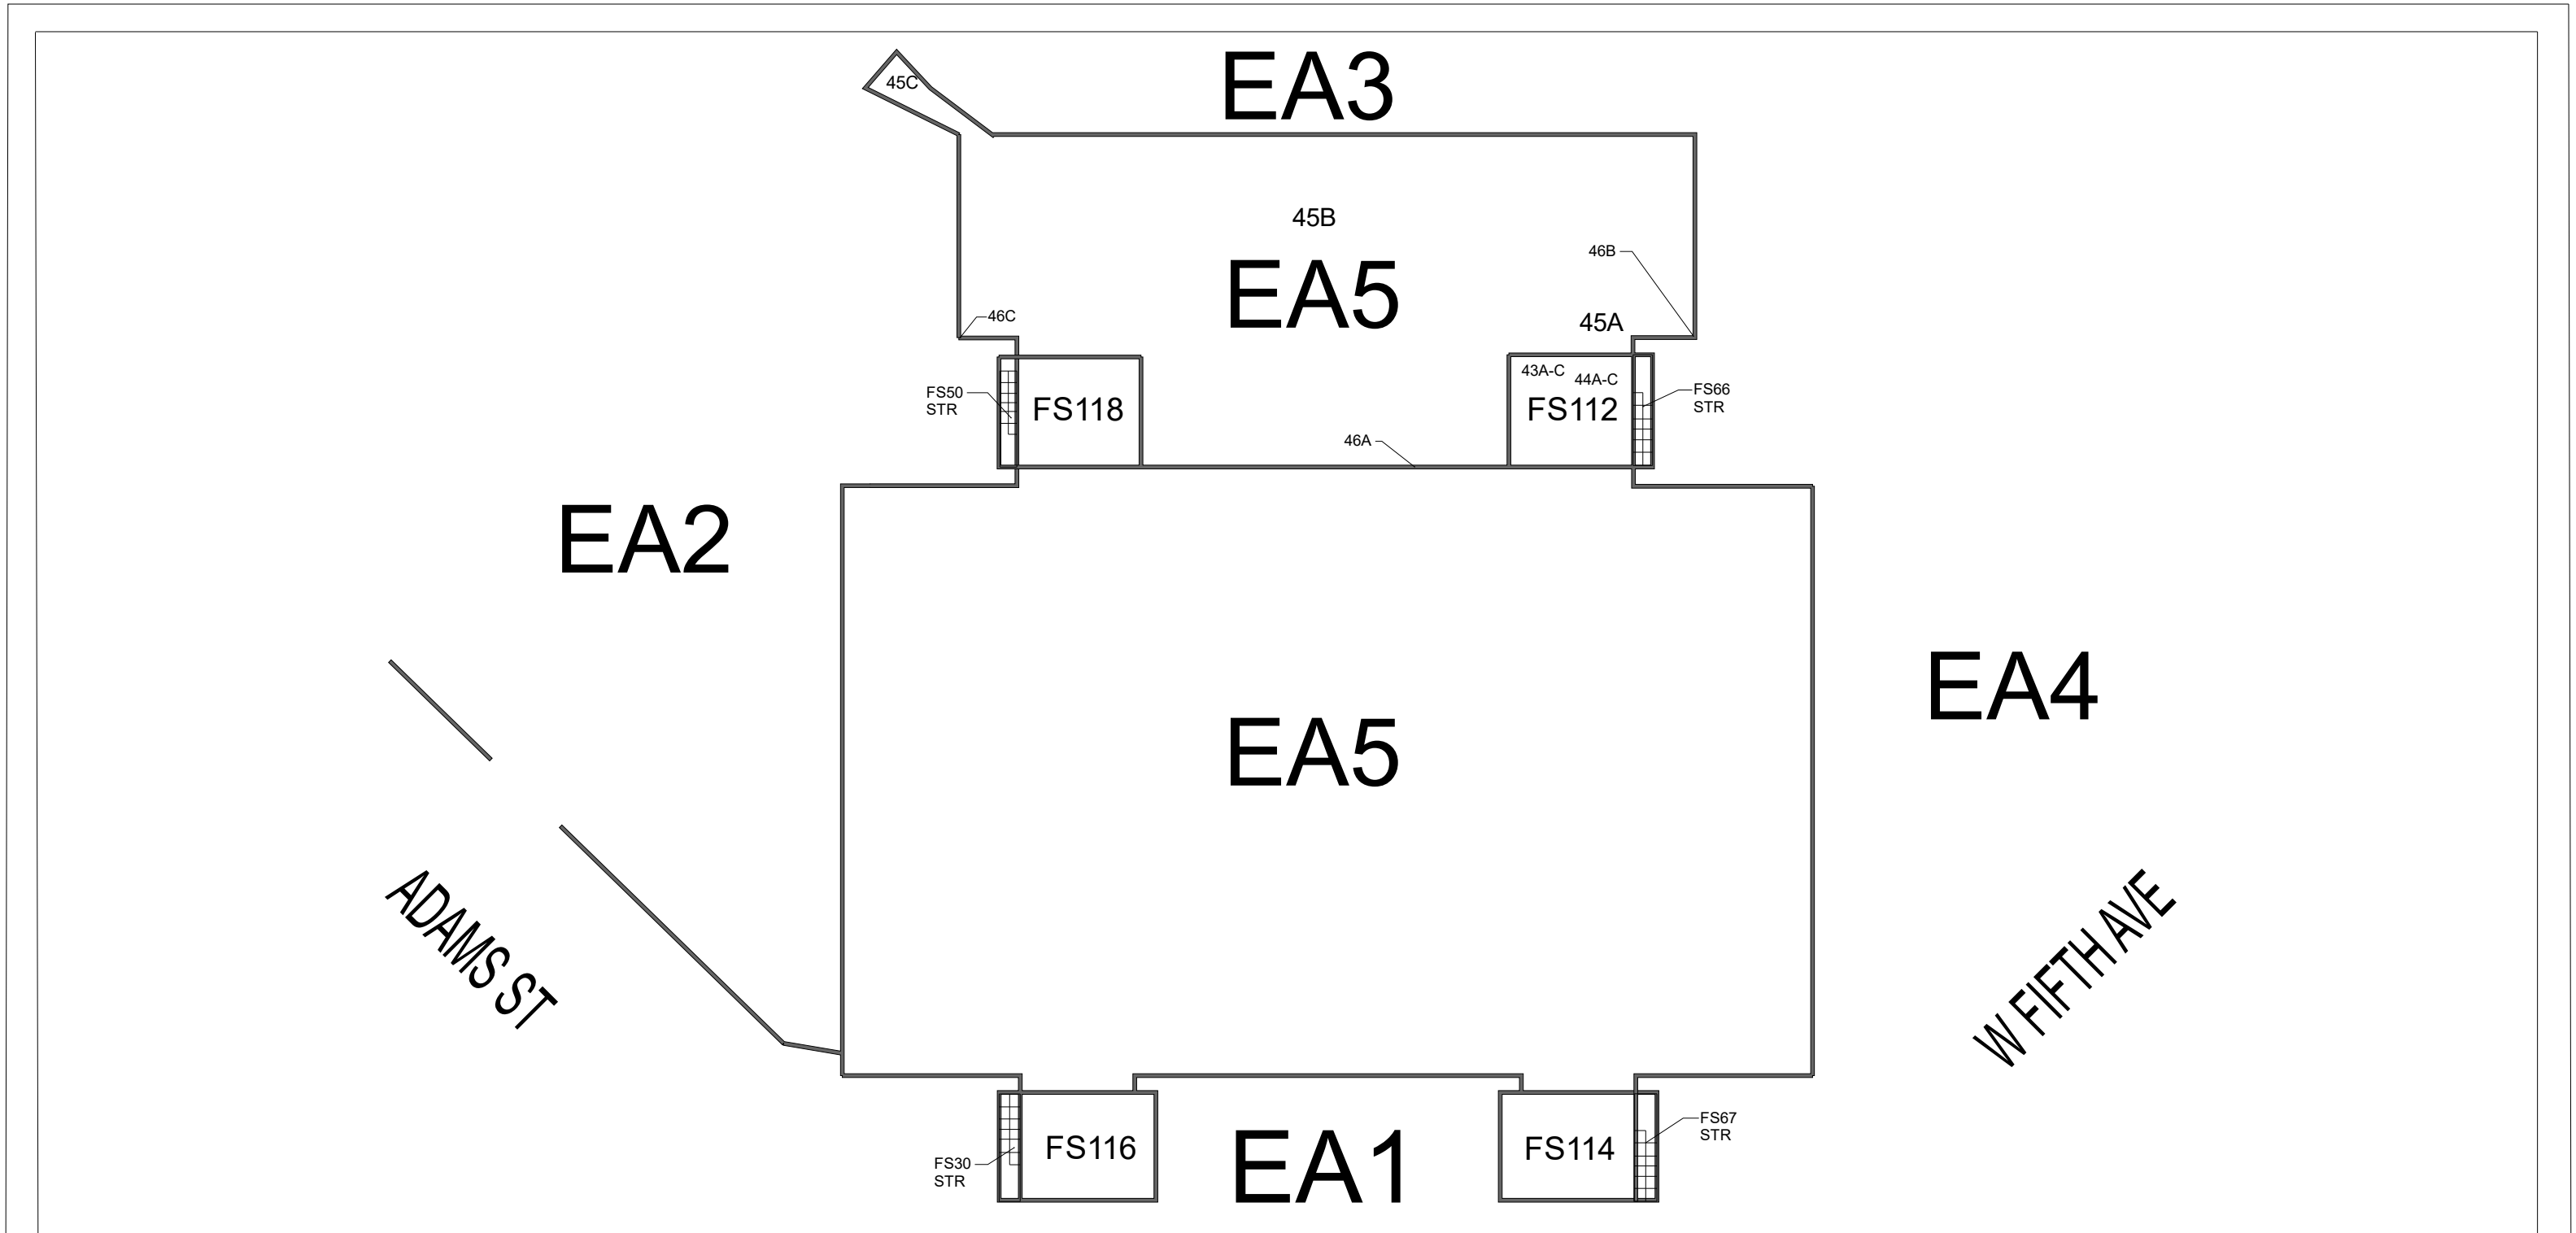
Figure 4 - Third Floor
401 Adams St - Genesis Convention Center
Gary, Indiana 46402

- Sample location
- ACM Sample location
-

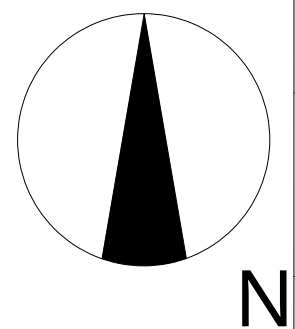
Approximate Building Area 90,390 SF

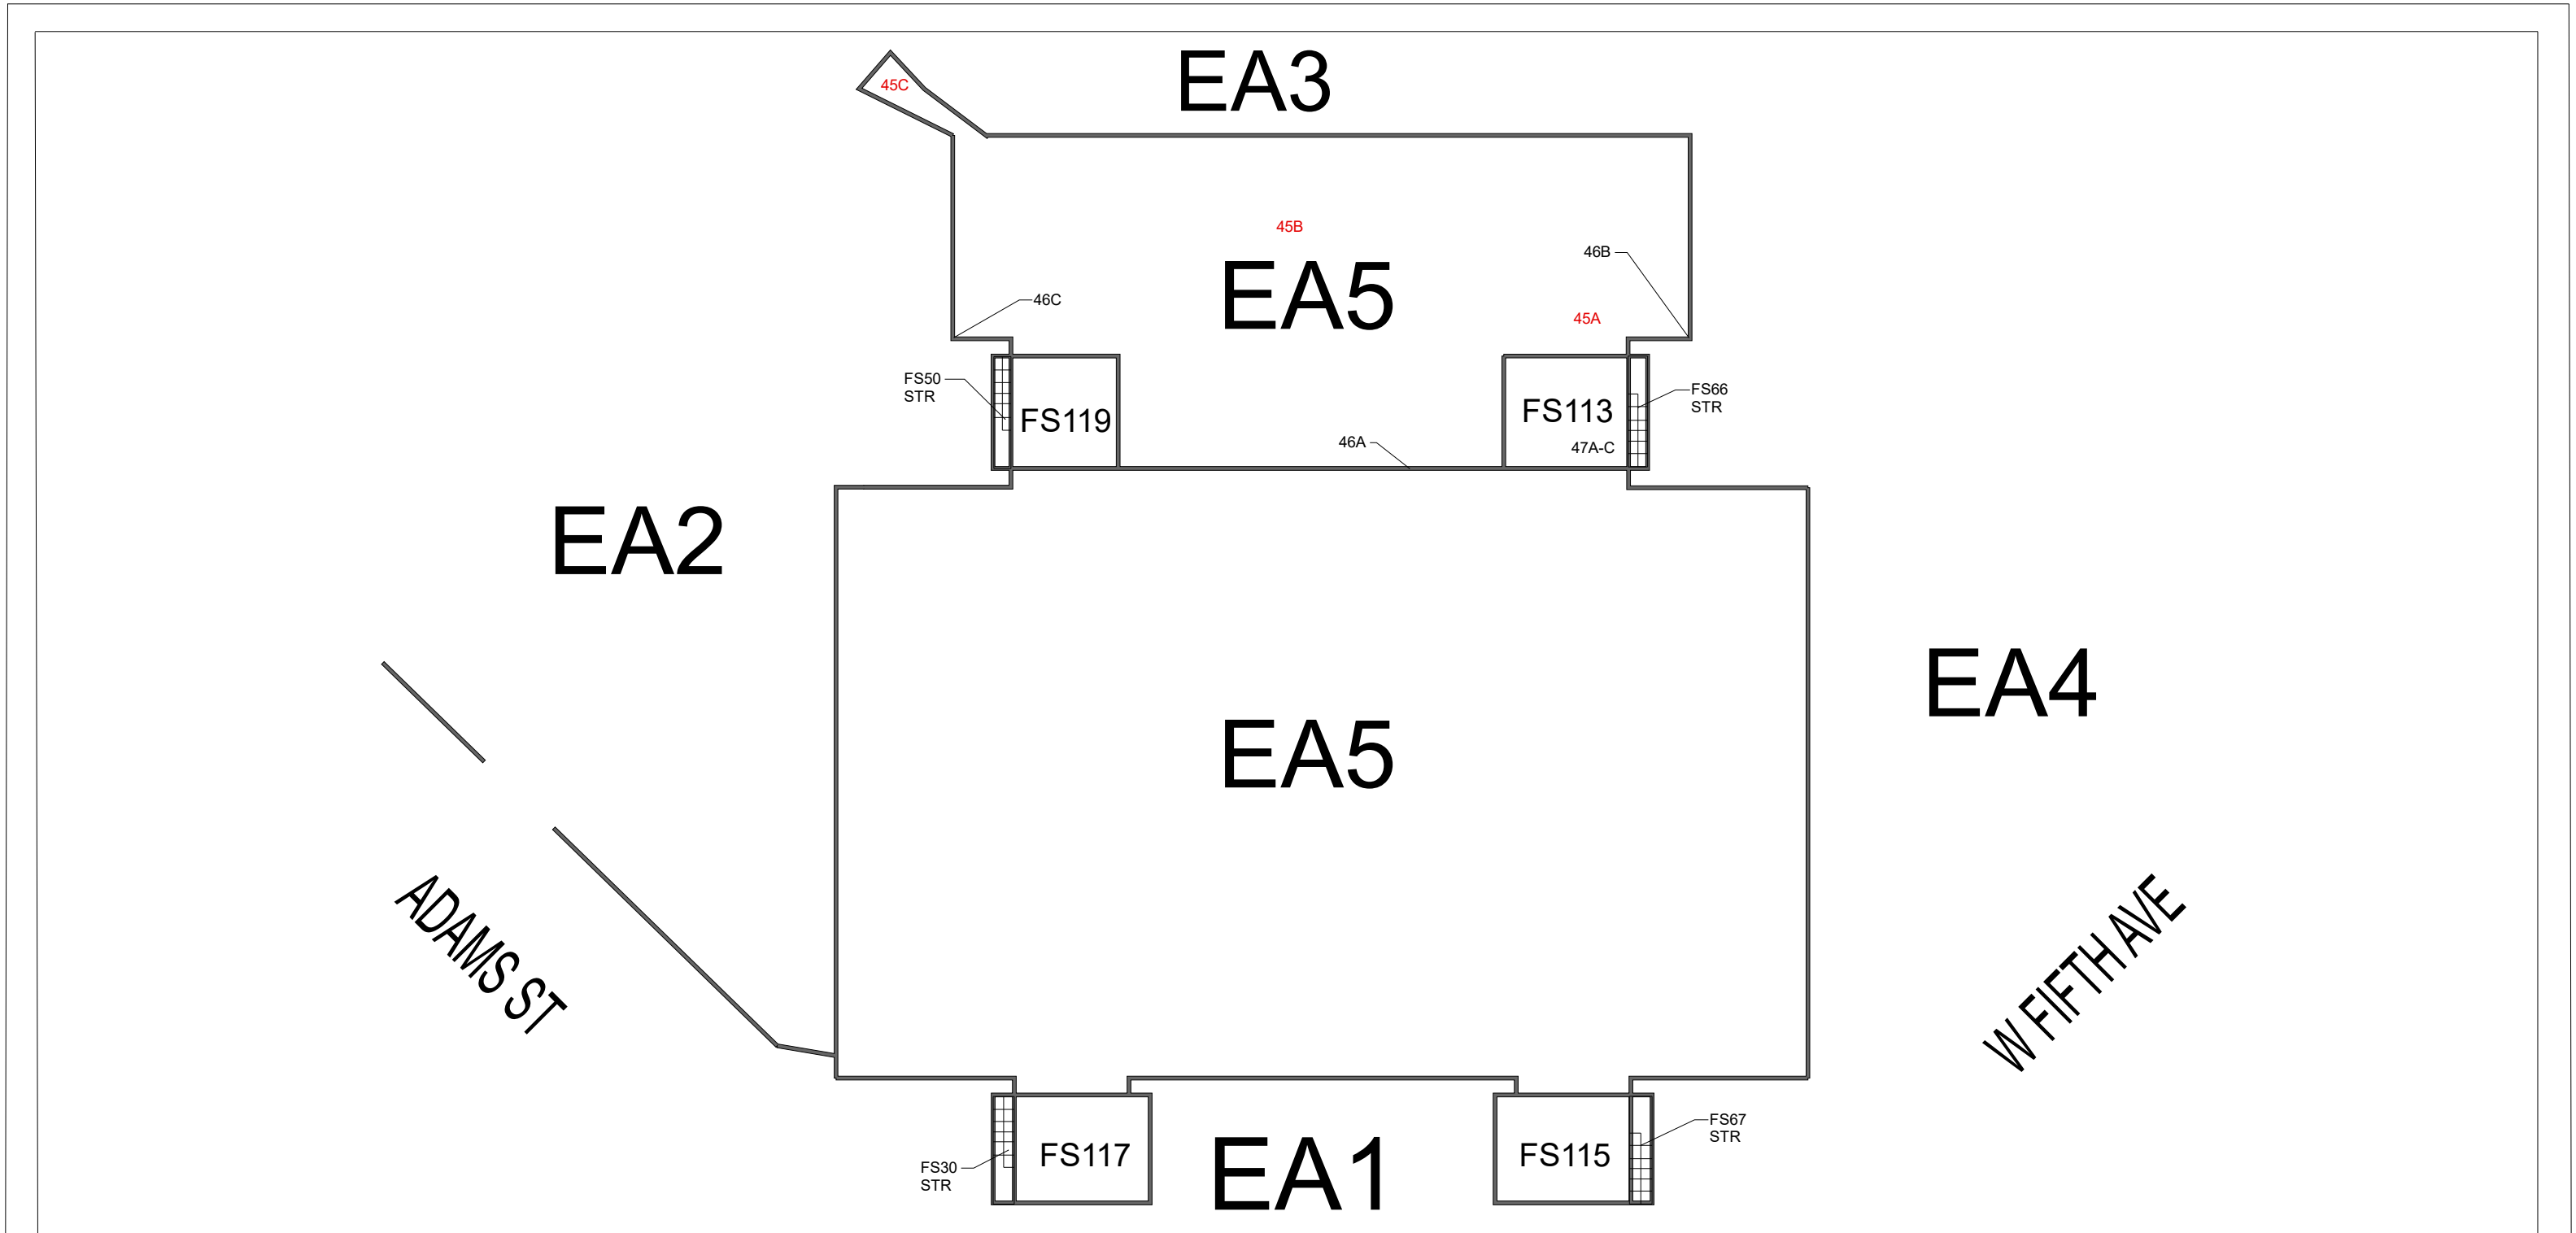
- Sample location
- ACM Sample location
- Functional space inaccessible
- Staircase

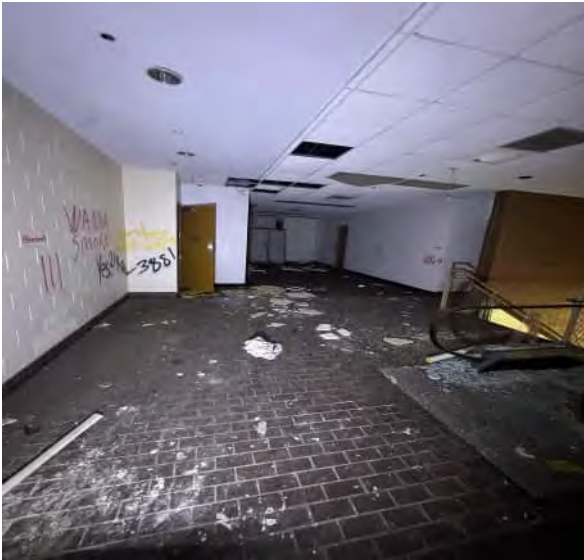
Photo 137: FS 111

Air Conditioners	FS2; FS5; FS16; FS25; FS30; FS32; FS33; FS35; FS39; FS42; FS45; FS48; FS53; FS54; FS66-FS69; FS71-FS77; FS93; FS111; FS112; FS113; FS115; FS117; FS118	67 UNITS	(3) 20 LB containers of Refrigerant (FS112)
Tires	EA2	2 UNITS	Car
Fridge, Freezer, Blast Chillers	FS16; FS40; FS41; FS76; FS100; FS112	9 UNITS

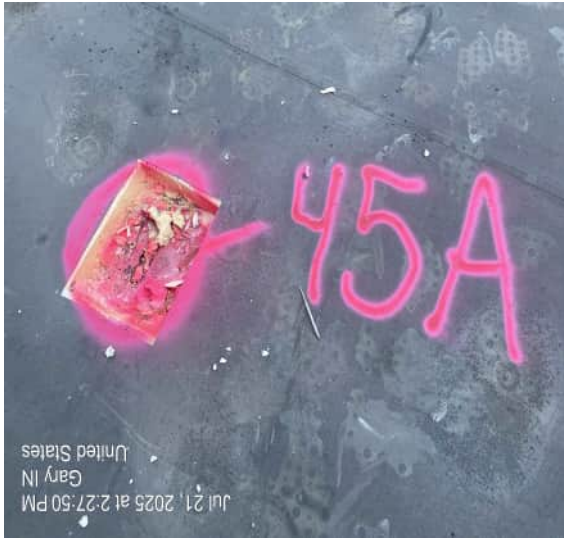
Photo 193: HA-45 (Positive ACM)
