Monitoring Results for State Forest Properties • 1996-2021

Indiana Forestry Best Management Practices

DNR
Indiana Department
of Natural Resources

Indiana State Forest BMP Report

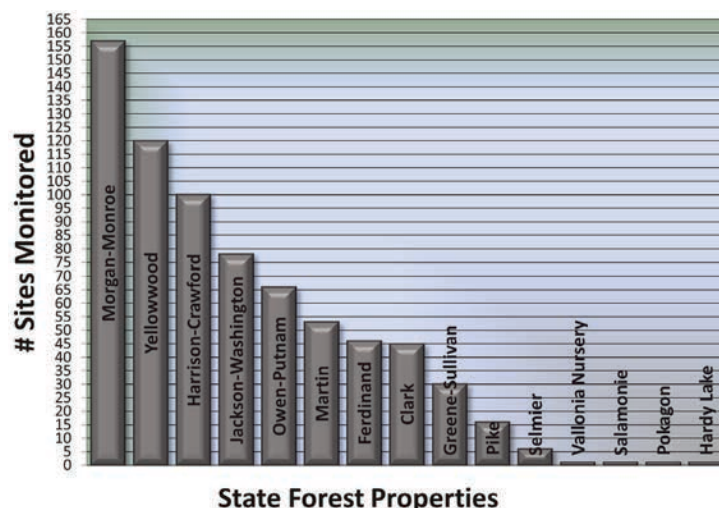
FIGURE 1

Figure 1. Timber harvests monitored for BMPs in Indiana State Forests and other DNR properties, by property.

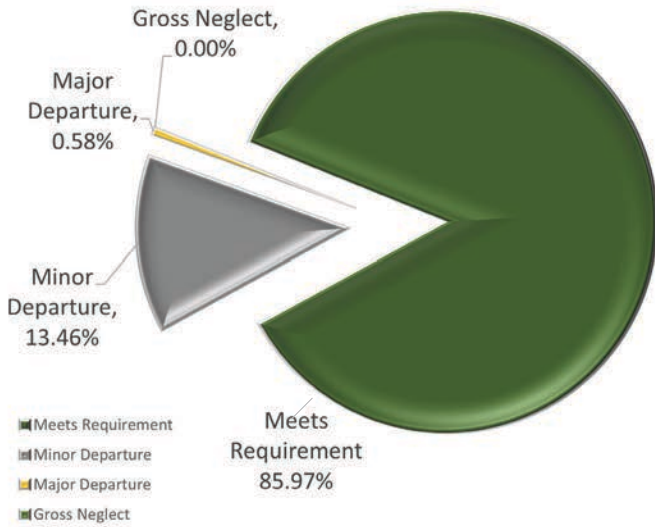
FIGURE 3

Figure 3. BMP application for 721 State Forest sites monitored from 1996-2021.

The application and effectiveness rates for BMPs used to protect sites after timber harvests are excellent for the 721 state forest sites monitored since 1996. The overall application rate is 85.97%, and the overall effectiveness rate is 91.90%.

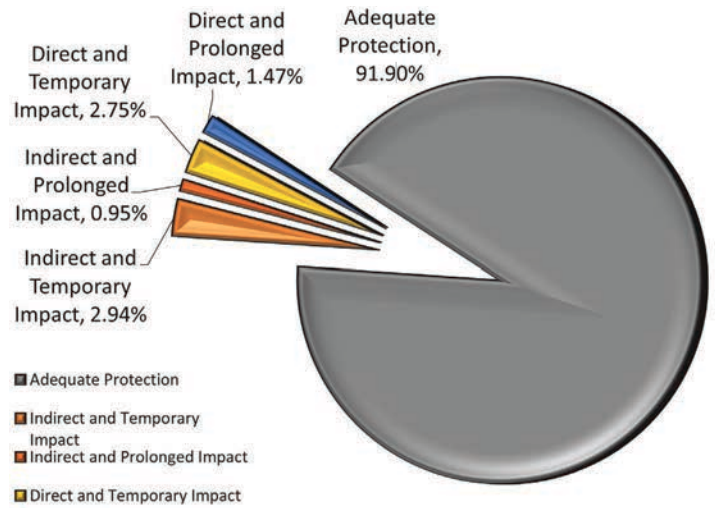
FIGURE 4

Figure 4. BMP effectiveness for 721 State Forest sites monitored from 1996-2021.

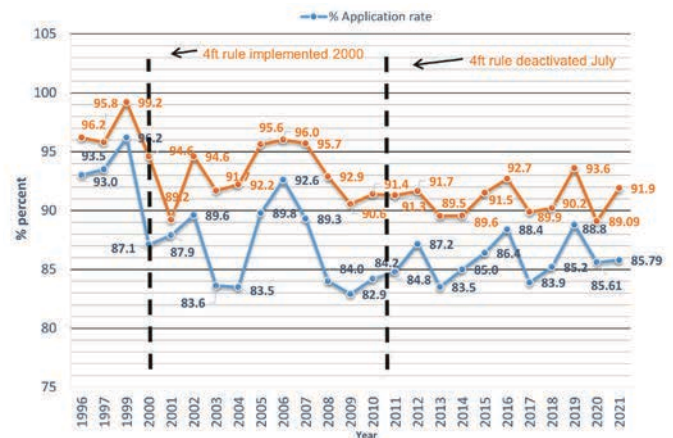
FIGURE 5

Figure 5: Yearly trends of BMP application and effectiveness on Indiana State Forests for 25 years of monitoring. These percentages are calculated for each year's data separately, not combined with the running totals from previous years.

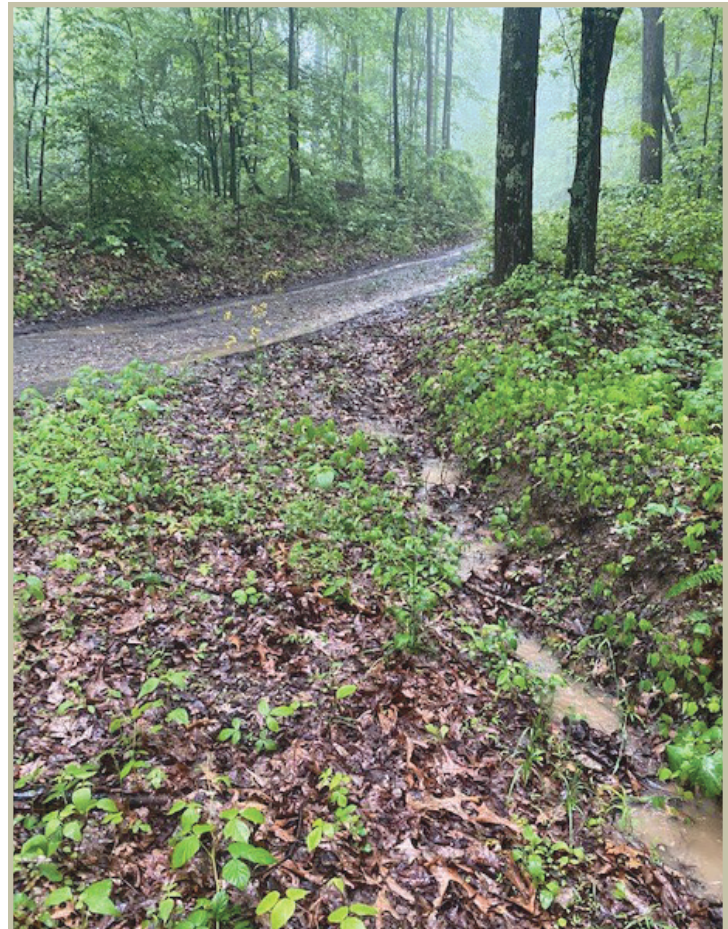
Crowning and cutouts promote good drainage and stable permanent access roads. This cutout is only partially working because rutting has partially blocked the access. Simple clean-out with a shovel would restore it to full working order. *Photo by Duane McCoy*

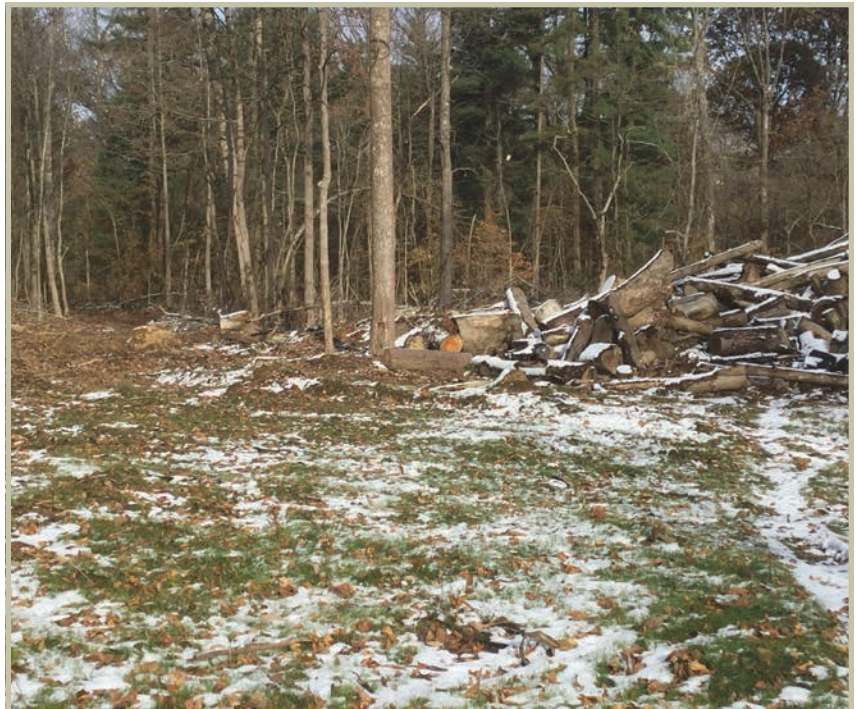
Seeding a log yard as soon as possible helps to get vegetative cover established quickly and protects the soil over winter.

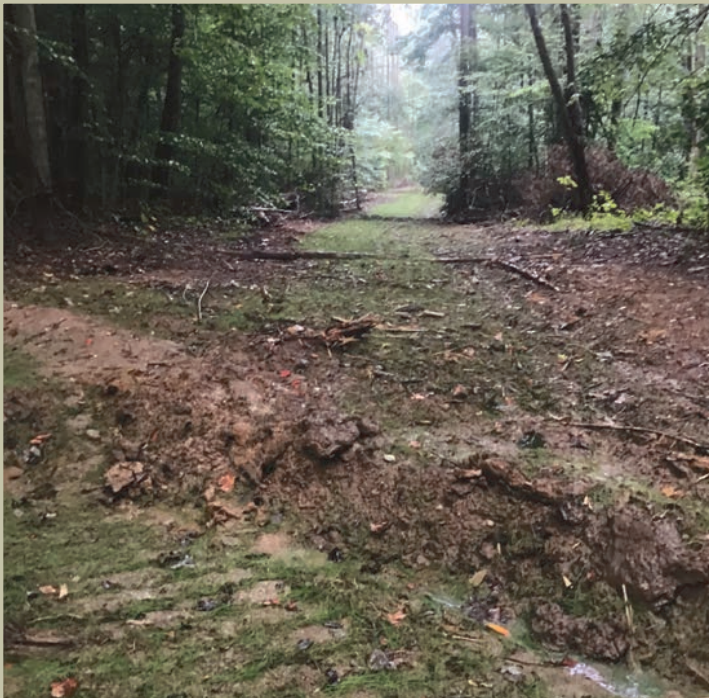
Well-constructed waterbars and seeding is allowing this skid trail at Owen-Putnam State Forest to heal quickly.
Photo by Duane McCoy

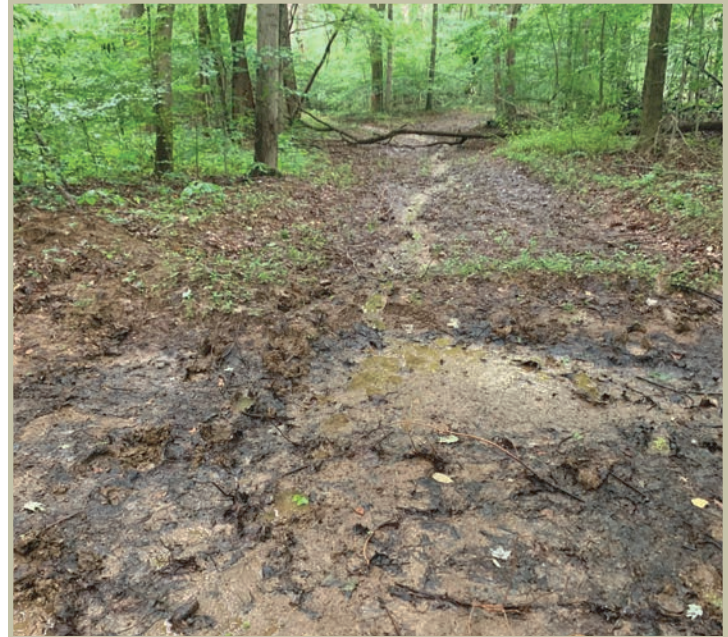
A poorly designed and implemented waterbar breached at the top of a hill allows runoff to continue down the hill on a skid trail, picking up volume and velocity, which increases erosion.
Photo by Jennifer Sobecki

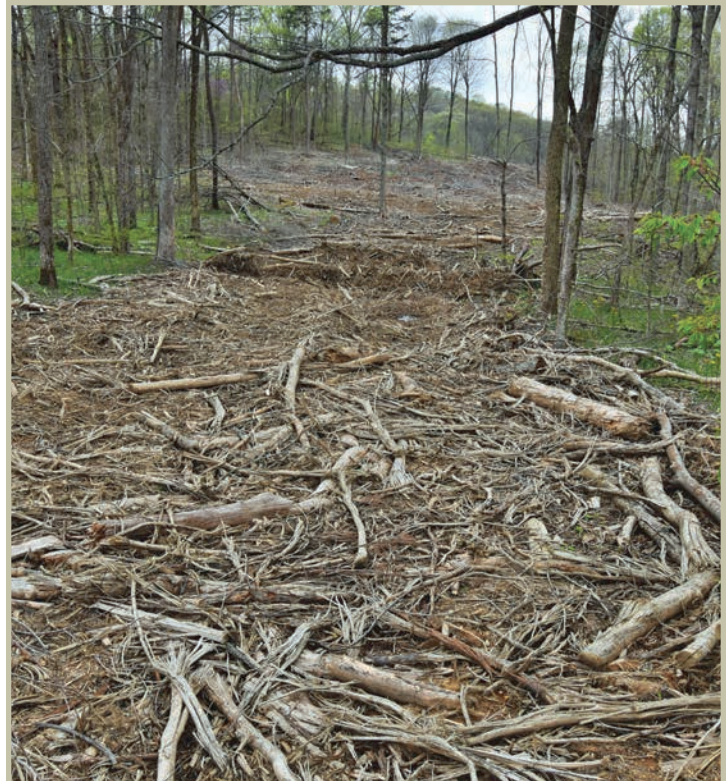
Use of debris to armor skid trails is a great practice to reduce erosion and close out skid trails.

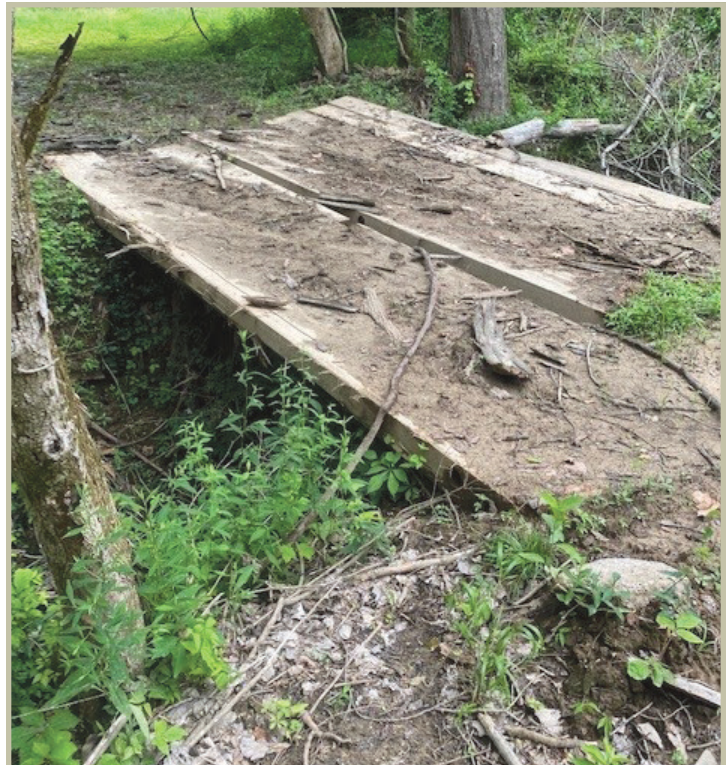
A temporary bridge can greatly reduce impact to streams during a timber harvest.

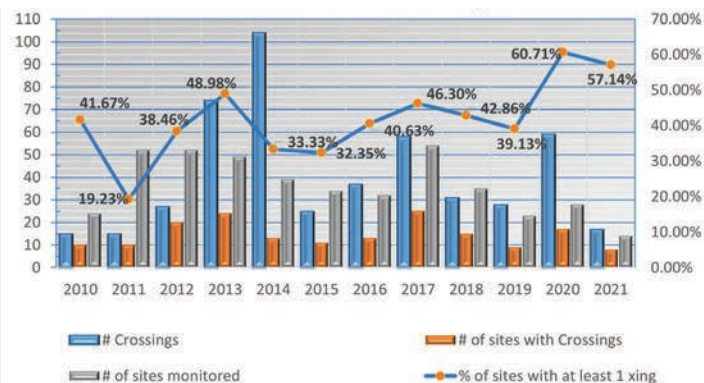
FIGURE 10

Figure 10. Stream crossing statistics from 2010-2021.

The number of crossings monitored on State Forests since 2010 is seen below in Figure 8. The graph also shows the number of sites per year with at least one crossing, the percentage of sites with crossings per year. The year 2014 had an elevated number of crossings due to one site. There was a large tornado salvage harvest at Clark State Forest that accounted for 60 crossings on that large salvage harvest (800 acres). Due to numerous obstructions from the tornado, multiple crossings were necessary in order to access the area.

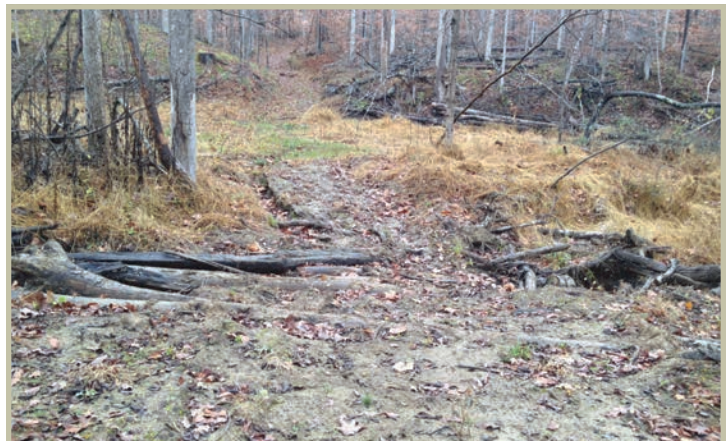
Logs used as temporary crossing of this drainage on private lands were not removed after the harvest. The blockage of the waterway will cause significant bank and bed erosion. *Photo by Jennifer Sobecki*

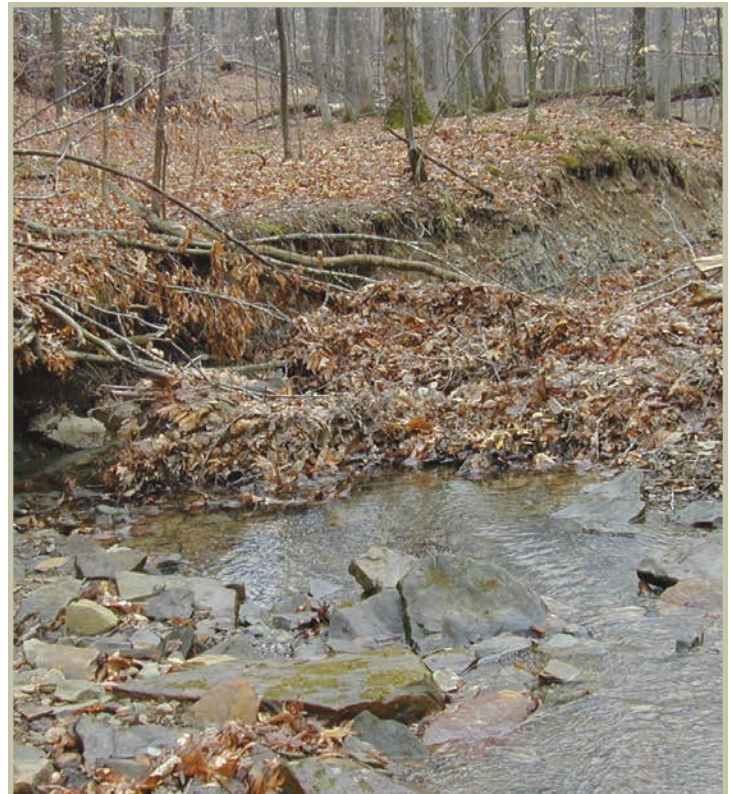
Logging debris left in the stream will allow buildup of more debris, which eventually leads to bank erosion.

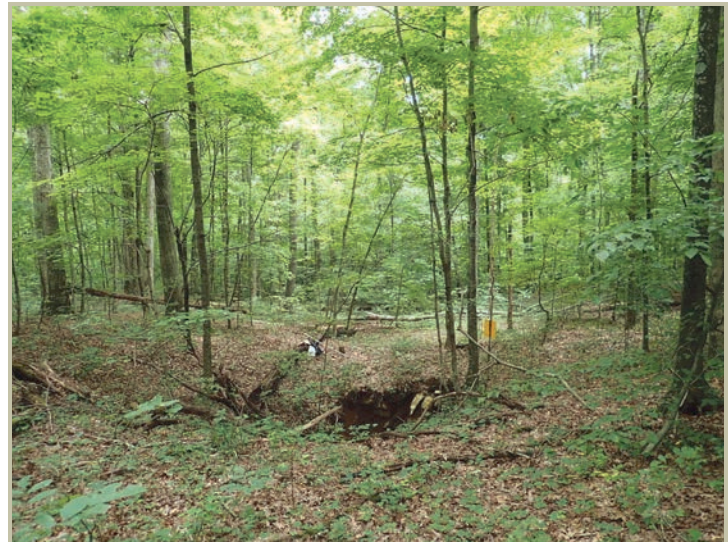
Sinkholes like this one require an RMZ ranging from 25-165 feet depending on the slope. Sinkholes often lead directly to underground water sources. *DNR Photo*

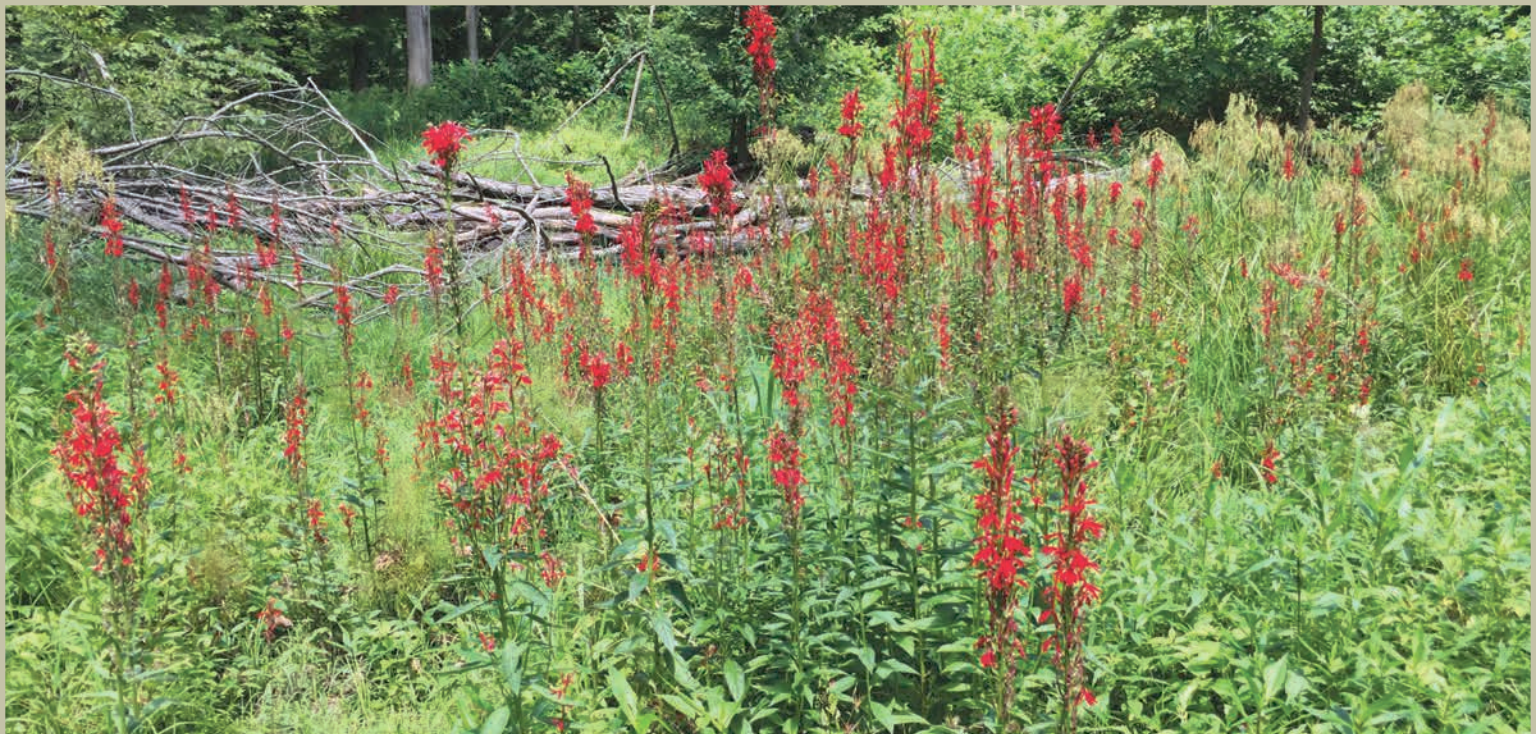
Cardinal flower takes dvantage of the increased light provided by this revegetated seasonally wet log landing.
Photo by Jennifer Sobecki
