NORTH WEBSTER STORM DRAIN
ENGINEERING FEASIBILITY STUDY

KOSCIUSKO COUNTY, INDIANA

October 29, 2002

EXECUTIVE SUMMARY

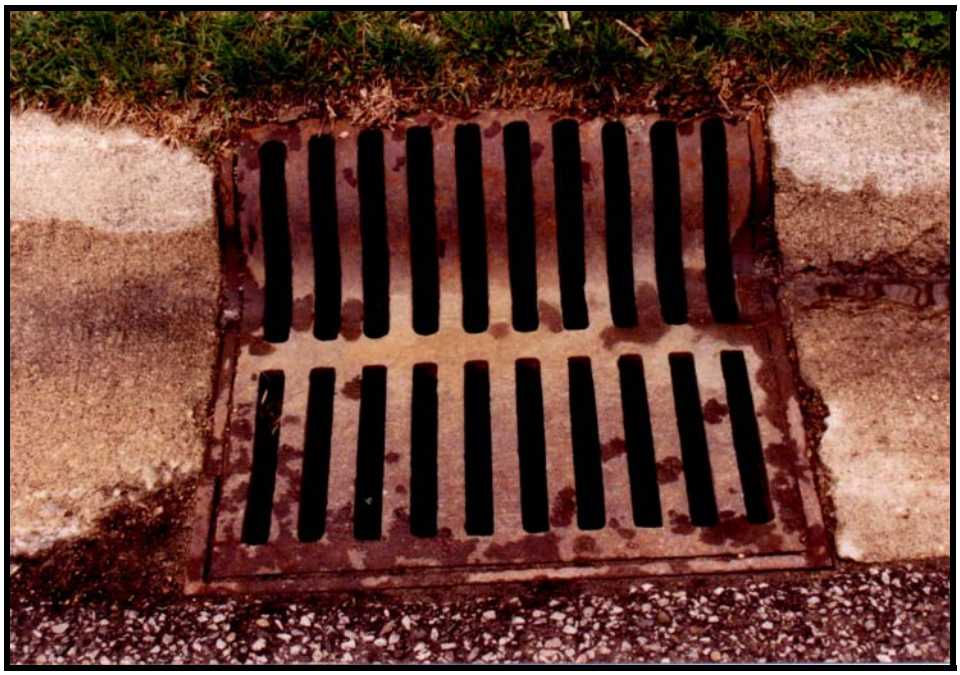
FIGURE 5. Drainage infrastructure example.

Town maps were modified and updated to include 18 drainage networks (Figure 1). Parts of the drainage infrastructure are old (Figure 5), but most of the older and newer drains are fitted with typical box drop structures also known as catch basins (Figure 6). Although it was beyond scope of the current study, some of the drain networks may require updating and resizing as development continues in the town and its watershed.
