Pavement Condition Report

Bedford-Grissom Municipal Airport

Project 13801869

January 2013

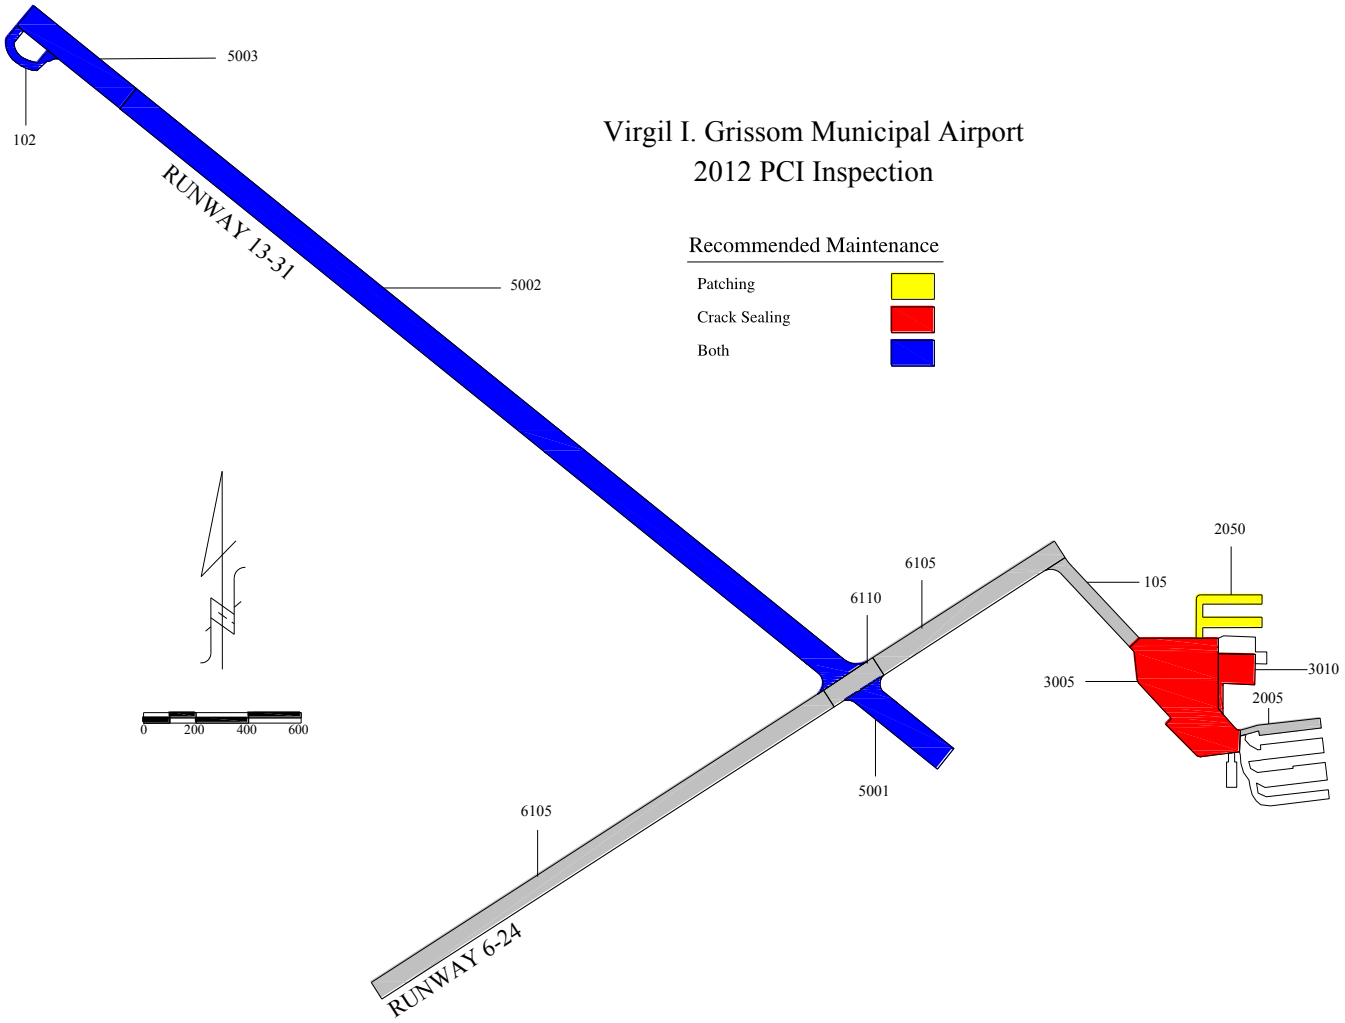
Analysis of potential maintenance projects identified approximately 1,200 square feet of patching needs and approximately 18,000 linear feet of crack sealing and crack repair needs, at an estimated total cost of approximately $31,000.

Virgil I. Grissom Municipal Airport
2012 PCI Inspection
Recommended Maintenance
Patching
Crack Sealing
Both
RUNWAY 13-31
RUNWAY 6-24
5003
102
5002
6105
6110
105
2050
3010
3005
2005
5001
6105
0
200
400
600

Work Item	Quantity	Unit	Cost
AC PATCH	1,243	SF	10,579
AC RESTORATIVE CRACK REPAIR	15,547	LF	18,967
AC SUSTAINING CRACK REPAIR	2,116	LF	1,803
Total:			**$31,349**

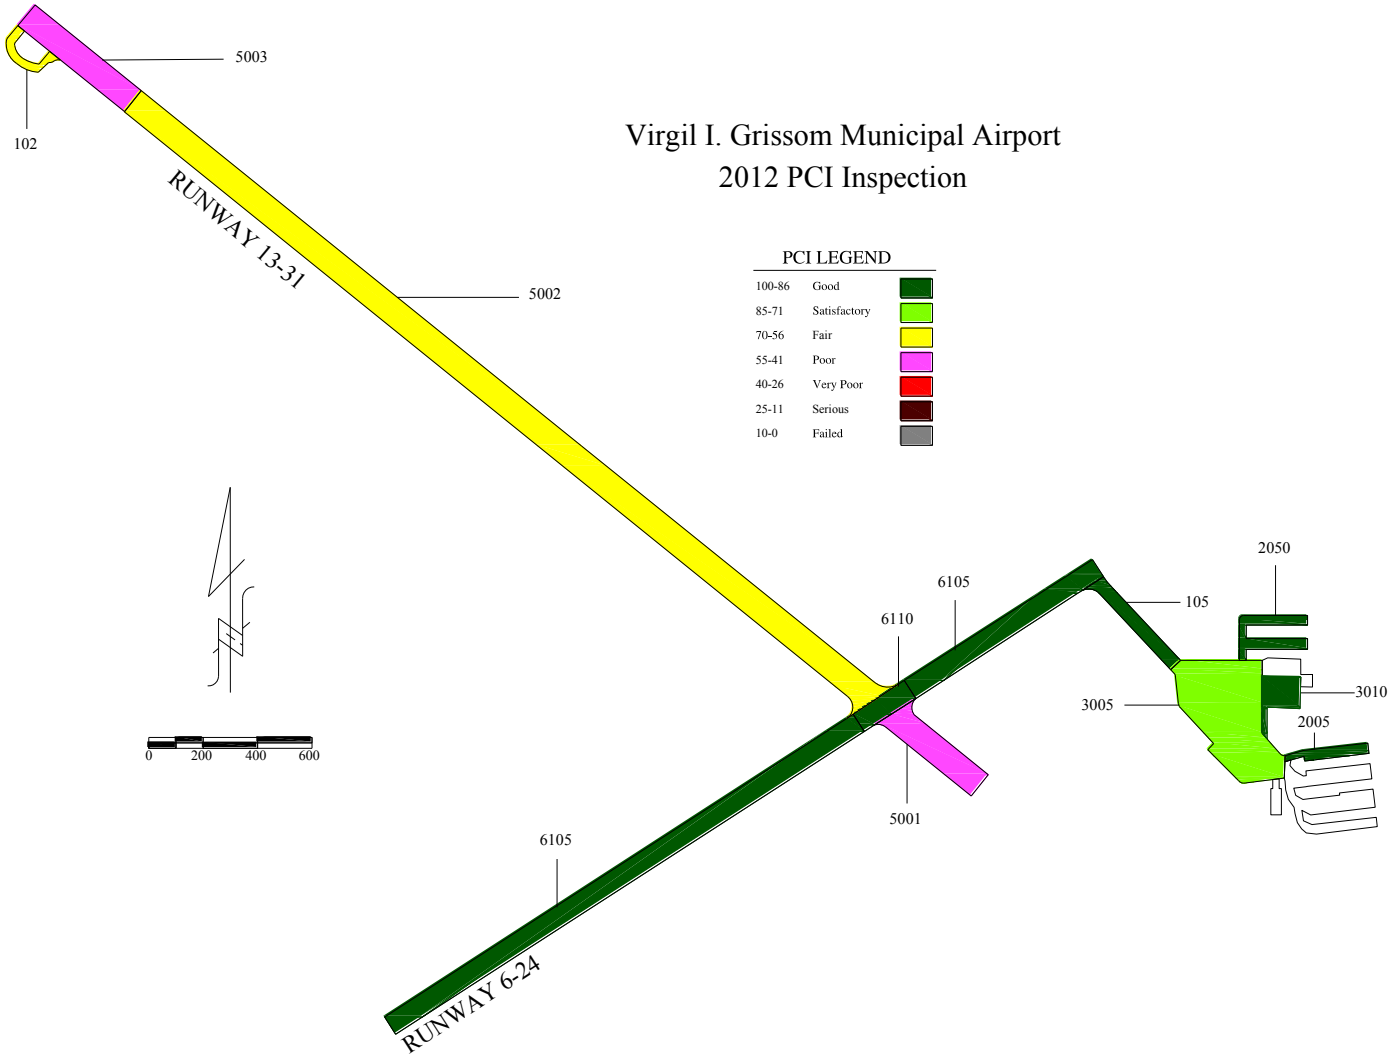
Figure 2-1. Inspected Pavement Condition

Two pavement sections: 5001 and 5003 both had a PCI rating of Poor, indicating that near –term maintenance needs may range from routine up to a requirement for reconstruction. The pavement within each of the PCI condition categories is shown in Figure 2-1. The inspected PCI is summarized by branch use in Figure 2-2, and the photographs that follow provide examples of the condition categories.

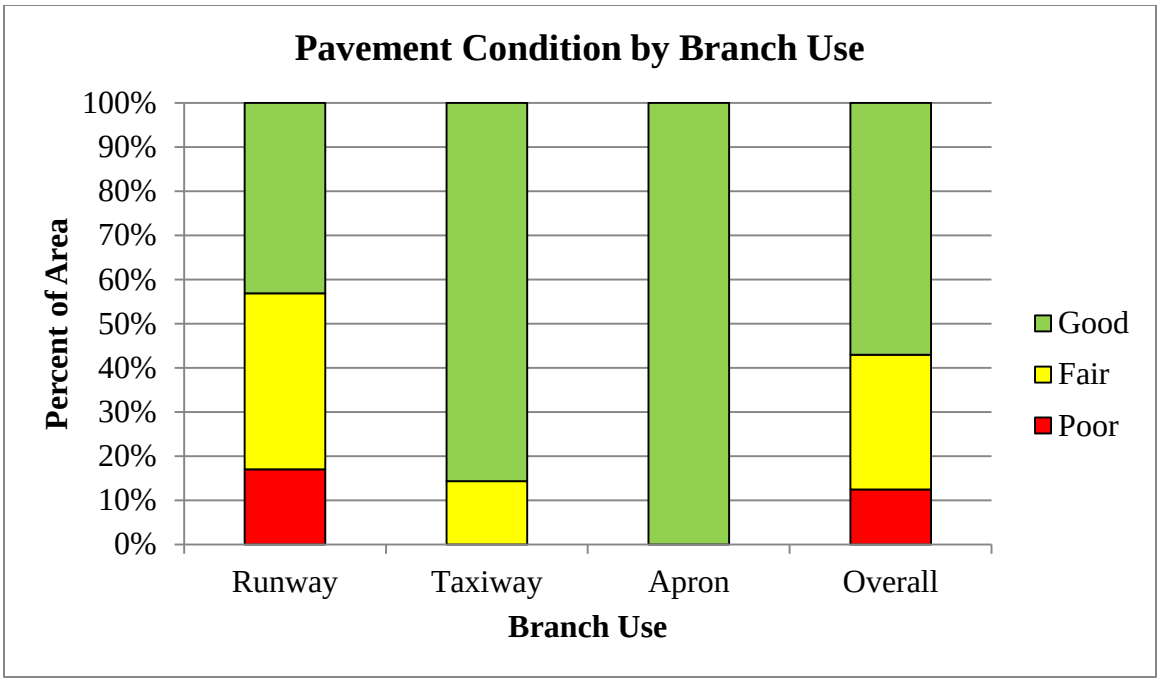
Figure 2-2. Pavement Condition by Branch Use

The overall Pavement Condition Index (PCI) for the airfield pavements was 77. Runways had an average inspected PCI of 76 and were above the desired MSL of 60. Taxiways had an average inspected PCI of 91, and ramps had an average inspected PCI of 76.
