Pavement Condition Report

Crawfordsville Municipal Airport

Project 13801869

January 2013

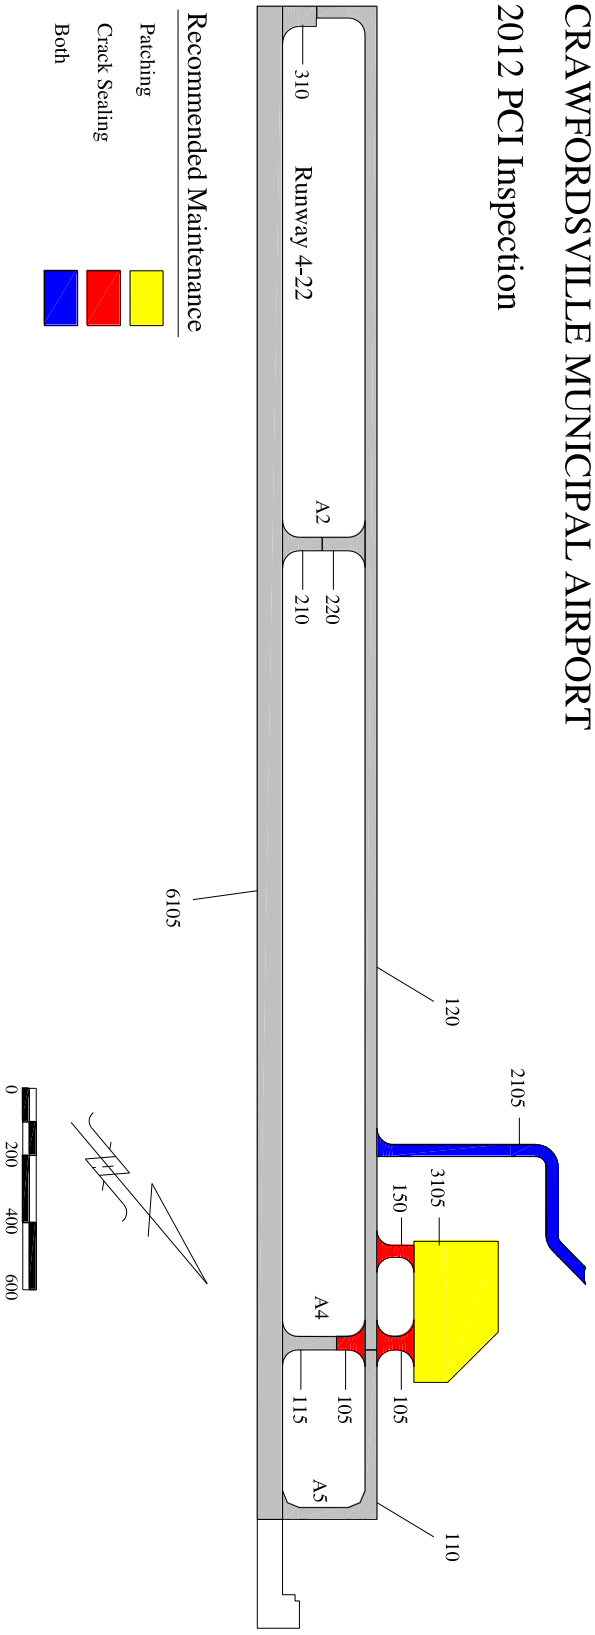
Analysis of potential maintenance projects identified approximately 130 square feet of patching needs and approximately 630 linear feet of crack sealing and crack repair needs, at an estimated total cost of approximately $2,700.

CRAWFORDSVILLE MUNICIPAL AIRPORT
2012 PCI Inspection
Runway 4-22
310
A2
220
210
6105
120
2105
3105
150
105
A4
105
115
A5
110
Recommended Maintenance
Patching
Crack Sealing
Both
0
200
400
600

Specific recommendations to help prioritize airfield maintenance are found in chapter 4 of this report. A summary of all identified maintenance needs is shown in the table below and in the figure on the following page.

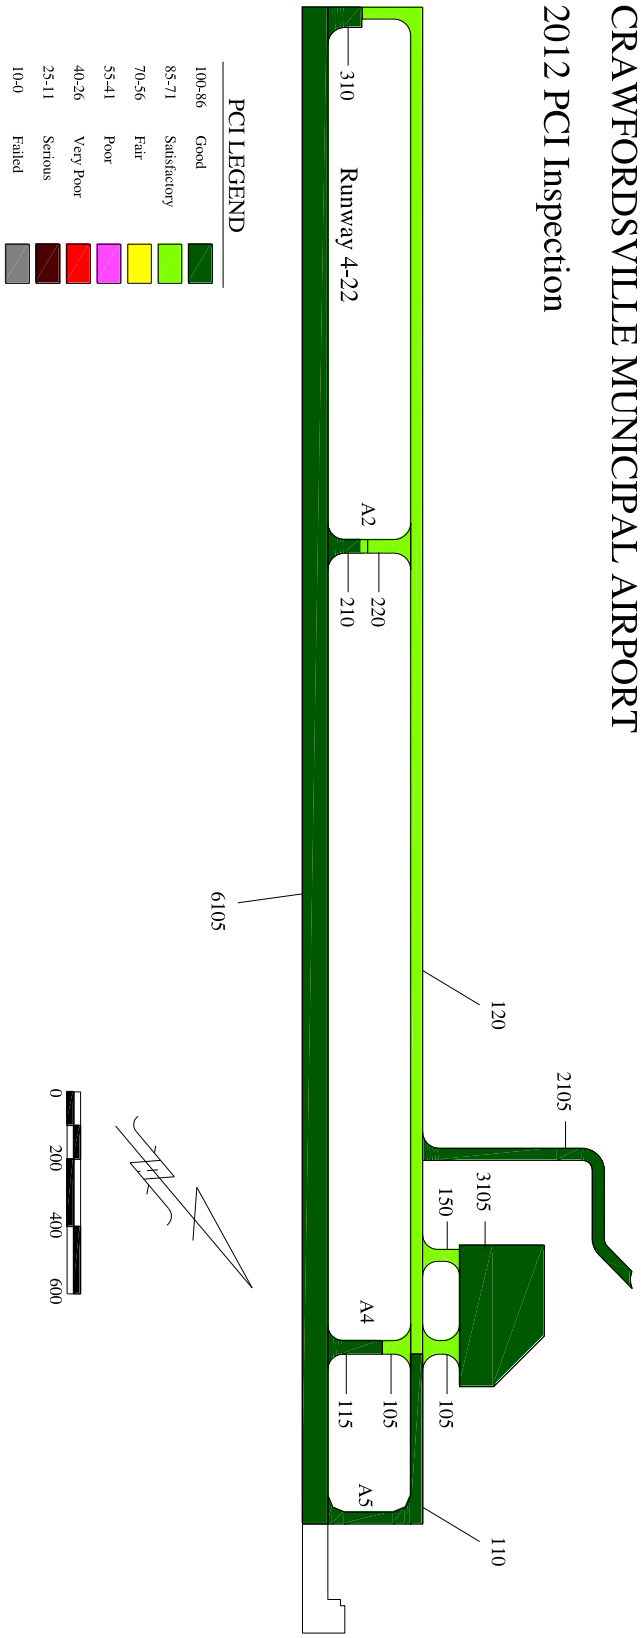
Figure 2-1. Inspected Pavement Condition

The pavement within each of the PCI condition categories is shown in Figure 2-1. The inspected PCI is summarized by branch use in Figure 2-2, and the photographs that follow provide examples of the condition categories.

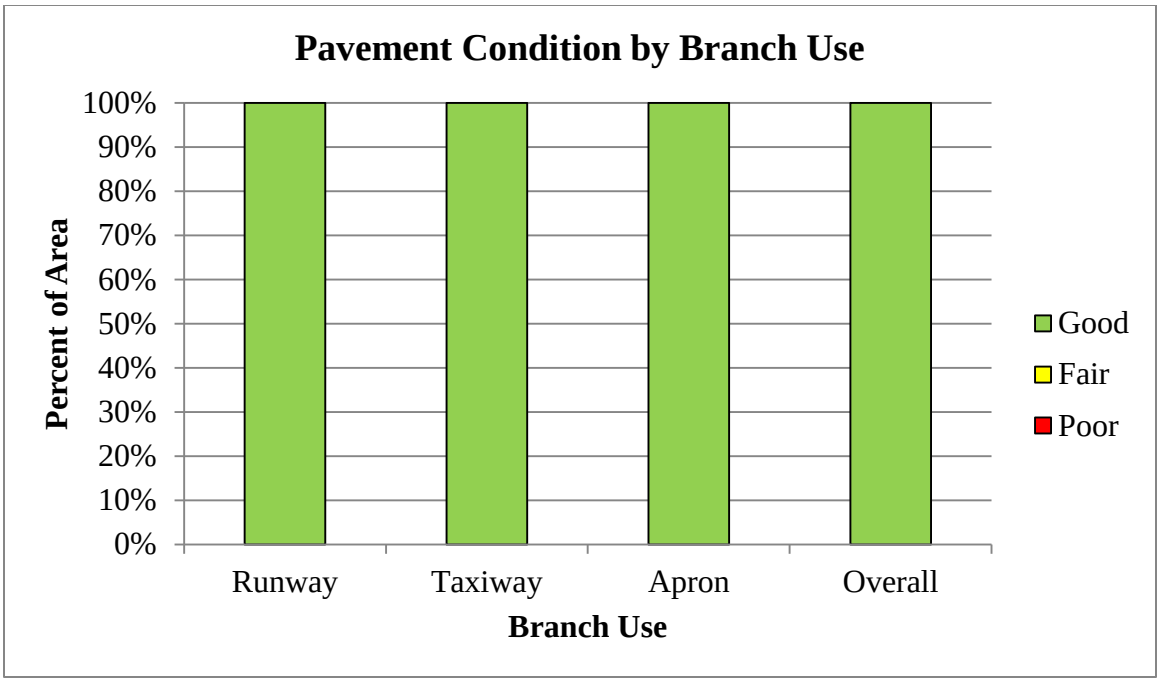
Figure 2-2. Pavement Condition by Branch Use

The overall Pavement Condition Index (PCI) for the airfield pavements was 90. Runway 4-22 has an average inspected PCI of 96 and was above the desired MSL of 60. Taxiways had an average inspected PCI of 80, and ramps had an average inspected PCI of 97.

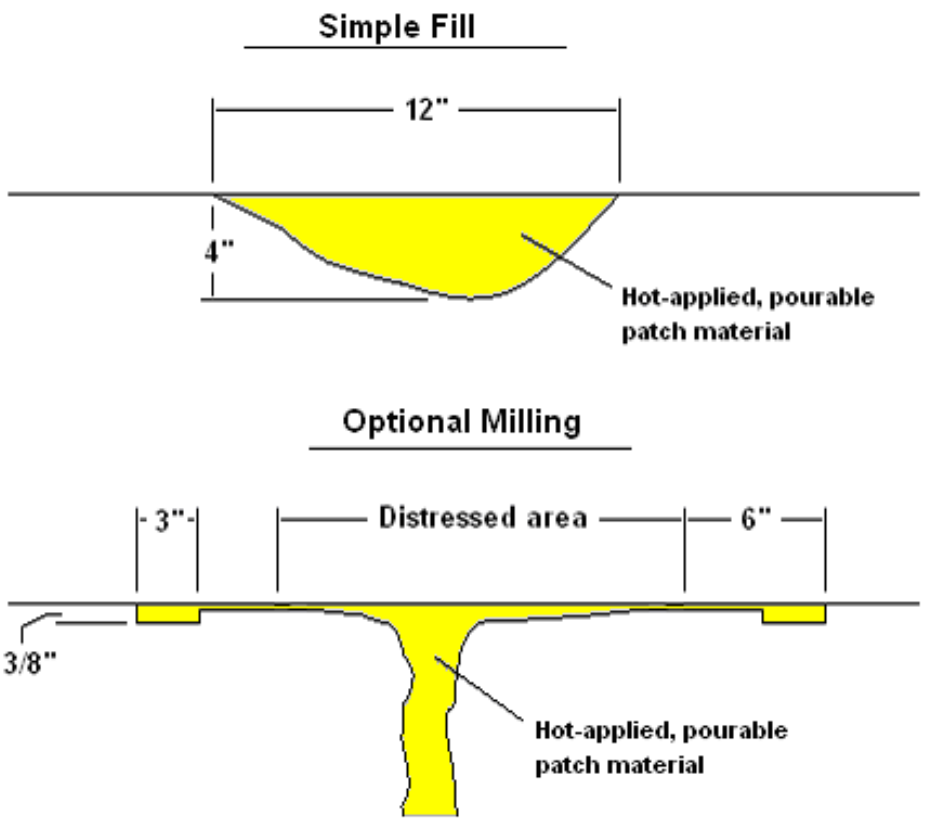
Patching (pourable materials)

Hot-applied, pourable materials generally are used to repair deficiencies larger than can be repaired by sealants, but smaller than those where traditional techniques would be required. Suggested uses for this type of repair include cracks over 2 inches wide, potholes less than 4 inches deep, as a leveling for small depressions, as a cap for settled utility cuts, and as a skin patch for areas of alligator cracking.

- Examine and mark the patch outline. Boundaries should extend to sound pavement.
- Apply patch material to clean, dry surfaces.
- A heating lance to preheat or dry existing pavement is recommended in cold or wet conditions.
- Patch material should be poured into the area to be repaired and leveled as appropriate.
- Patch edges should be sealed after application to assure good adhesion, preventing surface moisture from migrating under patch edges.
