Pavement Condition Report

Greensburg Municipal Airport

Project 13801869

January 2013

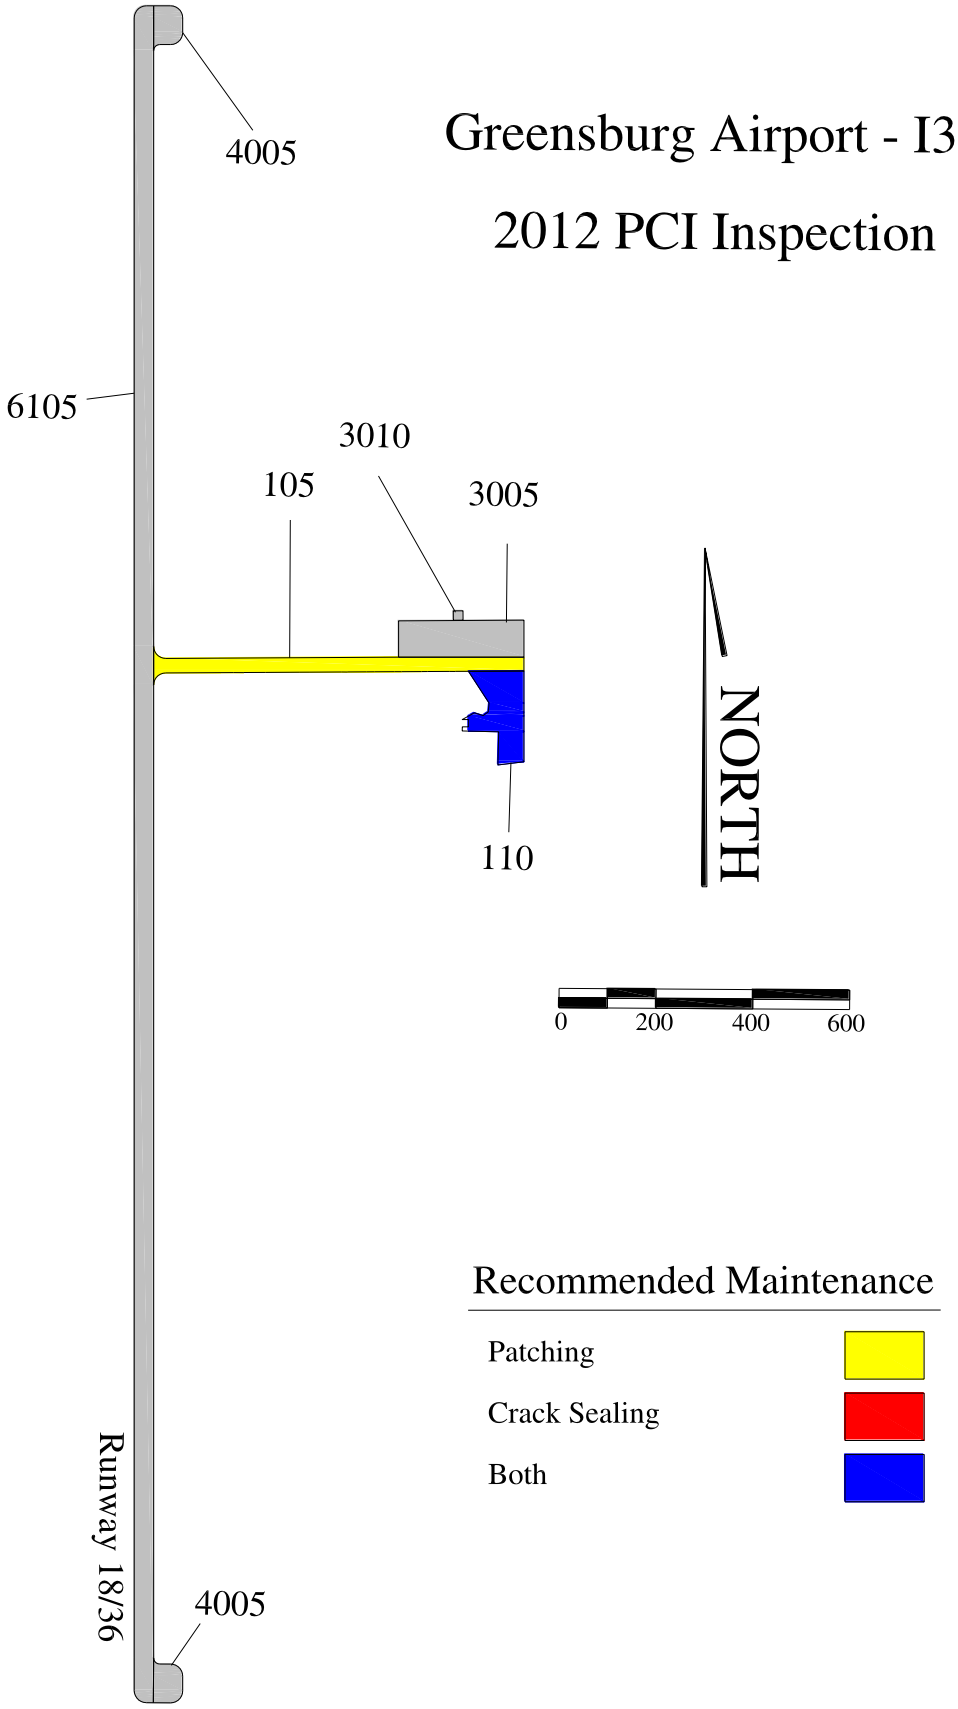
Analysis of potential maintenance projects identified approximately 700 square feet of patching needs and approximately 2,600 linear feet of crack sealing and crack repair needs, at an estimated total cost of approximately $9,200.

Greensburg Airport - I34
2012 PCI Inspection
4005
6105
3010
105
3005
110
NORTH
0
200
400
600
Recommended Maintenance
Patching
Crack Sealing
Both
Runway 18/36
4005

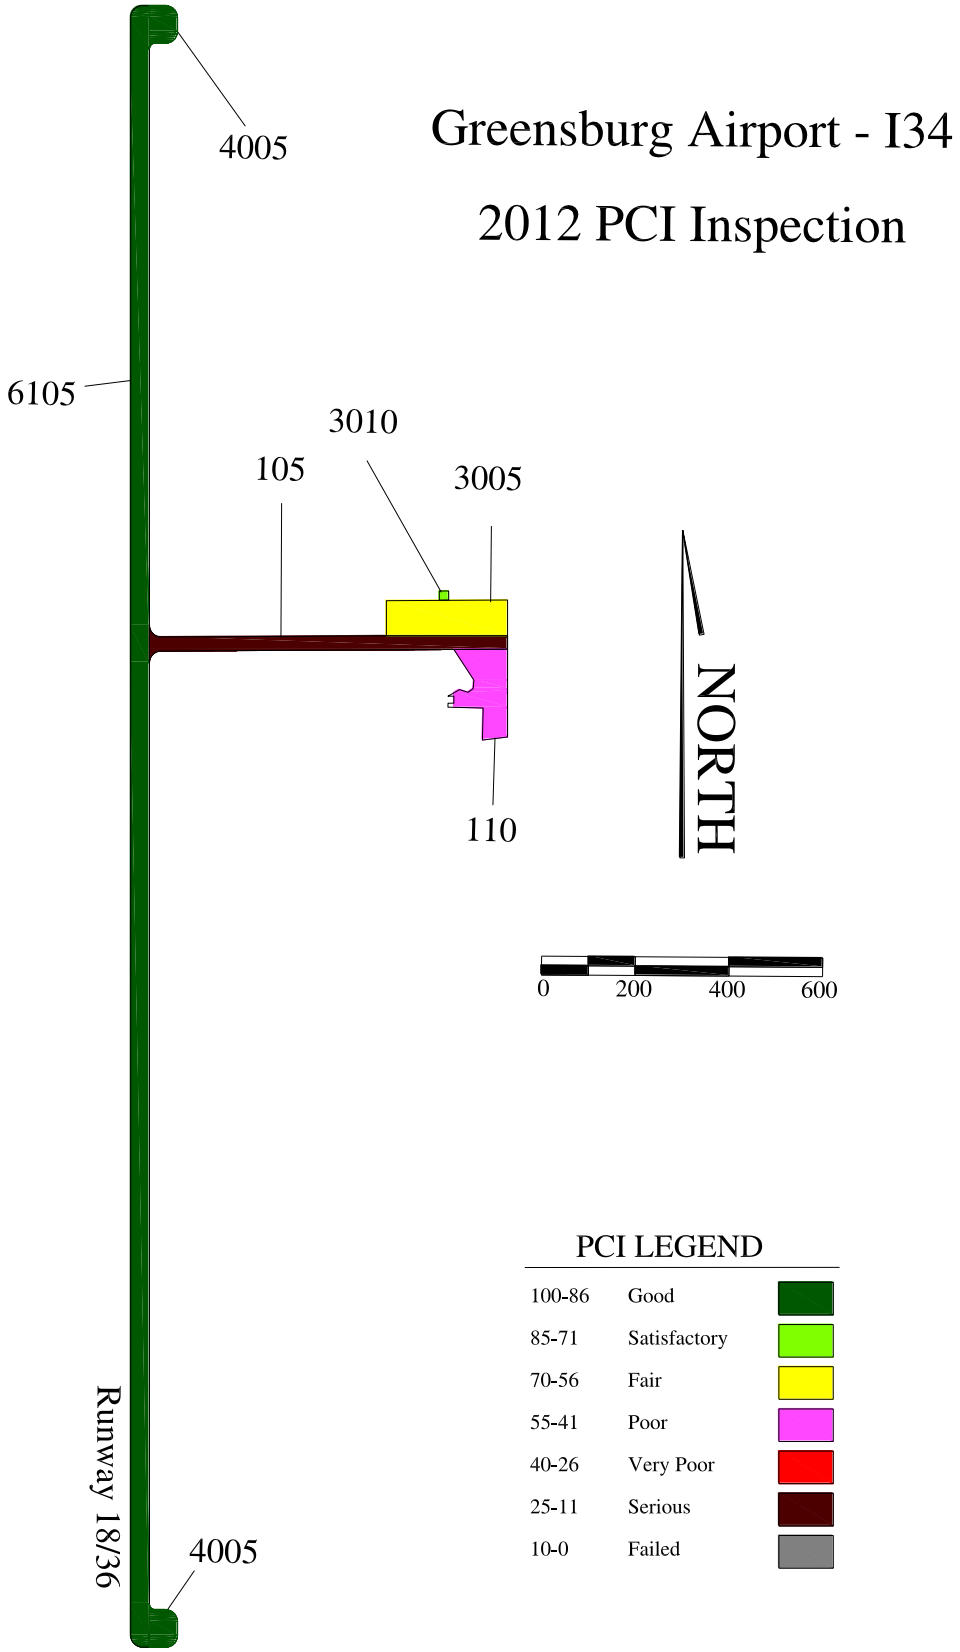
Figure 2-1. Inspected Pavement Condition

Pavement sections 105 and 110 had simplified PCI ratings of Poor, indicating that major M&R is needed to maintain serviceability. The pavement within each of the PCI condition categories is shown in Figure 2-1. The inspected PCI is summarized by branch use in Figure 2-2, and the photographs in Figure 2-3 through Figure 2-6 provide examples for each of the simplified condition categories.

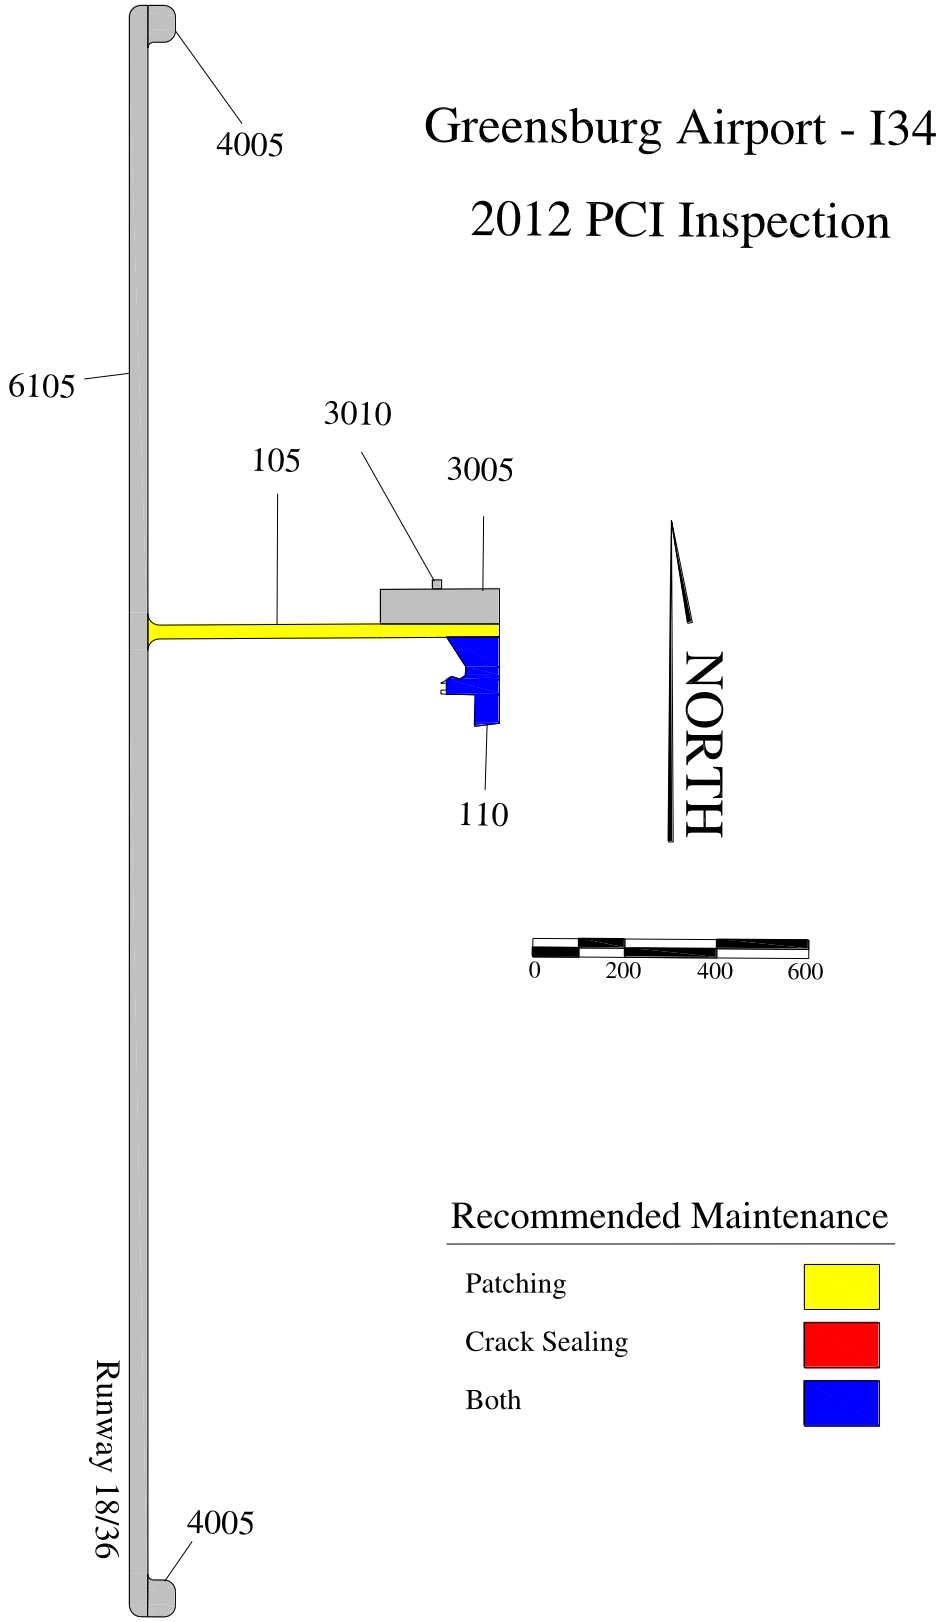
Figure 4-1. Recommended Maintenance

Feature	Work Item	Amount	Insp. PCI	Change	Est. PCI
110	AC RESTORATIVE CRACK REPAIR	2,629	43	5	48
	TOTAL:	2,629	L.F.		
EQUIPMENT: AIR COMPRESSOR, HEATING KETTLE, HAND TOOLS					
EST. MATERIALS: 526 POUNDS ASTM D3405 SEALANT OR EQUIVALENT					
EST. MATERIAL COST: $525					
EST. CREW HOURS: 13.1					
EST. CREW COST: $2,681					
EST. PROJECT COST: $3,207

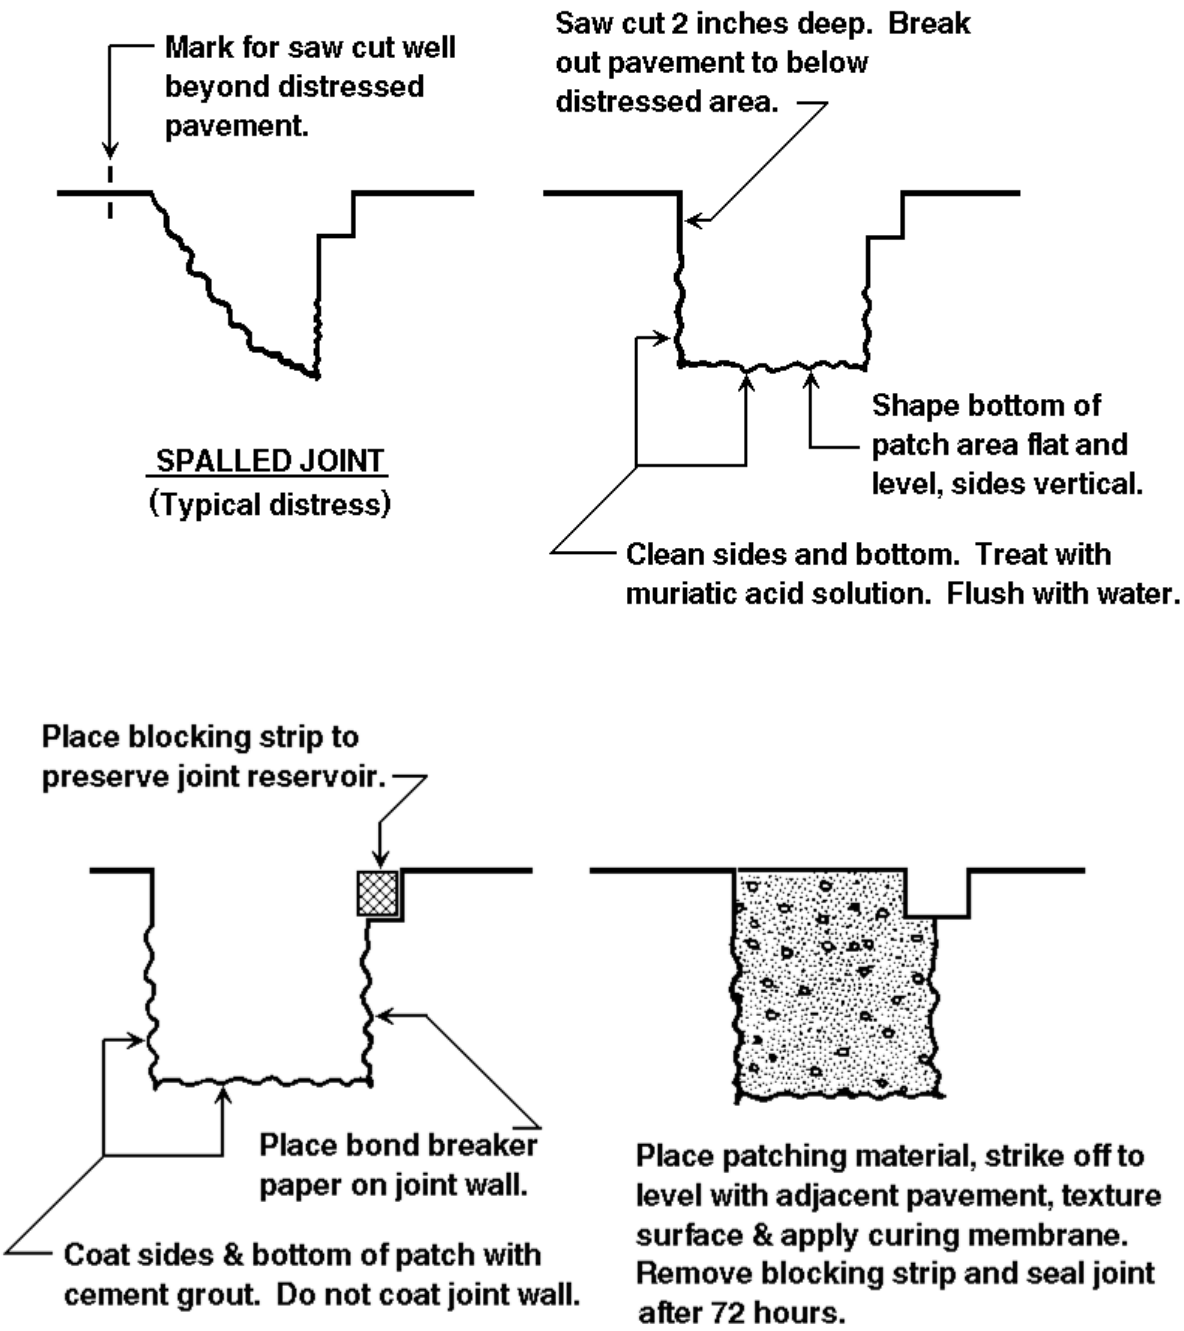
Mark for saw cut well beyond distressed pavement.
SPALLED JOINT
(Typical distress)
Saw cut 2 inches deep. Break out pavement to below distressed area.
Shape bottom of patch area flat and level, sides vertical.
Clean sides and bottom. Treat with muriatic acid solution. Flush with water.
Place blocking strip to preserve joint reservoir.
Place bond breaker paper on joint wall.
Coat sides & bottom of patch with cement grout. Do not coat joint wall.
Place patching material, strike off to level with adjacent pavement, texture surface & apply curing membrane. Remove blocking strip and seal joint after 72 hours.
