Pavement Condition Report

Kendallville Municipal Airport

Project 13801869

January 2013

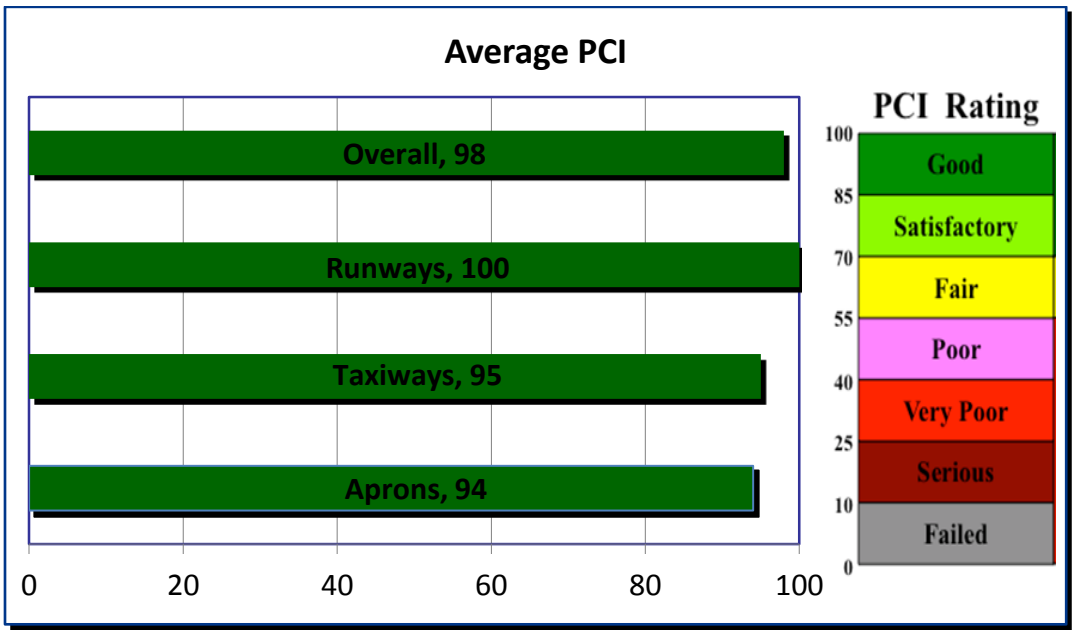
The overall Pavement Condition Index (PCI) for the airfield pavements was 98. Runway 9-27 had an average inspected PCI of 100 and was above the desired MSL of 60. Taxiways had an average inspected PCI of 95, and ramps had an average inspected PCI of 94.

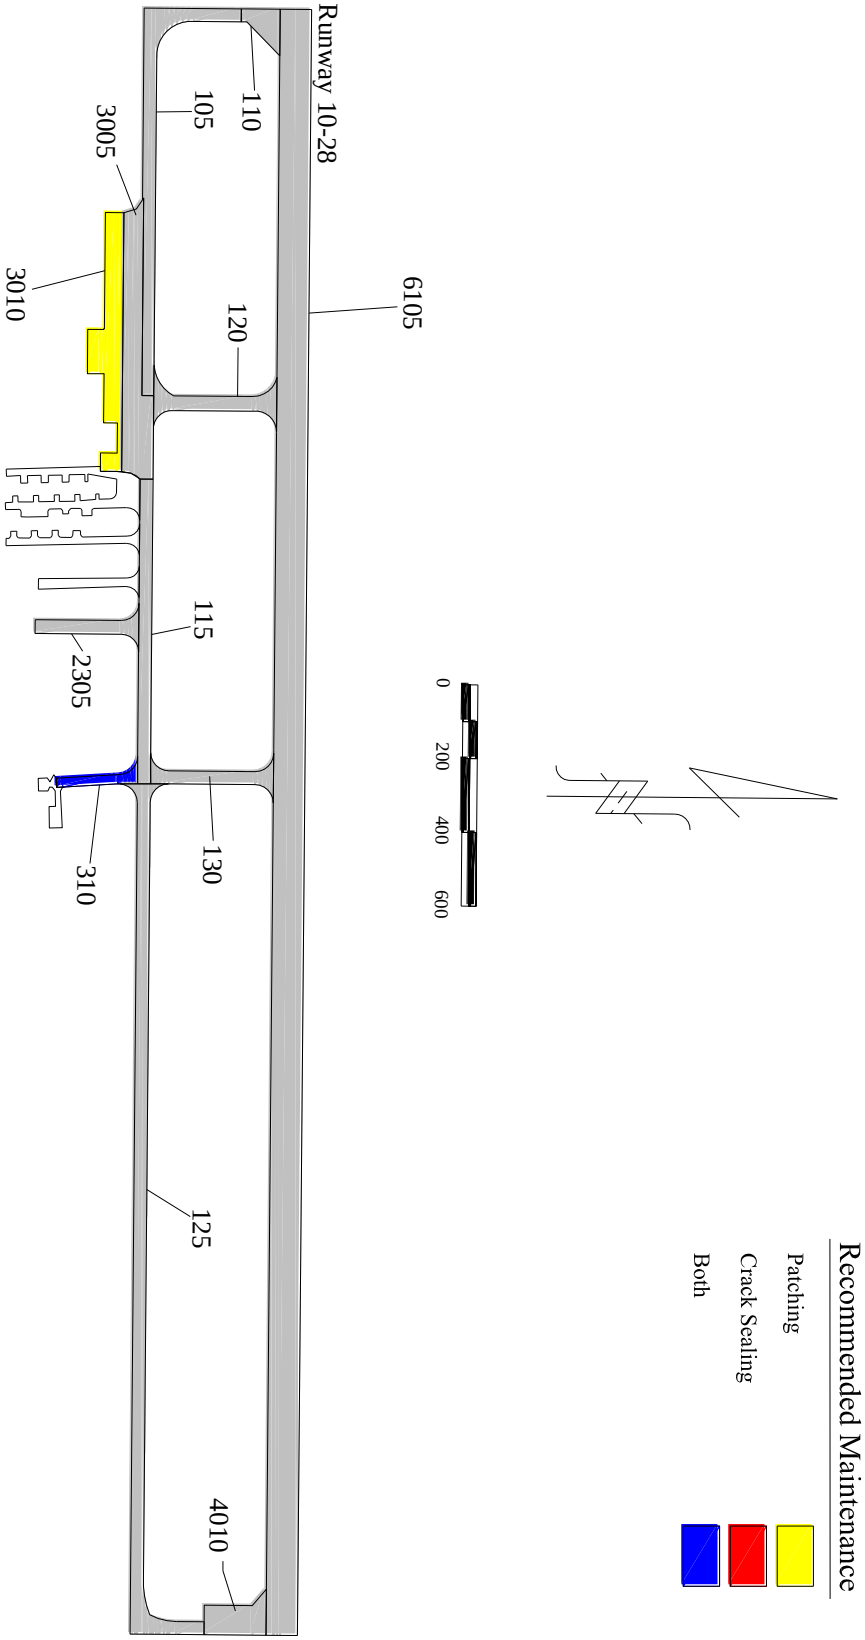
Analysis of potential maintenance projects identified approximately 100 square feet of patching needs and approximately 400 linear feet of crack sealing and crack repair needs, at an estimated total cost of approximately $1,500.

Work Item	Quantity	Unit	Cost
AC PATCH	87	SF	740
AC RESTORATIVE CRACK REPAIR	399	LF	486
PCC PATCHING	15	SF	249
Total:			**$1,475**

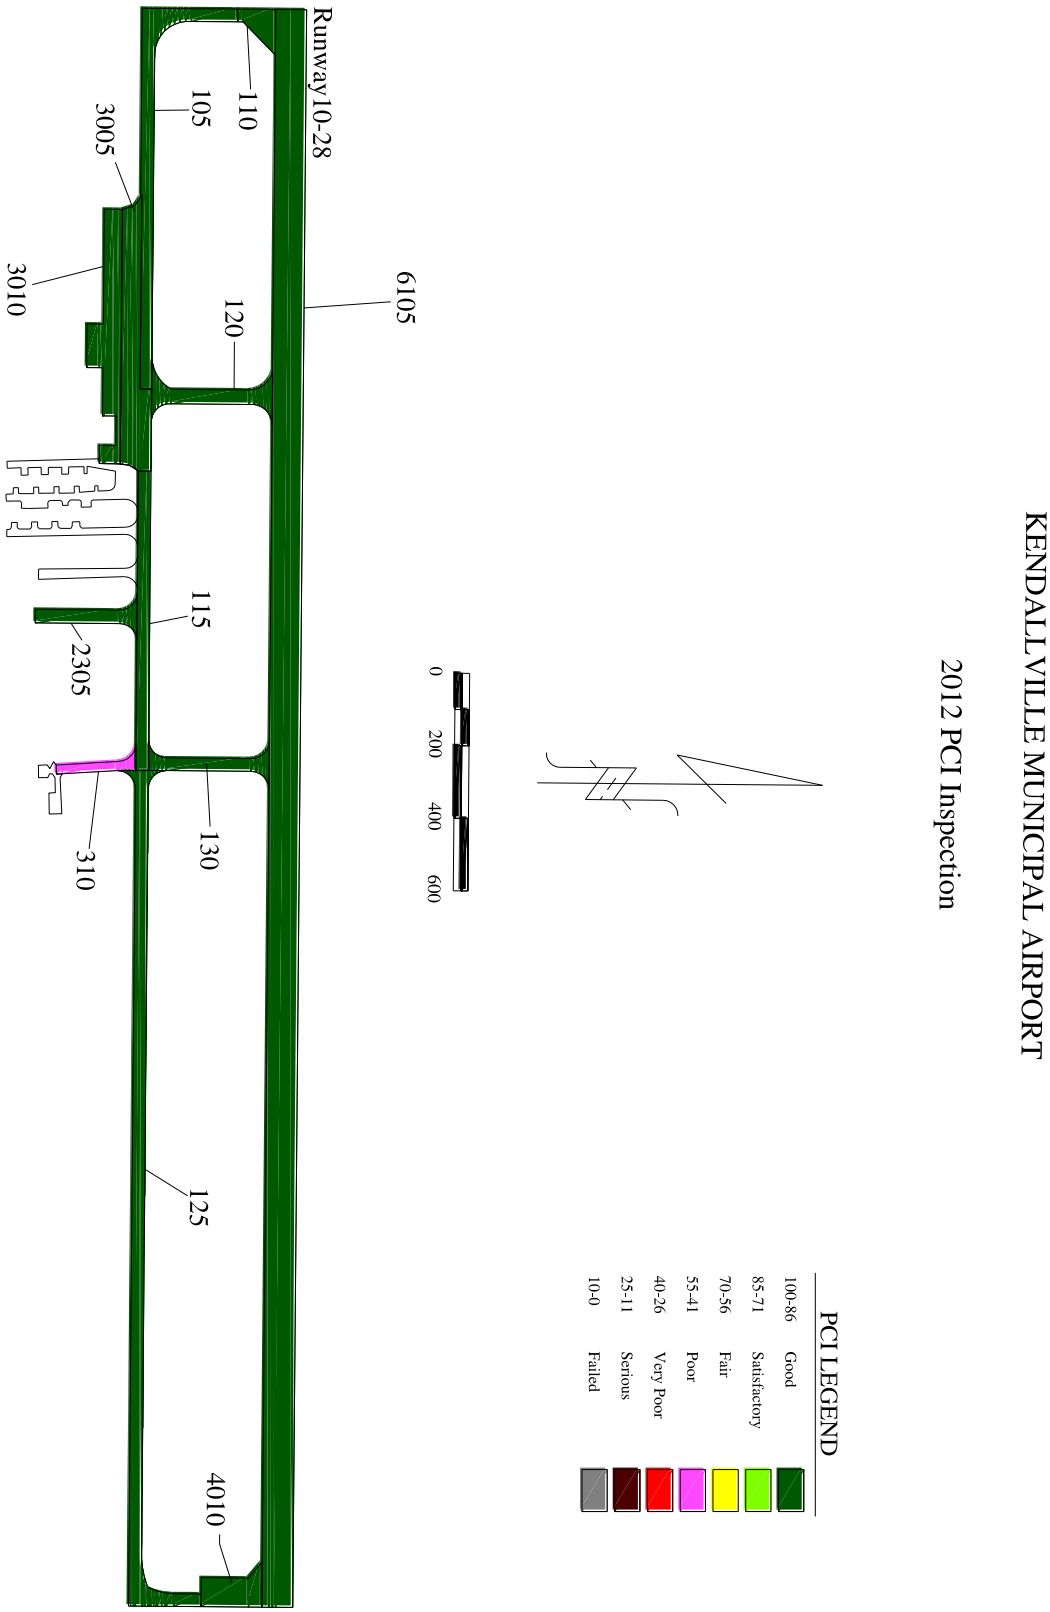
Figure 2-1. Inspected Pavement Condition

Pavement section 310 (Taxiway to Maintenance Hangar) had a PCI rating of Poor, indicating near-term maintenance needs may range from routine up to a requirement for reconstruction. The pavement within each of the PCI condition categories is shown in Figure 2-1. The inspected PCI is summarized by branch use in Figure 2-2, and the photographs that follow provide examples of the condition categories.

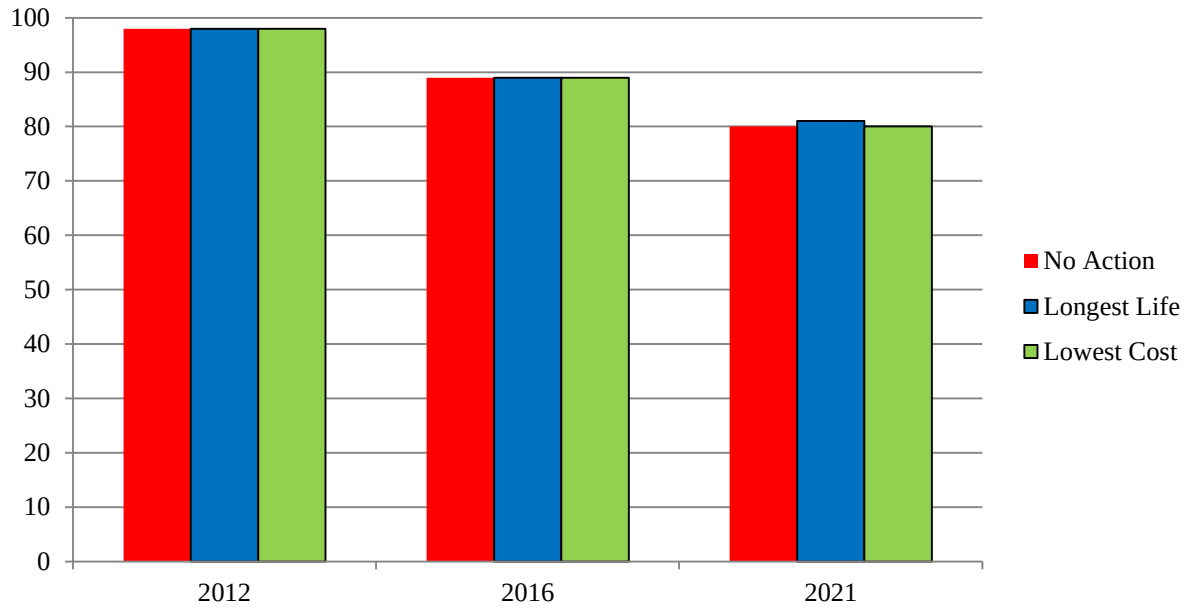
Figure 3-1. Programmed CIP

Figure 3-1 shows a projection of the overall airport pavement condition for the next 10 years based on implementing one of three capital improvement strategies:

The longest life CIP scenario is projected to cost approximately **$8,500** over the next 10 years. The lowest annual cost scenario is projected to cost approximately **$500** over the next 10 years. Examples of each capital improvement strategy and a complete listing of all viable capital projects are presented in Table 3-2 through Table 3-4.

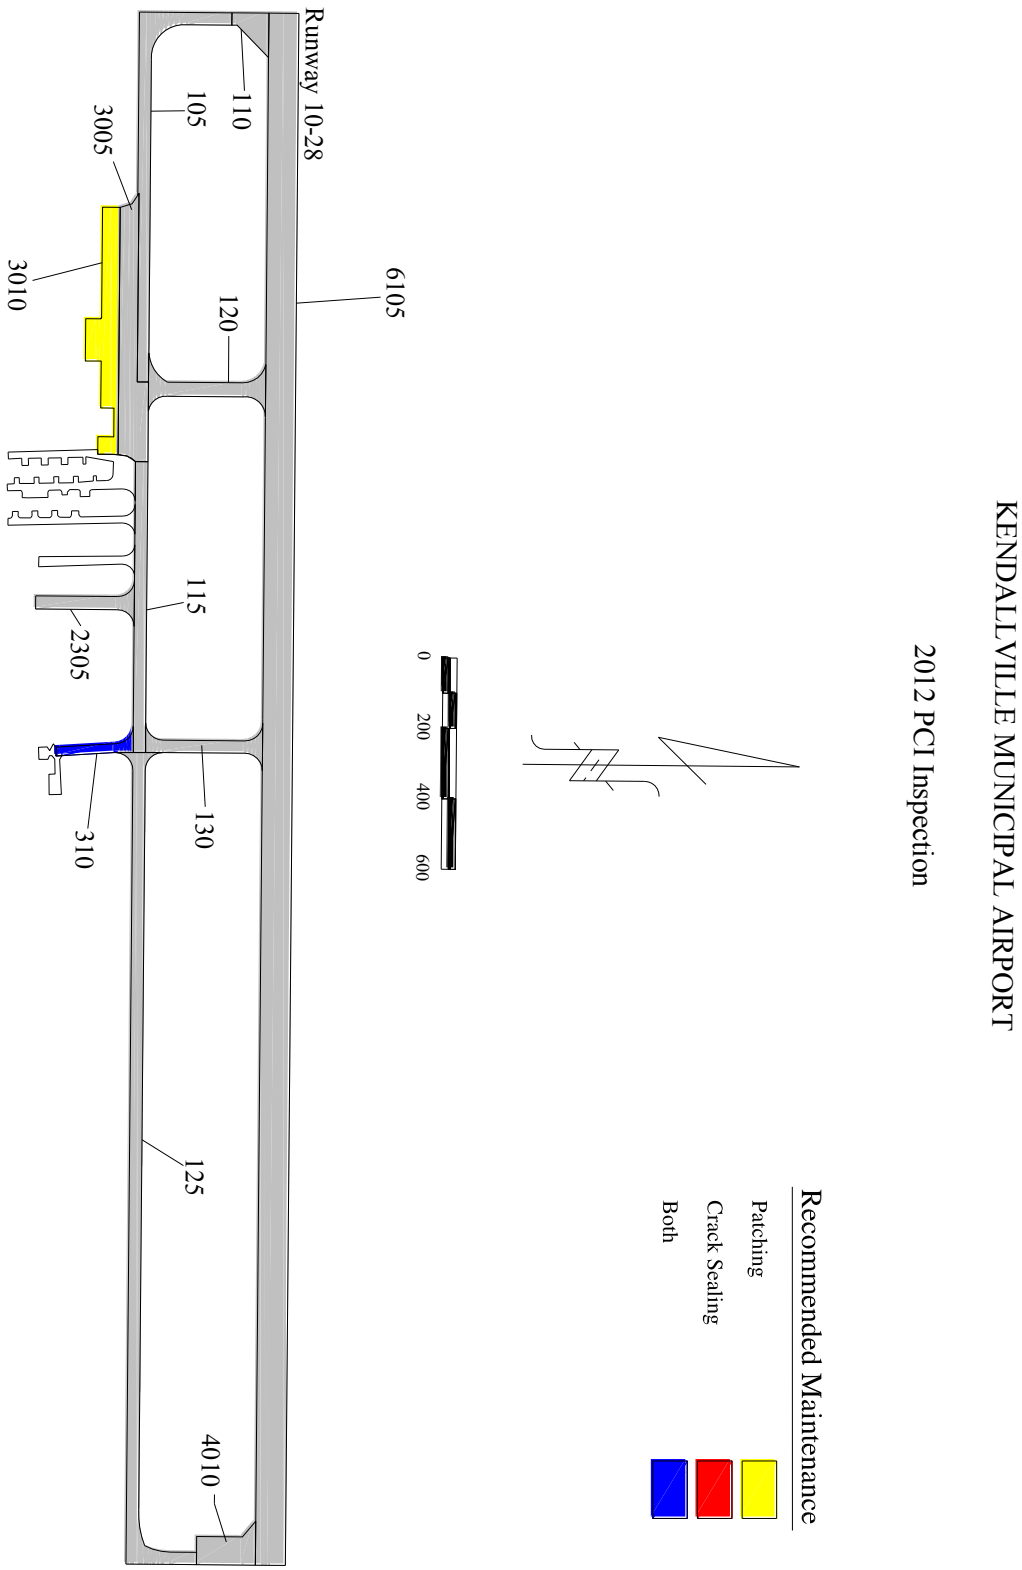
Figure 4-1. Recommended Maintenance

Feature	Work Item	Amount	Insp. PCI	Change	Est. PCI
310	AC RESTORATIVE CRACK REPAIR	399 L.F.	54	4	58
EQUIPMENT: AIR COMPRESSOR, HEATING KETTLE, HAND TOOLS					
EST. MATERIALS: 80 POUNDS ASTM D3405 SEALANT OR EQUIVALENT					
EST. MATERIAL COST: $79					
EST. CREW HOURS: 2.0					
EST. CREW COST: $406					
EST. PROJECT COST: $486
