Pavement Condition Report

Marion Municipal Airport

Project 13801869

January 2013

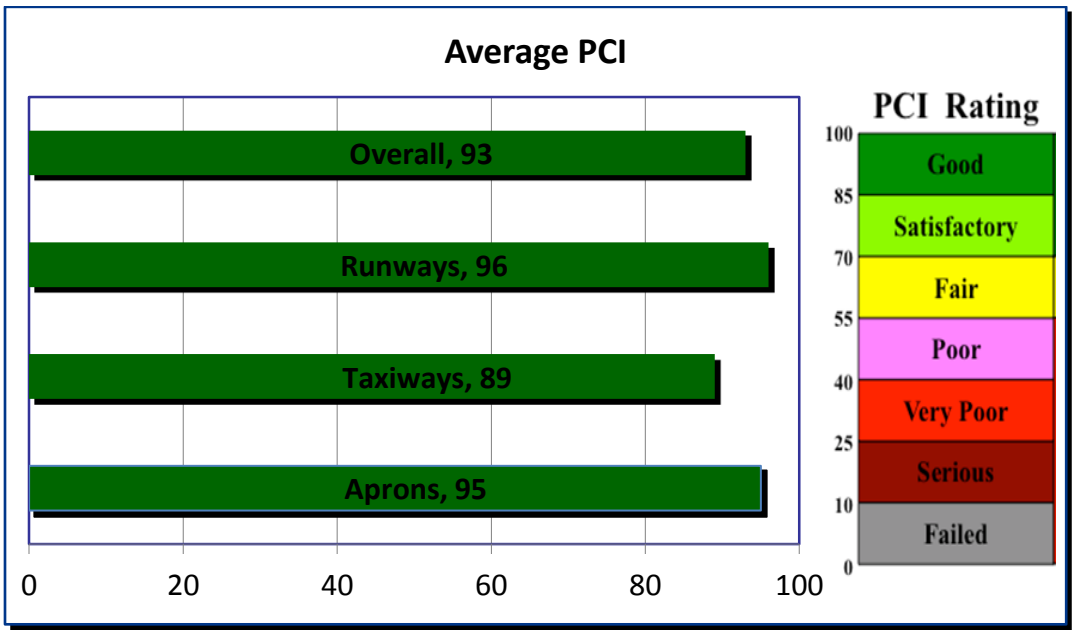
The overall Pavement Condition Index (PCI) for the airfield pavements was 93. Runways had an average inspected PCI of 96 and were above the desired MSL of 60. Taxiways had an average inspected PCI of 89, and ramps had an average inspected PCI of 95.

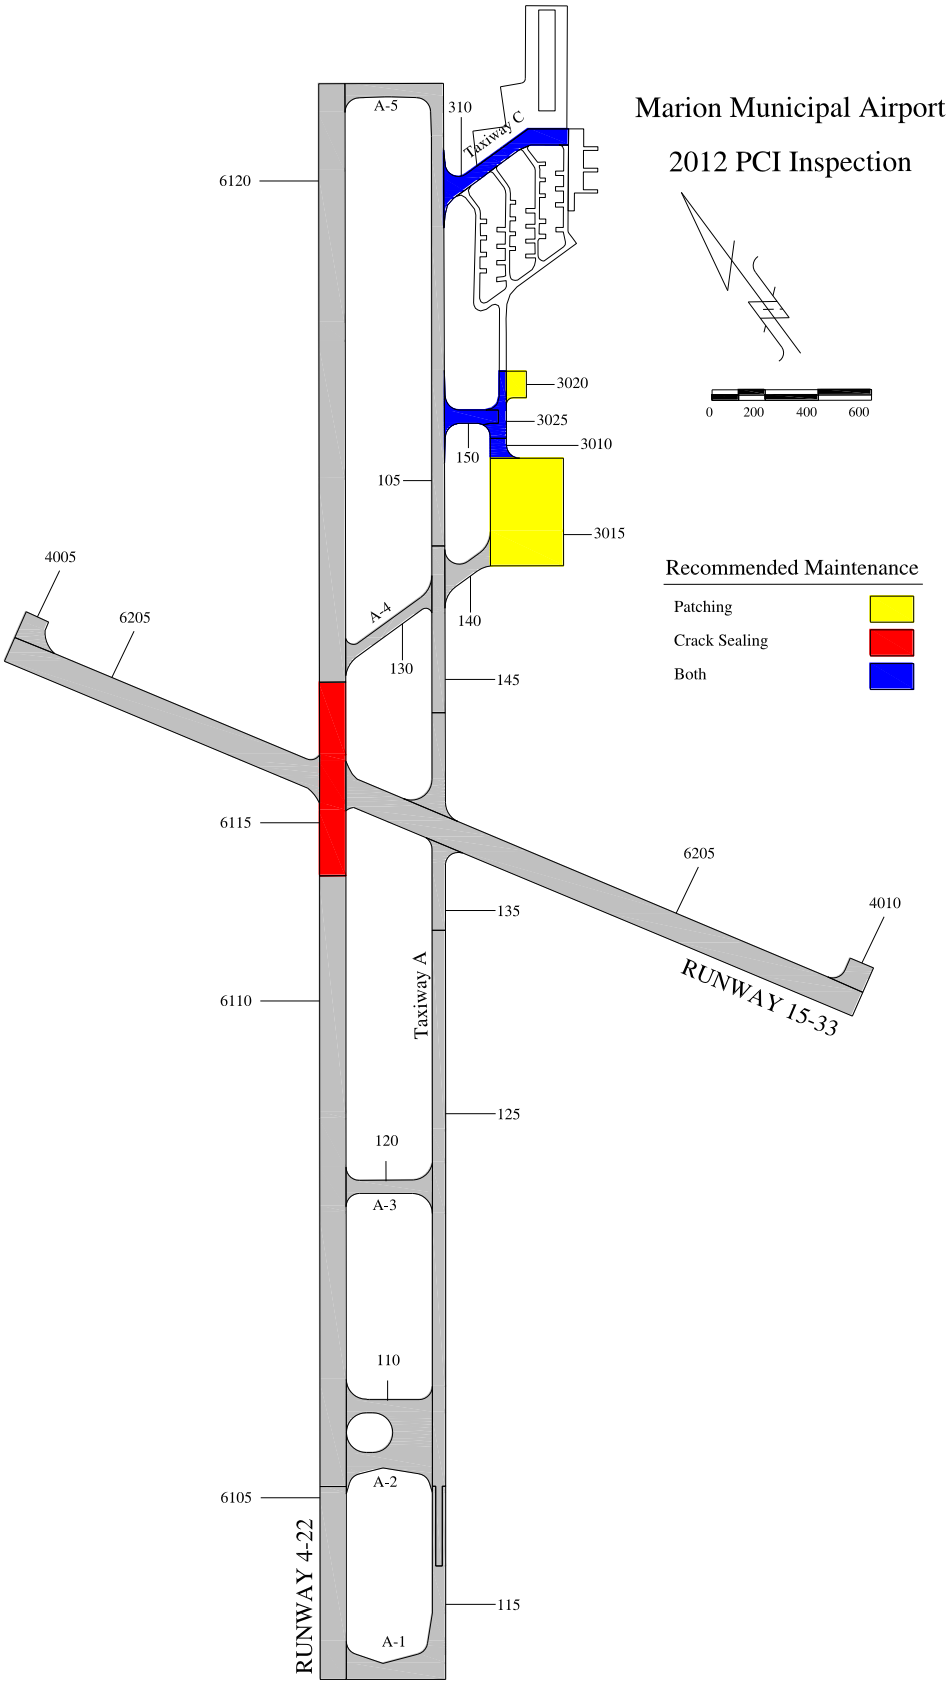
Analysis of potential maintenance projects identified approximately 150 square feet of patching needs and approximately 1,200 linear feet of crack sealing and crack repair needs, at an estimated total cost of approximately $2,700.

Marion Municipal Airport
2012 PCI Inspection
0 200 400 600
Recommended Maintenance
Patching
Crack Sealing
Both
A-5
310
Taxiway C
6120
3020
3025
3010
150
105
3015
4005
6205
A-4
140
130
145
6115
6205
4010
135
RUNWAY 15-33
Taxiway A
6110
125
120
A-3
110
A-2
6105
RUNWAY 4-22
115
A-1

Work Item	Quantity	Unit	Cost
AC PATCH	106	SF	906
AC RESTORATIVE CRACK REPAIR	255	LF	311
AC SUSTAINING CRACK REPAIR	901	LF	768
PCC PATCHING	46	SF	761
Total:			**$ 2,746**

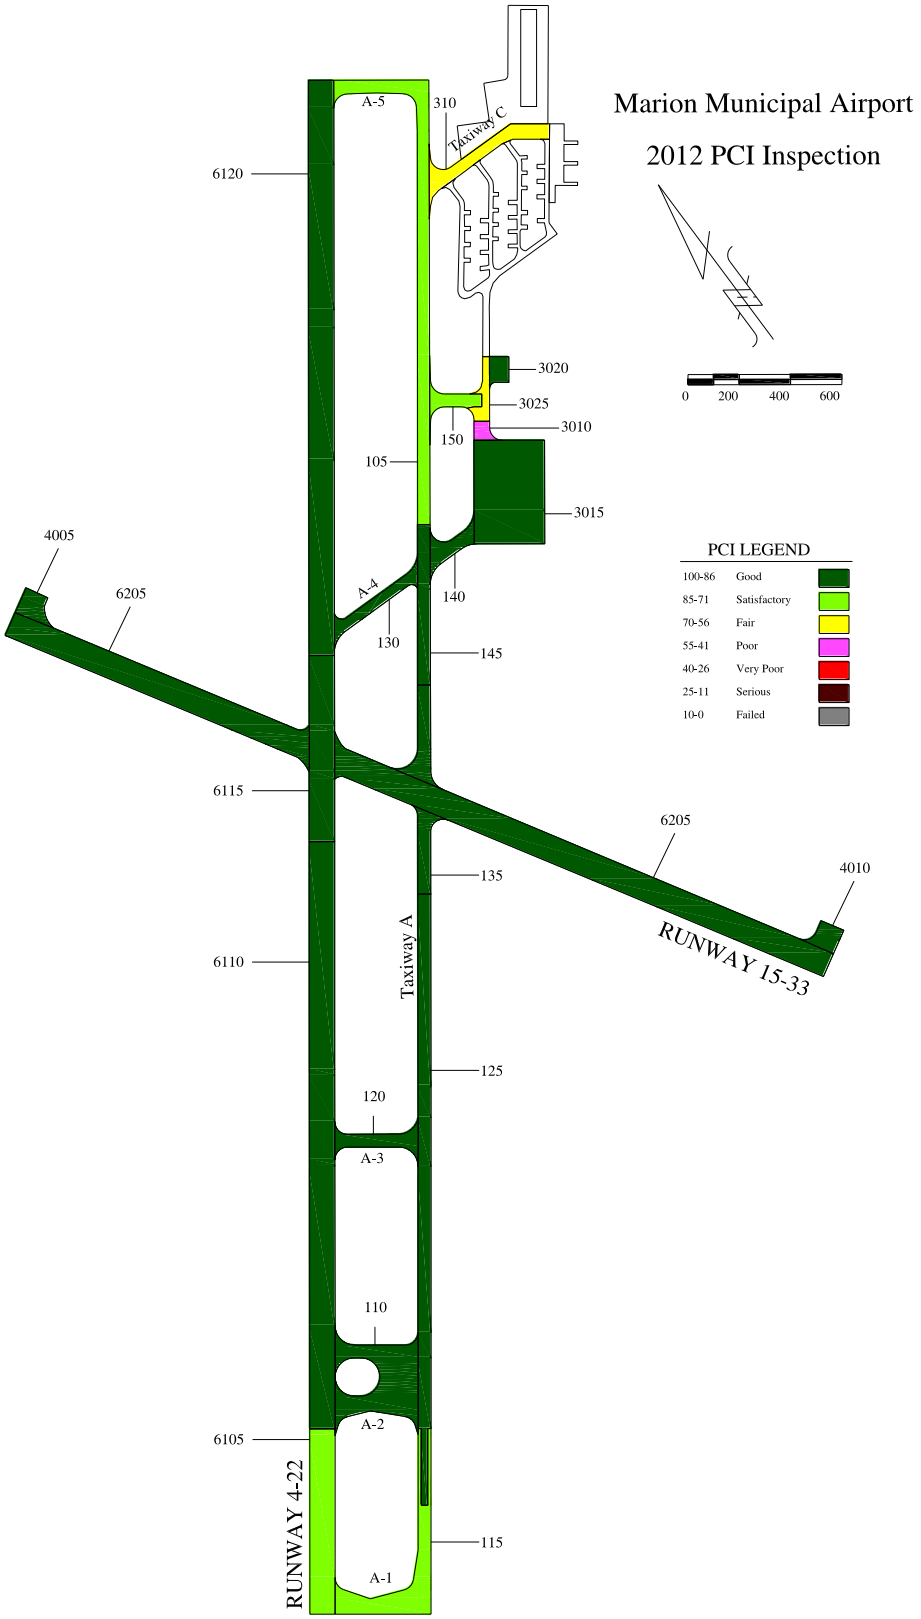
Figure 2-1. Inspected Pavement Condition

One pavement section 3010 (Ramp) had a PCI rating of Poor, indicating that near-term maintenance may range from routine up to requiring reconstruction to maintain serviceability. The pavement within each of the PCI condition categories is shown in Figure 2-1. The inspected PCI is summarized by branch use in Figure 2-2, and the photographs that follow provide examples of the condition categories.

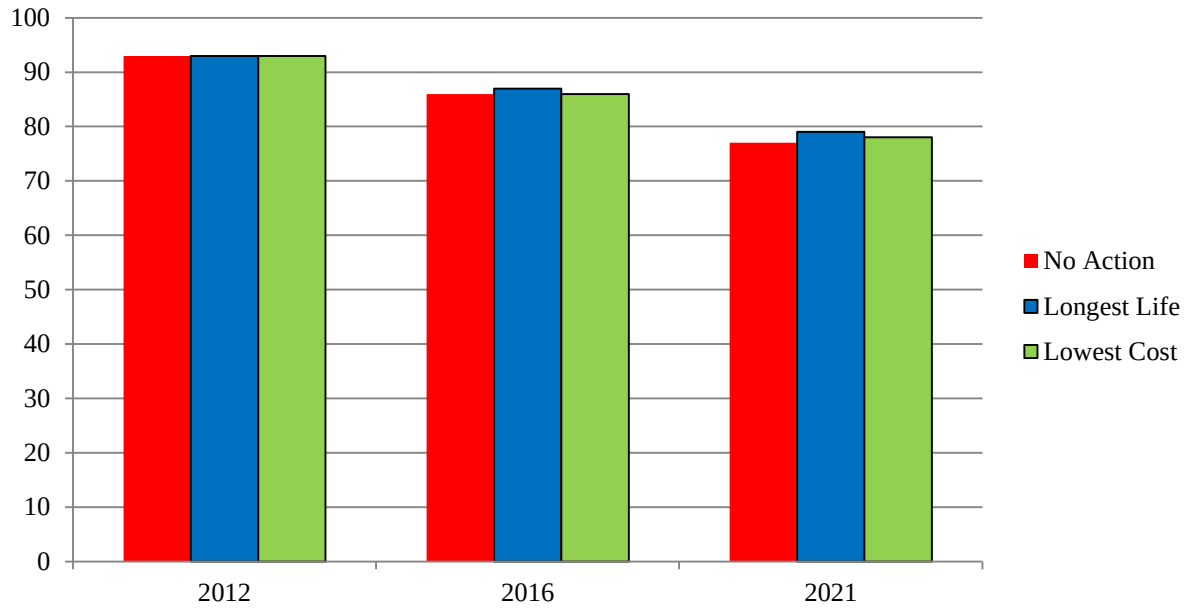
Figure 3-1. Programmed CIP

Figure 3-1 shows a projection of the overall airport pavement condition for the next 10 years based on implementing one of three capital improvement strategies:

The longest life CIP scenario is projected to cost approximately **$76,000** over the next 10 years. The lowest annual cost scenario is projected to cost approximately **$18,000** over the next 10 years. Examples of each capital improvement strategy and a complete listing of all viable capital projects are presented in Table 3-2 through Table 3-4.

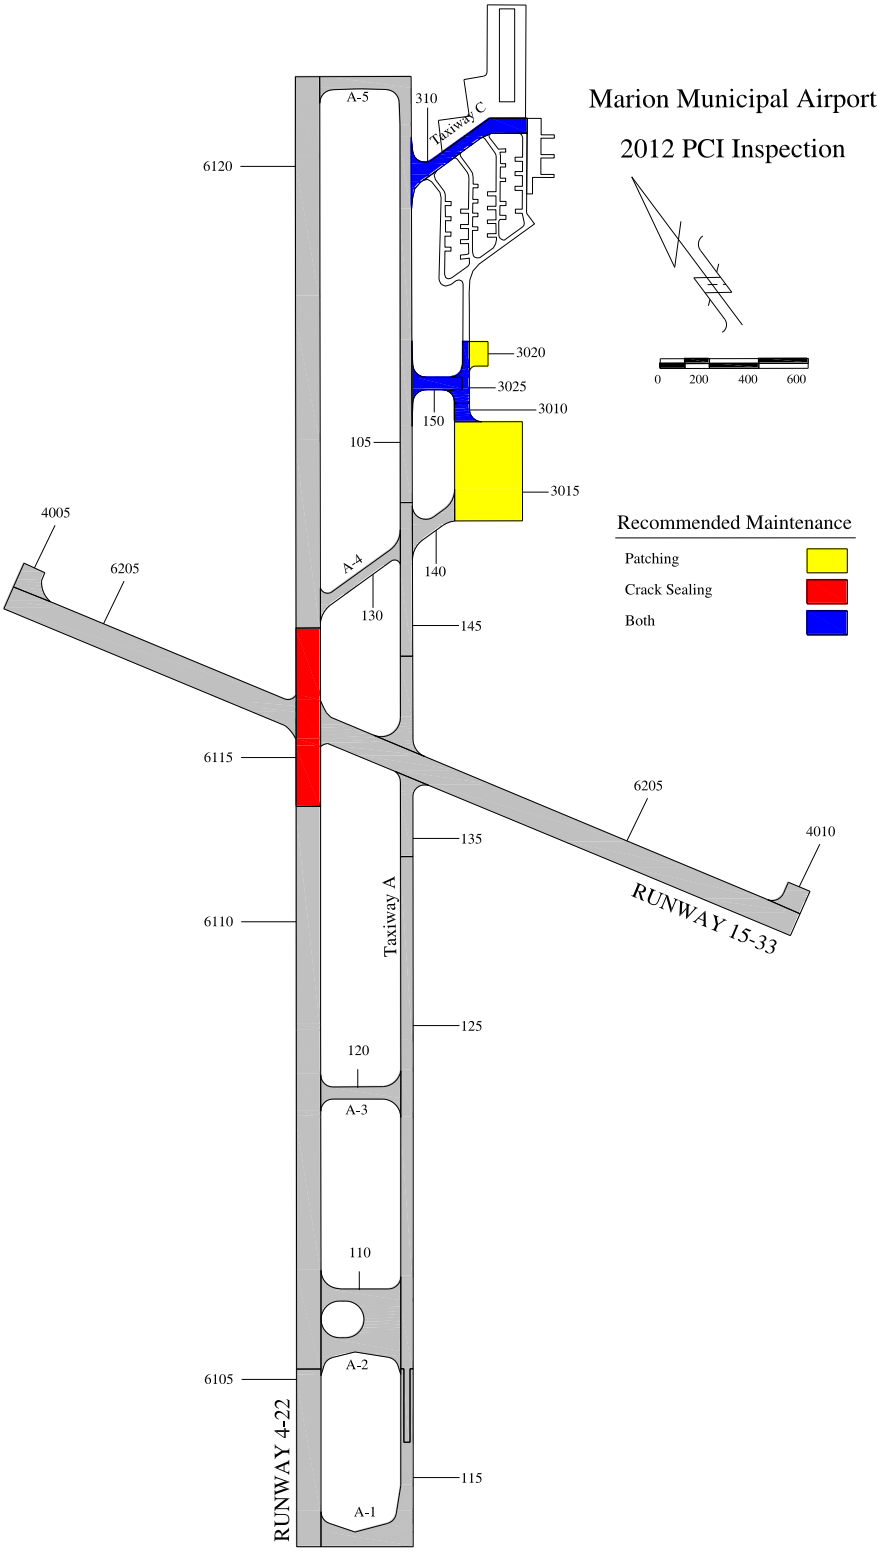
Figure 4-1. Recommended Maintenance

Feature	Work Item	Amount	Insp. PCI	Change	Est. PCI
150	AC SUSTAINING CRACK REPAIR	132	74	-	74
310	AC SUSTAINING CRACK REPAIR	468	63	-	63
3025	AC SUSTAINING CRACK REPAIR	68	63	-	63
6115	AC SUSTAINING CRACK REPAIR	233	91	-	91
	TOTAL:	901	L.F.		
EQUIPMENT: AIR COMPRESSOR, HEATING KETTLE, HAND TOOLS					
EST. MATERIALS: 180 POUNDS ASTM D3405 SEALANT OR EQUIVALENT					
EST. MATERIAL COST: $180					
EST. CREW HOURS: 3.9					
EST. CREW COST: $587					
EST. PROJECT COST: $768

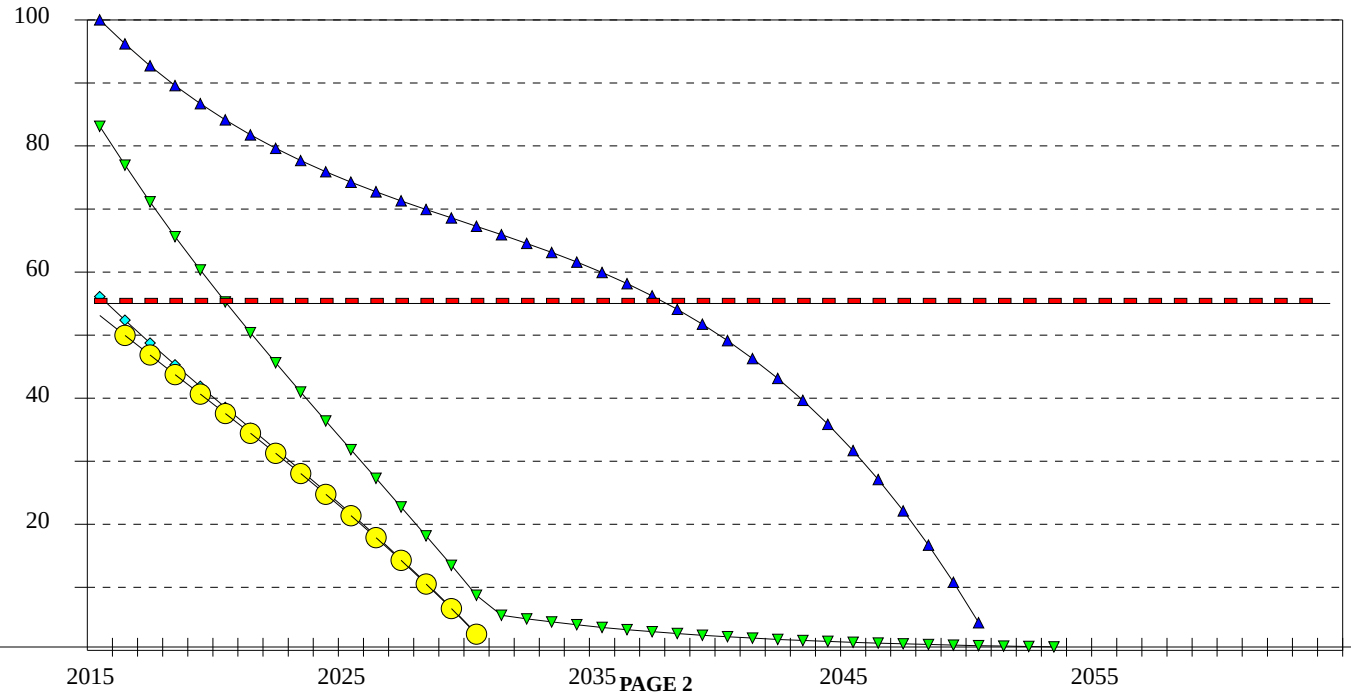
LEGEND	DESCRIPTION	COST	LIFE EXTENSION
▲	STRUCTURAL OVERLAY	$55,266	23 YEARS
▼	SURFACE TREATMENT	$11,844	6 YEARS
◇	CRACK REPAIR	$3,807	1 YEAR
○	NO ACTION	N/A	N/A
-	MINIMUM SERVICE LEVEL, CURRENTLY 55

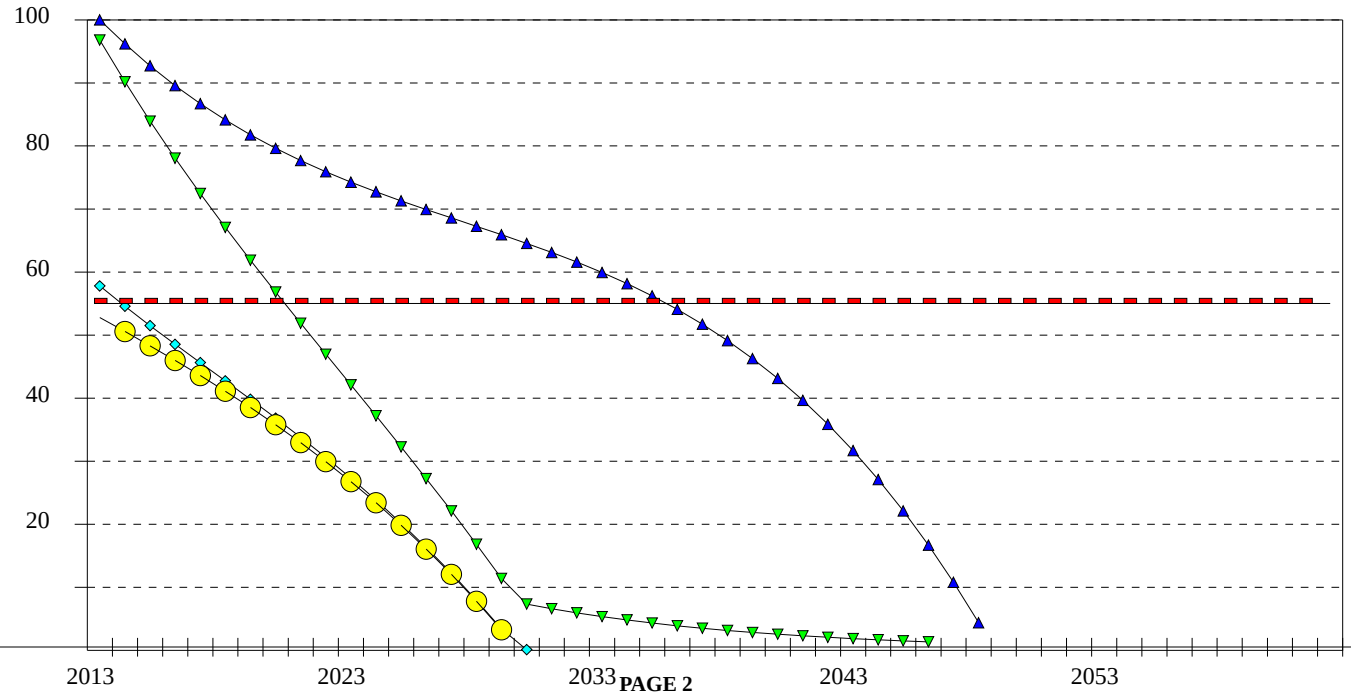
LEGEND	DESCRIPTION	COST	LIFE EXTENSION
▲	RESURFACING	$6,979	23 YEARS
▼	SURFACE TREATMENT	$1,999	8 YEARS
◇	CRACK REPAIR	$333	1 YEAR
○	NO ACTION	N/A	N/A
-	MINIMUM SERVICE LEVEL, CURRENTLY 55

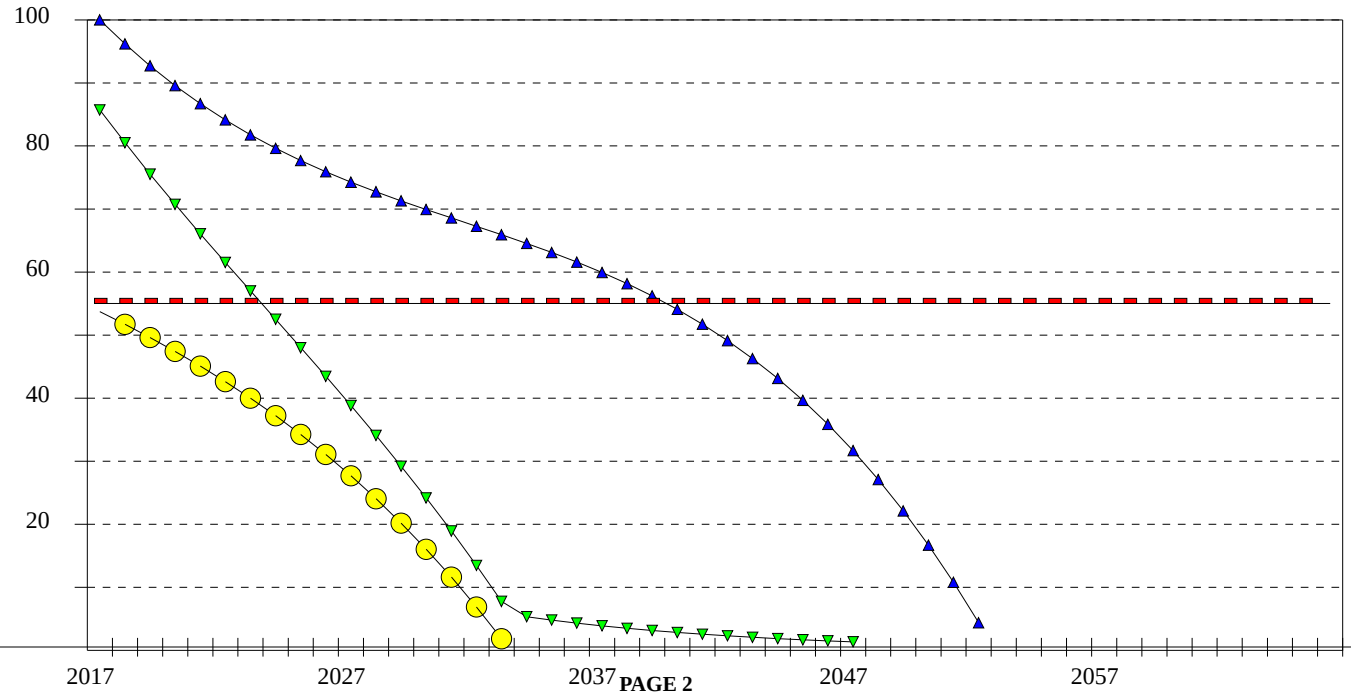
LEGEND	DESCRIPTION	COST	LIFE EXTENSION
▲	RESURFACING	$13,995	23 YEARS
▼	SURFACE TREATMENT	$3,857	7 YEARS
●	NO ACTION	N/A	N/A
-	MINIMUM SERVICE LEVEL, CURRENTLY 55

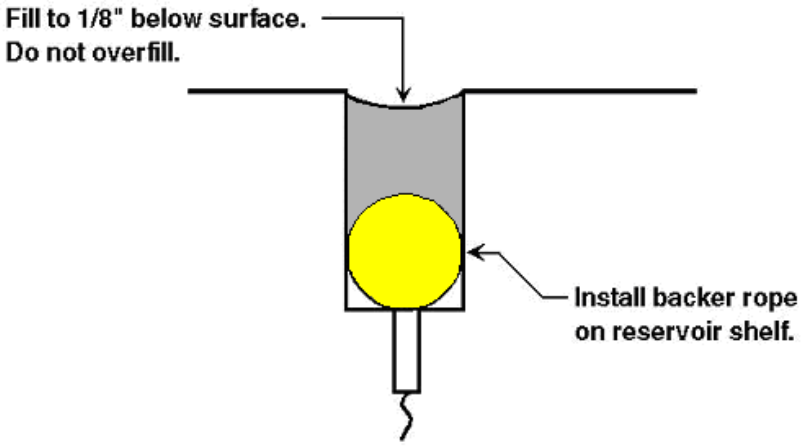
Clean joints exposing fresh, clean concrete and stone. Retain existing resevoir shape.

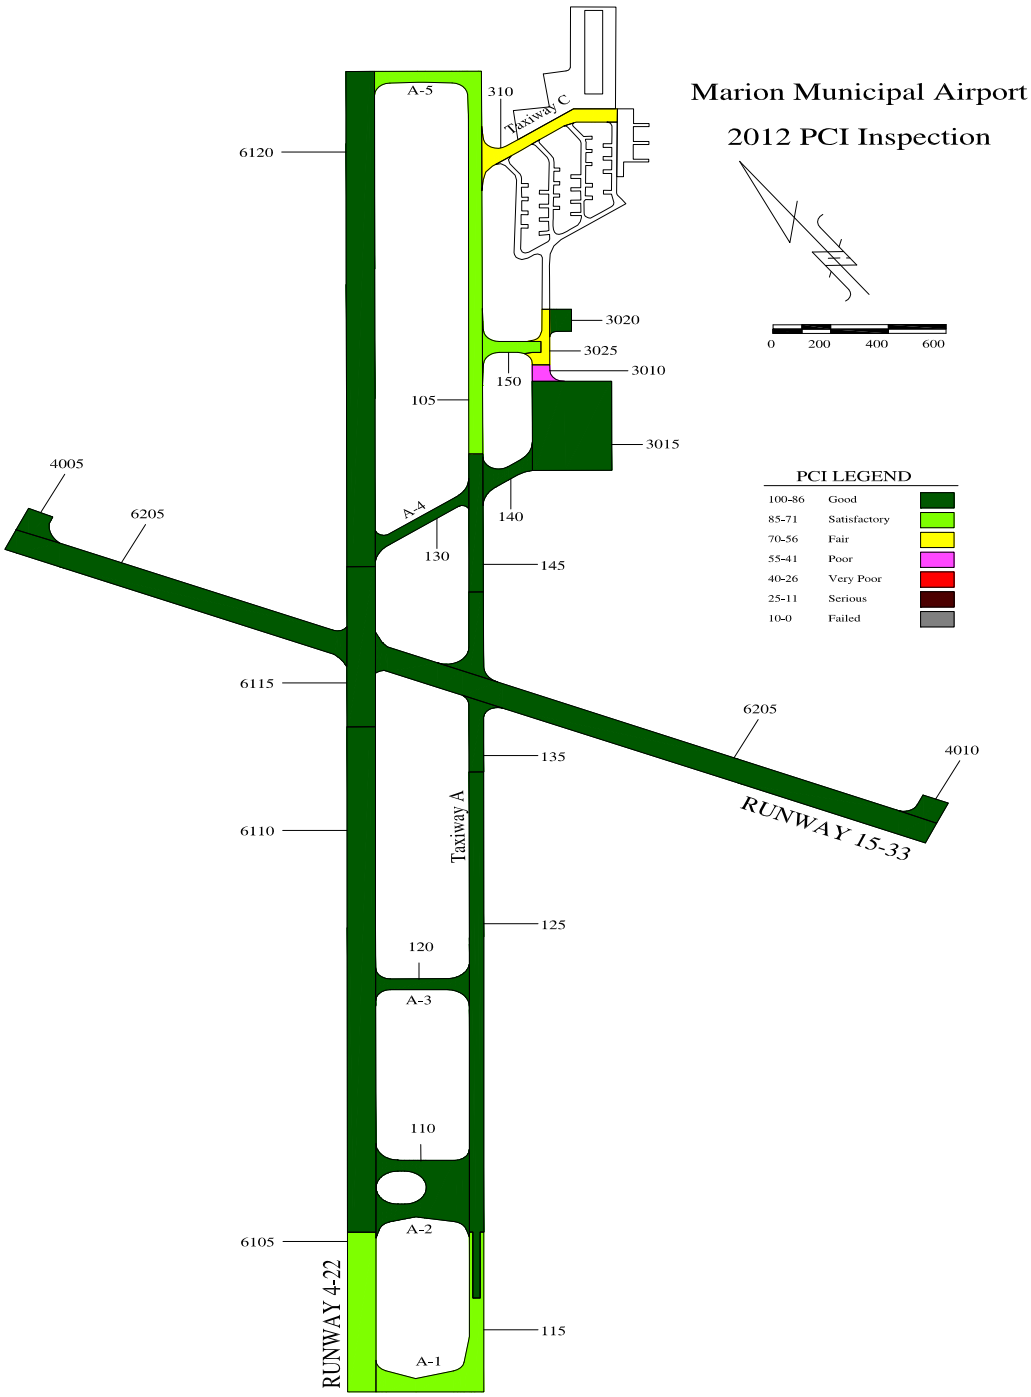
Marion Municipal Airport
2012 PCI Inspection
0 200 400 600
PCI LEGEND
100-86 Good
85-71 Satisfactory
70-56 Fair
55-41 Poor
40-26 Very Poor
25-11 Serious
10-0 Failed
A-5
310
Taxiway C
6120
3020
3025
3010
150
105
3015
4005
6205
A-4
140
130
145
6115
6205
4010
135
RUNWAY 15-33
Taxiway A
6110
125
120
A-3
110
A-2
6105
RUNWAY 4-22
115
A-1
