Pavement Condition Report

Peru Municipal Airport

Project 13801869

January 2013

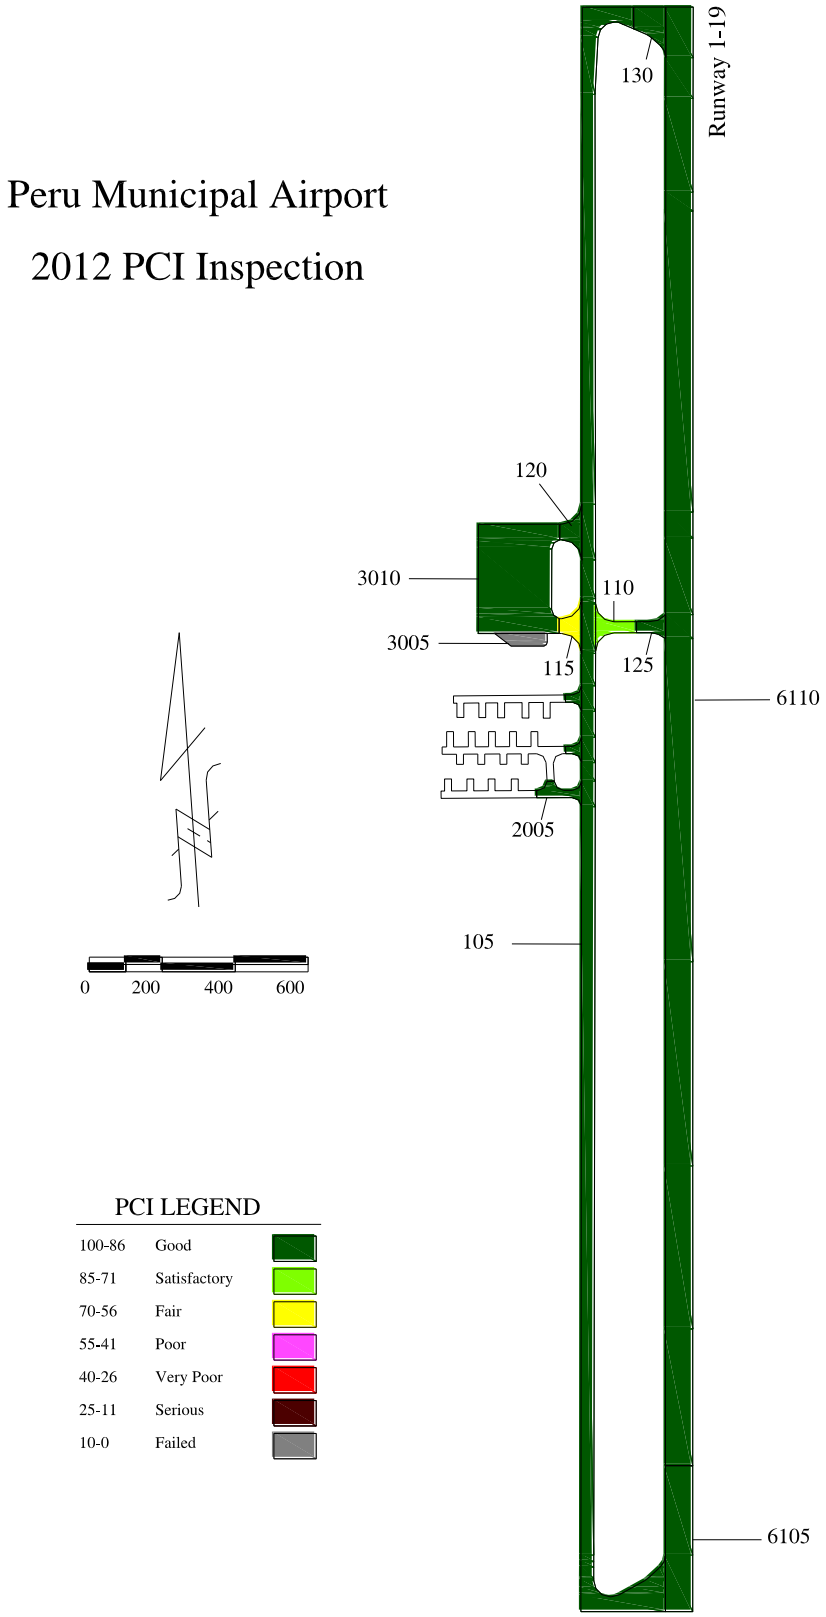
Figure 2-1. Inspected Pavement Condition

One pavement section: 3005 (Ramp Expansion) had a PCI rating of Failed, indicating that reconstruction is required. The pavement within each of the PCI condition categories is shown in Figure 2-1. The inspected PCI is summarized by branch use in Figure 2-2. The photographs that follow provide examples of the condition categories.

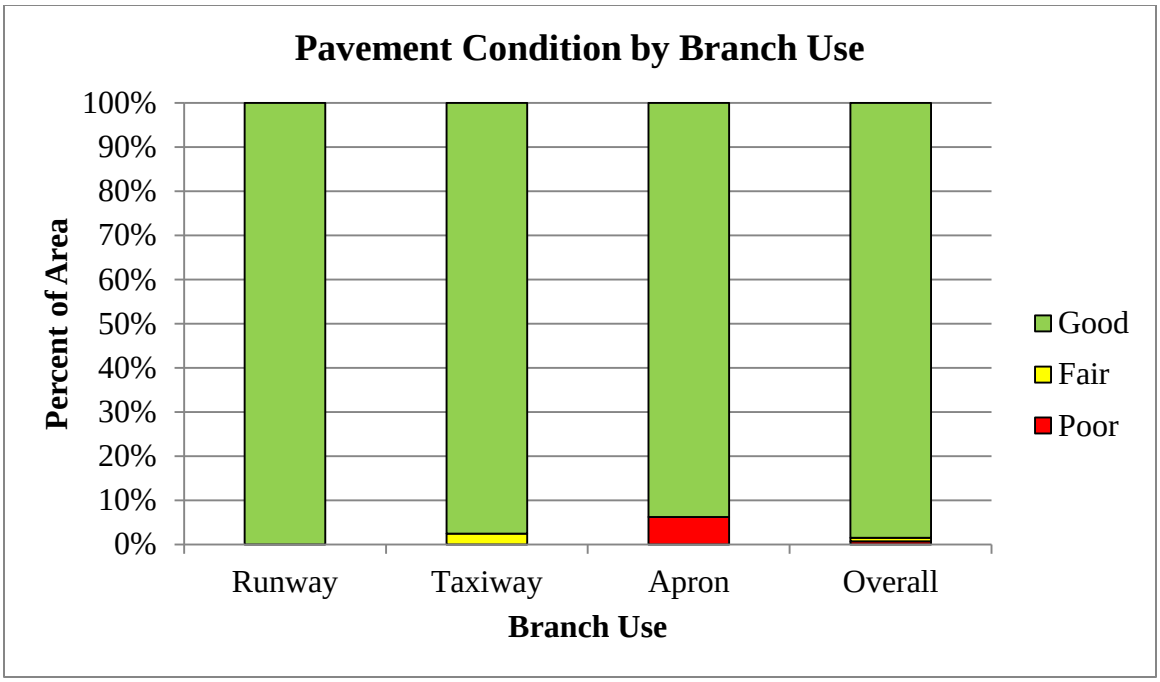
Figure 2-2. Pavement Condition by Branch Use

The overall Pavement Condition Index (PCI) for the airfield pavements was 94. Runways had an average inspected PCI of 96 and were above the desired MSL of 60. Taxiways had an average inspected PCI of 93, and ramps had an average inspected PCI of 87.

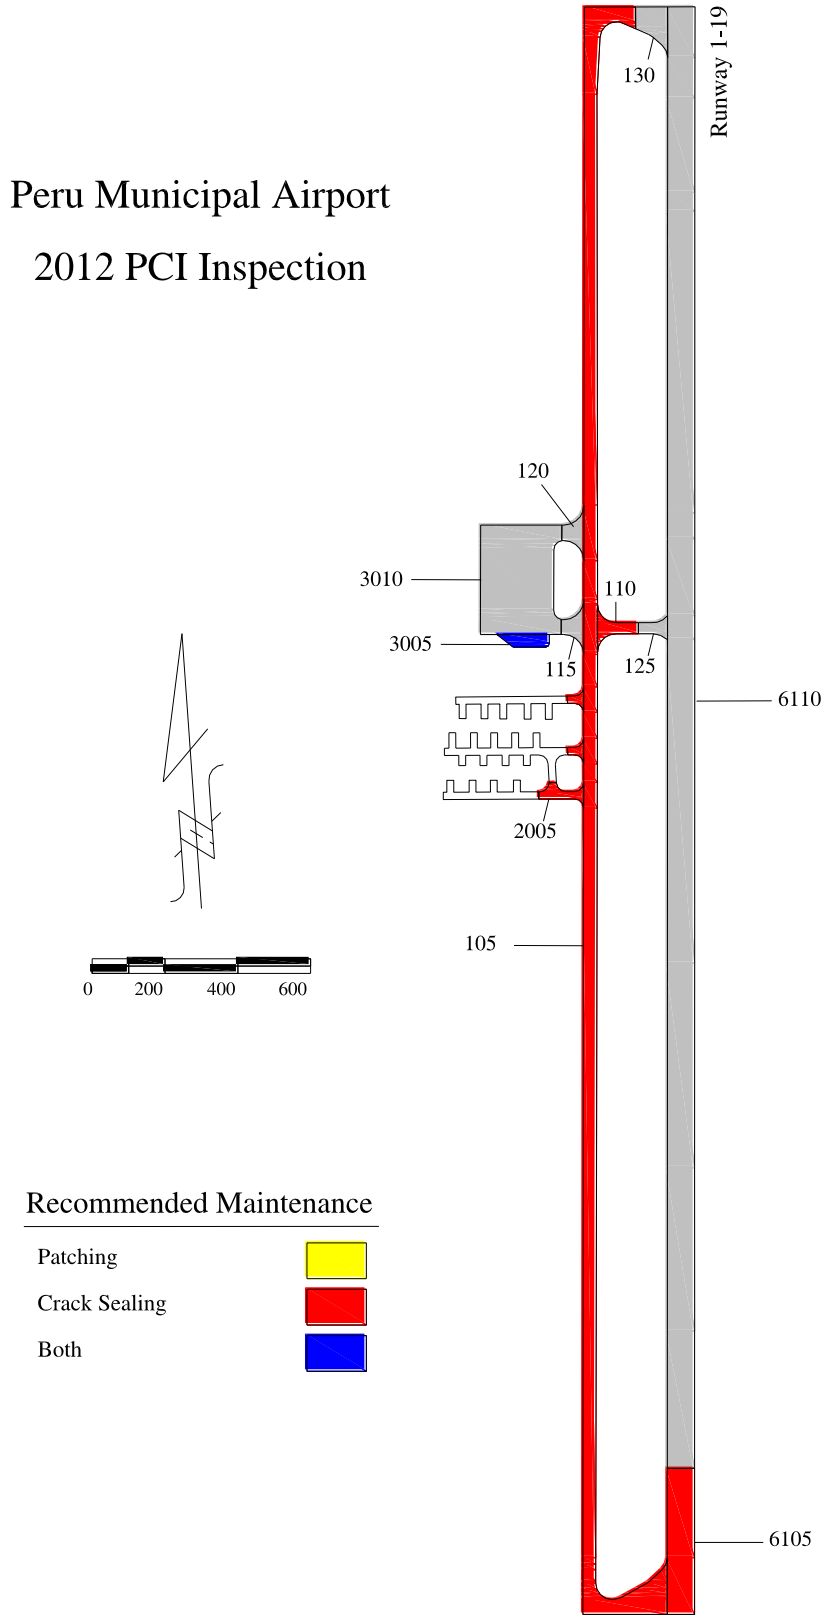
Figure 4-1. Recommended Maintenance

Analysis of potential maintenance projects identified approximately 2,500 square feet of patching needs and approximately 2,300 linear feet of crack sealing and crack repair needs, at an estimated total cost of approximately $34,000.

Feature	Work Item	Amount	Insp. PCI	Change	Est. PCI
3005	PCC RESTORATIVE SEAL REPAIR	526 L.F.	4	2	6
EQUIPMENT: ROUTER, SAND BLASTER, AIR COMPRESSOR, HEATING KETTLE, HAND TOOLS					
EST. MATERIALS: 105 POUNDS ASTM D3405 SEALANT OR EQUIVALENT					
EST. MATERIAL COST: $263					
EST. CREW HOURS: 4.4					
EST. CREW COST: $895					
EST. PROJECT COST: $1,158

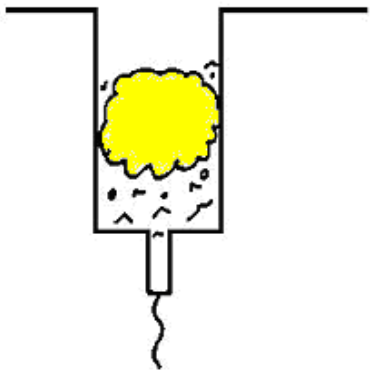
Typical failed joint sealant, w/ debris and incompressibles.
