Pavement Condition Report

Plymouth Municipal Airport

Project 13801869

January 2013

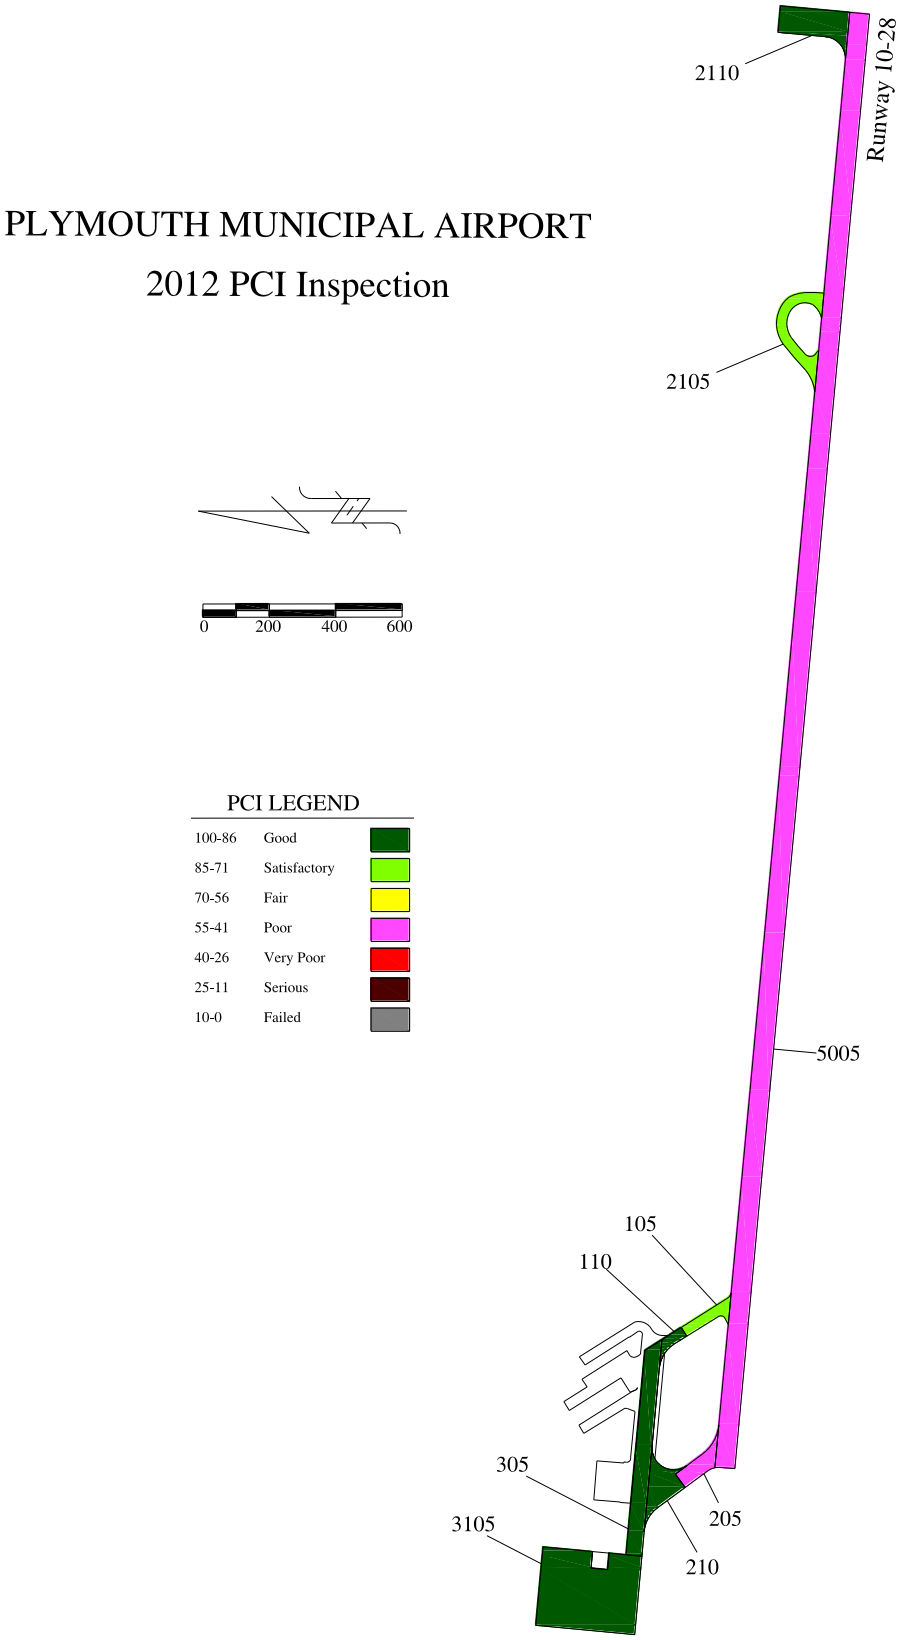
Figure 2-1. Inspected Pavement Condition

Two pavement sections had a PCI rating of Poor, indicating that near-term maintenance needs may range from routine up to a requirement for reconstruction. The pavement within each of the PCI condition categories is shown in Figure 2-1. The inspected PCI is summarized by branch use in Figure 2-2, and the photographs that follow provide examples of the condition categories.

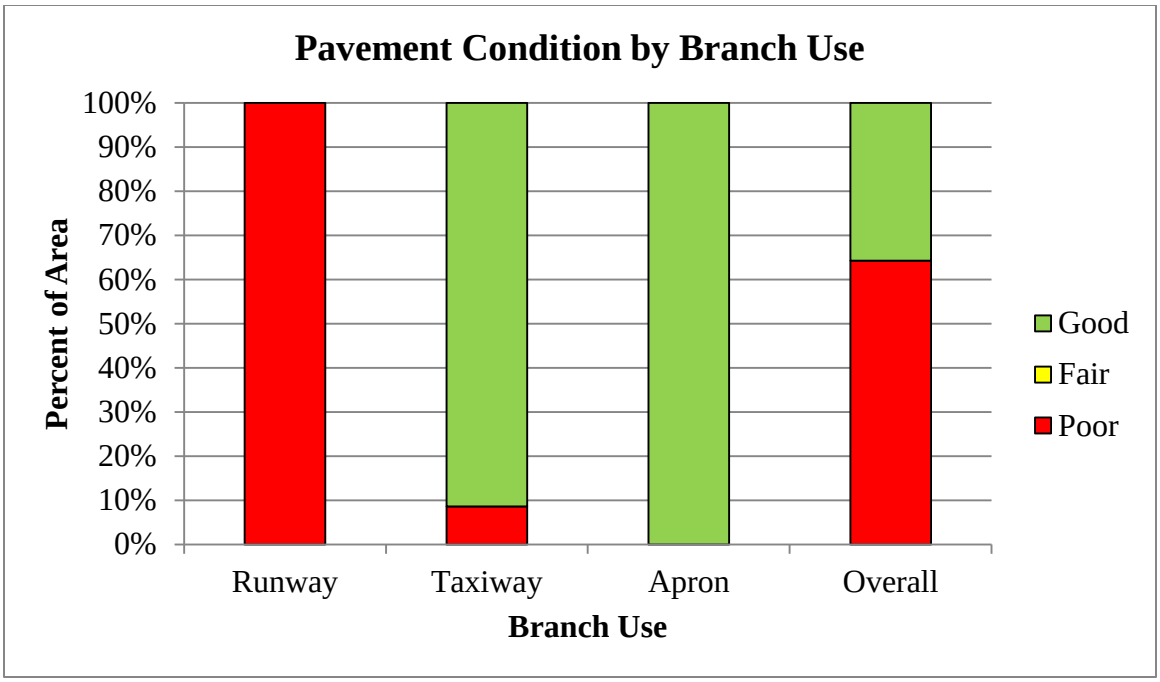
Figure 2-2. Pavement Condition by Branch Use

The overall Pavement Condition Index (PCI) for the airfield pavements was 68. Runways had an average inspected PCI of 55 and were at the desired MSL of 55. Taxiways had and average inspected PCI of 84, and ramps had an average inspected PCI of 99.

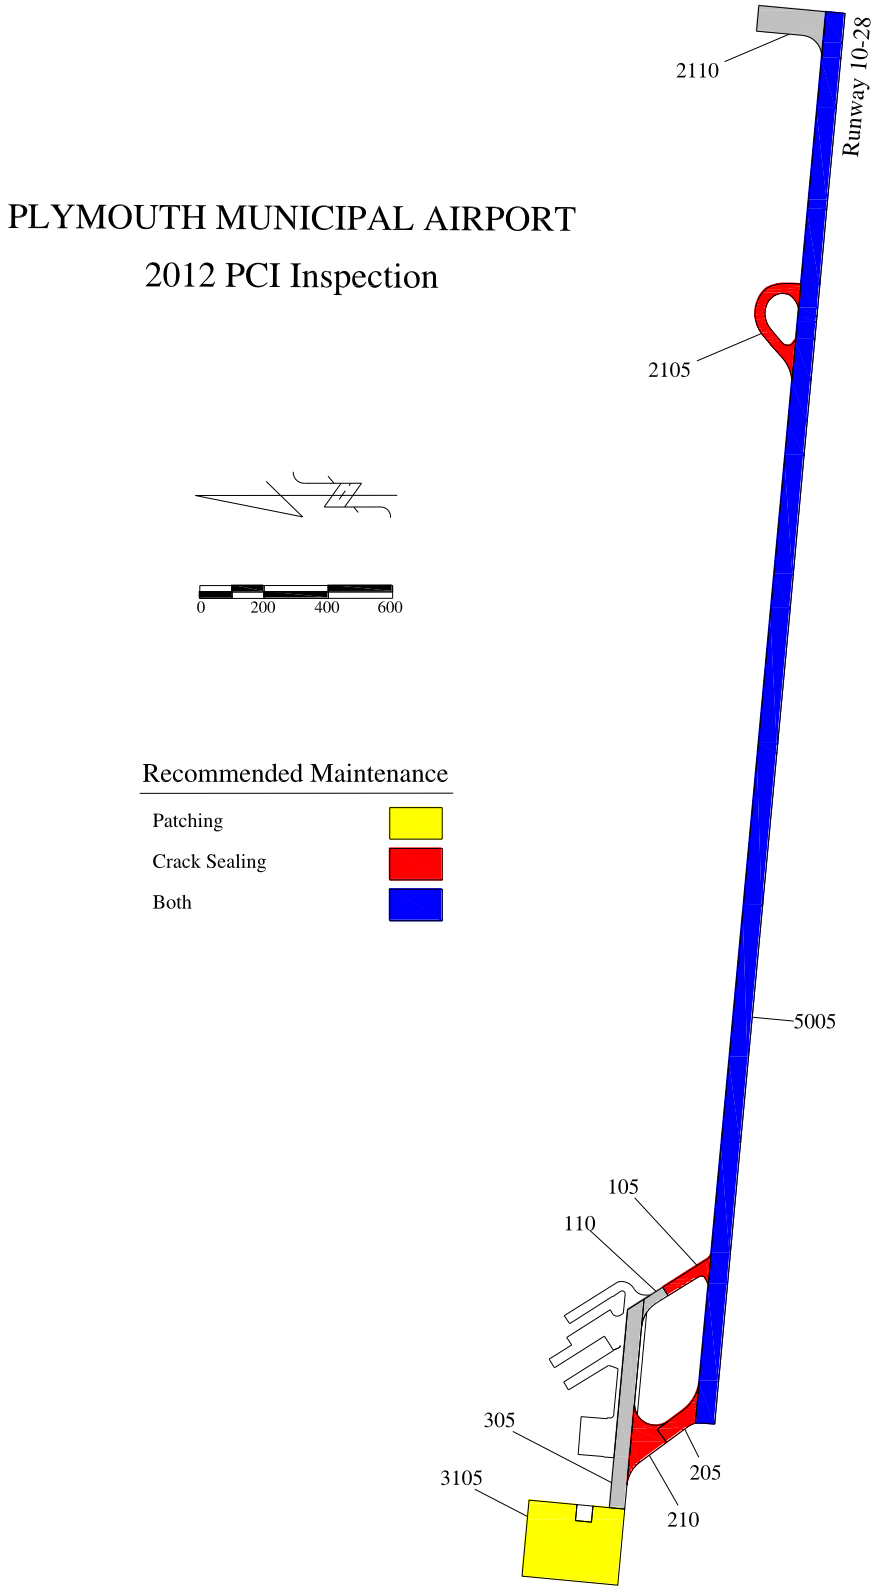
Figure 4-1. Recommended Maintenance

Analysis of potential maintenance projects identified approximately 310 square feet of patching needs and approximately 8,800 linear feet of crack sealing and crack repair needs, at an estimated total cost of approximately $11,000.

Specific recommendations to help prioritize airfield maintenance are found in chapter 4 of this report. A summary of all identified maintenance needs is shown in the table below and in the figure on the following page.

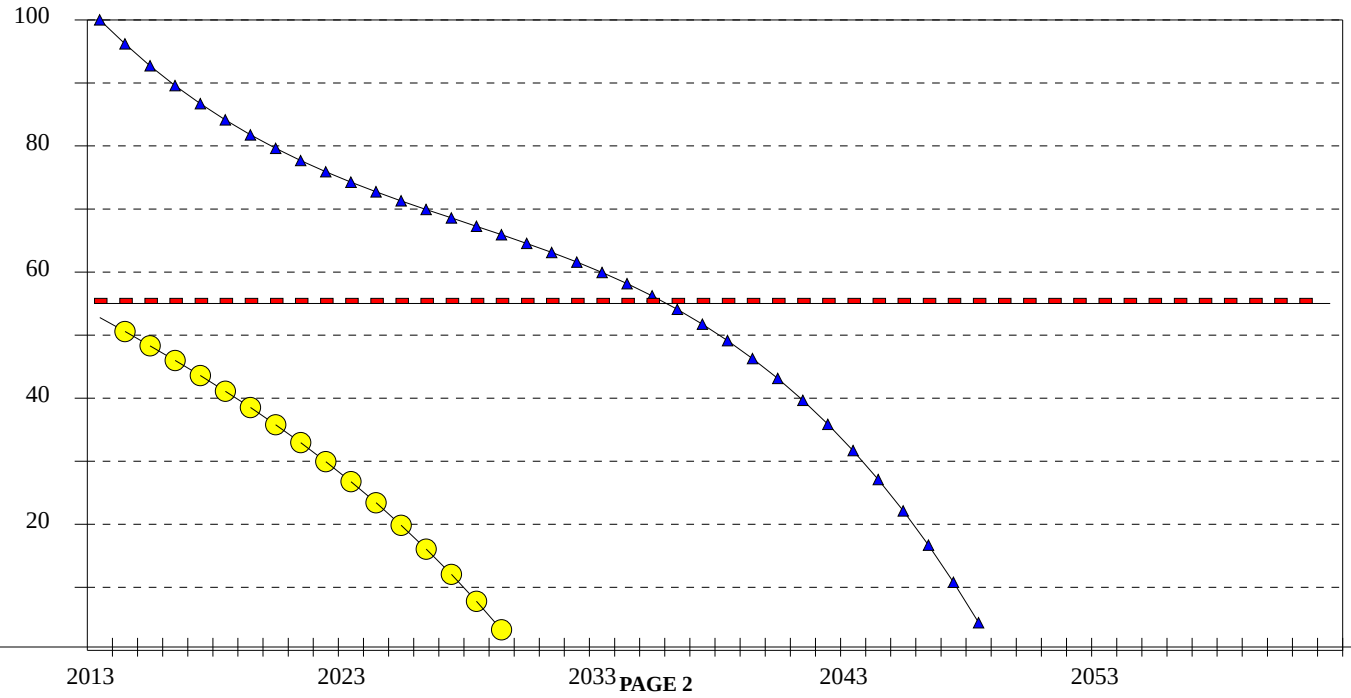
Runway 10-28 consisted of 1 section of AC pavement. The branch had a total area of 261,056 ft^2 with an area-weighted average PCI of 55 (Poor). The most common distresses were low-severity L&T cracking and low-severity raveling.

LEGEND	DESCRIPTION	COST	LIFE EXTENSION
▲	RESURFACING	$368,088	23 YEARS
●	NO ACTION	N/A	N/A
-	MINIMUM SERVICE LEVEL, CURRENTLY 55

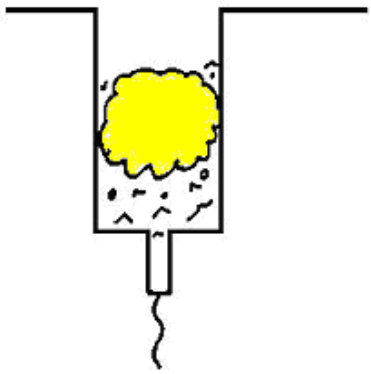
Typical failed joint sealant, w/ debris and incompressibles.
