Pipeline Safety Division Investigation Report

Investigation regarding: City Of Decatur Water Utility

UPPAC Database Record ID: 4483

Synopsis: Excavator struck and damaged an underground natural gas service while performing water work.

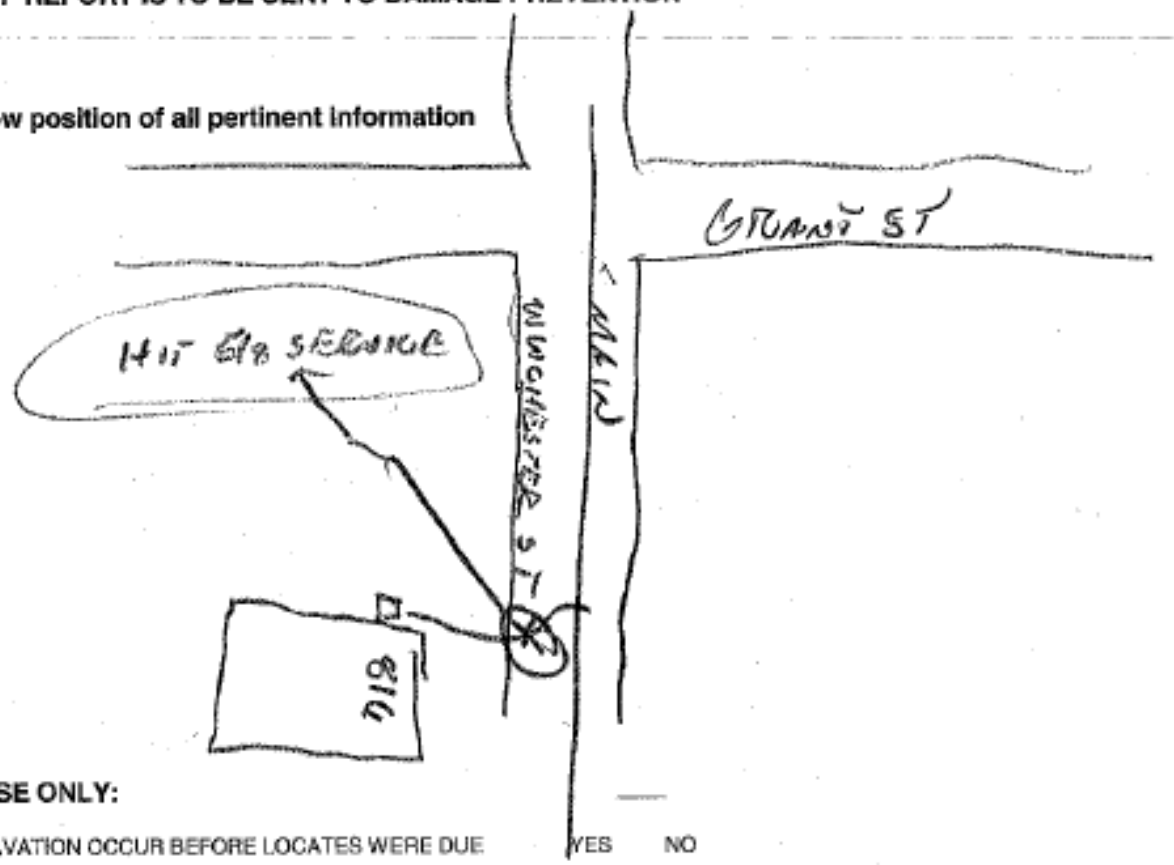
SKETCH: - Show position of all pertinent information

LOCATE MARKS ON SITE: YES (X) DISTANCE BETWEEN FACILITY AND LOCATE MARKS JUST MARKED OK NO ( )

COMMENTS: LOCATE MARKS JUST SAID OK
