United States Steel Corporation
Midwest Plant
Portage, Indiana

Enhanced Wastewater Process Monitoring Design

06-29-2018
Revised 12/21/2018

Photo Documentation of Repairs

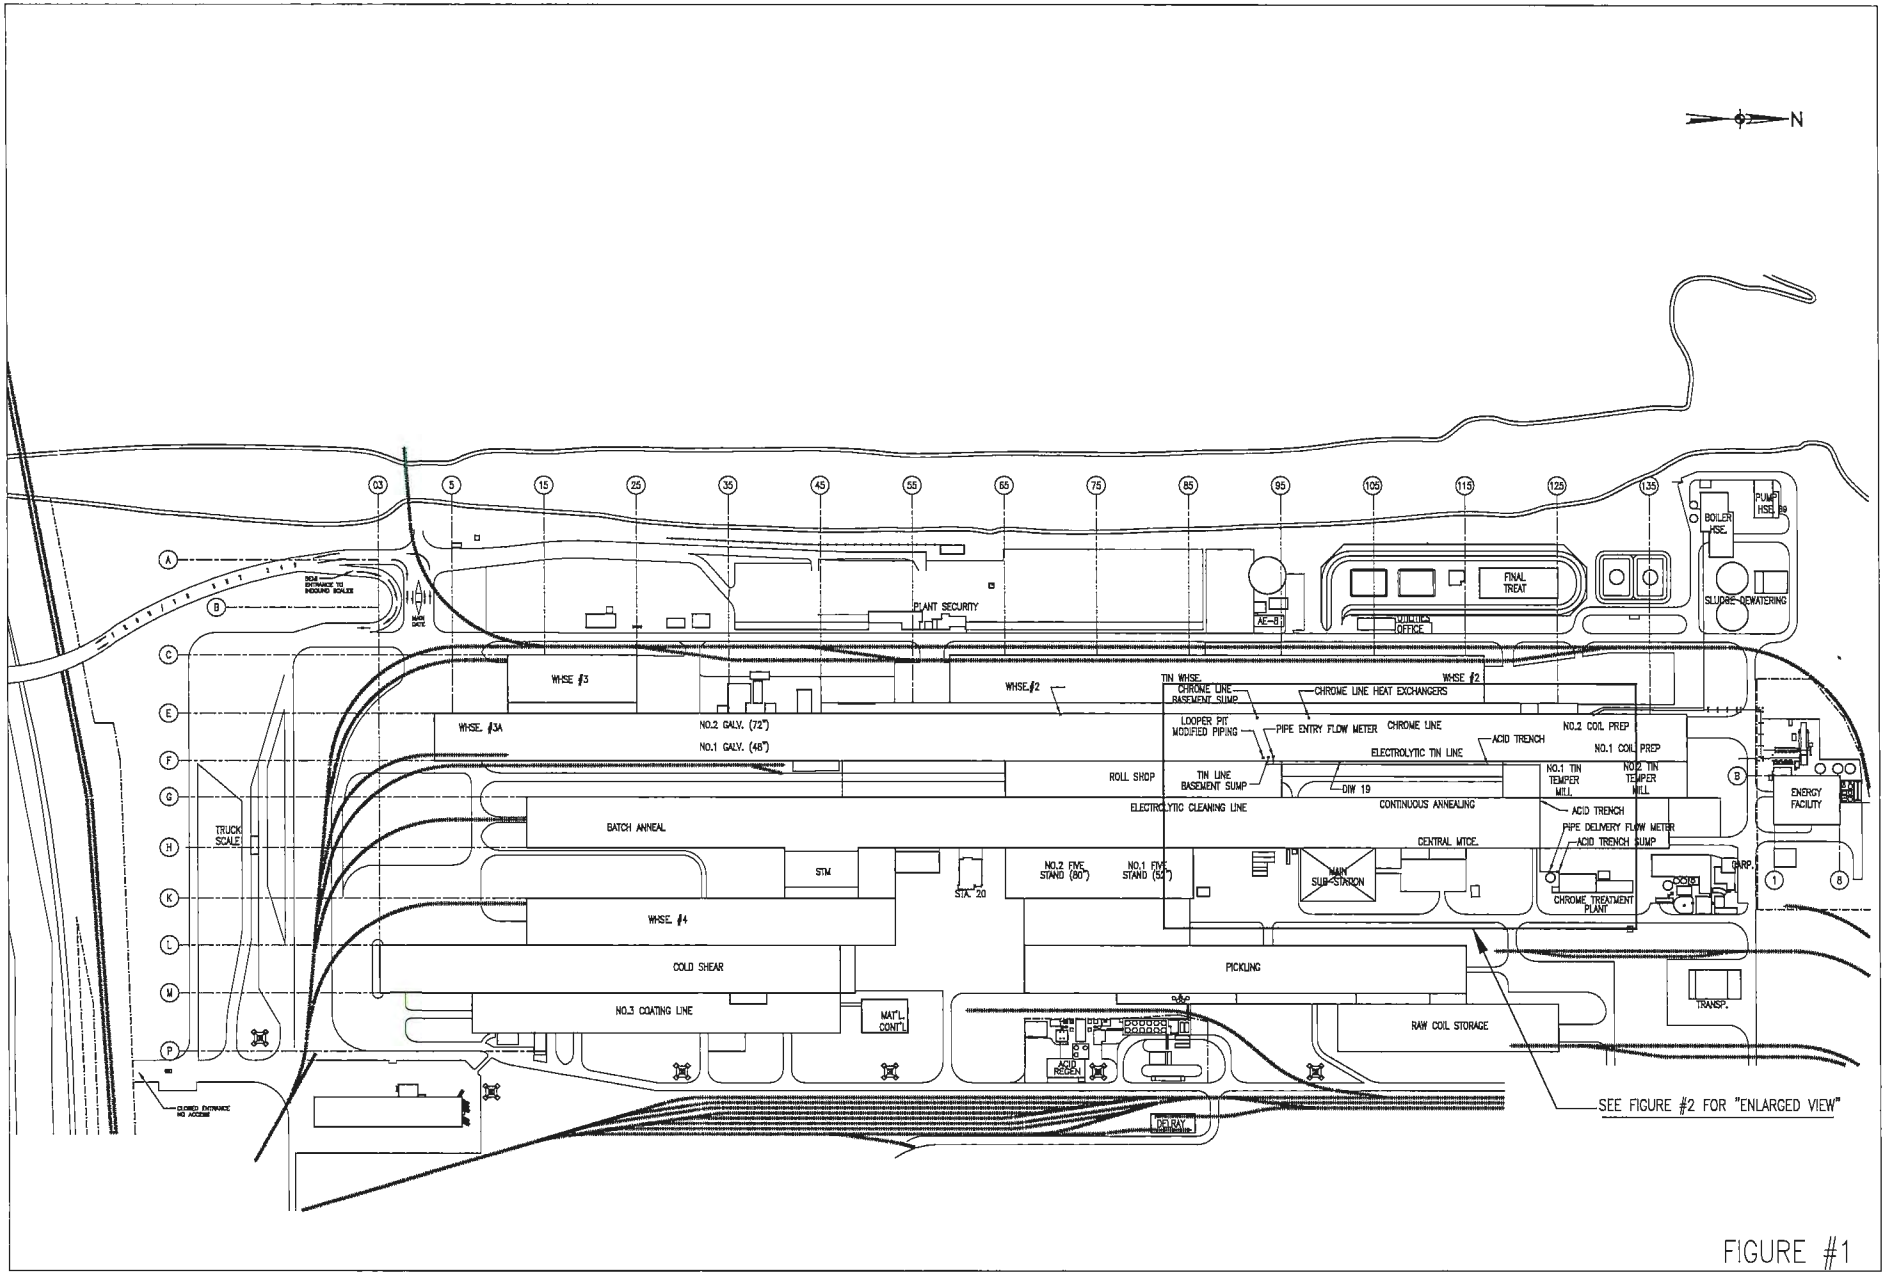
FIGURE #1

To address the integrity of the containment trench for the chrome process wastewater piping, the trench was cleaned, and new concrete bottom poured. The trench slope was reestablished to direct any flow in the trench to the chrome trench sump. Please see Figure 1 and Figure 2 in Appendix 1 for the location of the trench.

Two flow meters were installed at the inlet and outlet areas of the chrome plant influent wastewater piping. The pipe entry flow meter is located just after the combining of chrome wastewater flows from the Tin and Chrome Lines basement sumps and the pipe delivery flow meter is located just prior to discharge into the chrome plant equalization tank. Both installation locations were selected to minimize any hydraulic effects that may contribute towards accuracy errors. The pipeline is continuous and does not have any tie-ins along the length between the flow meters. Please see Figure 1 and Figure 2 in Appendix 1 for the location of the pipe entry and pipe delivery flow meters.

A drain was identified in the delivery looper pit of the Tin Line that discharged to the Final Treatment Plant. Rerouting this drain will ensure that all material collected in the looper pit will be pumped to the chrome treatment plant. Please see Figure 1 and Figure 2 in Appendix 1 for the location of the modified piping from the looper pit.

The containment around the Plater and ChemTreat heat exchangers will be refurbished to prevent any unplanned release from migrating from the area. Please see Figure 1 and Figure 2 in Appendix 1 for the location of these heat exchangers.

The Tin Annex contains an offline pickle cleaning solution (sulfuric acid) and a neat hydrochloric acid tank. Concrete around the top of manhole DIW 19 that discharges to the DIW process sewer has eroded and could allow migration of these acids to the Final Treatment Plant. This manhole in the Tin Annex will be permanently sealed. This will allow any tank leak to be fully contained. A vacuum truck will remove any accumulated material. Please see Figure 1 and Figure 2 in Appendix 1 for the location of manhole DIW 19.

An inline spare probe will be installed near the sump pumps to provide additional monitoring. The two conductivity probes will be tied to the plant alert/alarm system. The probes will be installed to alarm in the event a process water release is detected. A high concentration will automatically initiate a shutdown of the sump pumps. The appropriate alarm levels will be determined from concentrations above the normal process discharge range. Please see Figure 1 and Figure 2 in Appendix 1 for the location of the Tin Line basement sump.

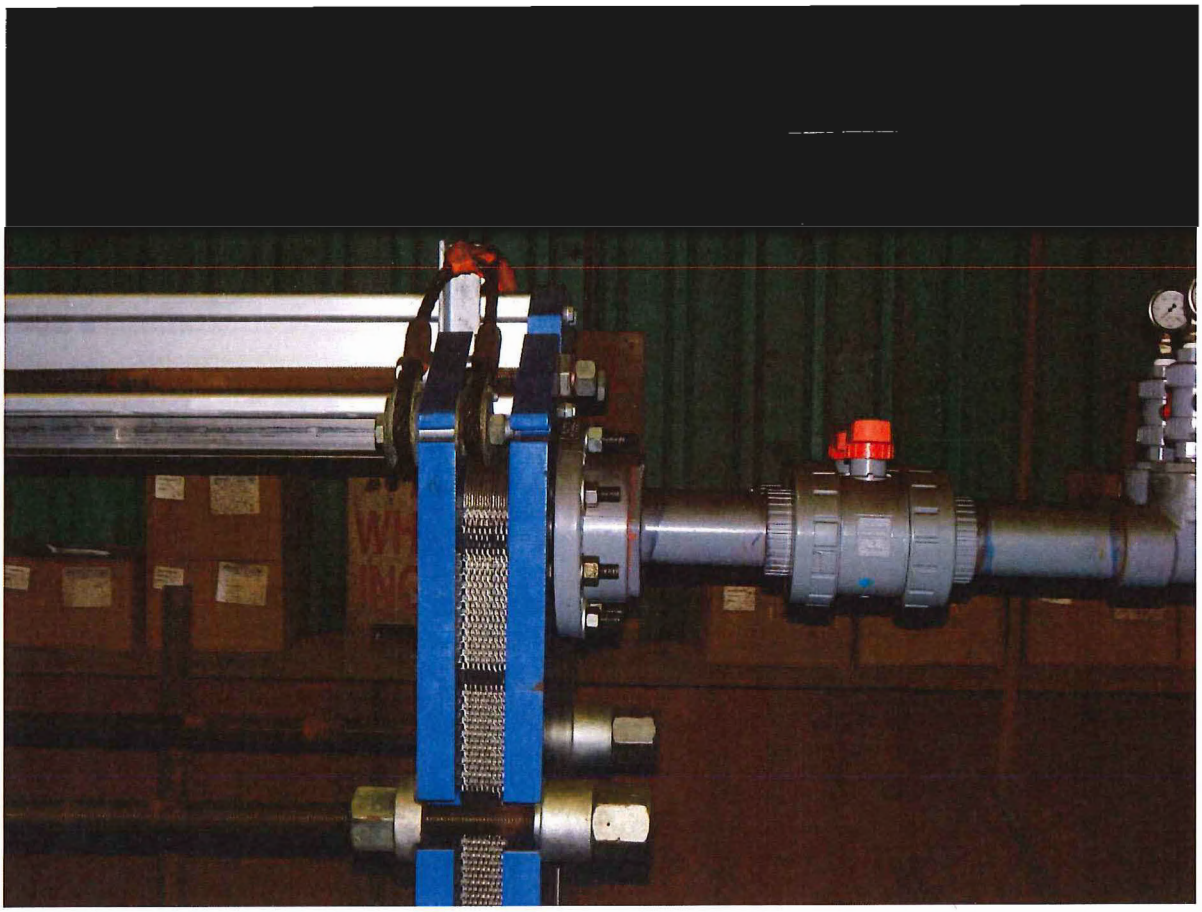
Picture 1: This picture shows the work performed pursuant to Consent Decree Paragraph 9.a.i., 9.a.ii., 9.a.iii., and 9.a.iv.

Picture 2: This picture shows the work performed pursuant to Consent Decree Paragraph 9.a.i., 9.a.ii., 9.a.iii., and 9.a.iv.

Picture 3: This picture shows the work performed pursuant to Consent Decree Paragraph 9.a.iv.

Picture 4: This picture shows newly installed double walled heat exchanger on January 15, 2018 pursuant to Consent Decree Paragraph 9.v.

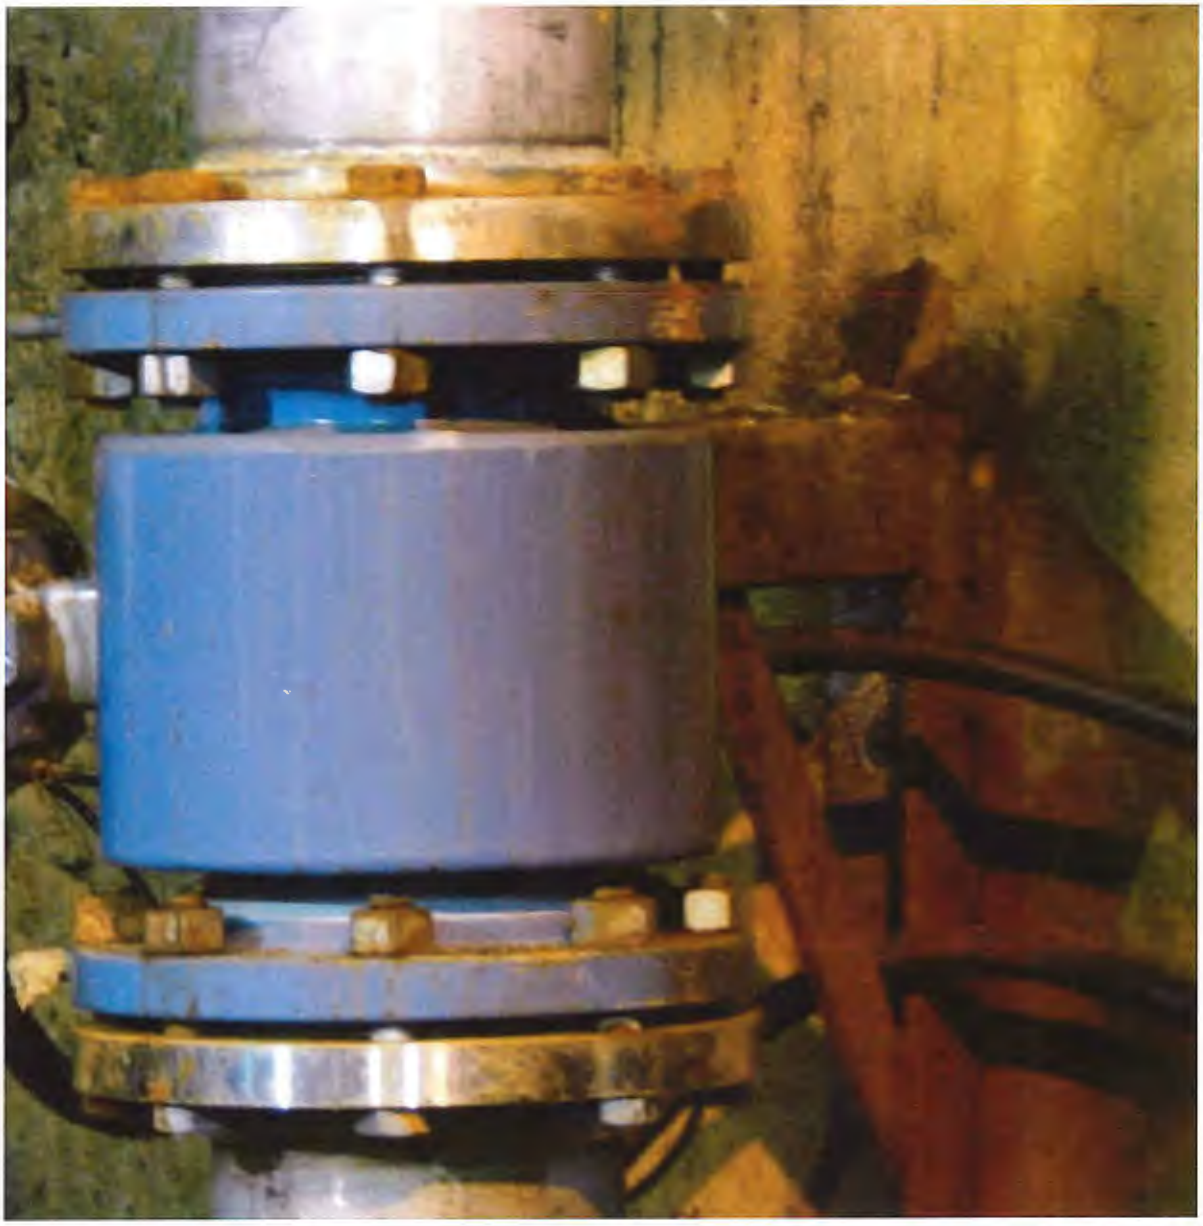
Picture 5: This picture shows the newly installed back up double walled heat exchanger pursuant to the Enhancend Wastewater Process Monitoring Design

Picture 6: Chrome containment trench: pictures of inlet flow meter on chrome transfer pipeline

Rosemount flow meters are installed at the entry and exit of the chrome plant influent wastewater piping. Due to the line and pump configuration, the flow at each meter location varies, but the meters trend together. These meters would detect a line failure. Other methods are employed to detect leaks including conductivity metering in key locations, periodic sampling and inspection.

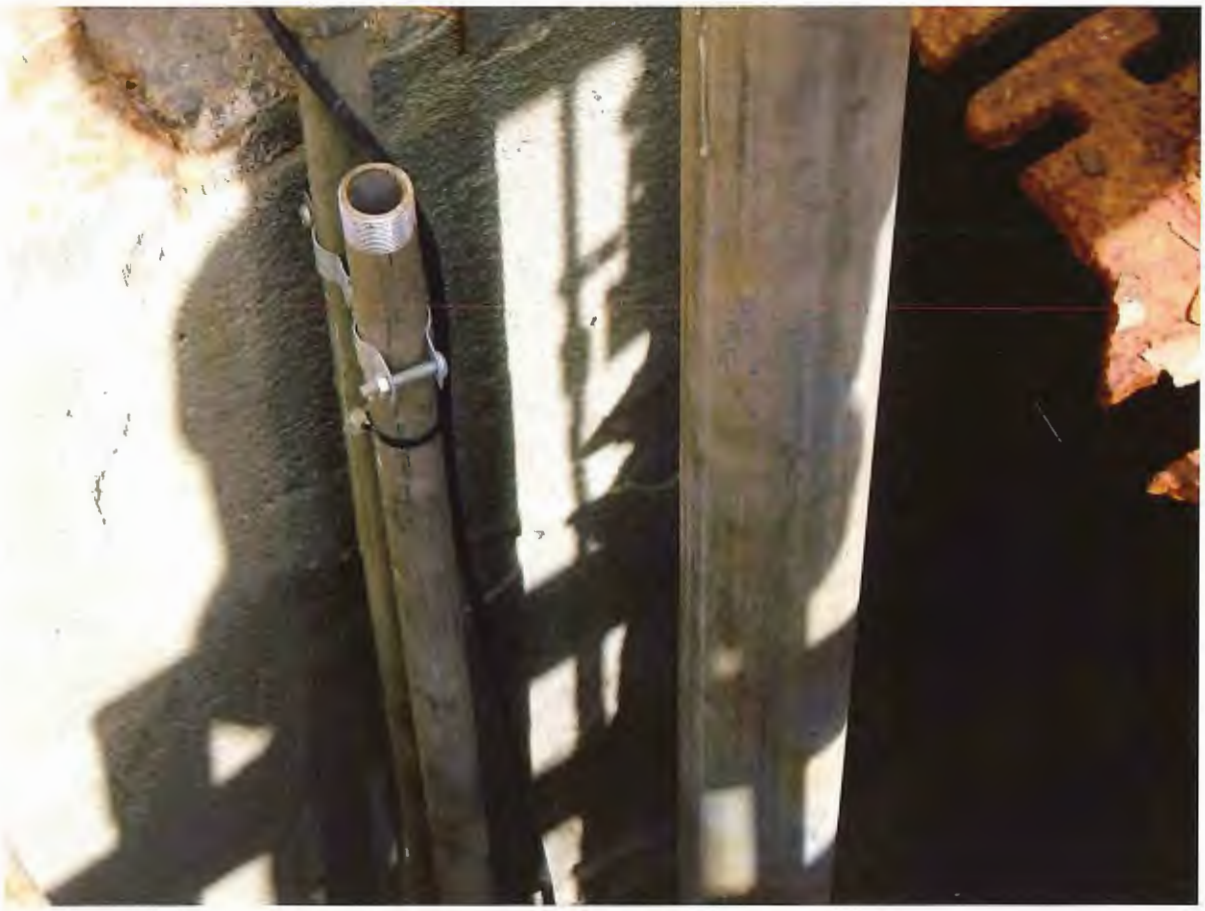
Picture 7: Chrome containment trench: pictures of outlet flow meter on chrome transfer pipeline

Picture 8: Chrome Line Plater: picture of conductivity probes installed

Picture 9: Chrome containment trench sump: Picture of high level float

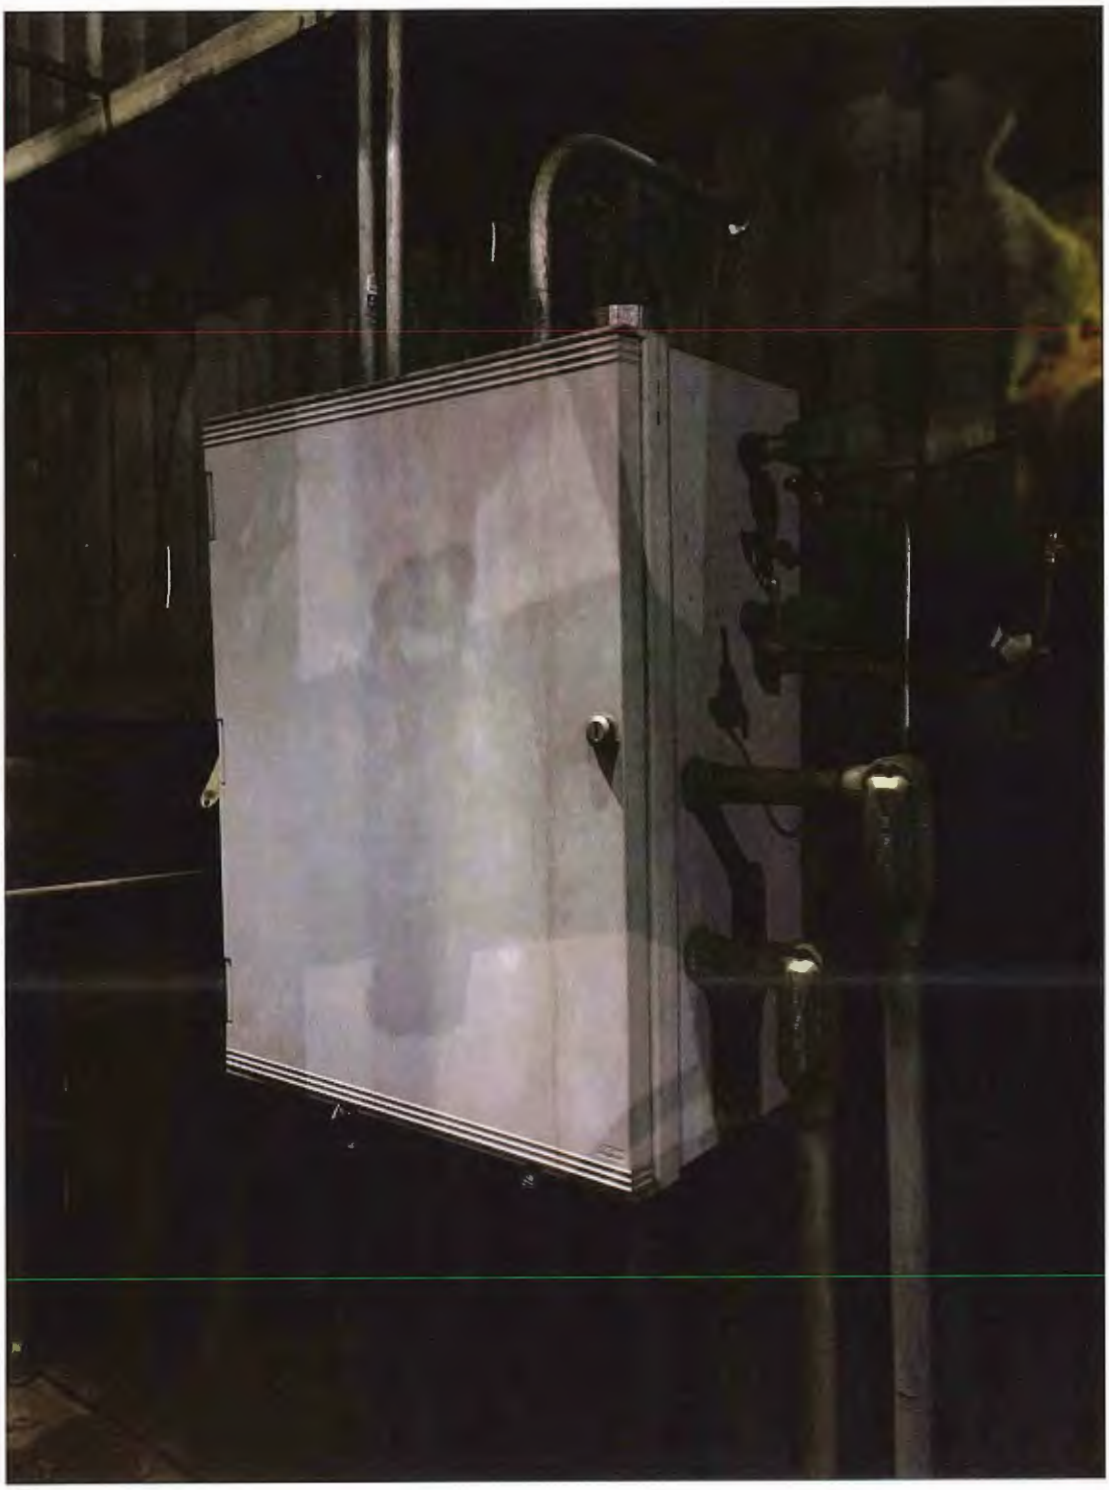
Picture 10: Final treatment plant discharge: Picture of ChemScan unit currently being trialed

Picture 11: Chrome Line Evaporator: Picture of reduntant level sensors installed on top of Evaporator

Picture 12: Chrome Line Evaporator: Picture of box housing relay installed to open vacuum breaker valve

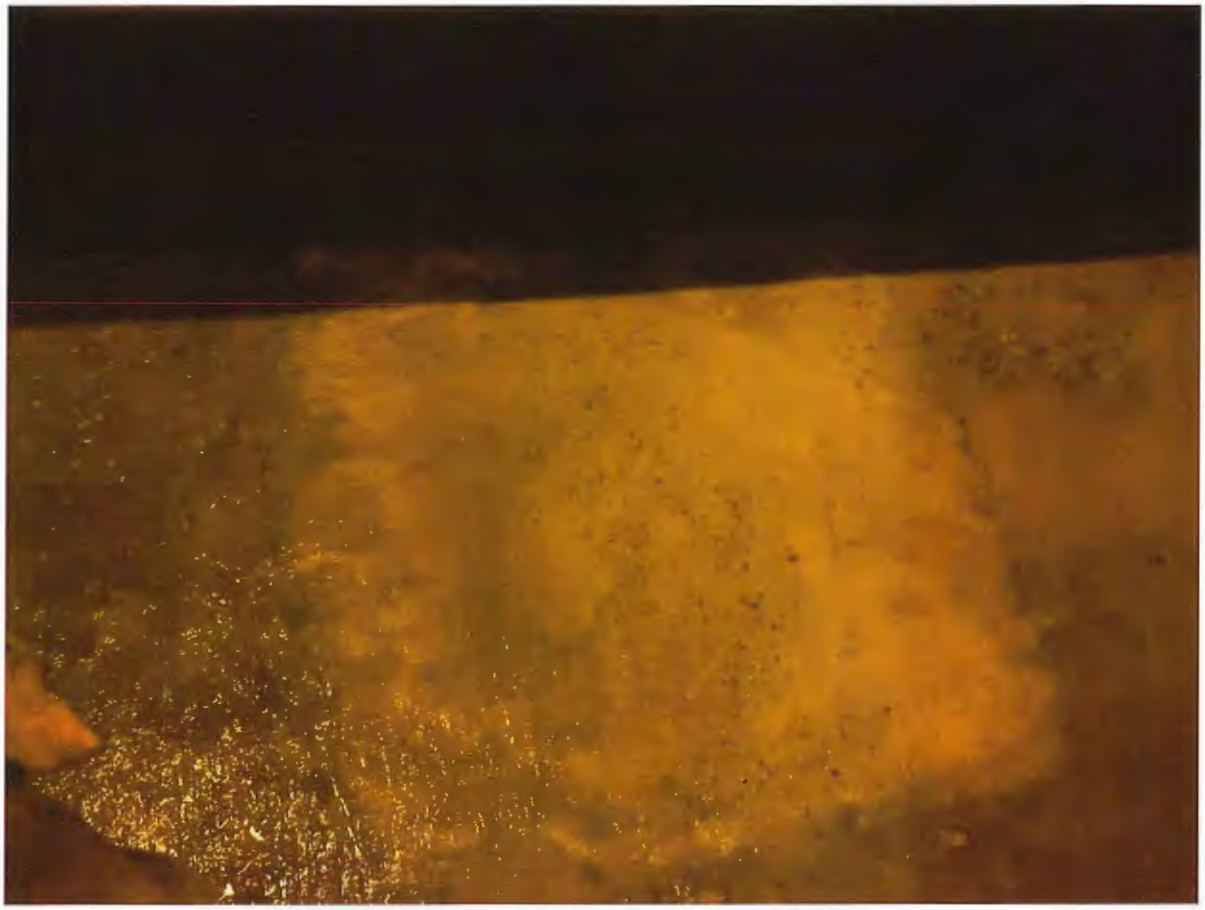
Picture 13: Tin Line Chem Treat Sump: Picture of Conductivity Meter Installed

Picture 14: Tin Line Looper Pit Sump: Picture of modifications to piping system to eliminate access to DIW

Picture 15: Tin Line Annex: Picture of repairs and sealing of DIW vault
