Pavement Condition Report

Auburn-DeKalb County Airport

Project 1480370

January 2014

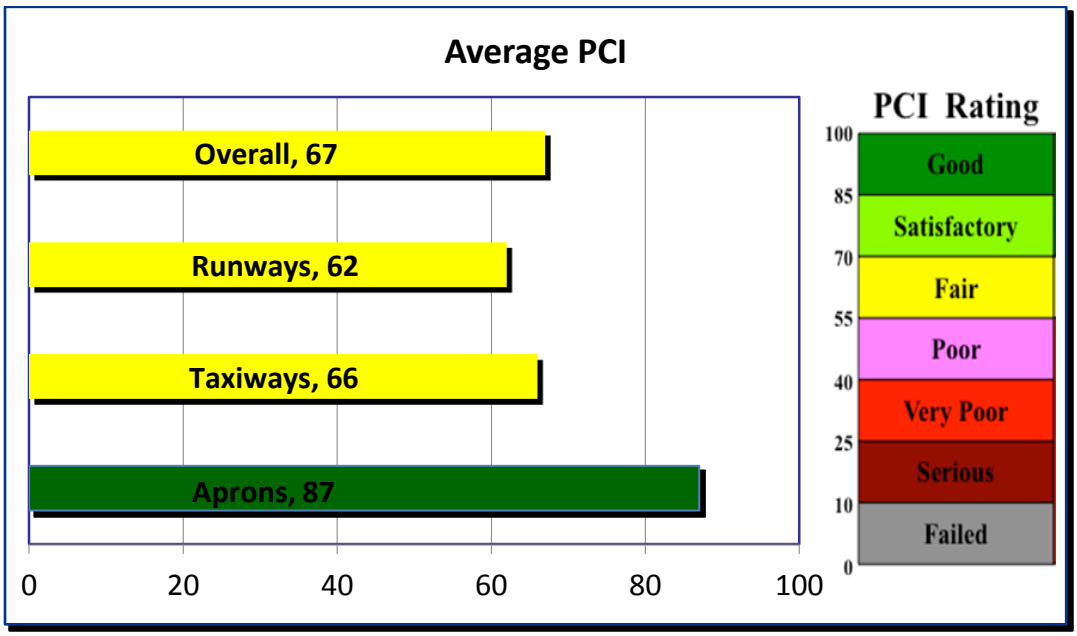
The overall Pavement Condition Index (PCI) for the airfield pavements was 67. Runways had an average inspected PCI of 62 and were above the desired MSL of 60. Taxiways had an average inspected PCI of 66, and ramps had an average inspected PCI of 87.

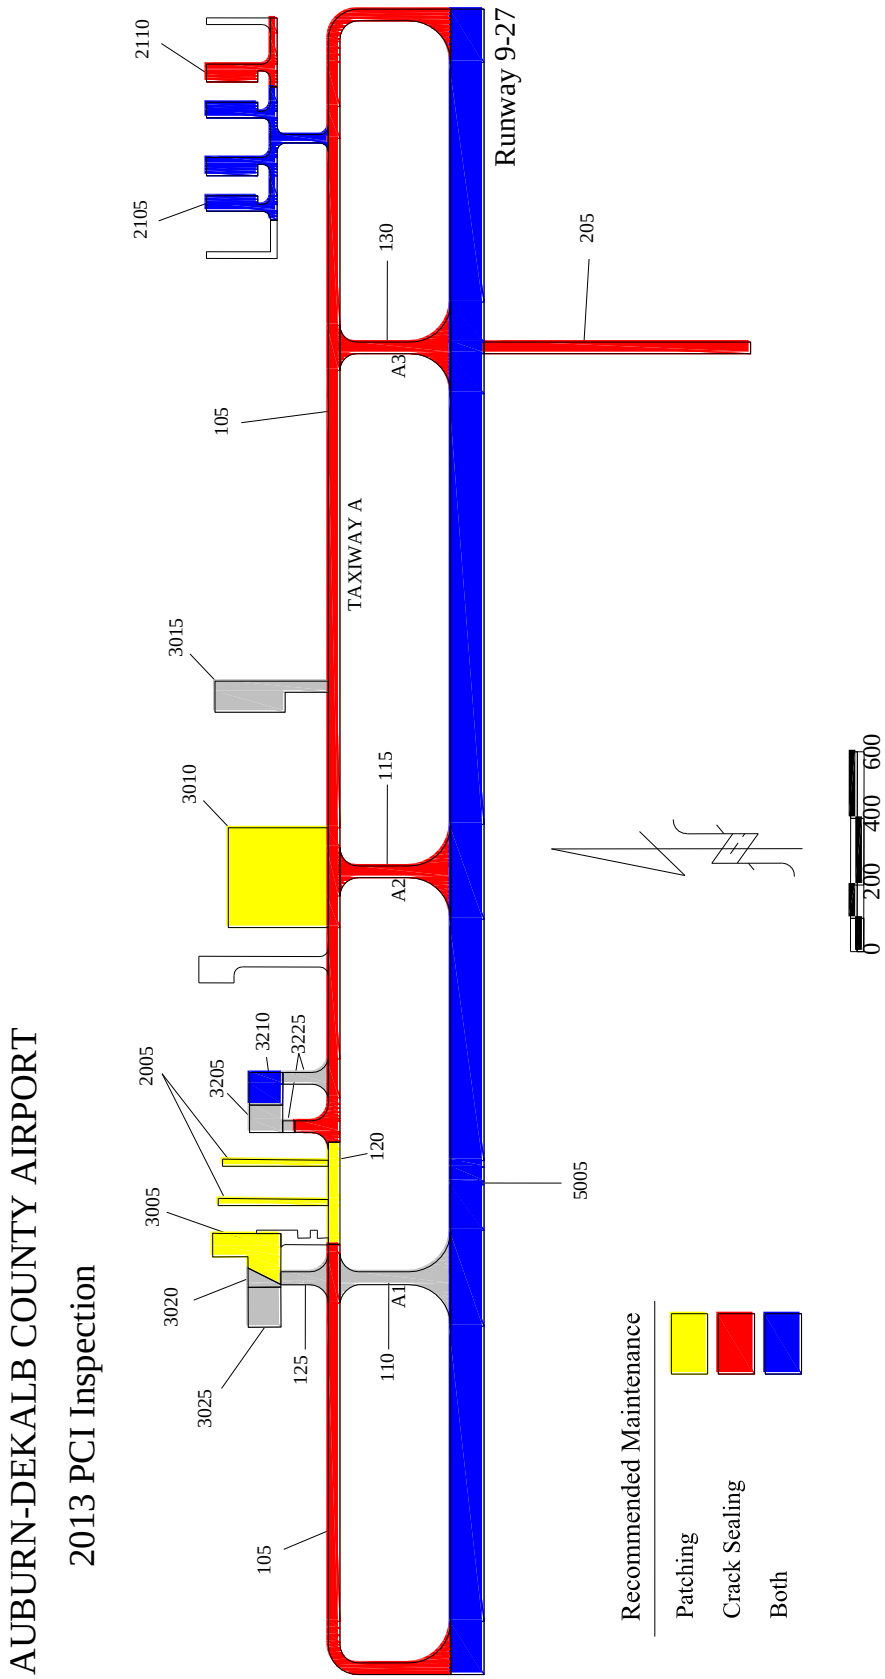
AUBURN-DEKALB COUNTY AIRPORT
2013 PCI Inspection
Runway 9-27
TAXIWAY A
A1
A2
A3
105
110
115
120
125
130
205
2105
2110
3005
3010
3015
3020
3025
3205
3210
3225
2005
5005
Recommended Maintenance
Patching
Crack Sealing
Both
0
200
400
600

Analysis of potential maintenance projects identified approximately 4,200 square feet of patching needs and approximately 13,000 linear feet of crack sealing and crack repair needs, at an estimated total cost of approximately $58,000.

Work Item	Quantity	Unit	Cost
AC PATCH	1,753	SF	15,207
AC RESTORATIVE CRACK REPAIR	3,100	LF	3,844
AC SUSTAINING CRACK REPAIR	9,498	LF	8,217
PCC SUSTAINING CRACK REPAIR	150	LF	129
PCC PATCH	20	SF	343
PCC SLAB REPAIR	2,400	SF	29,964
Total:			**$ 57,704**

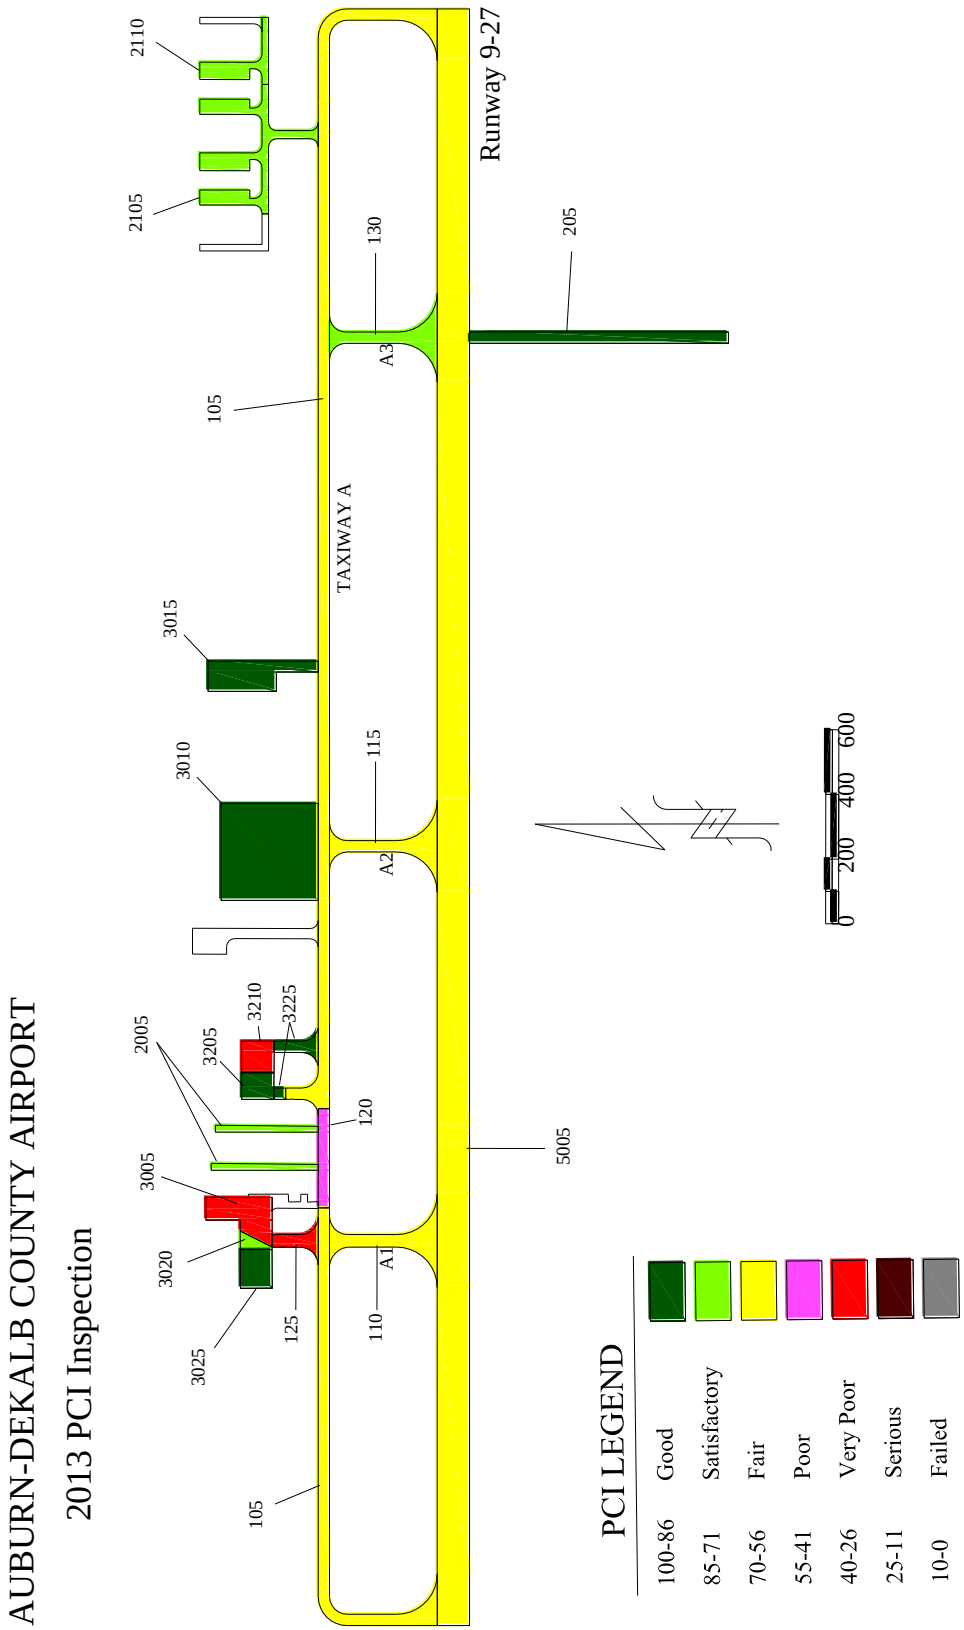
Figure 2-1. Inspected Pavement Condition

The pavement within each of the PCI condition categories is shown in Figure 2-1. The inspected PCI is summarized by branch use in Figure 2-2, and the photographs in Figure 2-3 through Figure 2-7 provide examples of the condition categories.

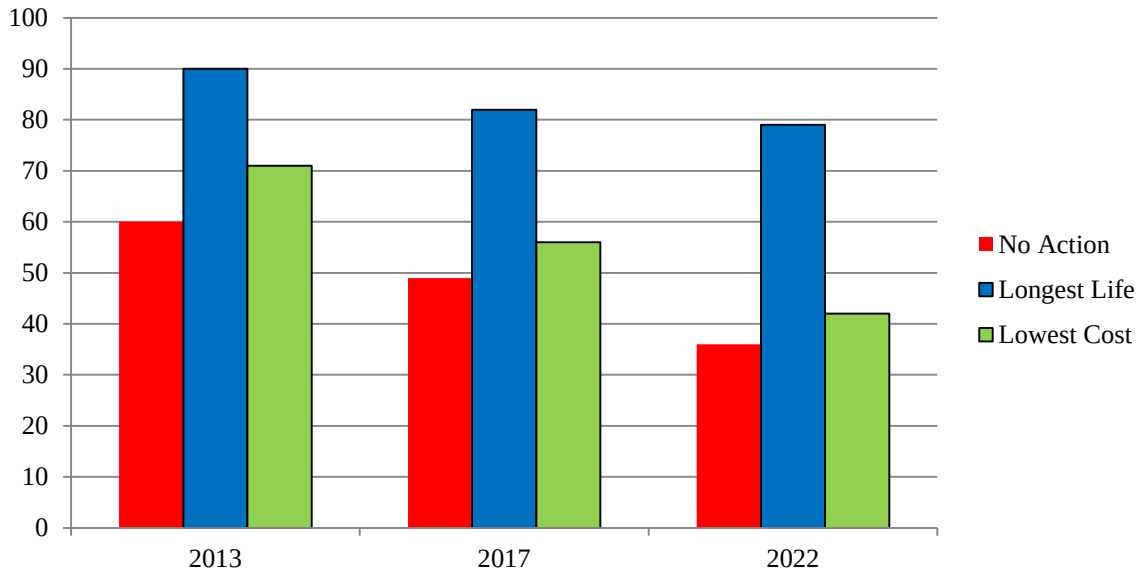
Figure 3-1. Programmed CIP

The table below provides a summary of the projected pavement rehabilitation needs for the next 5 years of the capital improvement program, starting in 2013. The estimated cost for the rehabilitation actions that provide the greatest increase in pavement service life is approximately $1.3 million in 2013 dollars. If no action is taken, the overall PCI is projected to drop to 60 by 2017.

The longest life CIP scenario is projected to cost approximately **$1.4 million** over the next 10 years. The lowest annual cost scenario is projected to cost approximately **$370,000** over the next 10 years. Examples of each capital improvement strategy and a complete listing of all viable capital projects are presented in Table 3-2 through Table 3-4.
