Pavement Condition Report

Kokomo Municipal Airport

Project 1480370

January 2014

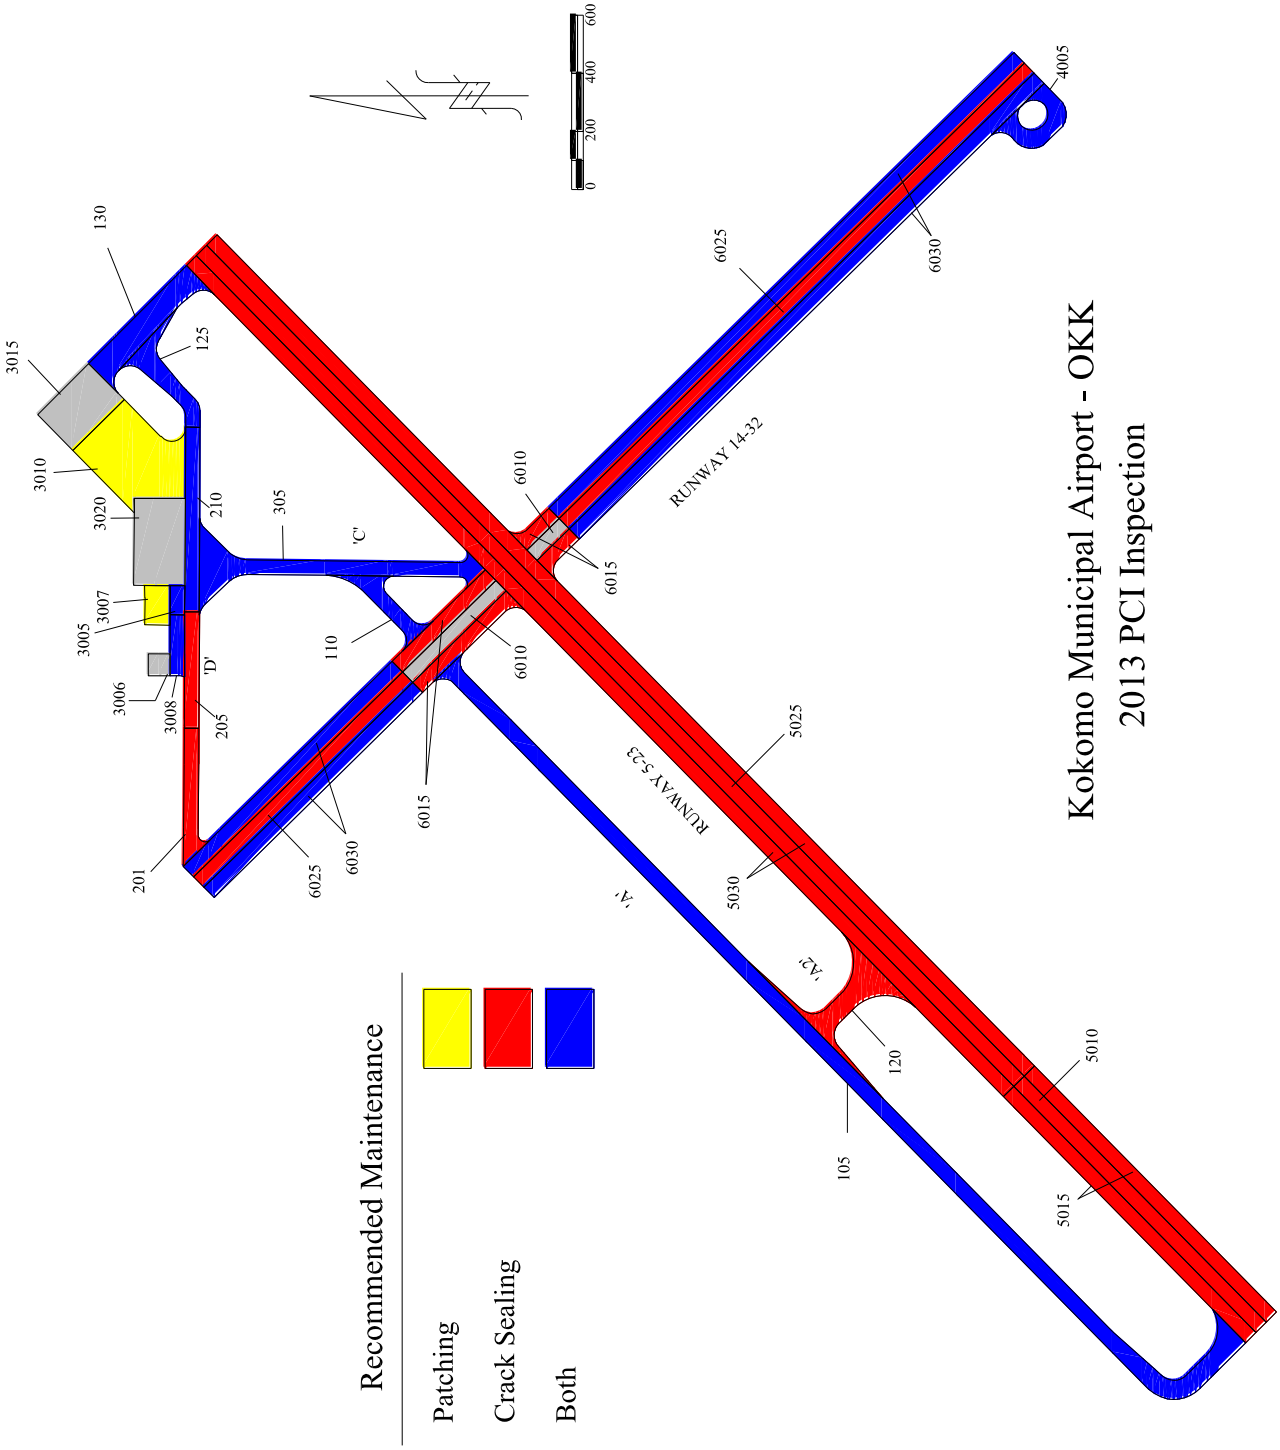
Kokomo Municipal Airport - OKK
2013 PCI Inspection
Recommended Maintenance
Patching
Crack Sealing
Both
RUNWAY 14-32
RUNWAY 5-23
'A'
'A2'
'C'
'D'
0
200
400
600
3015
130
125
3010
3020
210
305
3007
3005
3006
3008
205
110
201
6025
6030
6015
6010
5025
5030
120
105
5010
5015
4005

Analysis of potential maintenance projects identified approximately 960 square feet of patching needs and approximately 150,000 linear feet of crack sealing and crack repair needs, at an estimated total cost of approximately $190,000.

Specific recommendations to help prioritize airfield maintenance are found in chapter 4 of this report. A summary of all identified maintenance needs is shown in the table below and in the figure on the following page.

Work Item	Quantity	Unit	Cost
AC PATCH	917	SF	$7,955
AC RESTORATIVE CRACK REPAIR	132,108	LF	$163,814
AC SUSTAINING CRACK REPAIR	21,382	LF	$18,500
PCC PATCHING	46	SF	$775
Total:			**$191,044**

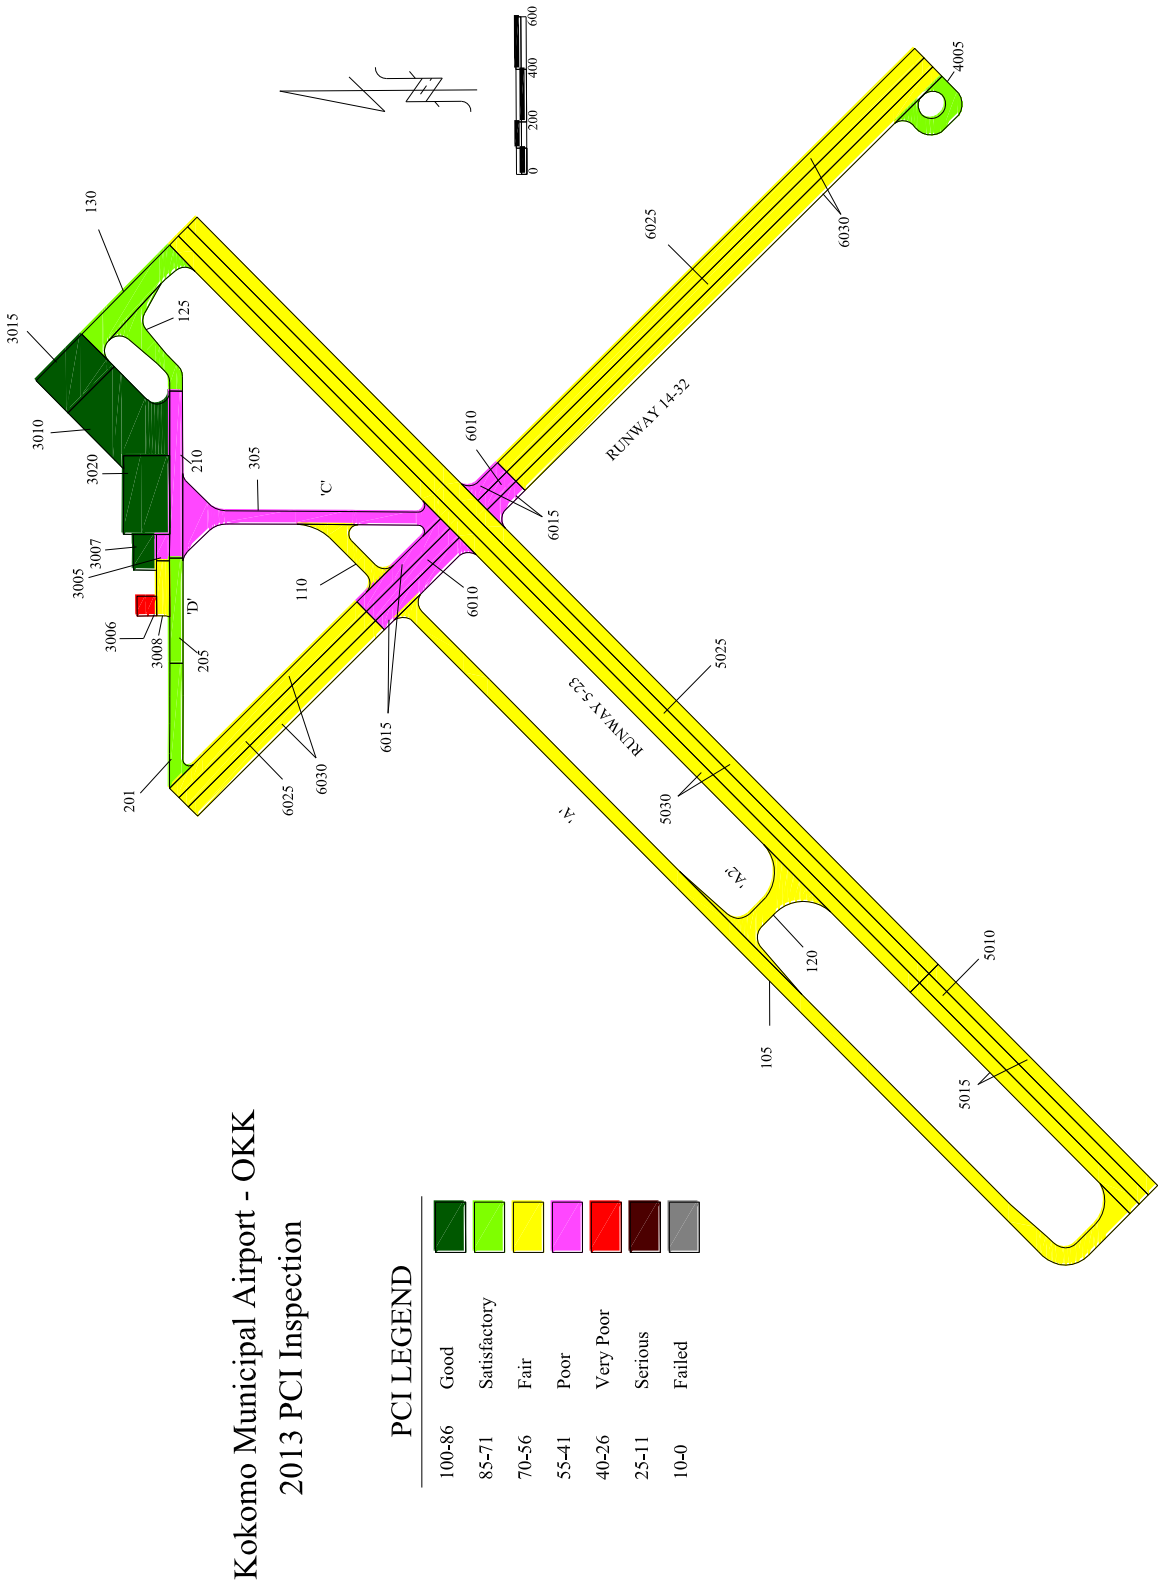
Figure 2-1. Inspected Pavement Condition

The pavement within each of the PCI condition categories is shown in Figure 2-1. The inspected PCI is summarized by branch use in Figure 2-2, and the photographs in Figure 2-3 through Figure 2-6 provide examples of the condition categories.

Feature 4005 had an 11 point PCI drop since last inspection due largely to the development of medium and high severity L&T cracking. Feature 6025 had a 13 point PCI drop since last inspection due to the development of medium severity L&T and joint reflective cracking not present at during the prior survey.

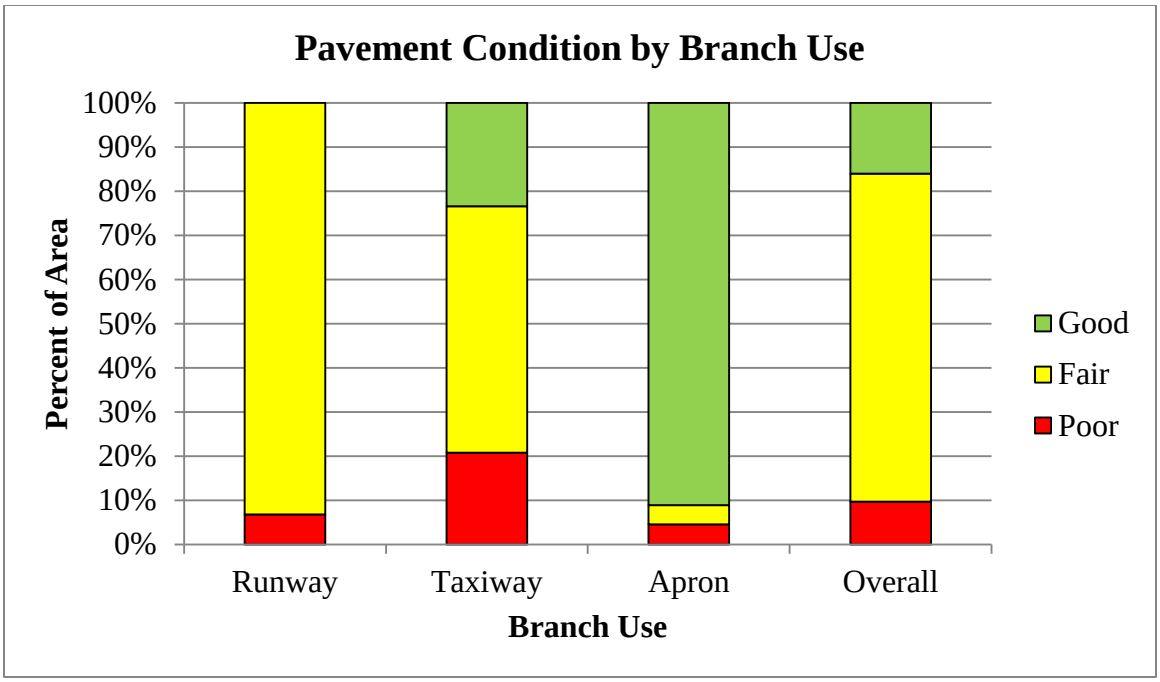
Figure 2-2. Pavement Condition by Branch Use

The overall Pavement Condition Index (PCI) for the airfield pavements was 66. Runways had an average inspected PCI of 63 and were above the desired MSL of 60. Taxiways had an average inspected PCI of 64, and ramps had an average inspected PCI of 87.
