January 2020 to December 2020

ANNUAL STATE OF THE ITR REPORT

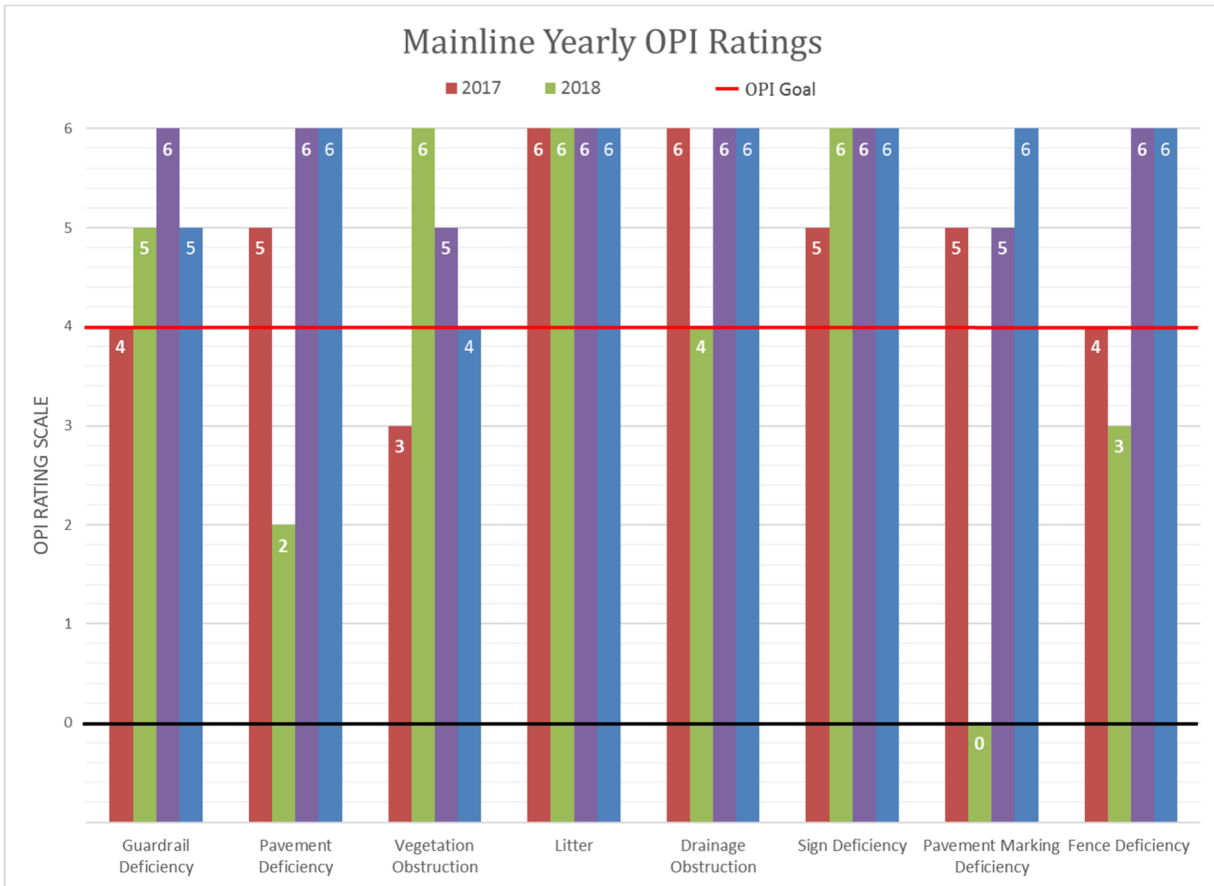
Figure 5.1: Mainline Yearly OPI Ratings

Table 5.2: Mainline Maintenance Items for ITR provides the total accumulated deficiencies for the entirety of the mainline. **Tables 5.3 – 5.7**, located in Appendix E, represent each maintenance district and list the number of deficiencies, deficiency rates, and OPI ratings for the eight mainline maintenance items. The ratings range from 0 to 6, with 6 being the highest. **Figure 5.1: Mainline Yearly OPI Ratings** illustrates the mainline maintenance OPI rating progression over the past four years in comparison to the 2020 ratings.

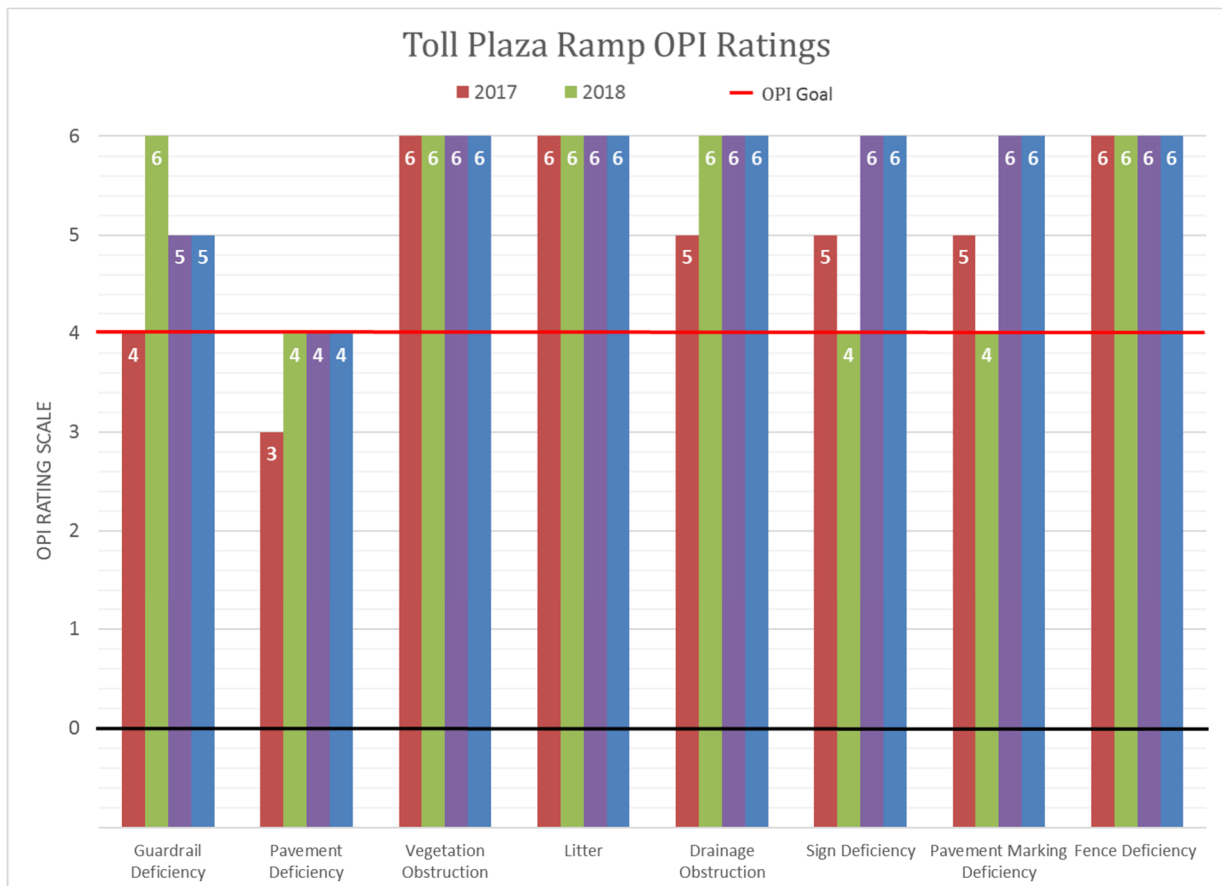
Figure 5.2: Toll Plaza Ramp OPI Ratings

Table 5.8: Toll Plaza Maintenance Items for ITR provides the total accumulated deficiencies for the entirety of the toll plazas. **Tables 5.9 – 5.13**, located in Appendix E, represent each maintenance district and list the number of deficiencies, deficiency rates, and OPI ratings for the eight toll plaza maintenance items. The ratings range from 0 to 6, with 6 being the highest. **Figure 5.2: Toll Plaza Ramp OPI Ratings** (located below) illustrates the Toll Plaza Ramp Maintenance OPI rating progression over the past four years in comparison to the 2020 ratings.

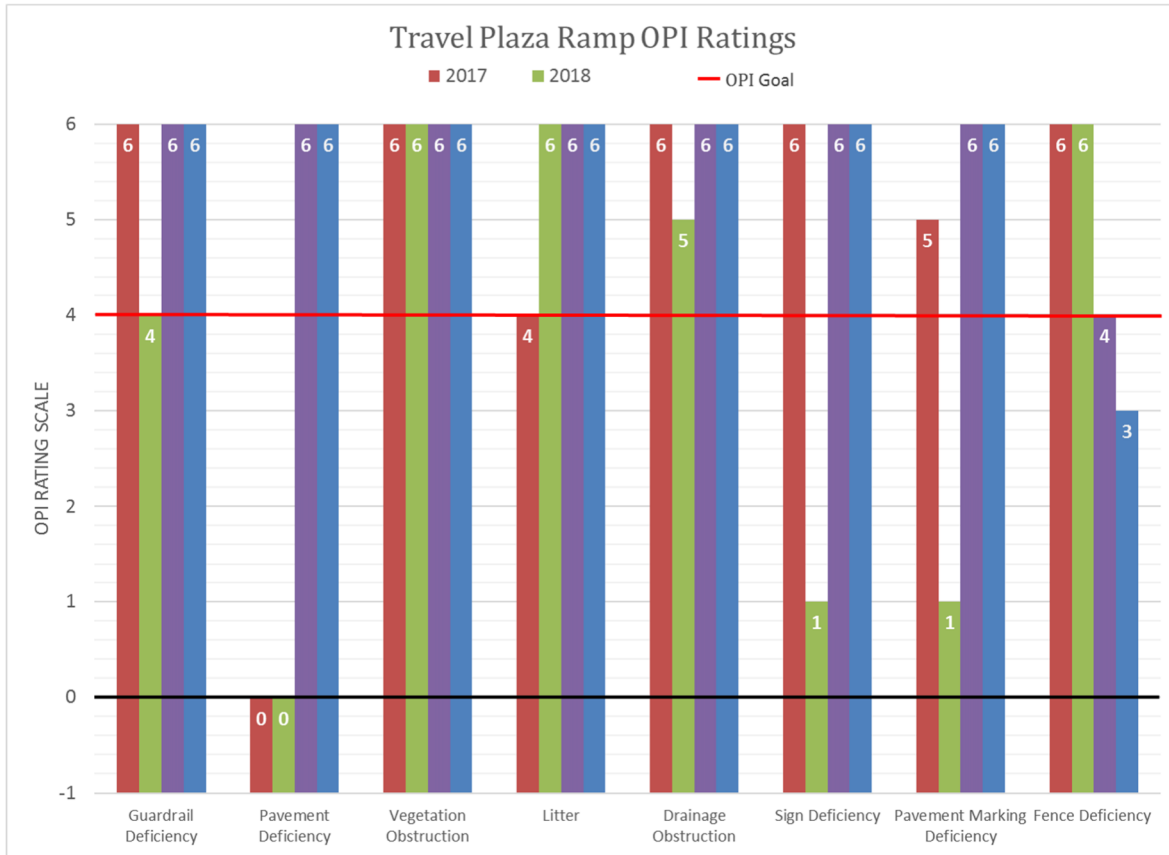
Figure 5.3: Travel Plaza Ramp OPI Ratings

Table 5.14: Travel Plaza and Truck Parking Maintenance Items for ITR provides the total accumulated deficiencies for the entirety of the travel plazas. **Tables 5.15 – 5.19**, located in Appendix E, represent each maintenance district and list the number of deficiencies, deficiency rates, and OPI ratings for the eight travel plaza maintenance items. The ratings range from 0 to 6, with 6 being the highest. **Figure 5.3: Travel Plaza Ramp OPI Ratings** (located below) illustrates the Toll Plaza Ramp Maintenance OPI rating progression over the past four years in comparison to the 2020 ratings.
