Des. No. 2002197
SR 159 at UNT to Splunge Creek
 Small Structure Project
 4.15 Miles North of SR 246
 Vigo County

Photo Orientation Map - North

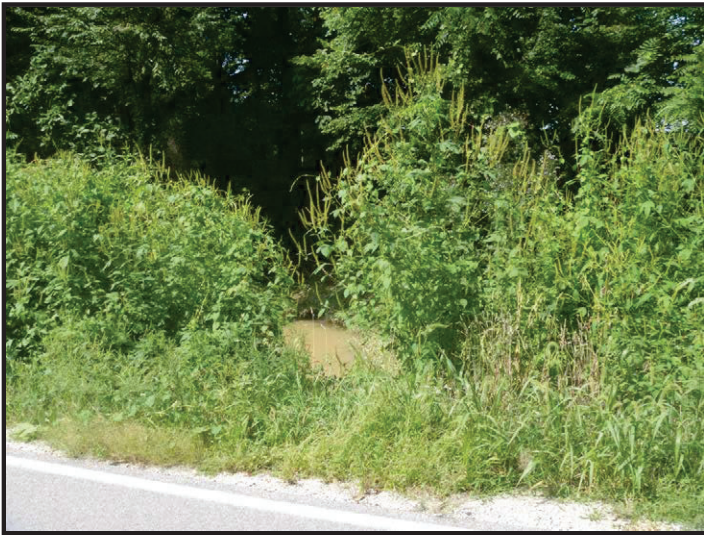
Photo 7 – SR 159 Crossing of UNT to Splunge Creek: Facing upstream to the southwest along UNT to Splunge Creek from the top of the SR 159 small structure.

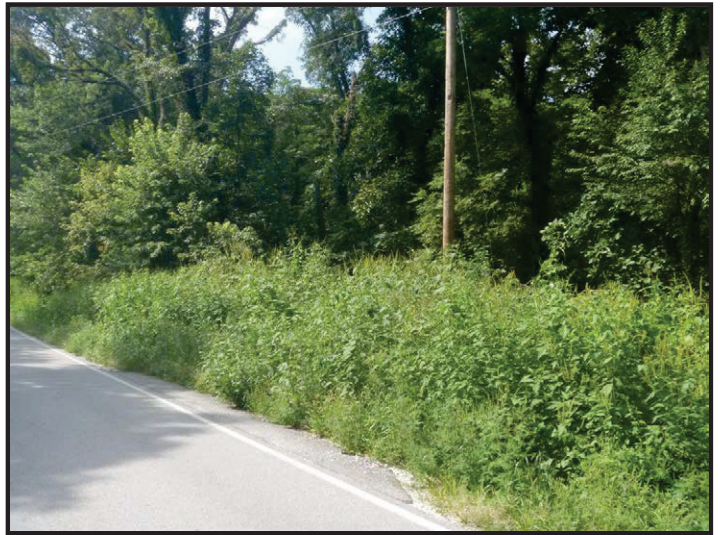
Photo 8 – SR 159 Crossing of UNT to Splunge Creek: Facing southwest toward the southwest quadrant at the SR 159 crossing of UNT to Splunge Creek. An access crosses UNT-2 immediately south of the creek.

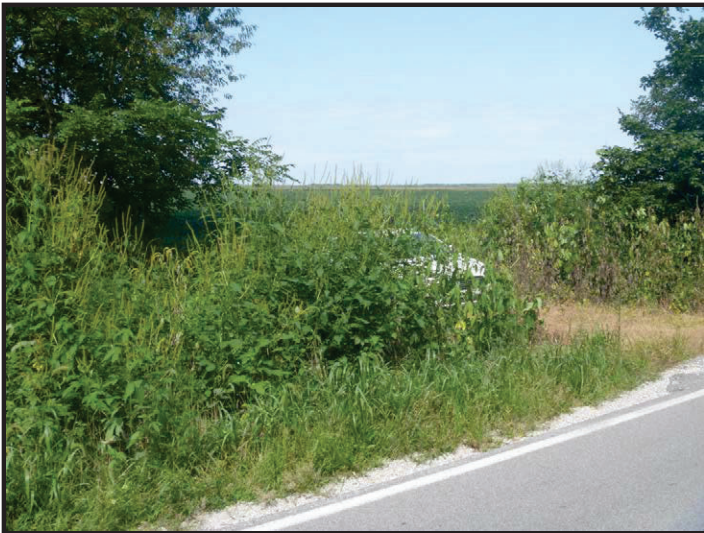
Photo 9 – SR 159 Crossing of UNT to Splunge Creek: Facing northwest toward the northwest quadrant at the SR 159 crossing of UNT to Splunge Creek. A field entrance is immediately north of the creek.

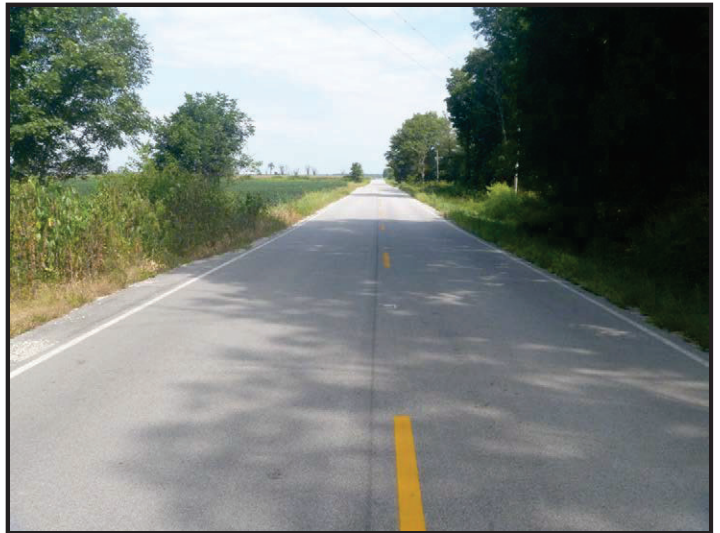
Photo 10 – SR 159 Crossing of UNT to Splunge Creek: Facing north along SR 159 from the top of the small structure at Splunge Creek. Topography is flat and land use is forested, agricultural, and rural residential.

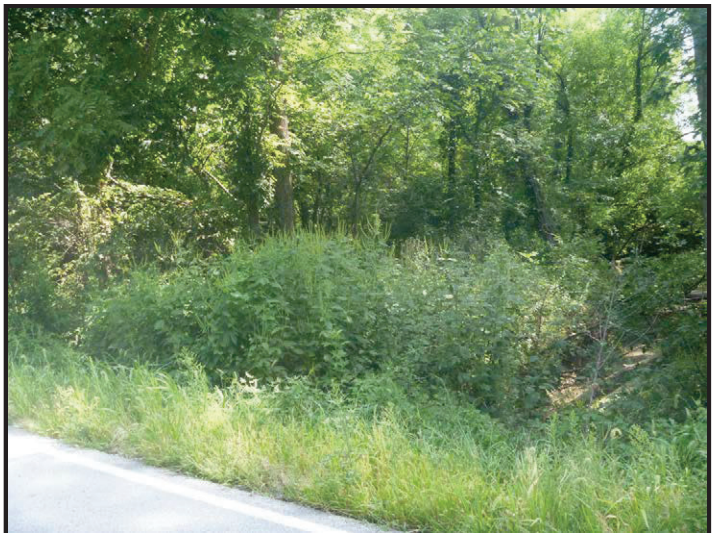
Photo 12 – SR 159 Crossing of UNT to Splunge Creek: Facing northeast toward the northeast quadrant at the SR 159 crossing of UNT to Splunge Creek.

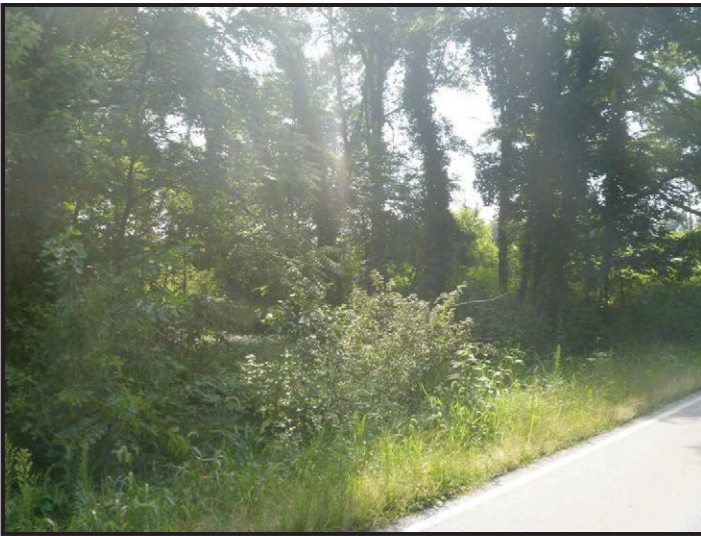
Photo 13 – SR 159 Crossing of UNT to Splunge Creek: Facing south-east toward the southeast quadrant at the SR 159 crossing of UNT to Splunge Creek. An access crossing UNT-1 is immediately south of the creek.

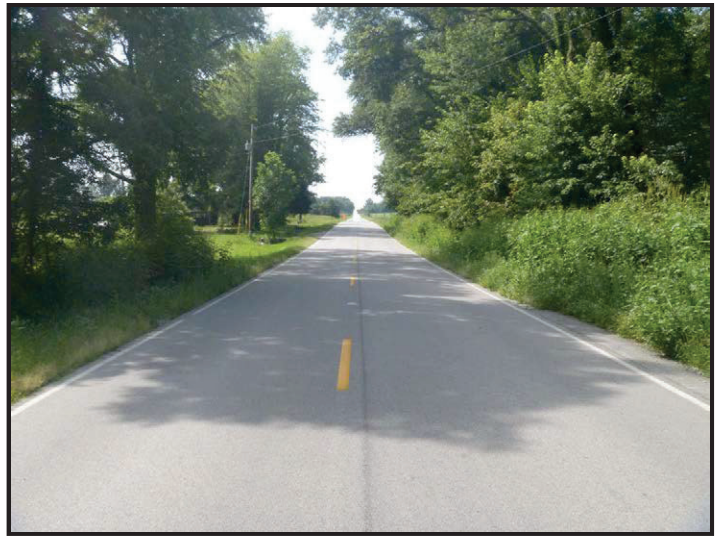
Photo 14 – SR 159 Crossing of UNT to Splunge Creek: Facing south along SR 159 from the top of the small structure at Splunge Creek. Topography is flat and land use is forested, and rural residential.

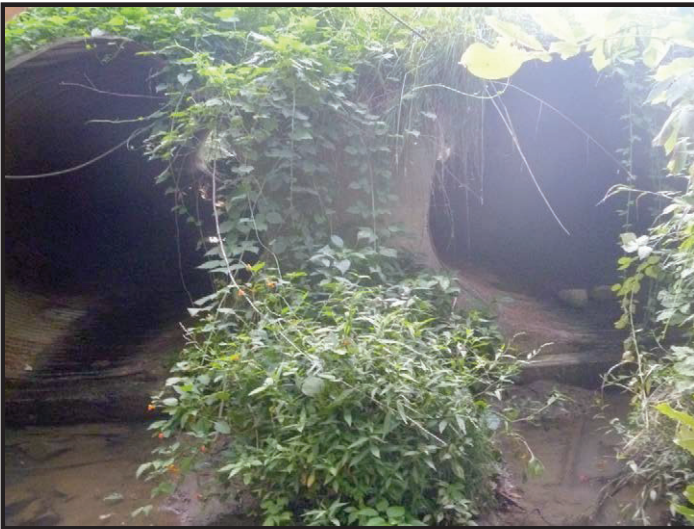
Photo 15 – SR 159 Culverts at UNT to Splunge Creek: Facing upstream to the west toward the outlet of Str. No. CV 159-084-23.30, from east of SR 159.

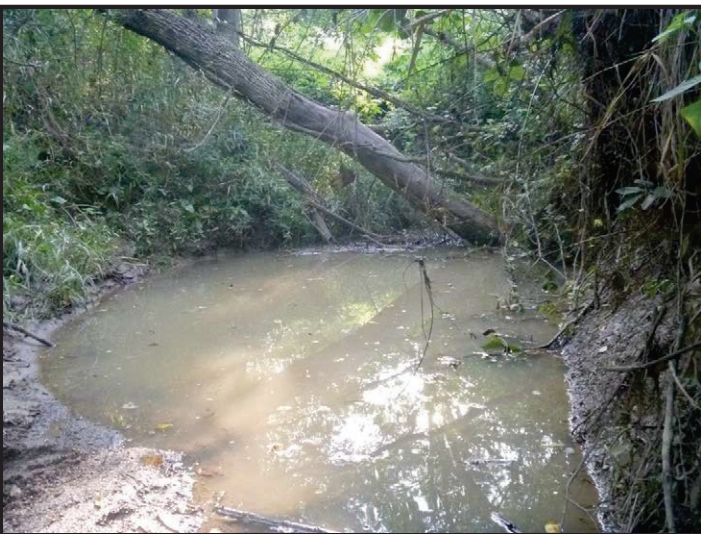
Photo 17 – UNT to Splunge Creek, Downstream from SR 159: Facing upstream to the west along UNT to Splunge Creek. The creek was ten feet wide in this area.

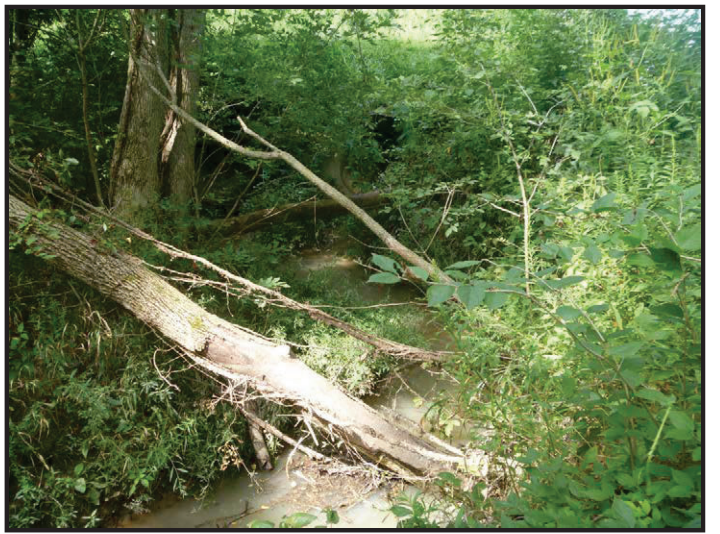
Photo 18 – UNT to Splunge Creek, Downstream from SR 159: Facing upstream to the southwest along UNT to Splunge Creek toward the structure outlet, from the north bank of the creek.

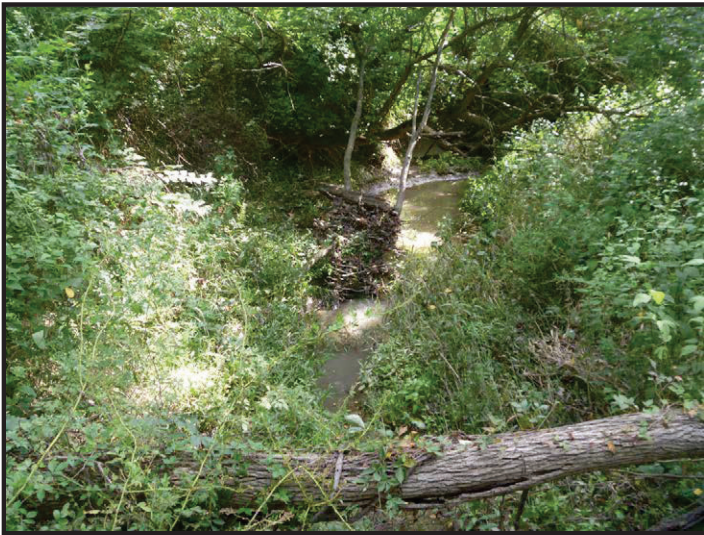
Photo 19 – UNT to Splunge Creek, Downstream from SR 159: Facing downstream to the east along UNT to Splunge Creek.

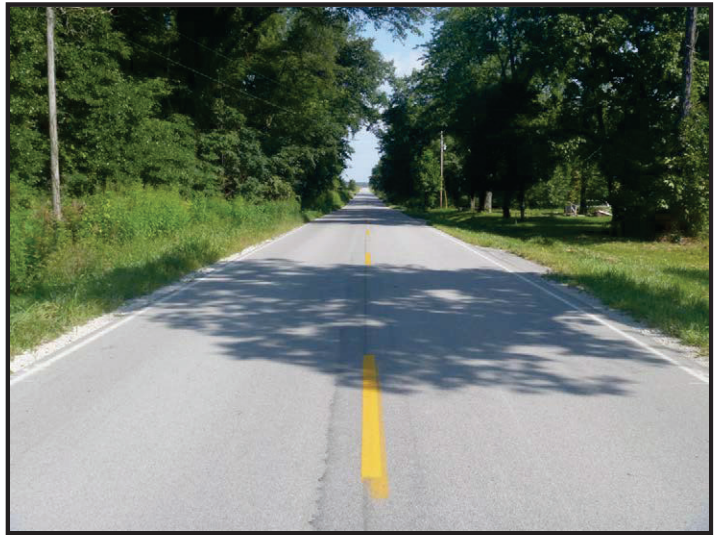
Photo 20 – South Project Setting, Toward AOI: Facing north along SR 159 from the southern limits of the AOI. Topography south of the culvert is generally flat. Land use is forested and rural residential (buildings razed).

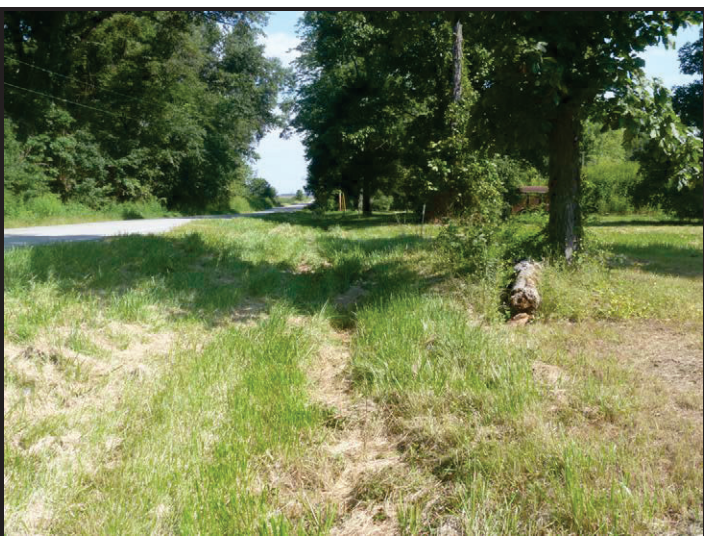
Photo 23 – Southeast Quadrant, RSD-1: Facing downgrade to the north along RSD-1 from the southern limits of the AOI. RSD-1 did not exhibit an OHWM or defined bed and bank.

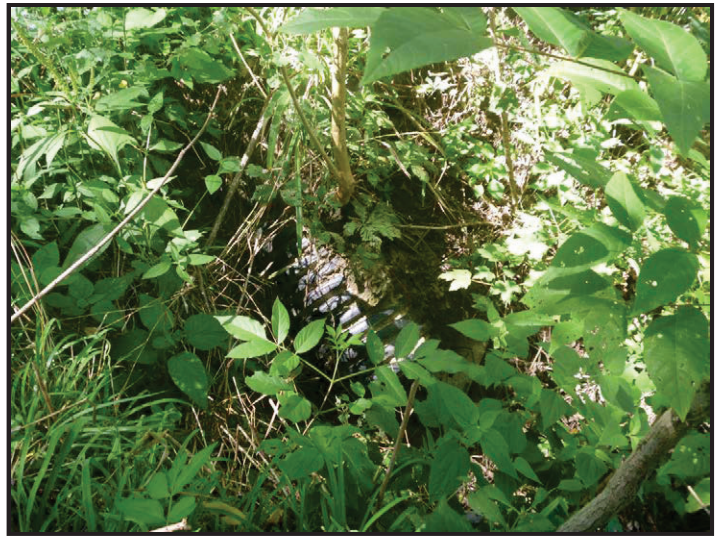
Photo 38 – Southeast Quadrant, RSD-1: Looking down at a plastic corrugated pipe, about six to eight inches in diameter within RSD-1.

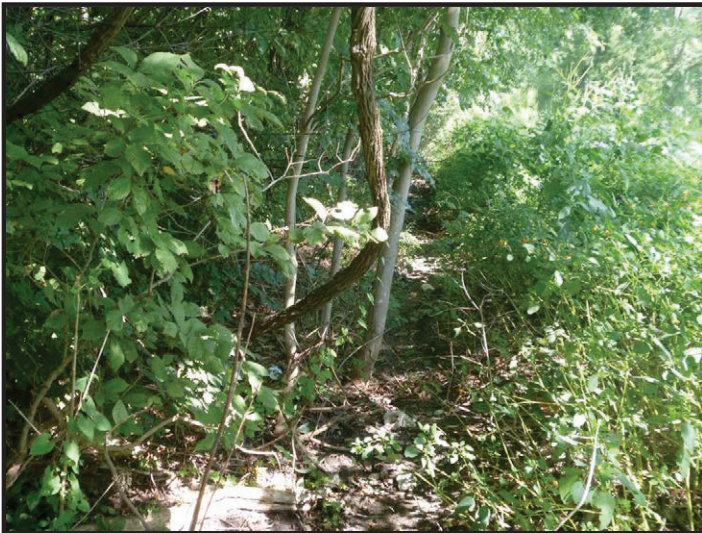
Photo 43 – Southwest Quadrant, RSD-2: Facing upgrade to the south from the beginning of RSD-2 along the west side of SR 159. RSD-2 does not exhibit an OHWM or defined bed and bank.

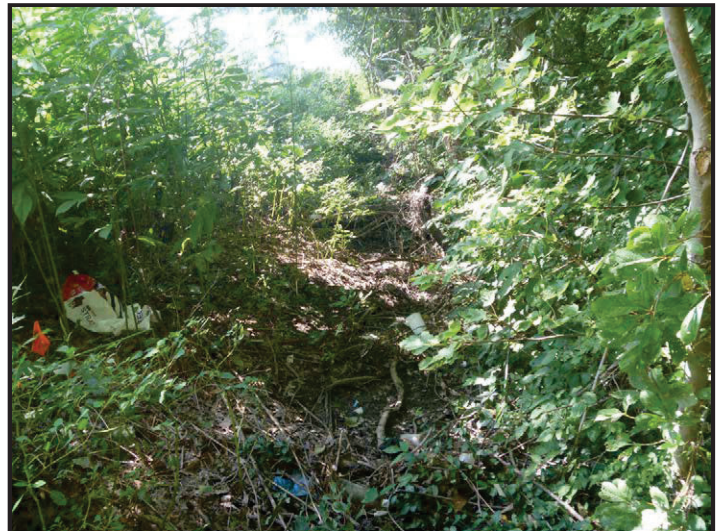
Photo 48 – Southwest Quadrant, RSD-2: Facing upgrade to the south along RSD-2 along the west side of SR 159. RSD-2 did not exhibit an OHWM or defined bed and bank.
