Pavement Condition Report

Anderson Municipal Airport

Project 1480370

January 2014

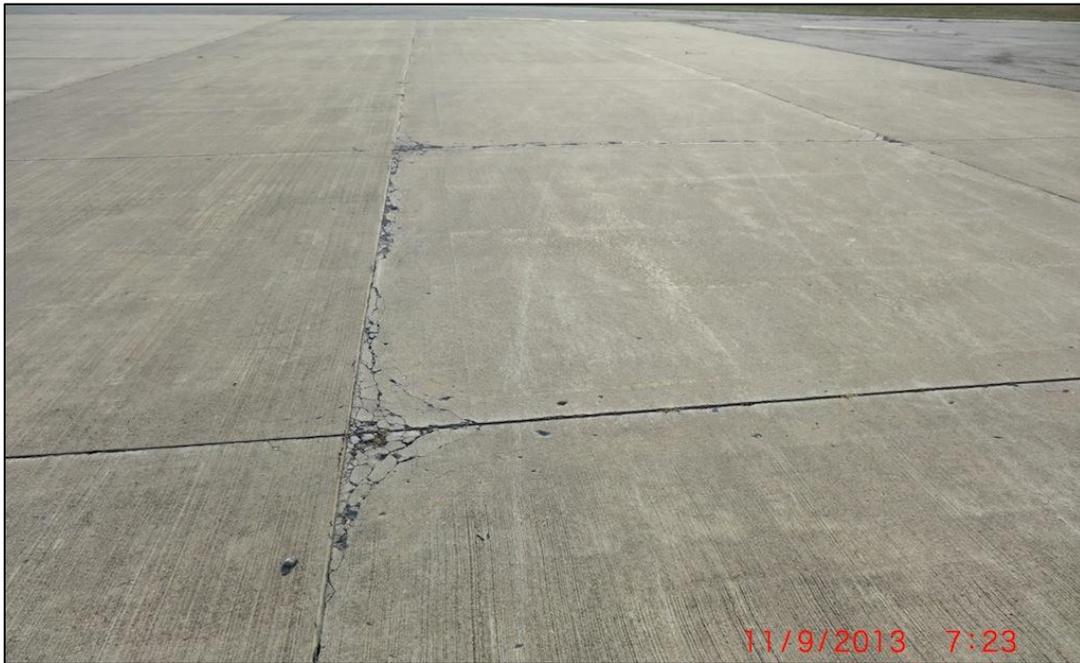
Figure 2-7. Typical PCC Maintenance Needs (Feature 3010)

The inspectors surveyed approximately 58,000 ft² of PCC pavement. The frequency of each distress type is shown in Table 2-3. The most common distress types were joint seal damage, durability cracking and spalls.

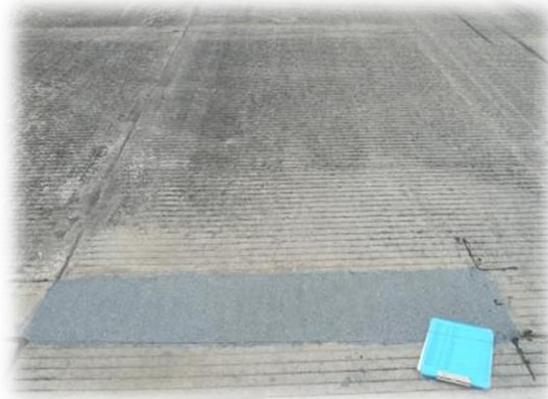
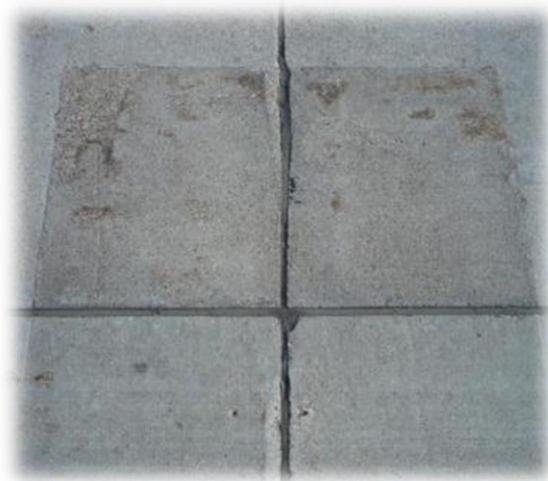
Patches, Large and Small

Large and small patches, by PCI inspection criteria, are distress conditions. Patches indicate deterioration and aging of pavement that contributes to shortened service life. However, patching also indicates that pavement is being maintained.

A patch that is performing well and shows no outward distress is recorded at low severity, and no corrective action is required. Medium-severity patches are serviceable but are beginning to deteriorate. Maintenance or replacement is indicated. At high severity, replacement is indicated.

By definition, small patches are smaller than 5 square feet in surface area, and they usually result from spall repair at slab joints and corners.

Large patches also may be the result of spall repair, but they often indicate more serious deficiencies, such as corner breaks or other full-depth failure smaller than panel size.
