Pavement Condition Report

Bloomington-Monroe County Airport

Project 15805741

February 2015

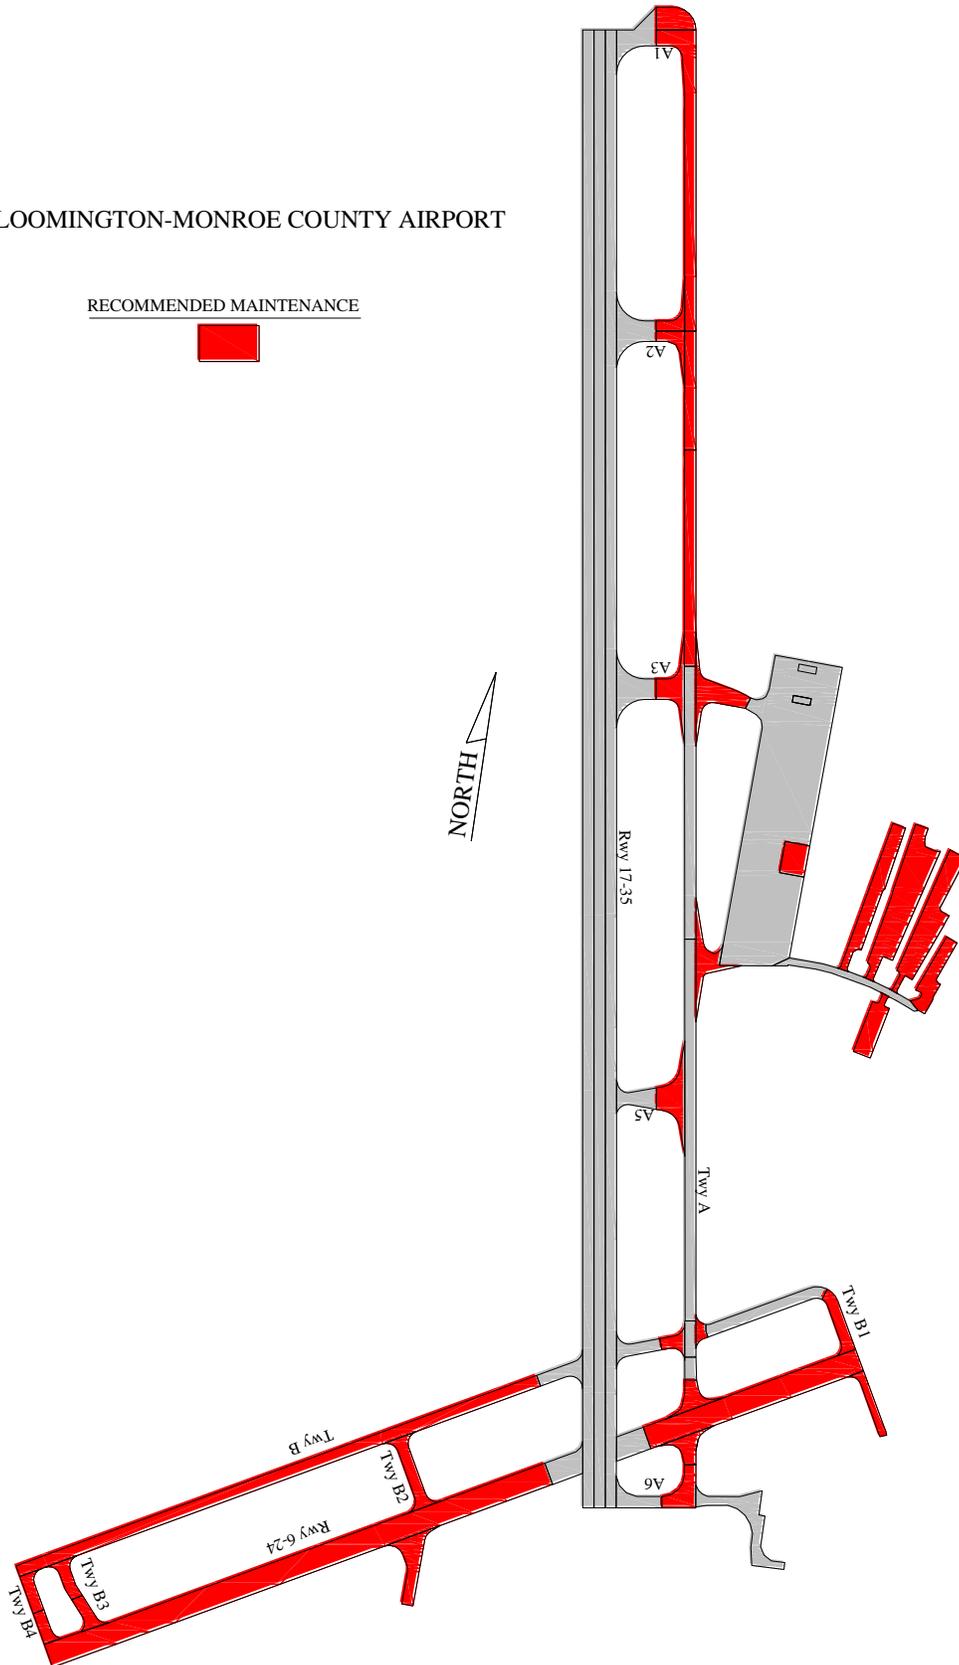
RECOMMENDED MAINTENANCE

Analysis of potential maintenance projects identified approximately 2,300 square feet of patching needs and approximately 26,000 linear feet of crack sealing and crack repair needs, at an estimated total cost of approximately \$49,000

Work Item	Quantity	Unit	Cost
PCC RESTORATIVE SEAL REPAIR	1,358	L.F.	3,048
AC SUSTAINING CRACK REPAIR	12,572	L.F.	10,877
AC RESTORATIVE CRACK REPAIR	12,110	L.F.	15,016
AC PATCH	2,285	S.F.	19,822
Total:			\$48,763

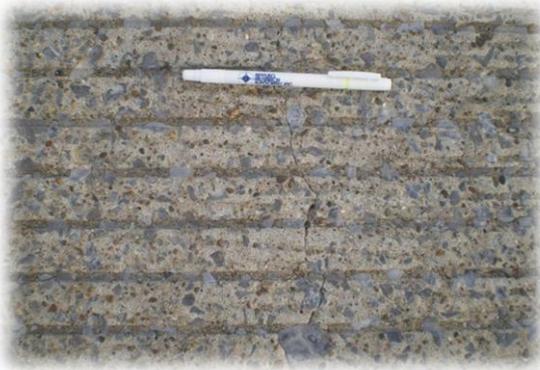
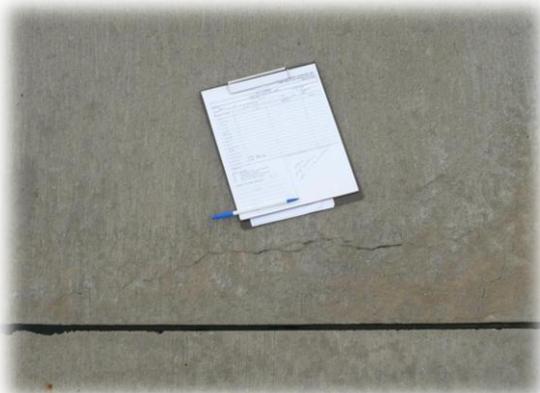
Shrinkage Cracking

Shrinkage cracks are small, non-working cracks visible at the pavement surface but not penetrating the full depth of concrete. Shrinkage cracks most commonly occur shortly after construction due to concrete shrinkage during the curing process.

Shrinkage cracks are usually so small that they are not visible until staining or loss of material at crack edges begins to take place. Shrinkage cracks do not represent structural weakness, and no corrective action is prescribed.

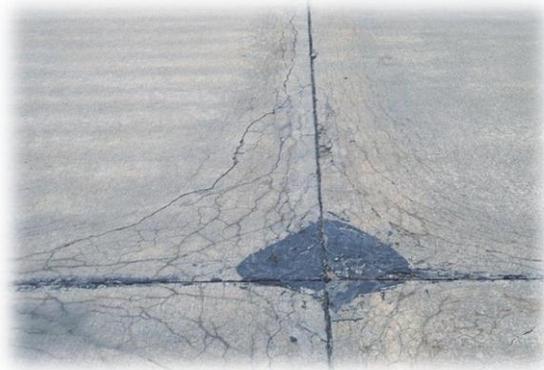
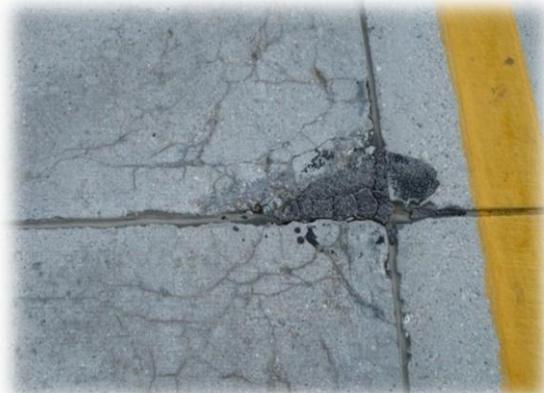
Durability Cracking

Durability cracking (D-cracking) is caused by environmental factors, the most common being freeze/thaw. D-cracking usually appears as either a pattern of hairline cracks running parallel to a joint or crack, or in a corner, where water tends to collect. D-cracking eventually leads to disintegration of the pavement, creating foreign object damage (FOD) potential.

At low severity, D-cracking is evident, but no disintegration has occurred. Medium severity is evident over a significant area of the slab, and some disintegration and FOD potential exist. High-severity D-cracking is evidenced by extensive cracking with loose and missing pieces and significant FOD potential.

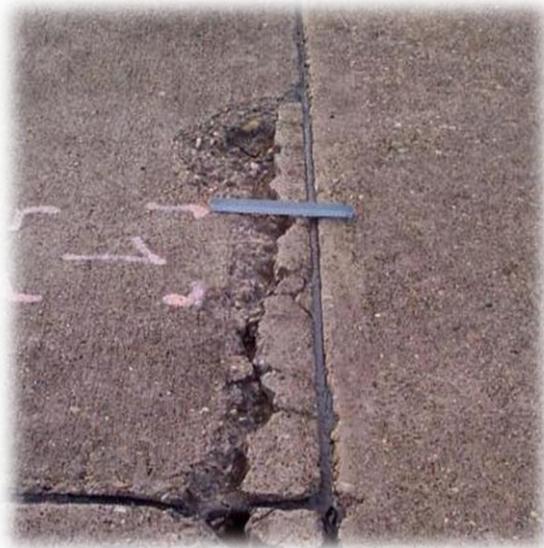
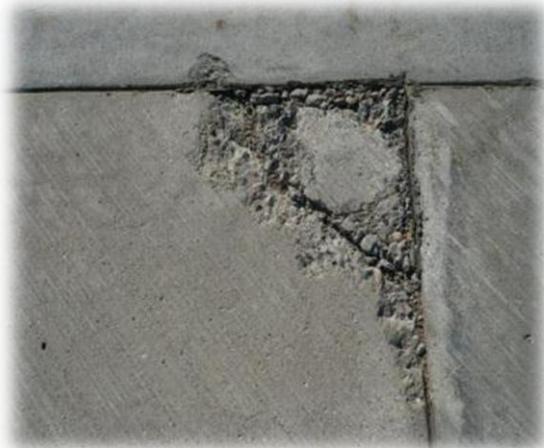
Joint Spall and Corner Spall

Spalls at slab joints and corners are caused by excessive internal stress in the pavement. Spalls occur when these stresses exceed the shear strength of the concrete.

Spalling usually results from thermal expansion during hot weather when slabs push and expand against one another. If the joints are filled with incompressible material, such as sand, stresses can become severe, causing spalls. Spalling can be reduced significantly by maintenance of joint sealant.

Spall repair requires patching. The extent and severity of spalling suggests the appropriate action. At low severity, spalled concrete remains securely in place in the slab. A low-severity spall should be monitored closely for further deterioration and should be patched when spalled particles become loose, or during the next scheduled patching activity. Medium- and high-severity spalls should be repaired immediately to prevent FOD. If the pavement can be restored to serviceable condition, spalls should be patched for long-term service. If the pavement is beyond repair, temporary patching should be considered to control FOD.

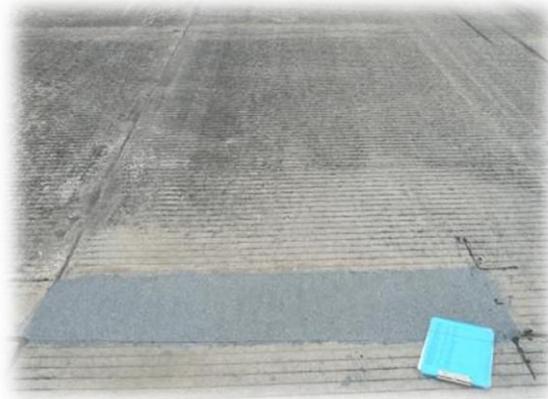
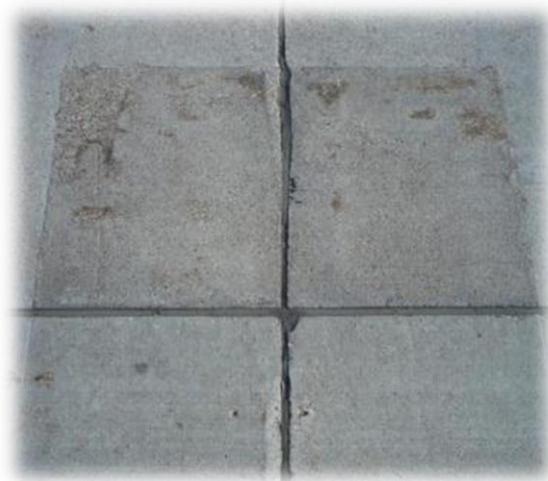
Patches, Large and Small

Large and small patches, by PCI inspection criteria, are distress conditions. Patches indicate deterioration and aging of pavement that contributes to shortened service life. However, patching also indicates that pavement is being maintained.

A patch that is performing well and shows no outward distress is recorded at low severity, and no corrective action is required. Medium-severity patches are serviceable but are beginning to deteriorate. Maintenance or replacement is indicated. At high severity, replacement is indicated.

By definition, small patches are smaller than 5 square feet in surface area, and they usually result from spall repair at slab joints and corners.

Large patches also may be the result of spall repair, but they often indicate more serious deficiencies, such as corner breaks or other full-depth failure smaller than panel size.

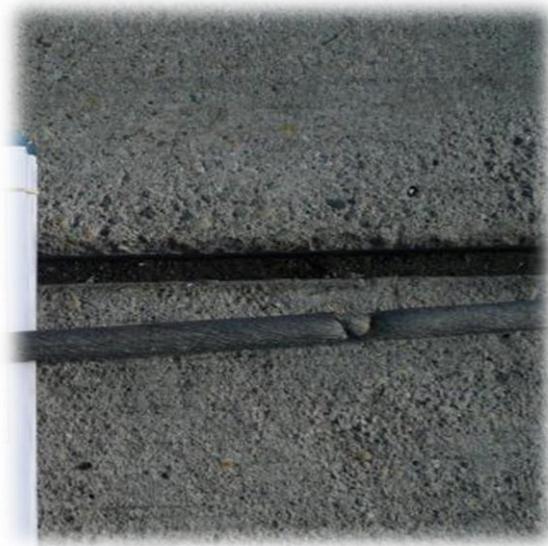
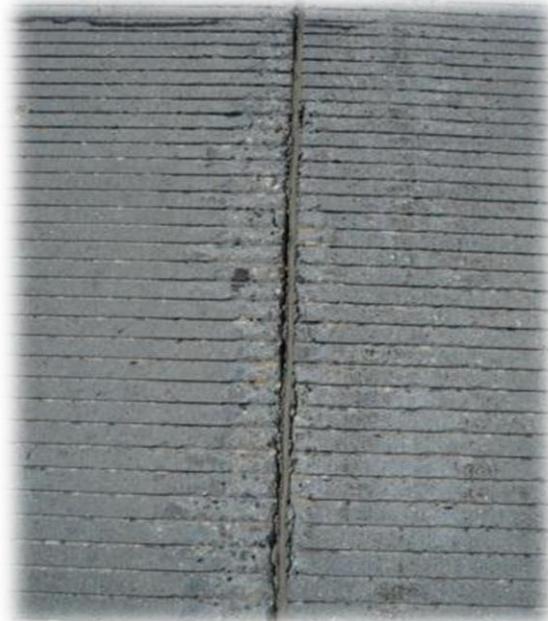
Joint Seal Damage

When joint sealant is in perfect condition (no damage), there is no distress.

At low severity, at least 10 percent of the sealant is debonded but still in contact with the joint edges. Medium-severity joint seal damage is recorded when at least 10 percent of the sealant has visible gaps smaller than 1/8 inch and is an indicator that replacement should be programmed as soon as is practical. In the meantime, aggressive inspection and sustaining maintenance is recommended to minimize subsurface damage from moisture penetration. At high severity, visible gaps exceed 1/8 inch, and the amount and degree of joint seal damage typically requires complete removal and replacement of the existing sealant.

On serviceable pavement, deteriorated joint sealant should be repaired or replaced to preserve pavement and subgrade integrity and prolong service life. The issue is not so clear-cut with unserviceable pavement. Pavement that can be restored to serviceable condition by maintenance activities such as patching and joint seal repair, or by slab replacement, should be so maintained as long as the process is cost-effective. However, when age and condition preclude economical return to serviceable condition by such means, joint seal repair would no longer be cost-effective and should be suspended except for an interim maintenance program to control FOD potential.

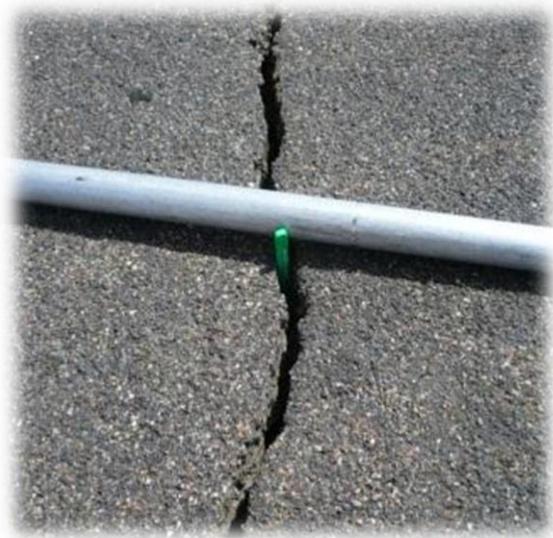
Longitudinal & Trans. Cracking

L&T cracks are caused by age, construction, and subsurface conditions. Age-related cracking occurs as oxidizing pavement loses components to the atmosphere and becomes more brittle. Consistent application of seal coats can help to prevent age-related cracks.

Construction-related cracking often develops along paving joints. Ensuring that joints are made when both sides are still hot, and near the same temperature, is one of the best ways to mitigate this potential problem.

Seasonal movement caused by changes in subsurface moisture or temperature differences also can cause pavement cracking. Asphalt pavement placed over a PCC pavement or cement stabilized base course may evidence reflective cracking from the underlying material. Wheel loads do not cause L&T cracks, although traffic may worsen their condition.

Low-severity L&T cracks are less than ¼ inch wide, or if sealed with suitable filler material in satisfactory condition can be any width less than 3 inches, if they are not spalled. Maintenance usually is not indicated for low-severity cracking. Moderately spalled cracks and cracks wider than ¼ inch which are not satisfactorily sealed are at medium severity. Medium-severity cracks should be sealed with a high-quality crack filling material. Severely spalled cracks and cracks wider than 3 inches are at high severity. High-severity L&T cracks normally require patching.

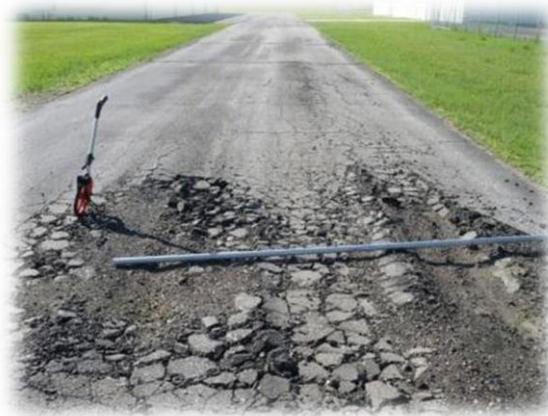
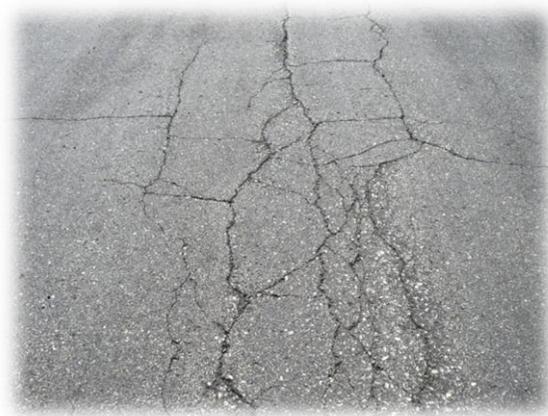
Alligator Cracking

Alligator cracks are a series of interconnected load-related cracks caused by fatigue of the asphalt surface. Alligator cracking is a significant structural distress and develops only in places subject to traffic loads. These cracks typically initiate at the bottom of the asphalt layer and propagate upward. Once a fatigue crack is visible at the surface, significant damage has already occurred.

At low severity, alligator cracks are evidenced by a series of parallel hairline cracks (usually in a wheel path). Medium-severity alligator cracking is a well-defined pattern of interconnected cracks, and some spalling may be present. High-severity alligator cracks have lost aggregate interlock between adjacent pieces, and the cracks may be severely spalled with FOD potential. Most likely, the pieces will move freely under traffic.

Alligator cracking is a serious structural failure that cannot be repaired with sealant. The proper repair is patching.

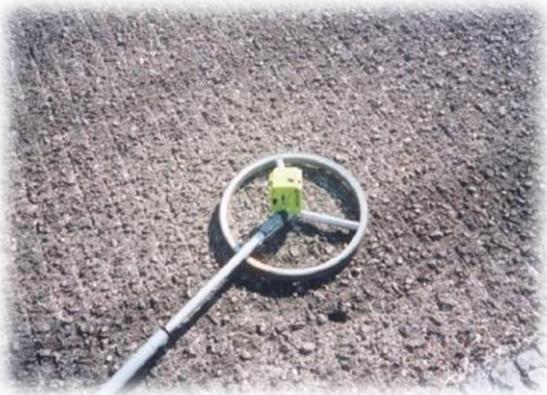
Raveling/Weathering

Raveling and weathering are the wearing away of the pavement surface. Failure can be caused by the dislodging of aggregate particles or the loss of asphalt binder. These distresses are usually evident over large areas and may indicate that the asphalt binder has hardened significantly.

Raveling: At low severity, 5 to 20 coarse aggregate particles are missing per square yard. Medium severity is defined by 20 to 40 missing coarse aggregate particles per square yard. At high severity, more than 40 coarse aggregate particles are missing per square yard, and the top layer of aggregate has eroded away.

Weathering: At low severity, edges of coarse aggregate are exposed less than 1 mm. At medium severity, loss of fine aggregate is noticeable and edges of coarse aggregate are exposed up to 6 mm (1/4 inch). High severity weathering has edges of coarse aggregate exposed > 6 mm, with considerable loss of fine aggregate matrix and potential for loss of coarse aggregate.

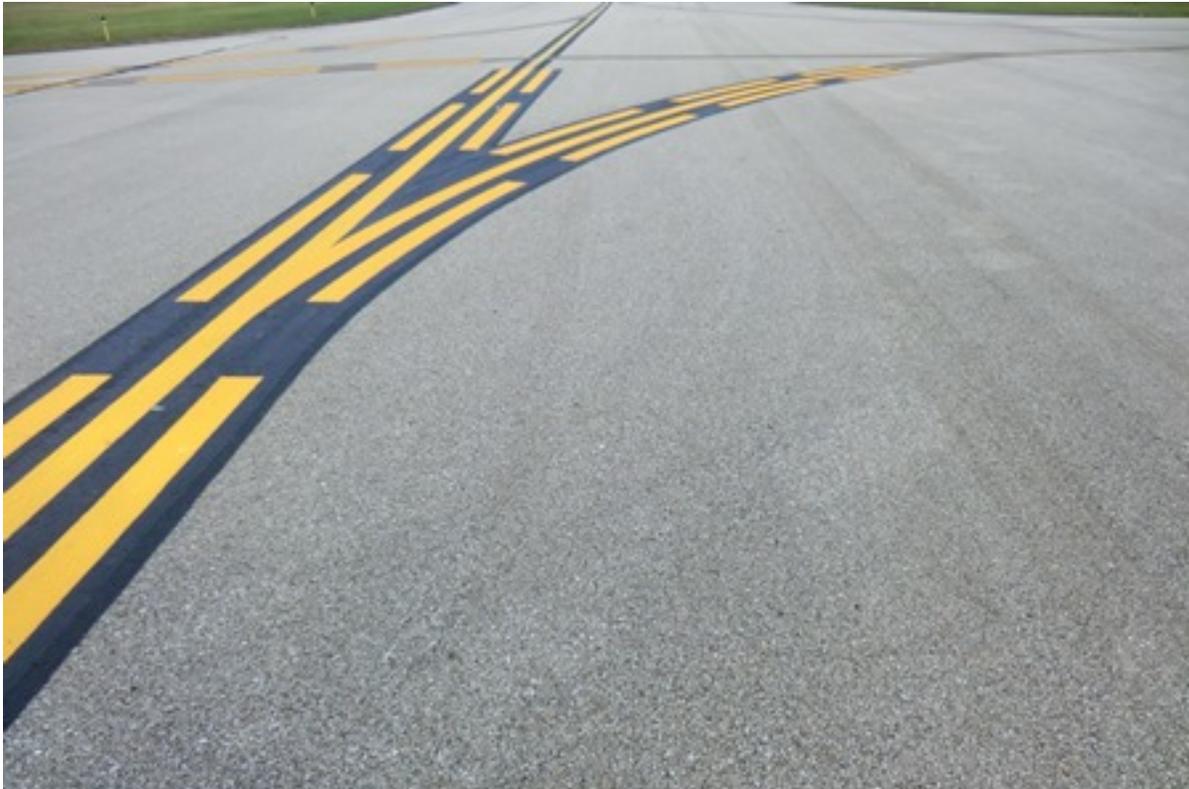
DISTRESS TYPE	SEVERITY	MEASURED QUANTITY	ESTIMATED TOTAL QUANTITY	UNITS	PERCENTAGE OF ALL DISTRESS
LONG.& TRANS. CRACK	MED	5	5	L.F.	11.9
LONG.& TRANS. CRACK	LOW	310	347	L.F.	88

APPROXIMATE AMOUNT OF DISTRESS RELATED TO LOAD ON THE PAVEMENT IS: 0 %
 APPROXIMATE AMOUNT OF DISTRESS RELATED TO MATERIALS PROBLEMS IN THE FEATURE IS: 67 %
 APPROXIMATE AMOUNT OF DISTRESS RELATED TO AGE OF PAVEMENT AND TRAFFIC REPETITIONS IS: 33 %

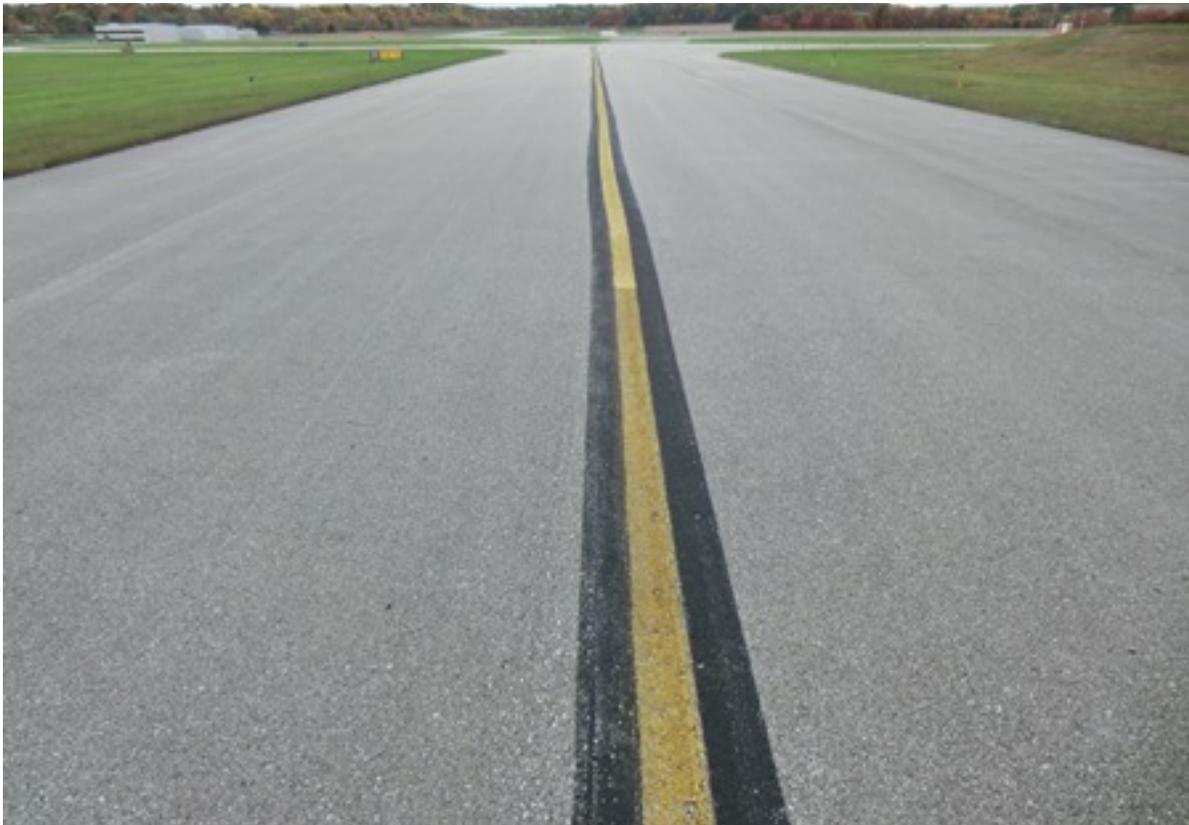
DISTRESS TYPE	SEVERITY	MEASURED QUANTITY	ESTIMATED TOTAL QUANTITY	UNITS	PERCENTAGE OF All DISTRESS
LONG.& TRANS. CRACK	LOW	30	55	L.F.	100

APPROXIMATE AMOUNT OF DISTRESS RELATED TO LOAD ON THE PAVEMENT IS:	0 %
APPROXIMATE AMOUNT OF DISTRESS RELATED TO MATERIALS PROBLEMS IN THE FEATURE IS:	67 %
APPROXIMATE AMOUNT OF DISTRESS RELATED TO AGE OF PAVEMENT AND TRAFFIC REPETITIONS IS:	33 %

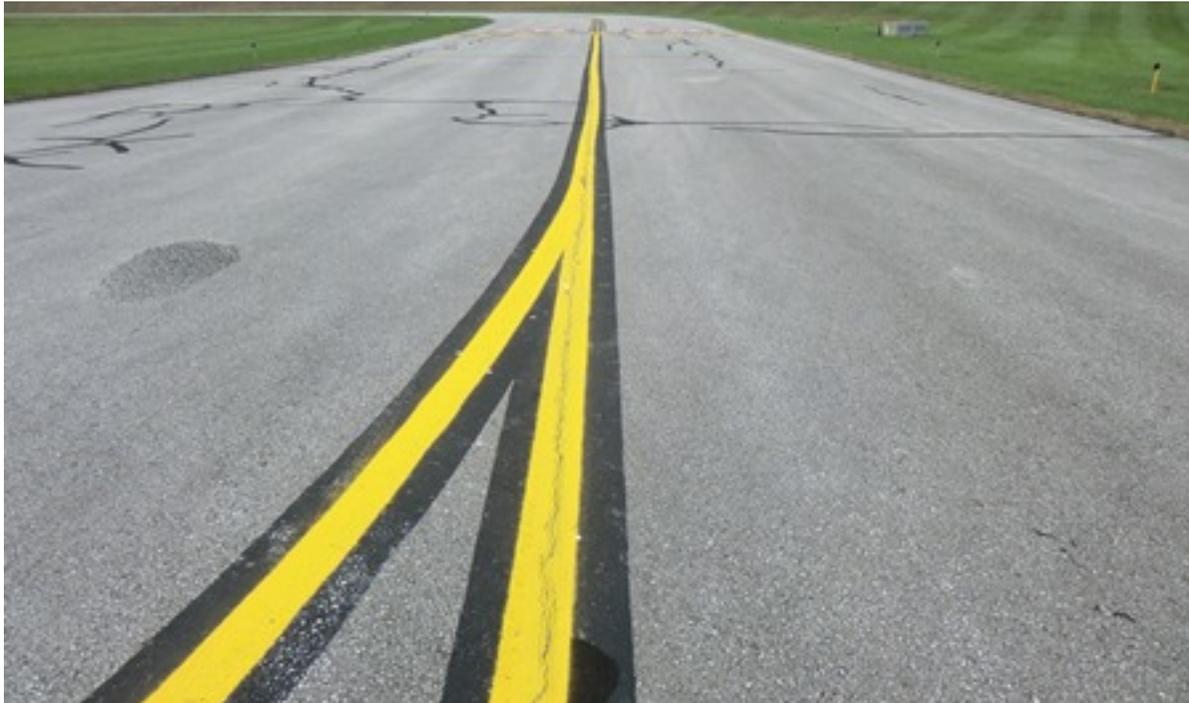
DISTRESS TYPE	SEVERITY	MEASURED QUANTITY	ESTIMATED TOTAL QUANTITY	UNITS	PERCENTAGE OF All DISTRESS
ALLIGATOR CRACKING	LOW	4	5	S.F.	9
BLEEDING	N/A	12	16	S.F.	1.2
JOINT REF. CRACKING	MED	104	138	L.F.	20.9
LONG.& TRANS. CRACK	MED	54	72	L.F.	13.6
LONG.& TRANS. CRACK	LOW	901	1,201	L.F.	52.9
WEATHERING	LOW	800	1,066	S.F.	2.1

APPROXIMATE AMOUNT OF DISTRESS RELATED TO LOAD ON THE PAVEMENT IS:	9 %
APPROXIMATE AMOUNT OF DISTRESS RELATED TO MATERIALS PROBLEMS IN THE FEATURE IS:	67 %
APPROXIMATE AMOUNT OF DISTRESS RELATED TO AGE OF PAVEMENT AND TRAFFIC REPETITIONS IS:	24 %

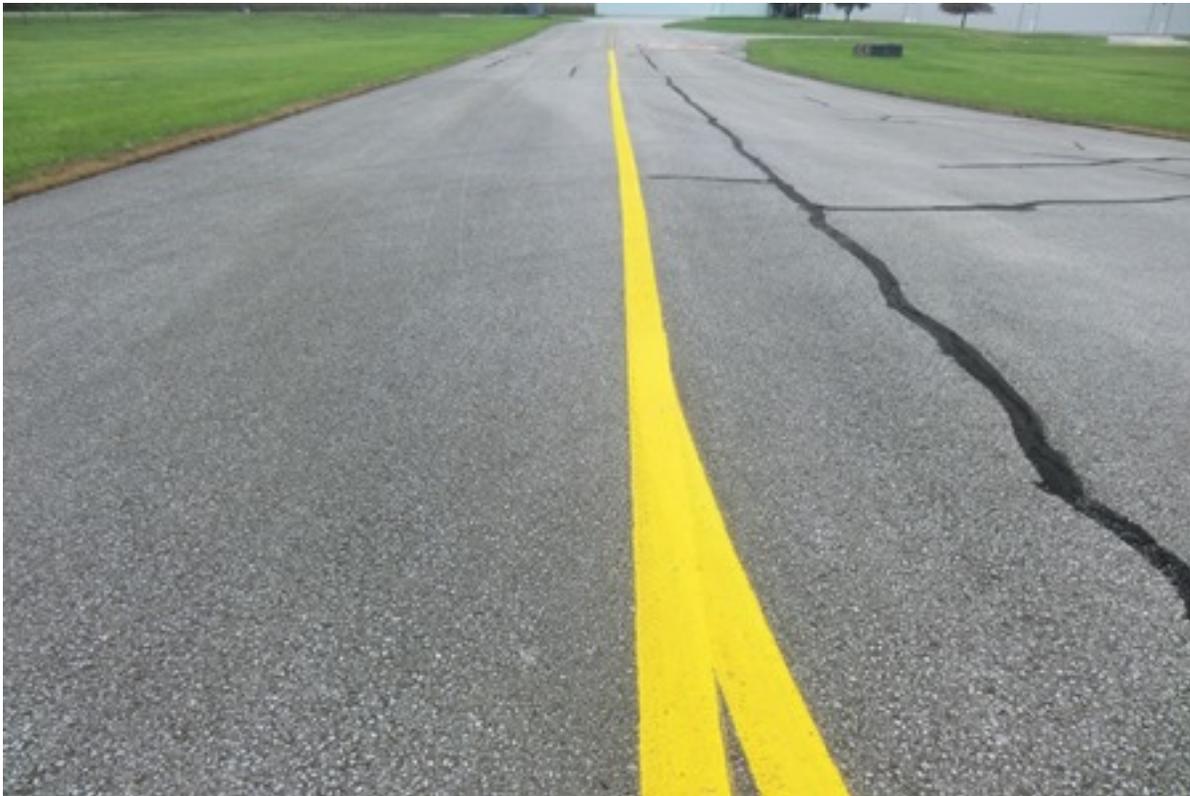
DISTRESS TYPE	SEVERITY	MEASURED QUANTITY	ESTIMATED TOTAL QUANTITY	UNITS	PERCENTAGE OF All DISTRESS
LONG.& TRANS. CRACK	MED	195	277	L.F.	54.8
LONG.& TRANS. CRACK	LOW	366	520	L.F.	45.1

APPROXIMATE AMOUNT OF DISTRESS RELATED TO LOAD ON THE PAVEMENT IS:	0 %
APPROXIMATE AMOUNT OF DISTRESS RELATED TO MATERIALS PROBLEMS IN THE FEATURE IS:	67 %
APPROXIMATE AMOUNT OF DISTRESS RELATED TO AGE OF PAVEMENT AND TRAFFIC REPETITIONS IS:	33 %

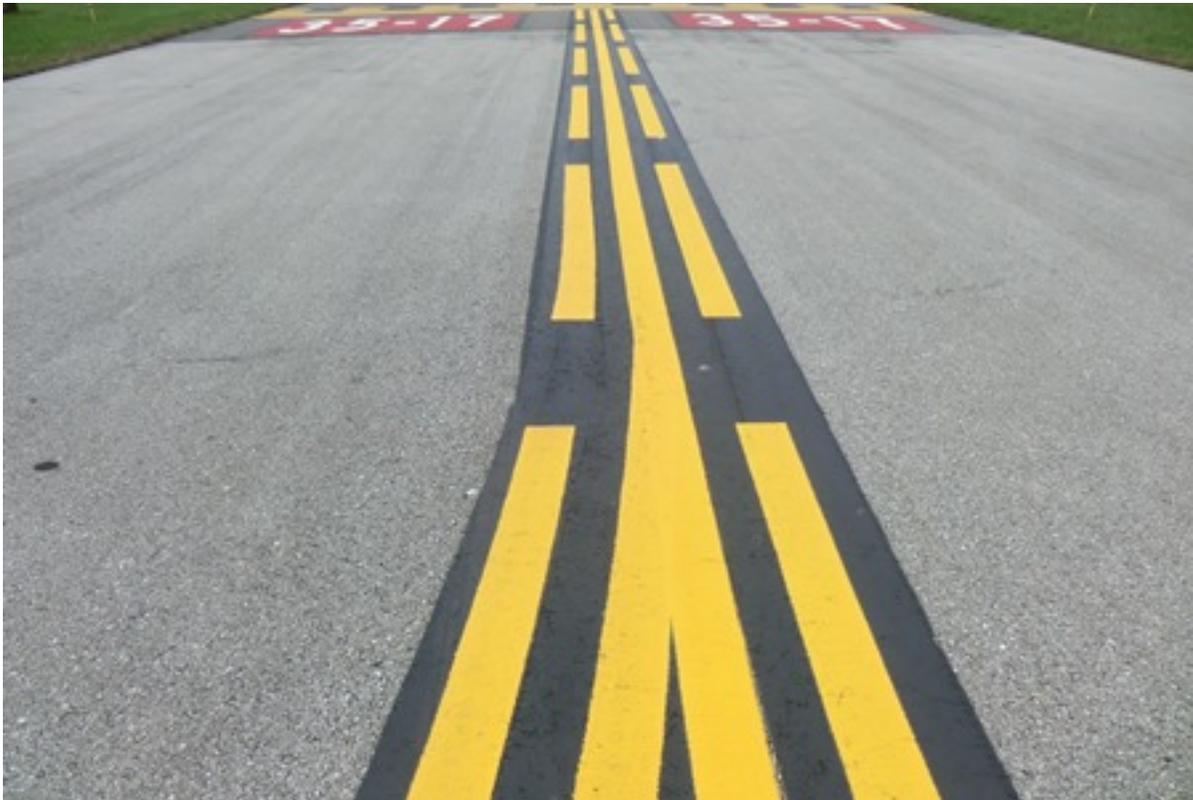
DISTRESS TYPE	SEVERITY	MEASURED QUANTITY	ESTIMATED TOTAL QUANTITY	UNITS	PERCENTAGE OF All DISTRESS
LONG.& TRANS. CRACK	MED	24	42	L.F.	56.7
LONG.& TRANS. CRACK	LOW	42	73	L.F.	43.2

APPROXIMATE AMOUNT OF DISTRESS RELATED TO LOAD ON THE PAVEMENT IS:	0 %
APPROXIMATE AMOUNT OF DISTRESS RELATED TO MATERIALS PROBLEMS IN THE FEATURE IS:	67 %
APPROXIMATE AMOUNT OF DISTRESS RELATED TO AGE OF PAVEMENT AND TRAFFIC REPETITIONS IS:	33 %

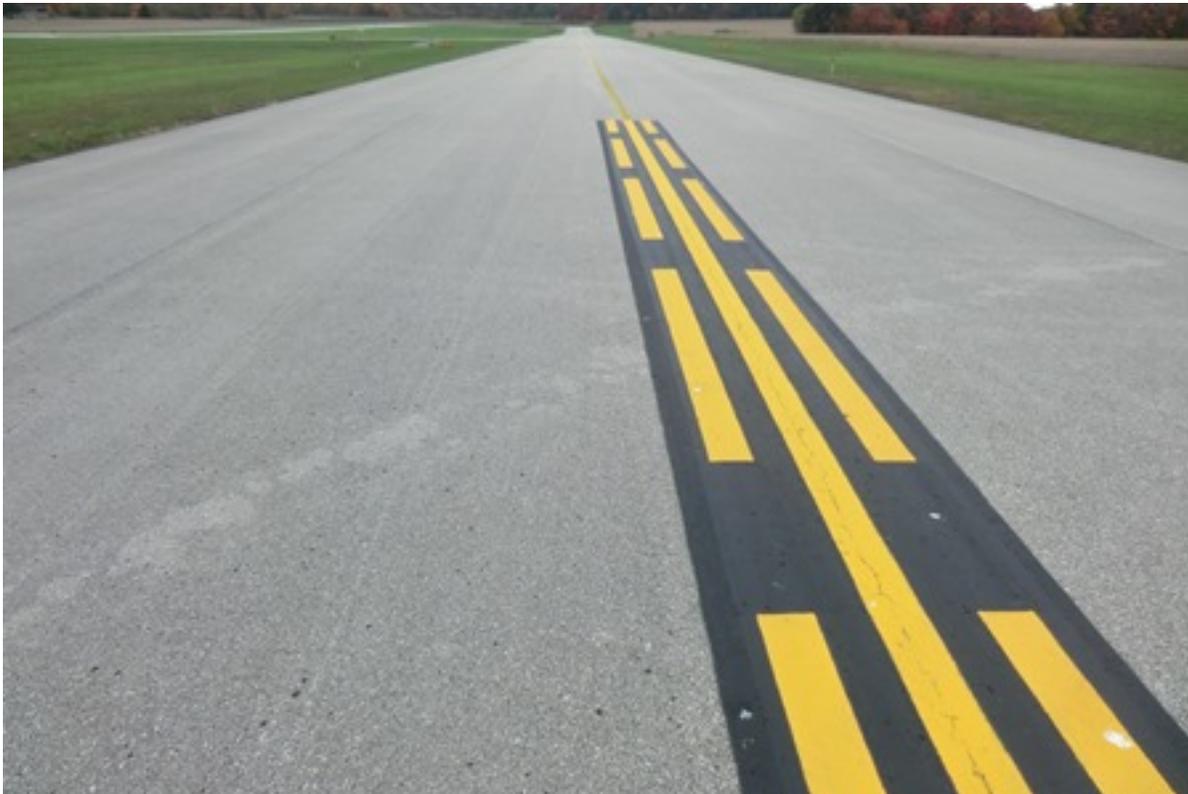
DISTRESS TYPE	SEVERITY	MEASURED QUANTITY	ESTIMATED TOTAL QUANTITY	UNITS	PERCENTAGE OF All DISTRESS
LONG.& TRANS. CRACK	MED	93	228	L.F.	29.1
LONG.& TRANS. CRACK	LOW	1,342	3,289	L.F.	70.8

APPROXIMATE AMOUNT OF DISTRESS RELATED TO LOAD ON THE PAVEMENT IS:	0 %
APPROXIMATE AMOUNT OF DISTRESS RELATED TO MATERIALS PROBLEMS IN THE FEATURE IS:	67 %
APPROXIMATE AMOUNT OF DISTRESS RELATED TO AGE OF PAVEMENT AND TRAFFIC REPETITIONS IS:	33 %

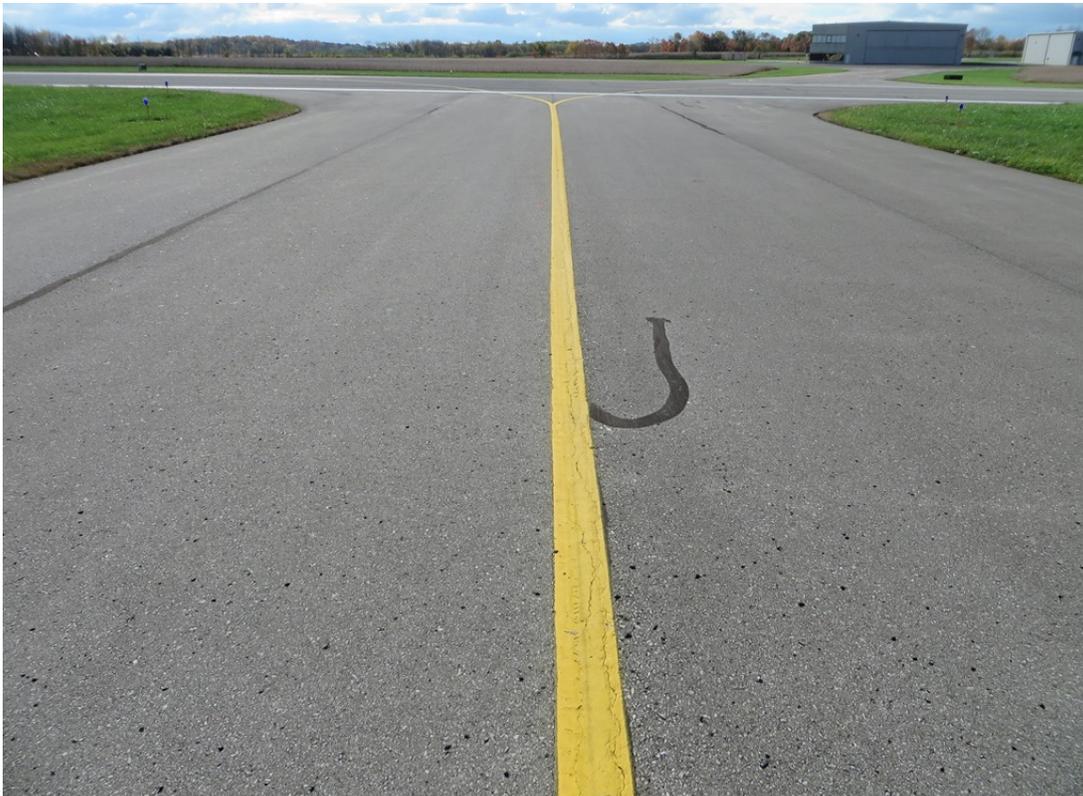
DISTRESS TYPE	SEVERITY	MEASURED QUANTITY	ESTIMATED TOTAL QUANTITY	UNITS	PERCENTAGE OF All DISTRESS
LONG.& TRANS. CRACK	MED	74	139	L.F.	37.7
LONG.& TRANS. CRACK	LOW	334	628	L.F.	62.2

APPROXIMATE AMOUNT OF DISTRESS RELATED TO LOAD ON THE PAVEMENT IS: 0 %
 APPROXIMATE AMOUNT OF DISTRESS RELATED TO MATERIALS PROBLEMS IN THE FEATURE IS: 67 %
 APPROXIMATE AMOUNT OF DISTRESS RELATED TO AGE OF PAVEMENT AND TRAFFIC REPETITIONS IS: 33 %

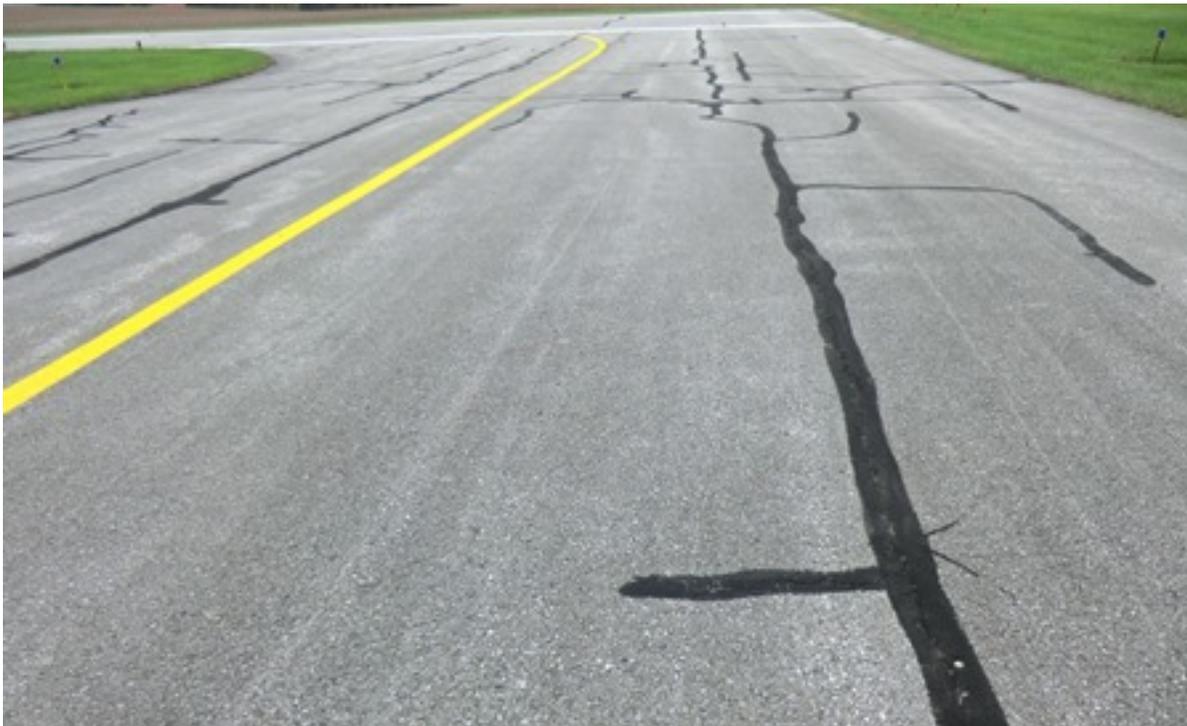
DISTRESS TYPE	SEVERITY	MEASURED QUANTITY	ESTIMATED TOTAL QUANTITY	UNITS	PERCENTAGE OF All DISTRESS
ALLIGATOR CRACKING	LOW	60	89	S.F.	21.9
LONG.& TRANS. CRACK	MED	139	207	L.F.	22.1
LONG.& TRANS. CRACK	LOW	1,135	1,690	L.F.	45.5
SWELL	LOW	175	260	S.F.	9.8
WEATHERING	MED	30	44	S.F.	.4

APPROXIMATE AMOUNT OF DISTRESS RELATED TO LOAD ON THE PAVEMENT IS:	22 %
APPROXIMATE AMOUNT OF DISTRESS RELATED TO MATERIALS PROBLEMS IN THE FEATURE IS:	55 %
APPROXIMATE AMOUNT OF DISTRESS RELATED TO AGE OF PAVEMENT AND TRAFFIC REPETITIONS IS:	23 %

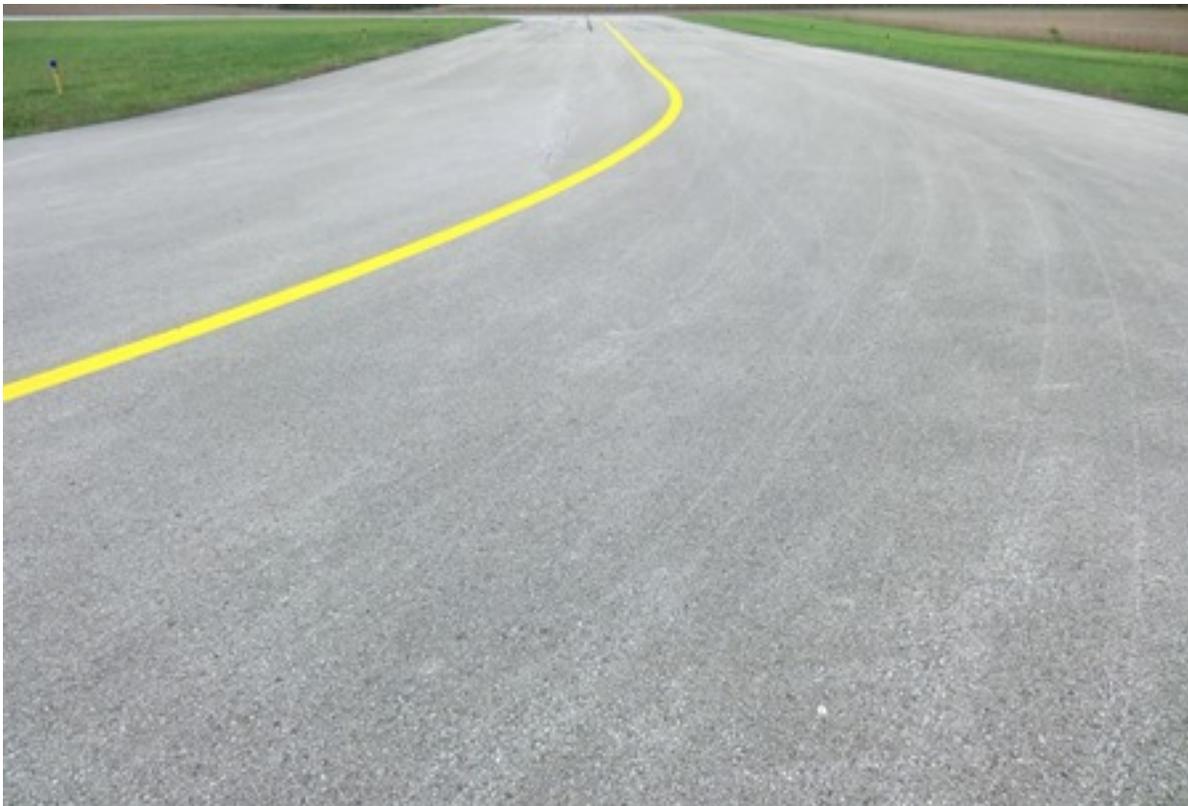
DISTRESS TYPE	SEVERITY	MEASURED QUANTITY	ESTIMATED TOTAL QUANTITY	UNITS	PERCENTAGE OF ALL DISTRESS
LONG.& TRANS. CRACK	MED	153	232	L.F.	64.7
LONG.& TRANS. CRACK	LOW	223	338	L.F.	35.2

APPROXIMATE AMOUNT OF DISTRESS RELATED TO LOAD ON THE PAVEMENT IS:	0 %
APPROXIMATE AMOUNT OF DISTRESS RELATED TO MATERIALS PROBLEMS IN THE FEATURE IS:	67 %
APPROXIMATE AMOUNT OF DISTRESS RELATED TO AGE OF PAVEMENT AND TRAFFIC REPETITIONS IS:	33 %

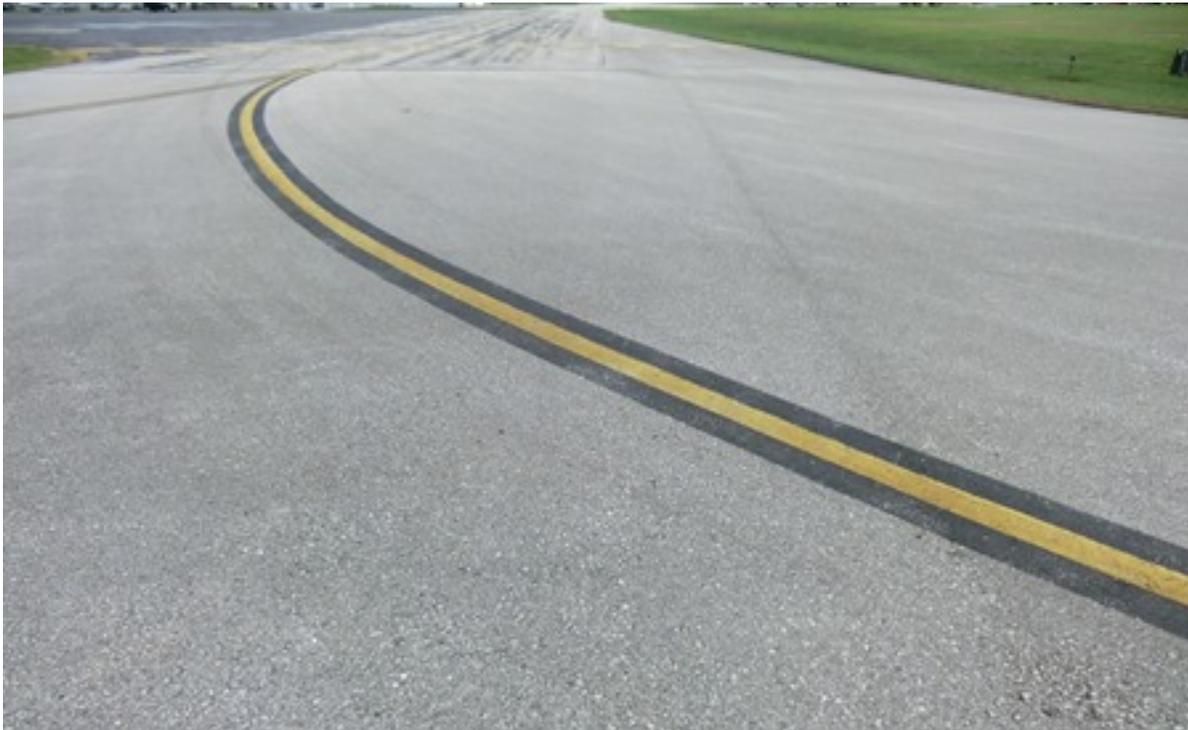
DISTRESS TYPE	SEVERITY	MEASURED QUANTITY	ESTIMATED TOTAL QUANTITY	UNITS	PERCENTAGE OF All DISTRESS
LONG.& TRANS. CRACK	MED	87	298	L.F.	44.5
LONG.& TRANS. CRACK	LOW	91	312	L.F.	19.7
SWELL	MED	24	82	S.F.	23.3
SWELL	LOW	26	89	S.F.	4.7
WEATHERING	MED	160	548	S.F.	7.6

APPROXIMATE AMOUNT OF DISTRESS RELATED TO LOAD ON THE PAVEMENT IS:	0 %
APPROXIMATE AMOUNT OF DISTRESS RELATED TO MATERIALS PROBLEMS IN THE FEATURE IS:	73 %
APPROXIMATE AMOUNT OF DISTRESS RELATED TO AGE OF PAVEMENT AND TRAFFIC REPETITIONS IS:	27 %

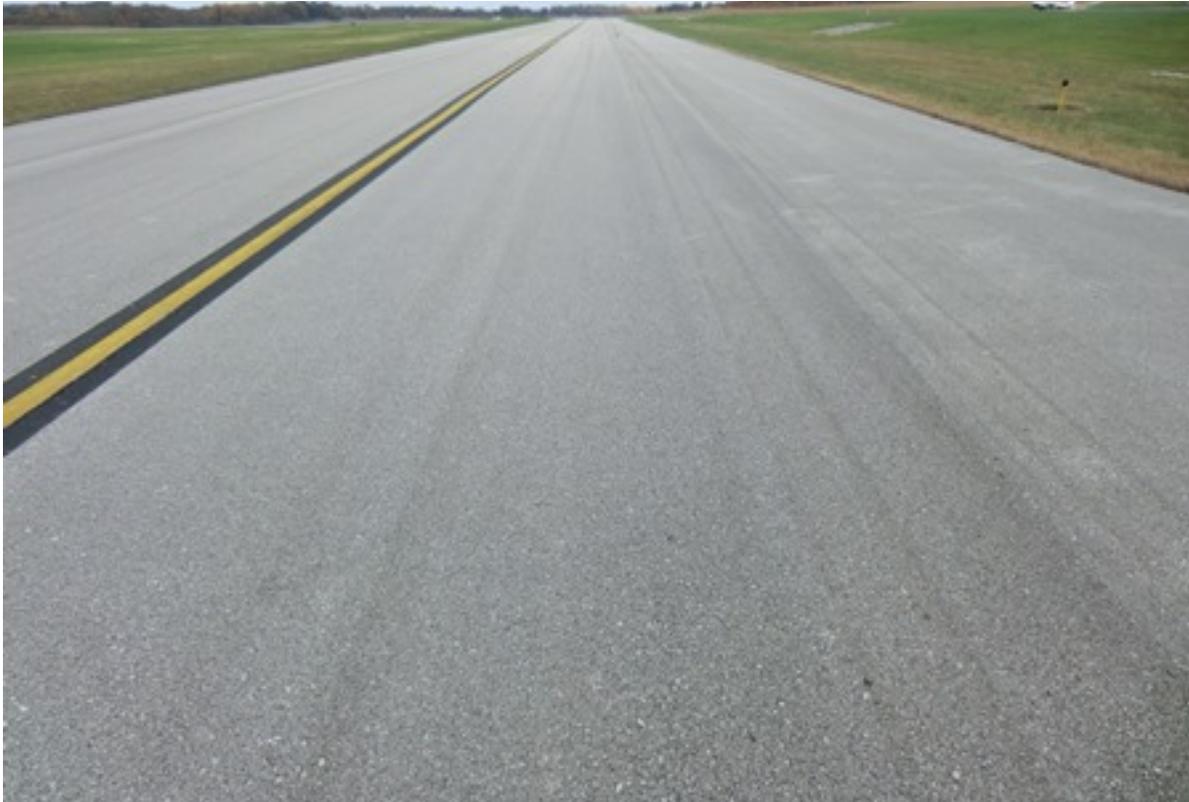
DISTRESS TYPE	SEVERITY	MEASURED QUANTITY	ESTIMATED TOTAL QUANTITY	UNITS	PERCENTAGE OF ALL DISTRESS
LONG.& TRANS. CRACK	LOW	422	1,018	L.F.	100

APPROXIMATE AMOUNT OF DISTRESS RELATED TO LOAD ON THE PAVEMENT IS:	0 %
APPROXIMATE AMOUNT OF DISTRESS RELATED TO MATERIALS PROBLEMS IN THE FEATURE IS:	67 %
APPROXIMATE AMOUNT OF DISTRESS RELATED TO AGE OF PAVEMENT AND TRAFFIC REPETITIONS IS:	33 %

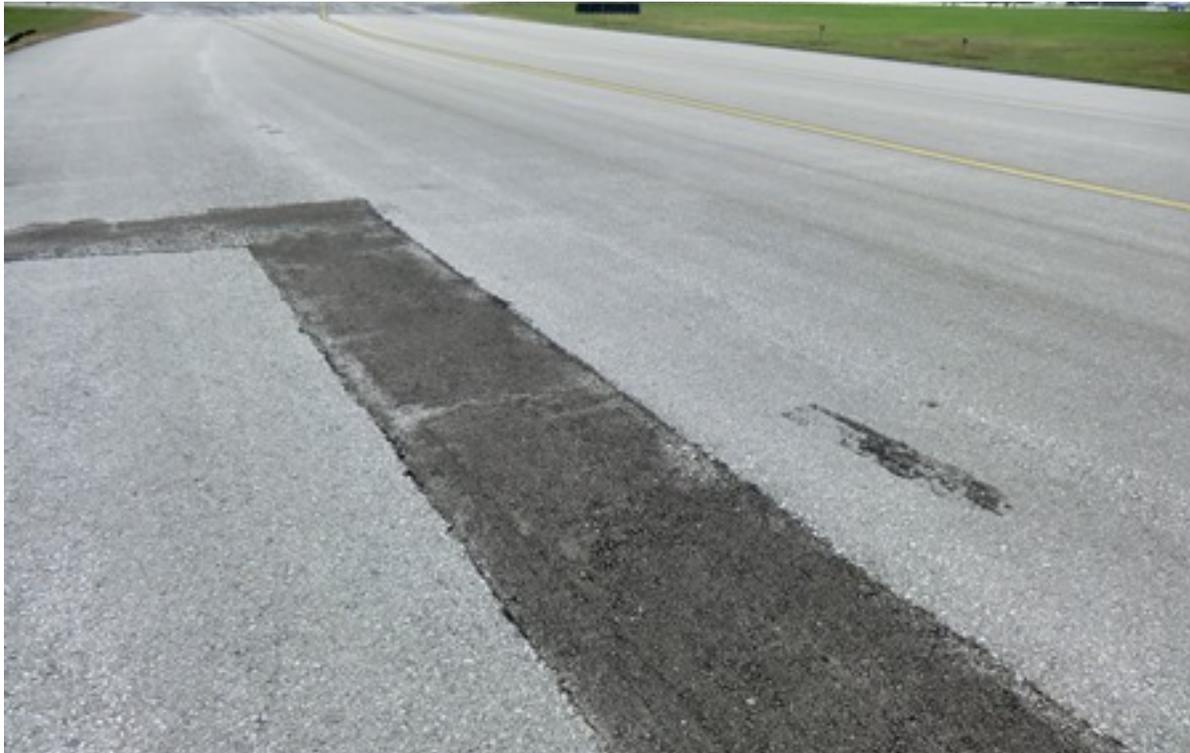
DISTRESS TYPE	SEVERITY	MEASURED QUANTITY	ESTIMATED TOTAL QUANTITY	UNITS	PERCENTAGE OF All DISTRESS
LONG.& TRANS. CRACK	MED	6	15	L.F.	16.7
LONG.& TRANS. CRACK	LOW	102	255	L.F.	45.7
PATCH & UTILITY CUT	LOW	134	335	S.F.	36.8
WEATHERING	LOW	50	125	S.F.	.6

APPROXIMATE AMOUNT OF DISTRESS RELATED TO LOAD ON THE PAVEMENT IS:	25 %
APPROXIMATE AMOUNT OF DISTRESS RELATED TO MATERIALS PROBLEMS IN THE FEATURE IS:	54 %
APPROXIMATE AMOUNT OF DISTRESS RELATED TO AGE OF PAVEMENT AND TRAFFIC REPETITIONS IS:	21 %

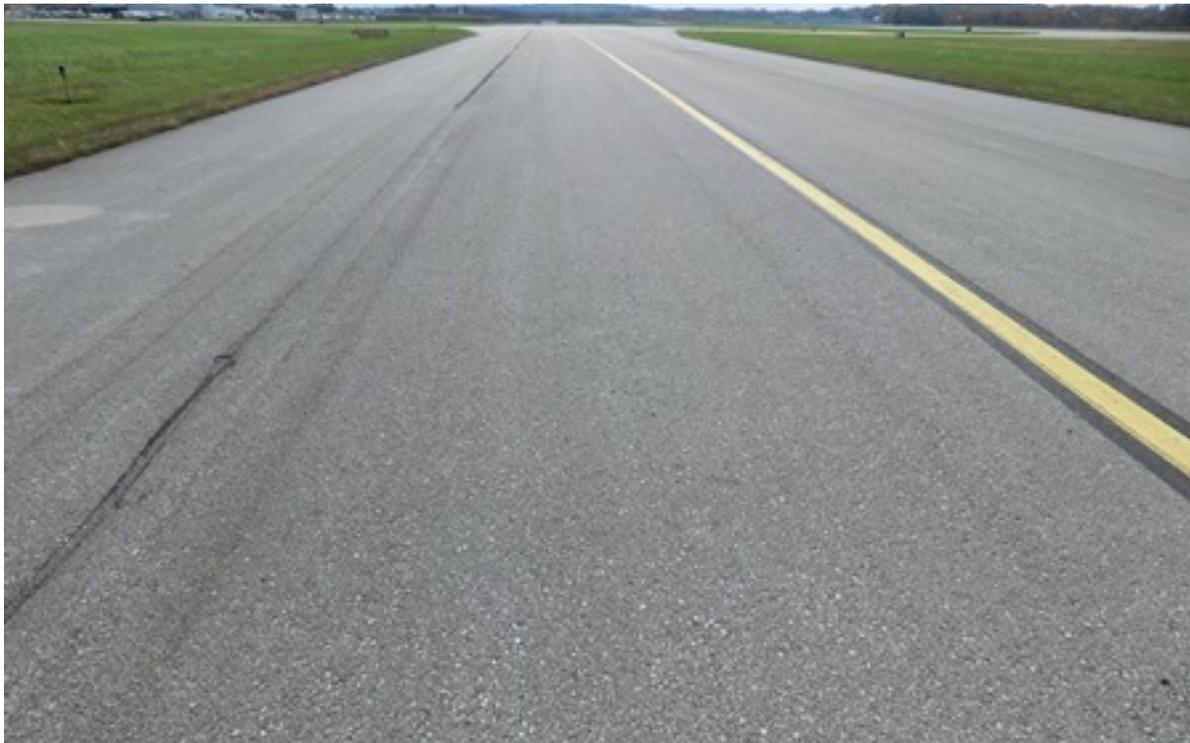
DISTRESS TYPE	SEVERITY	MEASURED QUANTITY	ESTIMATED TOTAL QUANTITY	UNITS	PERCENTAGE OF All DISTRESS
ALLIGATOR CRACKING	LOW	15	28	S.F.	19.1
LONG.& TRANS. CRACK	MED	132	253	L.F.	39.8
LONG.& TRANS. CRACK	LOW	592	1,134	L.F.	37.4
SWELL	LOW	51	97	S.F.	3.6

APPROXIMATE AMOUNT OF DISTRESS RELATED TO LOAD ON THE PAVEMENT IS:	19 %
APPROXIMATE AMOUNT OF DISTRESS RELATED TO MATERIALS PROBLEMS IN THE FEATURE IS:	55 %
APPROXIMATE AMOUNT OF DISTRESS RELATED TO AGE OF PAVEMENT AND TRAFFIC REPETITIONS IS:	26 %

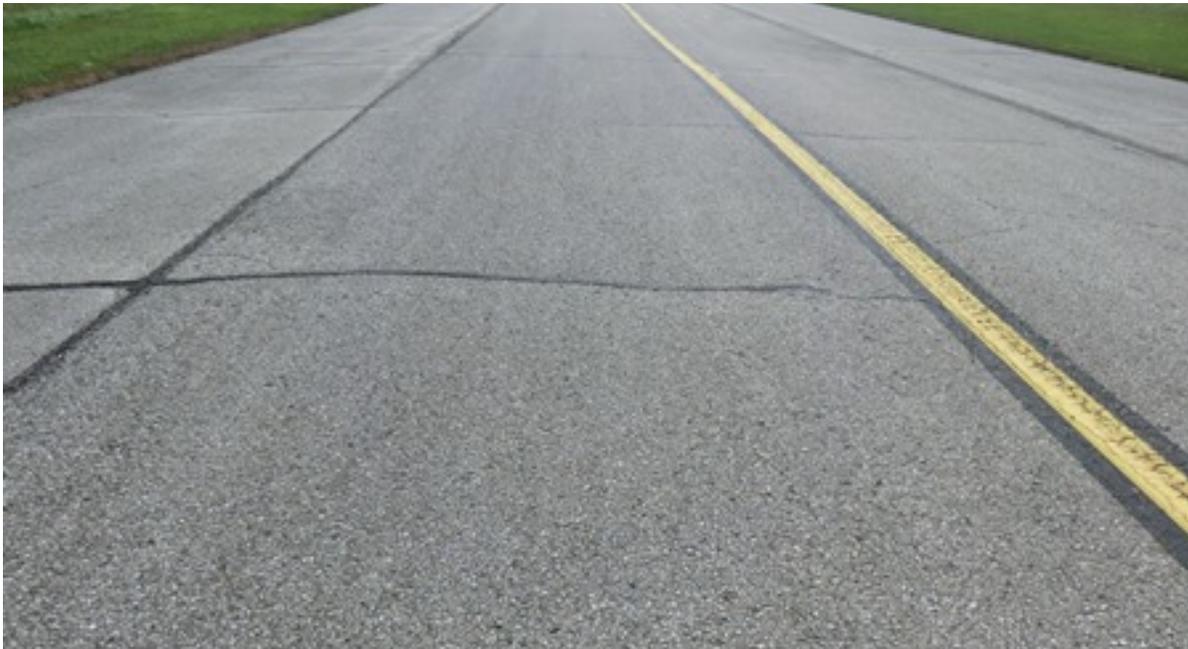
DISTRESS TYPE	SEVERITY	MEASURED QUANTITY	ESTIMATED TOTAL QUANTITY	UNITS	PERCENTAGE OF All DISTRESS
ALLIGATOR CRACKING	MED	7	14	S.F.	7.2
ALLIGATOR CRACKING	LOW	77	159	S.F.	18.1
BLOCK CRACKING	MED	200	413	S.F.	7.3
BLOCK CRACKING	LOW	1,904	3,939	S.F.	19.8
LONG.& TRANS. CRACK	MED	350	724	L.F.	16.7
LONG.& TRANS. CRACK	LOW	745	1,541	L.F.	17
RAVELING	LOW	281	581	S.F.	5.2
WEATHERING	MED	2,200	4,552	S.F.	8.3

APPROXIMATE AMOUNT OF DISTRESS RELATED TO LOAD ON THE PAVEMENT IS:	25 %
APPROXIMATE AMOUNT OF DISTRESS RELATED TO MATERIALS PROBLEMS IN THE FEATURE IS:	27 %
APPROXIMATE AMOUNT OF DISTRESS RELATED TO AGE OF PAVEMENT AND TRAFFIC REPETITIONS IS:	48 %

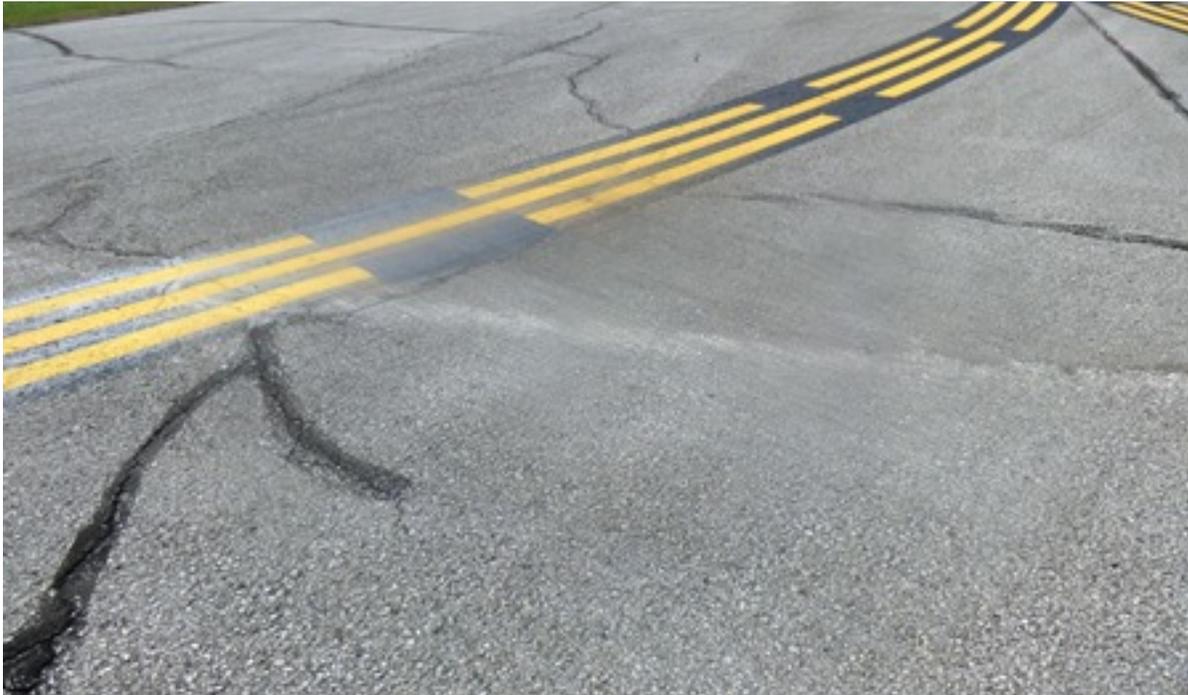
DISTRESS TYPE	SEVERITY	MEASURED QUANTITY	ESTIMATED TOTAL QUANTITY	UNITS	PERCENTAGE OF All DISTRESS
ALLIGATOR CRACKING	LOW	20	40	S.F.	21.1
LONG.& TRANS. CRACK	MED	136	277	L.F.	24.9
LONG.& TRANS. CRACK	LOW	487	992	L.F.	33.5
WEATHERING	HIGH	5	10	S.F.	3
WEATHERING	MED	1,400	2,852	S.F.	14.7
WEATHERING	LOW	1,100	2,241	S.F.	2.6

APPROXIMATE AMOUNT OF DISTRESS RELATED TO LOAD ON THE PAVEMENT IS:	21 %
APPROXIMATE AMOUNT OF DISTRESS RELATED TO MATERIALS PROBLEMS IN THE FEATURE IS:	46 %
APPROXIMATE AMOUNT OF DISTRESS RELATED TO AGE OF PAVEMENT AND TRAFFIC REPETITIONS IS:	33 %
