Pavement Condition Report

Bloomington-Monroe County Airport

Project 15805741

February 2015

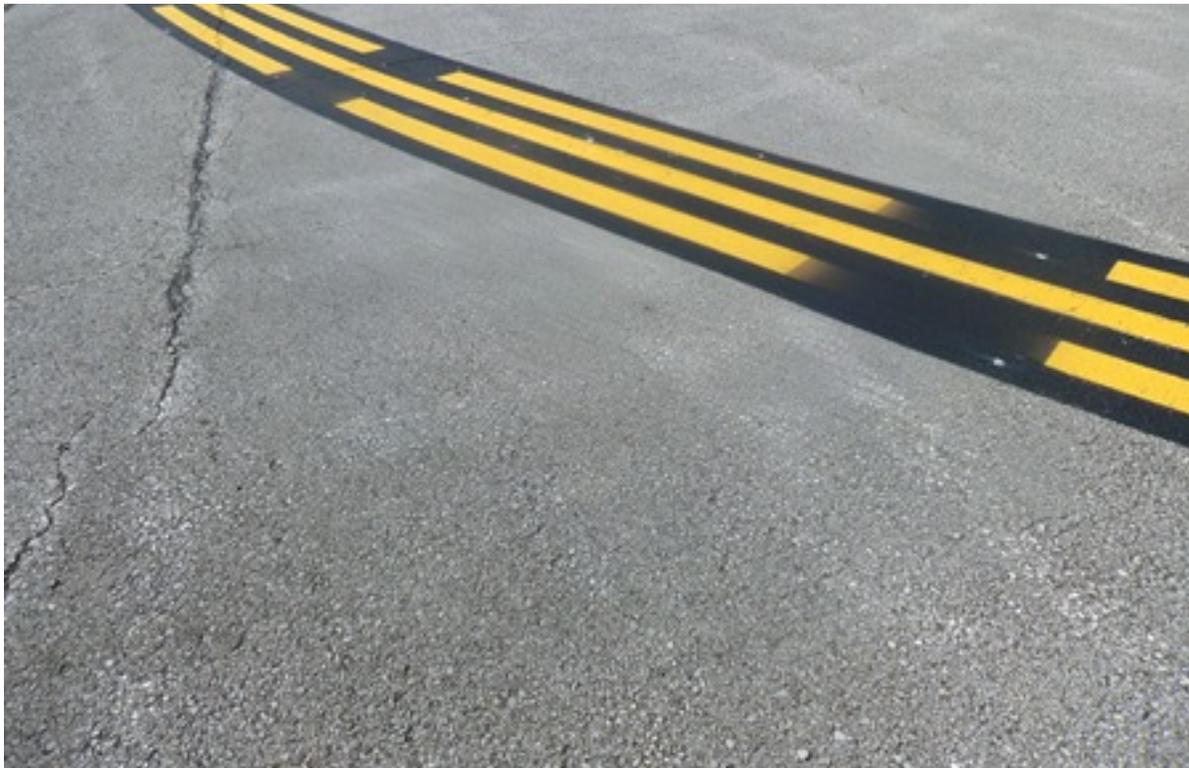
DISTRESS TYPE	SEVERITY	MEASURED QUANTITY	ESTIMATED TOTAL QUANTITY	UNITS	PERCENTAGE OF All DISTRESS
LONG.& TRANS. CRACK	MED	258	432	L.F.	52.4
LONG.& TRANS. CRACK	LOW	450	755	L.F.	44.5
WEATHERING	LOW	600	1,006	S.F.	2.9

APPROXIMATE AMOUNT OF DISTRESS RELATED TO LOAD ON THE PAVEMENT IS:	0 %
APPROXIMATE AMOUNT OF DISTRESS RELATED TO MATERIALS PROBLEMS IN THE FEATURE IS:	66 %
APPROXIMATE AMOUNT OF DISTRESS RELATED TO AGE OF PAVEMENT AND TRAFFIC REPETITIONS IS:	34 %

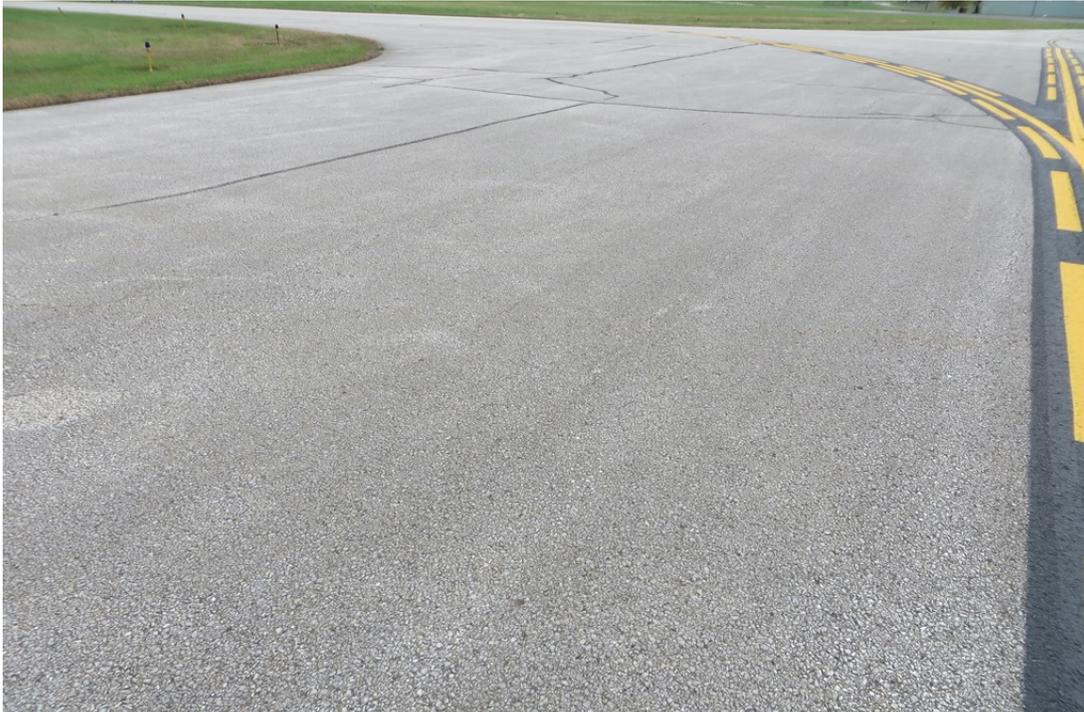
DISTRESS TYPE	SEVERITY	MEASURED QUANTITY	ESTIMATED TOTAL QUANTITY	UNITS	PERCENTAGE OF All DISTRESS
ALLIGATOR CRACKING	MED	3	5	S.F.	9.3
LONG.& TRANS. CRACK	MED	606	1,128	L.F.	53.4
LONG.& TRANS. CRACK	LOW	546	1,016	L.F.	29.3
WEATHERING	MED	400	744	S.F.	4.4
WEATHERING	LOW	2,000	3,724	S.F.	3.3

APPROXIMATE AMOUNT OF DISTRESS RELATED TO LOAD ON THE PAVEMENT IS:	9 %
APPROXIMATE AMOUNT OF DISTRESS RELATED TO MATERIALS PROBLEMS IN THE FEATURE IS:	58 %
APPROXIMATE AMOUNT OF DISTRESS RELATED TO AGE OF PAVEMENT AND TRAFFIC REPETITIONS IS:	33 %
