Pavement Condition Report

Frankfort Municipal Airport

Project 13801869

January 2013

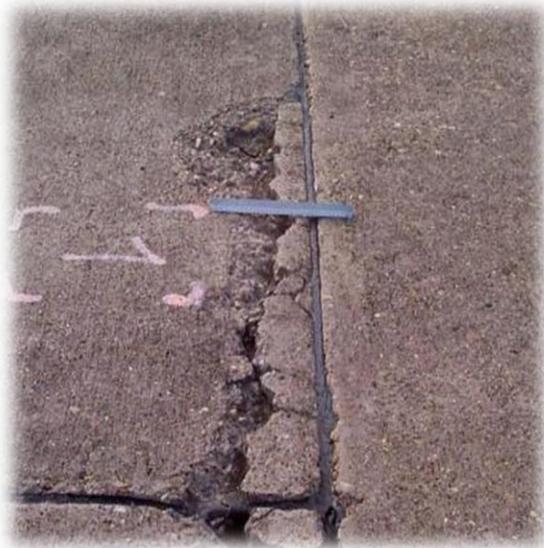
Joint Spall and Corner Spall

Spalls at slab joints and corners are caused by excessive internal stress in the pavement. Spalls occur when these stresses exceed the shear strength of the concrete.

Spalling usually results from thermal expansion during hot weather when slabs push and expand against one another. If the joints are filled with incompressible material, such as sand, stresses can become severe, causing spalls. Spalling can be reduced significantly by maintenance of joint sealant.

Spall repair requires patching. The extent and severity of spalling suggests the appropriate action. At low severity, spalled concrete remains securely in place in the slab. A low-severity spall should be monitored closely for further deterioration and should be patched when spalled particles become loose, or during the next scheduled patching activity. Medium- and high-severity spalls should be repaired immediately to prevent FOD. If the pavement can be restored to serviceable condition, spalls should be patched for long-term service. If the pavement is beyond repair, temporary patching should be considered to control FOD.

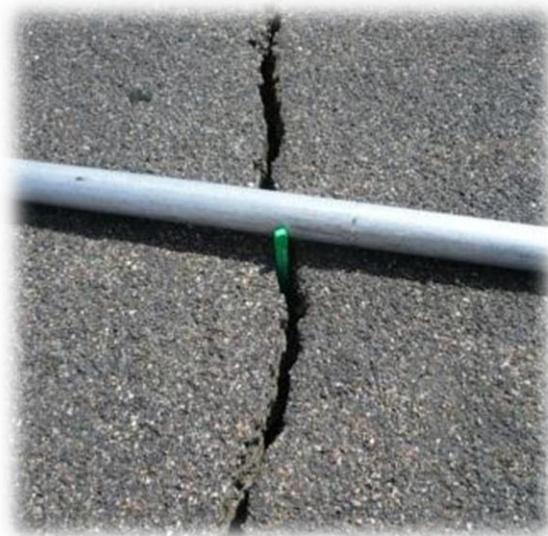
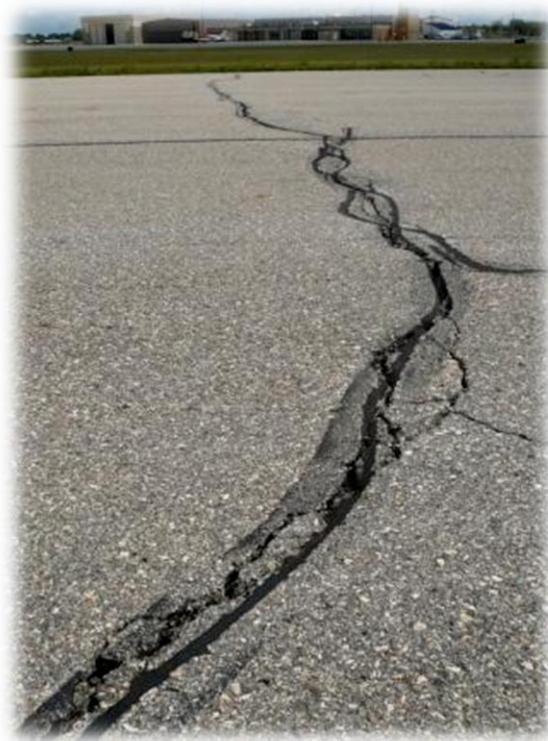
Longitudinal & Trans. Cracking

L&T cracks are caused by age, construction, and subsurface conditions. Age-related cracking occurs as oxidizing pavement loses components to the atmosphere and becomes more brittle. Consistent application of seal coats can help to prevent age-related cracks.

Construction-related cracking often develops along paving joints. Ensuring that joints are made when both sides are still hot, and near the same temperature, is one of the best ways to mitigate this potential problem.

Seasonal movement caused by changes in subsurface moisture or temperature differences also can cause pavement cracking. Asphalt pavement placed over a PCC pavement or cement stabilized base course may evidence reflective cracking from the underlying material. Wheel loads do not cause L&T cracks, although traffic may worsen their condition.

Low-severity L&T cracks are less than ¼ inch wide, or if sealed with suitable filler material in satisfactory condition can be any width less than 3 inches, if they are not spalled. Maintenance usually is not indicated for low-severity cracking. Moderately spalled cracks and cracks wider than ¼ inch which are not satisfactorily sealed are at medium severity. Medium-severity cracks should be sealed with a high-quality crack filling material. Severely spalled cracks and cracks wider than 3 inches are at high severity. High-severity L&T cracks normally require patching.
