Pavement Condition Report

French Lick Municipal Airport

Project 15805741

February 2015

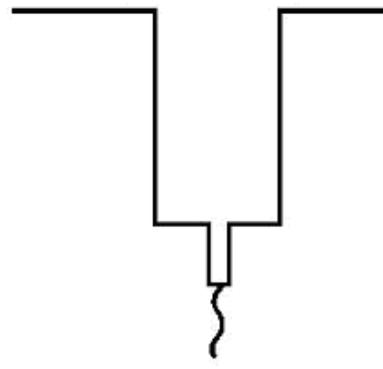
Clean joints exposing fresh, clean concrete and stone. Retain existing reservoir shape.

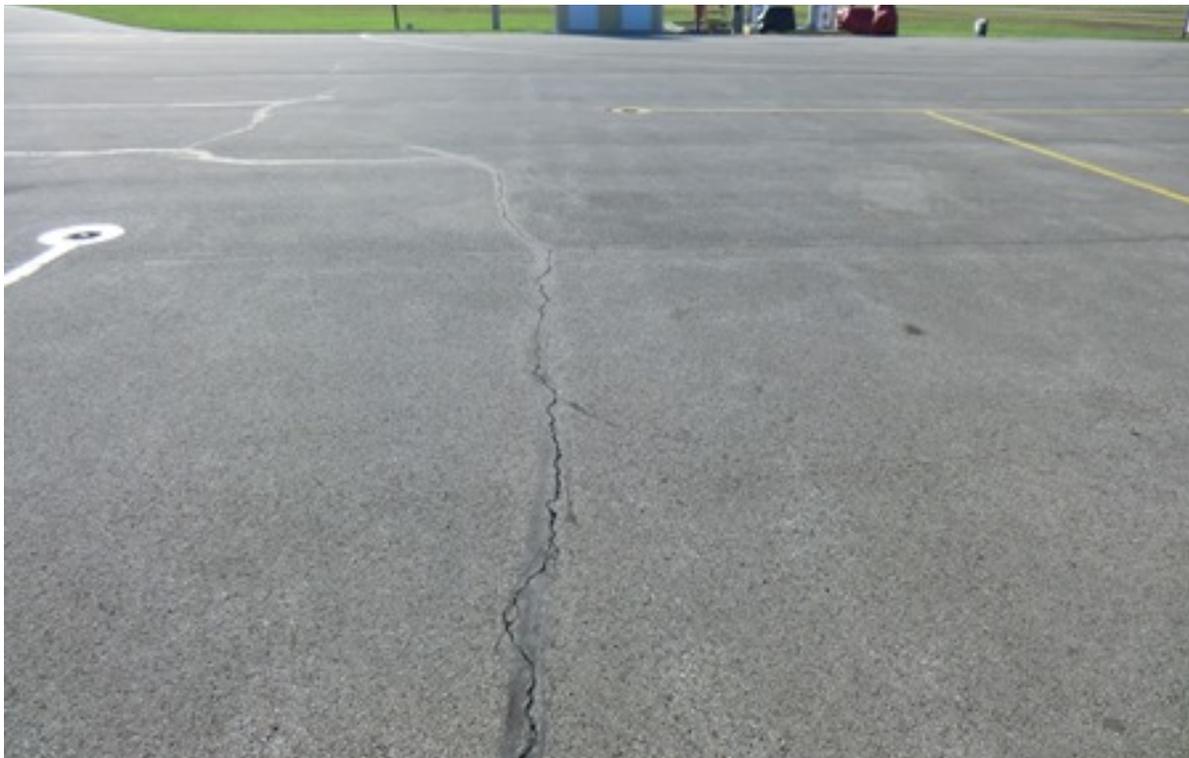
DISTRESS TYPE	SEVERITY	MEASURED QUANTITY	ESTIMATED TOTAL QUANTITY	UNITS	PERCENTAGE OF All DISTRESS
BLEEDING	N/A	18	53	S.F.	2.3
LONG.& TRANS. CRACK	MED	191	563	L.F.	33.4
LONG.& TRANS. CRACK	LOW	1,188	3,506	L.F.	64.1

APPROXIMATE AMOUNT OF DISTRESS RELATED TO LOAD ON THE PAVEMENT IS:	0 %
APPROXIMATE AMOUNT OF DISTRESS RELATED TO MATERIALS PROBLEMS IN THE FEATURE IS:	67 %
APPROXIMATE AMOUNT OF DISTRESS RELATED TO AGE OF PAVEMENT AND TRAFFIC REPETITIONS IS:	33 %

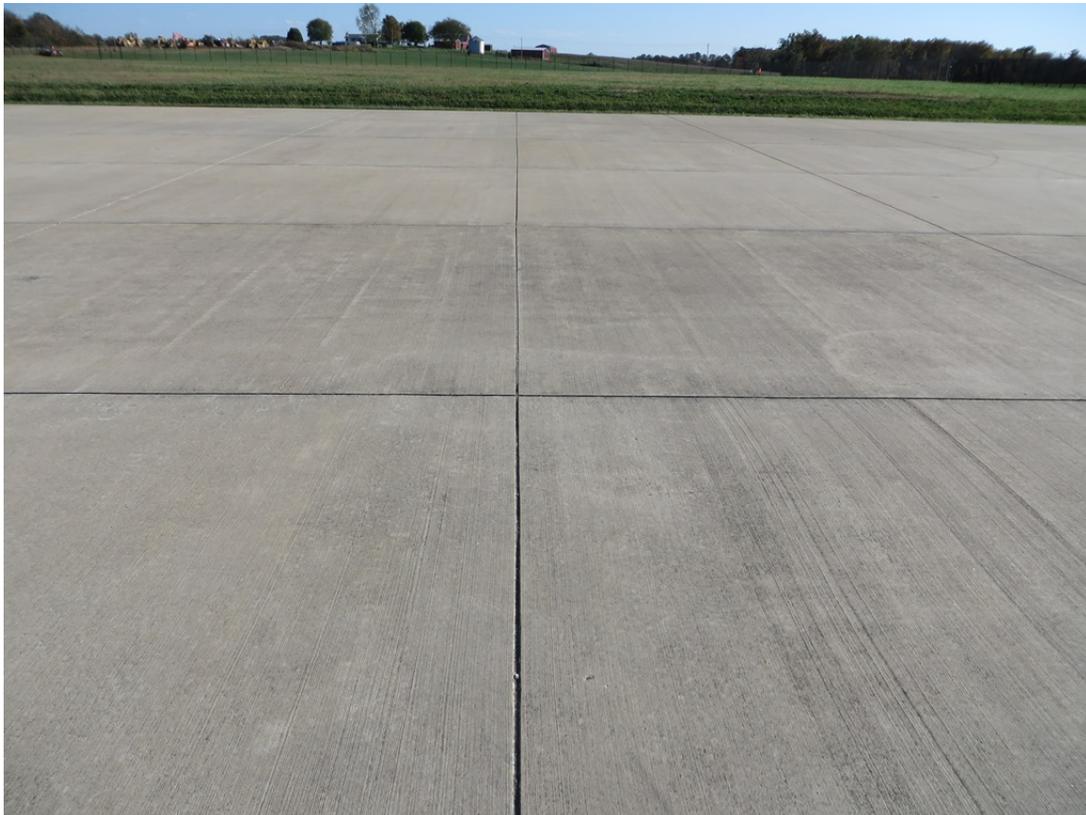
DISTRESS TYPE	SEVERITY	MEASURED QUANTITY	ESTIMATED TOTAL QUANTITY	UNITS	PERCENTAGE OF All DISTRESS
SPALLING-CORNERS	LOW	1	1	SLABS	100

APPROXIMATE AMOUNT OF DISTRESS RELATED TO LOAD ON THE PAVEMENT IS:	33 %
APPROXIMATE AMOUNT OF DISTRESS RELATED TO MATERIALS PROBLEMS IN THE FEATURE IS:	33 %
APPROXIMATE AMOUNT OF DISTRESS RELATED TO AGE OF PAVEMENT AND TRAFFIC REPETITIONS IS:	33 %

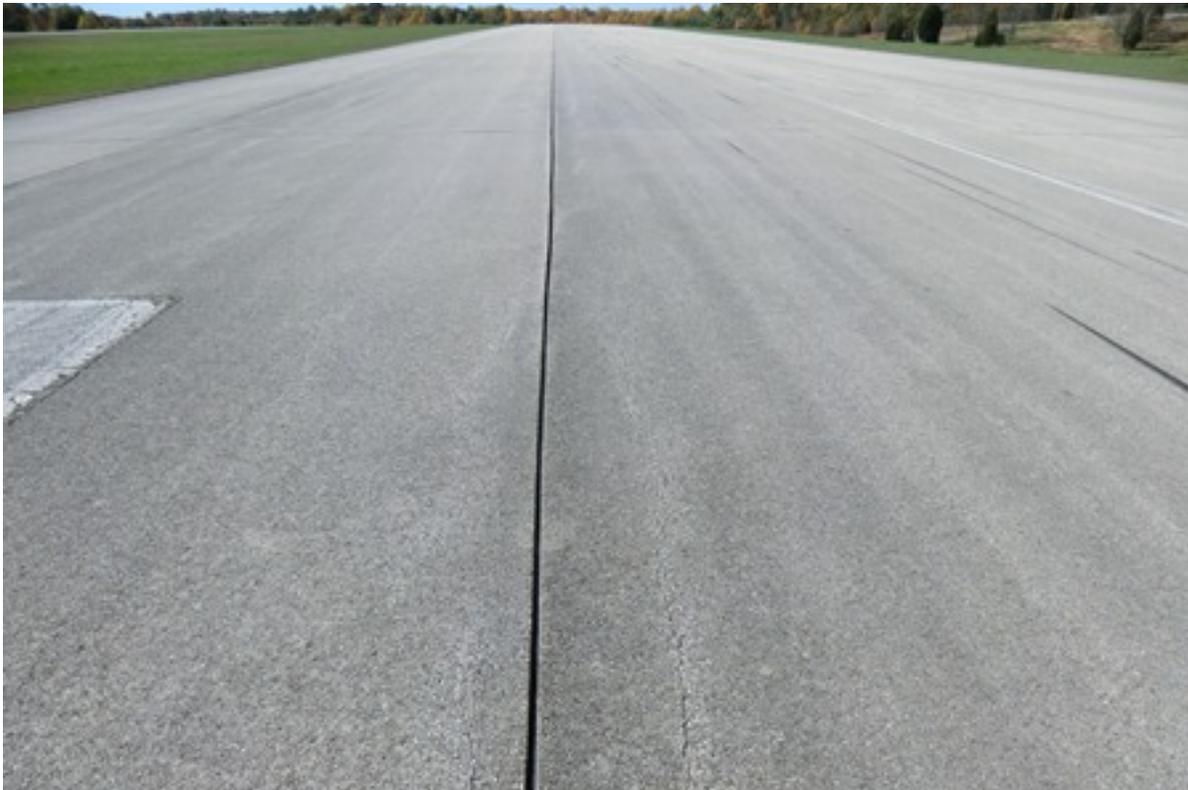
DISTRESS TYPE	SEVERITY	MEASURED QUANTITY	ESTIMATED TOTAL QUANTITY	UNITS	PERCENTAGE OF All DISTRESS
LONG.& TRANS. CRACK	MED	436	1,370	L.F.	49.3
LONG.& TRANS. CRACK	LOW	1,383	4,346	L.F.	50.6

APPROXIMATE AMOUNT OF DISTRESS RELATED TO LOAD ON THE PAVEMENT IS:	0 %
APPROXIMATE AMOUNT OF DISTRESS RELATED TO MATERIALS PROBLEMS IN THE FEATURE IS:	67 %
APPROXIMATE AMOUNT OF DISTRESS RELATED TO AGE OF PAVEMENT AND TRAFFIC REPETITIONS IS:	33 %

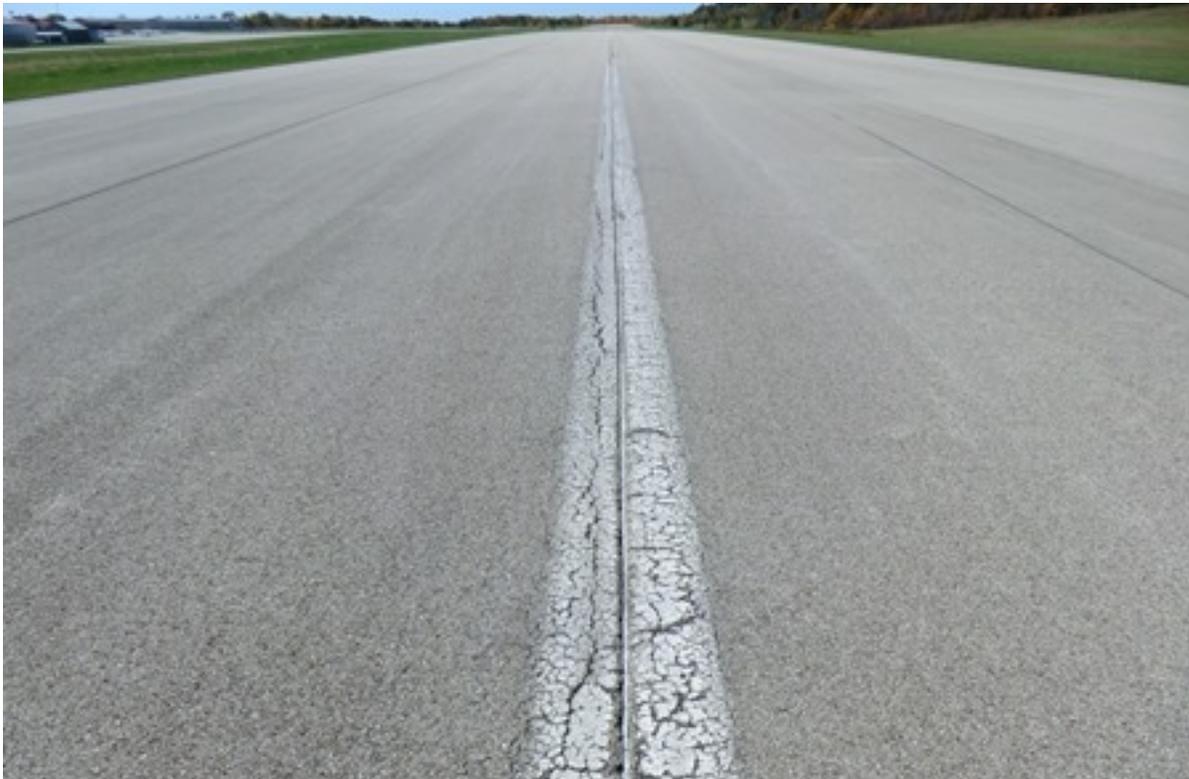
DISTRESS TYPE	SEVERITY	MEASURED QUANTITY	ESTIMATED TOTAL QUANTITY	UNITS	PERCENTAGE OF All DISTRESS
LONG.& TRANS. CRACK	MED	234	1,315	L.F.	39.4
LONG.& TRANS. CRACK	LOW	1,590	8,935	L.F.	60.5

APPROXIMATE AMOUNT OF DISTRESS RELATED TO LOAD ON THE PAVEMENT IS:	0 %
APPROXIMATE AMOUNT OF DISTRESS RELATED TO MATERIALS PROBLEMS IN THE FEATURE IS:	67 %
APPROXIMATE AMOUNT OF DISTRESS RELATED TO AGE OF PAVEMENT AND TRAFFIC REPETITIONS IS:	33 %

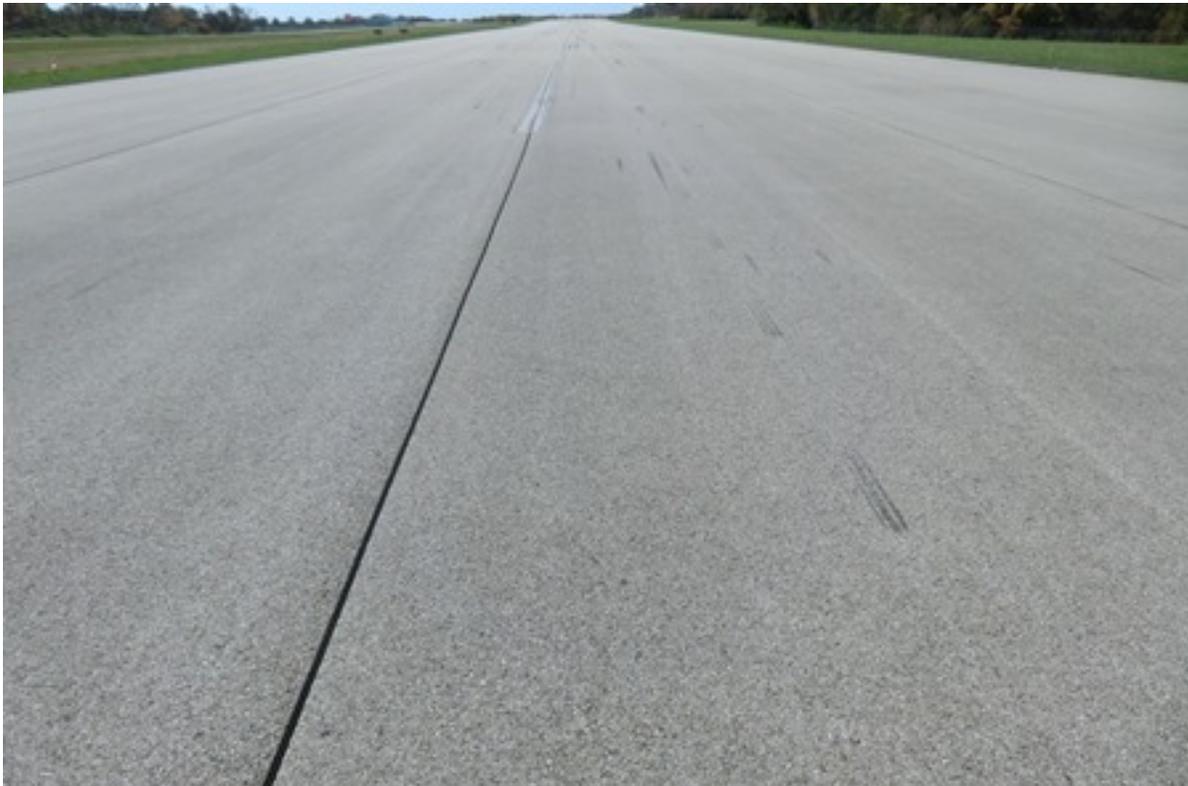
DISTRESS TYPE	SEVERITY	MEASURED QUANTITY	ESTIMATED TOTAL QUANTITY	UNITS	PERCENTAGE OF ALL DISTRESS
LONG.& TRANS. CRACK	MED	699	2,536	L.F.	71.9
LONG.& TRANS. CRACK	LOW	497	1,803	L.F.	28

APPROXIMATE AMOUNT OF DISTRESS RELATED TO LOAD ON THE PAVEMENT IS:	0 %
APPROXIMATE AMOUNT OF DISTRESS RELATED TO MATERIALS PROBLEMS IN THE FEATURE IS:	67 %
APPROXIMATE AMOUNT OF DISTRESS RELATED TO AGE OF PAVEMENT AND TRAFFIC REPETITIONS IS:	33 %
