# Pavement Condition Report

## Gary/Chicago International Airport

Project 13801869

**January 2013**

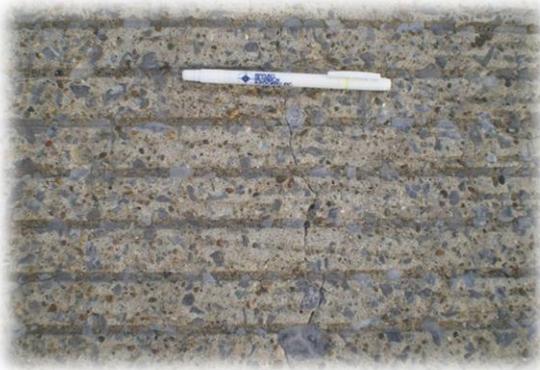
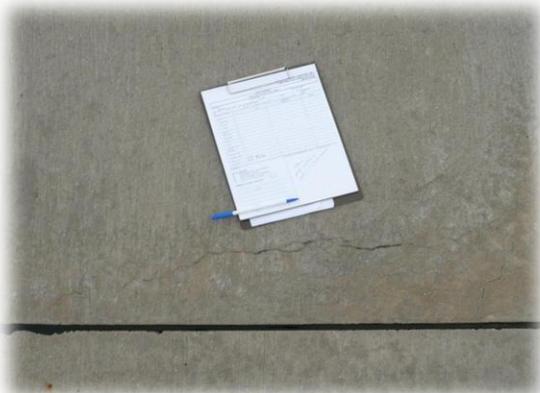
### Shrinkage Cracking

Shrinkage cracks are small, non-working cracks visible at the pavement surface but not penetrating the full depth of concrete. Shrinkage cracks most commonly occur shortly after construction due to concrete shrinkage during the curing process.

Shrinkage cracks are usually so small that they are not visible until staining or loss of material at crack edges begins to take place. Shrinkage cracks do not represent structural weakness, and no corrective action is prescribed.

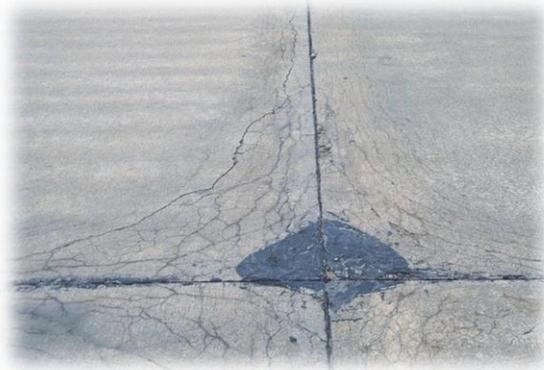
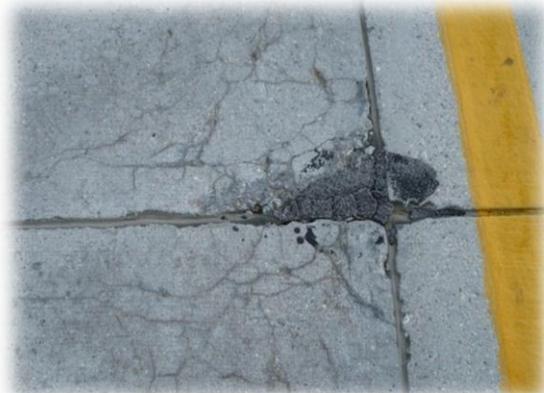
### Durability Cracking

Durability cracking (D-cracking) is caused by environmental factors, the most common being freeze/thaw. D-cracking usually appears as either a pattern of hairline cracks running parallel to a joint or crack, or in a corner, where water tends to collect. D-cracking eventually leads to disintegration of the pavement, creating foreign object damage (FOD) potential.

At low severity, D-cracking is evident, but no disintegration has occurred. Medium severity is evident over a significant area of the slab, and some disintegration and FOD potential exist. High-severity D-cracking is evidenced by extensive cracking with loose and missing pieces and significant FOD potential.

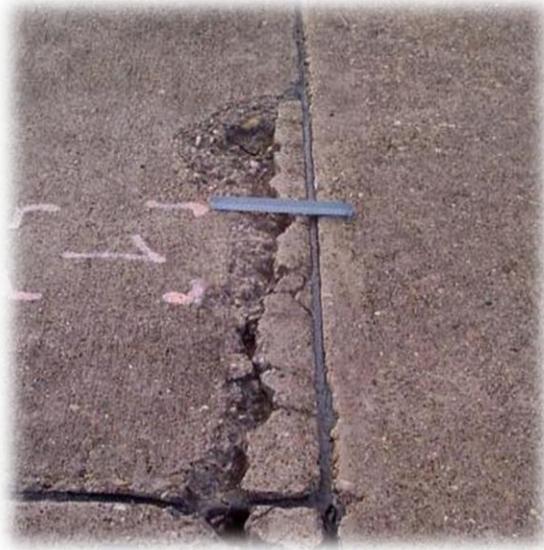
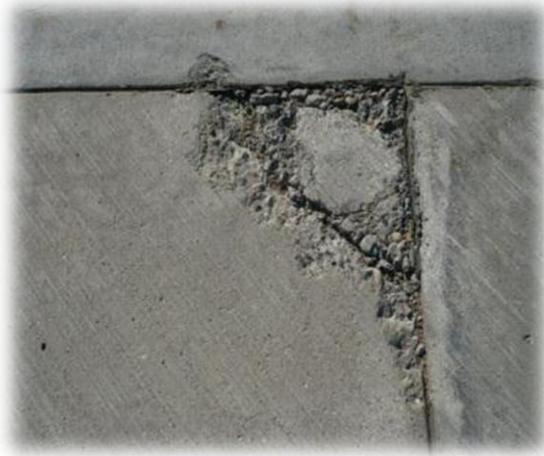
### *Joint Spall and Corner Spall*

Spalls at slab joints and corners are caused by excessive internal stress in the pavement. Spalls occur when these stresses exceed the shear strength of the concrete.

Spalling usually results from thermal expansion during hot weather when slabs push and expand against one another. If the joints are filled with incompressible material, such as sand, stresses can become severe, causing spalls. Spalling can be reduced significantly by maintenance of joint sealant.

Spall repair requires patching. The extent and severity of spalling suggests the appropriate action. At low severity, spalled concrete remains securely in place in the slab. A low-severity spall should be monitored closely for further deterioration and should be patched when spalled particles become loose, or during the next scheduled patching activity. Medium- and high-severity spalls should be repaired immediately to prevent FOD. If the pavement can be restored to serviceable condition, spalls should be patched for long-term service. If the pavement is beyond repair, temporary patching should be considered to control FOD.

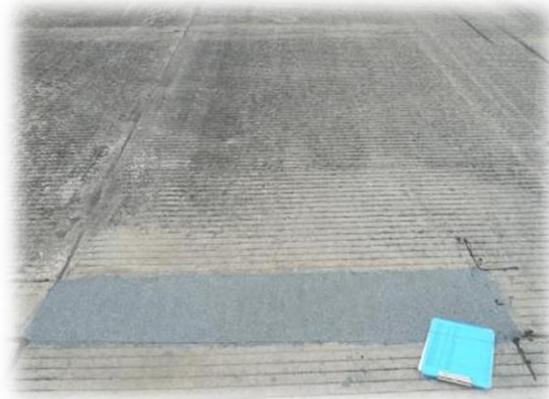
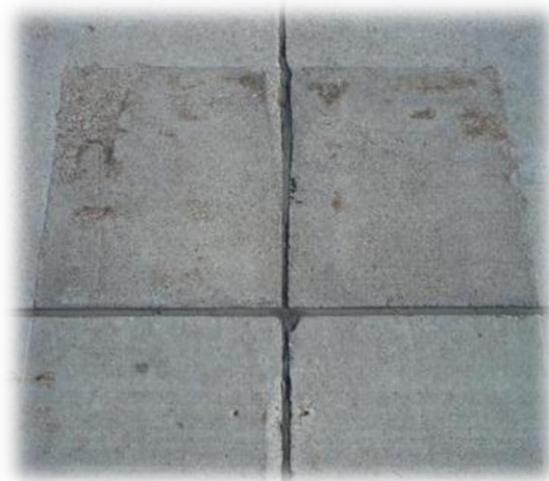
### *Patches, Large and Small*

Large and small patches, by PCI inspection criteria, are distress conditions. Patches indicate deterioration and aging of pavement that contributes to shortened service life. However, patching also indicates that pavement is being maintained.

A patch that is performing well and shows no outward distress is recorded at low severity, and no corrective action is required. Medium-severity patches are serviceable but are beginning to deteriorate. Maintenance or replacement is indicated. At high severity, replacement is indicated.

By definition, small patches are smaller than 5 square feet in surface area, and they usually result from spall repair at slab joints and corners.

Large patches also may be the result of spall repair, but they often indicate more serious deficiencies, such as corner breaks or other full-depth failure smaller than panel size.

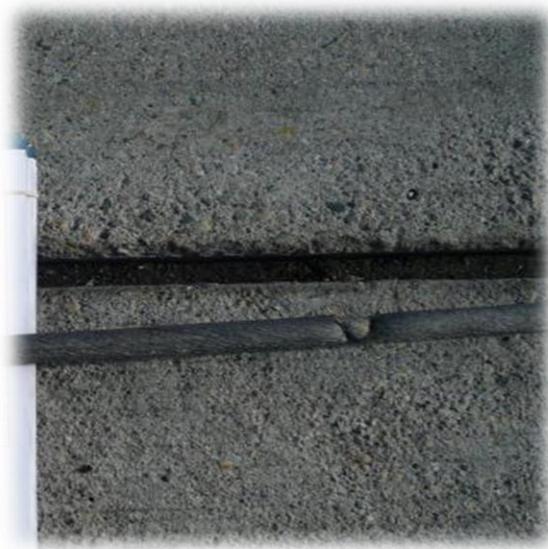
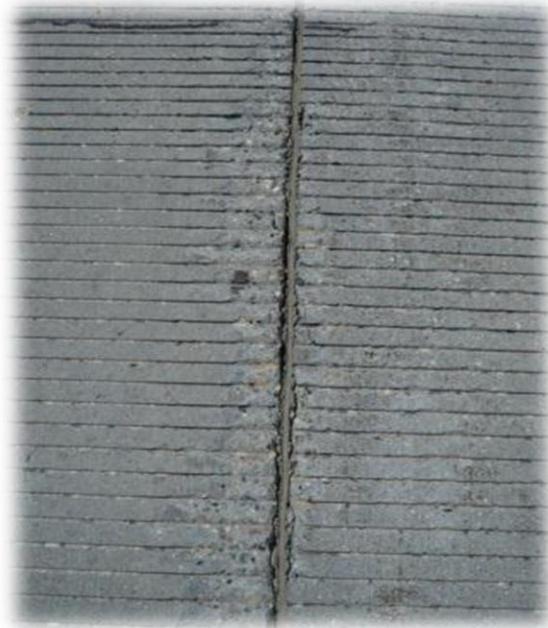
## Joint Seal Damage

When joint sealant is in perfect condition (no damage), there is no distress.

At low severity, at least 10 percent of the sealant is debonded but still in contact with the joint edges. Medium-severity joint seal damage is recorded when at least 10 percent of the sealant has visible gaps smaller than 1/8 inch and is an indicator that replacement should be programmed as soon as is practical. In the meantime, aggressive inspection and sustaining maintenance is recommended to minimize subsurface damage from moisture penetration. At high severity, visible gaps exceed 1/8 inch, and the amount and degree of joint seal damage typically requires complete removal and replacement of the existing sealant.

On serviceable pavement, deteriorated joint sealant should be repaired or replaced to preserve pavement and subgrade integrity and prolong service life. The issue is not so clear-cut with unserviceable pavement. Pavement that can be restored to serviceable condition by maintenance activities such as patching and joint seal repair, or by slab replacement, should be so maintained as long as the process is cost-effective. However, when age and condition preclude economical return to serviceable condition by such means, joint seal repair would no longer be cost-effective and should be suspended except for an interim maintenance program to control FOD potential.

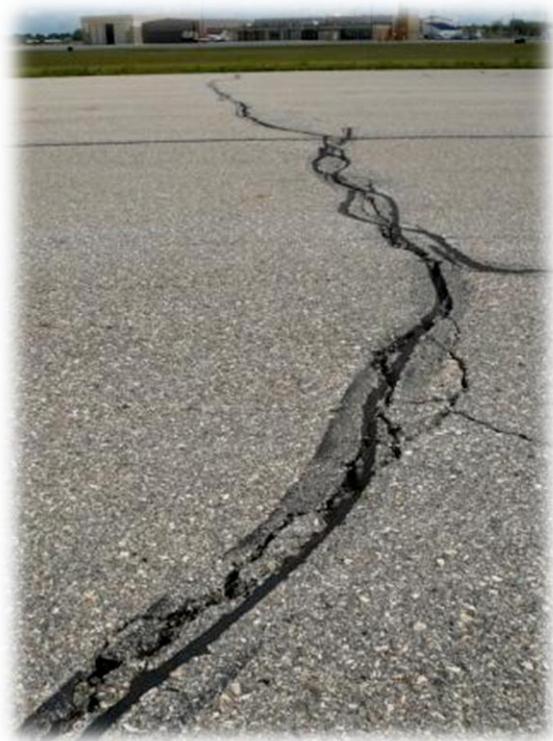
### *Longitudinal & Trans. Cracking*

L&T cracks are caused by age, construction, and subsurface conditions. Age-related cracking occurs as oxidizing pavement loses components to the atmosphere and becomes more brittle. Consistent application of seal coats can help to prevent age-related cracks.

Construction-related cracking often develops along paving joints. Ensuring that joints are made when both sides are still hot, and near the same temperature, is one of the best ways to mitigate this potential problem.

Seasonal movement caused by changes in subsurface moisture or temperature differences also can cause pavement cracking. Asphalt pavement placed over a PCC pavement or cement stabilized base course may evidence reflective cracking from the underlying material. Wheel loads do not cause L&T cracks, although traffic may worsen their condition.

Low-severity L&T cracks are less than ¼ inch wide, or if sealed with suitable filler material in satisfactory condition can be any width less than 3 inches, if they are not spalled. Maintenance usually is not indicated for low-severity cracking. Moderately spalled cracks and cracks wider than ¼ inch which are not satisfactorily sealed are at medium severity. Medium-severity cracks should be sealed with a high-quality crack filling material. Severely spalled cracks and cracks wider than 3 inches are at high severity. High-severity L&T cracks normally require patching.

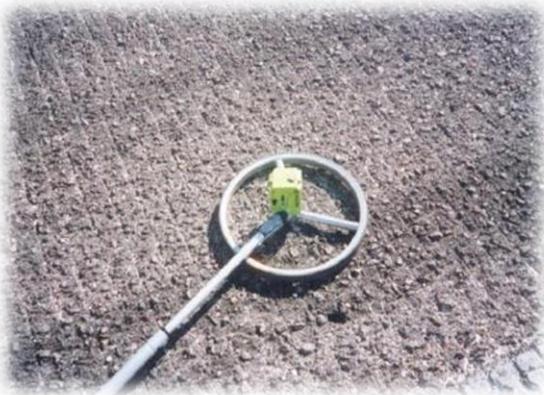
Raveling and weathering are the wearing away of the pavement surface. Failure can be caused by the dislodging of aggregate particles or the loss of asphalt binder. These distresses are usually evident over large areas and may indicate that the asphalt binder has hardened significantly.

Raveling: At low severity, 5 to 20 coarse aggregate particles are missing per square yard. Medium severity is defined by 20 to 40 missing coarse aggregate particles per square yard. At high severity, more than 40 coarse aggregate particles are missing per square yard, and the top layer of aggregate has eroded away.

Weathering: At low severity, edges of coarse aggregate are exposed less than 1 mm. At medium severity, loss of fine aggregate is noticeable and edges of coarse aggregate are exposed up to 6 mm (1/4 inch). High severity weathering has edges of coarse aggregate exposed > 6 mm, with considerable loss of fine aggregate matrix and potential for loss of coarse aggregate.

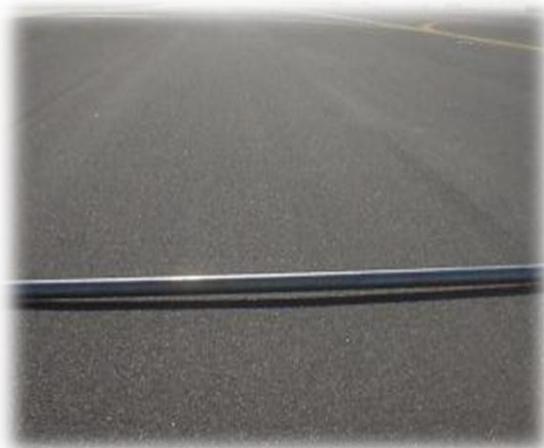
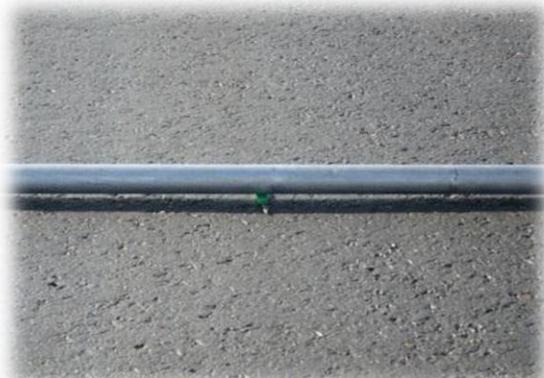
### Rutting

Ruts are localized areas of pavement having elevations lower than the surrounding sections.

Rutting is due to base and subgrade consolidation caused by excessive wheel loads or poor compaction. Ruts indicate structural failure and can cause hydroplaning.

At low severity, ruts have an average depth of ¼ to ½ inches. At medium severity, ruts have an average depth of ½ to 1 inch. At high severity, ruts have an average depth greater than 1 inch. Patching is the appropriate repair for ruts.

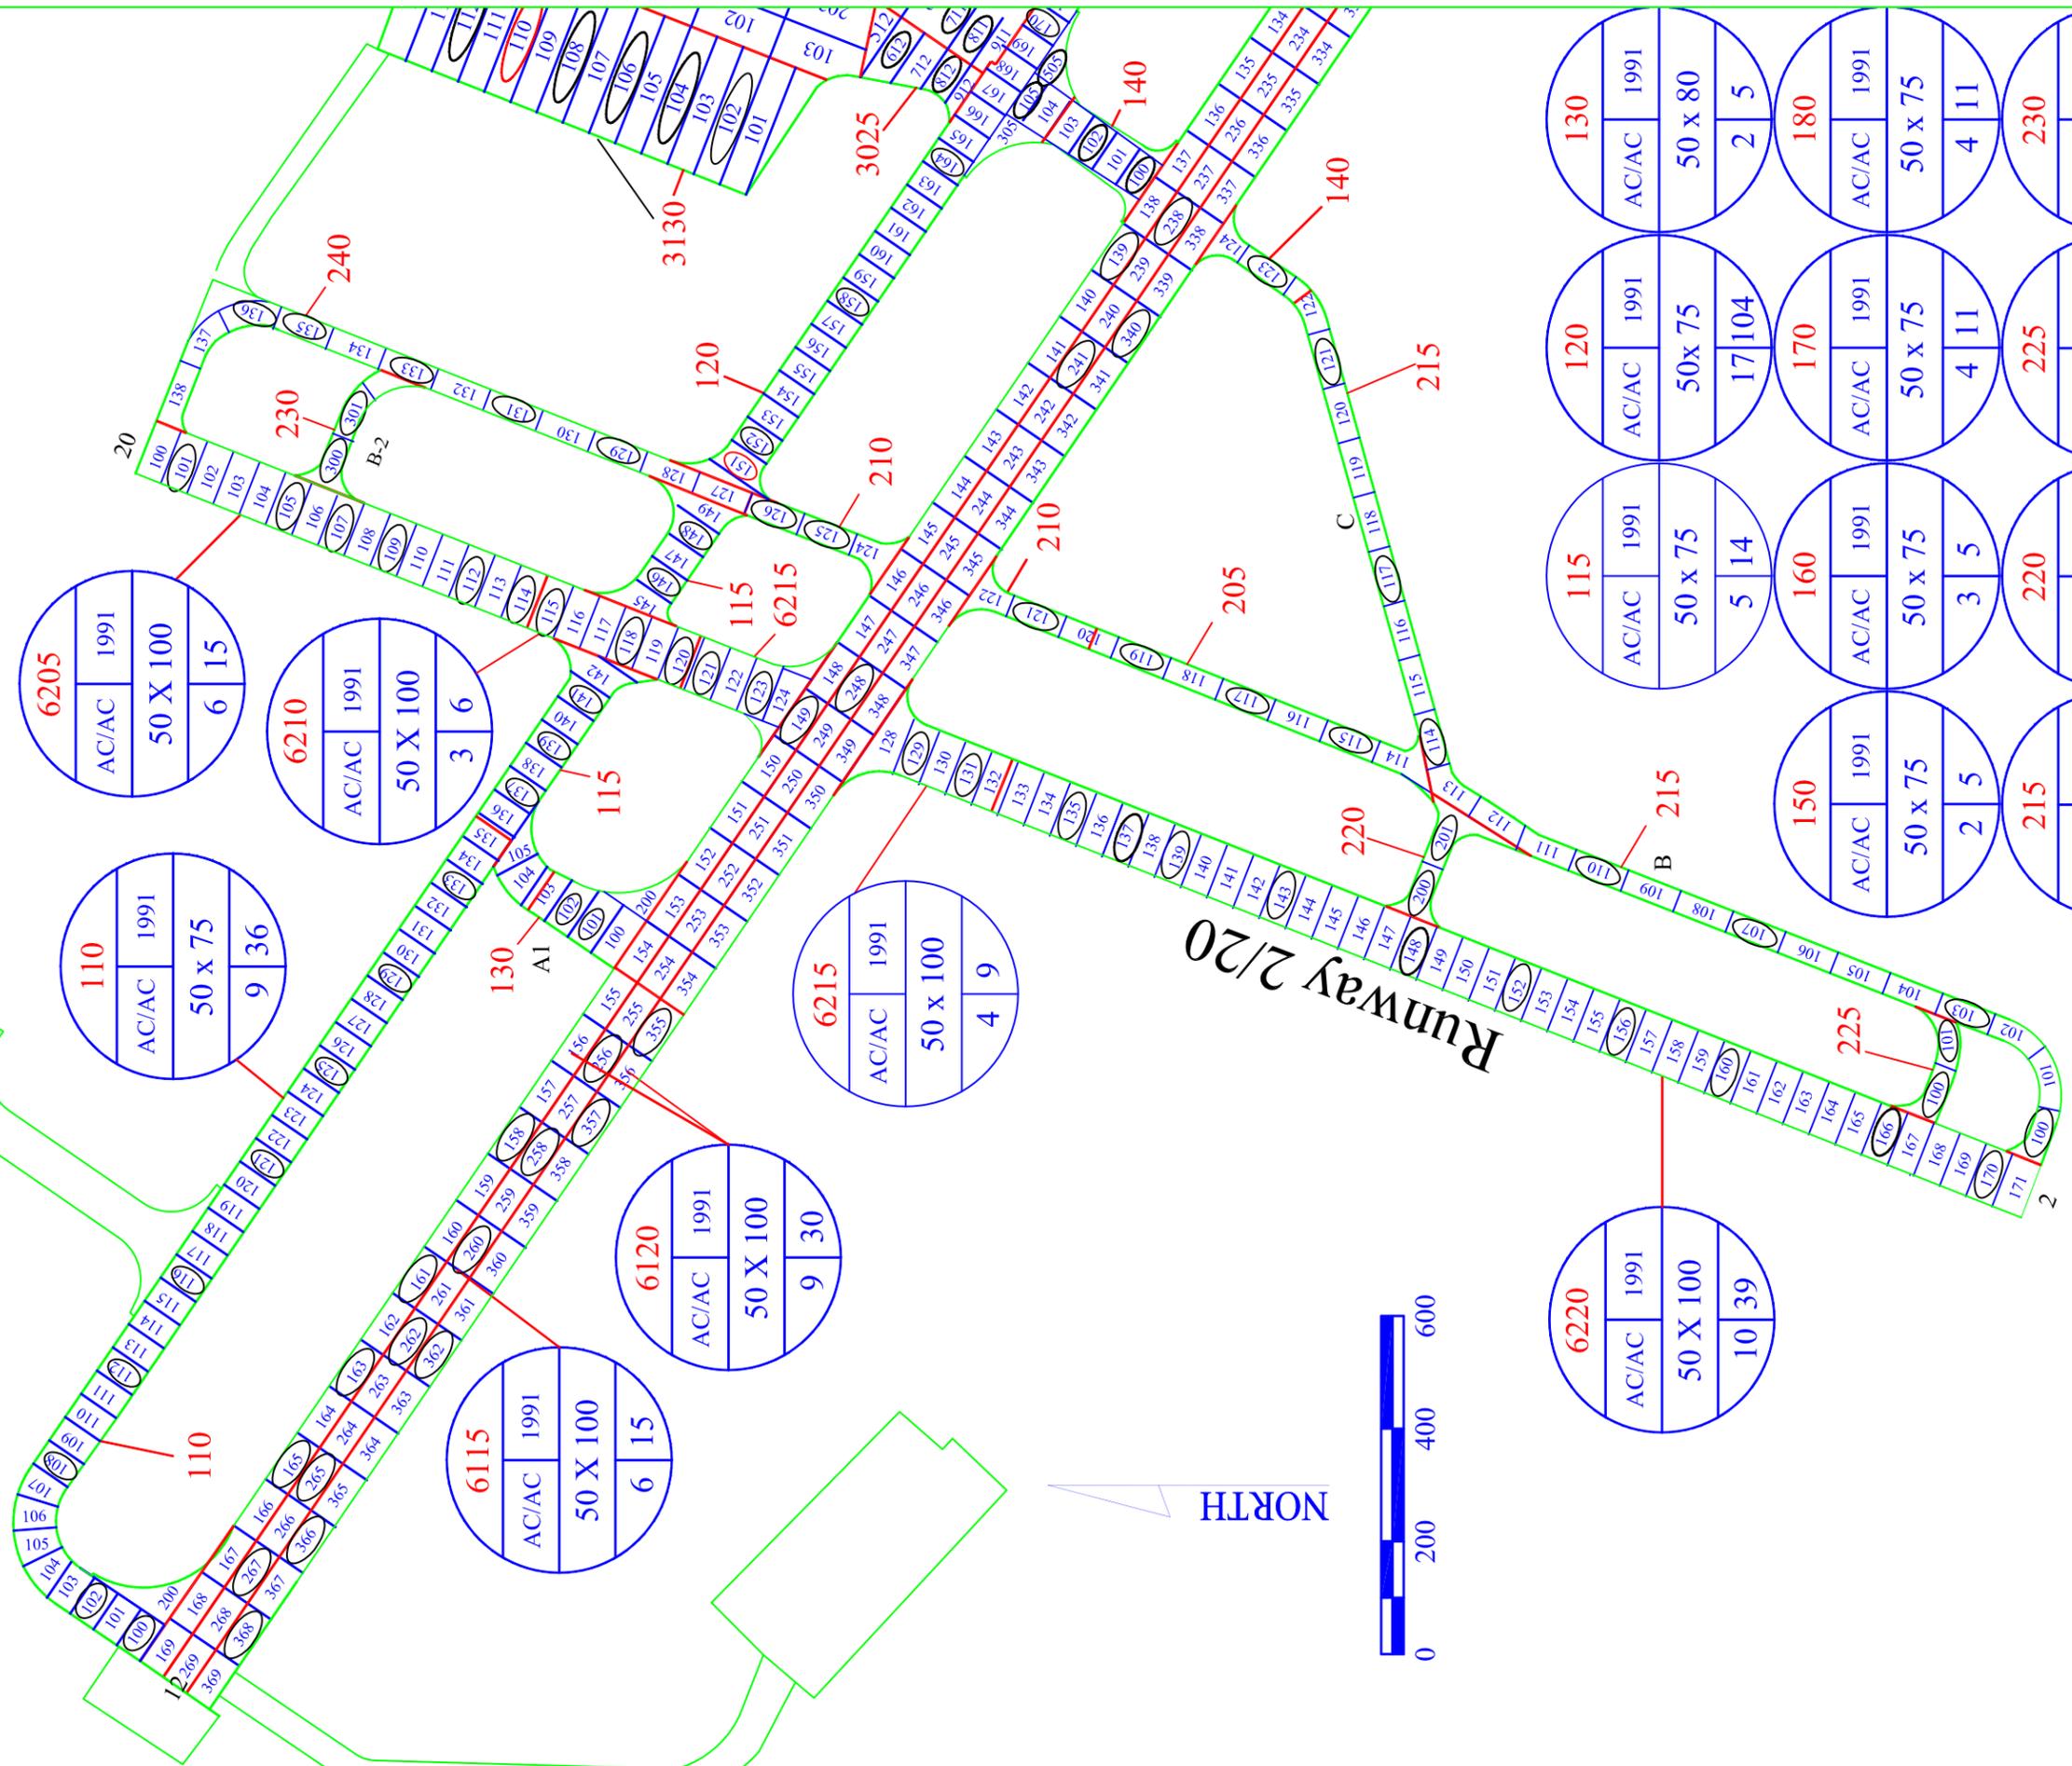
Rev.	2012 REVISIONS	AN
	Description	By
<b>PCI Inspection Map</b>		
Indiana Dept. of Transportation		
Gary/Chicago Regional Airport - GYY		
Gary, Indiana		
121.9		
		Page: 1/3

# Gary International Airport 2012 PCI Inspection
