Pavement Condition Report

Indianapolis Metropolitan Airport

Project 13801869

January 2013

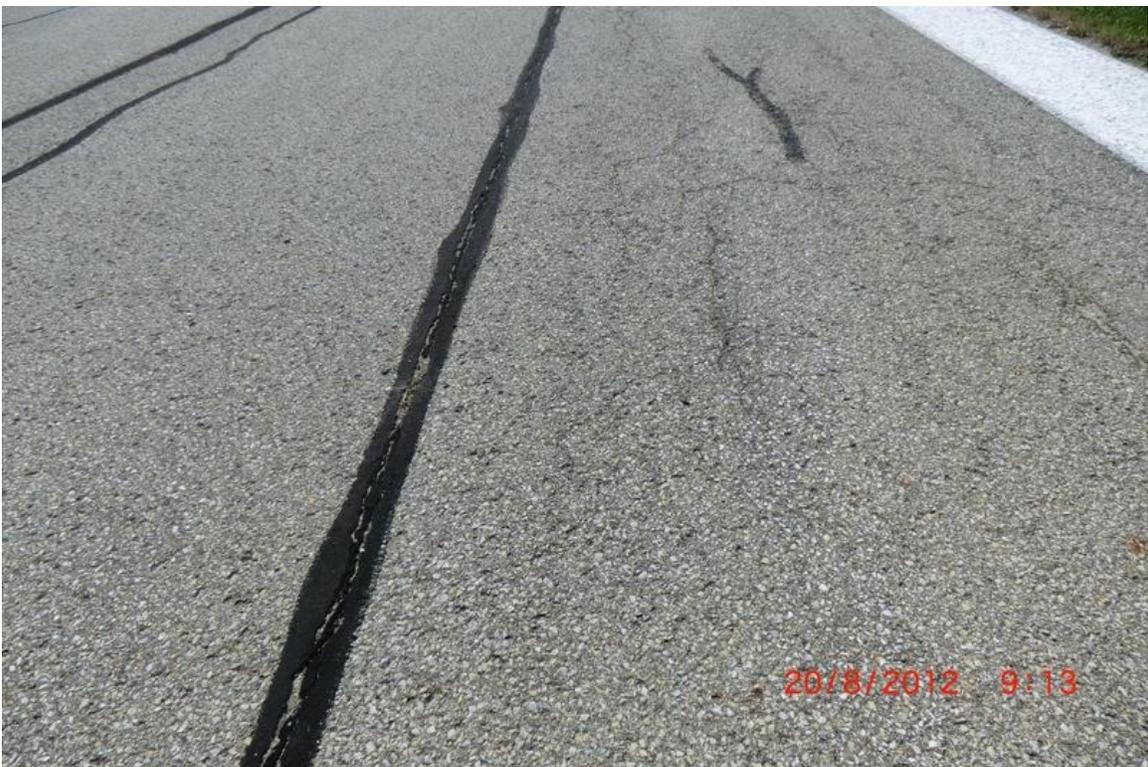
Figure 2-7. Typical Very Poor AAC Pavement (Feature 5005)

Pavement sections 120, 210, 211, 311, 515 and 5005 had simplified PCI ratings of Very Poor, indicating that near-term maintenance needs will be extensive in nature in order to maintain serviceability. The pavement within each of the PCI condition categories is shown in Figure 2-1. The inspected PCI is summarized by branch use in Figure 2-2, and the photographs that follow provide examples of the condition categories.

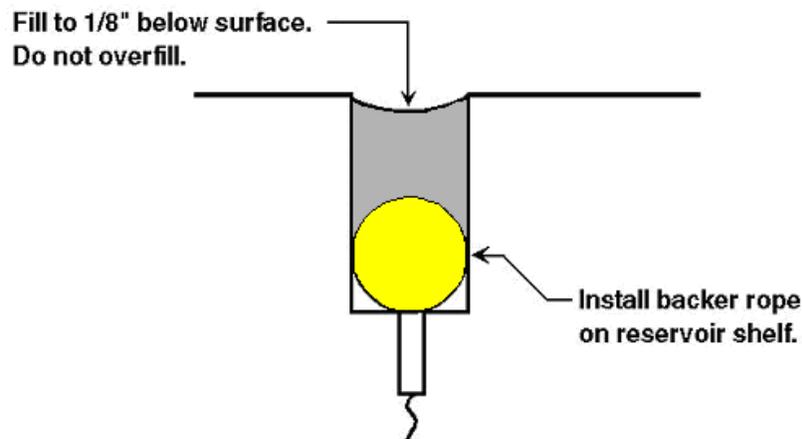
Typical failed joint sealant, w/ debris and incompressibles.

Clean joints exposing fresh, clean concrete and stone. Retain existing reservoir shape.

- Rout a reservoir for the sealant $\frac{1}{2}$ inch wide and 1 inch deep.
- Cracks wider than $\frac{1}{2}$ inch should have reservoirs $\frac{1}{4}$ inch wider than the crack. Reservoir height above backer rope should be less than reservoir width, or as recommended by manufacturer.
- Routed cracks should be cleaned to expose fresh, vital pavement on the vertical crack edge.
- Cracks should be cleaned to remove all sand, debris, and other materials from the crack.
- Backing material should be placed into the crack.
- Apply sealant to within $\frac{1}{4}$ inch of pavement surface, following manufacturer's instructions.
- Clean the surrounding pavement area.

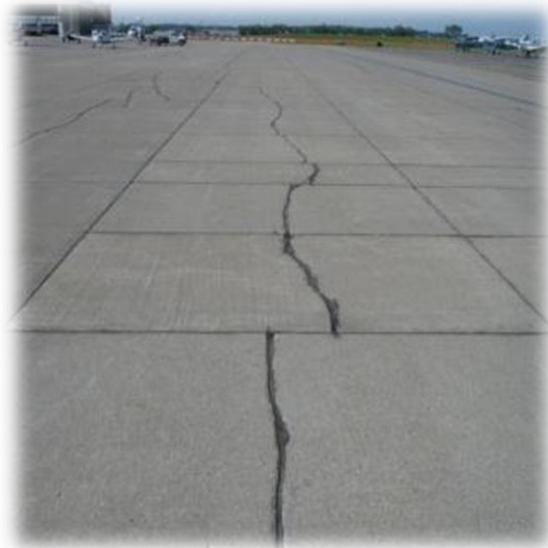
At low severity, a crack is less than 1/8 inch wide with little spalling, and no corrective action is indicated. At medium severity, LTD cracks can be up to 1 inch wide with moderate spalling and should be repaired using procedures similar to joint sealing. At high severity, cracks exceed 1 inch in width and may be severely spalled. High-severity LTD cracking is evidence of serious load failure, and correction may require patching or slab replacement. If distress occurs in several adjacent slabs at medium or high severity, major rehabilitation of that area is indicated.

A slab divided into four or more pieces is said to be “divided” or “shattered.” Shattered slab is a separate distress category and indicates a significant structural failure. A shattered slab has lost its ability to distribute loads. Shattered slabs are rated in three severities, but the recommended action in any case is slab replacement.
