# Pavement Condition Report

## North Vernon Airport

Project 13801869

**January 2013**

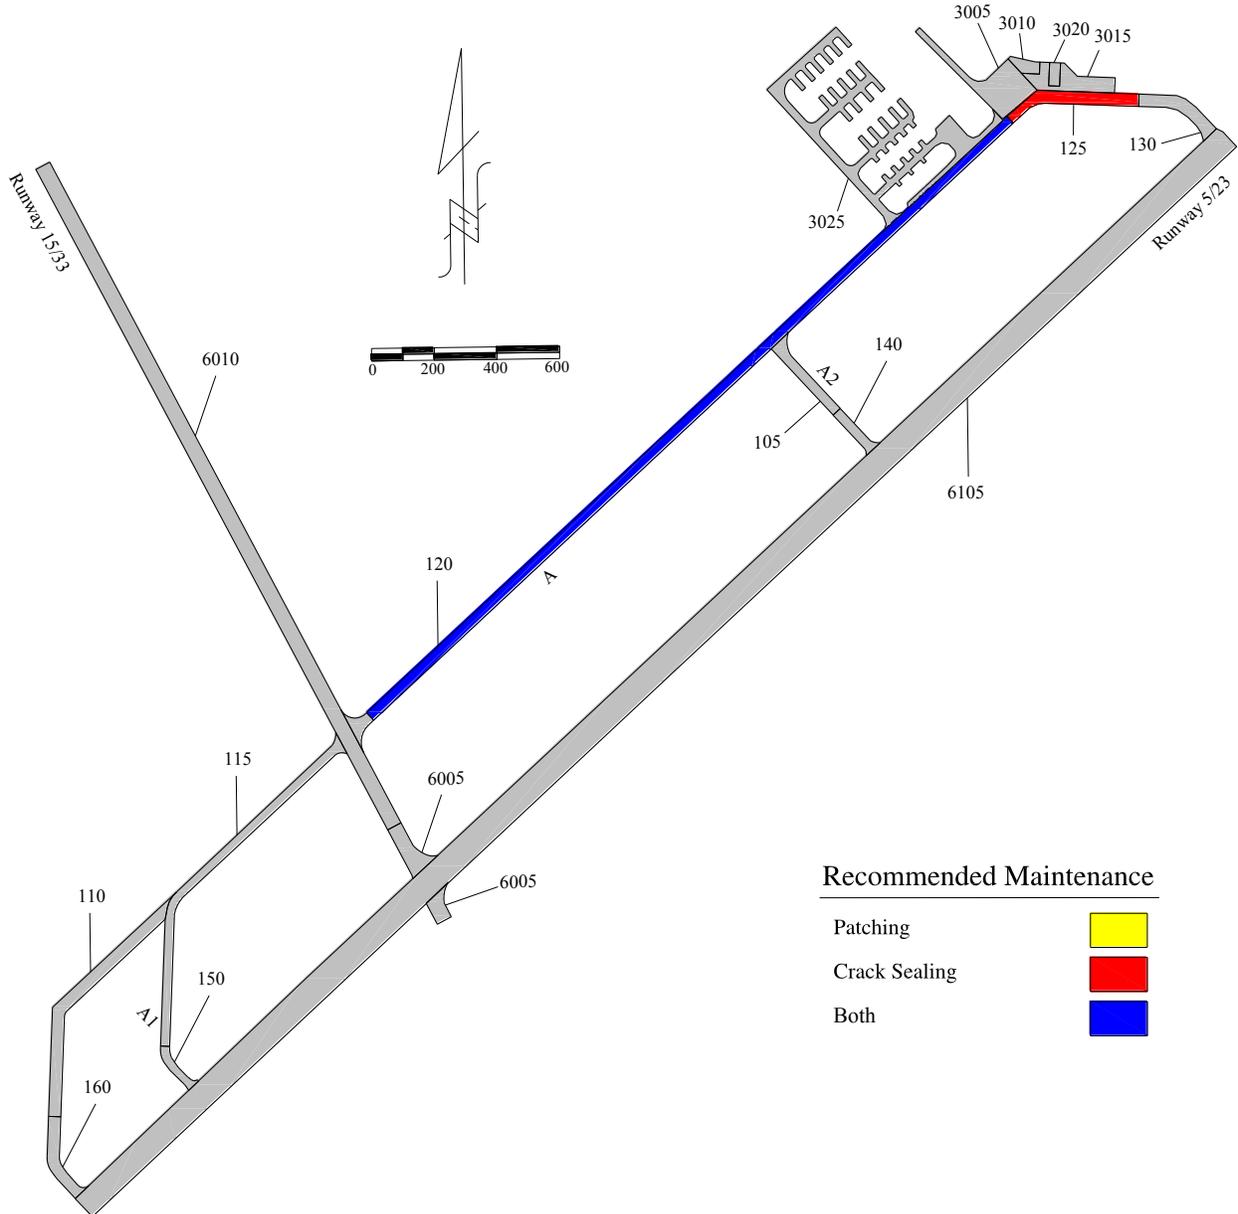
## 2012 PCI Inspection

Analysis of potential maintenance projects identified approximately 100 square feet of patching needs and approximately 120 linear feet of crack sealing and crack repair needs, at an estimated total cost of less than \$1,000.

Work Item	Quantity	Unit	Cost
AC PATCH	90	SF	\$765
AC RESTORATIVE CRACK REPAIR	71	LF	\$86
AC SUSTAINING CRACK REPAIR	50	LF	\$43
<b>Total:</b>			<b>\$894</b>

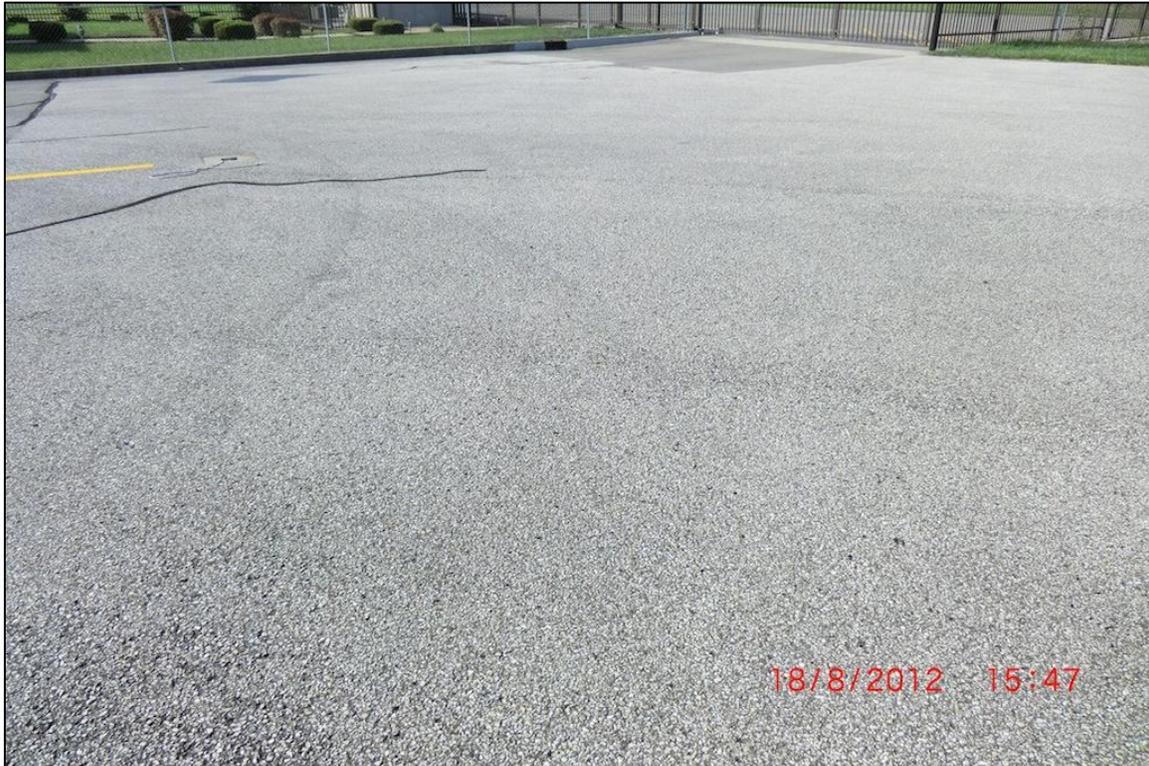
Figure 2-5. Typical Satisfactory AAC Pavement (Feature 3010)

Recent airport maintenance and reconstruction efforts have changed the area of section 3015 and restored some of the prior medium-severity cracks to low-severity.
